# R-1 PROFILES

WALTON  
PROGRAM SUPPORT GIS  
DIVISION OF WATER RESOURCE MANAGEMENT  
FLORIDA DEPARTMENT OF ENVIRONMENTAL PROTECTION

RANGE: R-1  
EST DATE: NOV1980  
SURVEY DATE: 04APR19  
AZIMUTH: 190.0

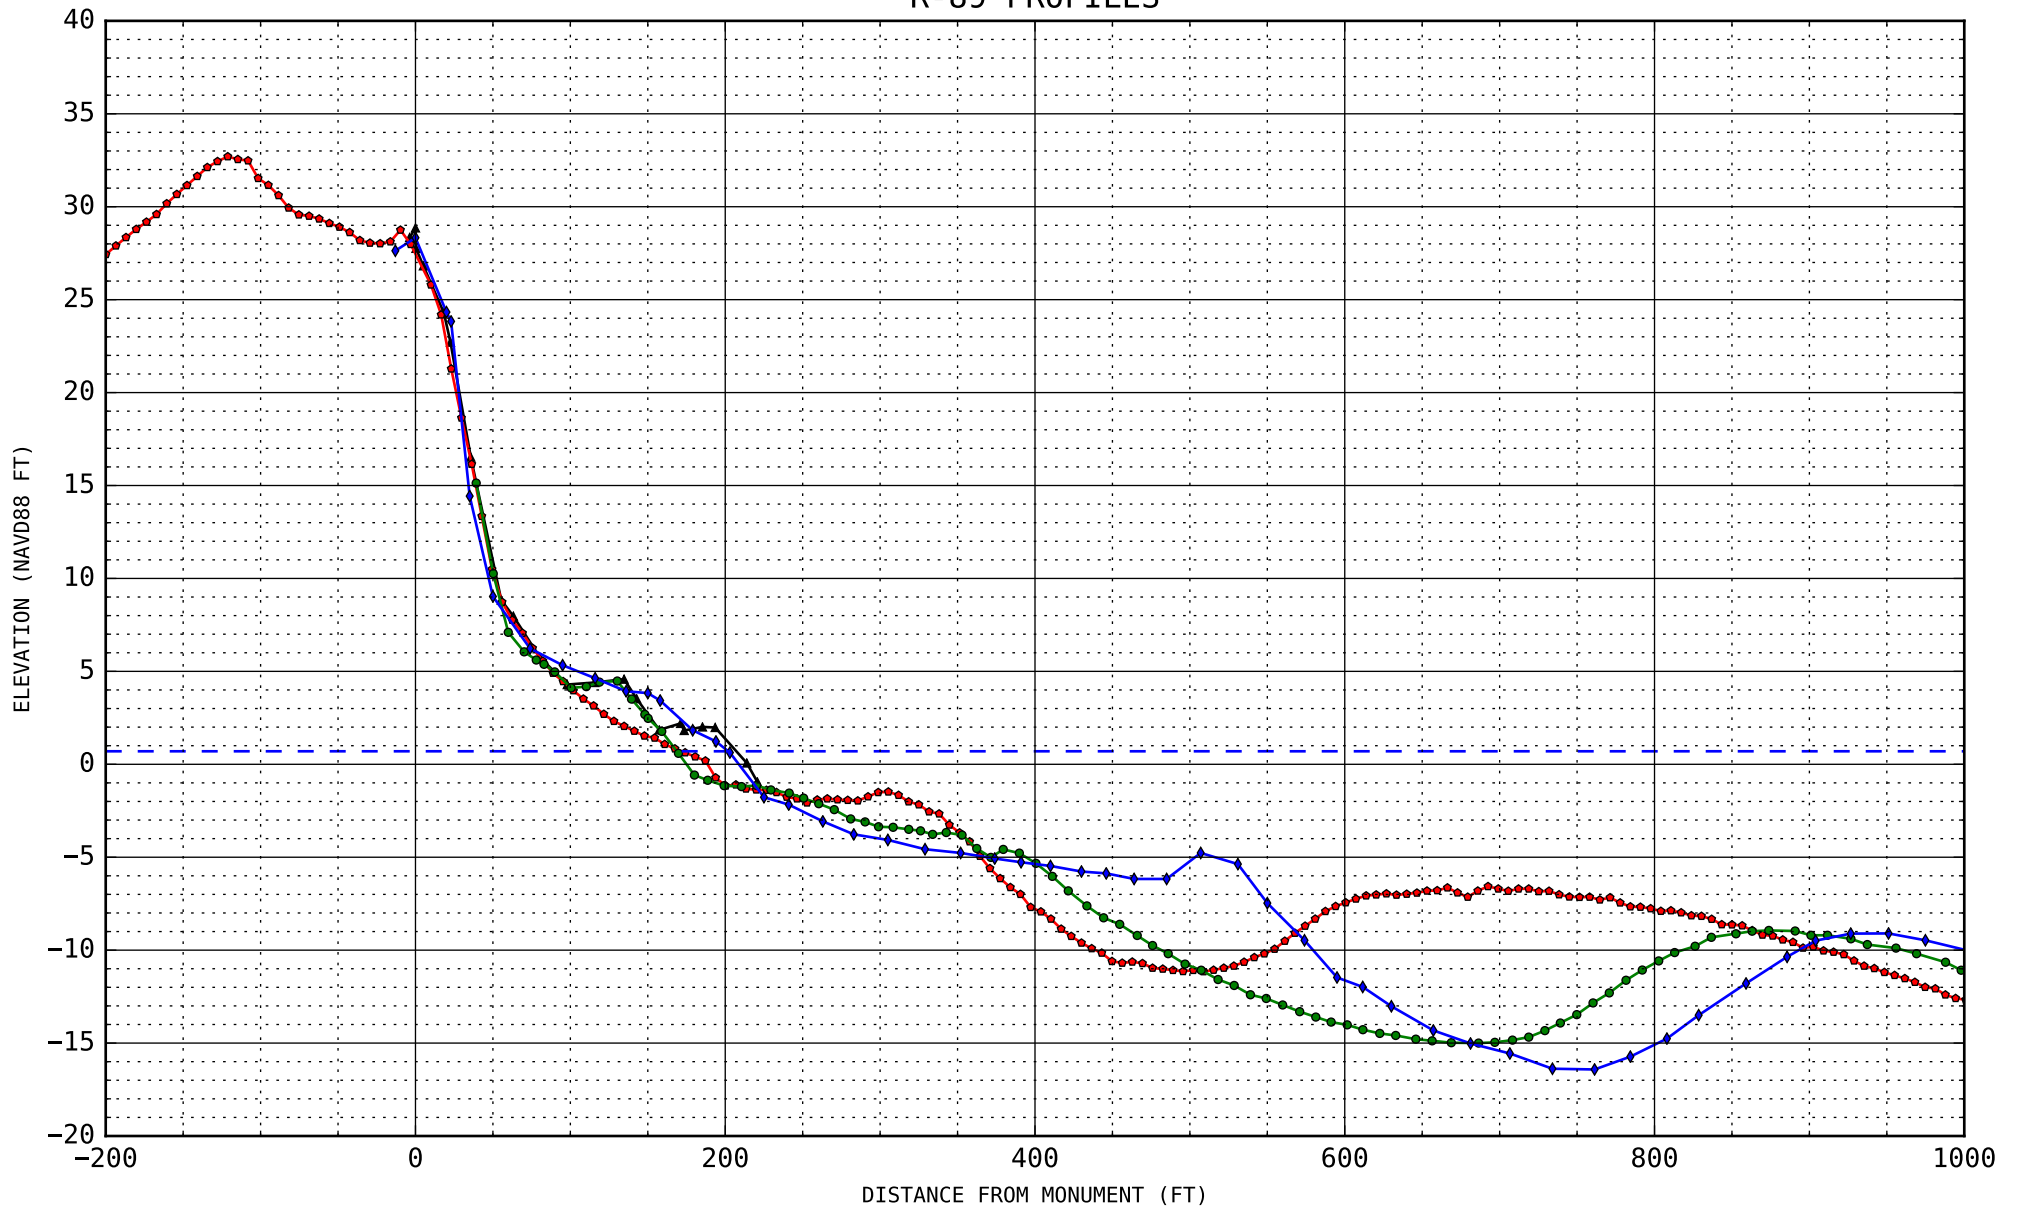
# R-89 PROFILES

- ▲ 2019-APR CONDITION BY DEP
- 2018-OCT MONITORING BY USACE-LIDAR
- 2013-SEP MONITORING BY USACE
- ◆ 2007-FEB MONITORING BY MAE
- - - MHW CONTOUR (0.7 FT)

RANGE: R-89  
EST DATE: OCT1995  
SURVEY DATE: 18APR19  
AZIMUTH: 202.0

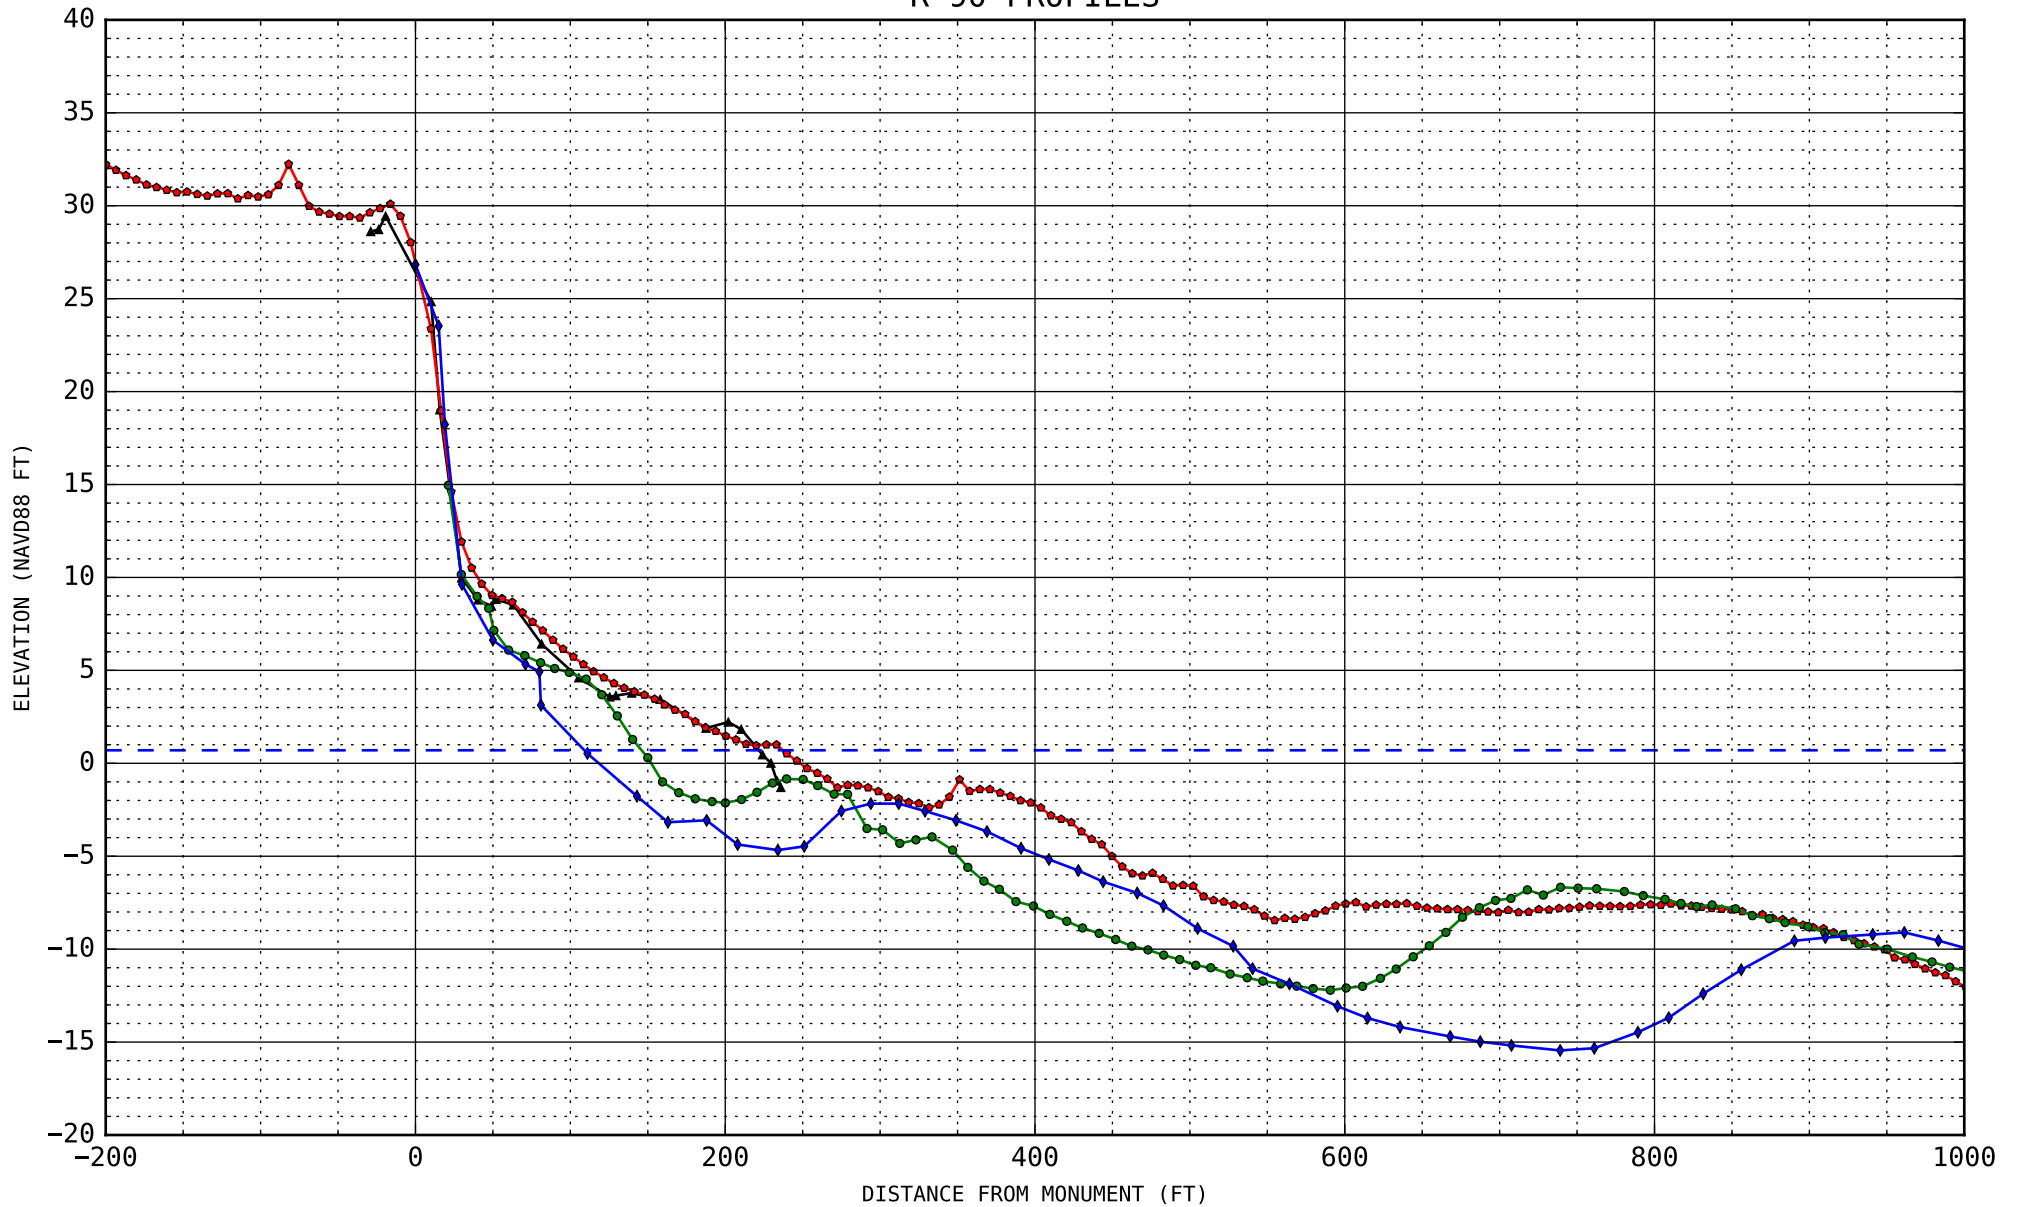
# R-90 PROFILES

- ▲ 2019-APR CONDITION BY DEP
- 2018-OCT MONITORING BY USACE-LIDAR
- 2013-SEP MONITORING BY USACE
- ◆ 2007-FEB MONITORING BY MAE
- - - MHW CONTOUR (0.7 FT)

RANGE: R-90  
EST DATE: OCT1995  
SURVEY DATE: 18APR19  
AZIMUTH: 202.0

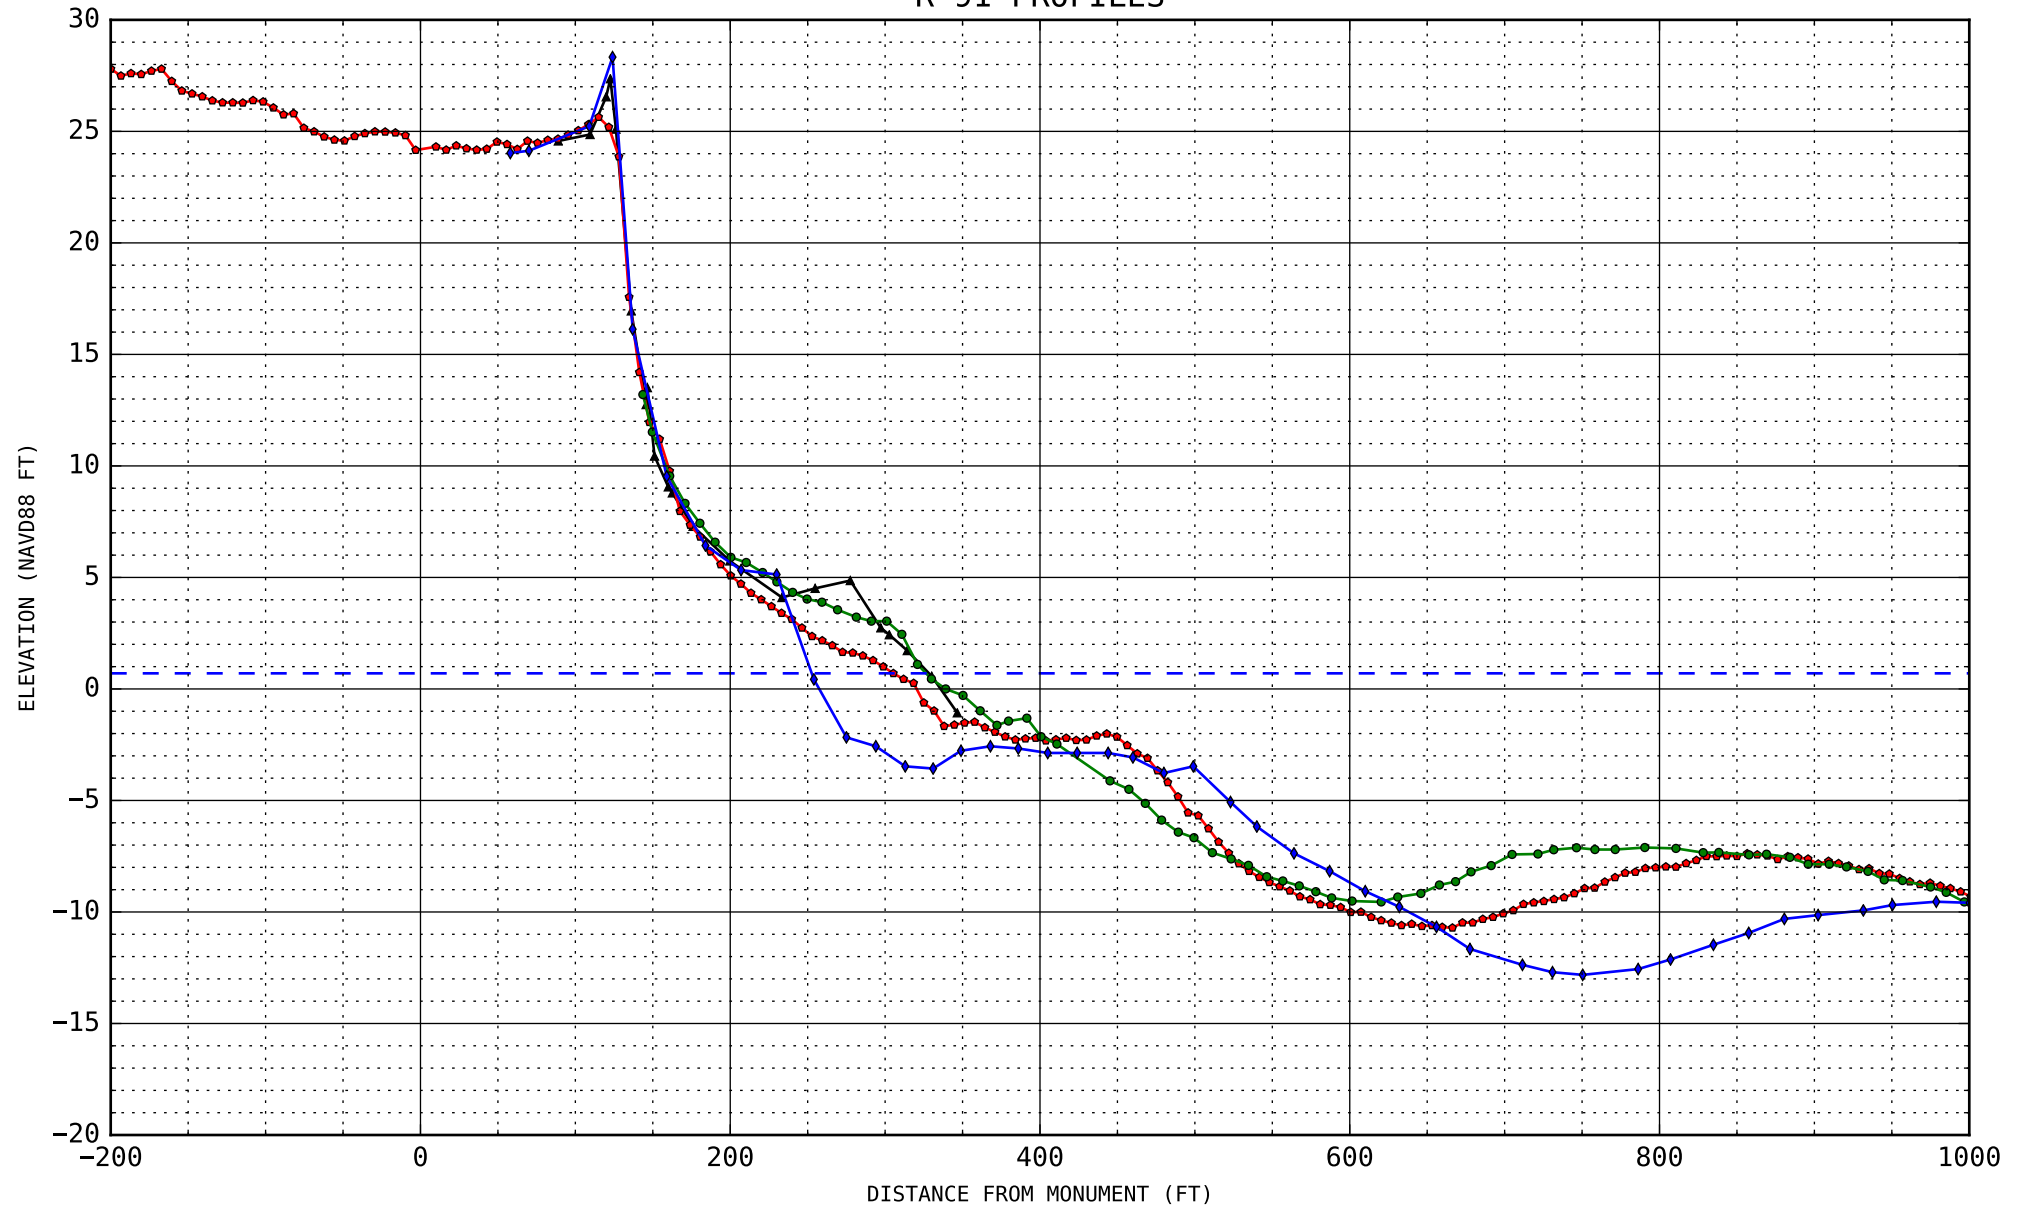
# R-91 PROFILES

- ▲ 2019-APR CONDITION BY DEP
- 2018-OCT MONITORING BY USACE-LIDAR
- 2013-SEP MONITORING BY USACE
- ◆ 2007-FEB MONITORING BY MAE
- - - MHW CONTOUR (0.7 FT)

RANGE: R-91  
EST DATE: OCT1995  
SURVEY DATE: 18APR19  
AZIMUTH: 202.0

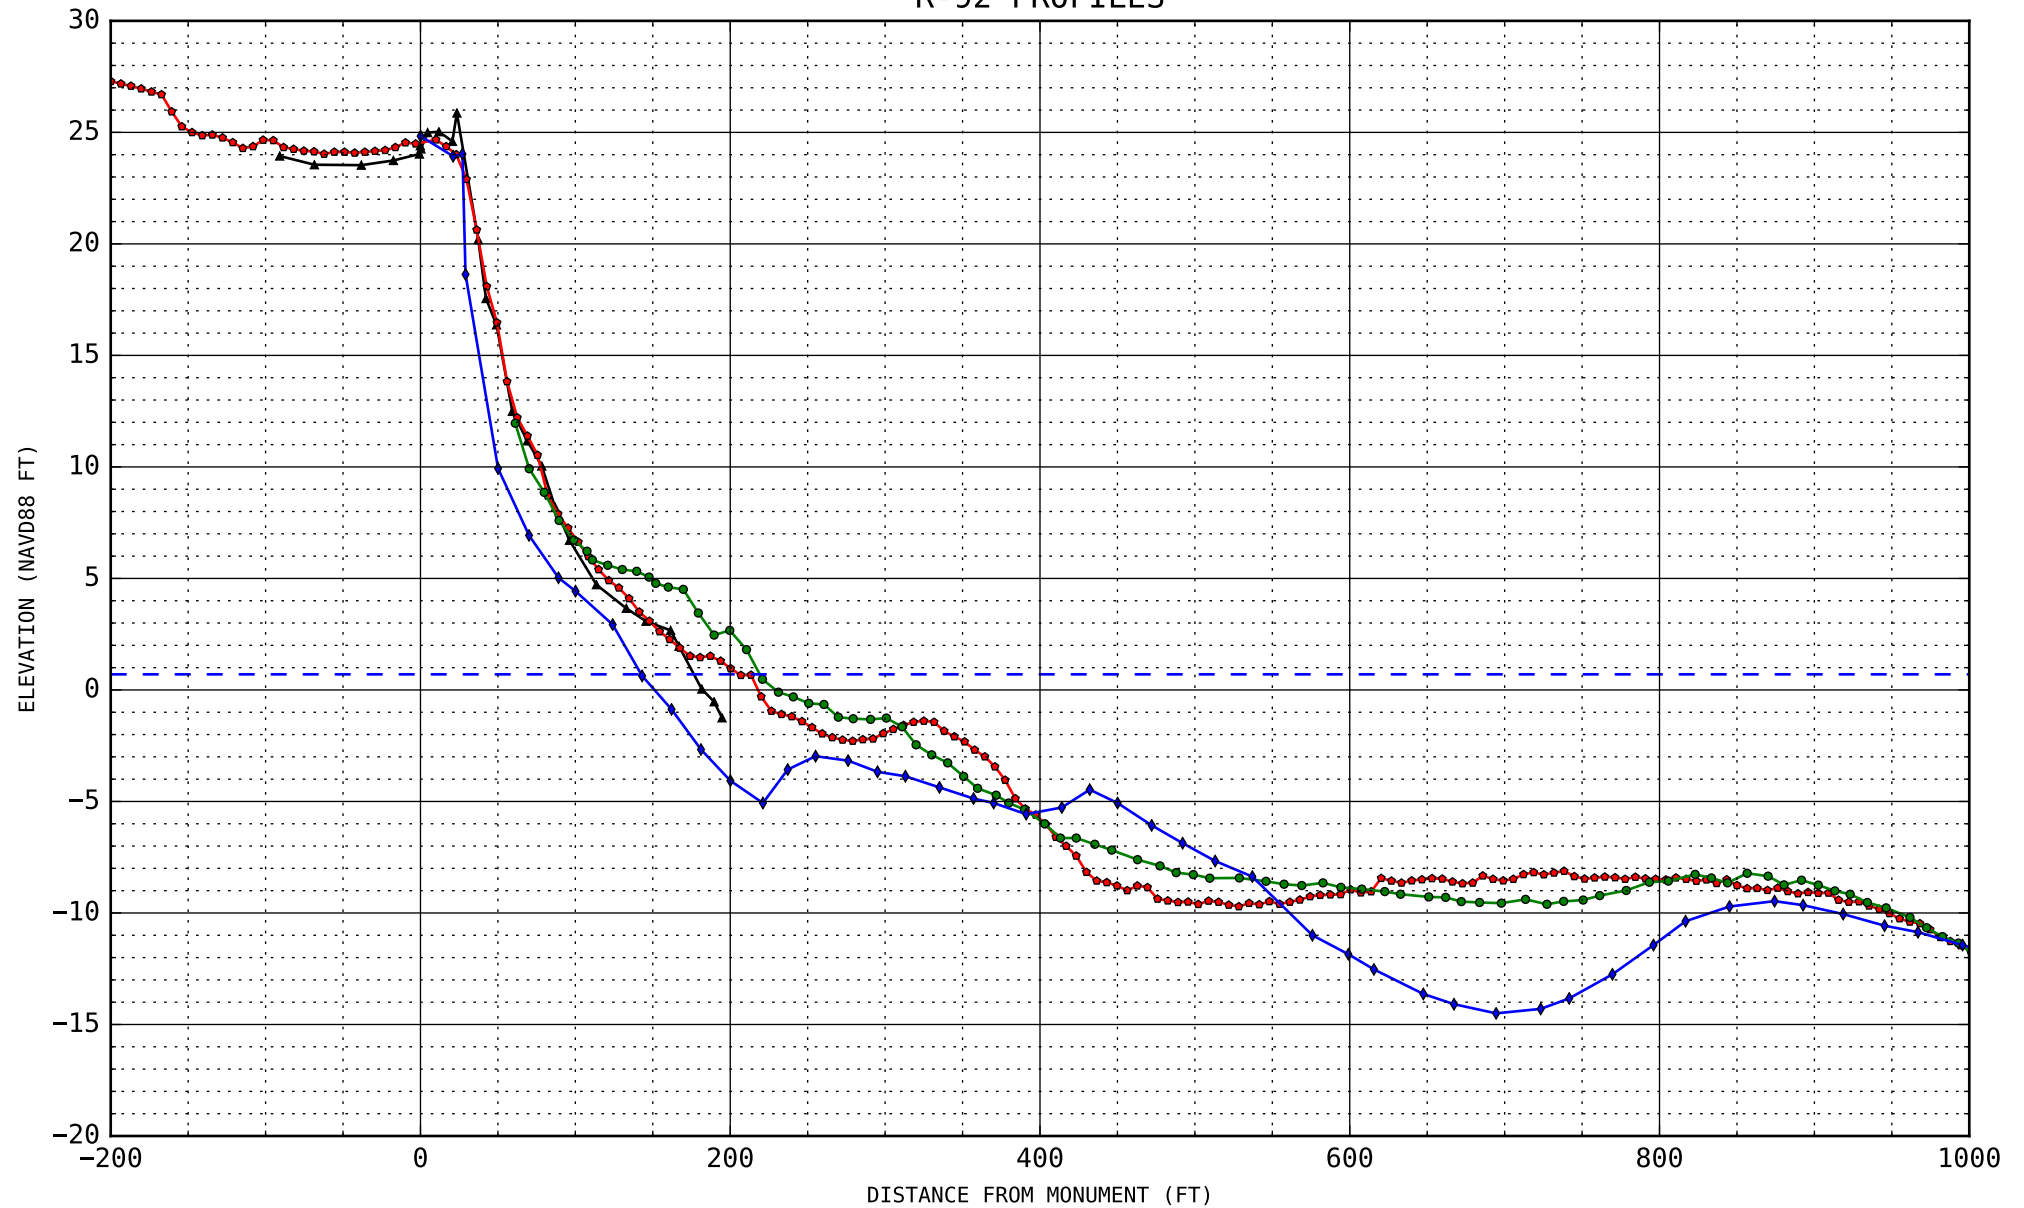
# R-92 PROFILES

- ▲ 2019-APR CONDITION BY DEP
- 2018-OCT MONITORING BY USACE-LIDAR
- 2013-SEP MONITORING BY USACE
- ◆ 2007-FEB MONITORING BY MAE
- - - MHW CONTOUR (0.7 FT)

RANGE: R-92  
EST DATE: NOV1980  
SURVEY DATE: 18APR19  
AZIMUTH: 202.0

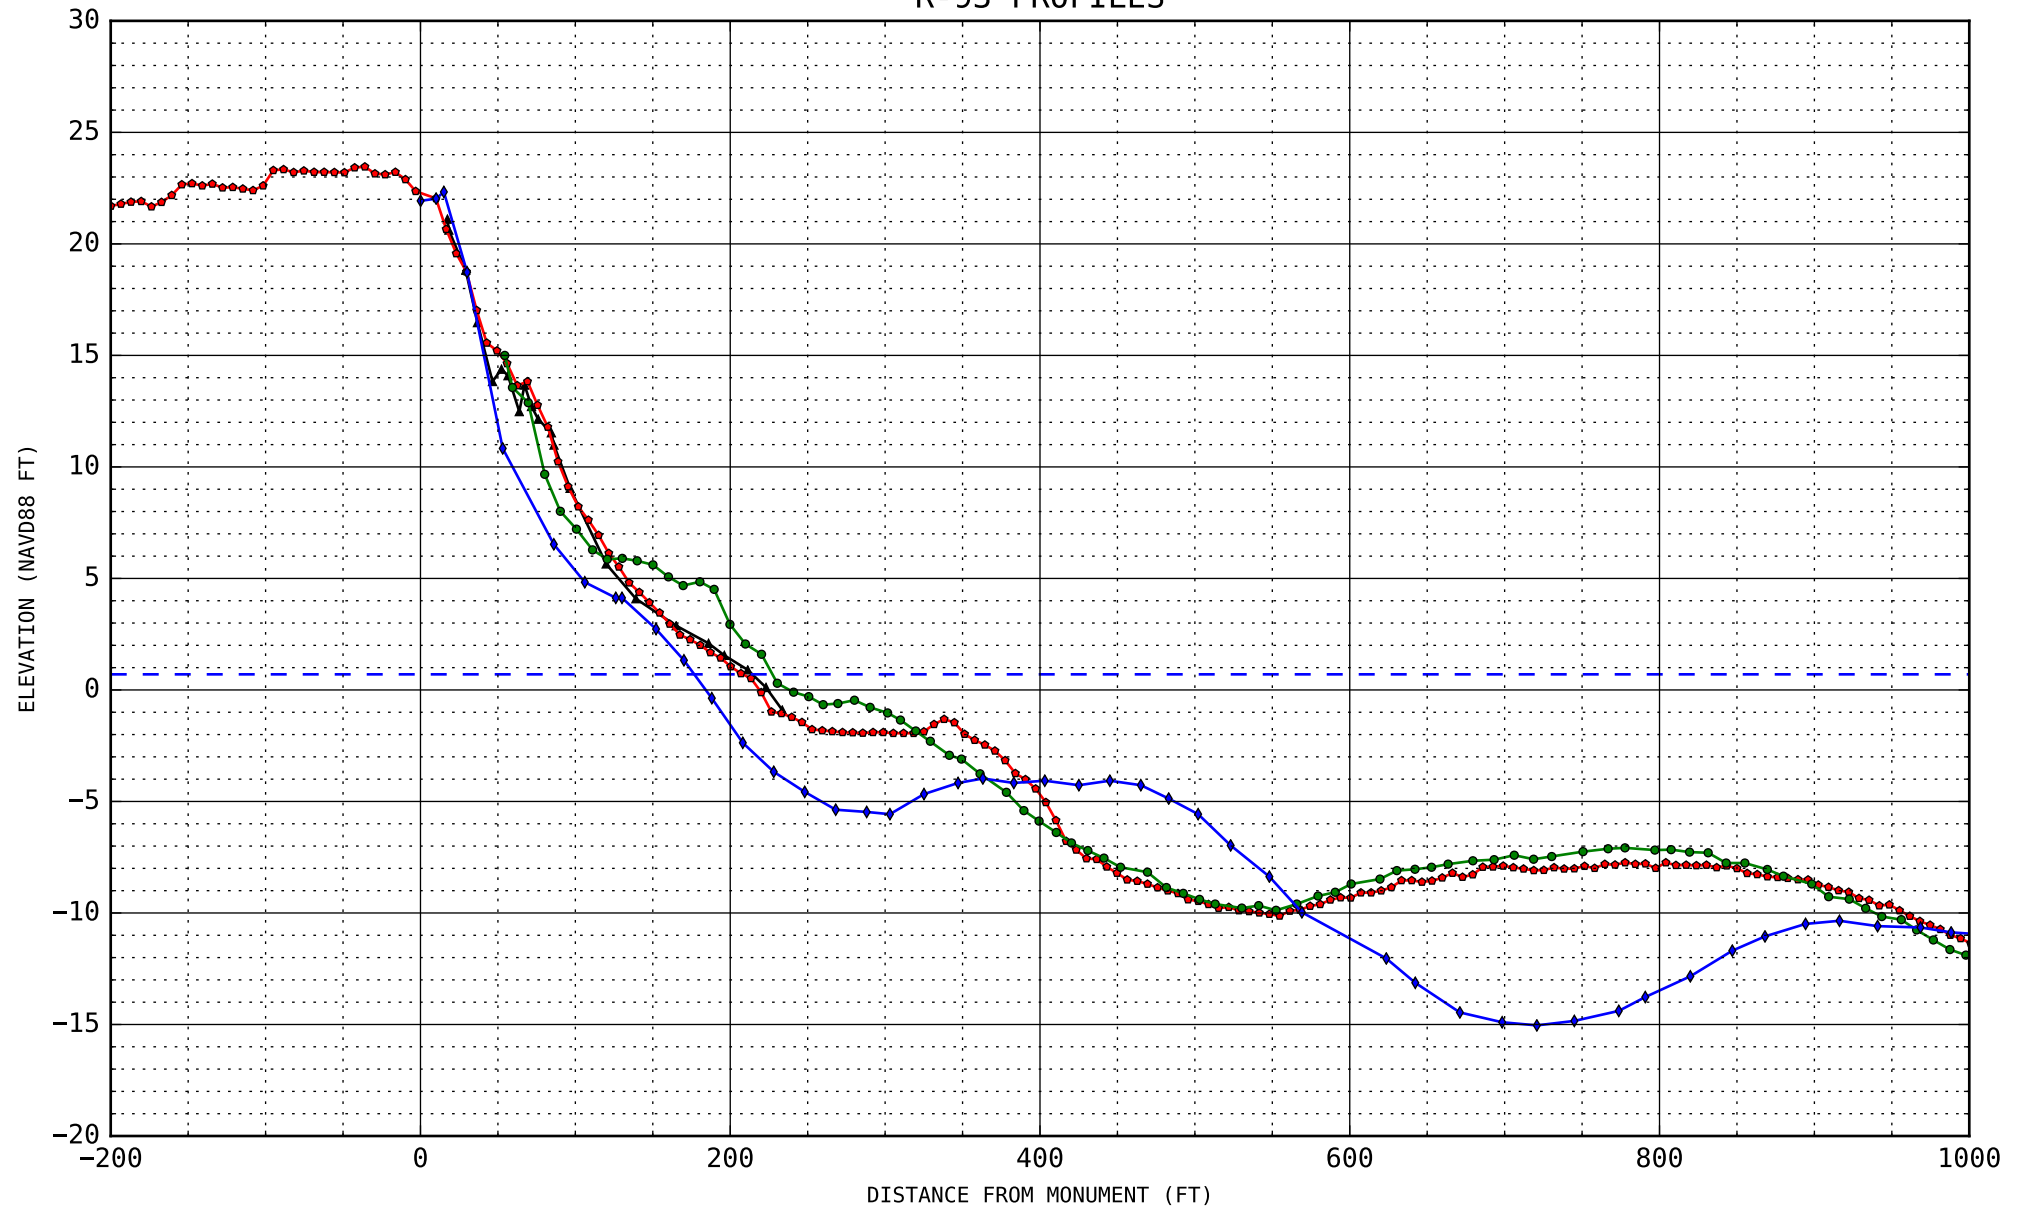
# R-93 PROFILES

- ▲ 2019-APR CONDITION BY DEP
- 2018-OCT MONITORING BY USACE-LIDAR
- 2013-SEP MONITORING BY USACE
- ◆ 2007-FEB MONITORING BY MAE
- - - MHW CONTOUR (0.7 FT)

RANGE: R-93  
EST DATE: OCT1995  
SURVEY DATE: 18APR19  
AZIMUTH: 202.0

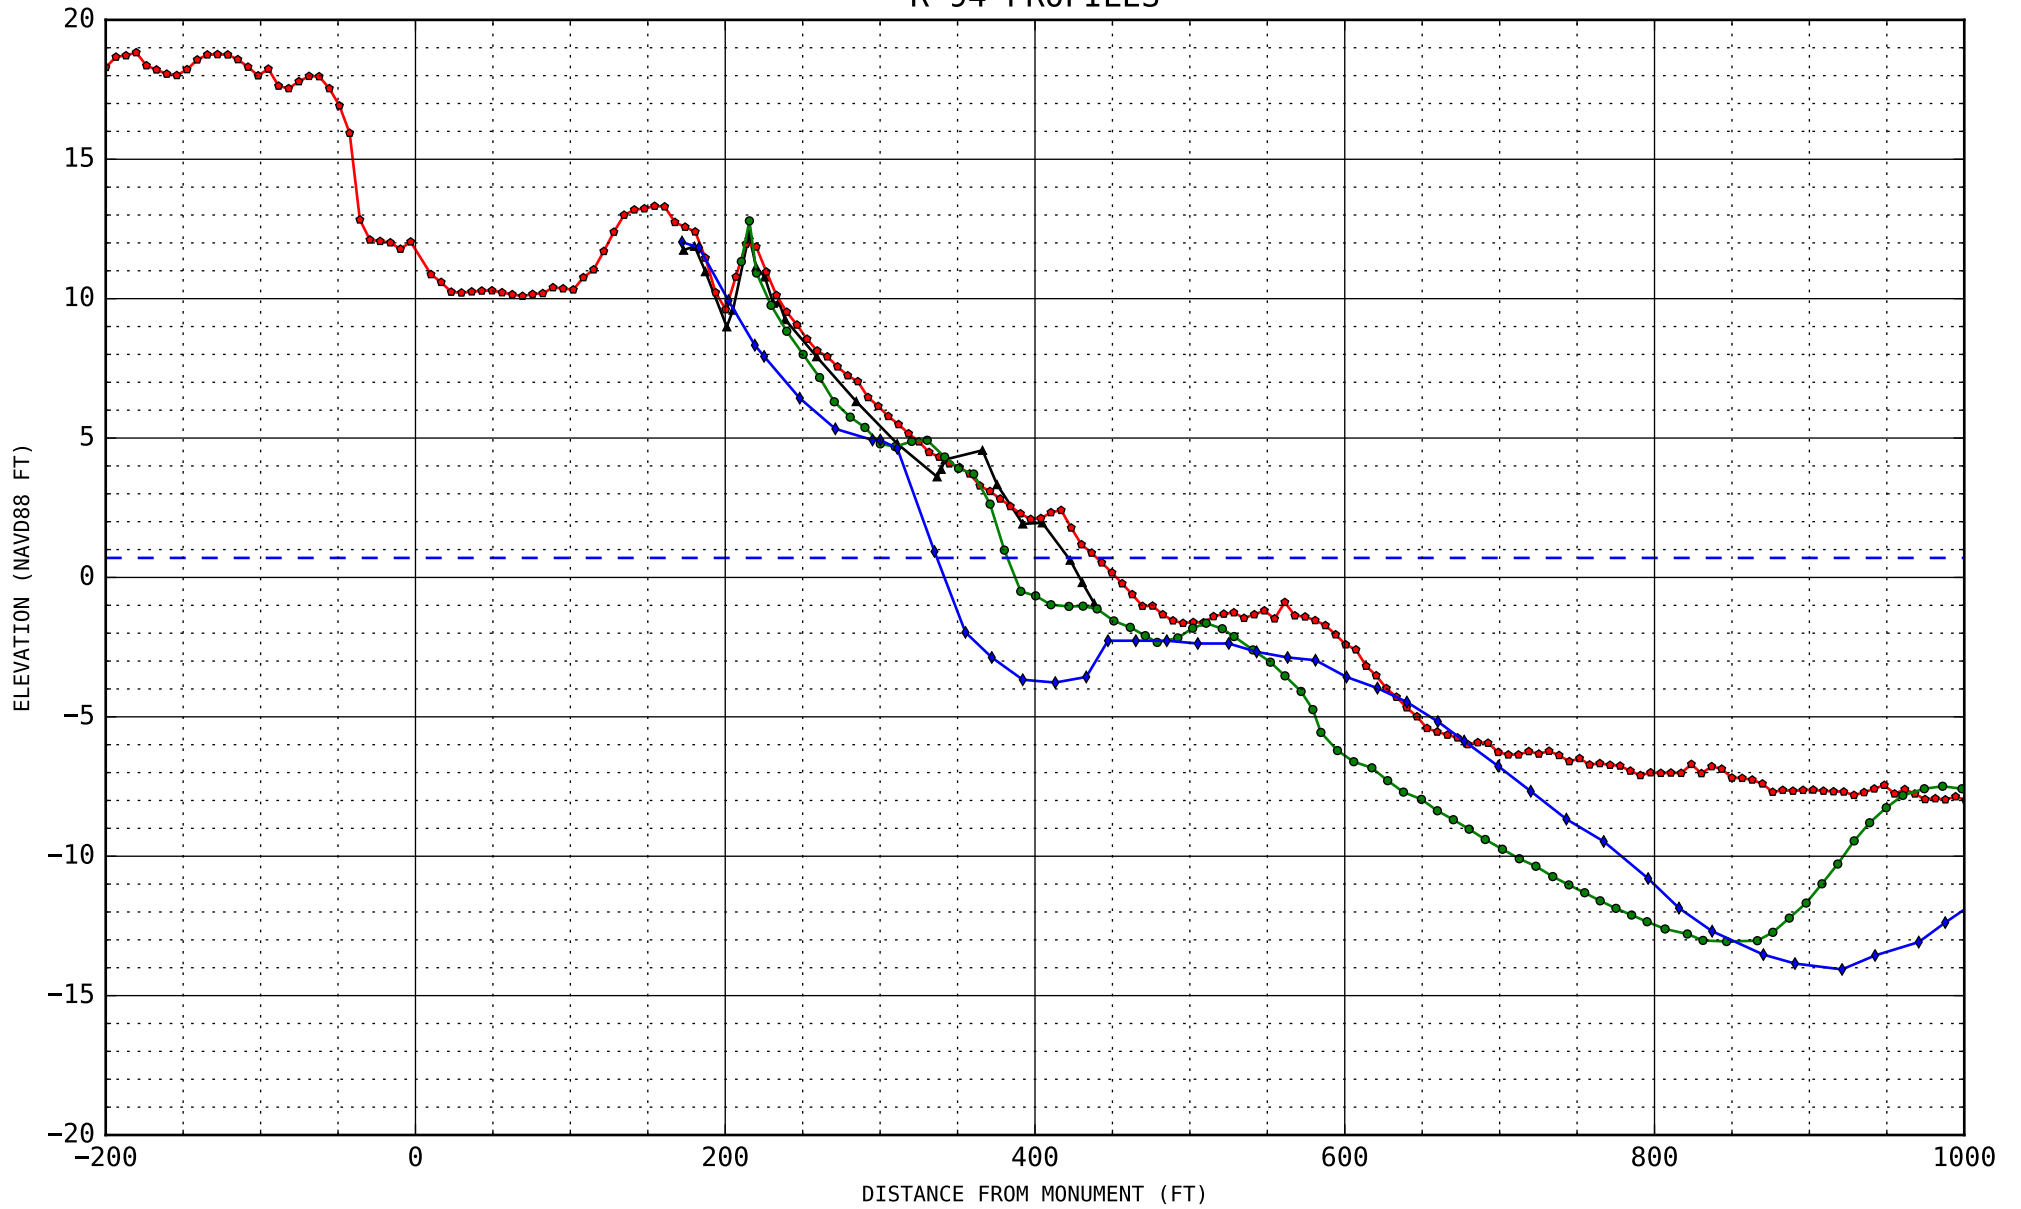
# R-94 PROFILES

- ▲ 2019-APR CONDITION BY DEP
- 2018-OCT MONITORING BY USACE-LIDAR
- 2013-SEP MONITORING BY USACE
- ◆ 2007-FEB MONITORING BY MAE
- - - MHW CONTOUR (0.7 FT)

RANGE: R-94  
EST DATE: OCT1995  
SURVEY DATE: 18APR19  
AZIMUTH: 202.0

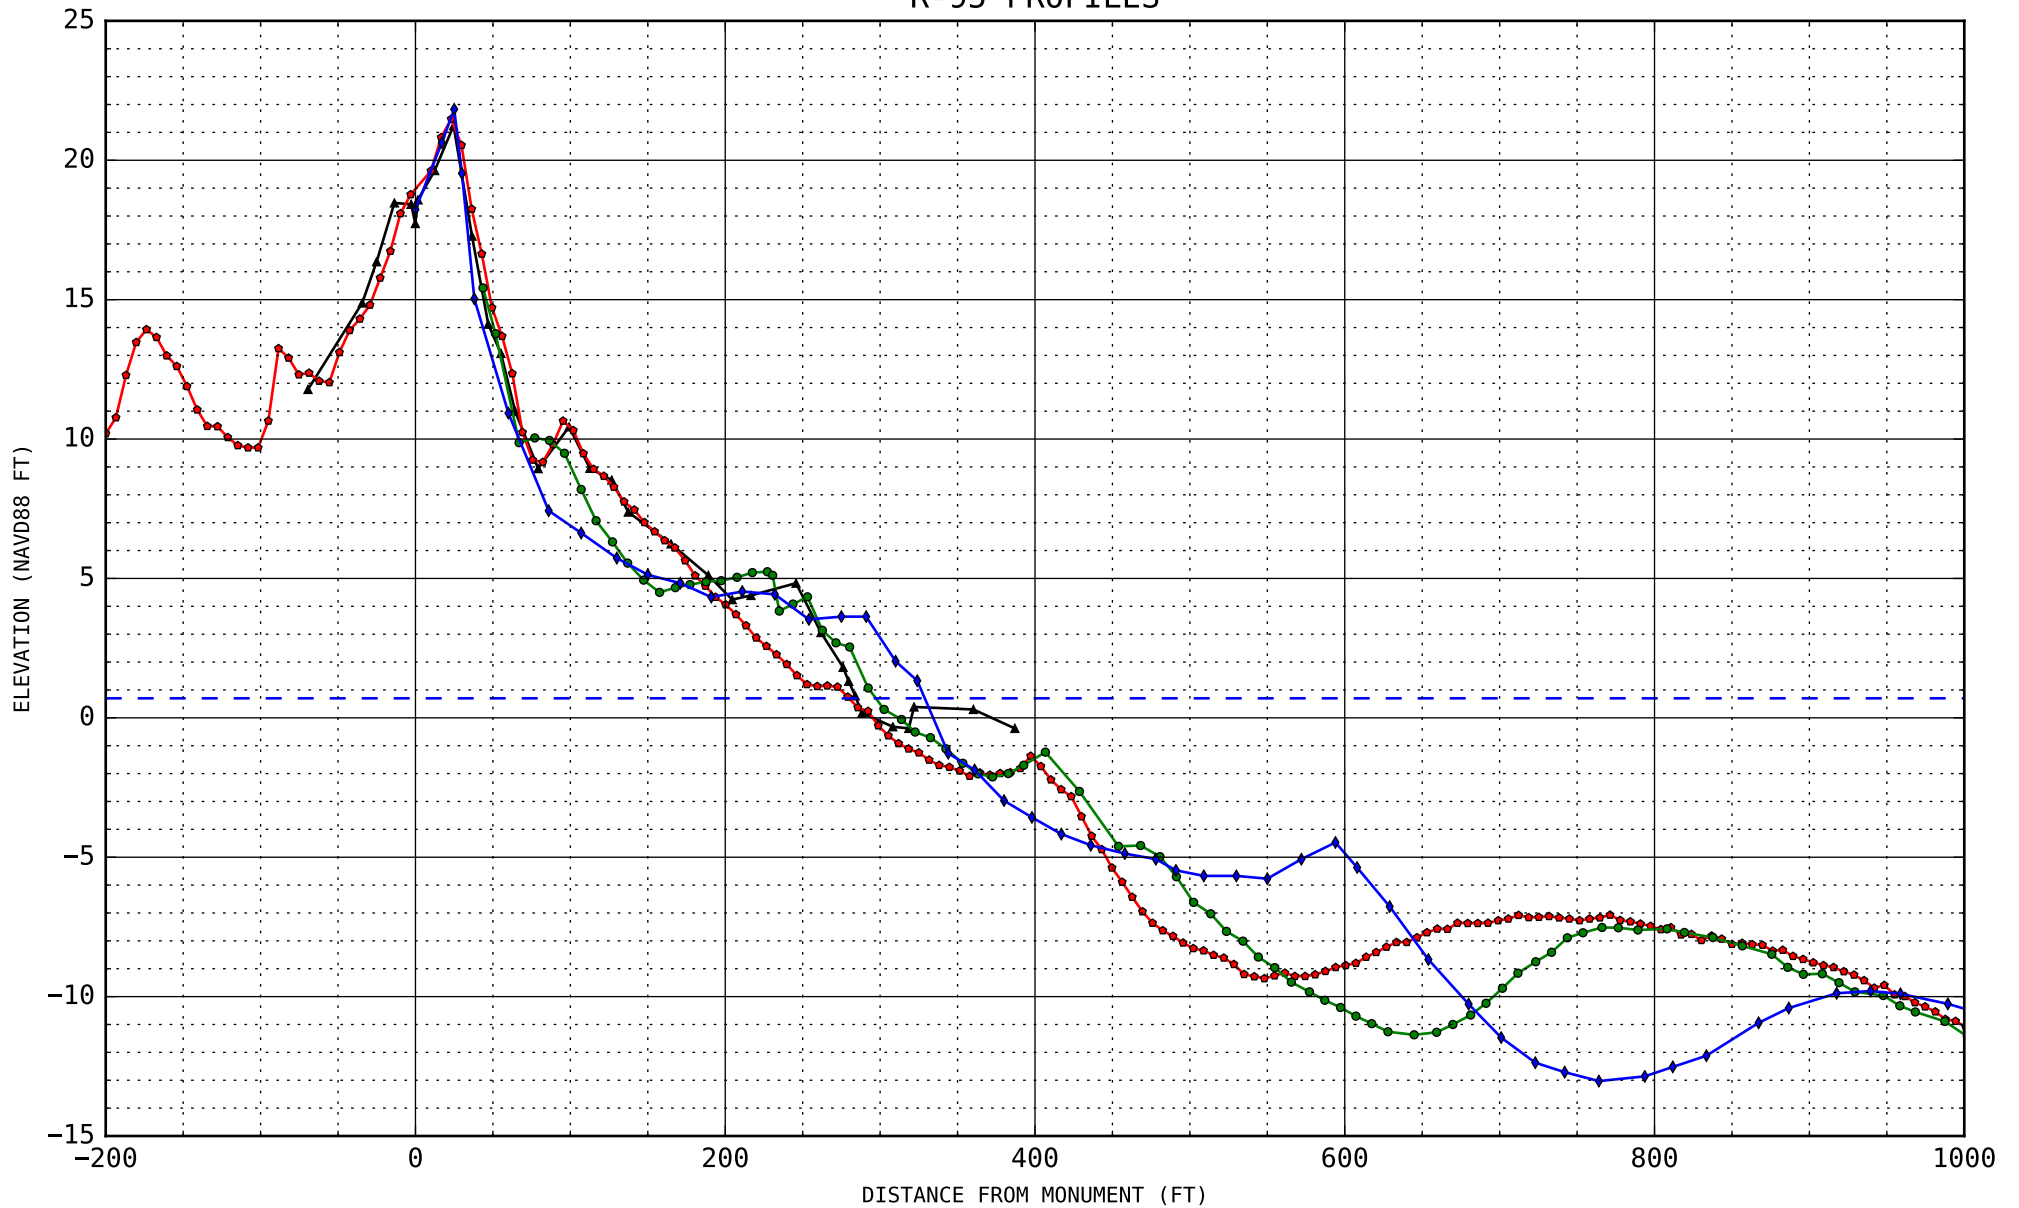
# R-95 PROFILES

- ▲ 2019-APR CONDITION BY DEP
- 2018-OCT MONITORING BY USACE-LIDAR
- 2013-SEP MONITORING BY USACE
- ◆ 2007-FEB MONITORING BY MAE
- - - MHW CONTOUR (0.7 FT)

RANGE: R-95  
EST DATE: OCT1995  
SURVEY DATE: 18APR19  
AZIMUTH: 202.0

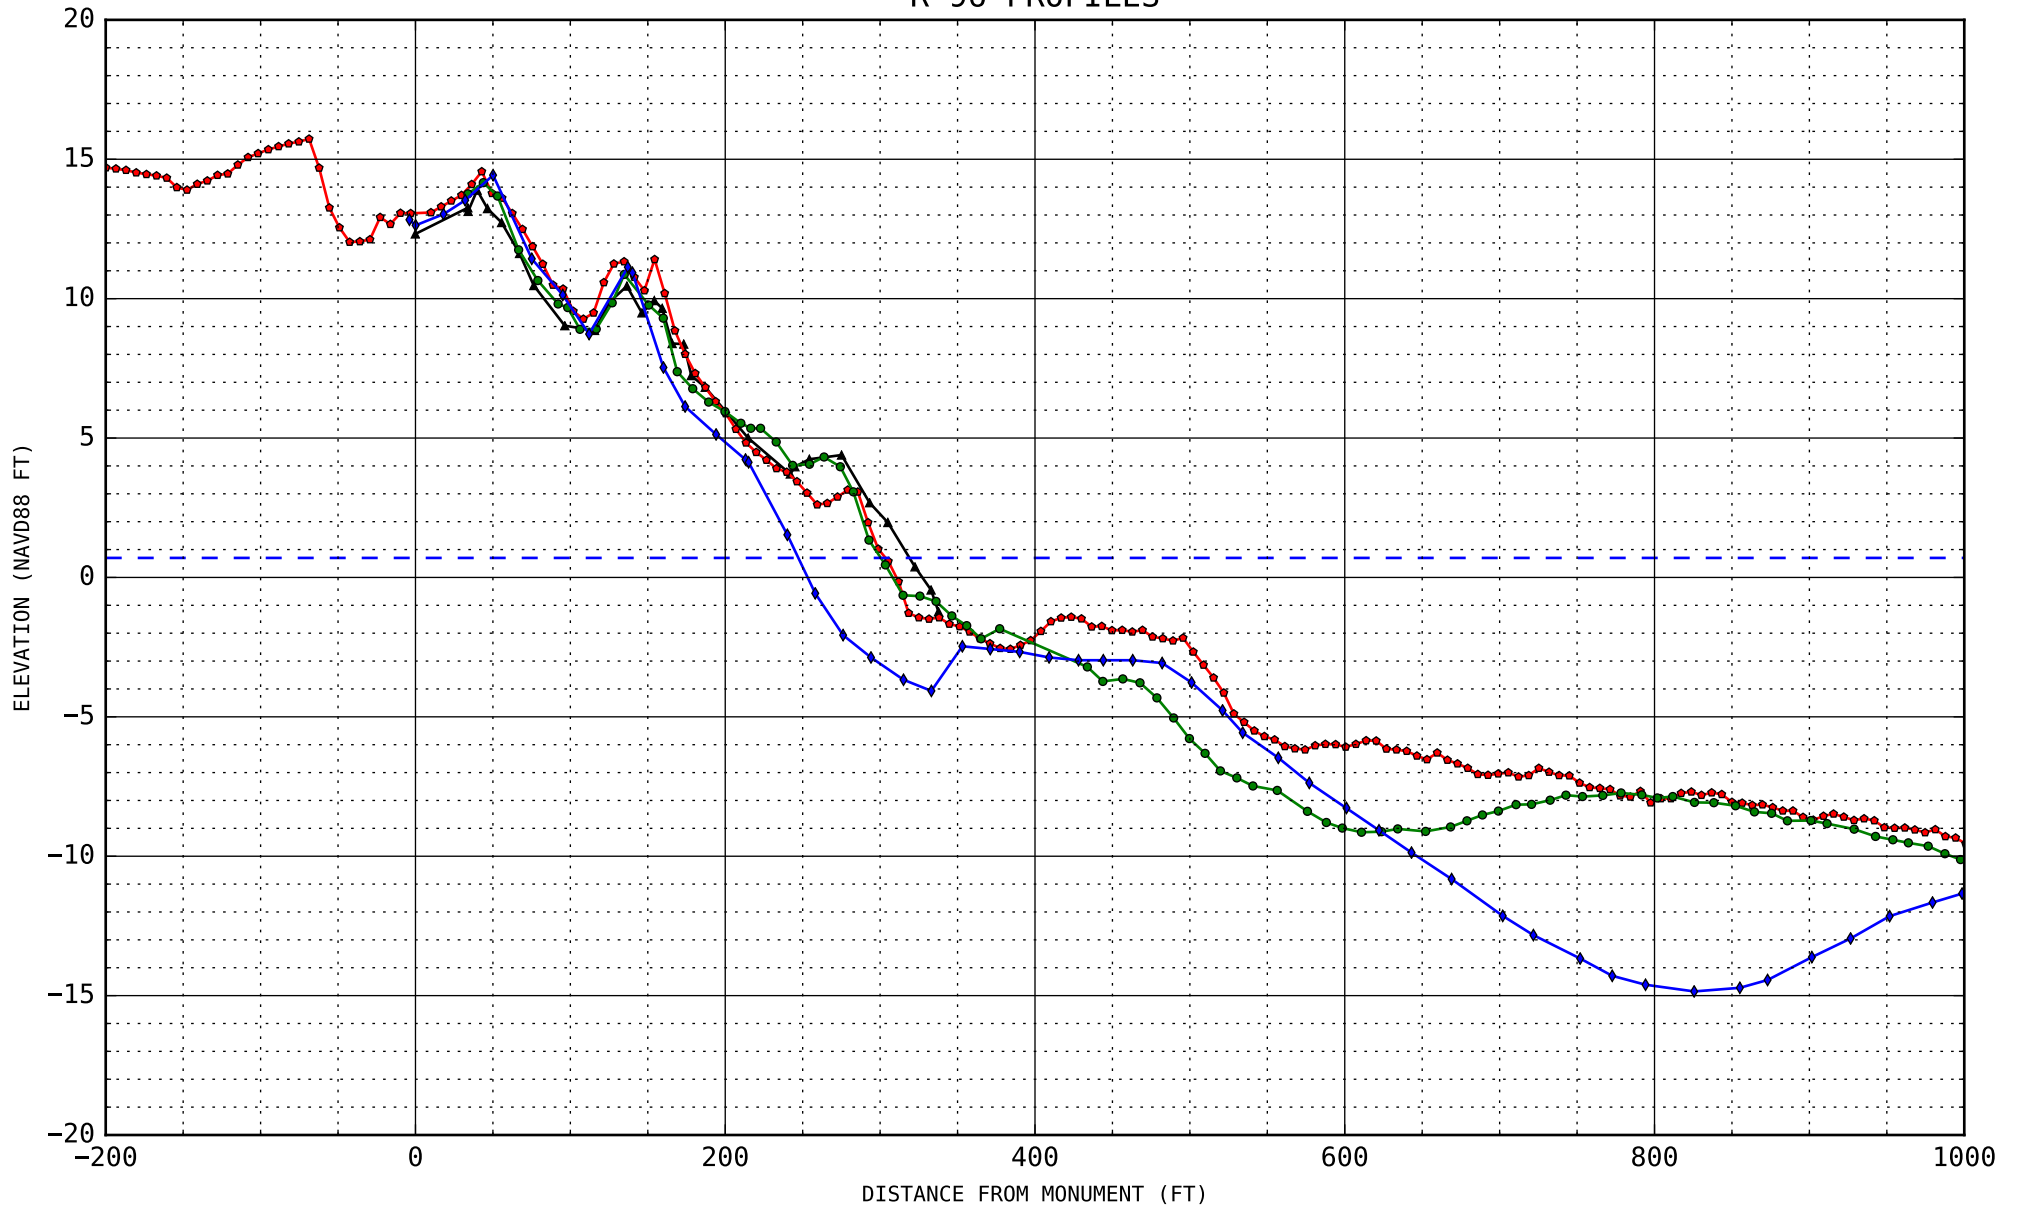
# R-96 PROFILES

- ▲ 2019-APR CONDITION BY DEP
- 2018-OCT MONITORING BY USACE-LIDAR
- 2013-SEP MONITORING BY USACE
- ◆ 2007-FEB MONITORING BY MAE
- - - MHW CONTOUR (0.7 FT)

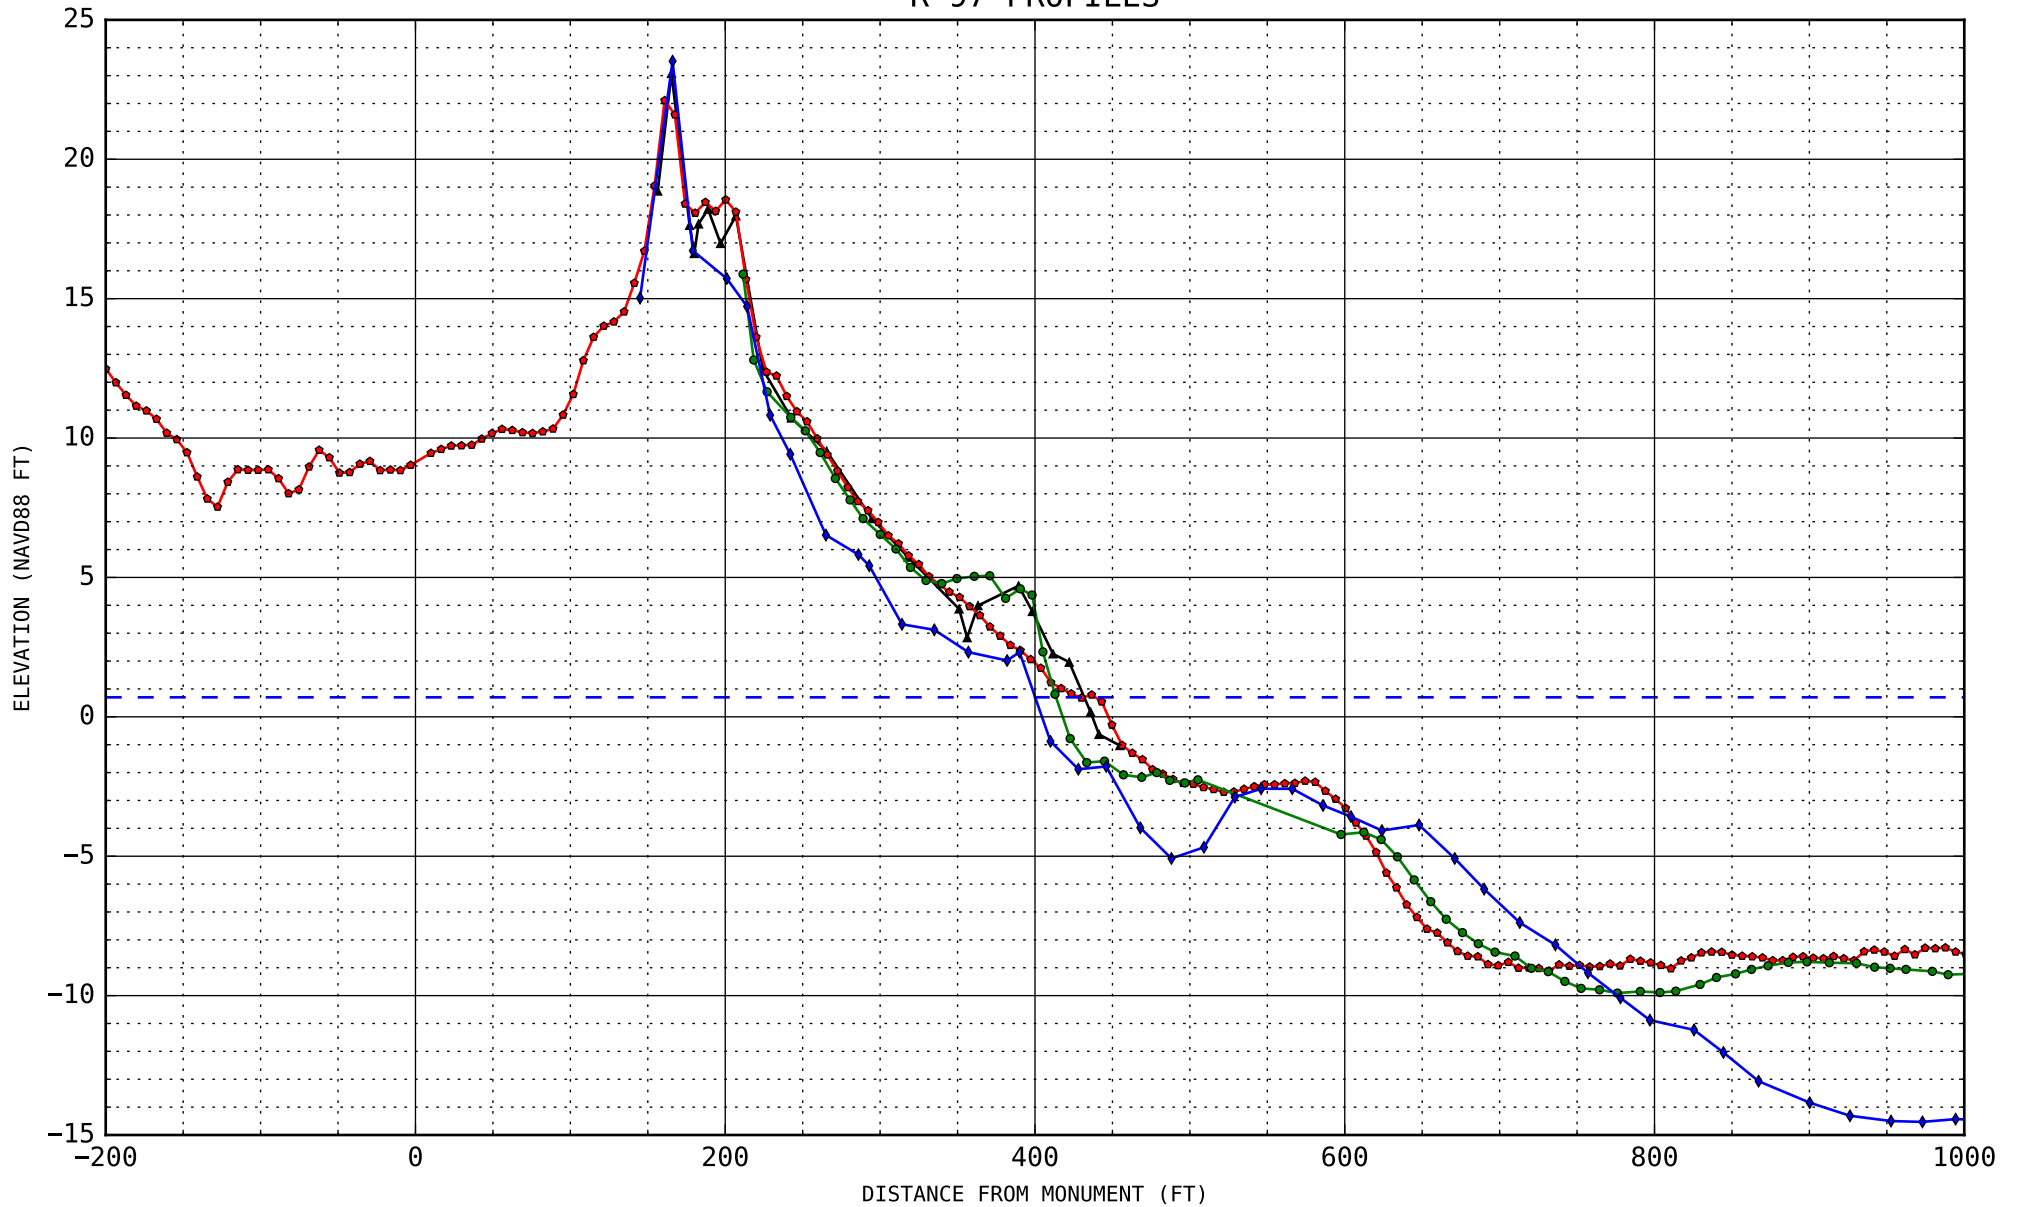
# R-97 PROFILES

- ▲ 2019-APR CONDITION BY DEP
- 2018-OCT MONITORING BY USACE-LIDAR
- 2013-SEP MONITORING BY USACE
- ◆ 2007-FEB MONITORING BY MAE
- - - MHW CONTOUR (0.7 FT)

RANGE: R-97  
EST DATE: OCT1995  
SURVEY DATE: 18APR19  
AZIMUTH: 202.0
