# R-1 PROFILES

WALTON  
PROGRAM SUPPORT GIS  
DIVISION OF WATER RESOURCE MANAGEMENT  
FLORIDA DEPARTMENT OF ENVIRONMENTAL PROTECTION

RANGE: R-1  
EST DATE: NOV1980  
SURVEY DATE: 04APR19  
AZIMUTH: 190.0

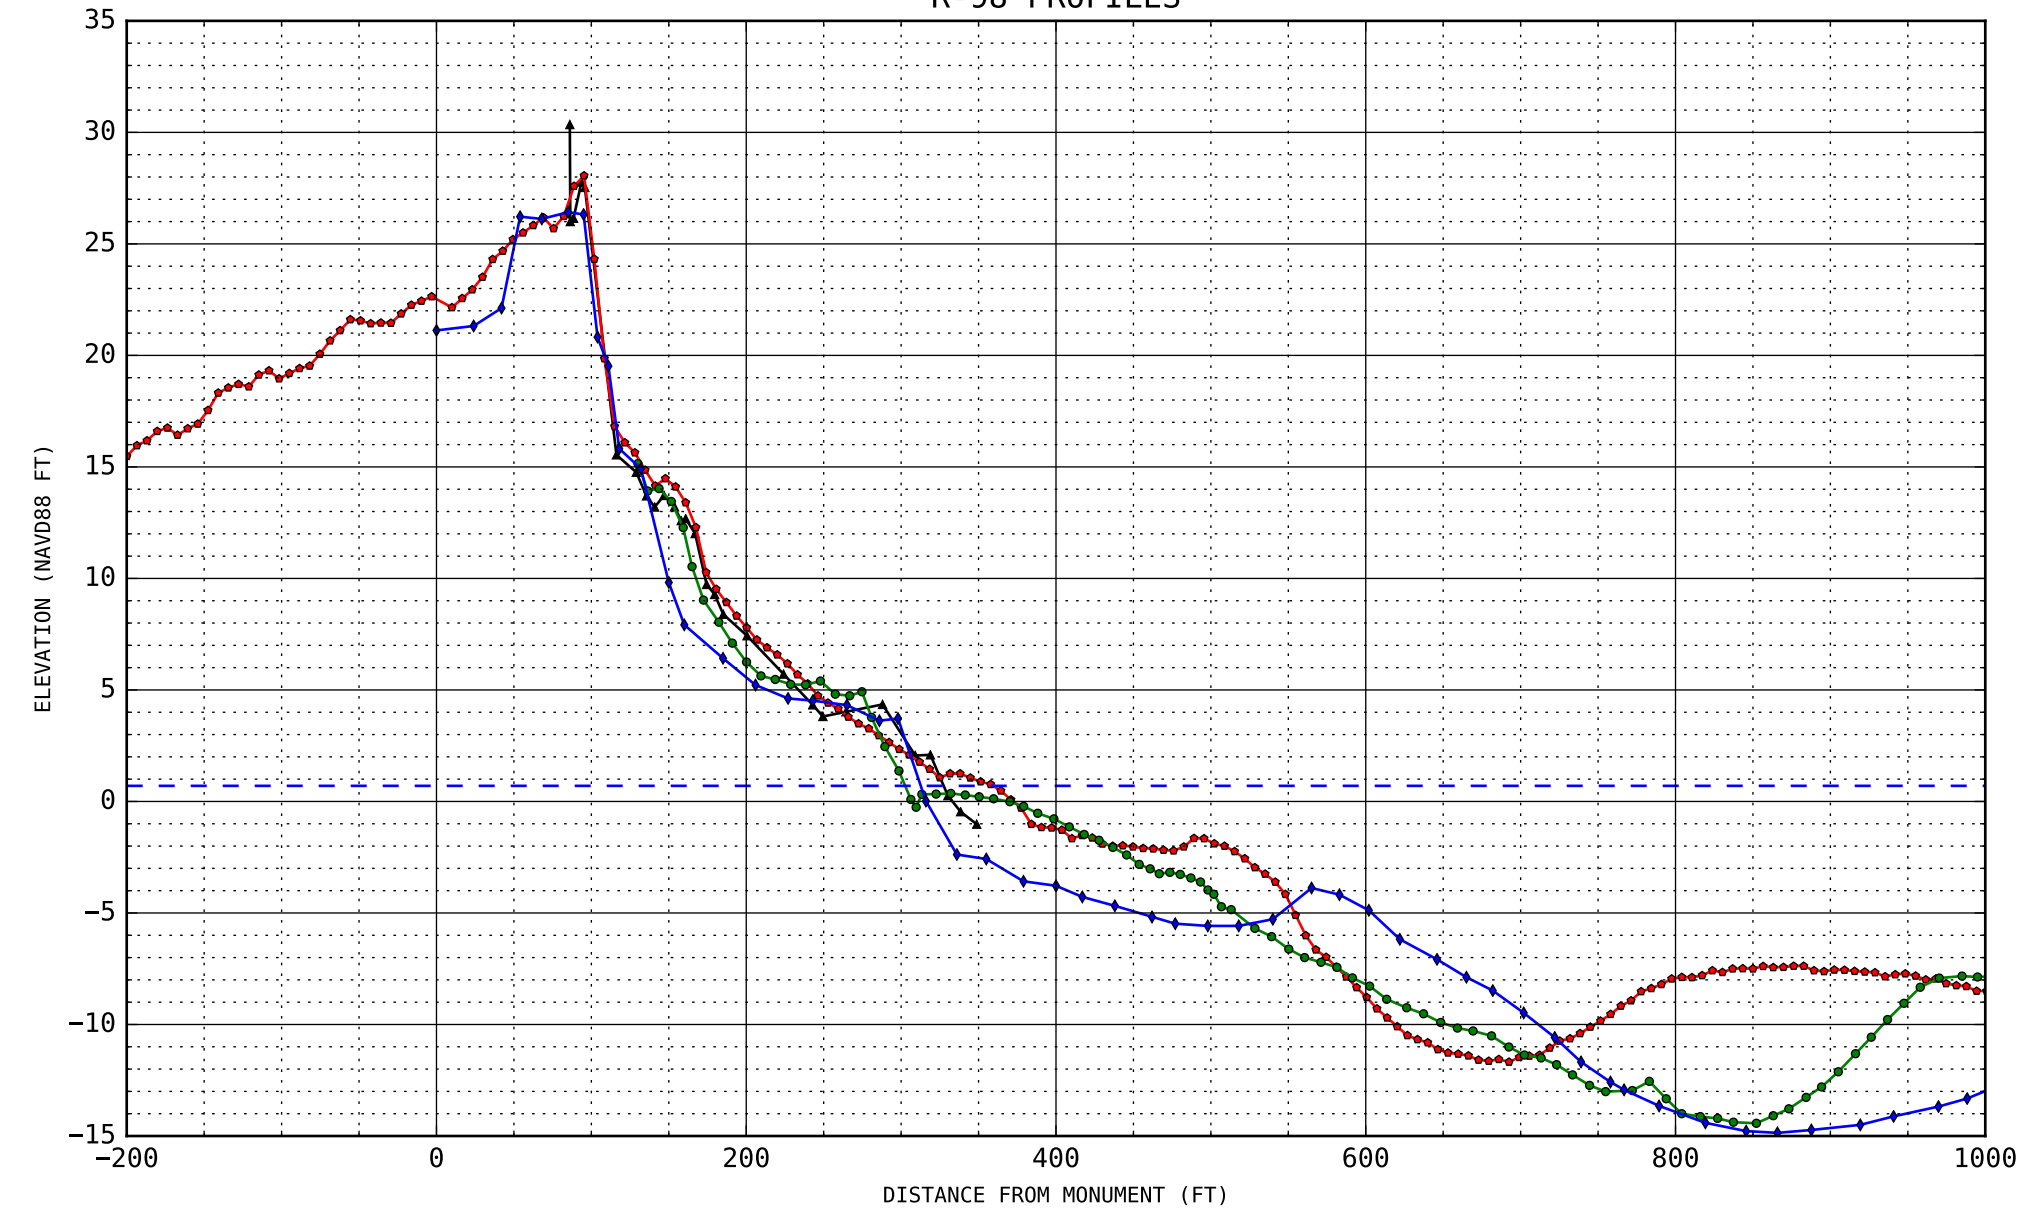
# R-98 PROFILES

- ▲ 2019-APR CONDITION BY DEP
- 2018-OCT MONITORING BY USACE-LIDAR
- 2013-SEP MONITORING BY USACE
- ◆ 2007-FEB MONITORING BY MAE
- - - MHW CONTOUR (0.7 FT)

RANGE: R-98  
 EST DATE: NOV1980  
 SURVEY DATE: 18APR19  
 AZIMUTH: 202.0

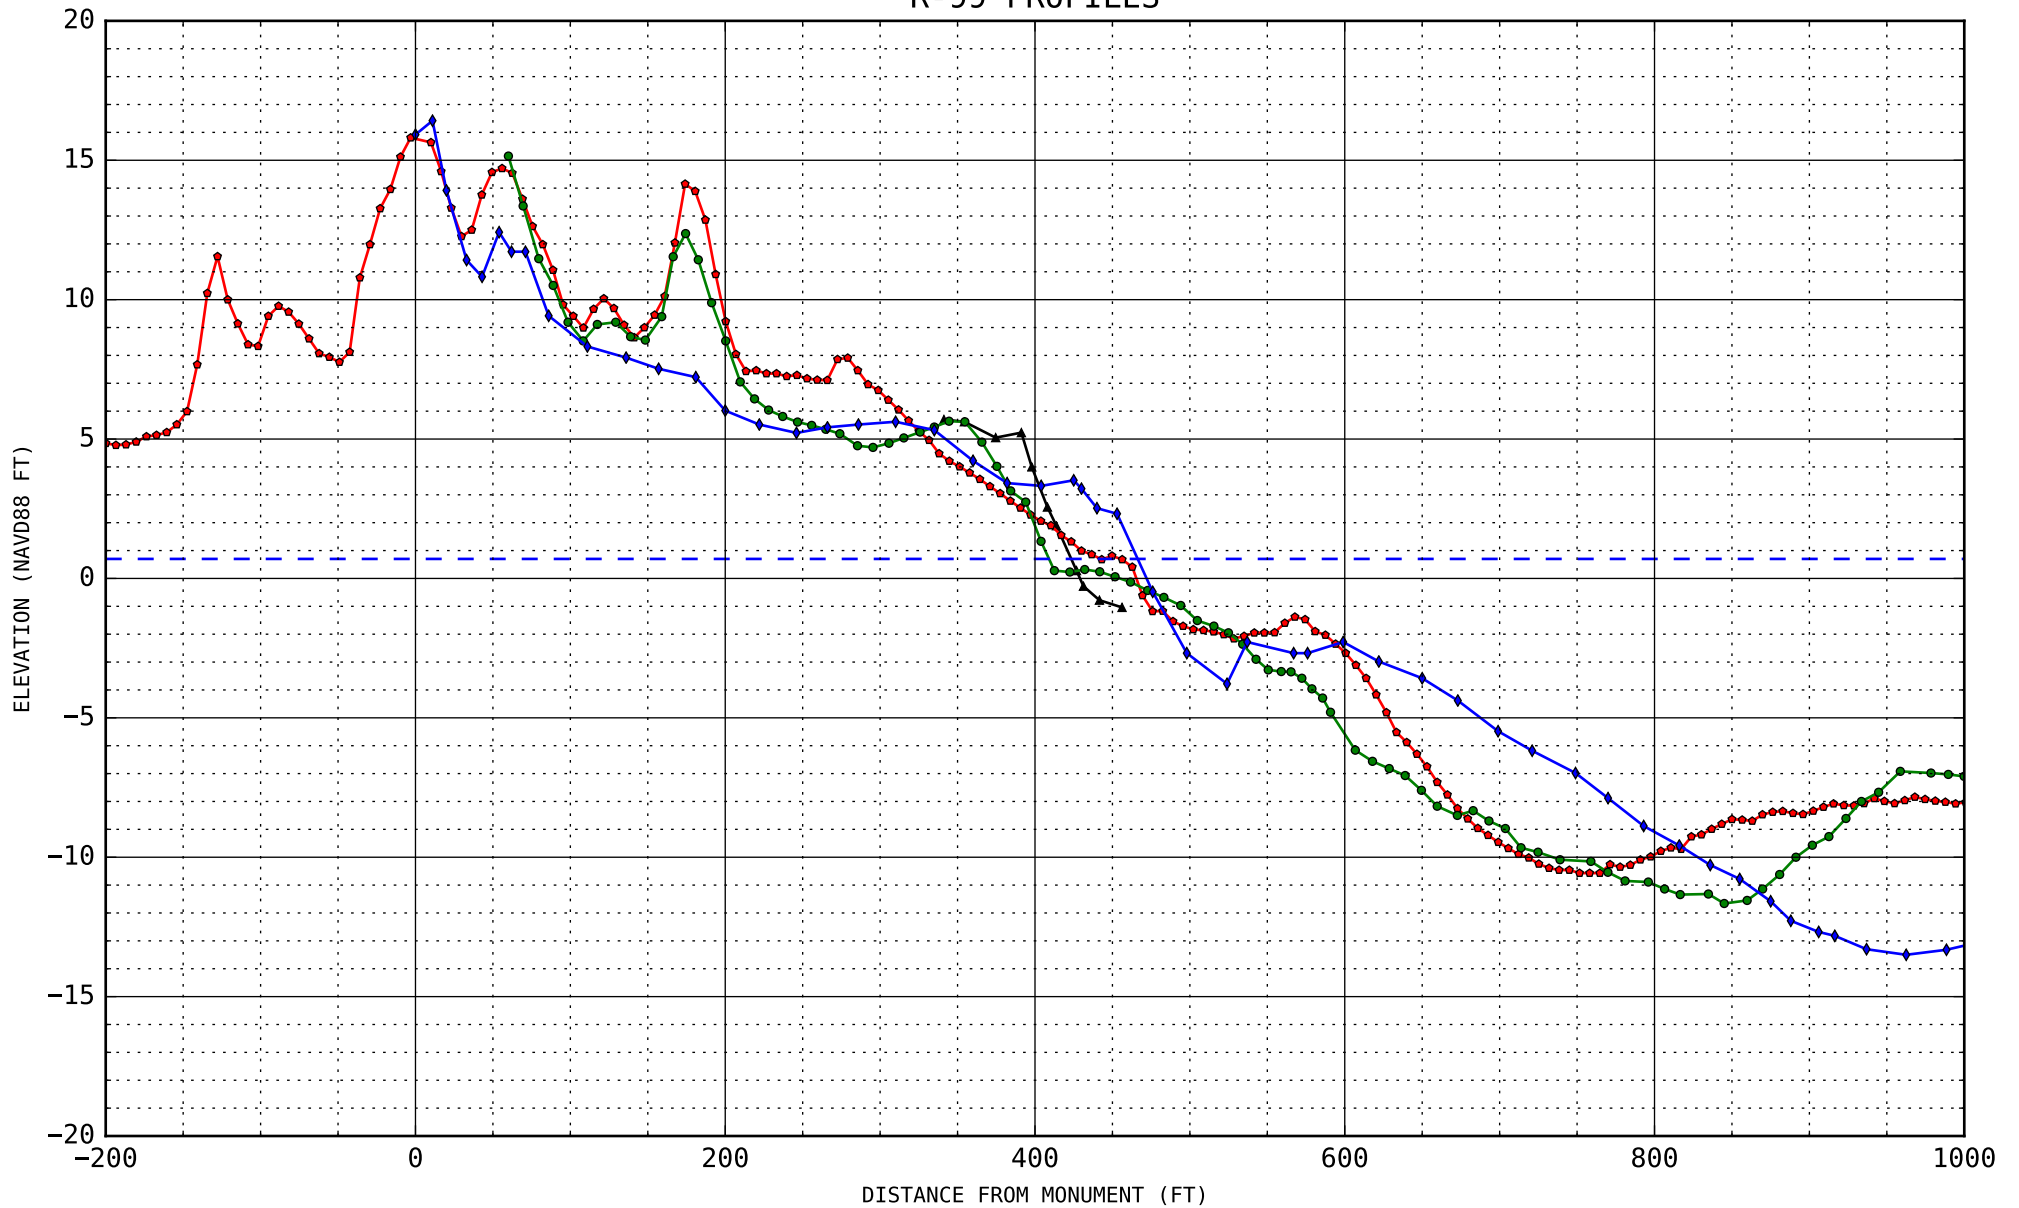
# R-99 PROFILES

- ▲ 2019-APR CONDITION BY DEP
- 2018-OCT MONITORING BY USACE-LIDAR
- 2013-SEP MONITORING BY USACE
- ◆ 2007-FEB MONITORING BY MAE
- - - MHW CONTOUR (0.7 FT)

RANGE: R-99  
EST DATE: OCT1995  
SURVEY DATE: 18APR19  
AZIMUTH: 202.0

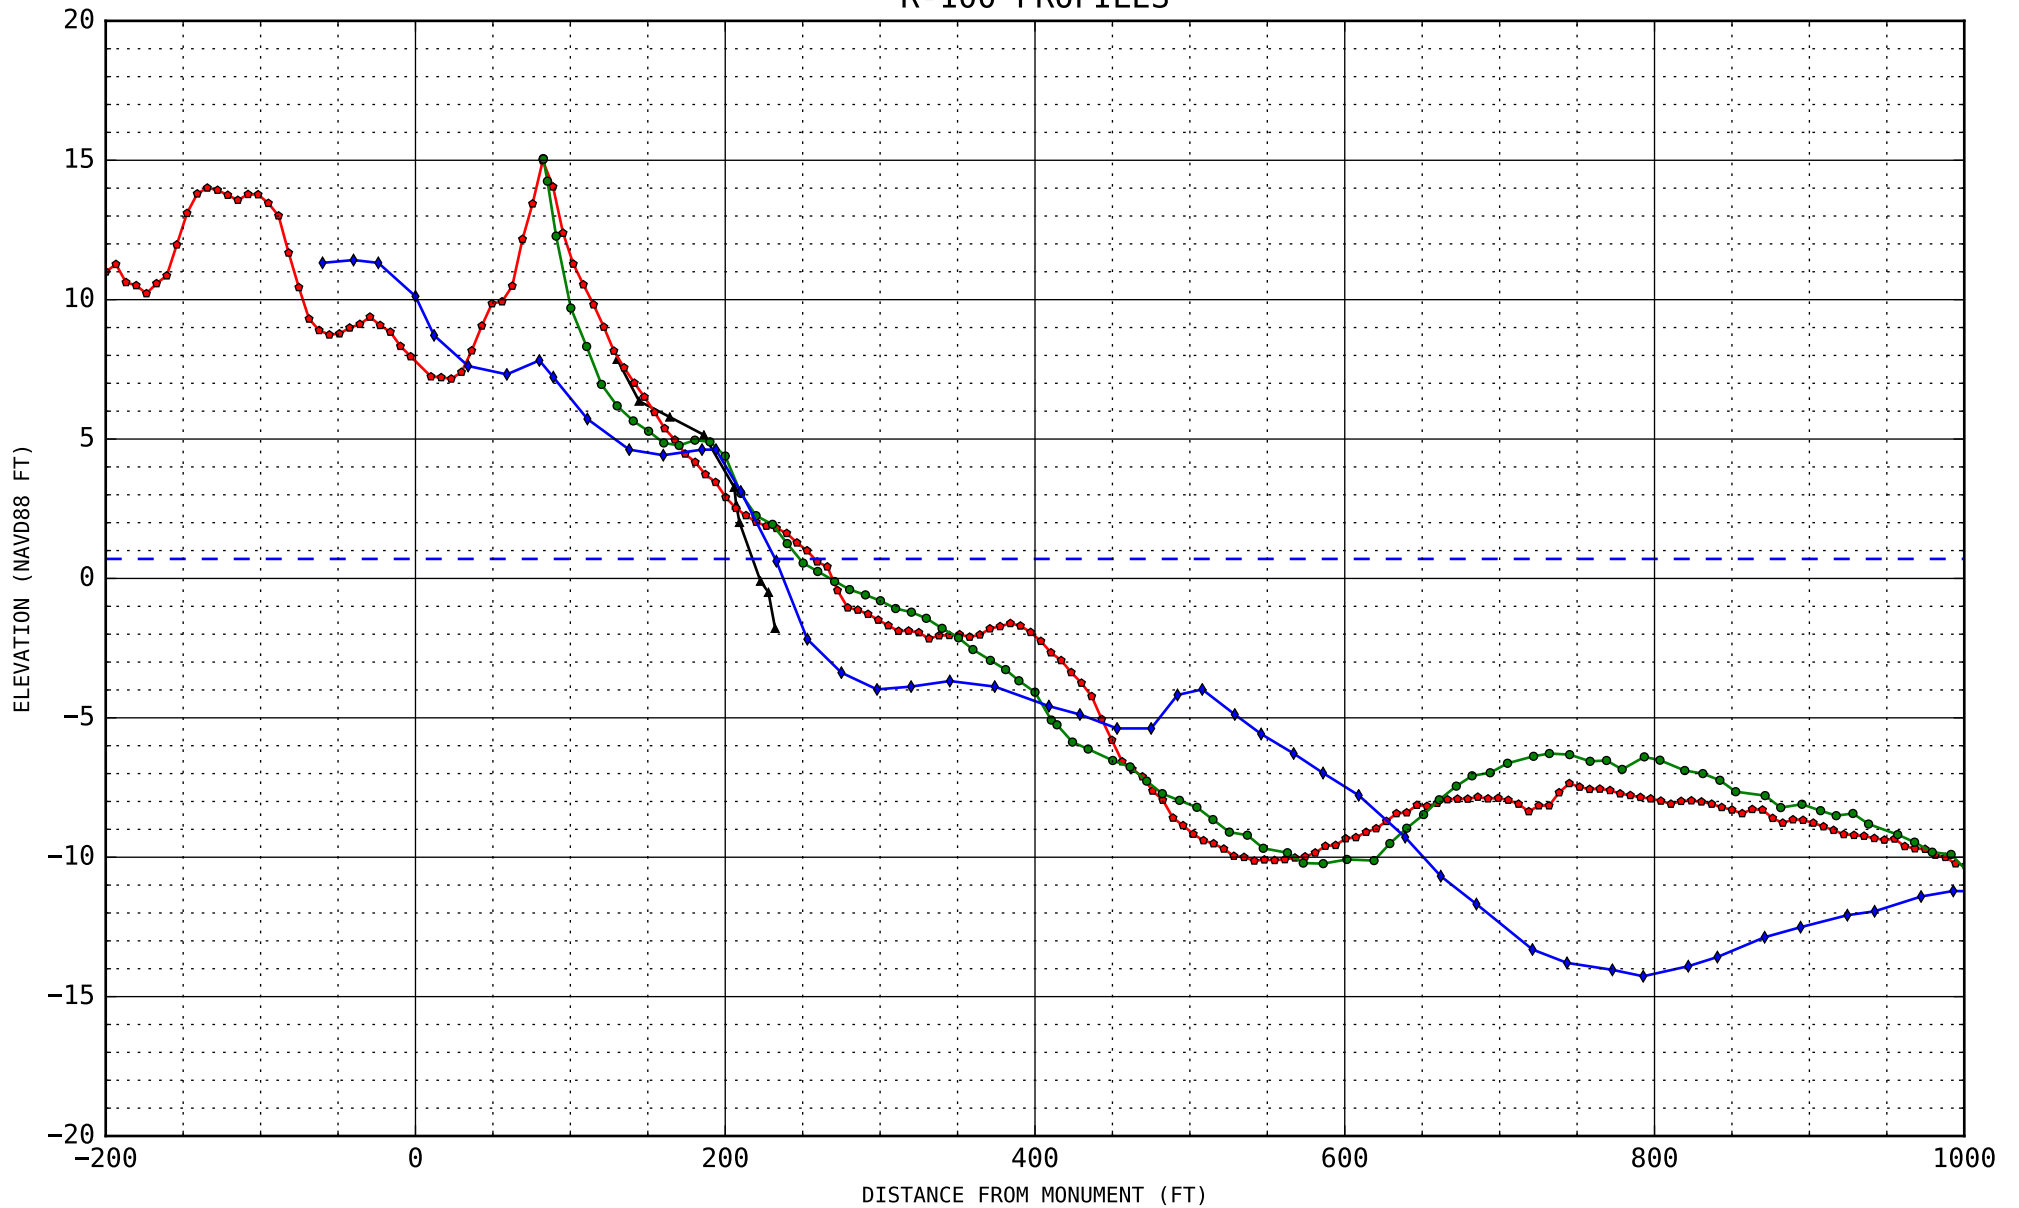
# R-100 PROFILES

- ▲ 2019-APR CONDITION BY DEP
- 2018-OCT MONITORING BY USACE-LIDAR
- 2013-SEP MONITORING BY USACE
- ◆ 2007-FEB MONITORING BY MAE
- - - MHW CONTOUR (0.7 FT)

RANGE: R-100  
EST DATE: OCT1995  
SURVEY DATE: 18APR19  
AZIMUTH: 202.0

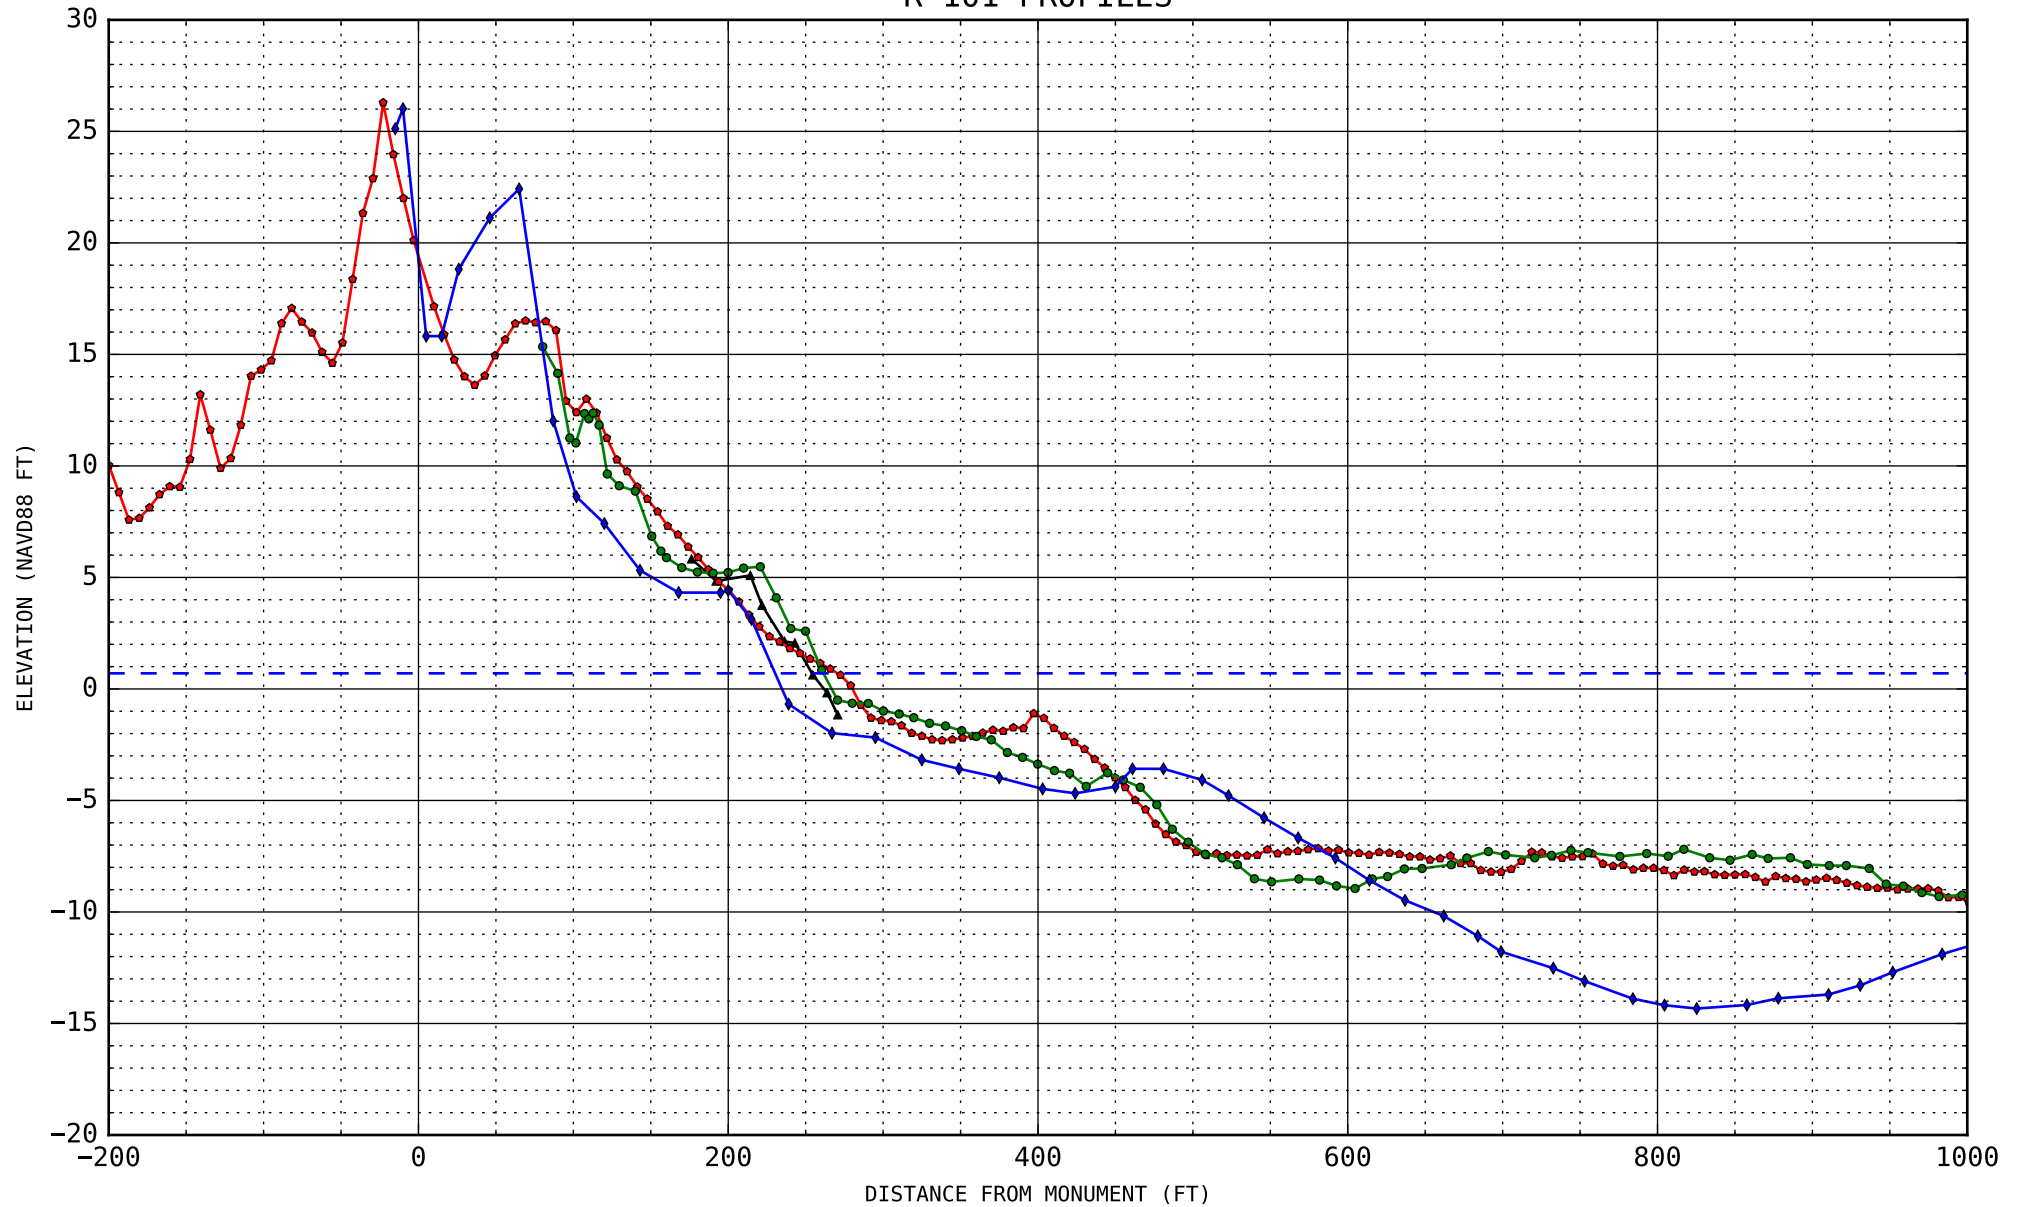
# R-101 PROFILES

- ▲ 2019-APR CONDITION BY DEP
- 2018-OCT MONITORING BY USACE-LIDAR
- 2013-SEP MONITORING BY USACE
- ◆ 2007-FEB MONITORING BY MAE
- - - MHW CONTOUR (0.7 FT)

RANGE: R-101  
EST DATE: OCT1995  
SURVEY DATE: 18APR19  
AZIMUTH: 202.0

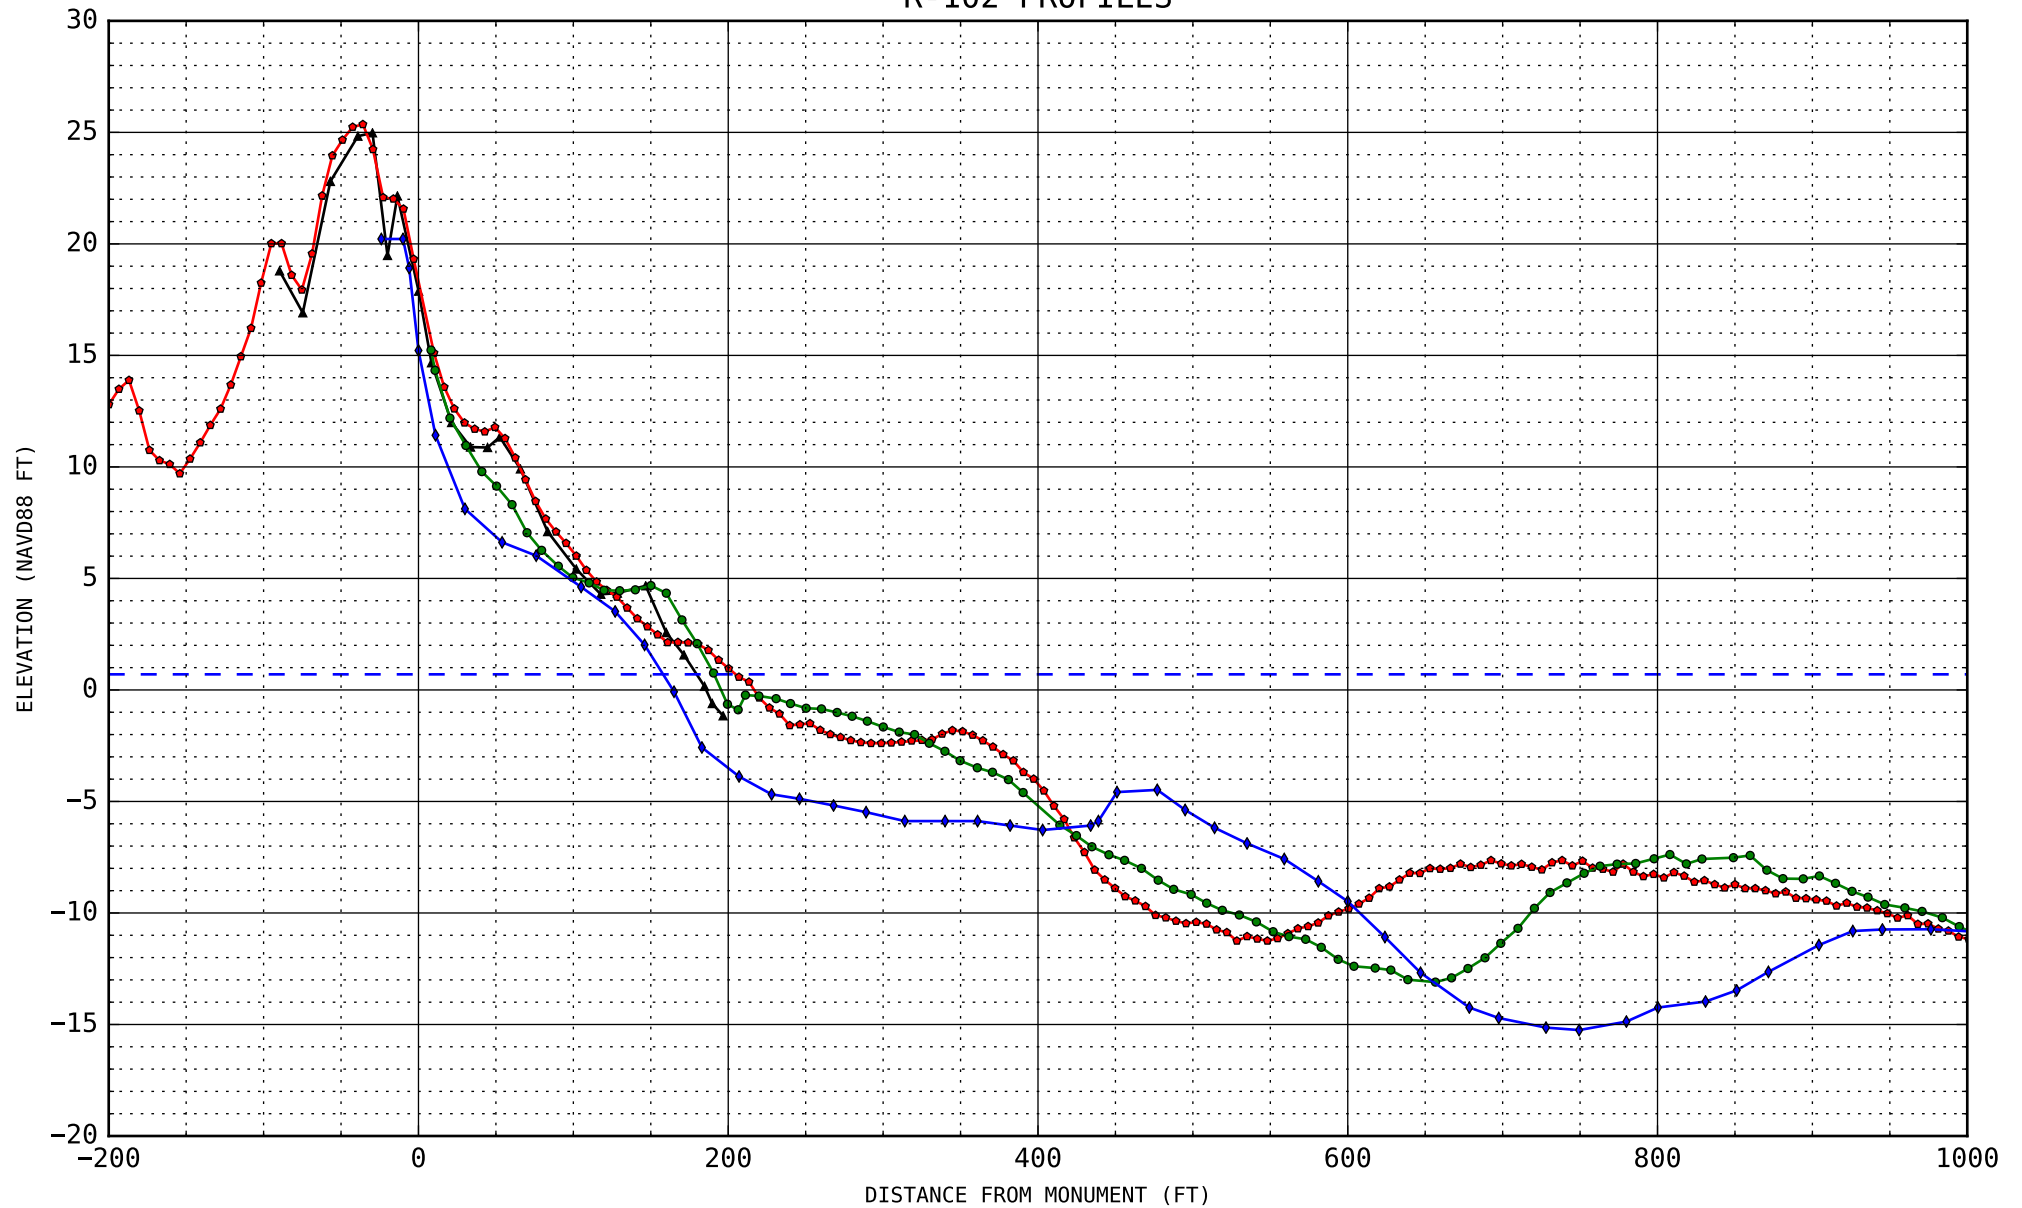
# R-102 PROFILES

- ▲ 2019-APR CONDITION BY DEP
- 2018-OCT MONITORING BY USACE-LIDAR
- 2013-SEP MONITORING BY USACE
- ◆ 2007-FEB MONITORING BY MAE
- - - MHW CONTOUR (0.7 FT)

RANGE: R-102  
EST DATE: JUN1973  
SURVEY DATE: 18APR19  
AZIMUTH: 202.0

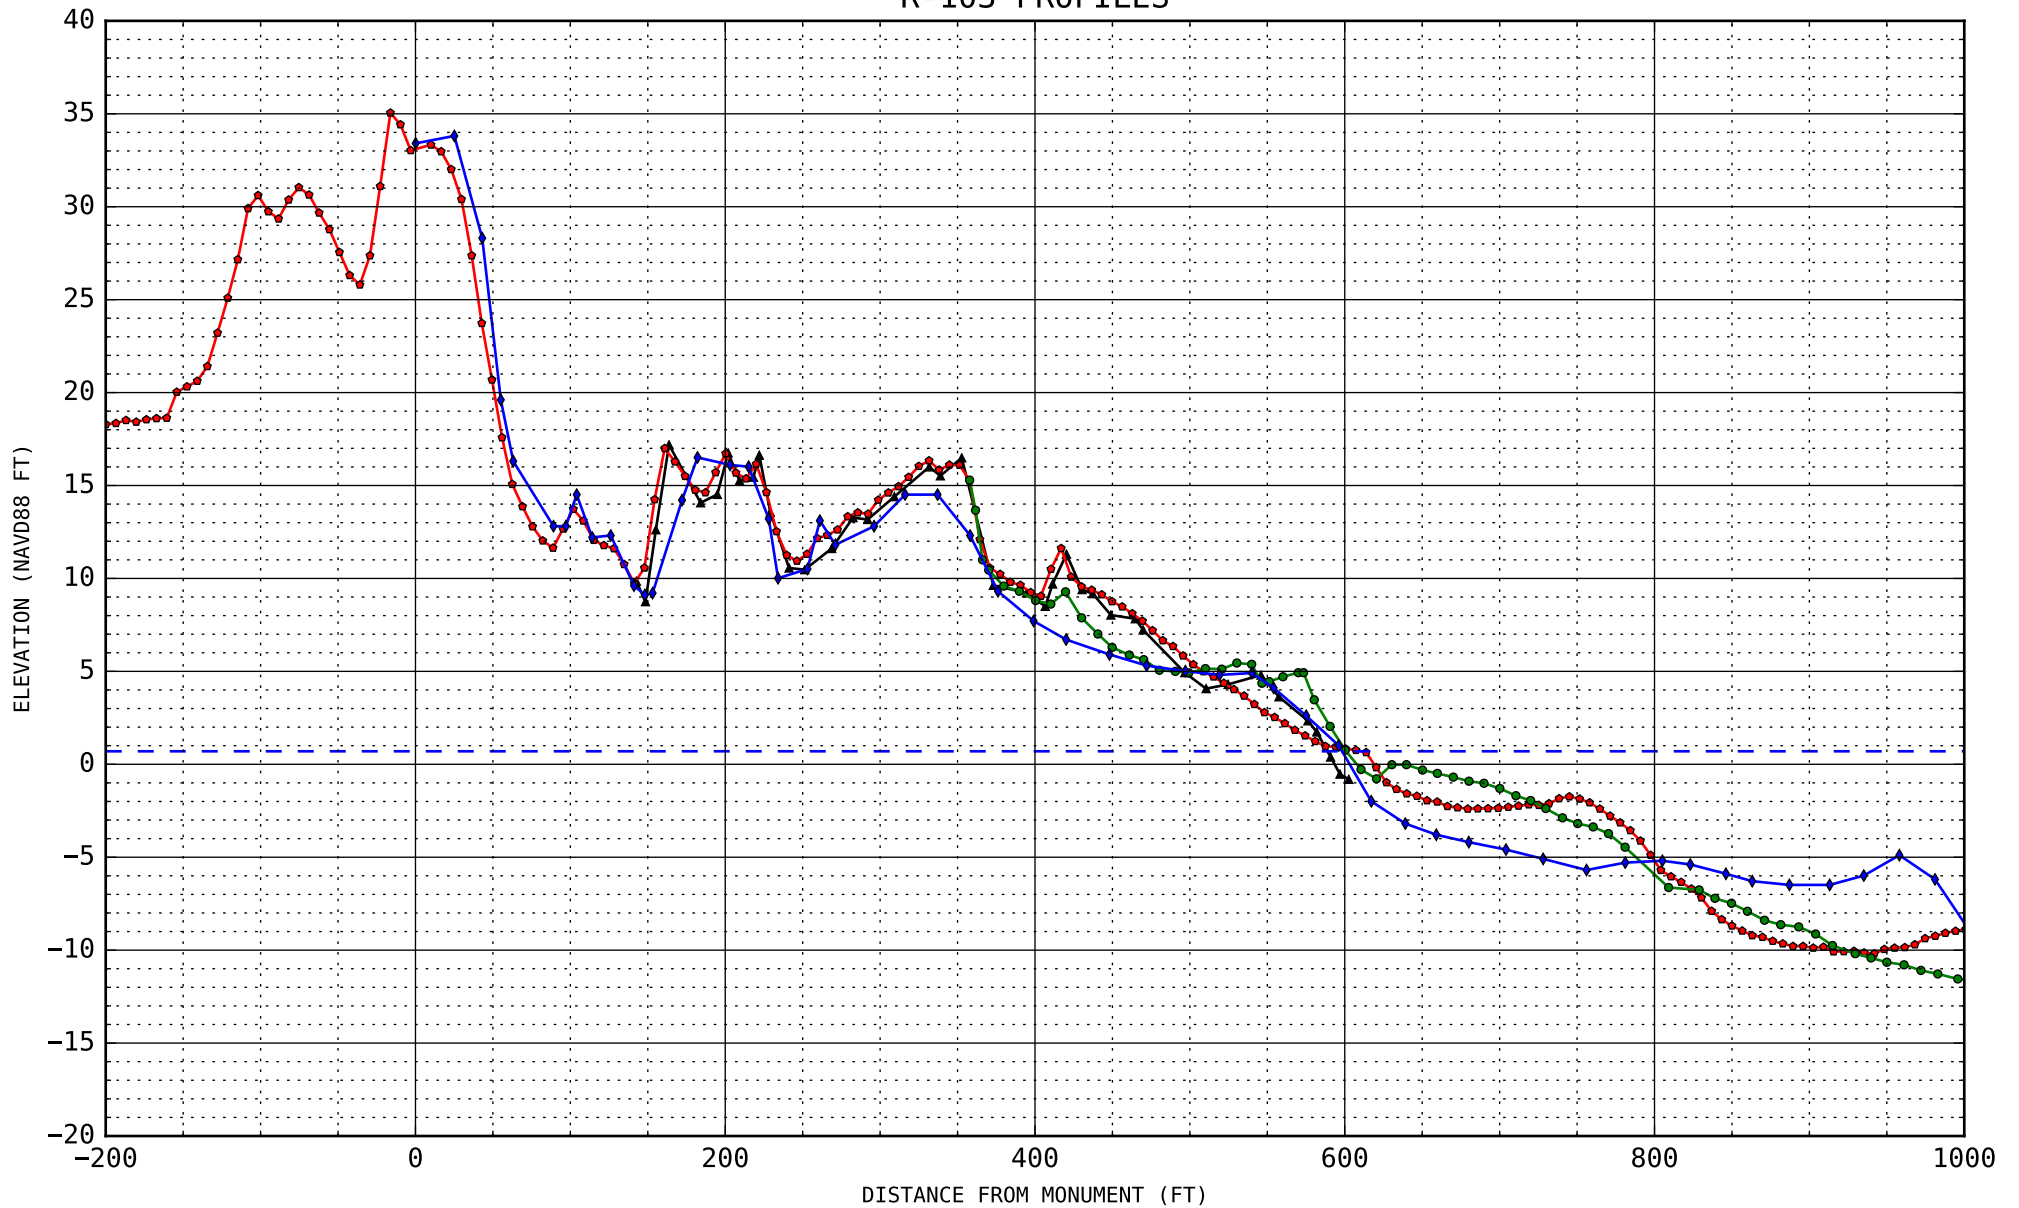
# R-103 PROFILES

- ▲ 2019-APR CONDITION BY DEP
- 2018-OCT MONITORING BY USACE-LIDAR
- 2013-SEP MONITORING BY USACE
- ◆ 2007-FEB MONITORING BY MAE
- - - MHW CONTOUR (0.7 FT)

RANGE: R-103  
EST DATE: JUN1973  
SURVEY DATE: 18APR19  
AZIMUTH: 202.0

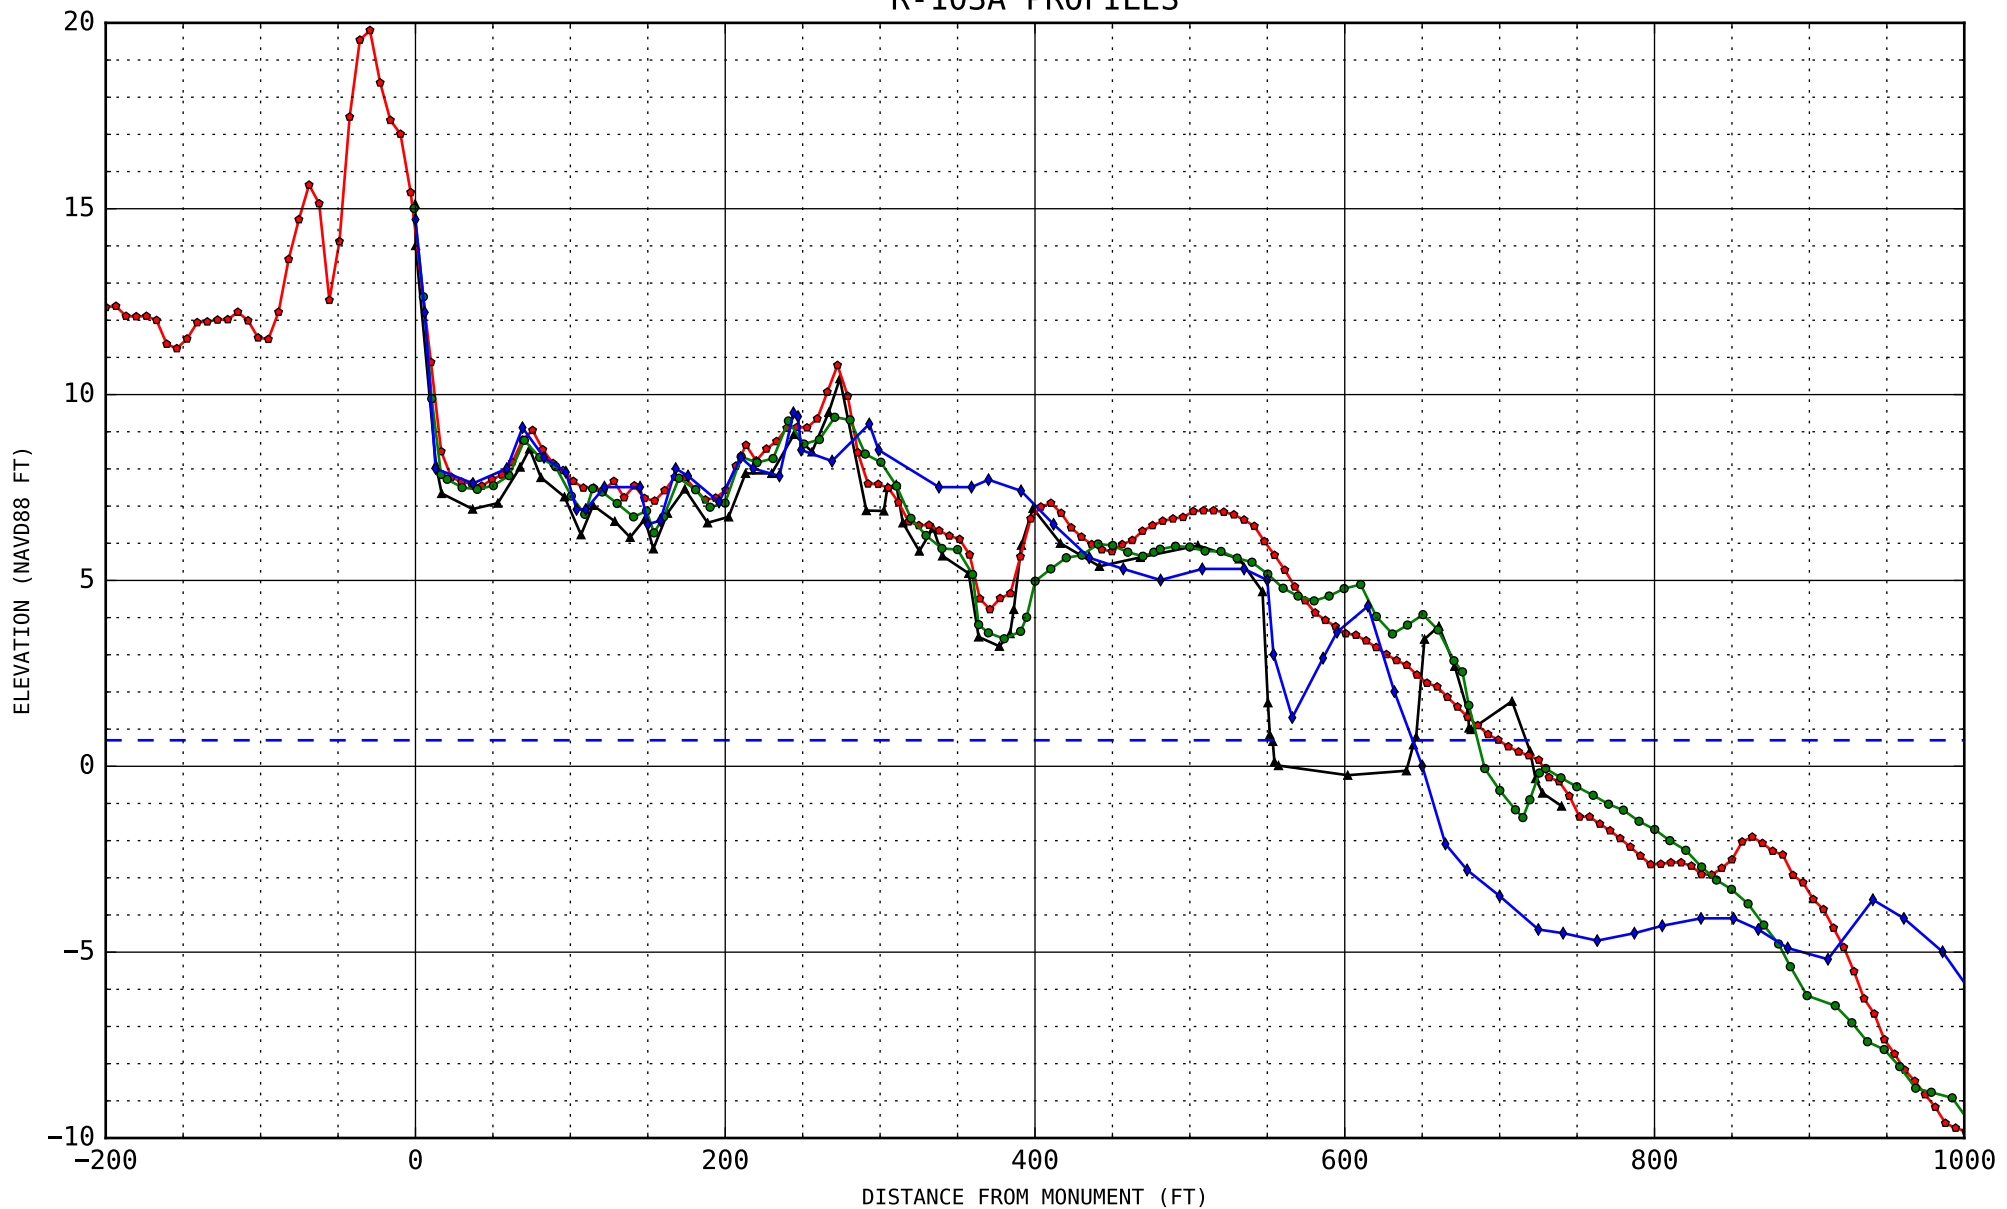
# R-103A PROFILES

- ▲ 2019-APR CONDITION BY DEP
- 2018-OCT MONITORING BY USACE-LIDAR
- 2013-SEP MONITORING BY USACE
- ◆ 2007-FEB MONITORING BY MAE
- - - MHW CONTOUR (0.7 FT)

RANGE: R-103A  
 EST DATE: NOV1980  
 SURVEY DATE: 18APR19  
 AZIMUTH: 202.0

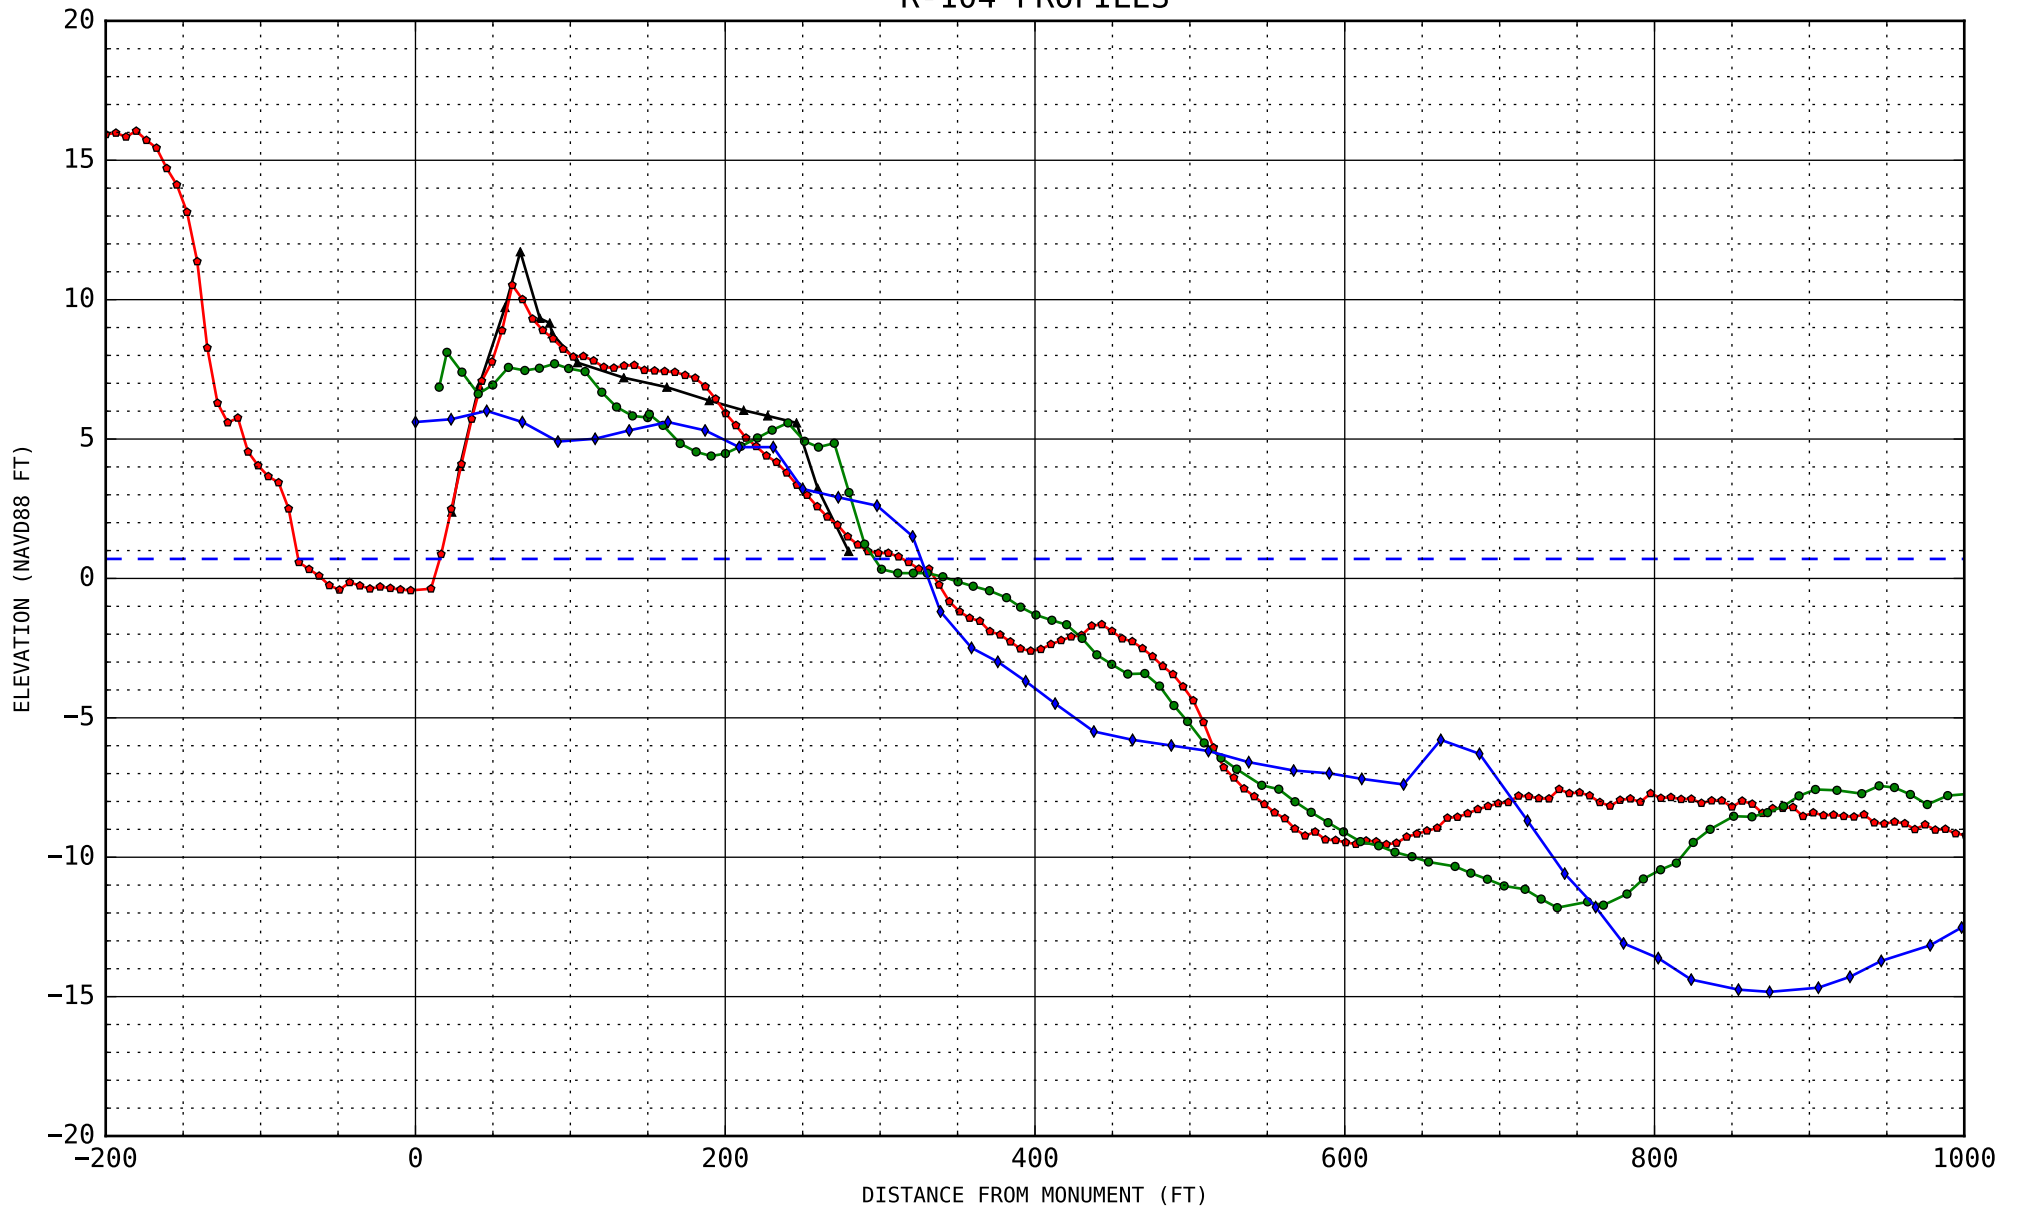
# R-104 PROFILES

- ▲ 2019-APR CONDITION BY DEP
- 2018-OCT MONITORING BY USACE-LIDAR
- 2013-SEP MONITORING BY USACE
- ◆ 2007-FEB MONITORING BY MAE
- - - MHW CONTOUR (0.7 FT)

RANGE: R-104  
EST DATE: OCT1995  
SURVEY DATE: 19APR19  
AZIMUTH: 202.0

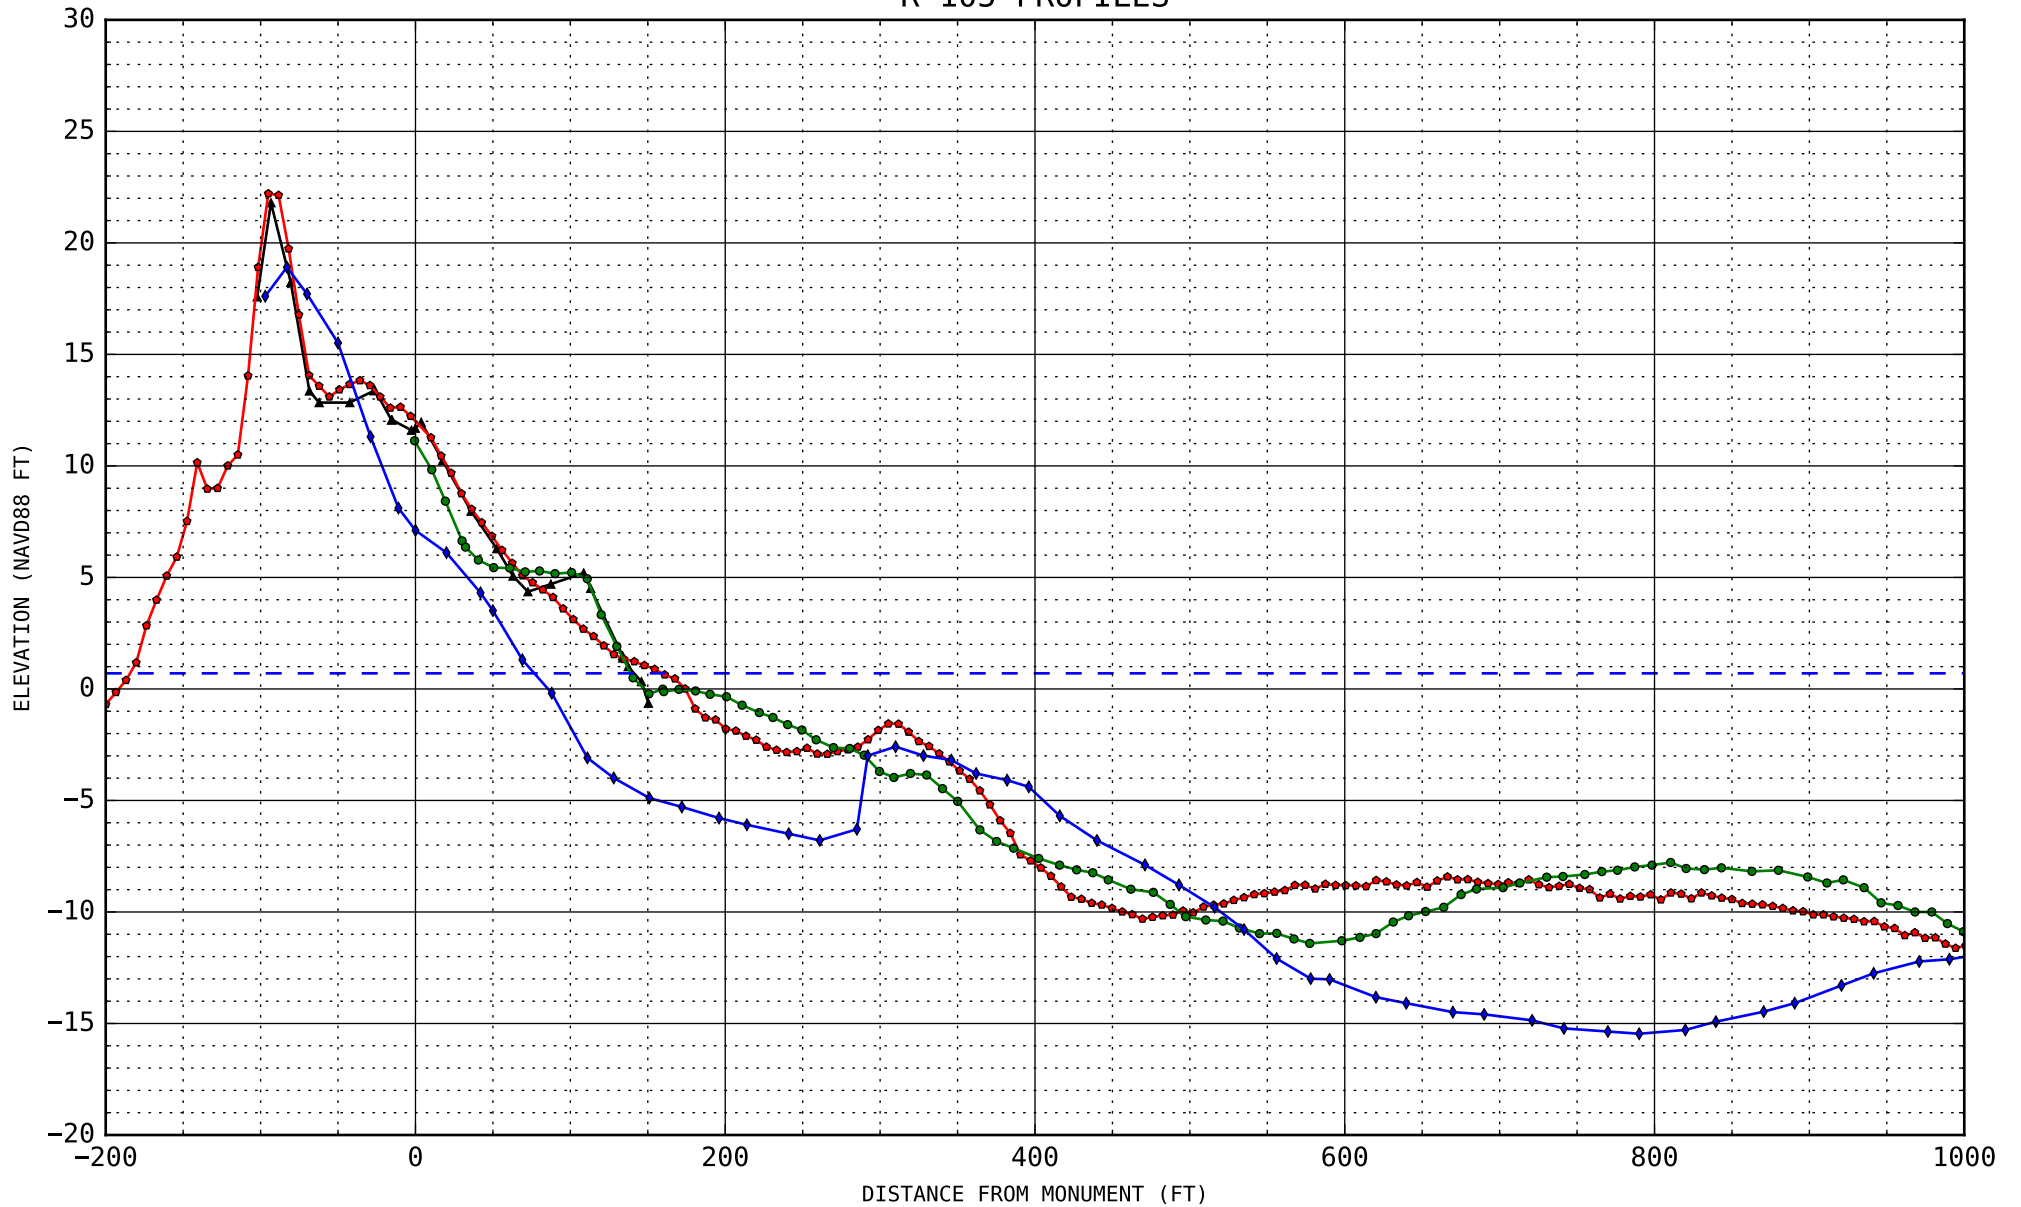
# R-105 PROFILES

- ▲ 2019-APR CONDITION BY DEP
- 2018-OCT MONITORING BY USACE-LIDAR
- 2013-SEP MONITORING BY USACE
- ◆ 2007-FEB MONITORING BY MAE
- - - MHW CONTOUR (0.7 FT)

RANGE: R-105  
EST DATE: M&E1997  
SURVEY DATE: 19APR19  
AZIMUTH: 202.0
