# R-1 PROFILES

WALTON  
PROGRAM SUPPORT GIS  
DIVISION OF WATER RESOURCE MANAGEMENT  
FLORIDA DEPARTMENT OF ENVIRONMENTAL PROTECTION

RANGE: R-1  
EST DATE: NOV1980  
SURVEY DATE: 04APR19  
AZIMUTH: 190.0

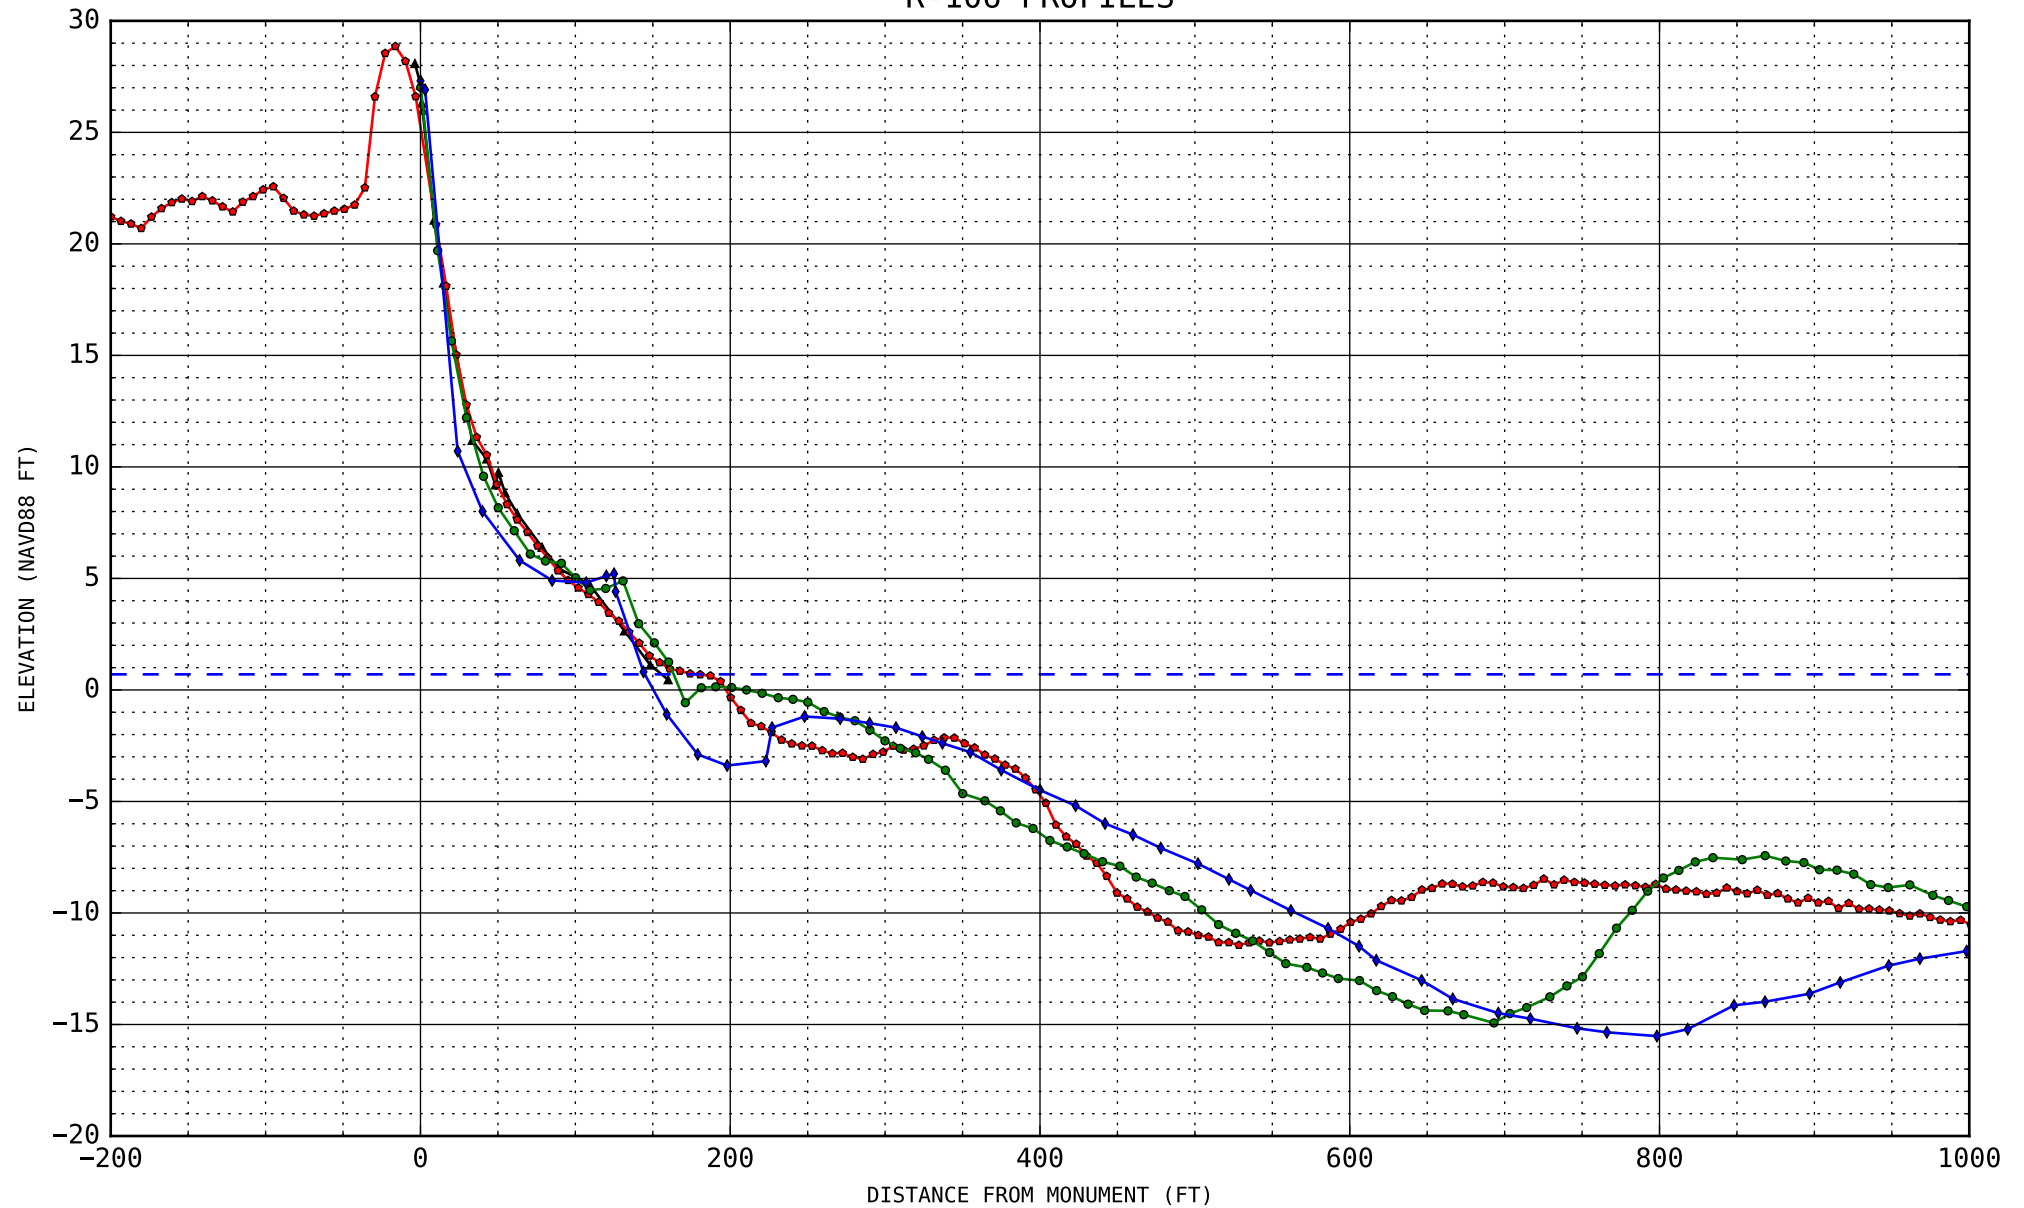
# R-106 PROFILES

- ▲ 2019-APR CONDITION BY DEP
- 2018-OCT MONITORING BY USACE-LIDAR
- 2013-SEP MONITORING BY USACE
- ◆ 2007-FEB MONITORING BY MAE
- - - MHW CONTOUR (0.7 FT)

RANGE: R-106  
EST DATE: NOV1980  
SURVEY DATE: 19APR19  
AZIMUTH: 202.0

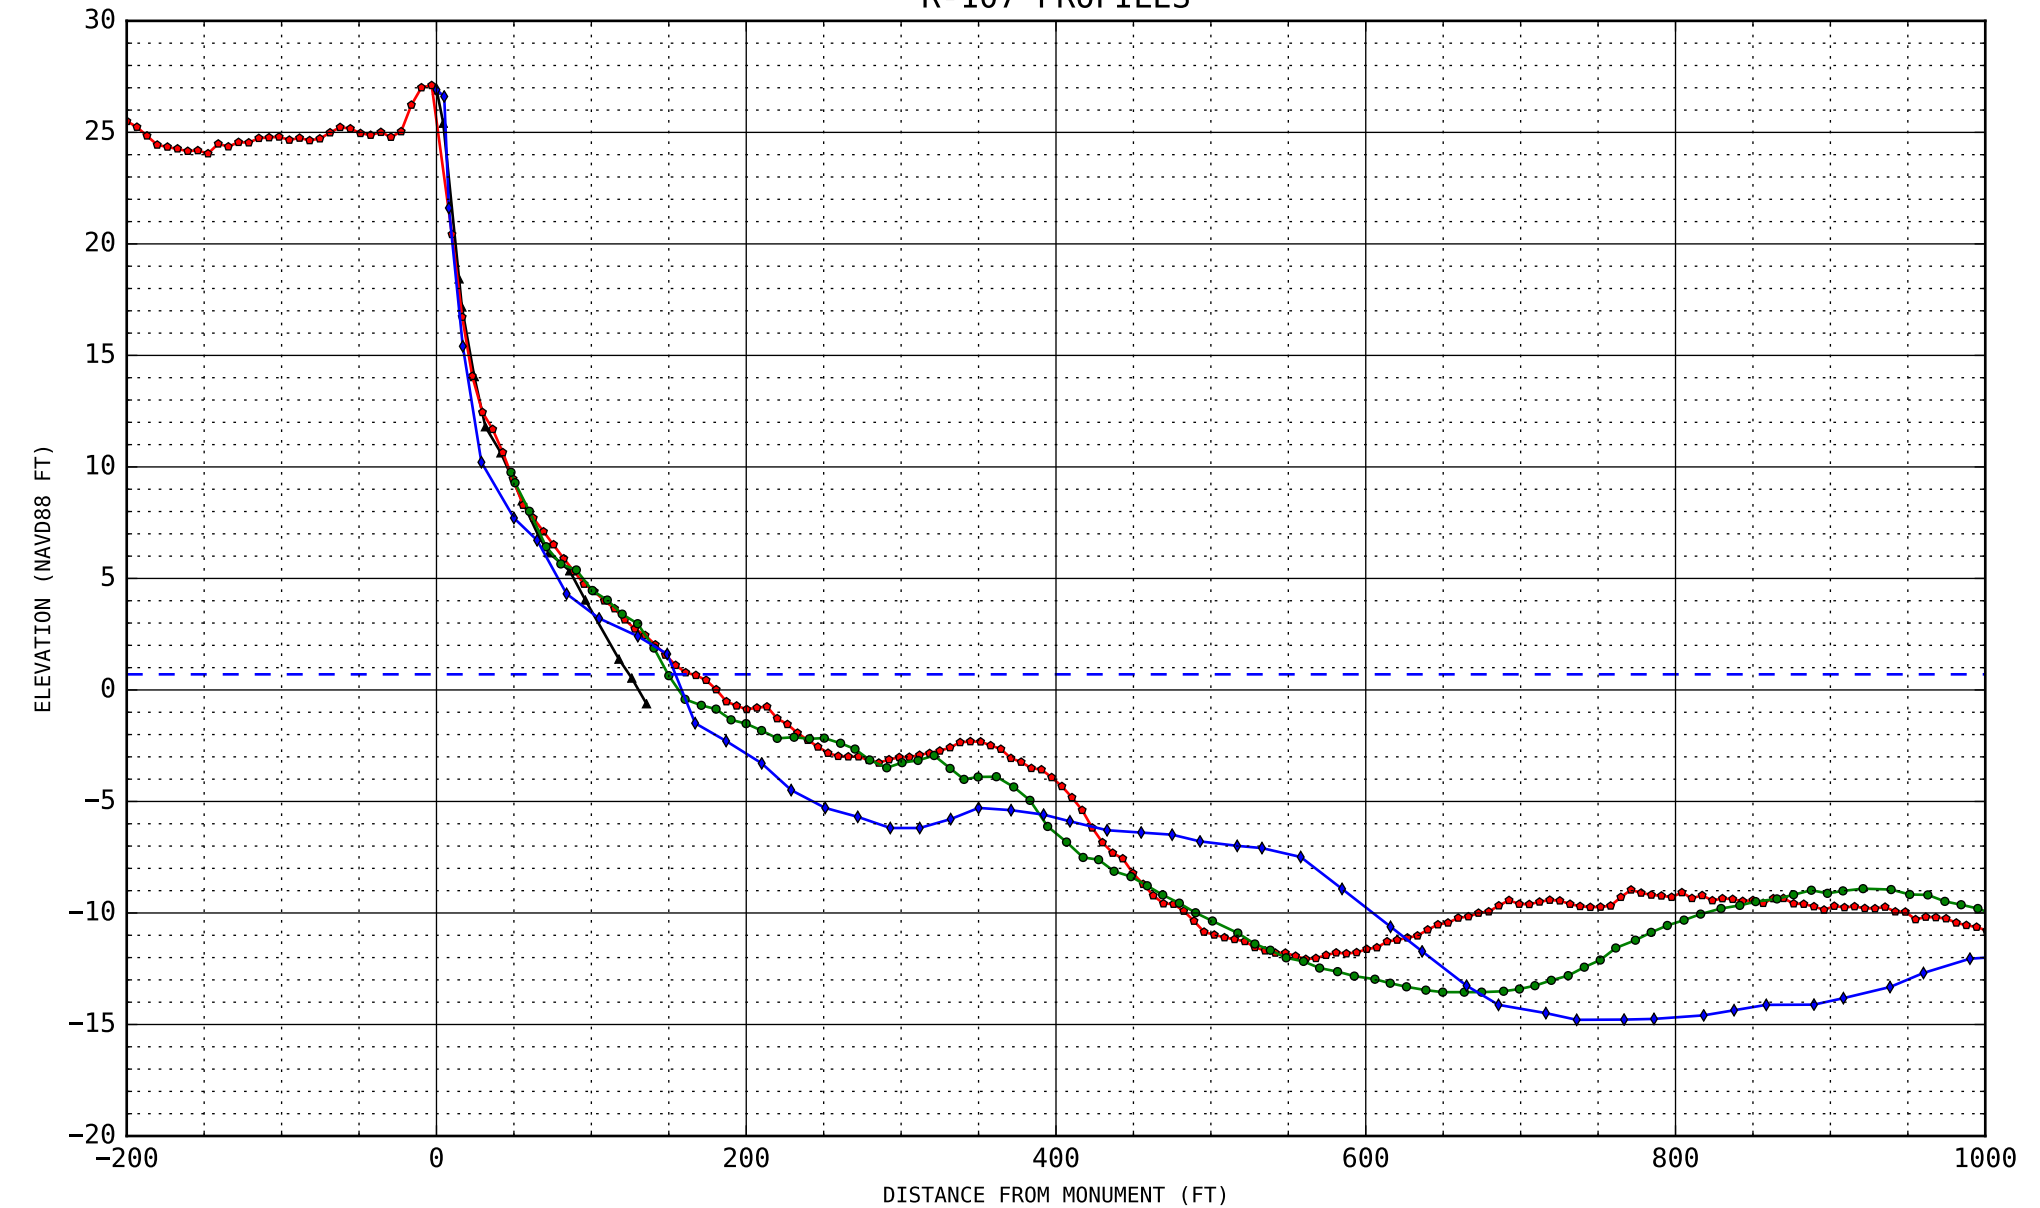
# R-107 PROFILES

- ▲ 2019-APR CONDITION BY DEP
- 2018-OCT MONITORING BY USACE-LIDAR
- 2013-SEP MONITORING BY USACE
- ◆ 2007-FEB MONITORING BY MAE
- - - MHW CONTOUR (0.7 FT)

RANGE: R-107  
EST DATE: OCT1994  
SURVEY DATE: 19APR19  
AZIMUTH: 202.0

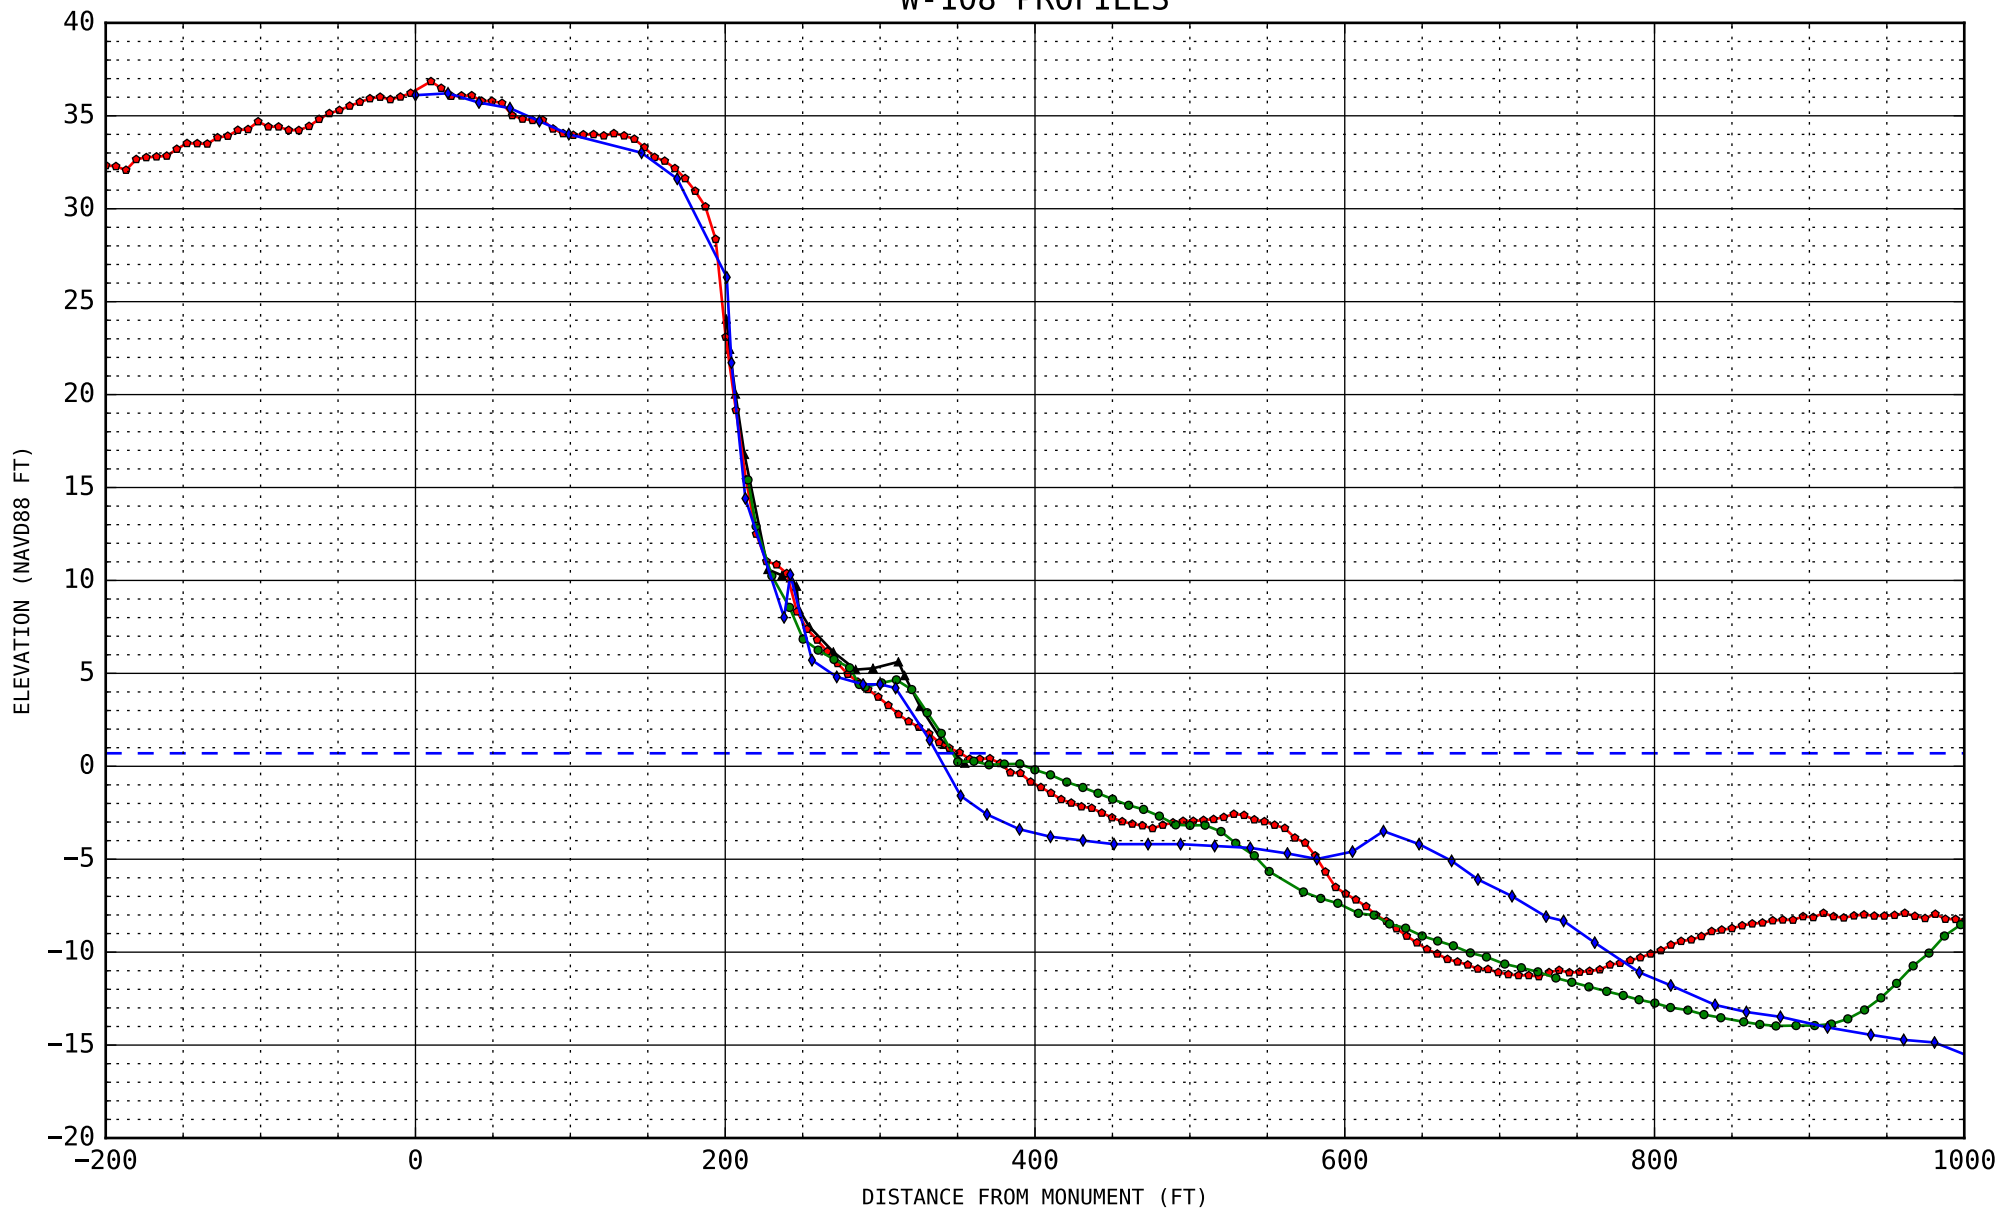
# W-108 PROFILES

- ▲ 2019-APR CONDITION BY DEP
- 2018-OCT MONITORING BY USACE-LIDAR
- 2013-SEP MONITORING BY USACE
- ◆ 2007-FEB MONITORING BY MAE
- - - MHW CONTOUR (0.7 FT)

RANGE: W-108  
EST DATE: AUG1976  
SURVEY DATE: 19APR19  
AZIMUTH: 202.0

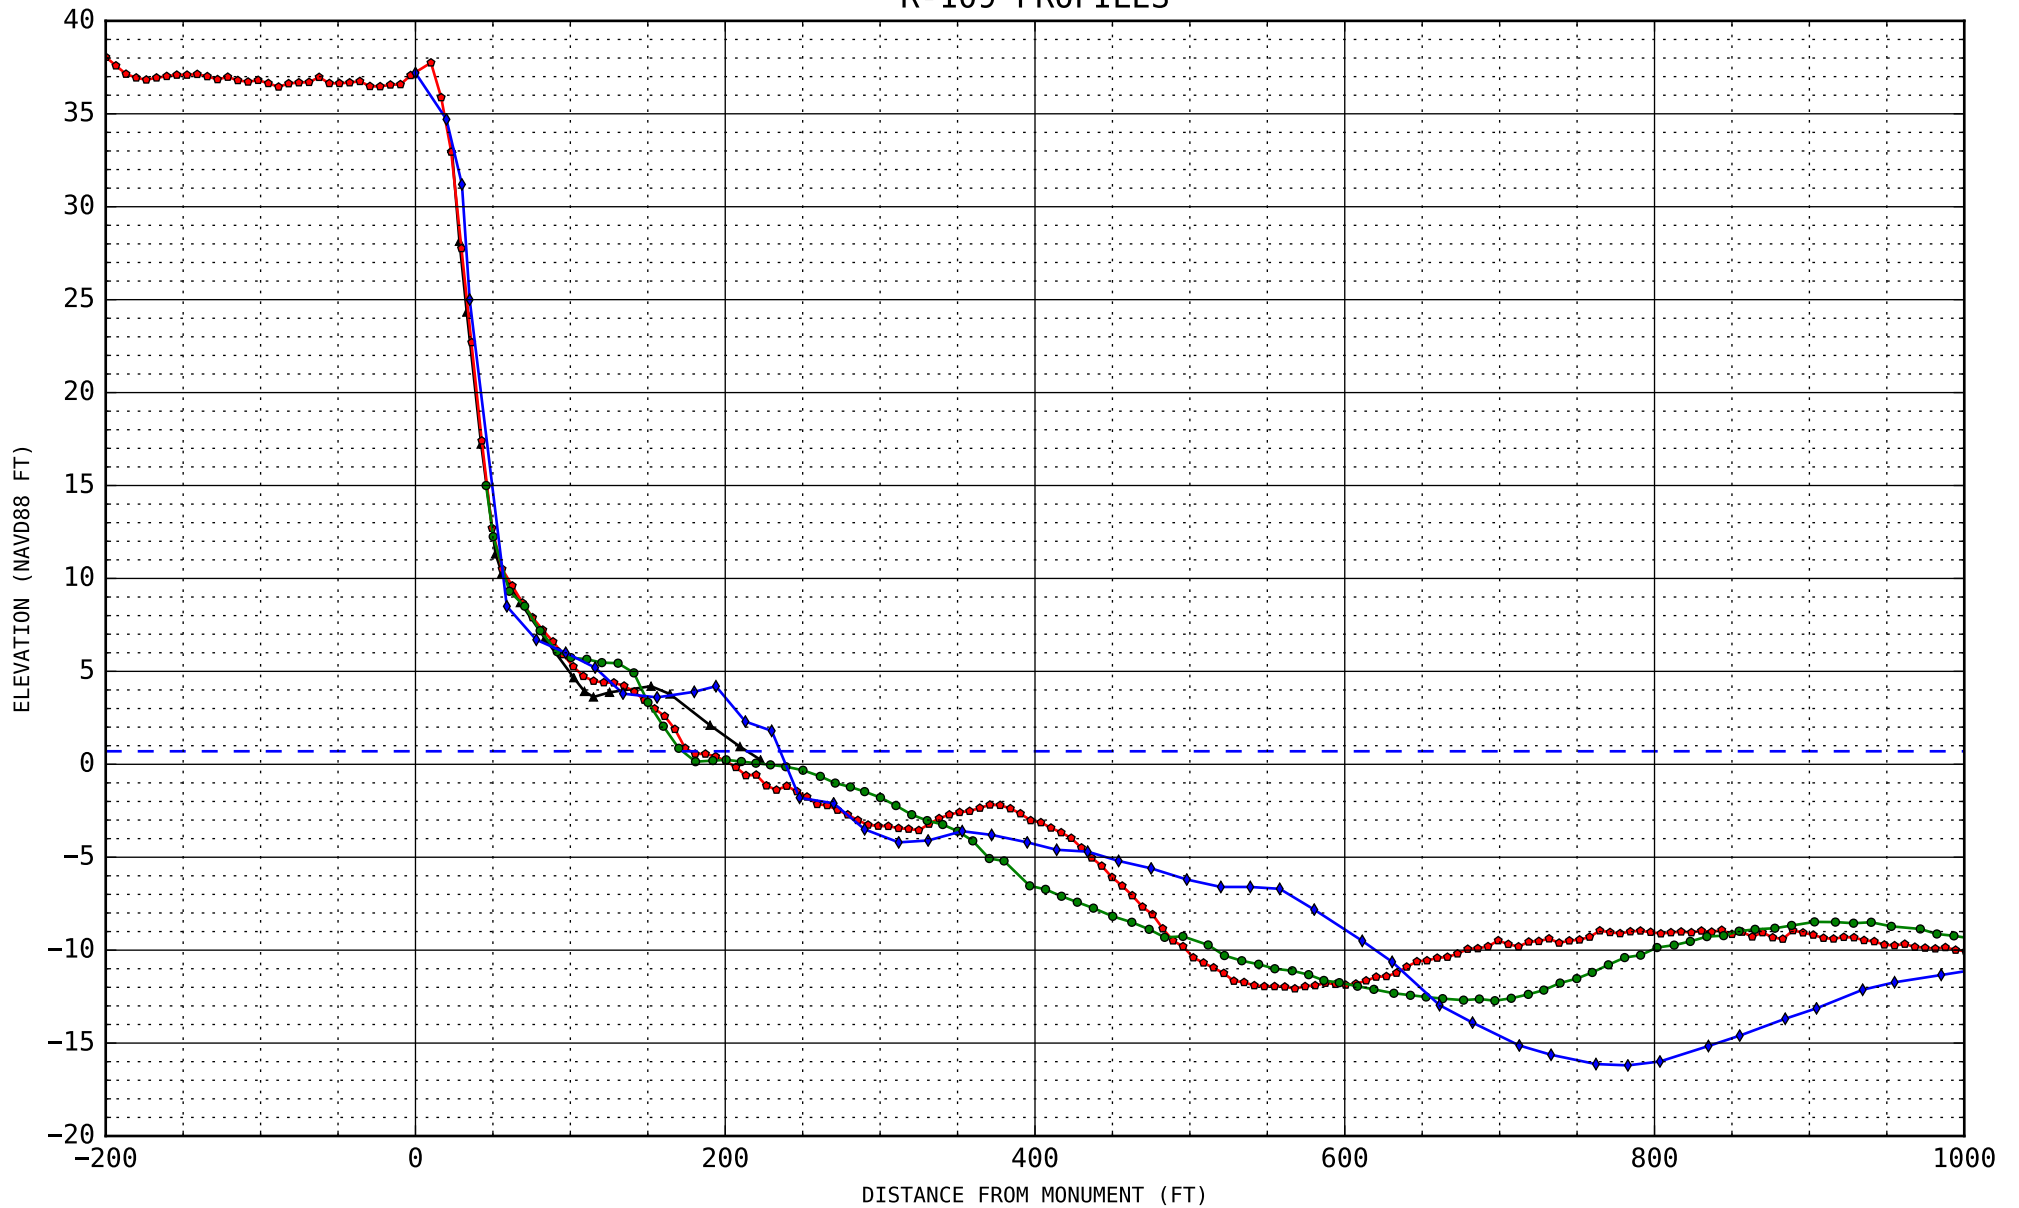
# R-109 PROFILES

- ▲ 2019-APR CONDITION BY DEP
- 2018-OCT MONITORING BY USACE-LIDAR
- 2013-SEP MONITORING BY USACE
- ◆ 2007-FEB MONITORING BY MAE
- - - MHW CONTOUR (0.7 FT)

RANGE: R-109  
EST DATE: JUN1973  
SURVEY DATE: 19APR19  
AZIMUTH: 202.0

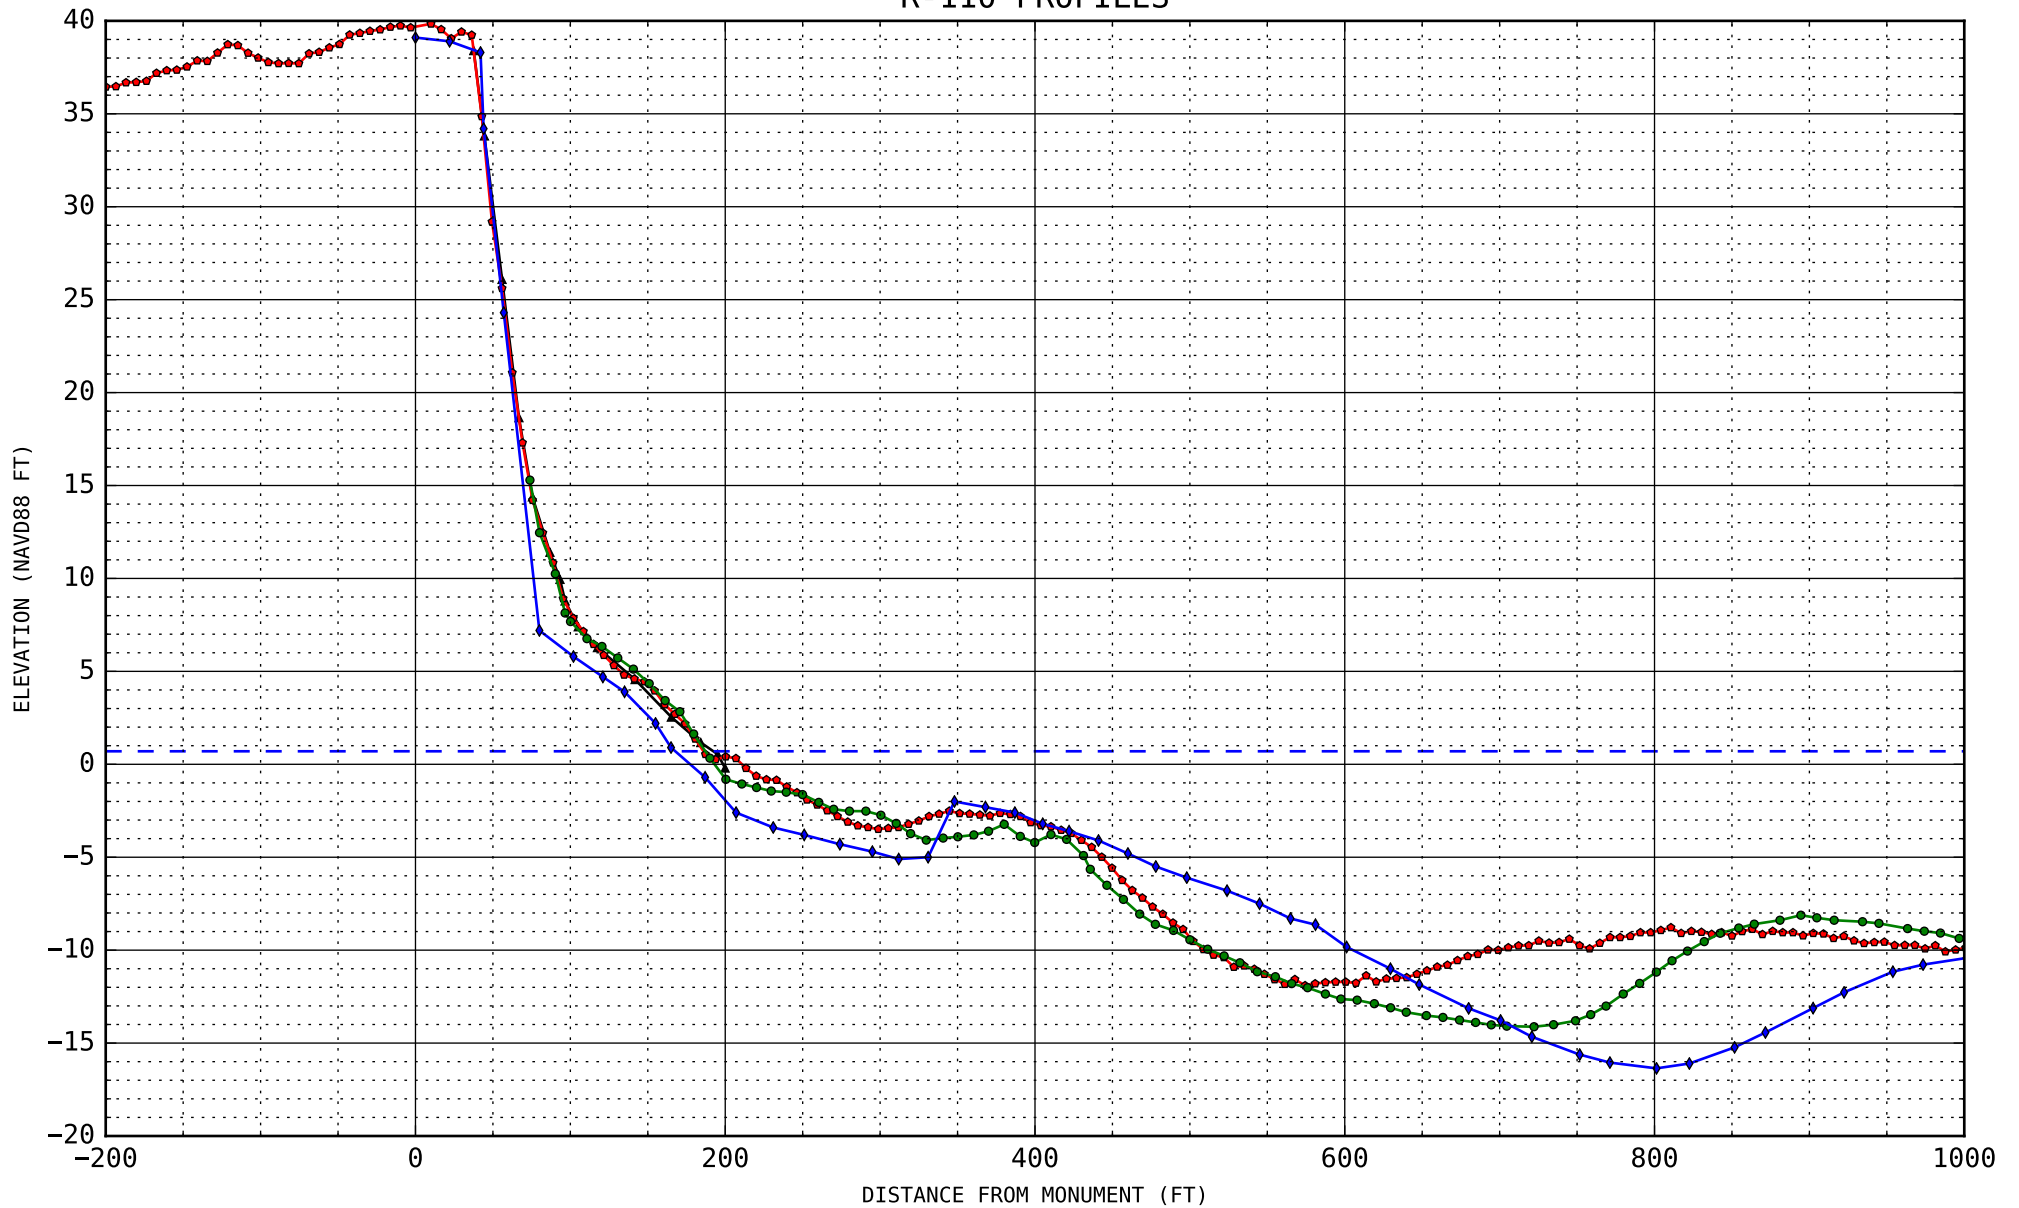
# R-110 PROFILES

- ▲ 2019-APR CONDITION BY DEP
- 2018-OCT MONITORING BY USACE-LIDAR
- 2013-SEP MONITORING BY USACE
- ◆ 2007-FEB MONITORING BY MAE
- - - MHW CONTOUR (0.7 FT)

RANGE: R-110  
EST DATE: NOV1980  
SURVEY DATE: 19APR19  
AZIMUTH: 202.0

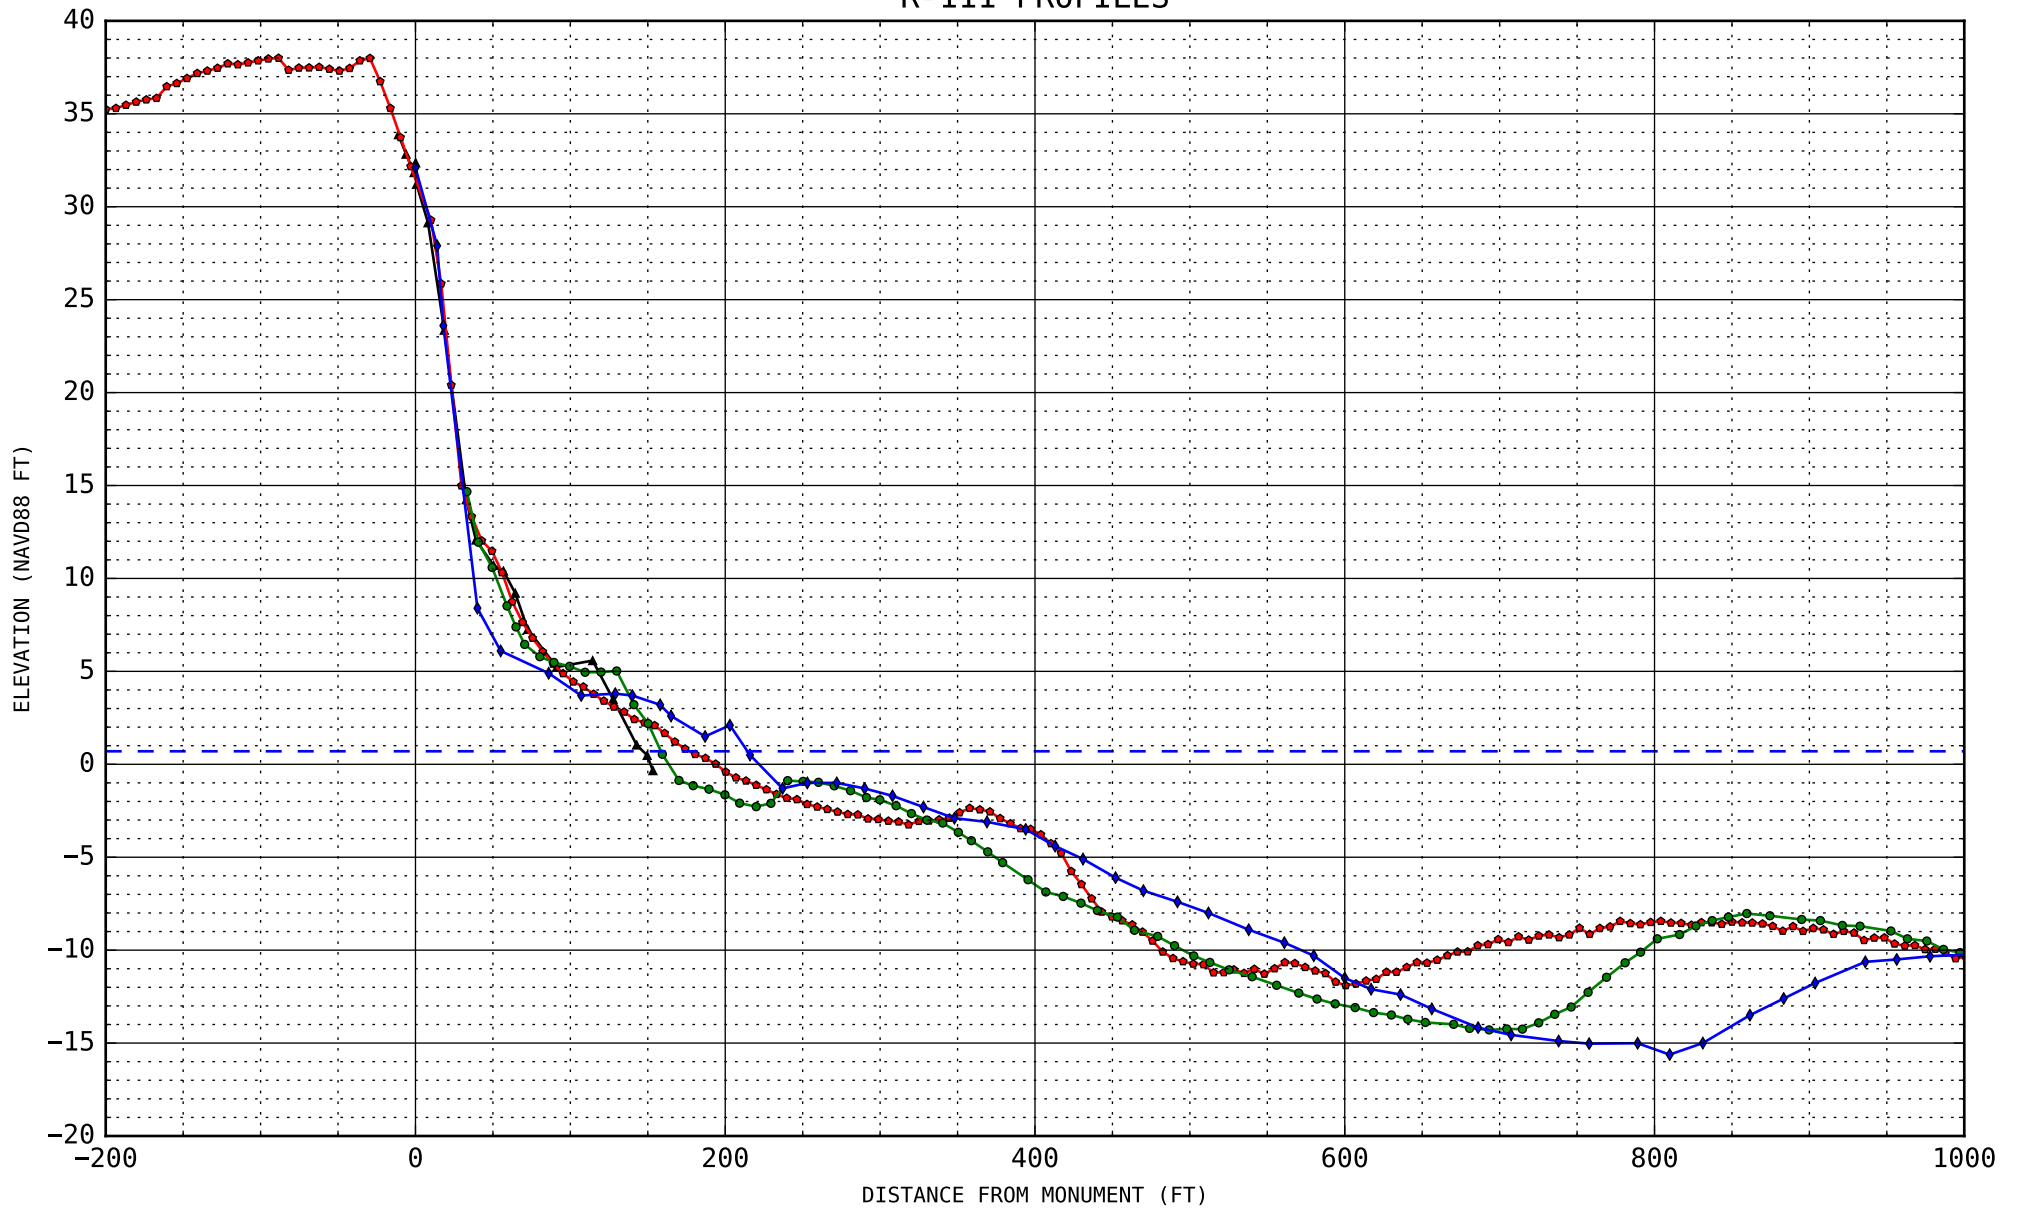
# R-111 PROFILES

- ▲ 2019-APR CONDITION BY DEP
- 2018-OCT MONITORING BY USACE-LIDAR
- 2013-SEP MONITORING BY USACE
- ◆ 2007-FEB MONITORING BY MAE
- - - MHW CONTOUR (0.7 FT)

RANGE: R-111  
EST DATE: OCT1994  
SURVEY DATE: 19APR19  
AZIMUTH: 202.0

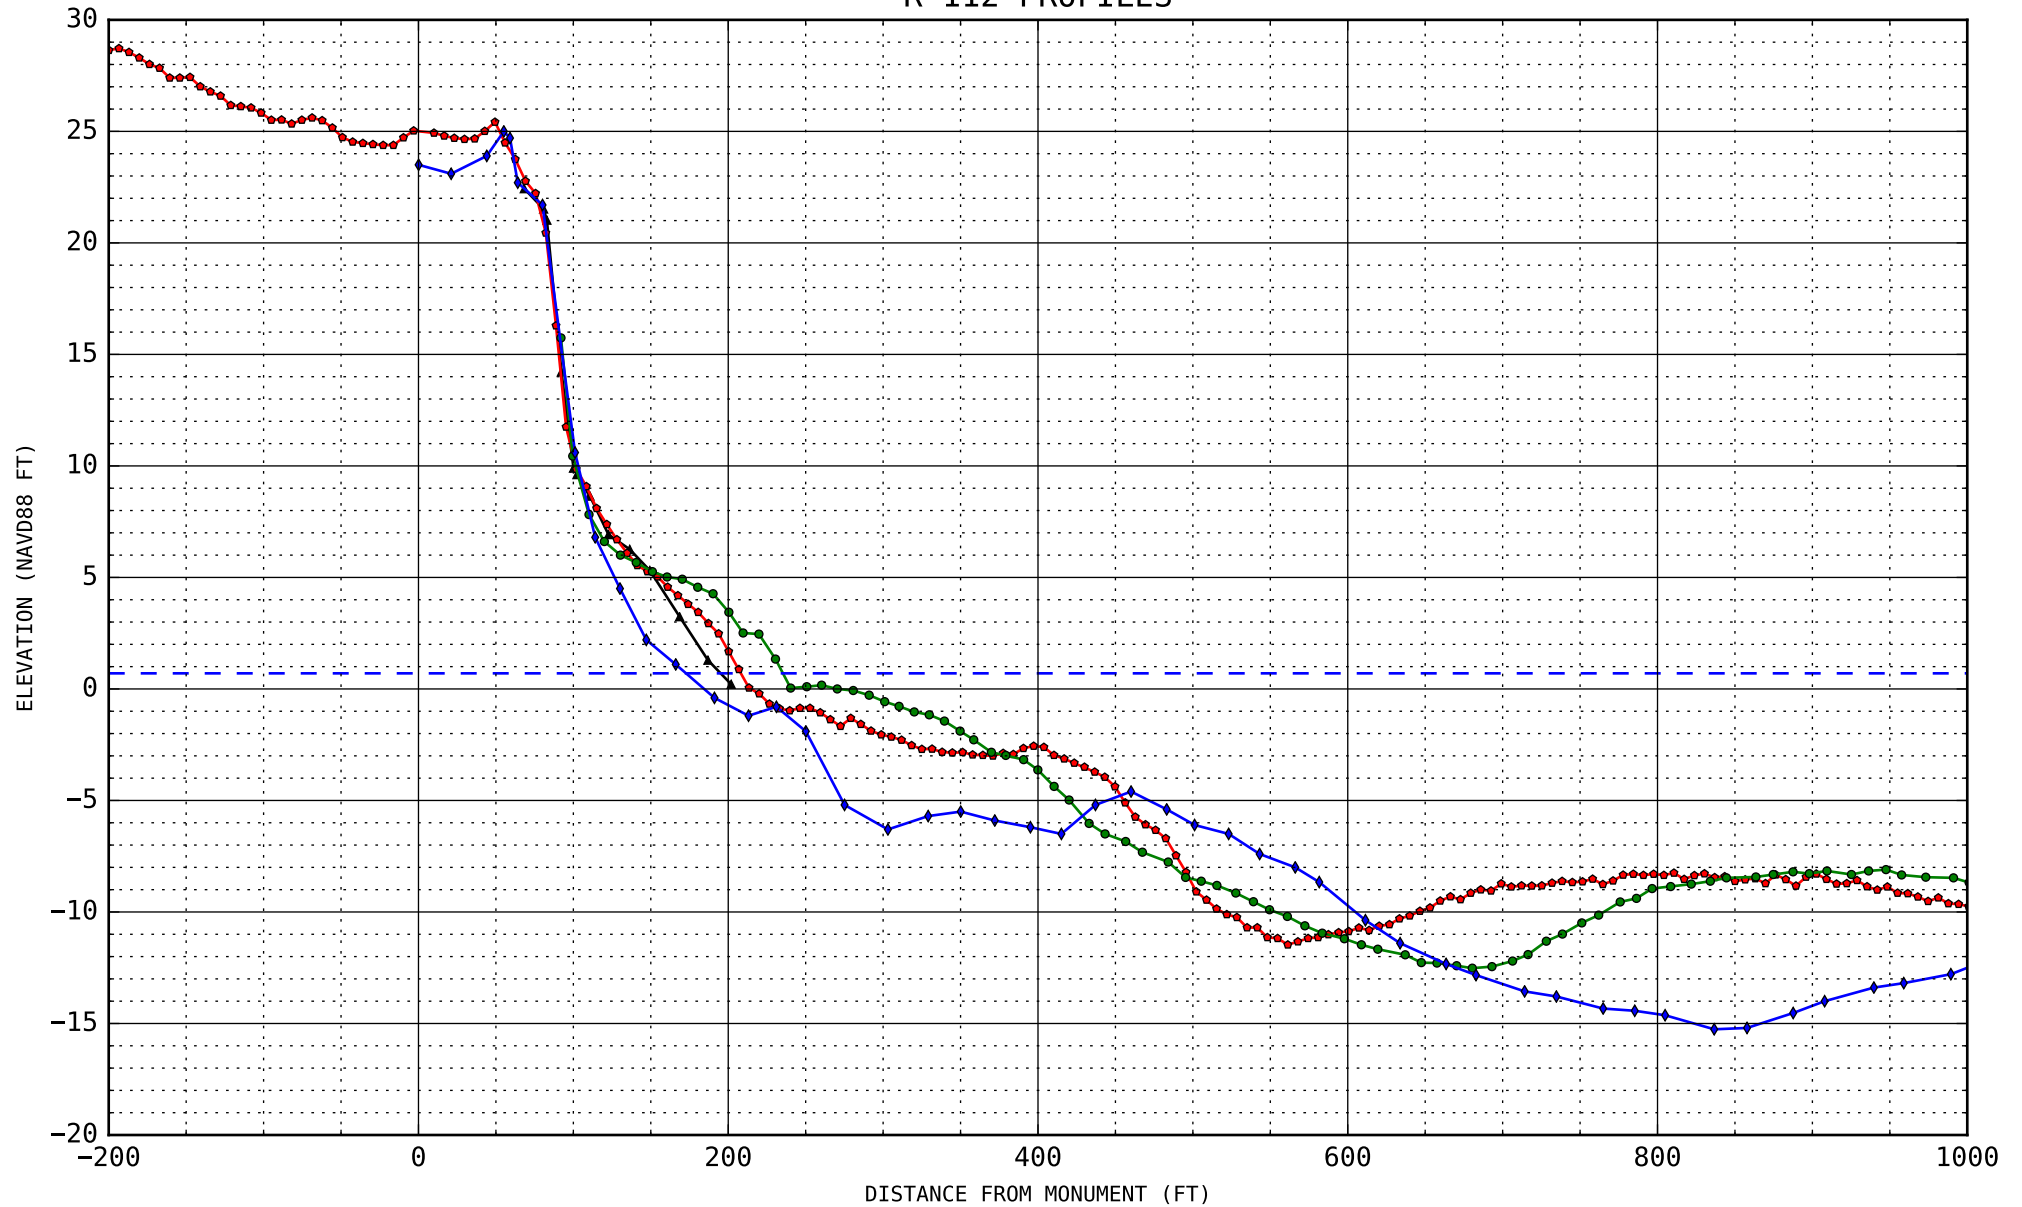
# R-112 PROFILES

- ▲ 2019-APR CONDITION BY DEP
- 2018-OCT MONITORING BY USACE-LIDAR
- 2013-SEP MONITORING BY USACE
- ◆ 2007-FEB MONITORING BY MAE
- - - MHW CONTOUR (0.7 FT)

RANGE: R-112  
 EST DATE: JUN1973  
 SURVEY DATE: 19APR19  
 AZIMUTH: 202.0

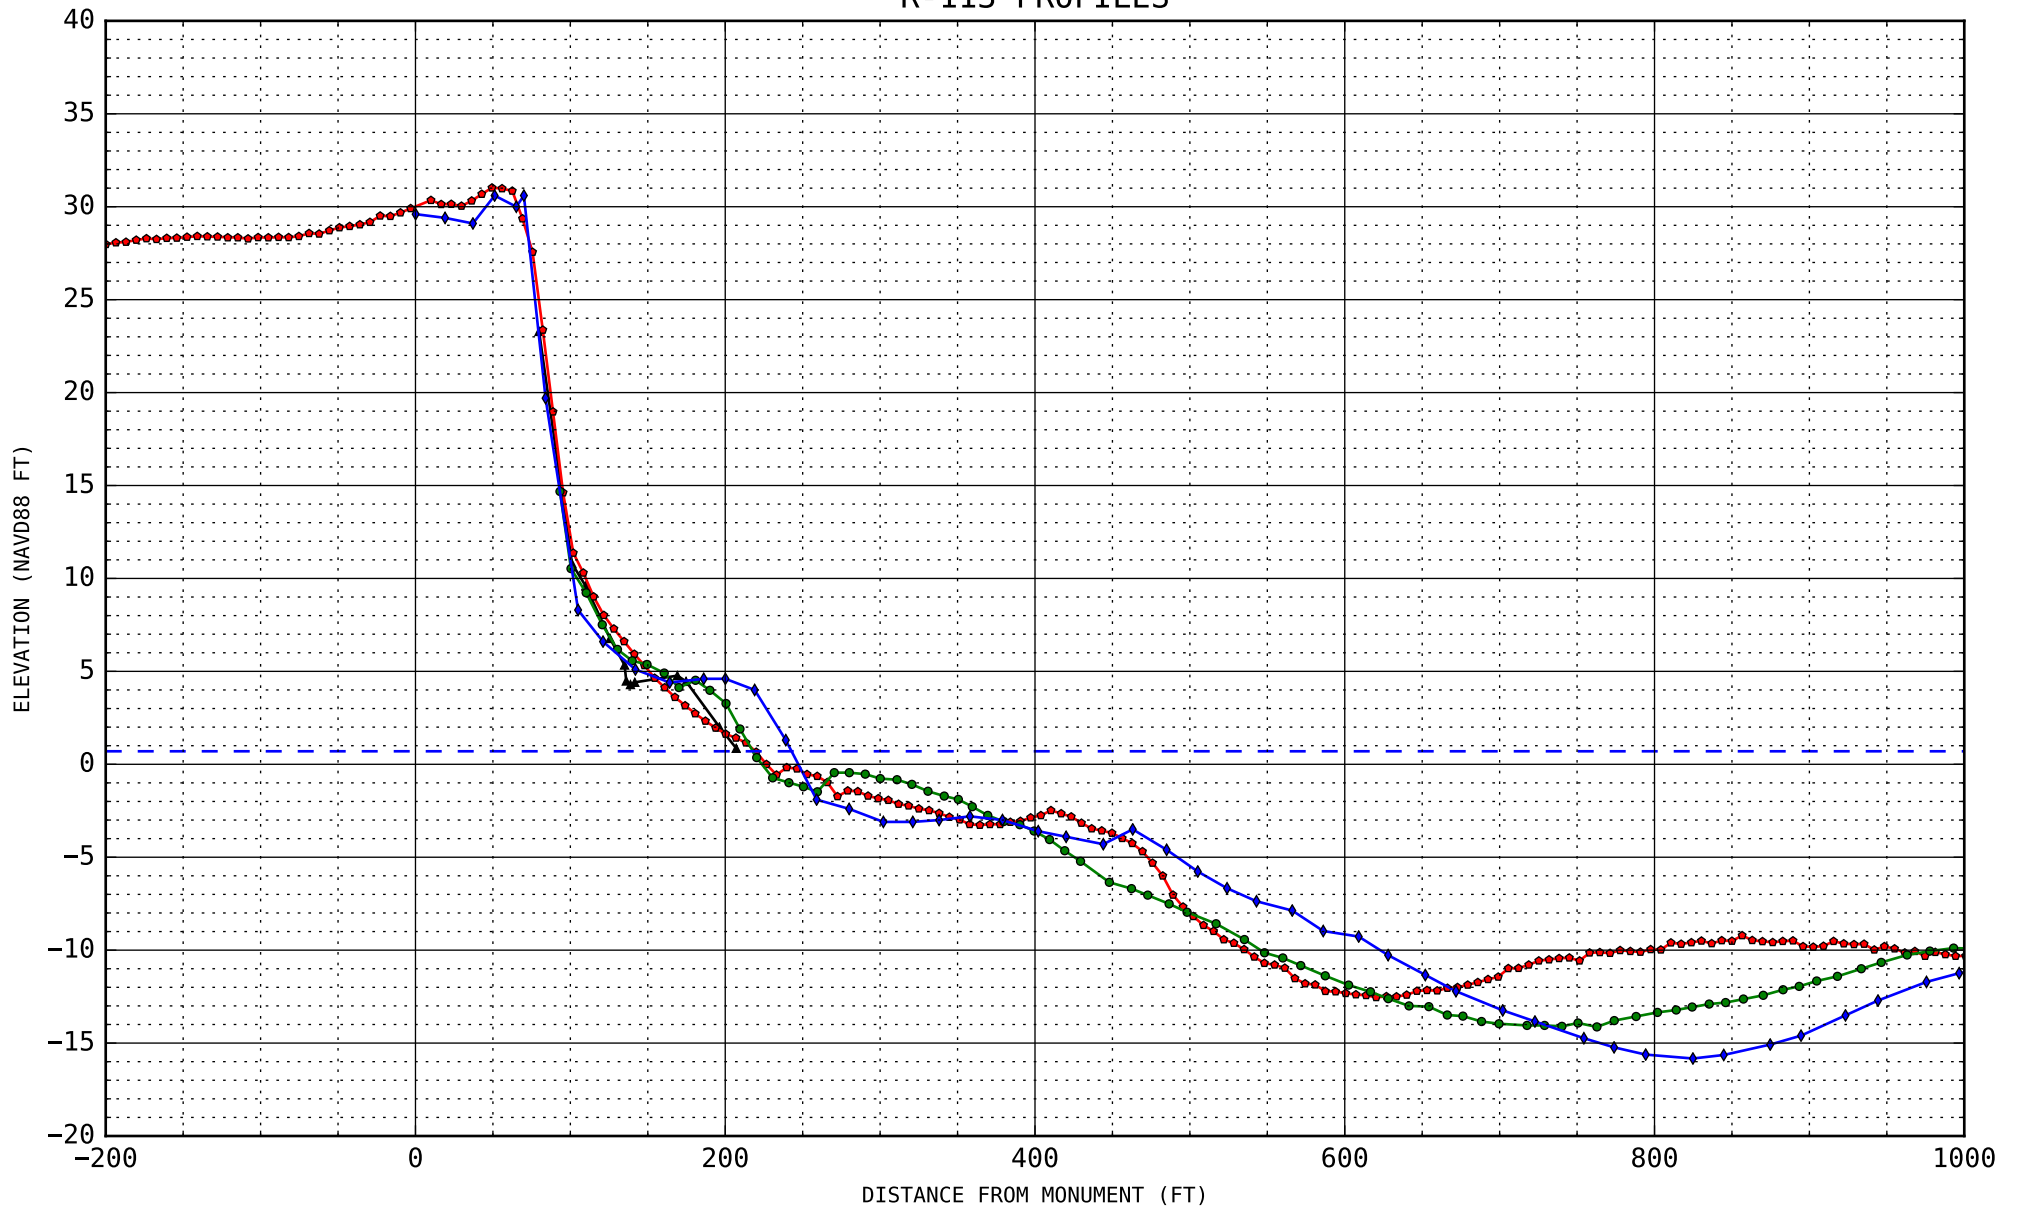
# R-113 PROFILES

- ▲ 2019-APR CONDITION BY DEP
- 2018-OCT MONITORING BY USACE-LIDAR
- 2013-SEP MONITORING BY USACE
- ◆ 2007-FEB MONITORING BY MAE
- - - MHW CONTOUR (0.7 FT)

RANGE: R-113  
EST DATE: NOV1980  
SURVEY DATE: 19APR19  
AZIMUTH: 202.0

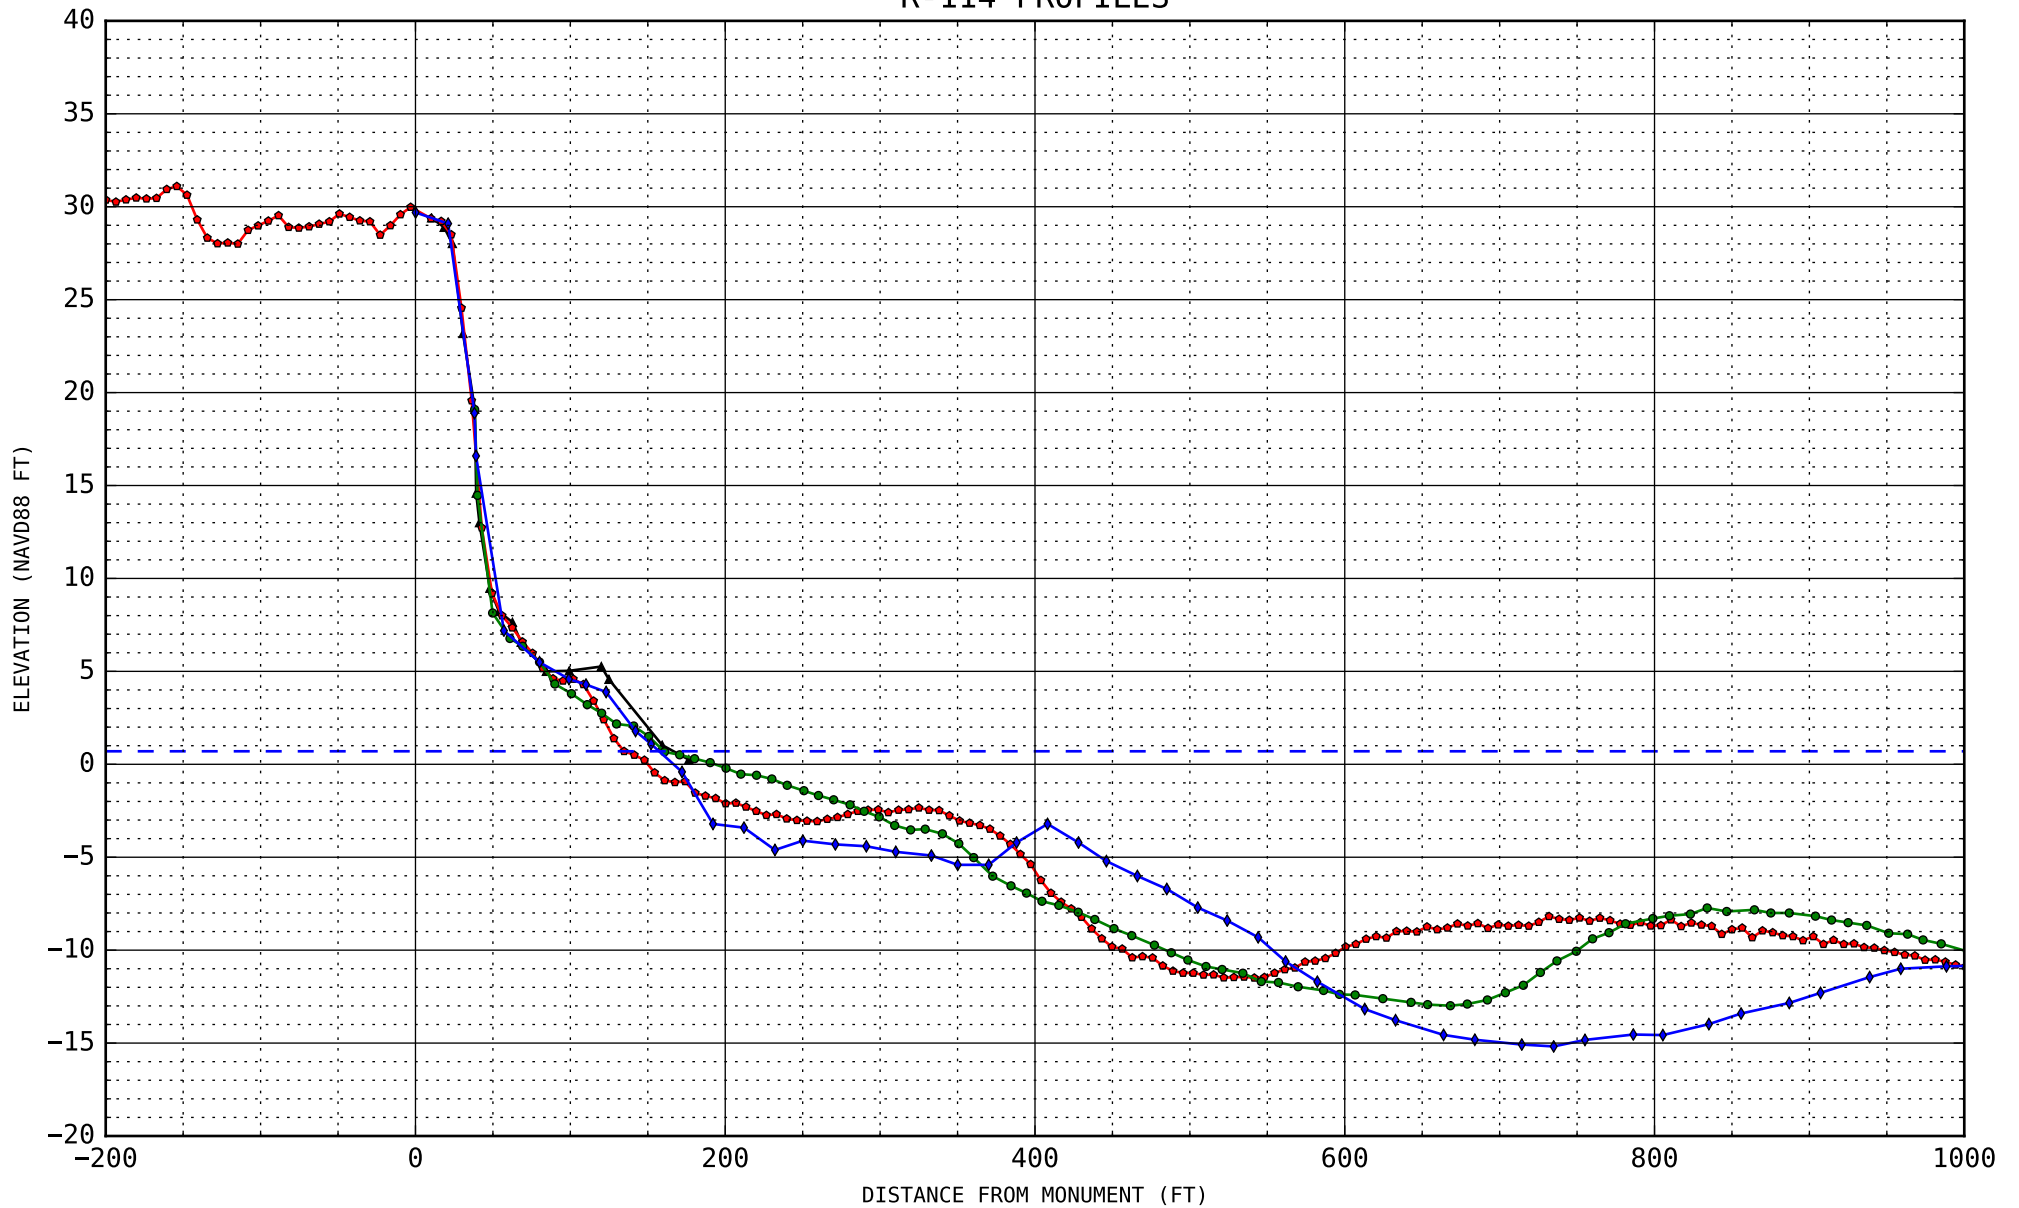
# R-114 PROFILES

- ▲ 2019-APR CONDITION BY DEP
- 2018-OCT MONITORING BY USACE-LIDAR
- 2013-SEP MONITORING BY USACE
- ◆ 2007-FEB MONITORING BY MAE
- - - MHW CONTOUR (0.7 FT)

RANGE: R-114  
EST DATE: NOV1980  
SURVEY DATE: 19APR19  
AZIMUTH: 202.0
