# R-1 PROFILES

WALTON  
PROGRAM SUPPORT GIS  
DIVISION OF WATER RESOURCE MANAGEMENT  
FLORIDA DEPARTMENT OF ENVIRONMENTAL PROTECTION

RANGE: R-1  
EST DATE: NOV1980  
SURVEY DATE: 04APR19  
AZIMUTH: 190.0

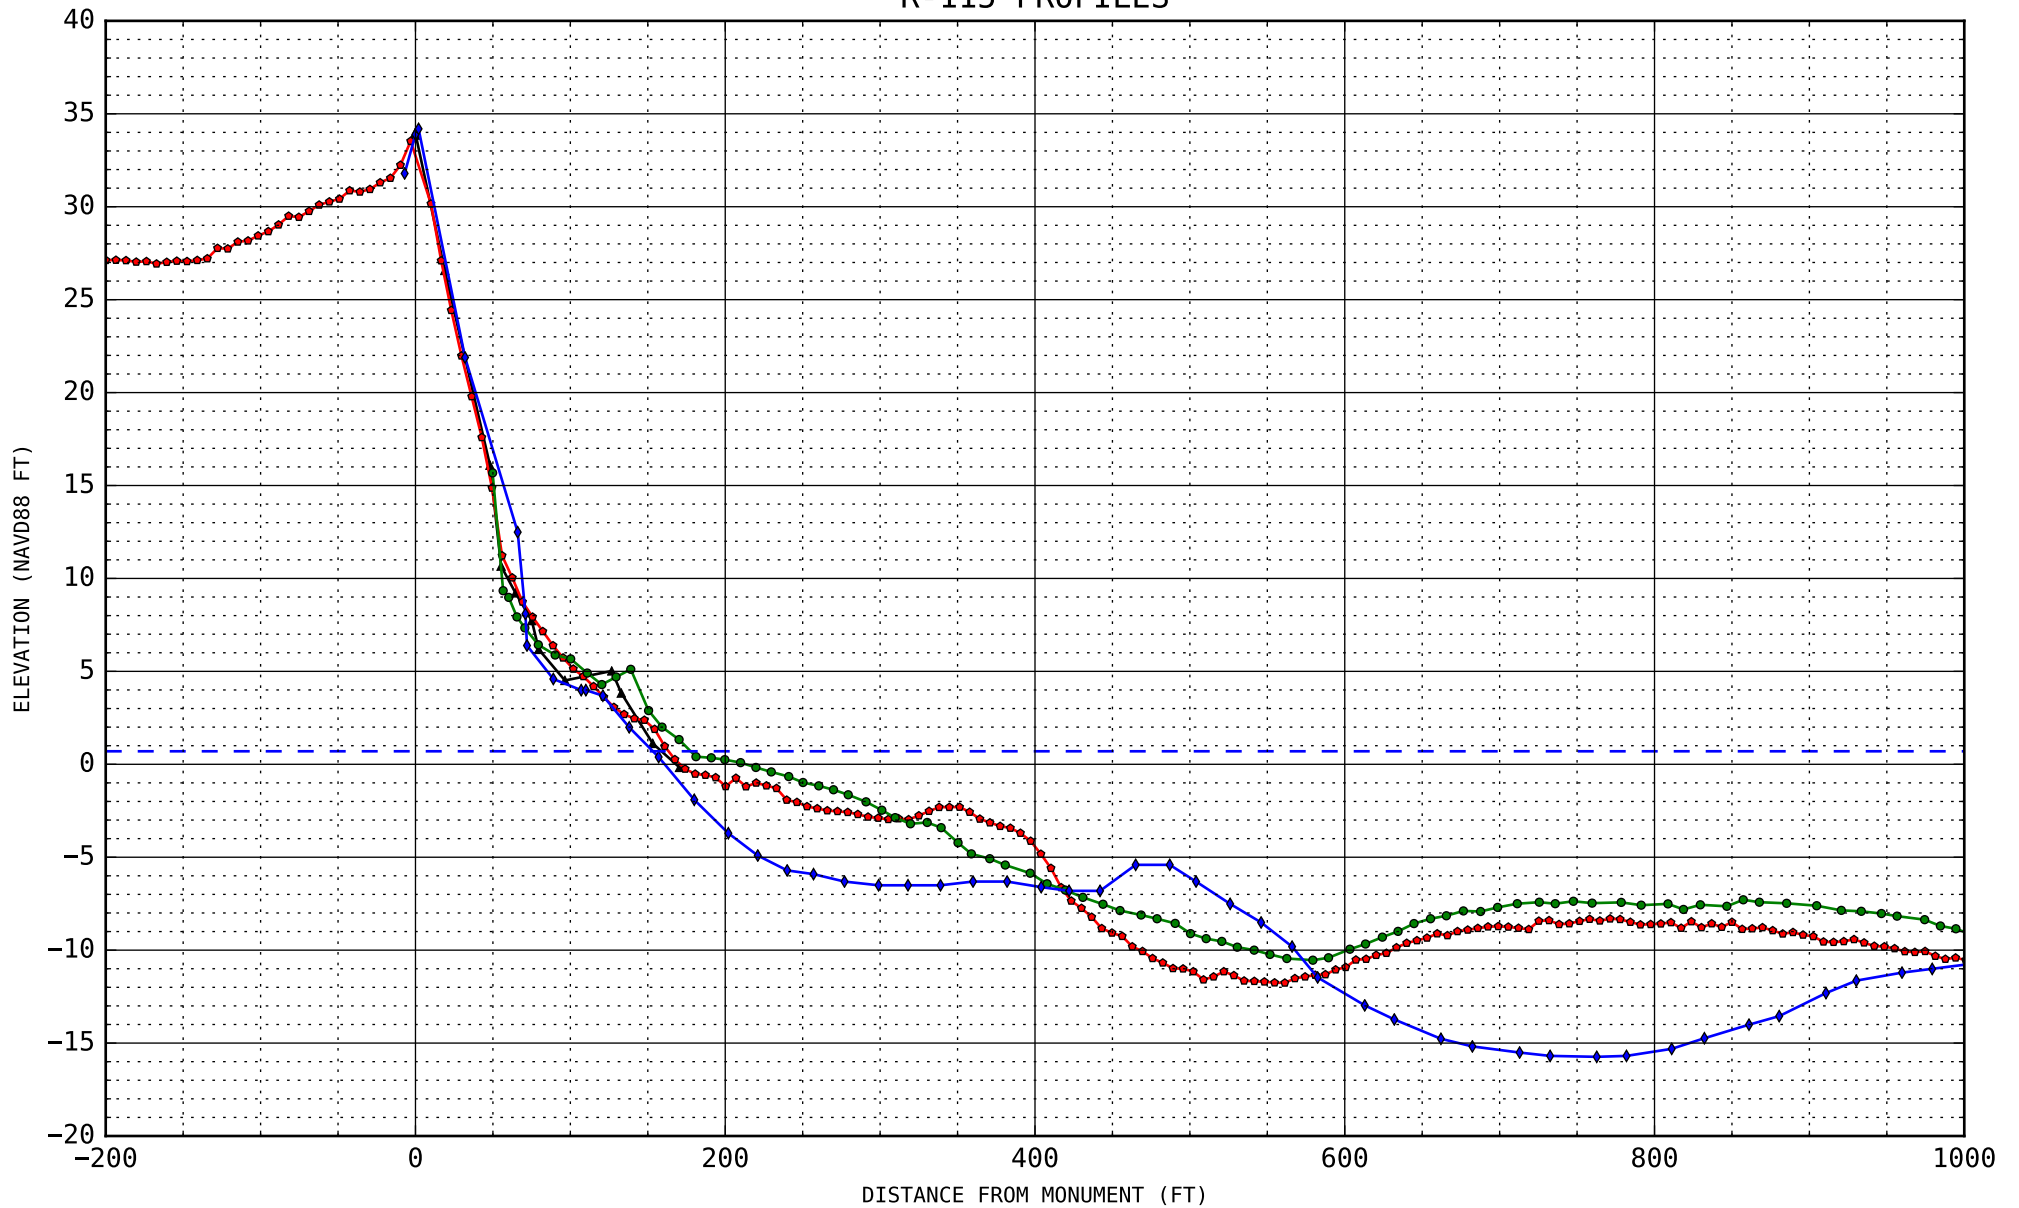
# R-115 PROFILES

- ▲ 2019-APR CONDITION BY DEP
- 2018-OCT MONITORING BY USACE-LIDAR
- 2013-SEP MONITORING BY USACE
- ◆ 2007-FEB MONITORING BY MAE
- - - MHW CONTOUR (0.7 FT)

RANGE: R-115  
EST DATE: OCT1995  
SURVEY DATE: 19APR19  
AZIMUTH: 202.0

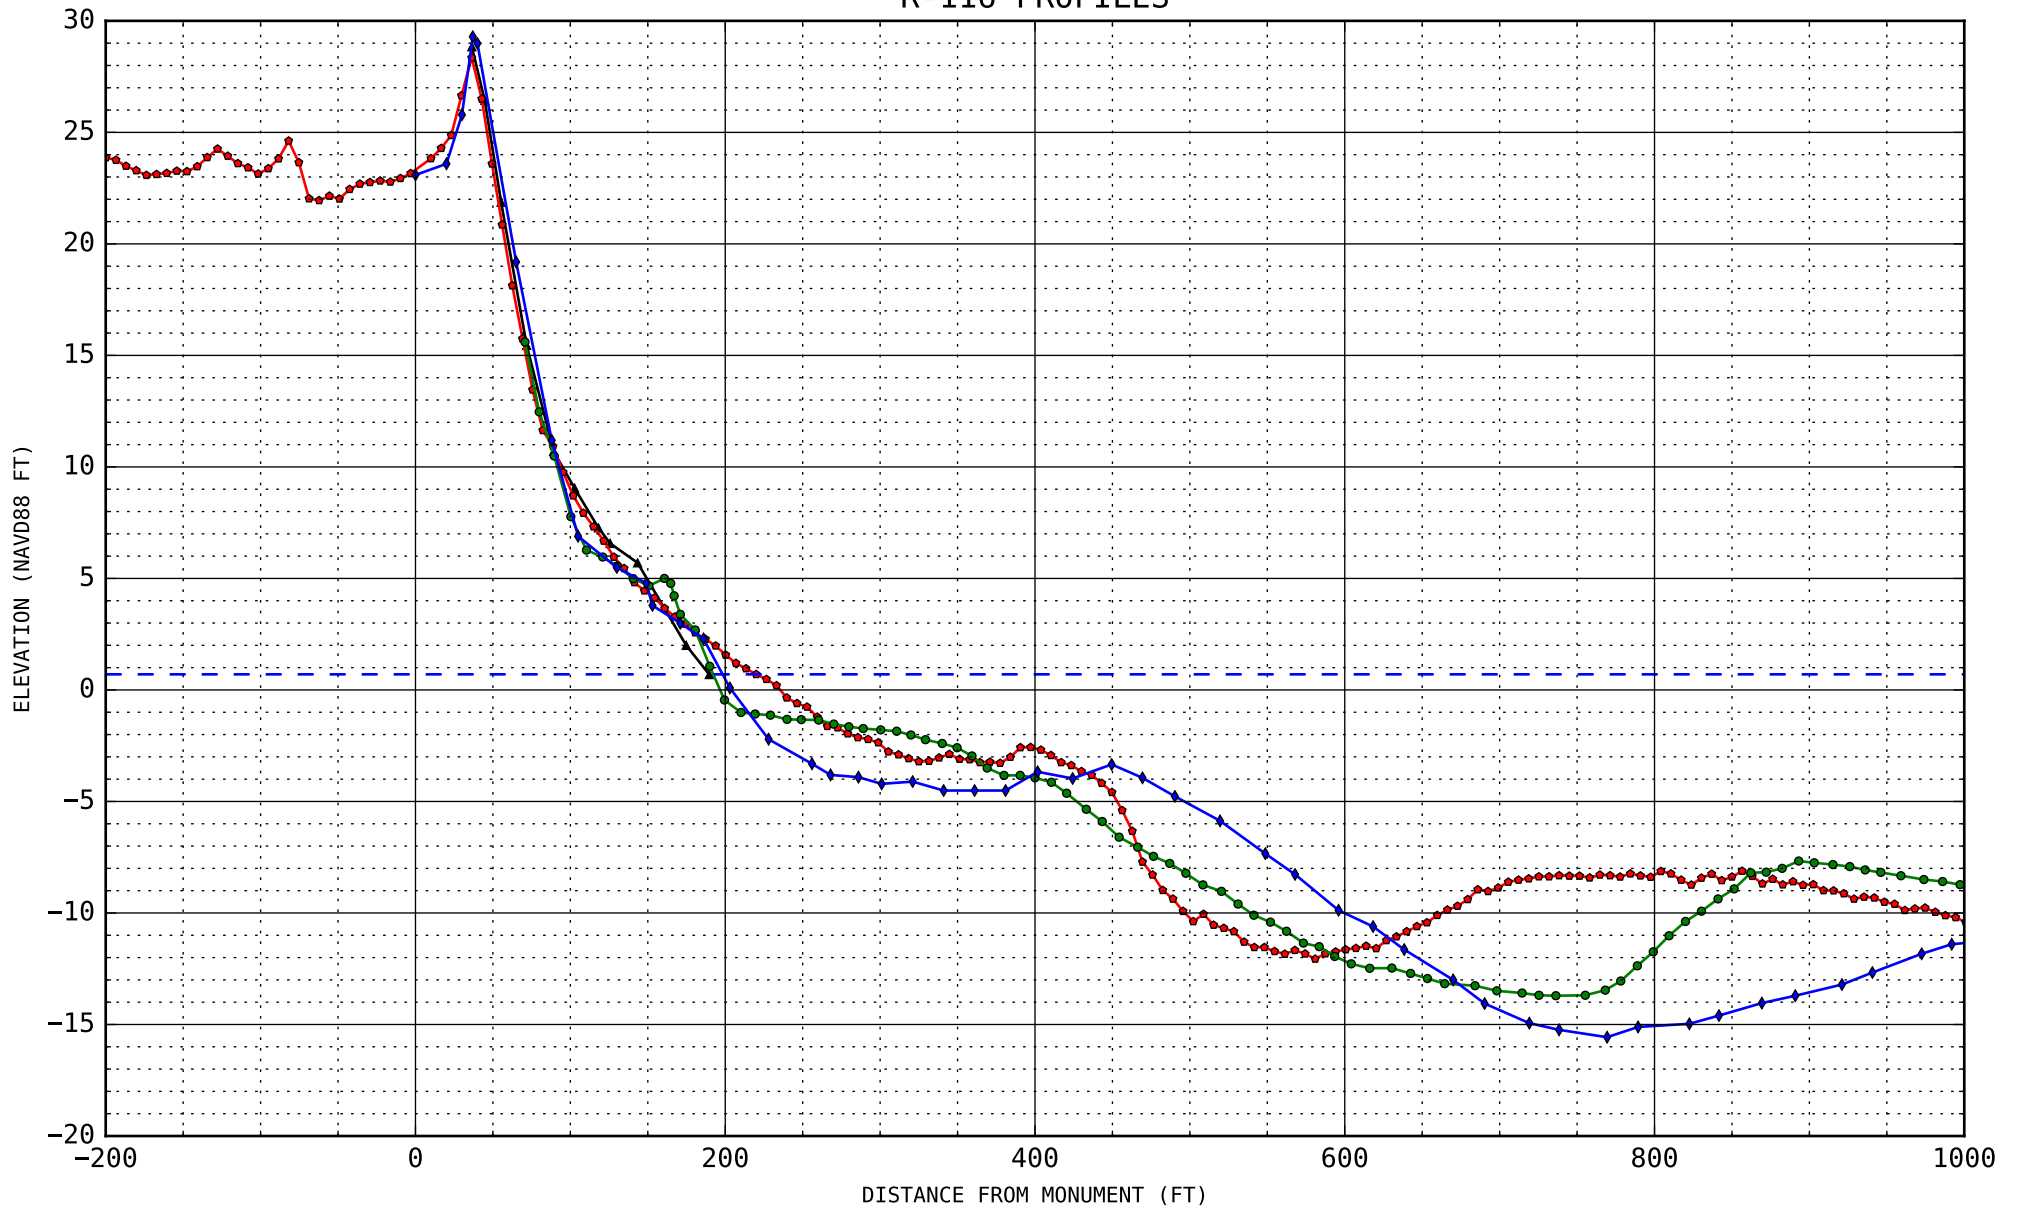
# R-116 PROFILES

- ▲ 2019-APR CONDITION BY DEP
- 2018-OCT MONITORING BY USACE-LIDAR
- 2013-SEP MONITORING BY USACE
- ◆ 2007-FEB MONITORING BY MAE
- - - MHW CONTOUR (0.7 FT)

RANGE: R-116  
 EST DATE: NOV1980  
 SURVEY DATE: 19APR19  
 AZIMUTH: 202.0

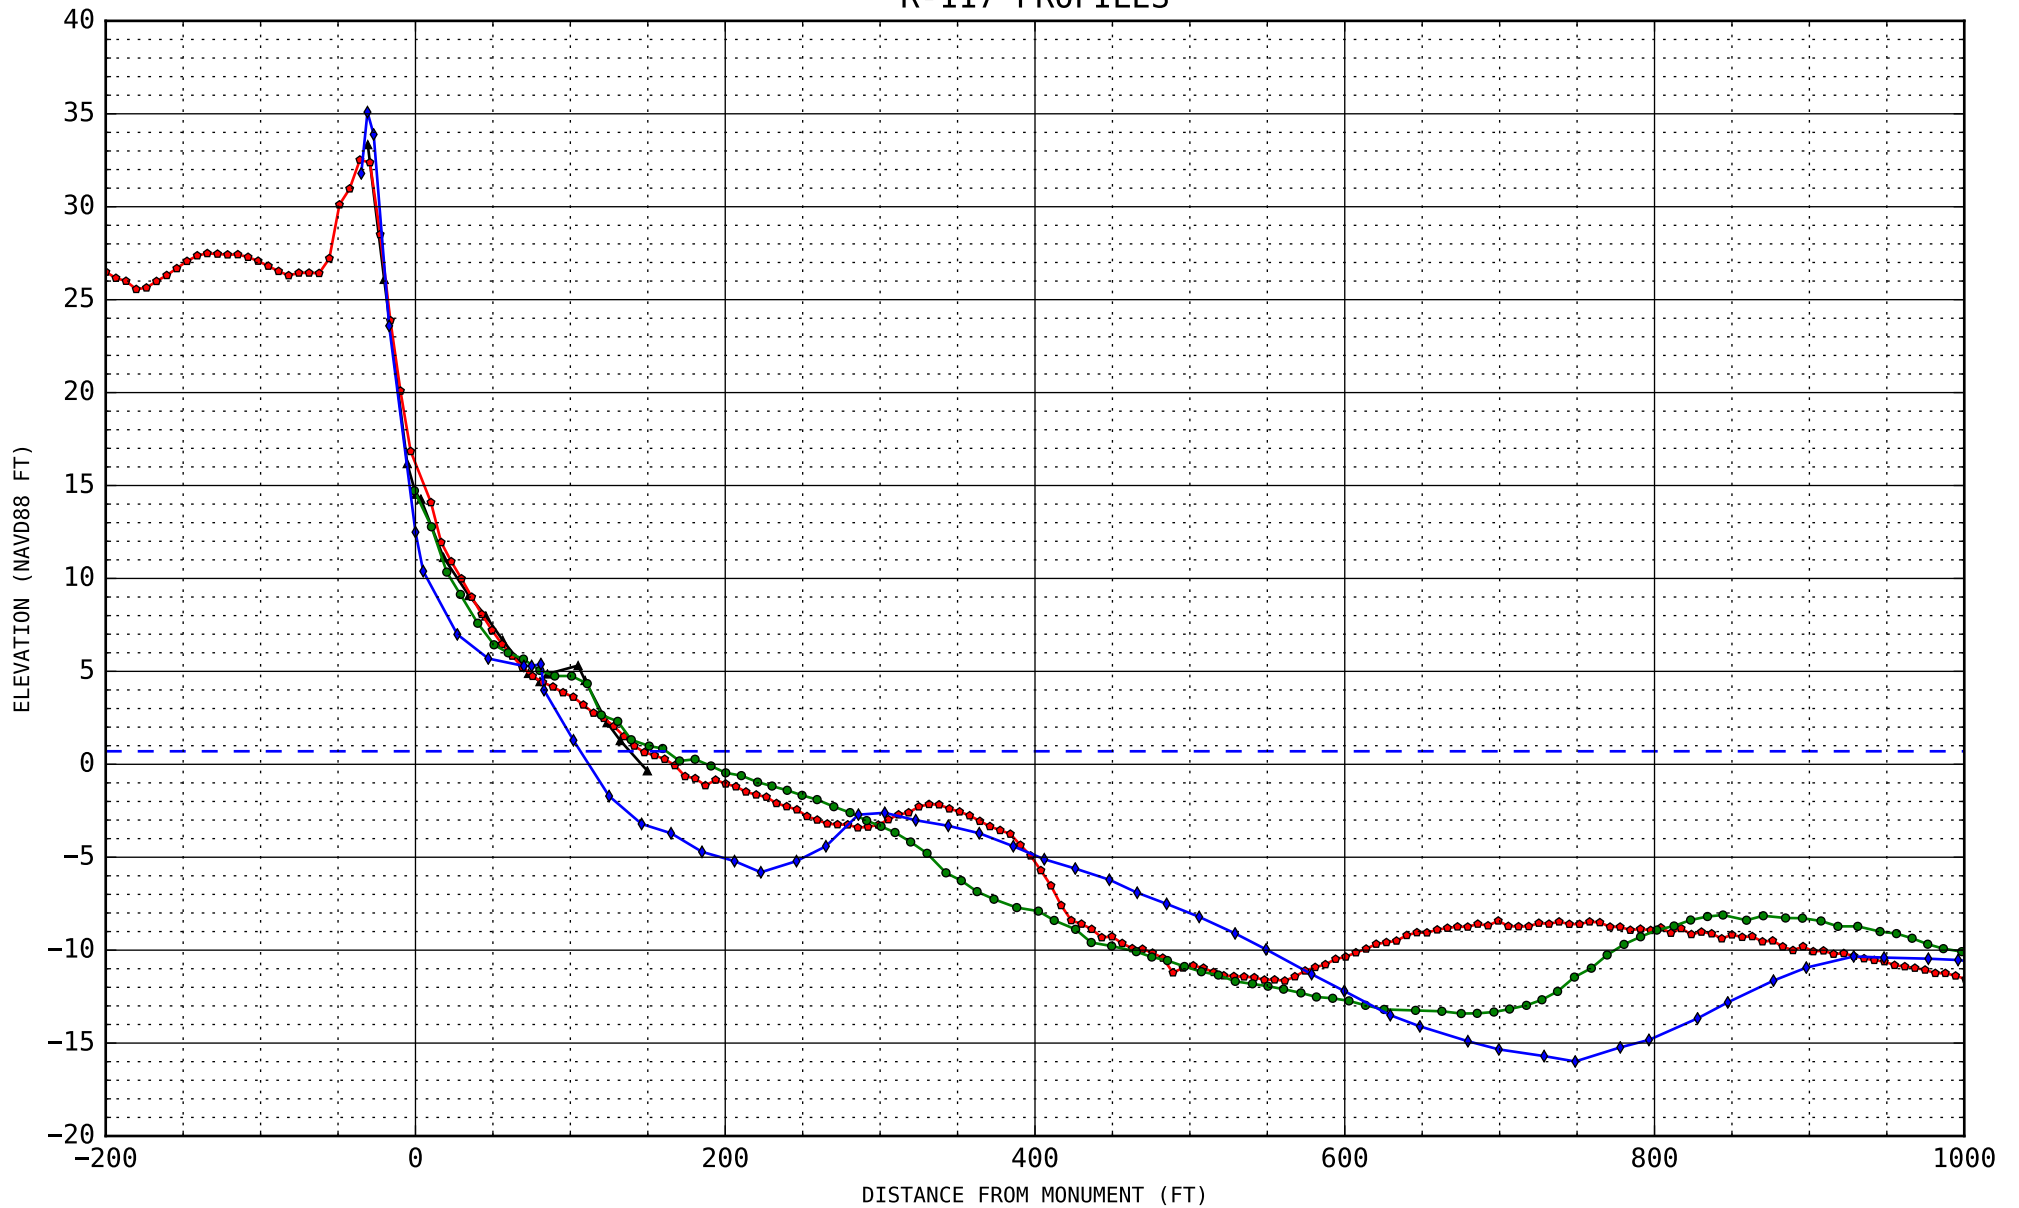
# R-117 PROFILES

- ▲ 2019-APR CONDITION BY DEP
- 2018-OCT MONITORING BY USACE-LIDAR
- 2013-SEP MONITORING BY USACE
- ◆ 2007-FEB MONITORING BY MAE
- - - MHW CONTOUR (0.7 FT)

RANGE: R-117  
EST DATE: NOV1980  
SURVEY DATE: 19APR19  
AZIMUTH: 202.0

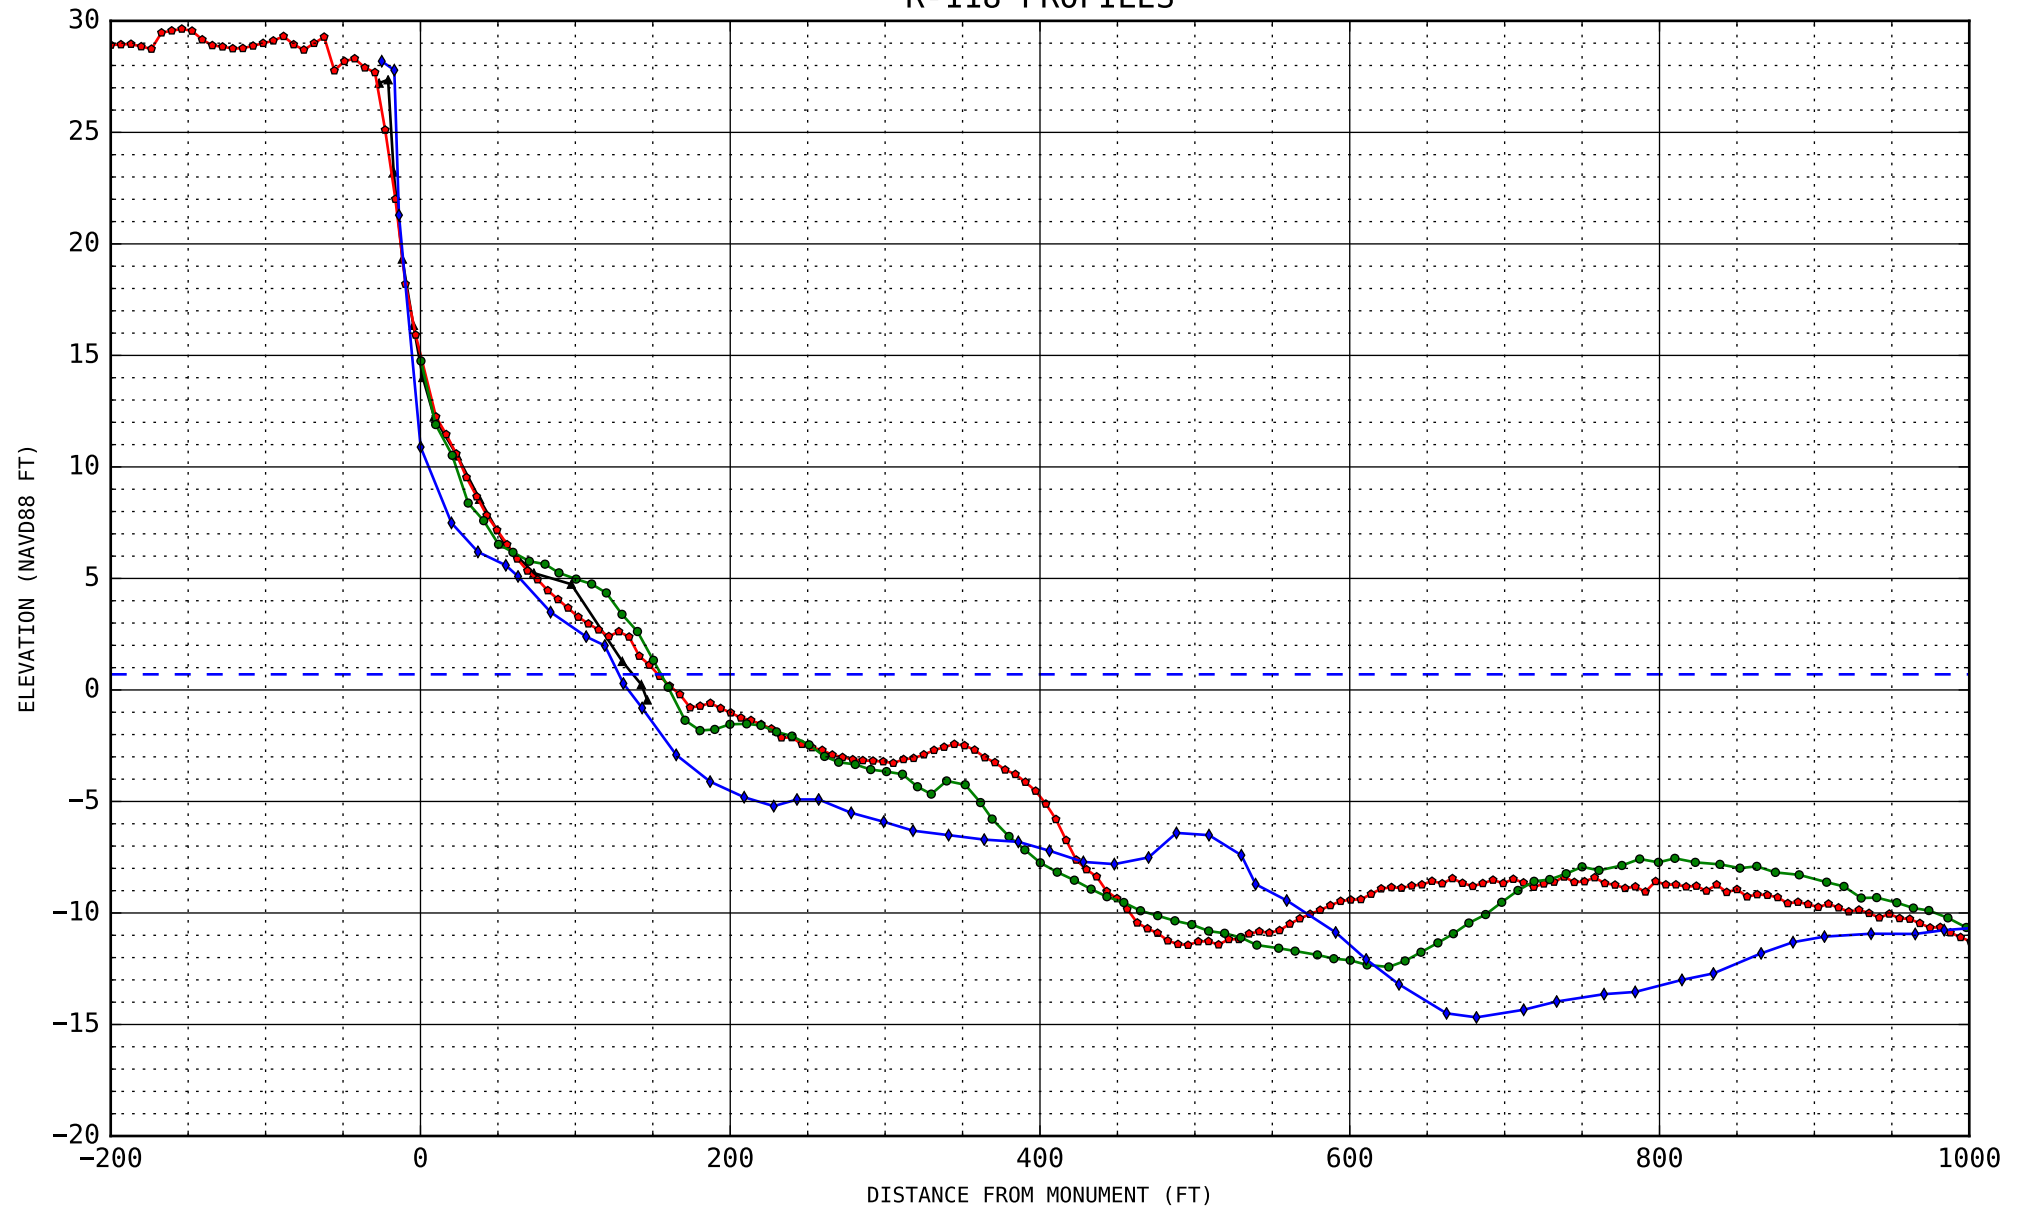
# R-118 PROFILES

- ▲ 2019-APR CONDITION BY DEP
- 2018-OCT MONITORING BY USACE-LIDAR
- 2013-SEP MONITORING BY USACE
- ◆ 2007-FEB MONITORING BY MAE
- - - MHW CONTOUR (0.7 FT)

RANGE: R-118  
EST DATE: OCT1994  
SURVEY DATE: 19APR19  
AZIMUTH: 202.0

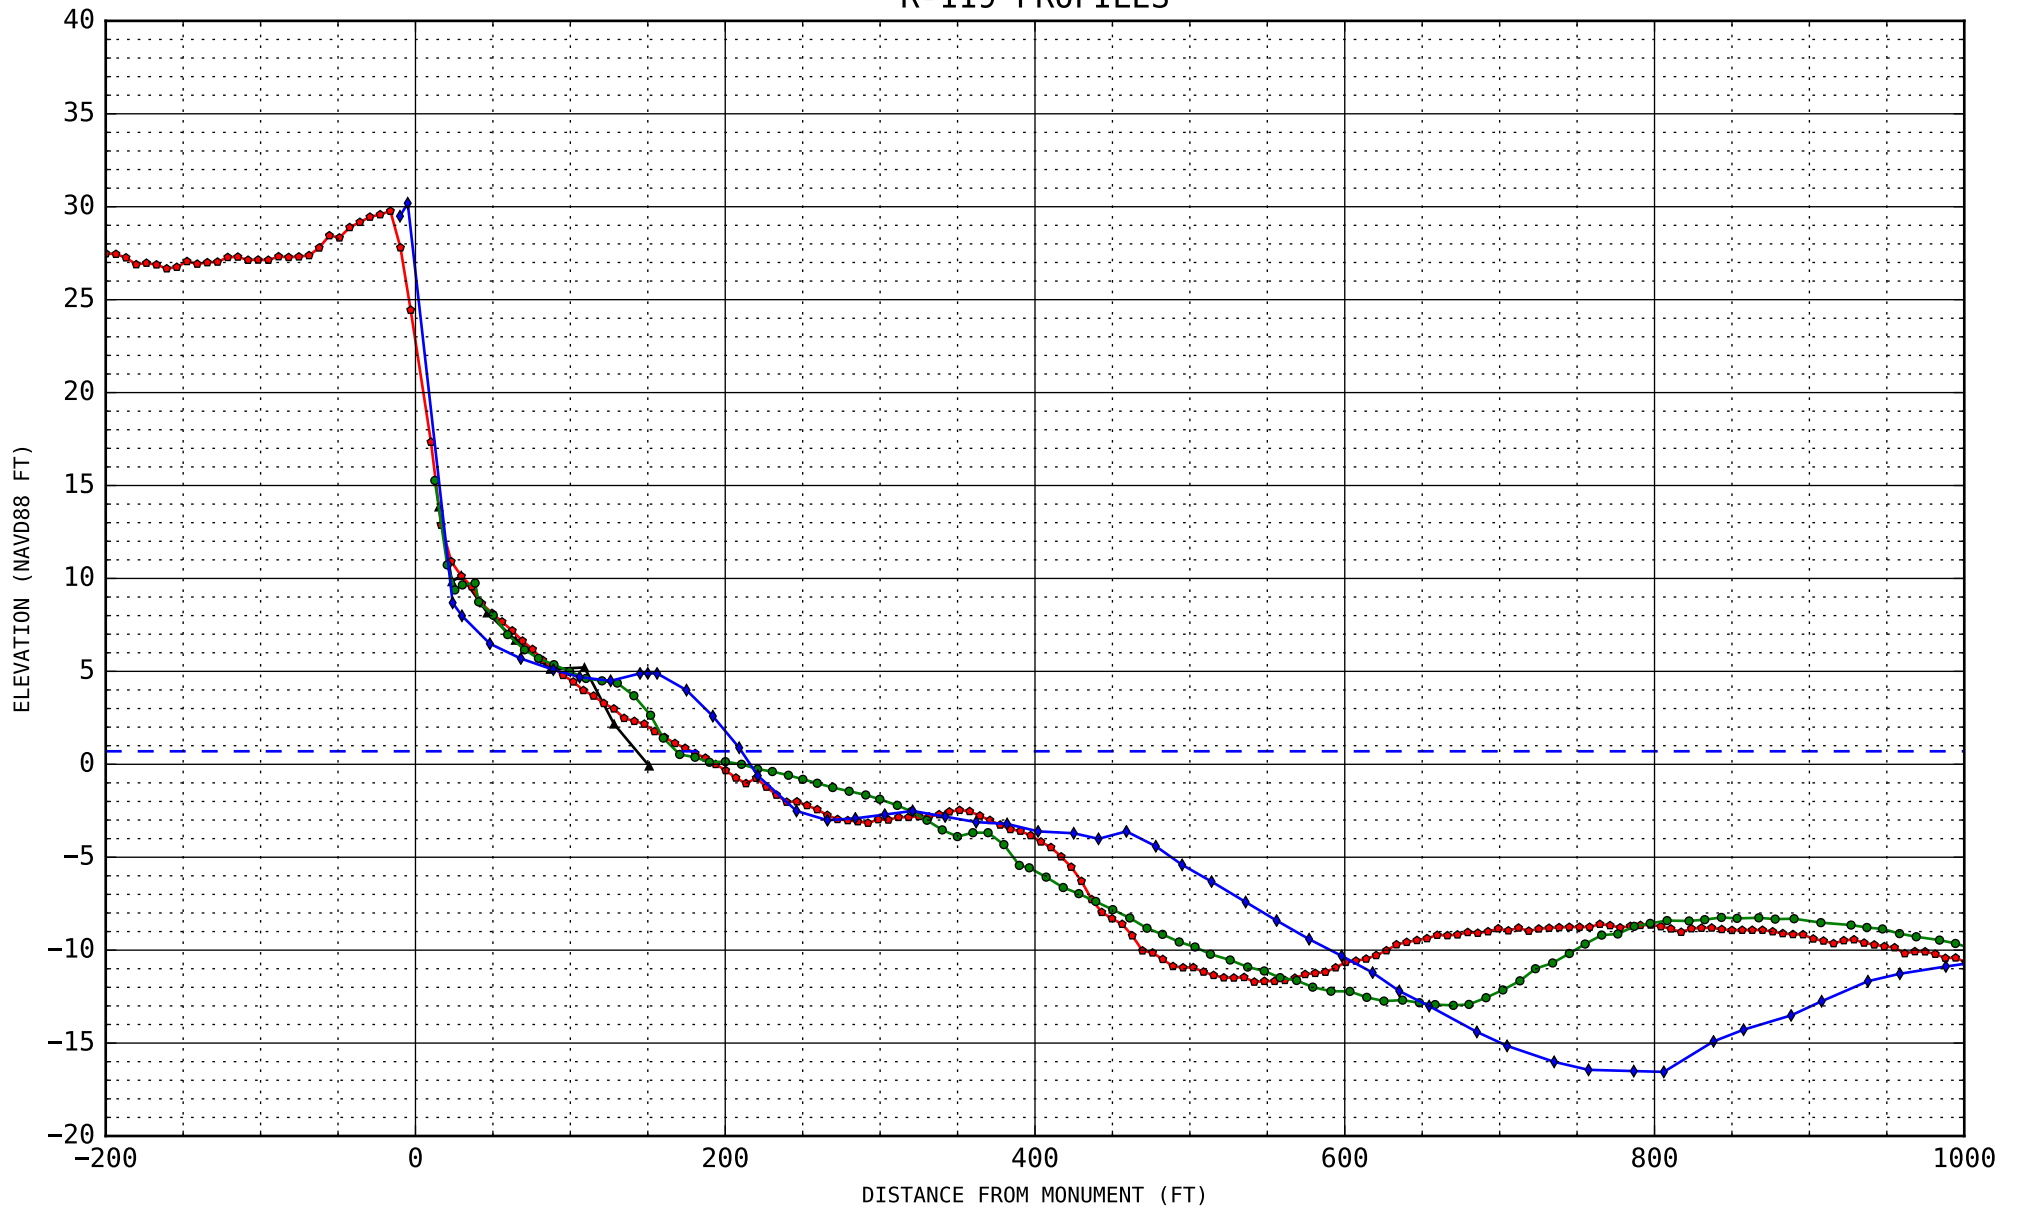
# R-119 PROFILES

- ▲ 2019-APR CONDITION BY DEP
- 2018-OCT MONITORING BY USACE-LIDAR
- 2013-SEP MONITORING BY USACE
- ◆ 2007-FEB MONITORING BY MAE
- - - MHW CONTOUR (0.7 FT)

RANGE: R-119  
EST DATE: M&E1997  
SURVEY DATE: 19APR19  
AZIMUTH: 202.0

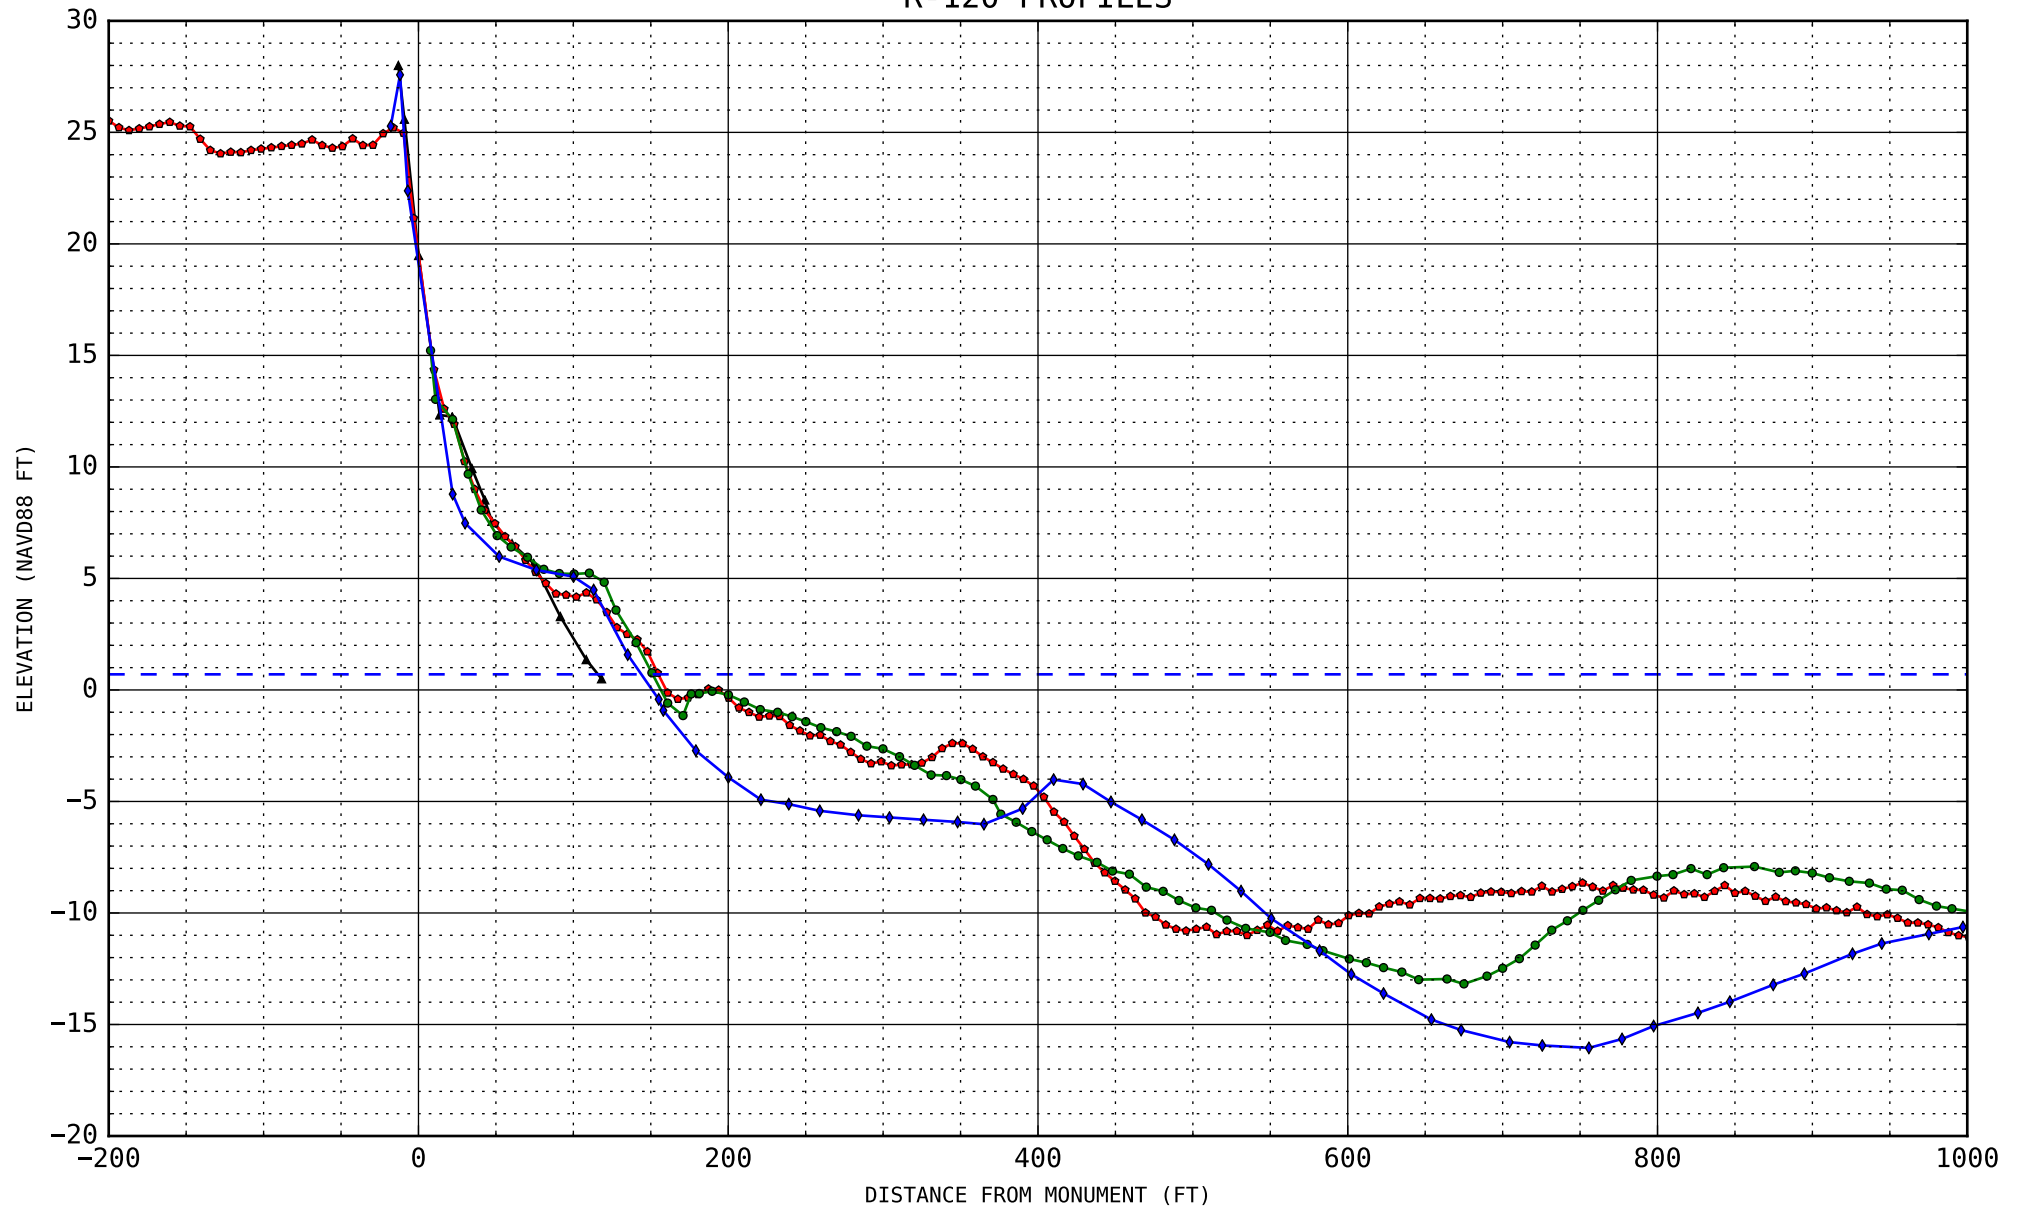
# R-120 PROFILES

- ▲ 2019-APR CONDITION BY DEP
- 2018-OCT MONITORING BY USACE-LIDAR
- 2013-SEP MONITORING BY USACE
- ◆ 2007-FEB MONITORING BY MAE
- - - MHW CONTOUR (0.7 FT)

RANGE: R-120  
 EST DATE: OCT1995  
 SURVEY DATE: 19APR19  
 AZIMUTH: 202.0

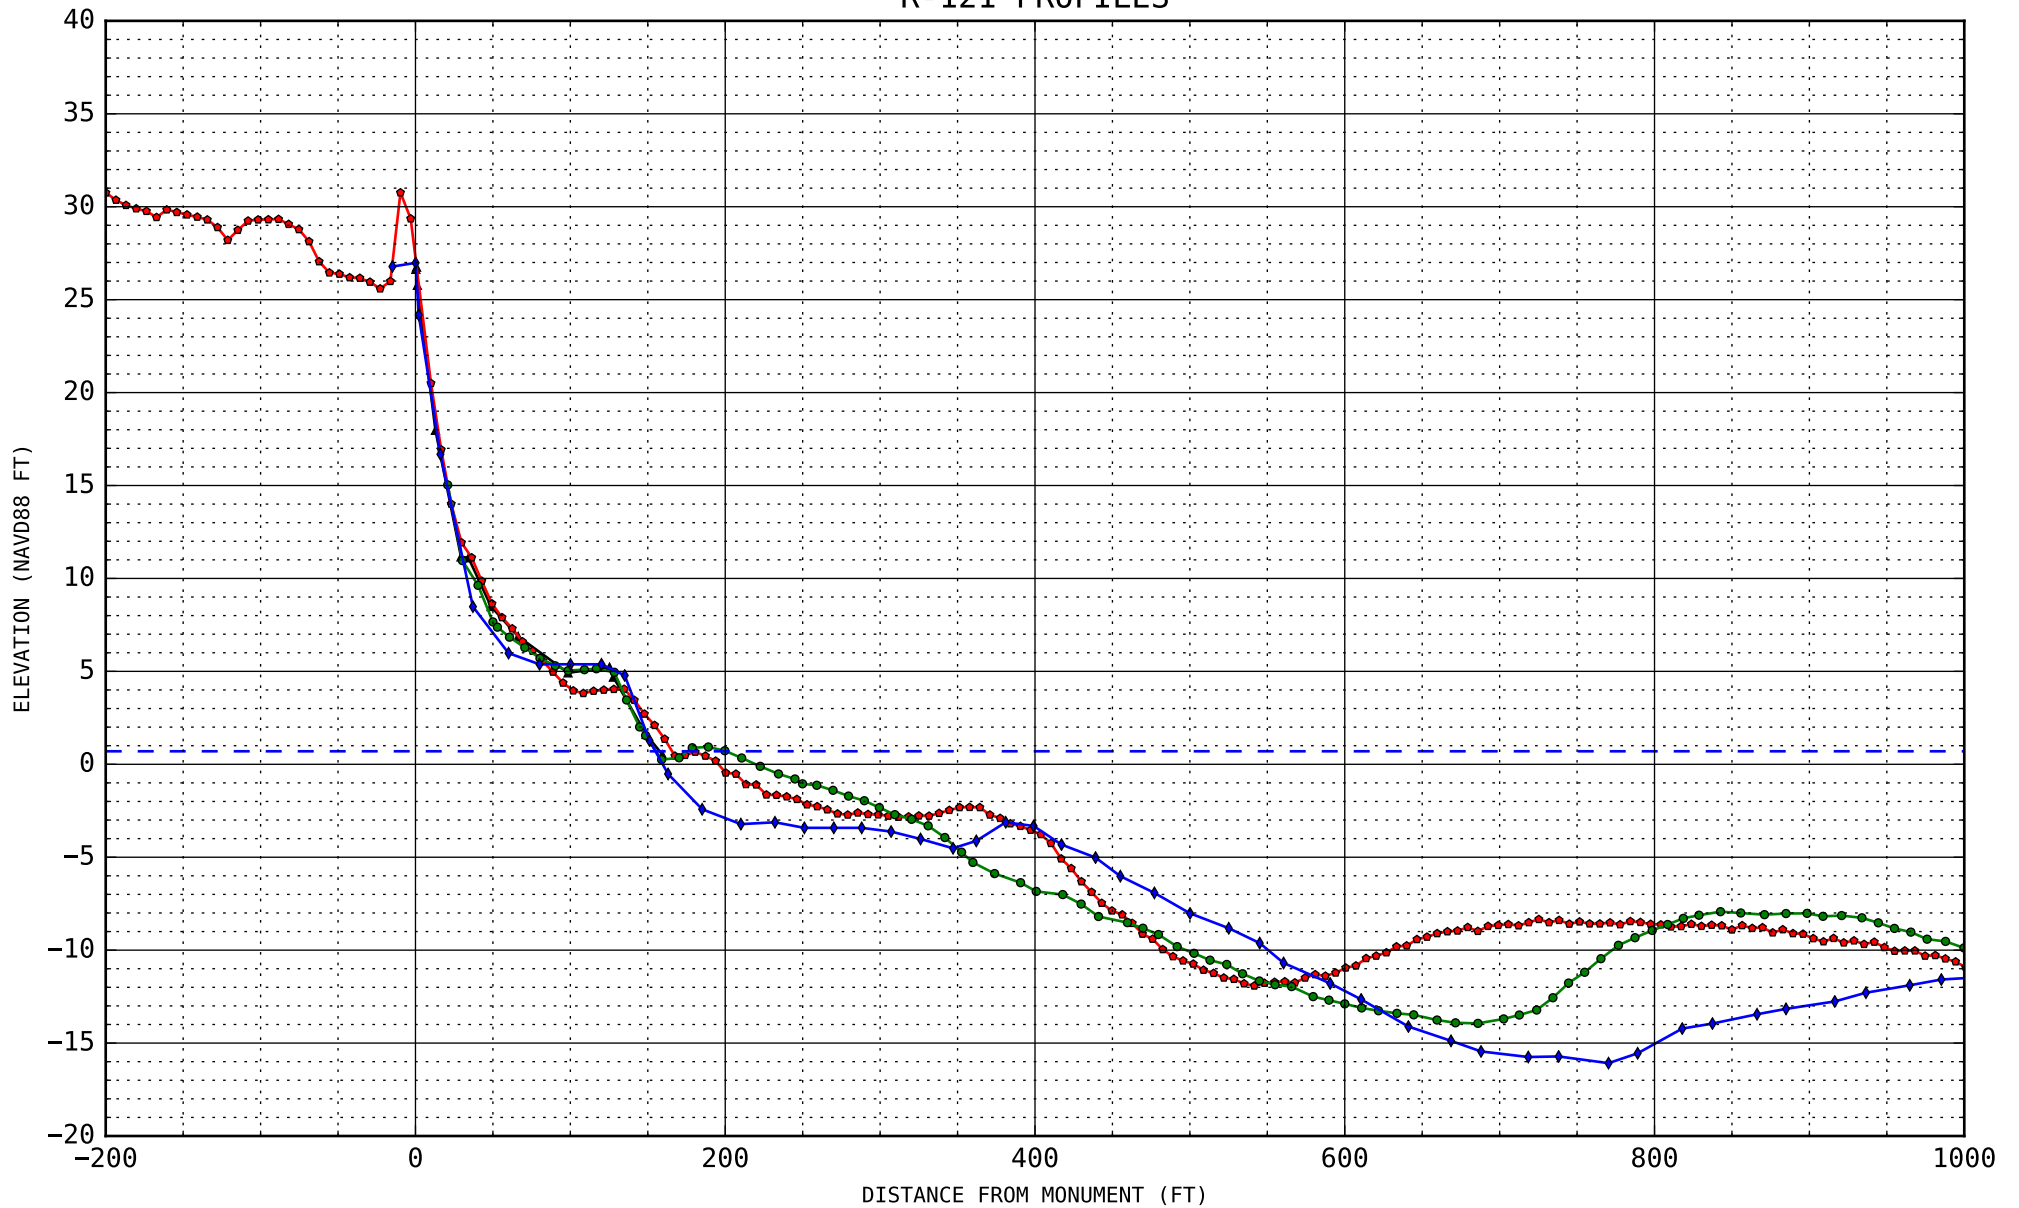
# R-121 PROFILES

- ▲ 2019-APR CONDITION BY DEP
- 2018-OCT MONITORING BY USACE-LIDAR
- 2013-SEP MONITORING BY USACE
- ◆ 2007-FEB MONITORING BY MAE
- - - MHW CONTOUR (0.7 FT)

RANGE: R-121  
EST DATE: OCT1995  
SURVEY DATE: 19APR19  
AZIMUTH: 202.0

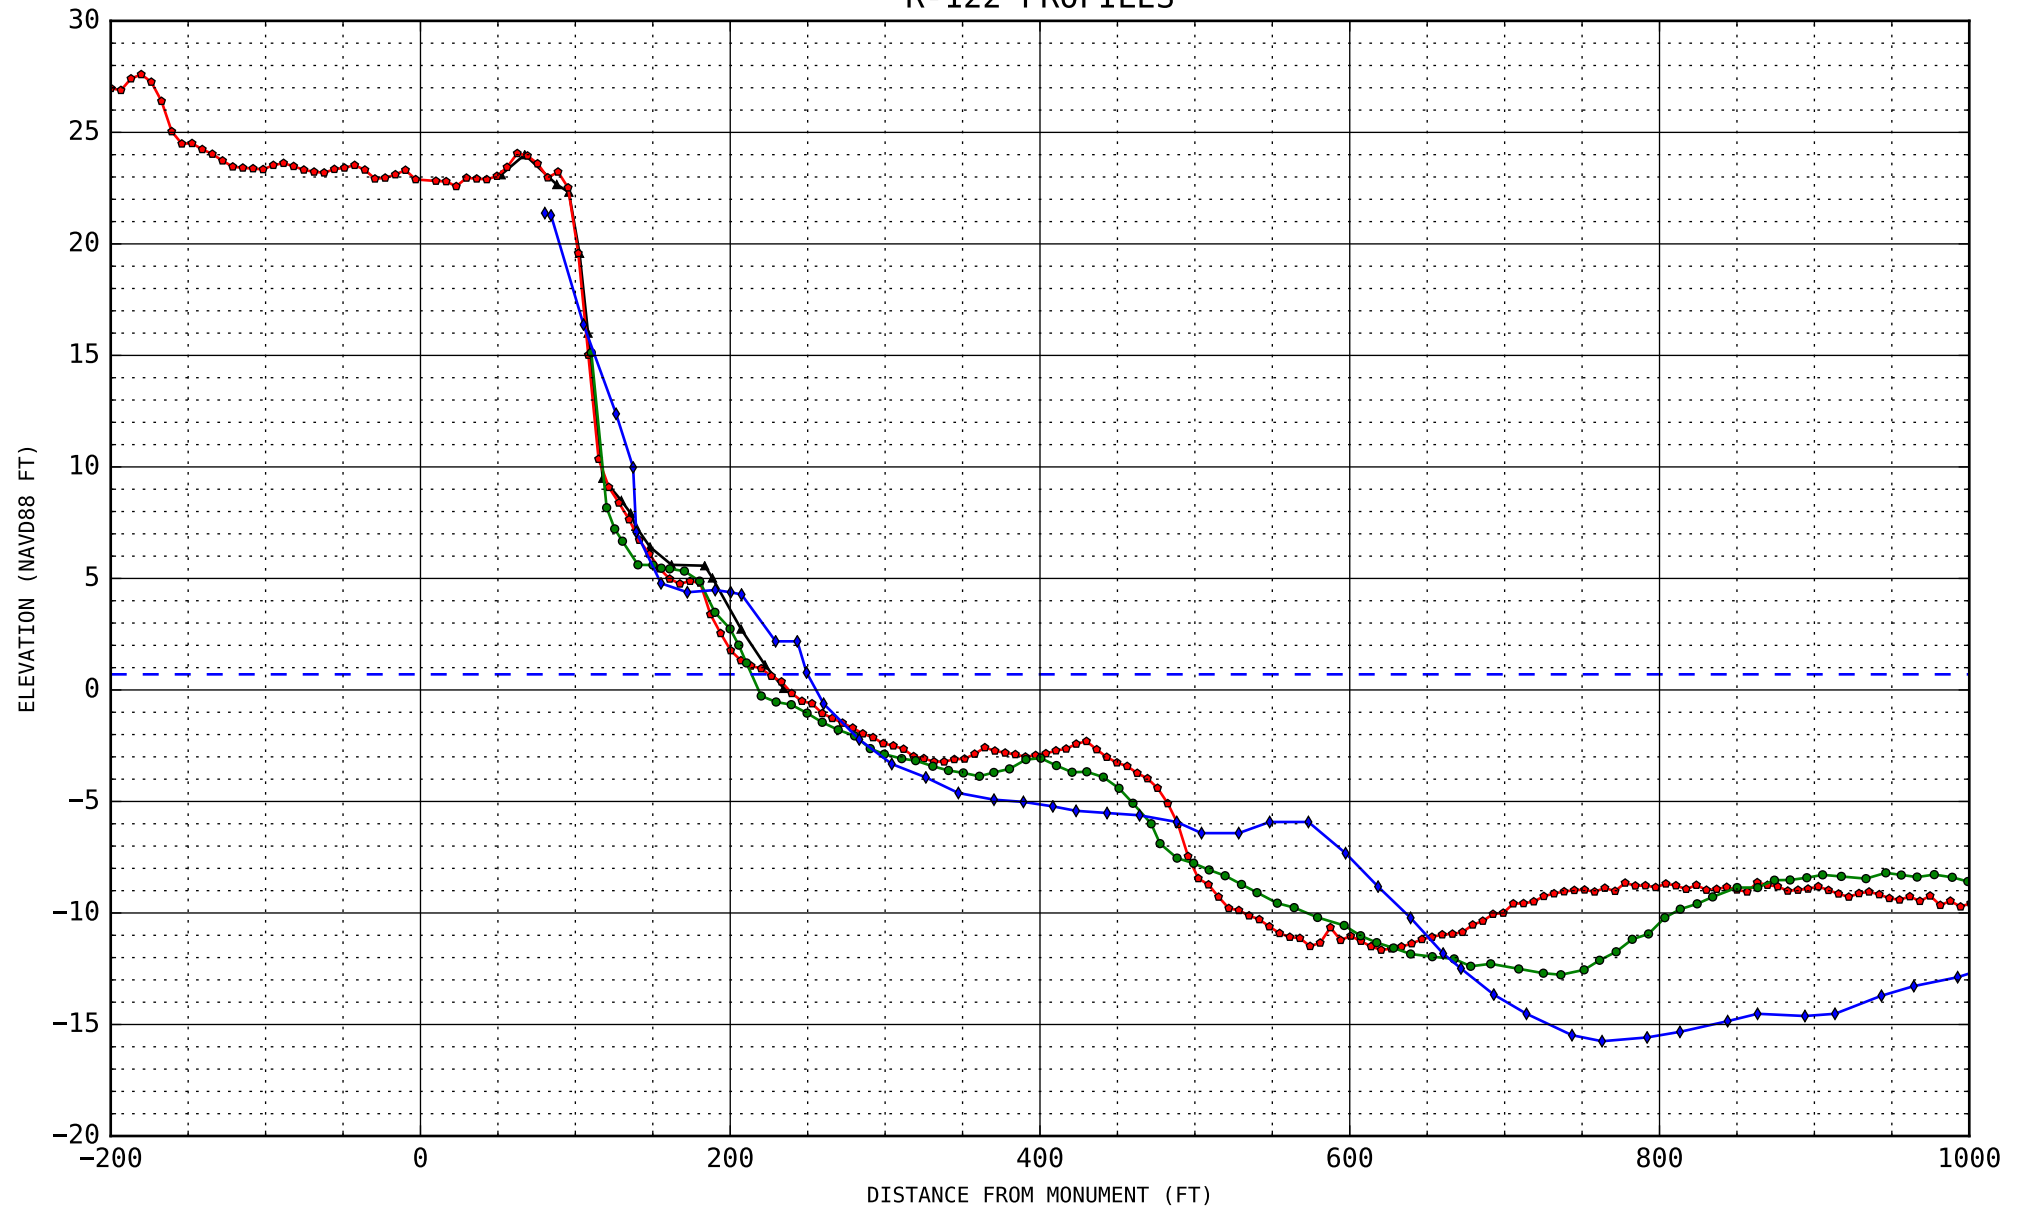
# R-122 PROFILES

- ▲ 2019-APR CONDITION BY DEP
- 2018-OCT MONITORING BY USACE-LIDAR
- 2013-SEP MONITORING BY USACE
- ◆ 2007-FEB MONITORING BY MAE
- - - MHW CONTOUR (0.7 FT)

RANGE: R-122  
EST DATE: OCT1995  
SURVEY DATE: 19APR19  
AZIMUTH: 202.0

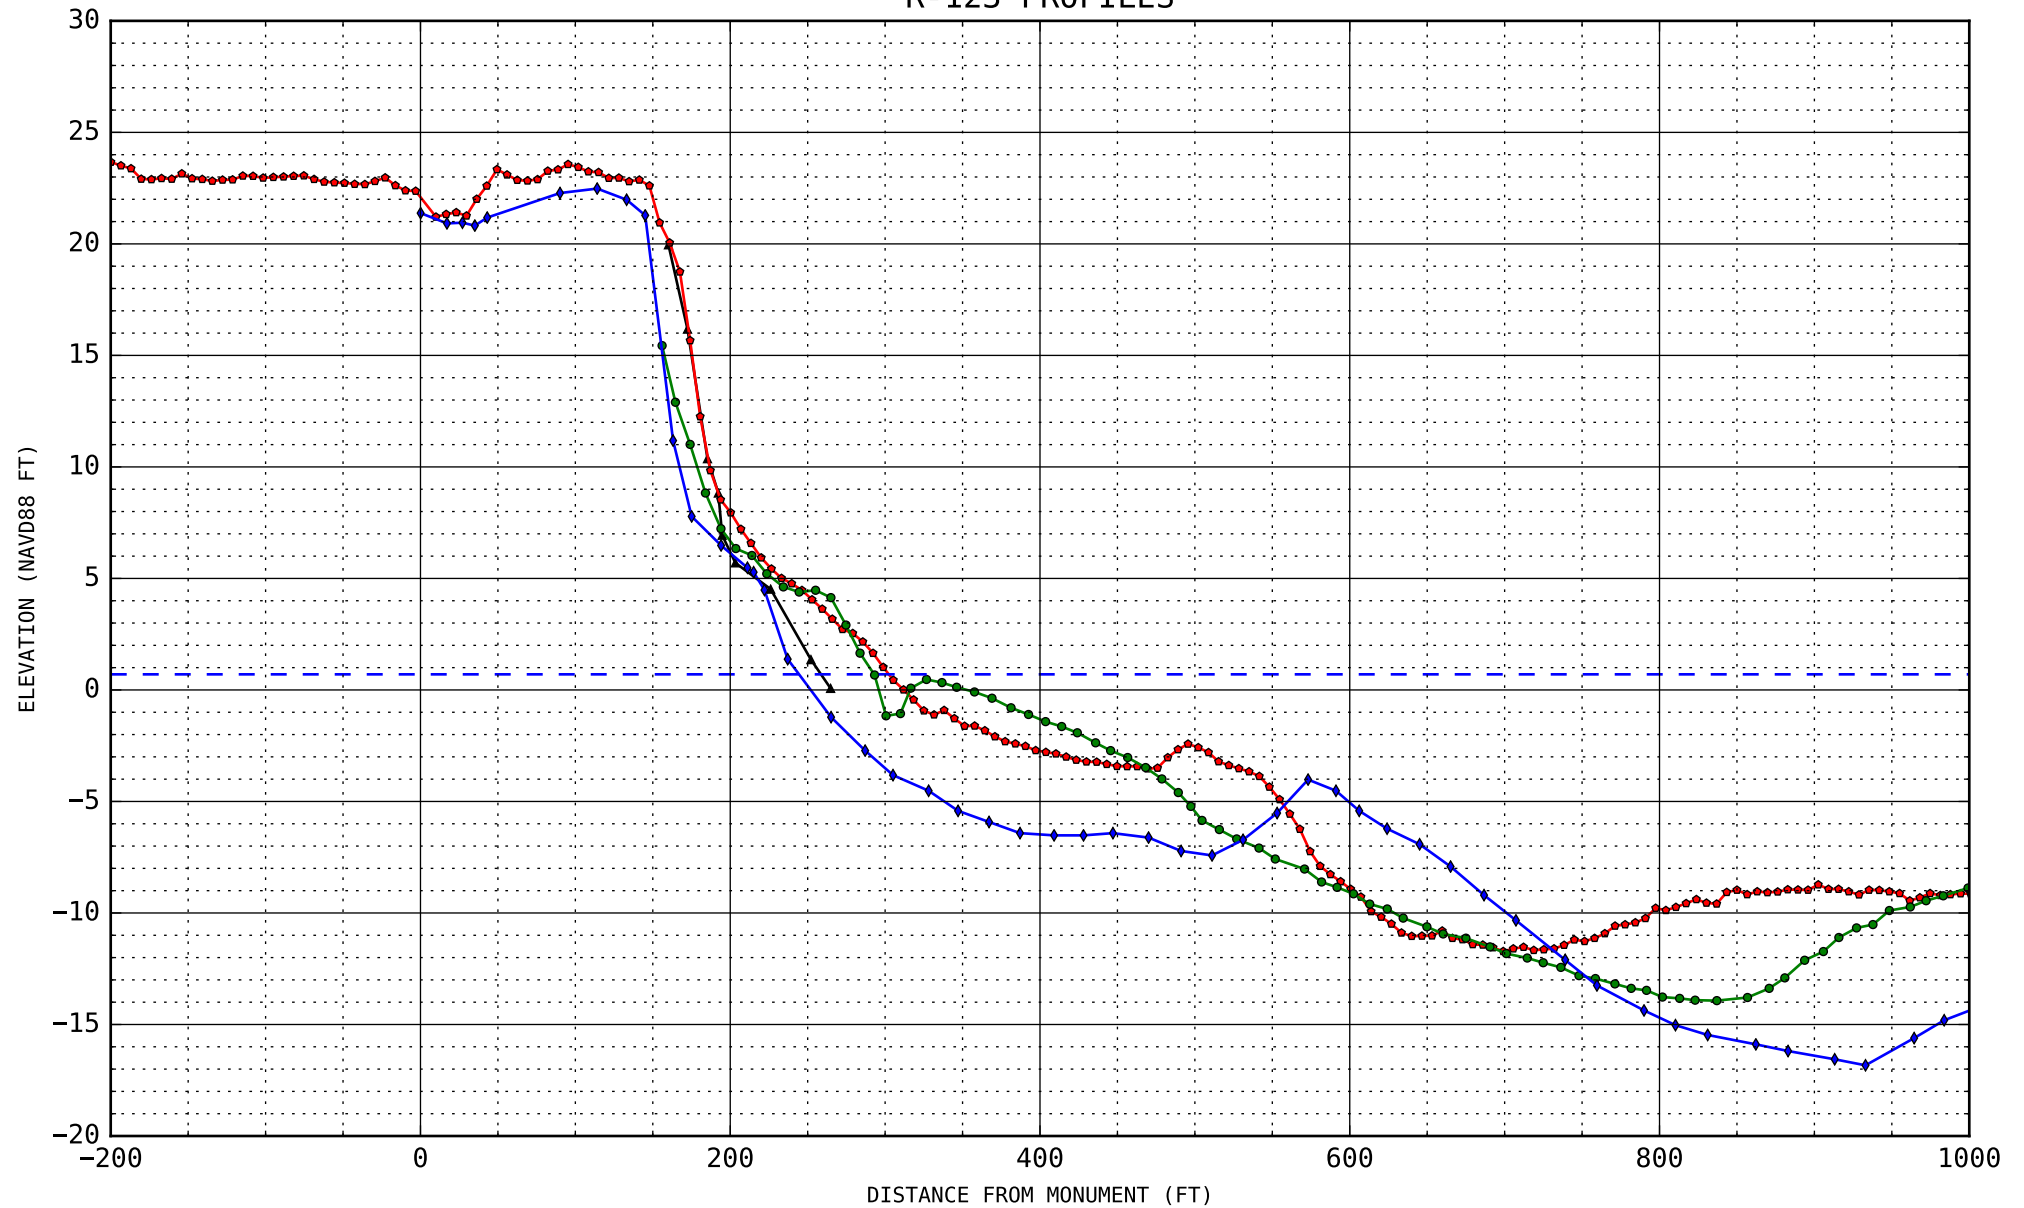
# R-123 PROFILES

- ▲ 2019-APR CONDITION BY DEP
- 2018-OCT MONITORING BY USACE-LIDAR
- 2013-SEP MONITORING BY USACE
- ◆ 2007-FEB MONITORING BY MAE
- - - MHW CONTOUR (0.7 FT)

RANGE: R-123  
EST DATE: OCT1995  
SURVEY DATE: 19APR19  
AZIMUTH: 202.0
