# R-1 PROFILES

WALTON  
PROGRAM SUPPORT GIS  
DIVISION OF WATER RESOURCE MANAGEMENT  
FLORIDA DEPARTMENT OF ENVIRONMENTAL PROTECTION

RANGE: R-1  
EST DATE: NOV1980  
SURVEY DATE: 04APR19  
AZIMUTH: 190.0

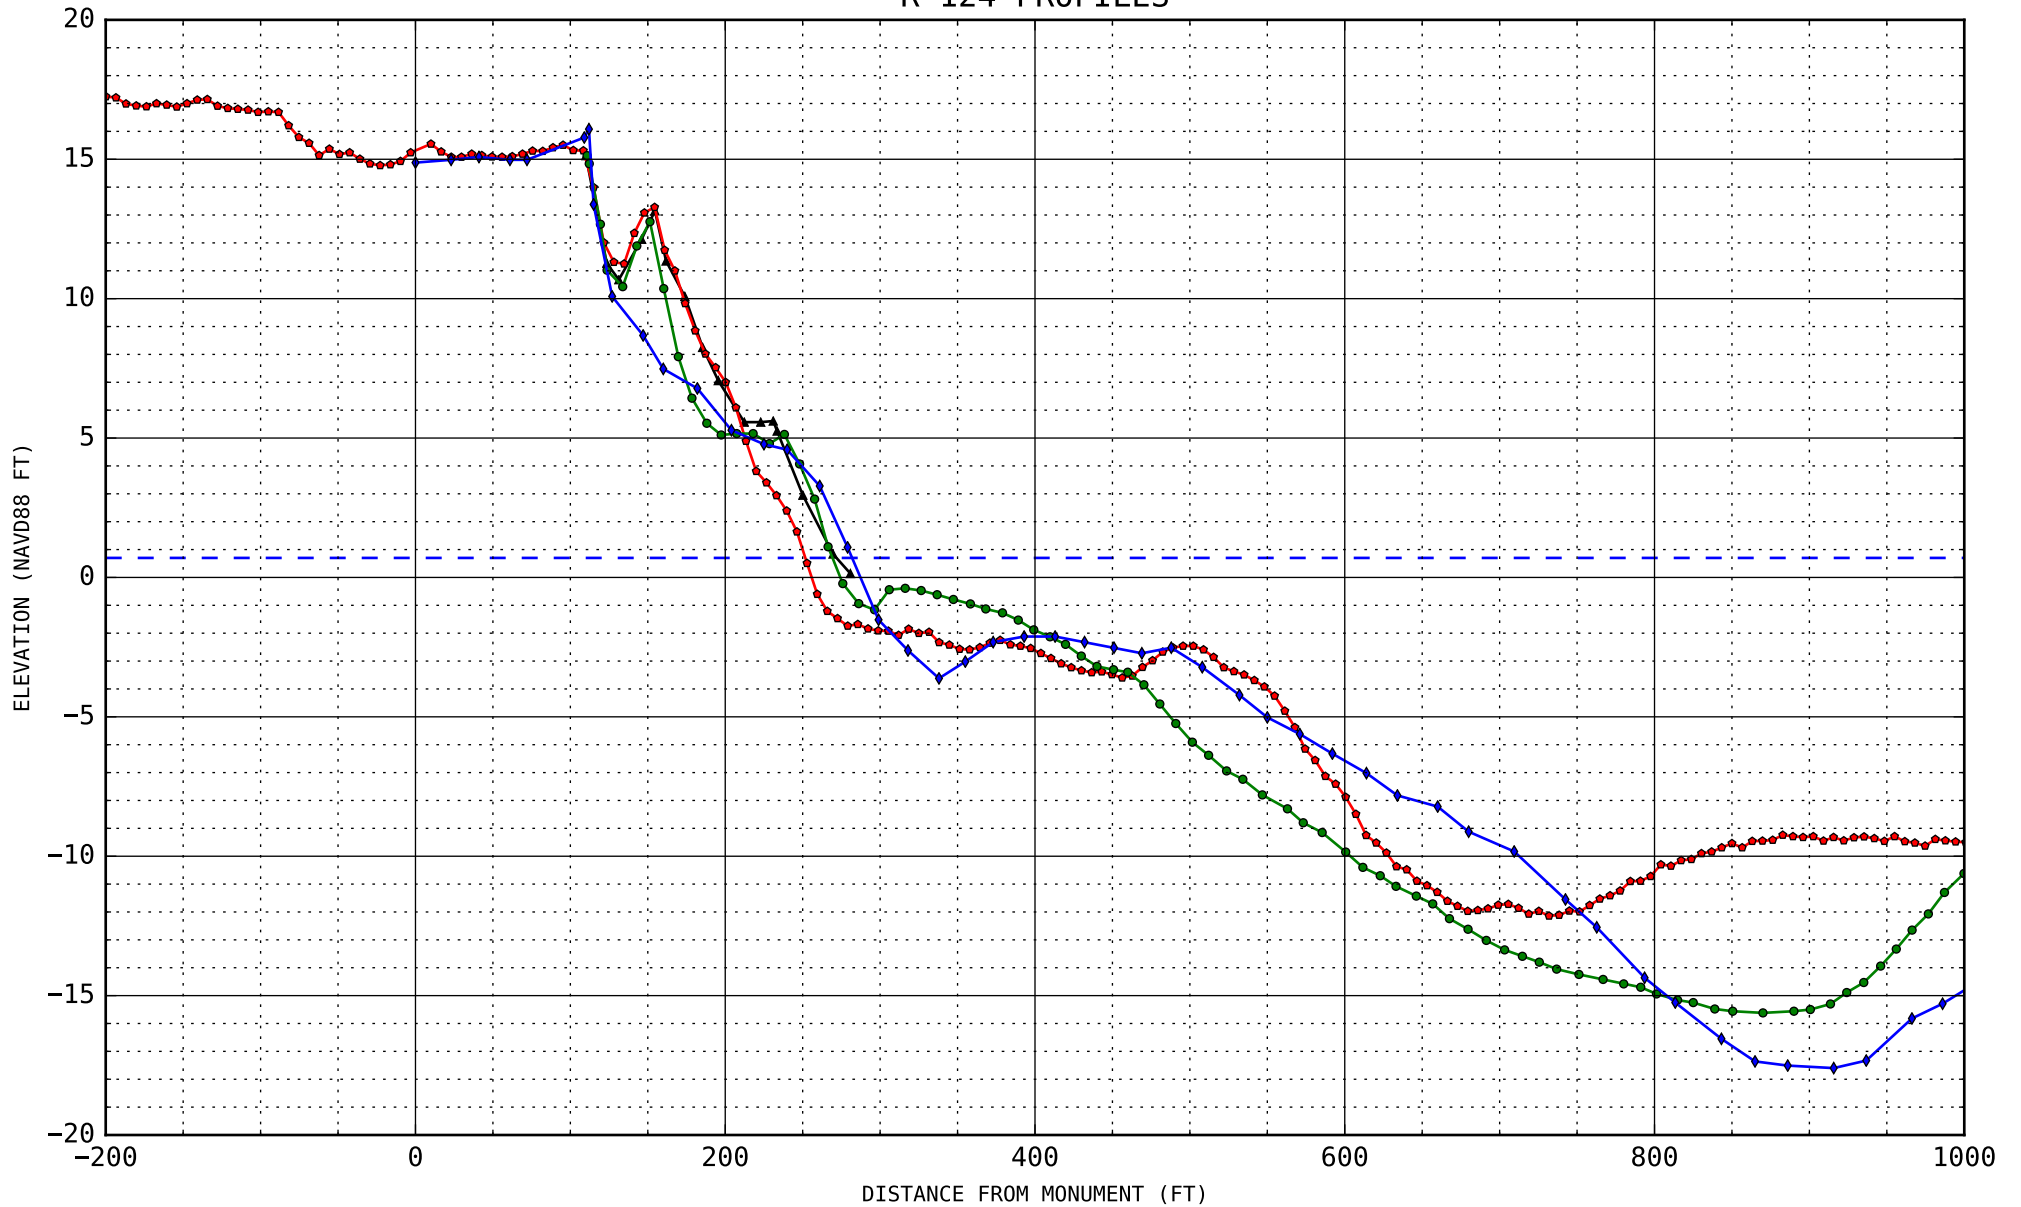
# R-124 PROFILES

- ▲ 2019-APR CONDITION BY DEP
- 2018-OCT MONITORING BY USACE-LIDAR
- 2013-SEP MONITORING BY USACE
- ◆ 2007-FEB MONITORING BY MAE
- - - MHW CONTOUR (0.7 FT)

RANGE: R-124  
EST DATE: NOV1980  
SURVEY DATE: 19APR19  
AZIMUTH: 202.0

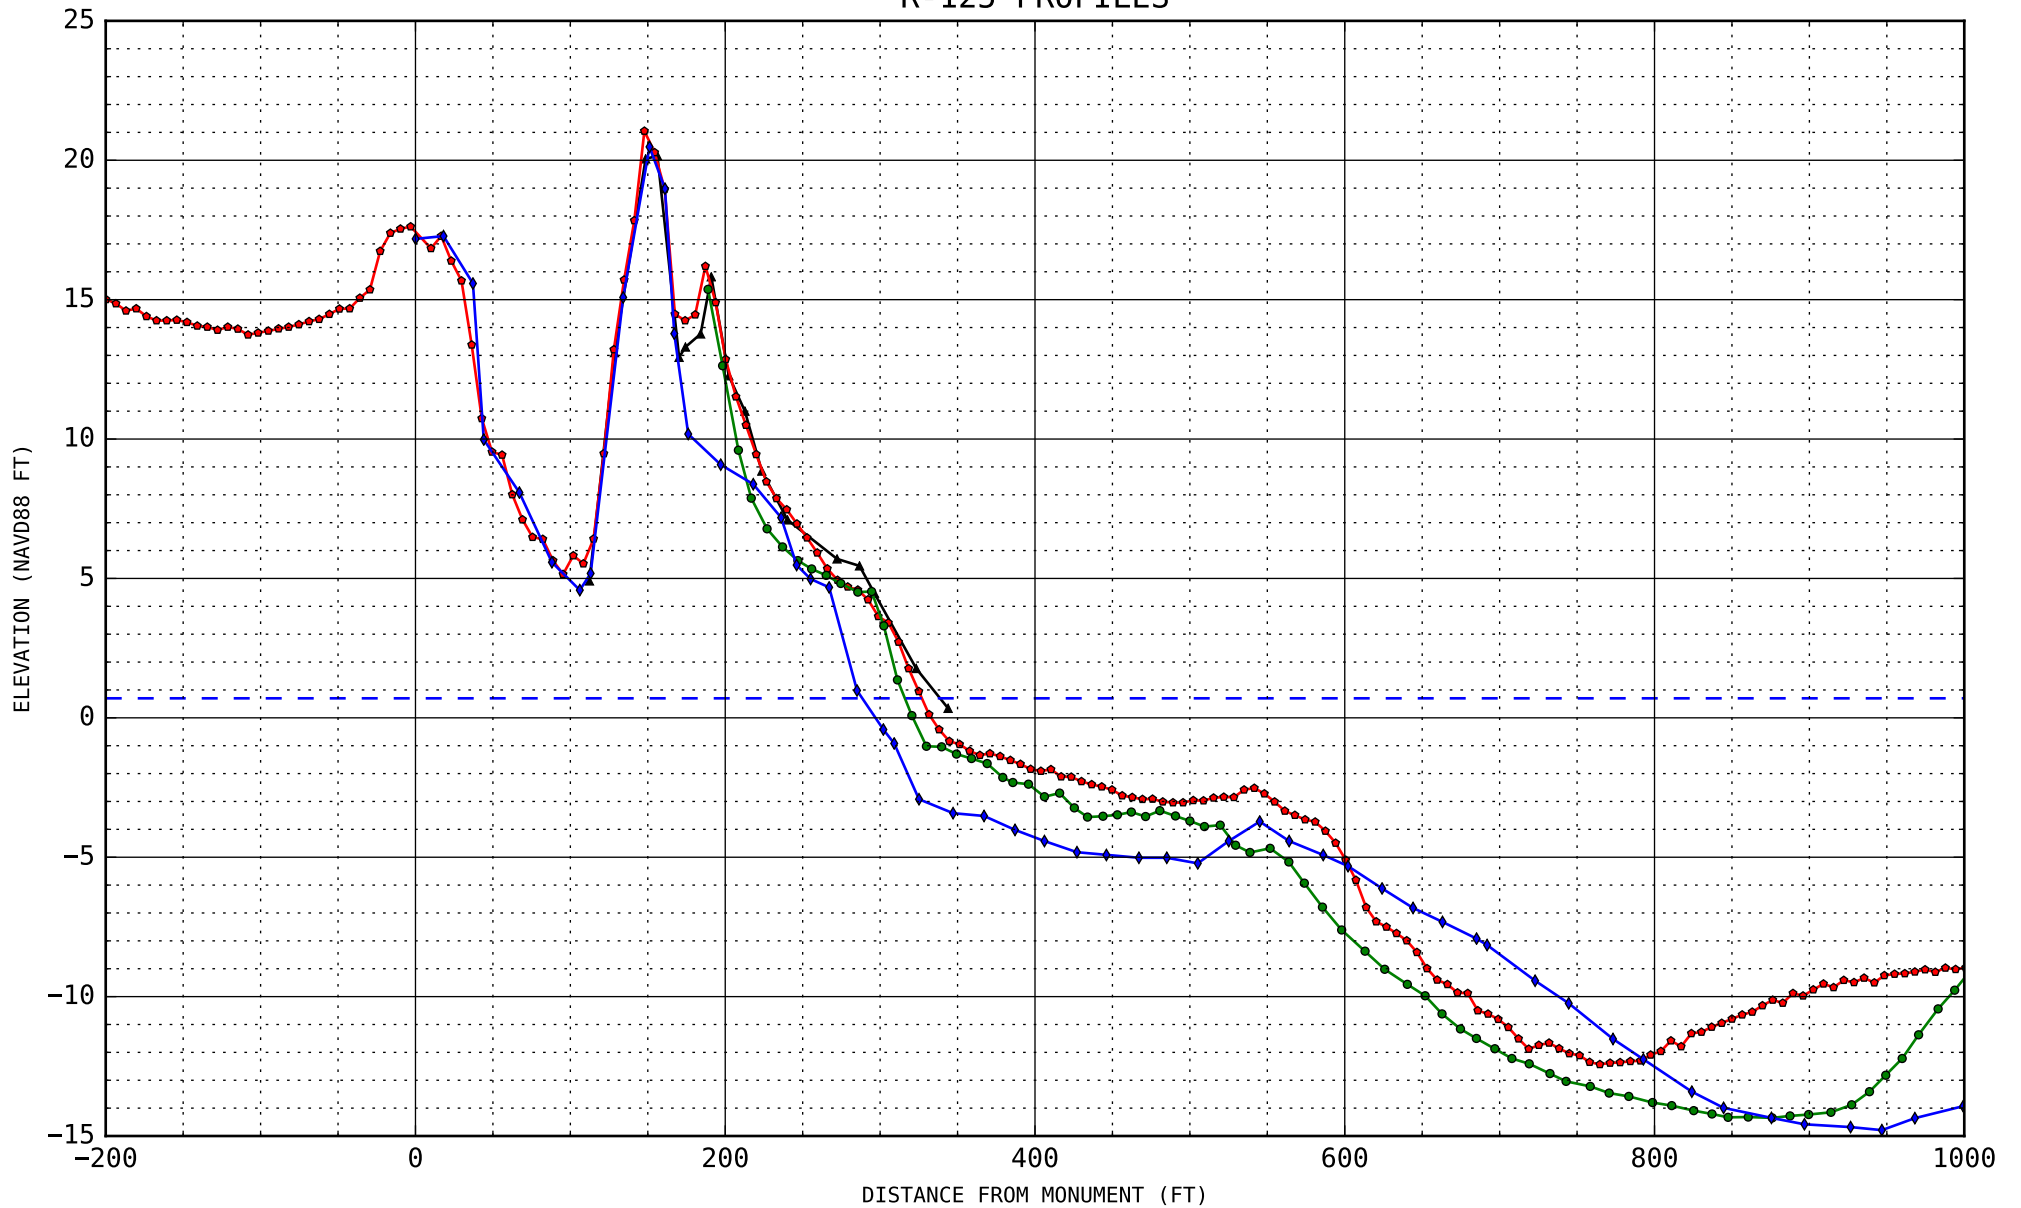
# R-125 PROFILES

- ▲ 2019-APR CONDITION BY DEP
- 2018-OCT MONITORING BY USACE-LIDAR
- 2013-SEP MONITORING BY USACE
- ◆ 2007-FEB MONITORING BY MAE
- - - MHW CONTOUR (0.7 FT)

RANGE: R-125  
EST DATE: OCT1995  
SURVEY DATE: 19APR19  
AZIMUTH: 202.0

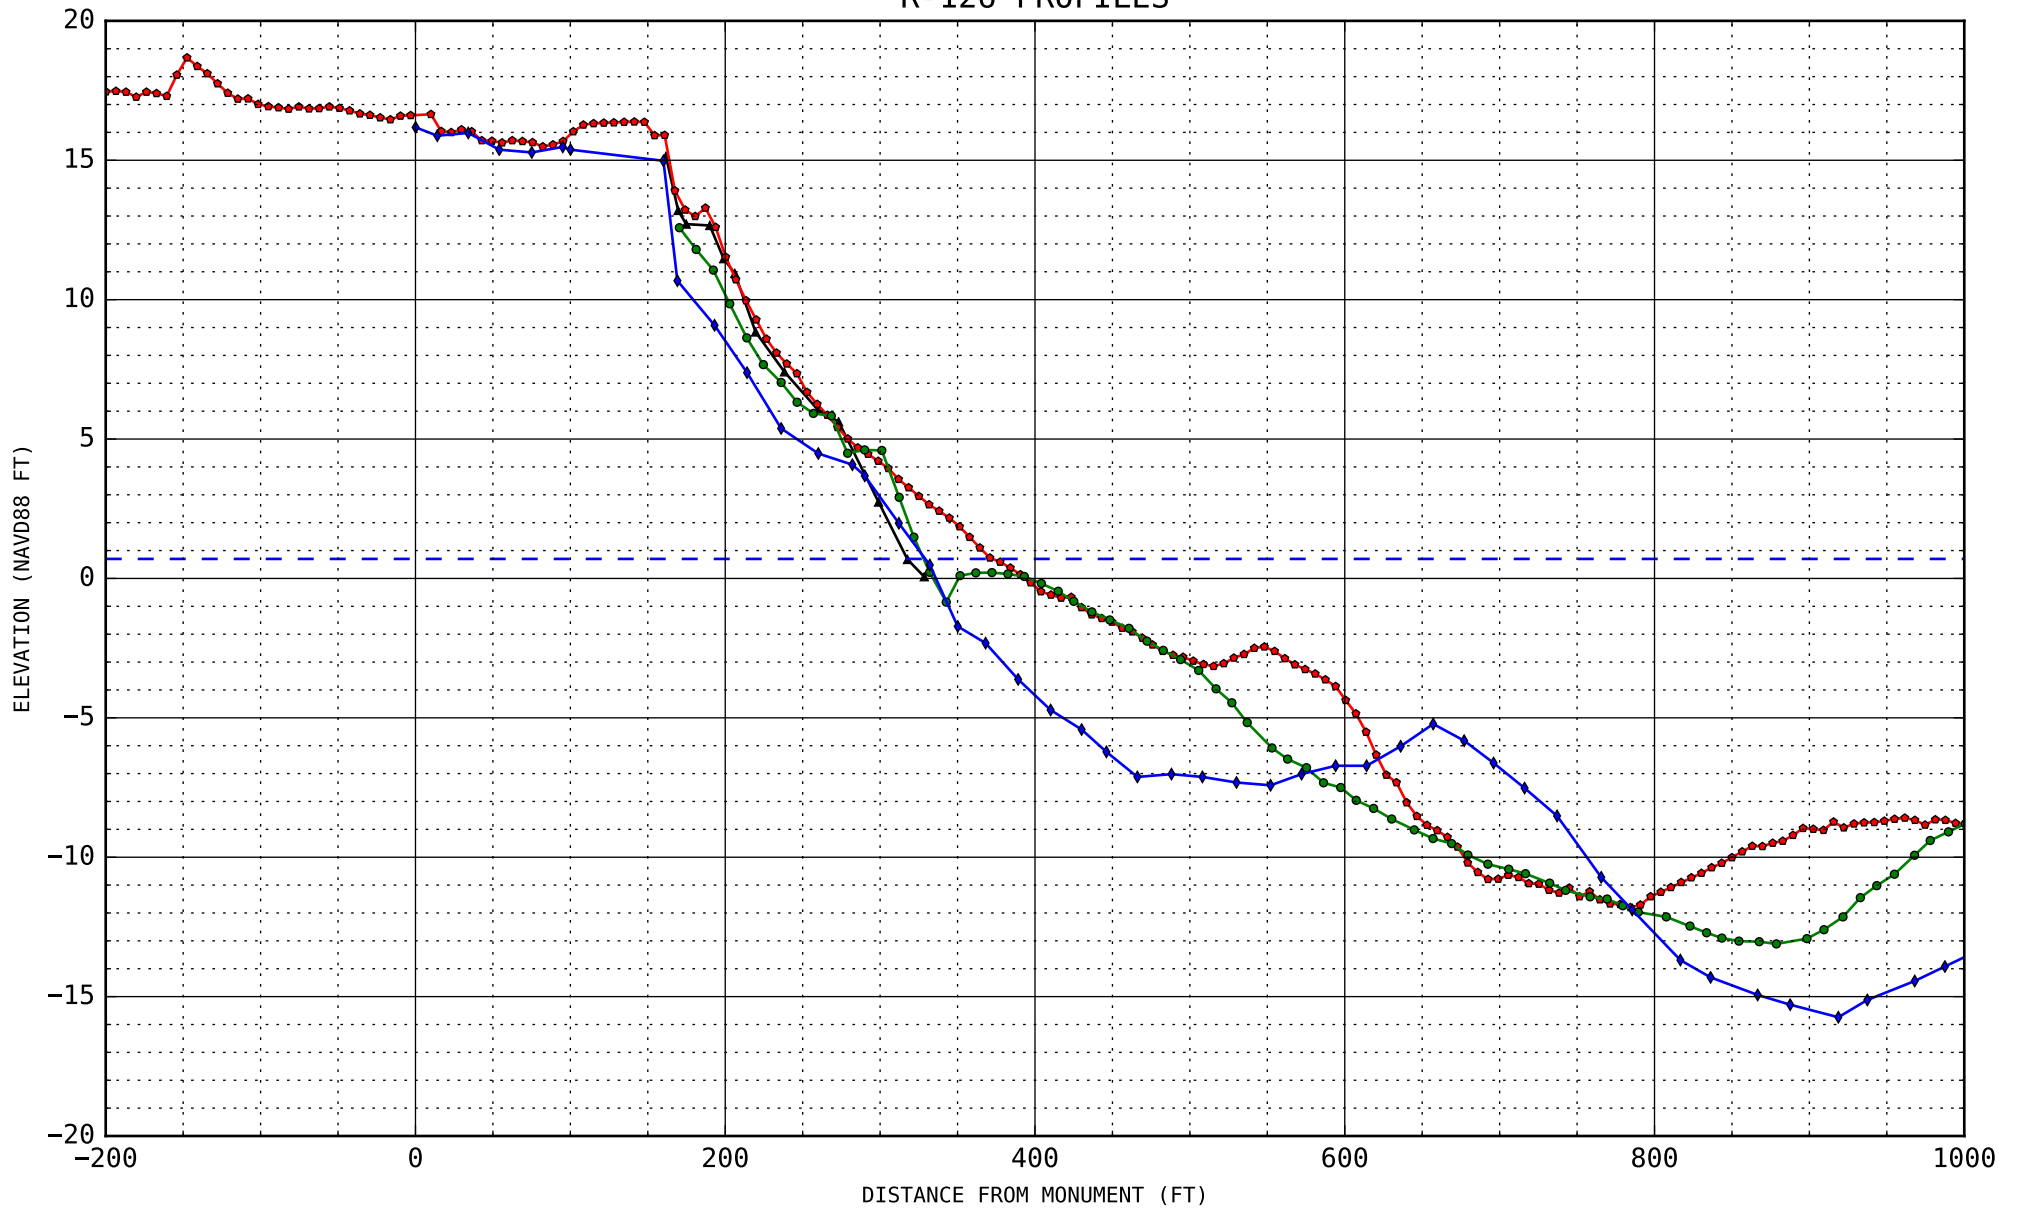
# R-126 PROFILES

- ▲ 2019-APR CONDITION BY DEP
- 2018-OCT MONITORING BY USACE-LIDAR
- 2013-SEP MONITORING BY USACE
- ◆ 2007-FEB MONITORING BY MAE
- - - MHW CONTOUR (0.7 FT)

RANGE: R-126  
EST DATE: AUG1976  
SURVEY DATE: 19APR19  
AZIMUTH: 202.0

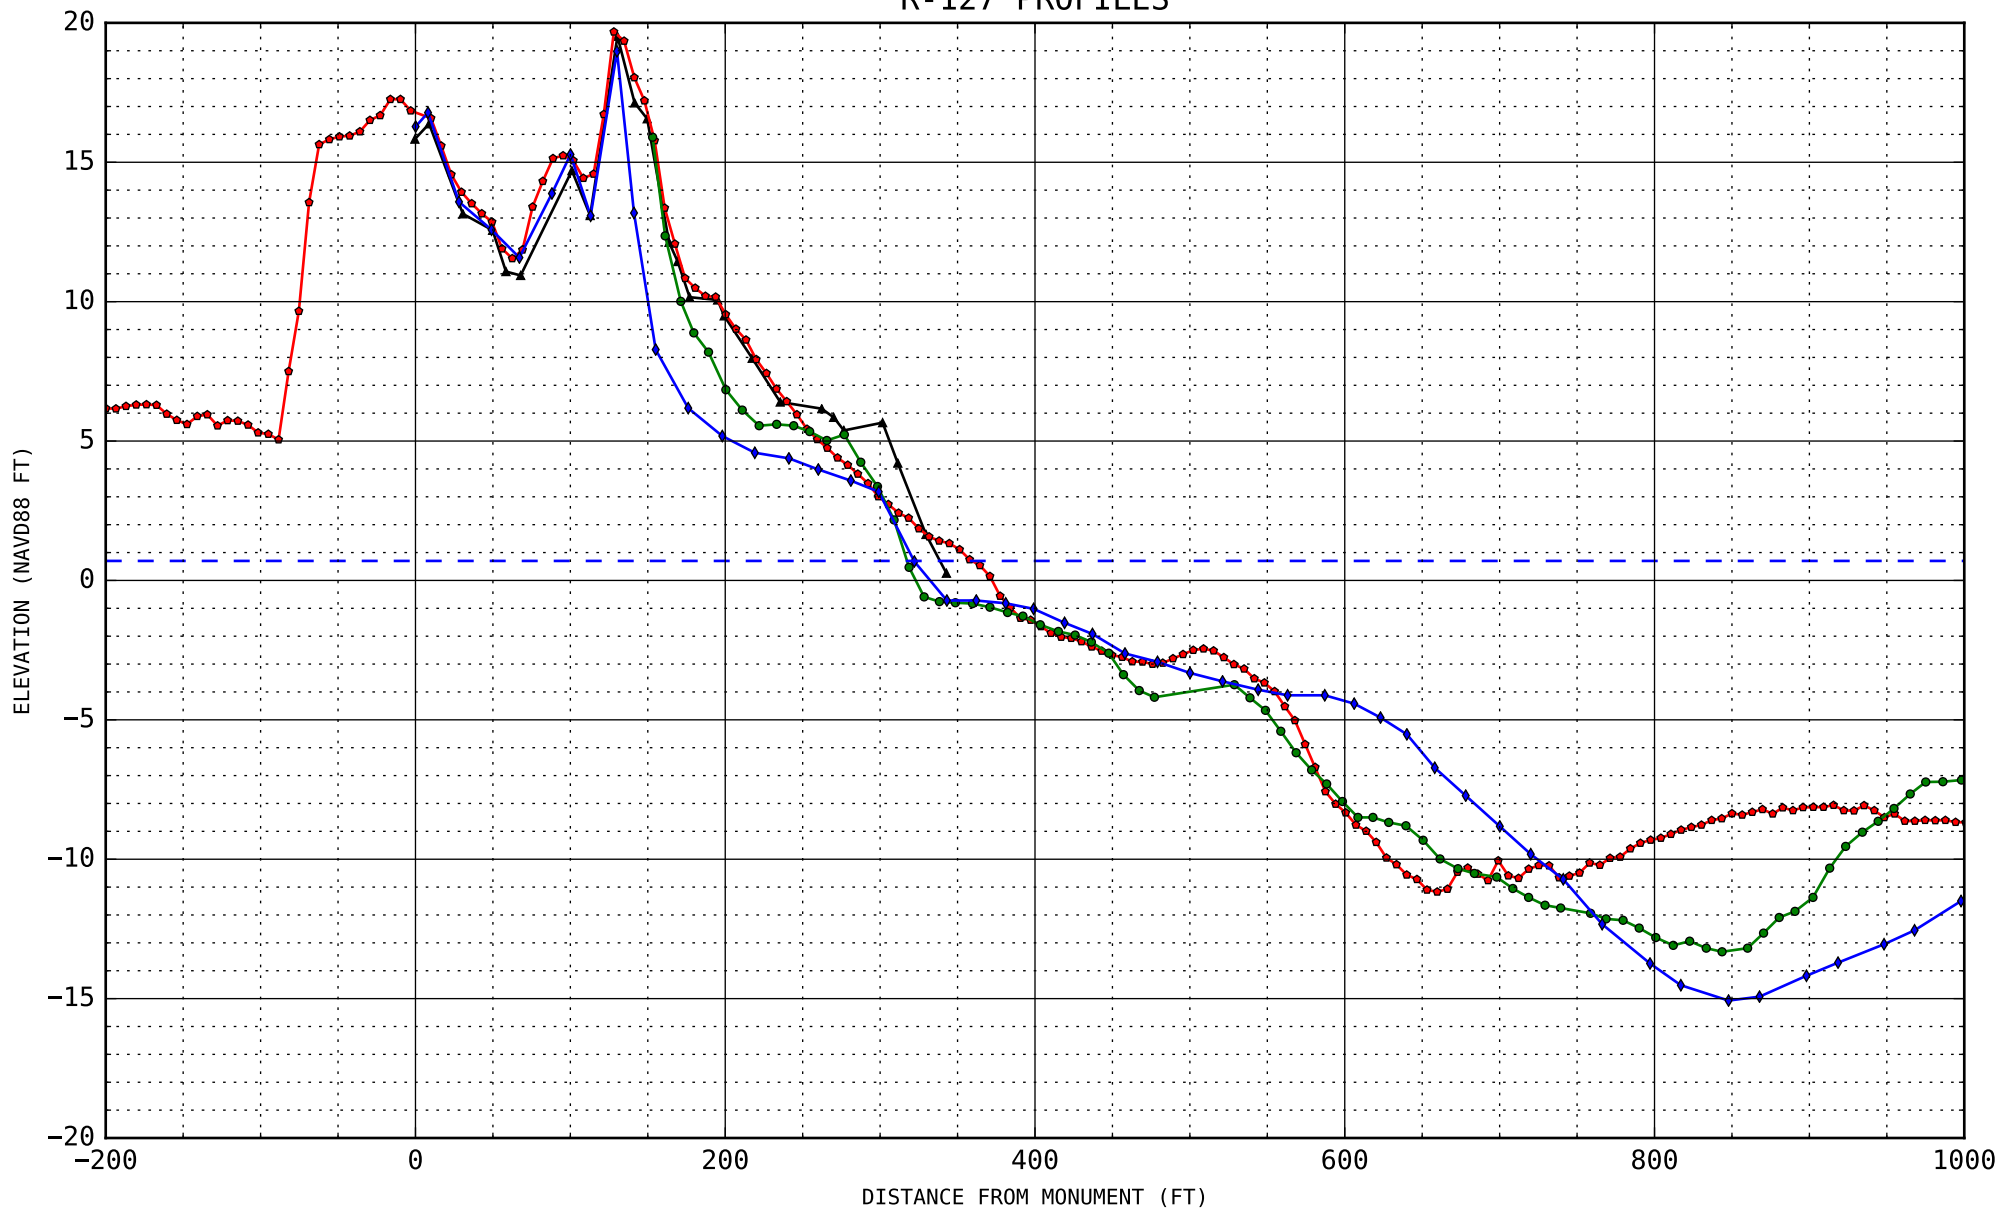
# R-127 PROFILES

- ▲ 2019-APR CONDITION BY DEP
- 2018-OCT MONITORING BY USACE-LIDAR
- 2013-SEP MONITORING BY USACE
- ◆ 2007-FEB MONITORING BY MAE
- - - MHW CONTOUR (0.7 FT)
