# **INDIAN RIVER COUNTY SECTOR 7 BEACH RESTORATION PROJECT 1-YEAR MONITORING REPORT**

**FLORIDA DEPARTMENT OF ENVIRONMENTAL PROTECTION  
BUREAU OF BEACHES AND COASTAL SYSTEMS  
(PERMIT No. 0215960-001-JC)**

**JANUARY 2009**

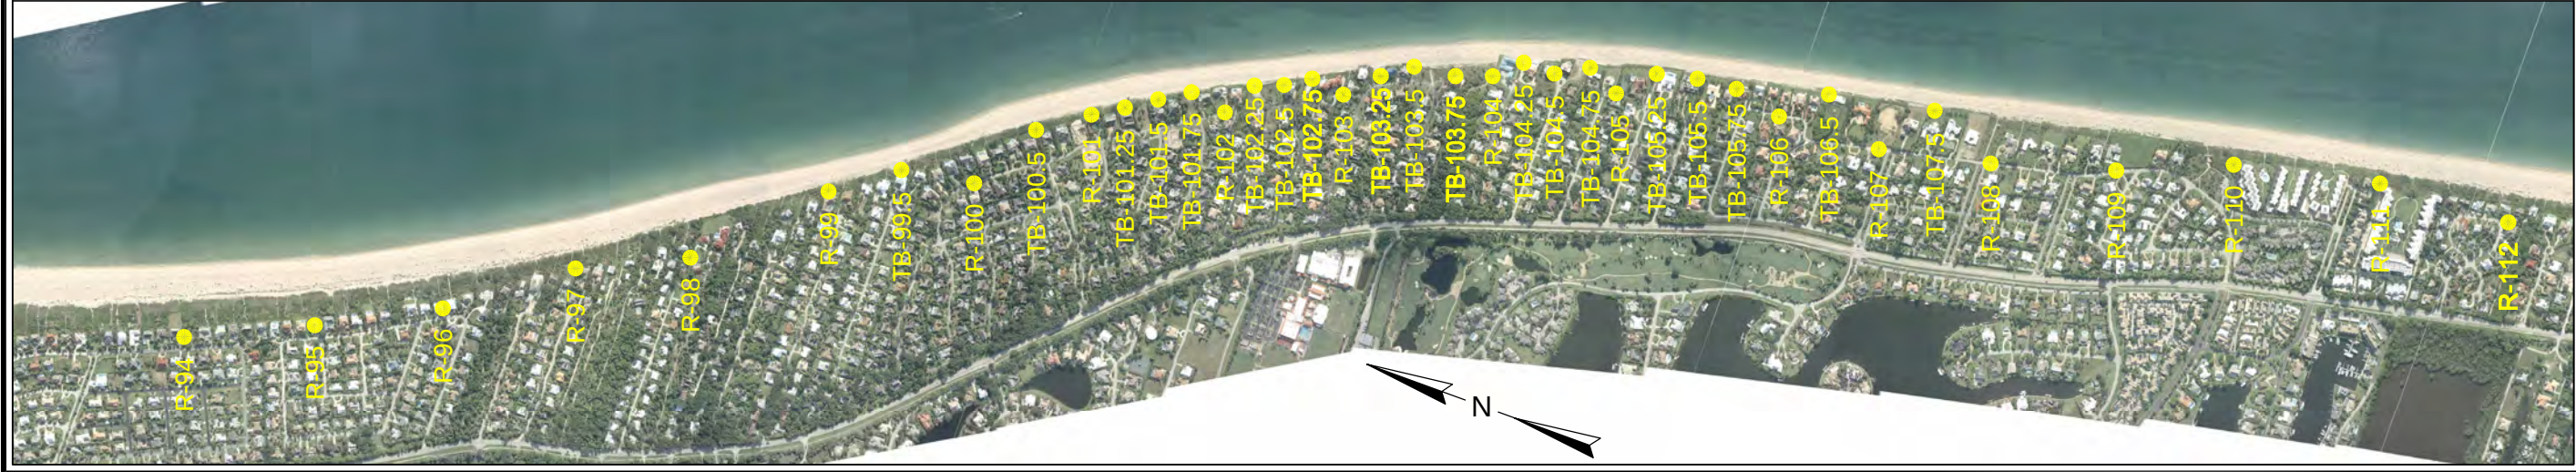
Figure 3  
Volume Changes Above Depth of Closure  
Indian River County Sector 7  
1-Year Post Construction Monitoring Report

Project Area (R-97.5 to R-108) – The project area experienced an average loss of approximately 28,000 c.y. of material above MHW and an additional loss of 64,000 c.y. above the DOC (Table 2). The northern half of the project area is where most of the loss was experienced. From R-98 to R-102.5, there was an average loss of 115,000 c.y. of material above the DOC (36,000 c.y. loss above MHW). The southern half of the project area gained material. From R-102.5 to R-106.5, an average gain of 32,100 c.y. was calculated above the DOC (9,400 c.y. gain above the MHW). The overall loss is an expected result of project spreading, longshore drift, and overall effects of a headland. The beaches south of the project area, as discussed in the next section, will benefit from this process.

South of Project Area – The beach profile data depicts a gain of material both above MHW and below MHW. The beach profiles gained a net of approximately 17,600 c.y. in the active profile (above DOC, Table 2) and experienced increases of 11,630 c.y. above MHW. This gain is the expected result of longshore drift as material from the project area is spread to the south in the direction of the net longshore sediment transport.

Overall, the monitored area experienced a net volume loss of 68,700 c.y. between the 2007 post-construction and 1-year monitoring period. Approximately 78% of the placed volume remains within the project limits and 94% remains within the entire surveyed area from R-94 through R-112. This demonstrates that the project experienced spreading and cross-shore equilibration since the material was initially placed.

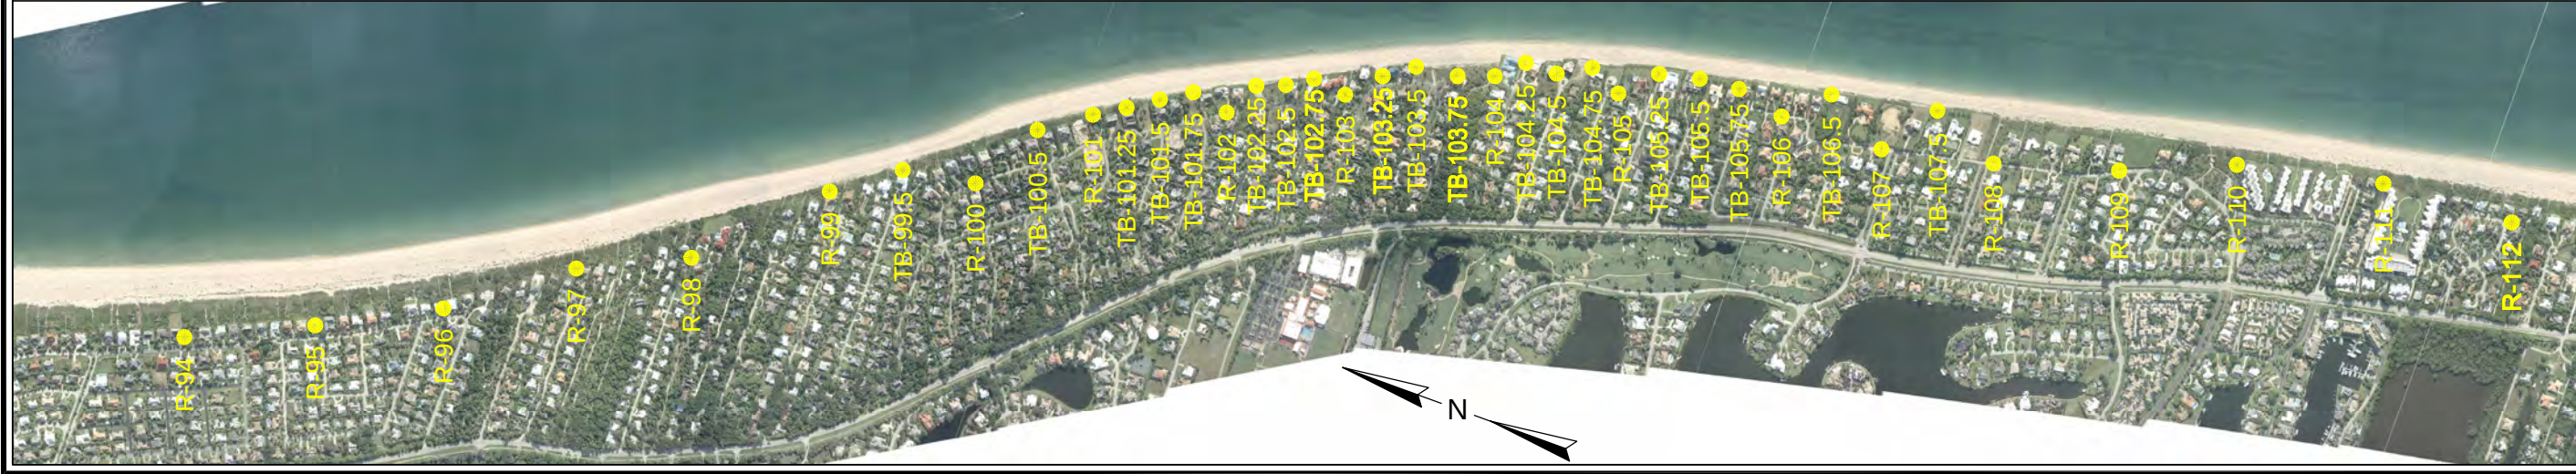
Figure 4  
Shoreline Position Changes  
Indian River County Sector 7  
1-Year Post Construction Monitoring Report

North of Project Area - The shoreline immediately north of the project area (R-94 to R-97.5) experienced overall shoreline accretion. Immediately after the nourishment project, this stretch of shoreline receded approximately 30 feet (Table 3, Figure 4). Over the past year, the shoreline accretion is consistent with the onshore movement of sand from the nearshore. In the 1-year period following construction of the beach, the shoreline position between R-97.5 and R-94 has advanced. The average shoreline gain for this area is 40.6 feet based on the MHW shoreline position (Table 3, Figure 4). The berm location gained an average of 27.3 feet over the 1-year monitoring period.

Project Area (R-97.5 to R-108) – The project shoreline receded between R-97.5 and R-108 by an average of 11.1 feet (Table 3, Figure 4). However, there is a substantial loss north of R-102.5 with an average loss of 26.8 feet, while south of R-102.5 (to R-108) the shoreline experienced an average gain of 2.8 feet. The berm position also showed similar changes both north and south of R-102.5. The berm position receded an average of 33.4 feet to the north of R-102.5 and experienced an average gain of 3.6 feet to the south of R-102.5 (to R-108). Overall, there was an average loss of 13.8 feet to the berm position within the project area. This change is likely the result of the material in the northern part of the project area spreading to other areas and further cross-shore equilibration of the construction beach profile. The overall performance is consistent with the "feeder beach" design concept.

South of Project Area – The shoreline south of R-108 experienced a gain to both the MHW shoreline and the location of the berm. The MHW shoreline position gained an average of 14.1 feet and the berm width increased an average of 15.5 feet during the 1-year monitoring period (Table 3, Figure 4).

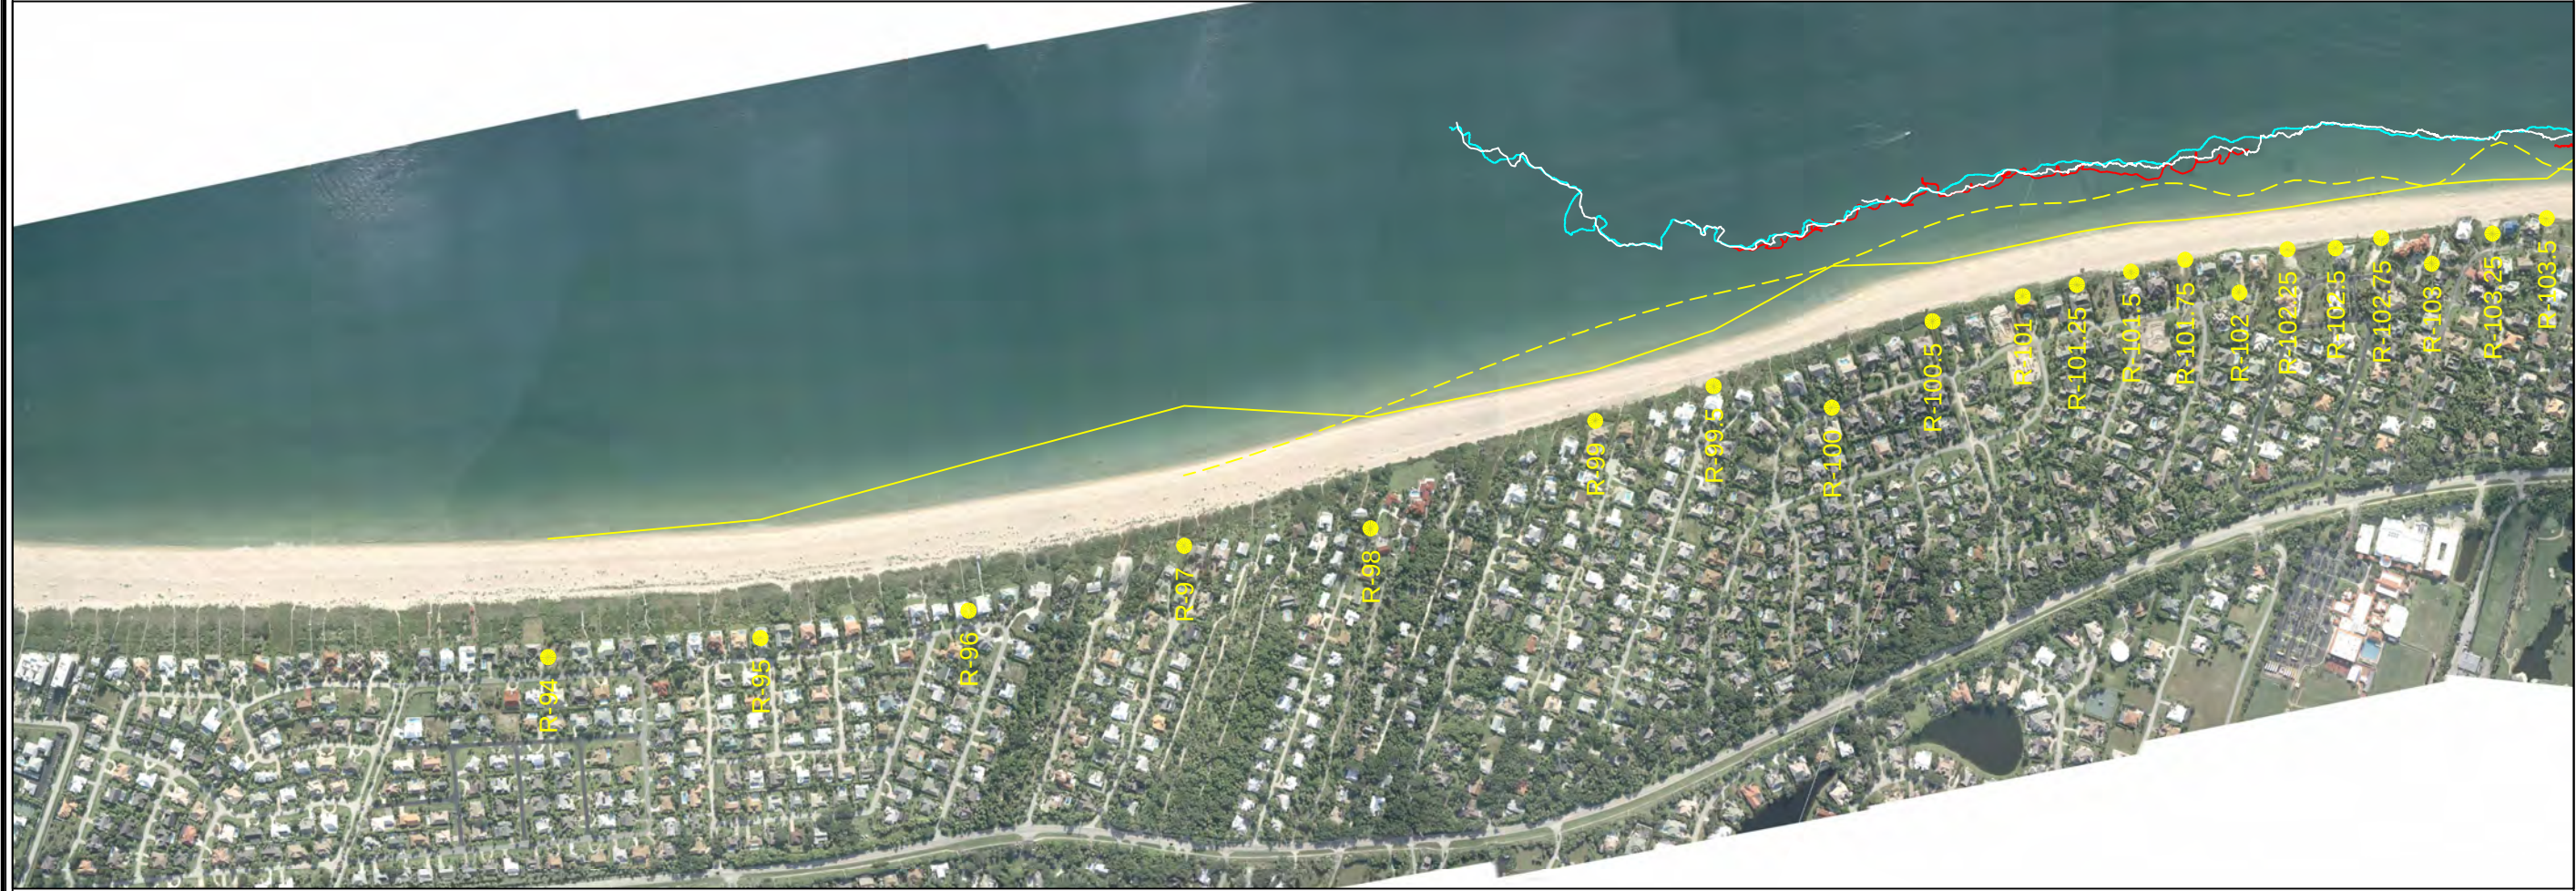
Figure 5a  
 Equilibrium Toe of Fill Changes  
 Indian River County Sector 7  
 1-Year Post Construction Monitoring Report

The project was designed with the intent of no direct impacts to the nearshore hardbottom. The GENESIS shoreline model was utilized to predict the project toe of fill throughout the project life, and the model was used as a design tool in the development of a no-impact project. The toe of fill for the 1-year monitoring period is based on an analysis of the beach profile survey data. To assess the performance of the project, the observed toe of fill is compared to diver-mapped landward edges of hardbottom and model-predicted toe of fill.

Figure 5 presents the 1-year post-construction observed toe of fill overlaid on the 2008 aerial photography showing the diver-mapped landward edges of hardbottom and the GENESIS model-predicted toe of fill for the 1-year post-construction monitoring period. The observed toe of fill is in general agreement with the model prediction. At R-97 the observed toe of fill is significantly seaward of the model prediction; however, this area historically gains sand and there is not any adjacent hardbottom in this area. From R-98 to approximately R-103.5, the observed toe of fill generally occurs long the -5 ft. NAVD contour (Appendix A), and is landward of the model-predicted toe of fill. Overall, the observed toe of fill for this monitoring period is landward of the diver-mapped edge of hardbottom.

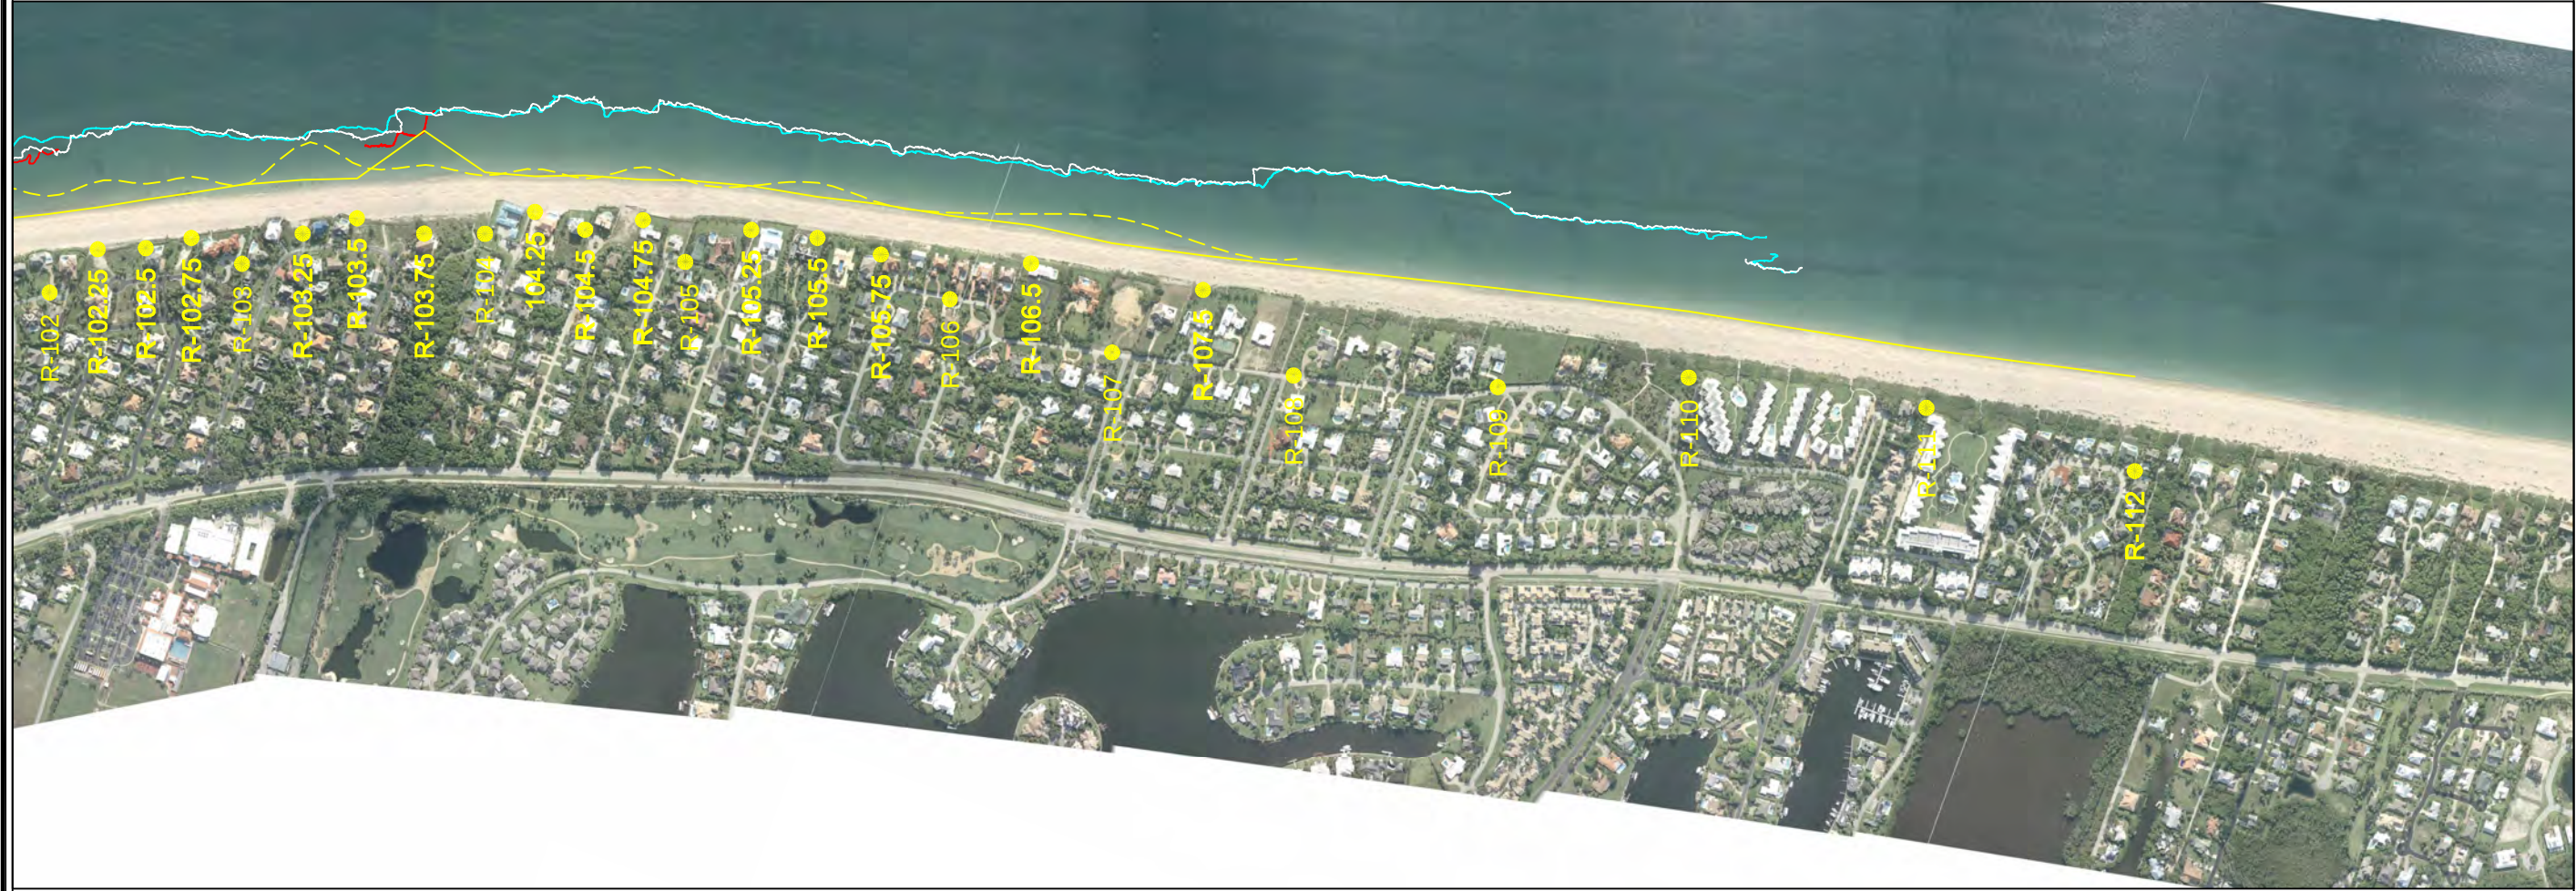
Figure 5b  
Equilibrium Toe of Fill Changes  
Indian River County Sector 7  
1-Year Post Construction Monitoring Report

- The observed toe of fill has not impacted the diver-mapped landward edge of hardbottom.
