# **St. Lucie County**

## **South County Beach & Dune Restoration Project**

### **Draft Mitigation Plan**

**October 14, 2010**

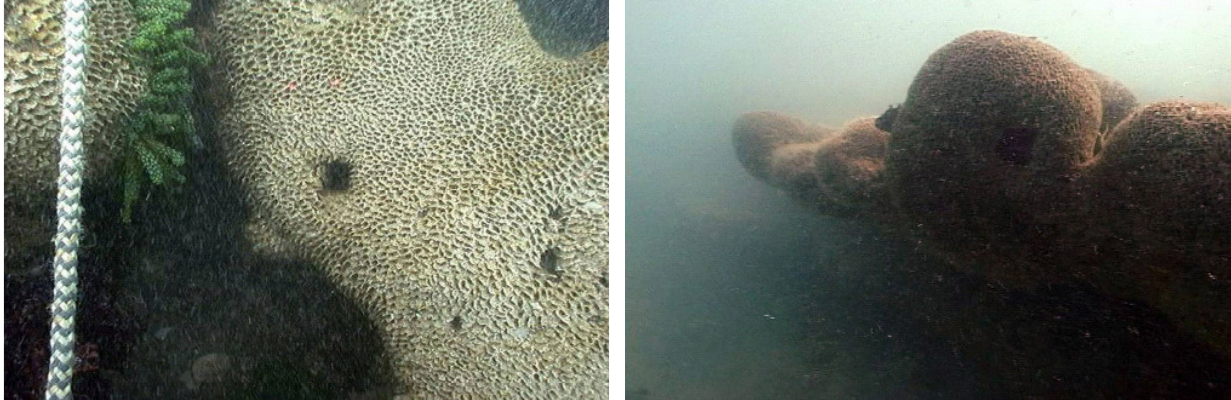
**Figure 5: Representative images from CSA (2010a) of Hardbottom Community One, which consists of low- to medium-relief hardbottom with a wormrock component.**

Ecological functions of nearshore hardbottom communities within the Project area vary depending upon the dominant floral and faunal species observed and the community structure. Hardbottom Community One (CSA 2010a), located within the footprint of the Project's north segment (R-87.7 to R-90.3), is often discontinuous and patchy along the landward edge of hardbottom, approximately 11 to 48m (36 to 157 feet) from the mean high water line (MHWL). Hardbottom Community One consists of low- to medium-relief hardbottom with a significant wormrock (*Phragmatopoma lapidosa*) component (approximately 10% coverage along monitoring transects) relatively close to shore, and supports biota such as hydroids, encrusting sponges, macroalgae, and turf algae. The physical characteristics of this community type facilitate the establishment and proliferation of *P. lapidosa*, while also supporting a large percent cover of robust, canopy-forming red algae. This community type provides shelter and nutrient source to many invertebrate, fish, and turtle species. Additionally, wormrock is reef-building and contributes to the biological diversity of the nearshore environment. Figure 5 provides visuals of this community type.

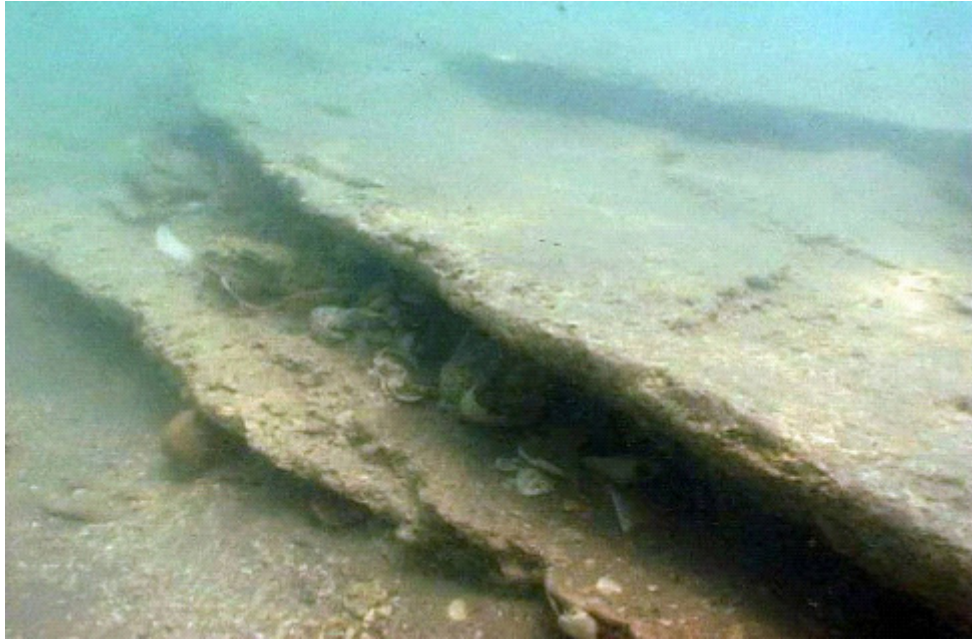
**Figure 7: Representative photo (CSA 2010a) of Hardbottom Community Two, characterized by consolidated coquina rock ledge with little epibiotic growth.**

Hardbottom Community Two is characterized by low-relief consolidated coquina rock ledges approximately 26 to 42m (85 to 138 feet) from MHWL. The ledge is well-defined, undercut with exposed consolidated coquina rock ledge with little or no epibiotic cover (CSA 2010a). This community did not have the wormrock component or robust macroalgae evident in Hardbottom Community One and appears to be constantly subjected to the dynamics of the nearshore environment: sand movement, scouring, and alternating burial/exposure. Because of the ephemeral nature of this community type, in addition to the general absence of extensive biotic coverage, ecological functions likely include temporary shelter for motile invertebrates and fish. Figure 7 depicts this community type and Figures 8 through 13 exhibit the expanses of HB, PEHB, and sand along cross-shore monitoring transects within the limits of this community type, as field-verified by CSA (2010a).
