### **BASELINE NEARSHORE HARDBOTTOM CHARACTERIZATION REPORT**

# Baseline Nearshore Hard Bottom Characterization Survey for the St. Lucie County South Beach Project

January 2010

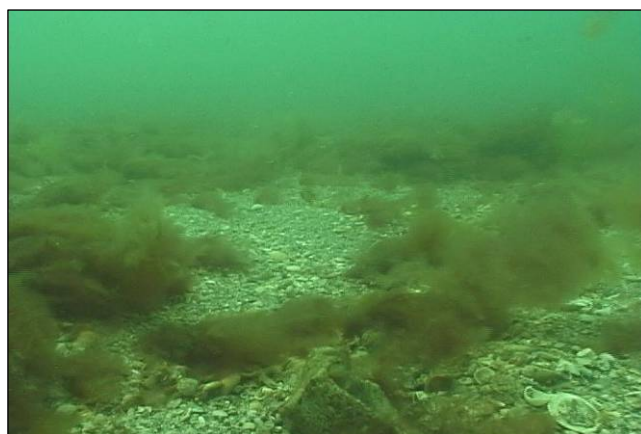
Photo 2. Consolidated shell hash mound observed at the 285-m mark along potential pipeline corridor PC-4.

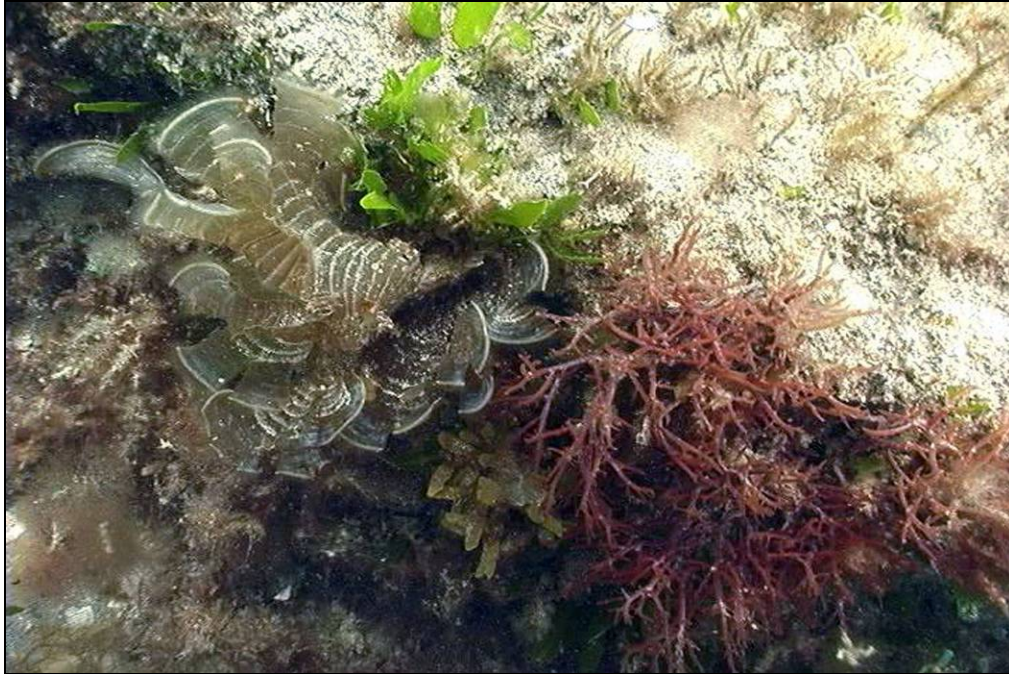
Image A-1. Digitized frame extracted from quantitative video data collected along Transect R-80.4 (0-28 m) showing *Padina* sp., *Caulerpa prolifera/brachypus*, *Gracilaria* sp., and turf algae.

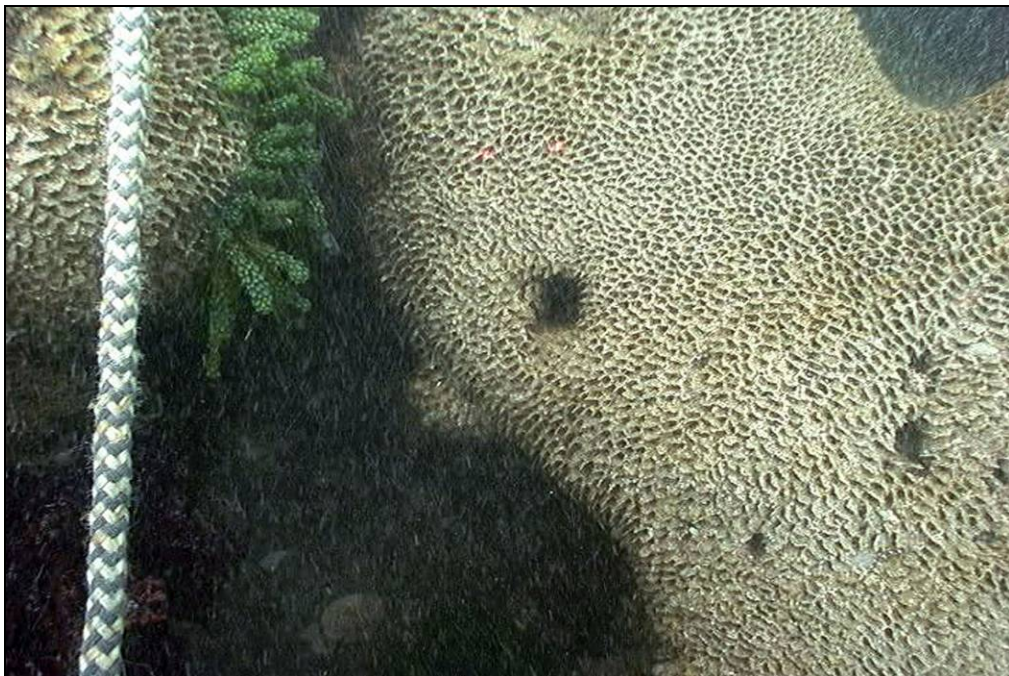
Image A-2. Digitized frame extracted from quantitative video data collected along Transect R-88.7 (0-20 m) showing sabellariid wormrock (*Phragmatopoma lapidosa*) and *Caulerpa* cf. *laetevirens*.

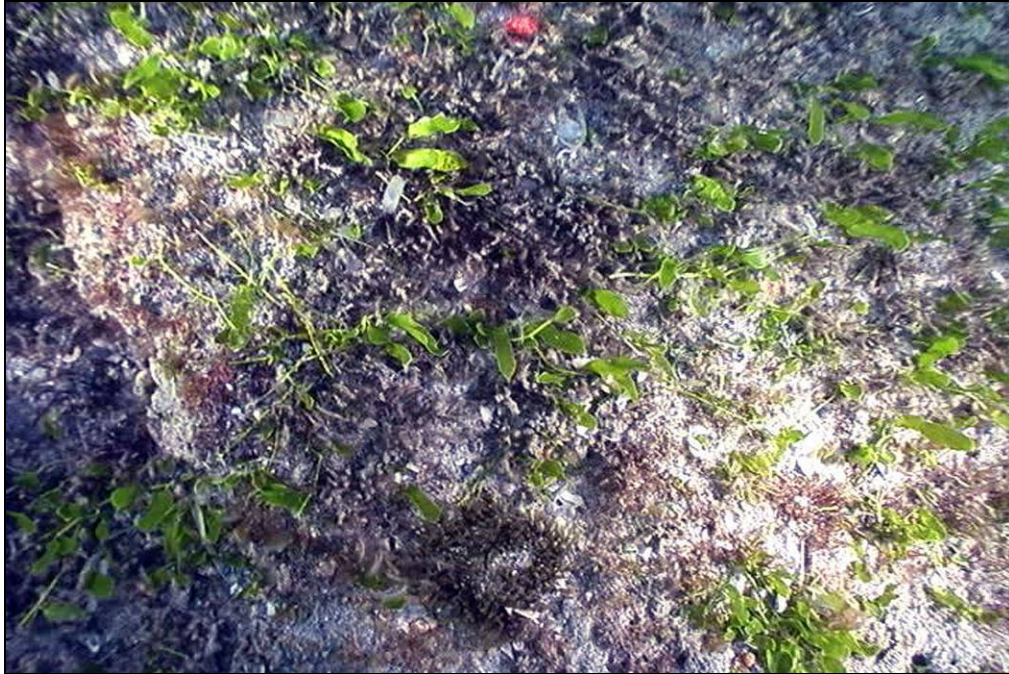
Image A-3. Digitized frame extracted from quantitative video data collected along Transect R-93.5 (0-20 m) showing *Caulerpa prolifera/brachypus*, turf algae, and biotic turf.

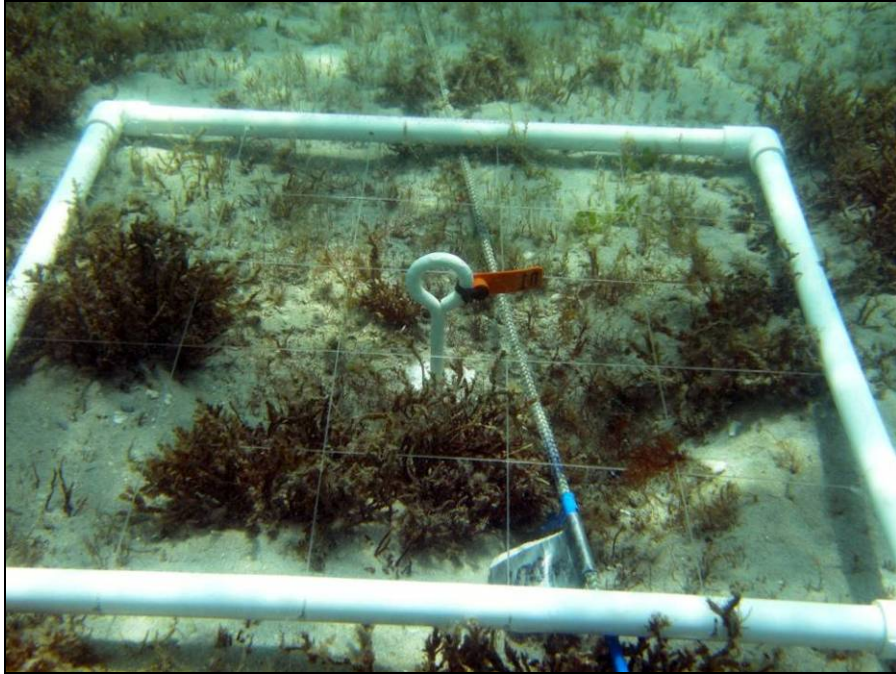
Image A-7. Photograph of *in-situ* quadrat on Transect R-85 at 100 m containing *Bryothamnion seaforthii*, turf algae, rock, and sediment over hard substrate.

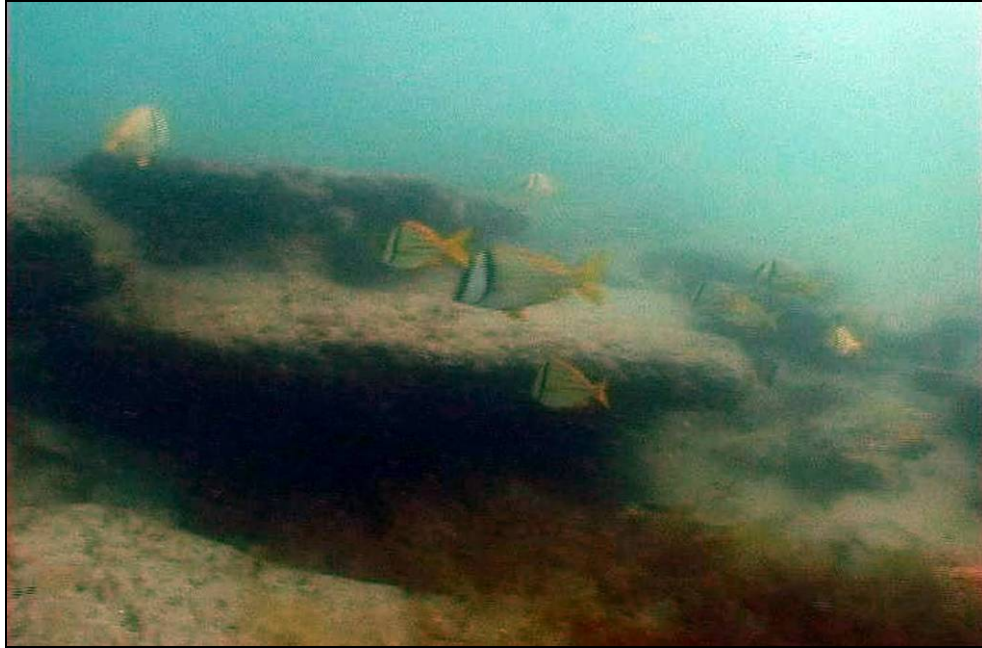
Image A-9. Nearshore hard-bottom edge Community Three observed near Transect R-110. Low- to medium-relief, hard-bottom ledges/slabs with porkfish (*Anisotremus virginicus*), turf algae, and broken algal wrack accumulation are shown in photograph.

Nearshore hard bottom Community Three consisted of a medium-relief broken rock slab ledge. This ledge was often discontinuous and observed in the northern (Transects R-77.7 to R-82.8) and southern (Transects R-109.2 to R-112) extent of the survey area. This hard bottom community was dominated by large (1- to 3-m diameter), flat rock structures found in deeper (3 to 4 m) water and was considerably farther from the shoreline (10 to 196 m from MHWL) when compared to the other nearshore hard bottom communities. This area supported many faunal species not observed in the more nearshore hard bottom areas including spiny lobster (*Panulirus argus*), octocorals (*Leptogorgia* sp.), holothuroids, and a variety of encrusting sponges. Fishes observed in this community included porkfish (*Anisotremus virginicus*), sheepshead (*Archosargus probatocephalus*), striped burrfish (*Chilomycterus schoepfii*), highhat (*Pareques acuminatus*), juvenile angelfish (*Pomacanthus* sp.), and many other species of newly settled juvenile fishes.

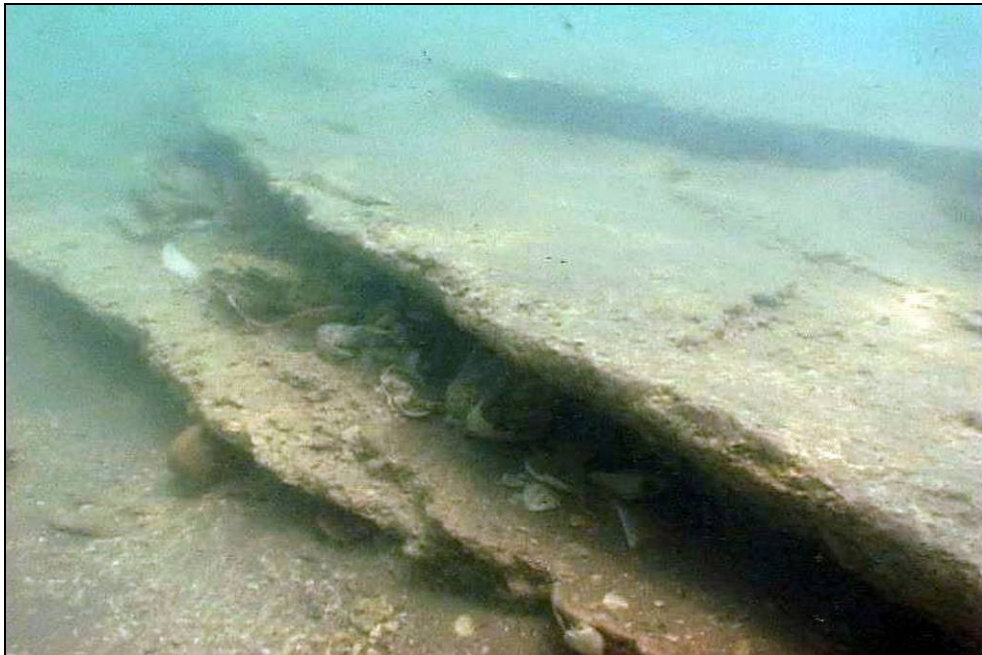
Image A-10. Nearshore hard-bottom Community Two observed near Transect R-105.9. Low-relief consolidated coquina hard-bottom ledges with limited benthic growth and large shell rubble are shown in photograph.

Nearshore hard bottom Community Two consisted of low-relief consolidated coquina rock ledges and was observed from FDEP Range Monument R-100 south to Range Monument R-106. The nearshore ledge was similar to hard bottom Community One in proximity to shoreline with distance from the 2008 MHWL ranging from approximately 26 m to 42 m. The hard bottom ledge was typically well defined, undercut exposed consolidated coquina rock ledge with little to no benthic cover. Sand along the hard bottom edge in this area was coarse in size with areas of large consolidated shell rubble. Where macroalgae was observed, it was typically composed of turf algae and low-growing green algae *Caulerpa* cf. *laetevirens*, *Caulerpa sertularioides*, and *Codium* sp. Sabellariid wormrock was observed in very low densities in northern portions of this area near Range Monument R-101 and in the extreme southern end along Transect R-105.9, but was not a large component of this nearshore hard bottom community. Fishes observed in this community included sand drum (*Umbrina coroides*), spottail pinfish, electric ray (*Narcine brasiliensis*), hairy blenny (*Labrisomus nuchipinnis*), and grey snapper (*Lutjanus griseus*).

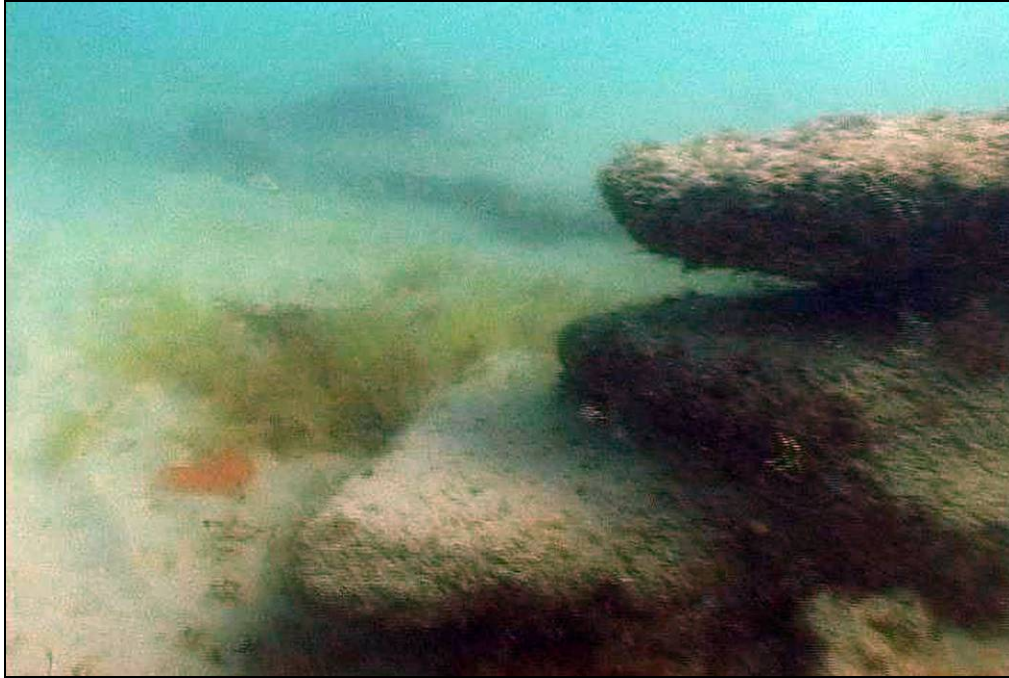
Image A-11. Nearshore hard-bottom Community Three observed near Transect R-80.4. Low- to medium-relief large hard-bottom slab ledge with turf algae is shown in photograph.

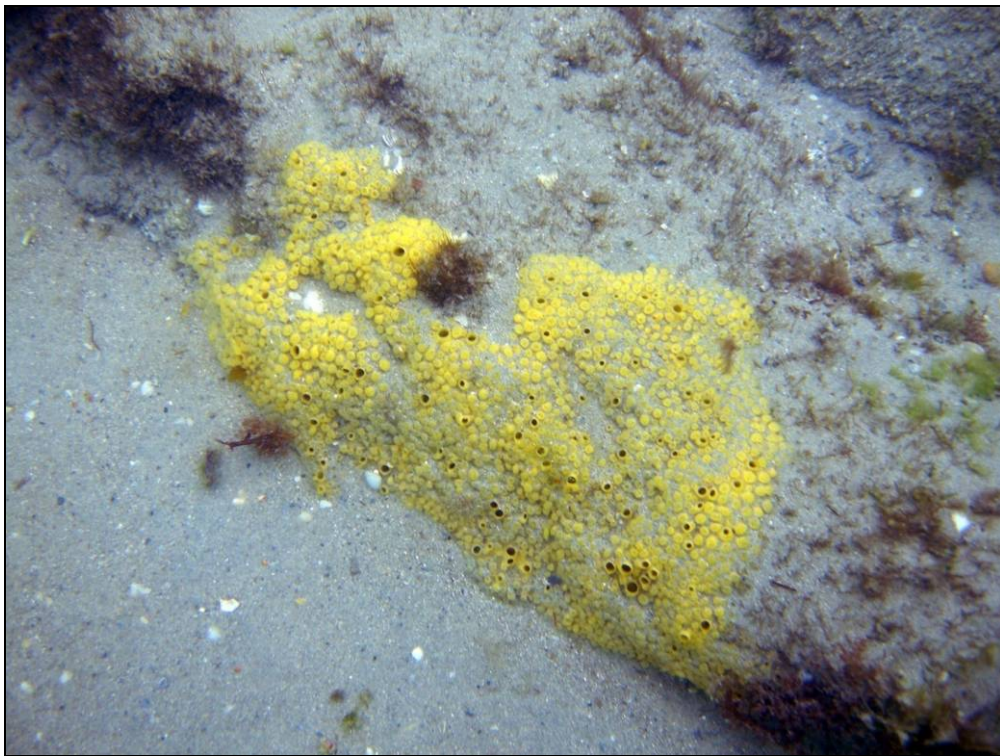
Image A-14. Boring sponge *Cliona celata* observed at the 136-m mark along Transect R-86.3.

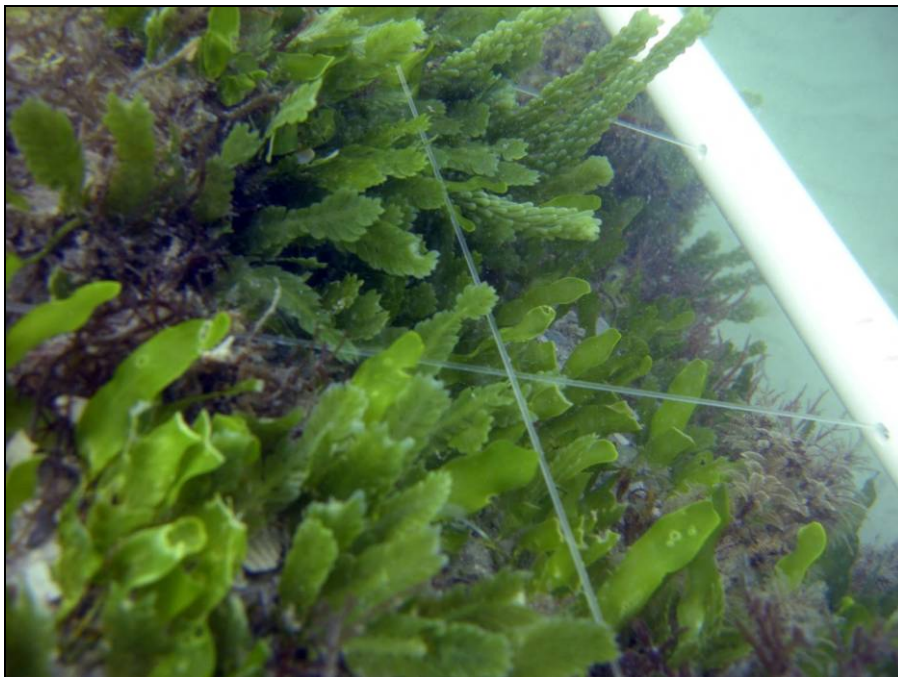
Image A-16. Photograph of *Caulerpa prolifera/brachypus*, *C. mexicana*, and *C. cf. laetevirens* identified within *in-situ* quadrat along Transect R-90 (80 m).

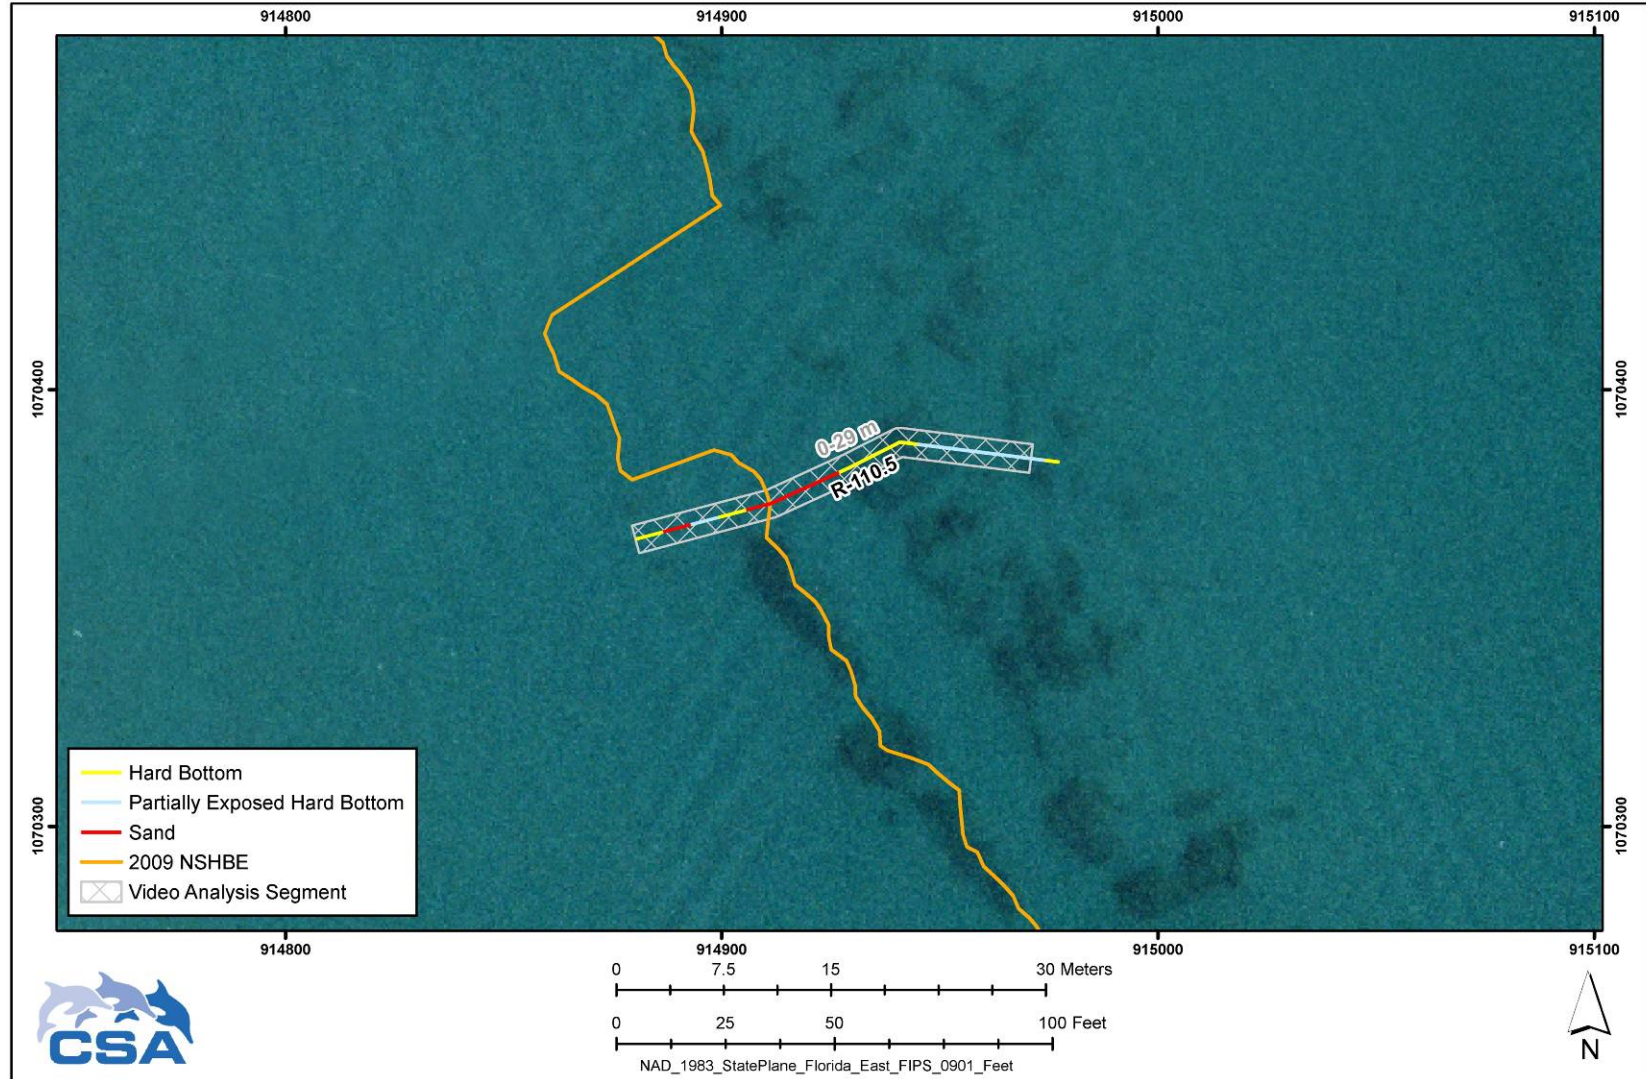
Figure D-19. Transect R-110.5 established during the Baseline Nearshore Hard Bottom Characterization Survey for the St. Lucie County South Beach Project. Yellow lines denote hard bottom, blue lines denote partially exposed hard bottom, red lines denote sand and/or shell hash gaps, and orange line denotes mapped nearshore hard bottom edge (NSHBE). Box indicates the transect segment selected for video analysis. Hard bottom survey conducted 15 July 2009.

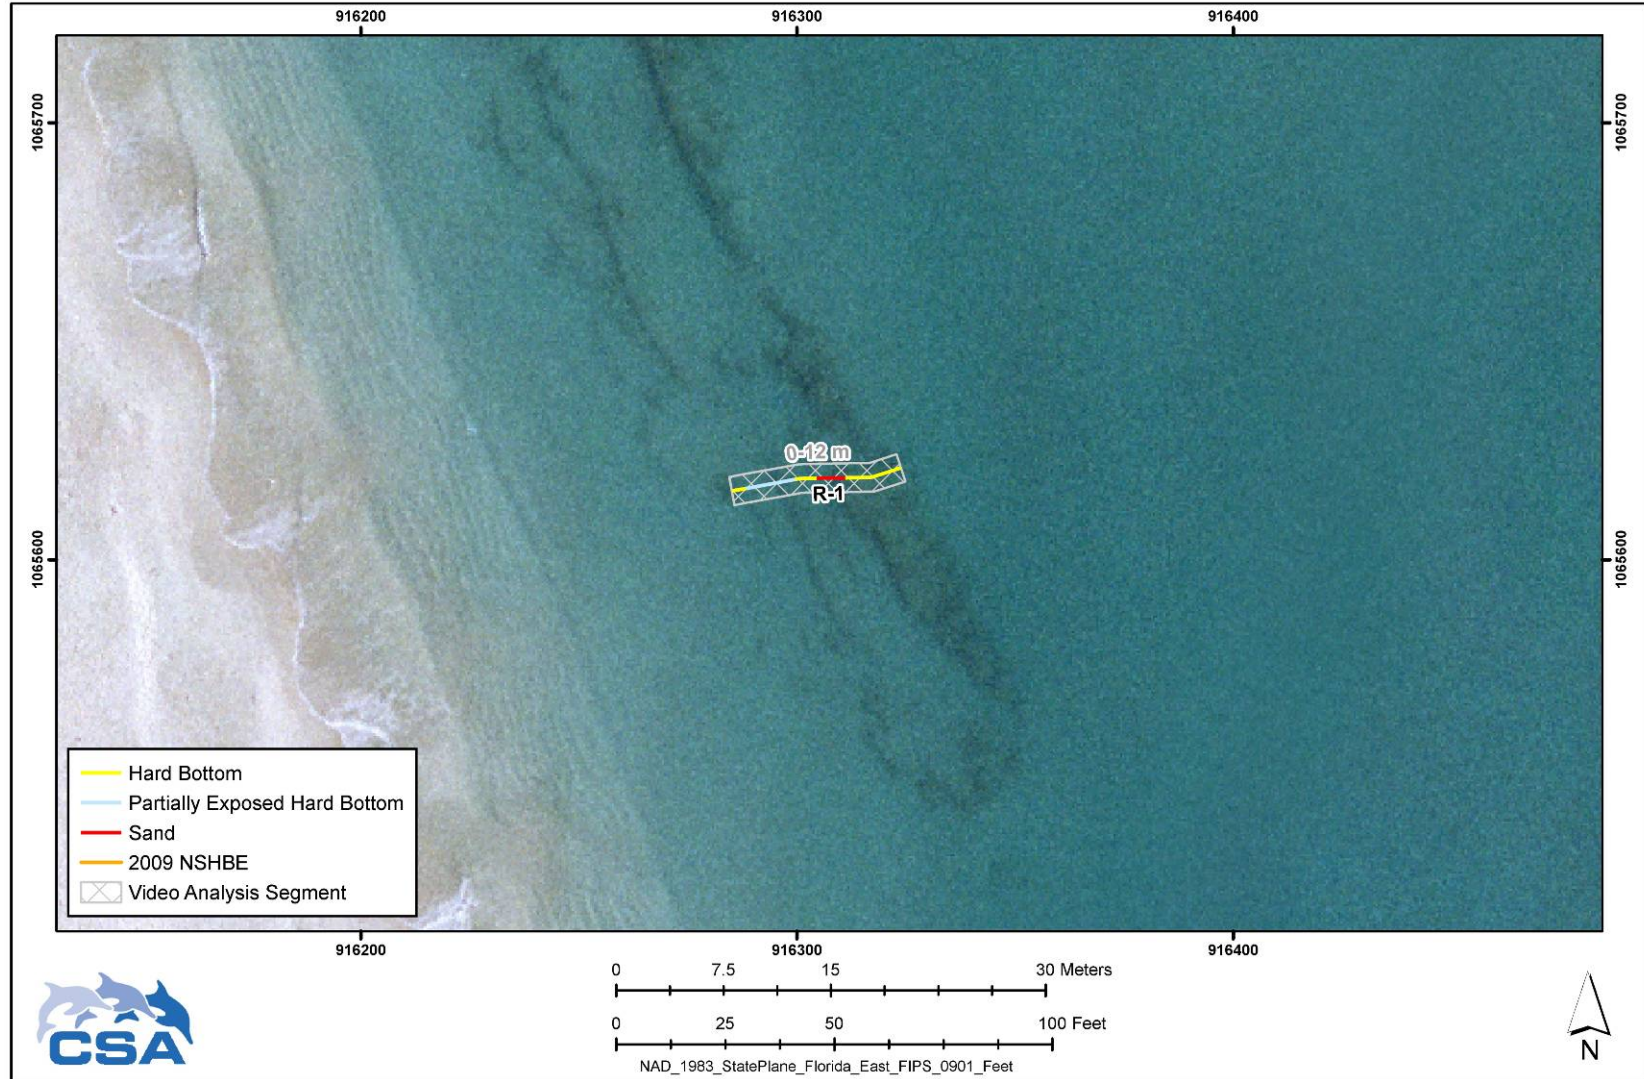
Figure D-21. Transect R-1 established during the Baseline Nearshore Hard Bottom Characterization Survey for the St. Lucie County South Beach Project. Yellow lines denote hard bottom, blue line denotes partially exposed hard bottom, red line denotes sand and/or shell hash gaps, and orange line denotes mapped nearshore hard bottom edge (NSHBE). Box indicates the transect segment selected for video analysis. Hard bottom survey conducted 15 August 2009.

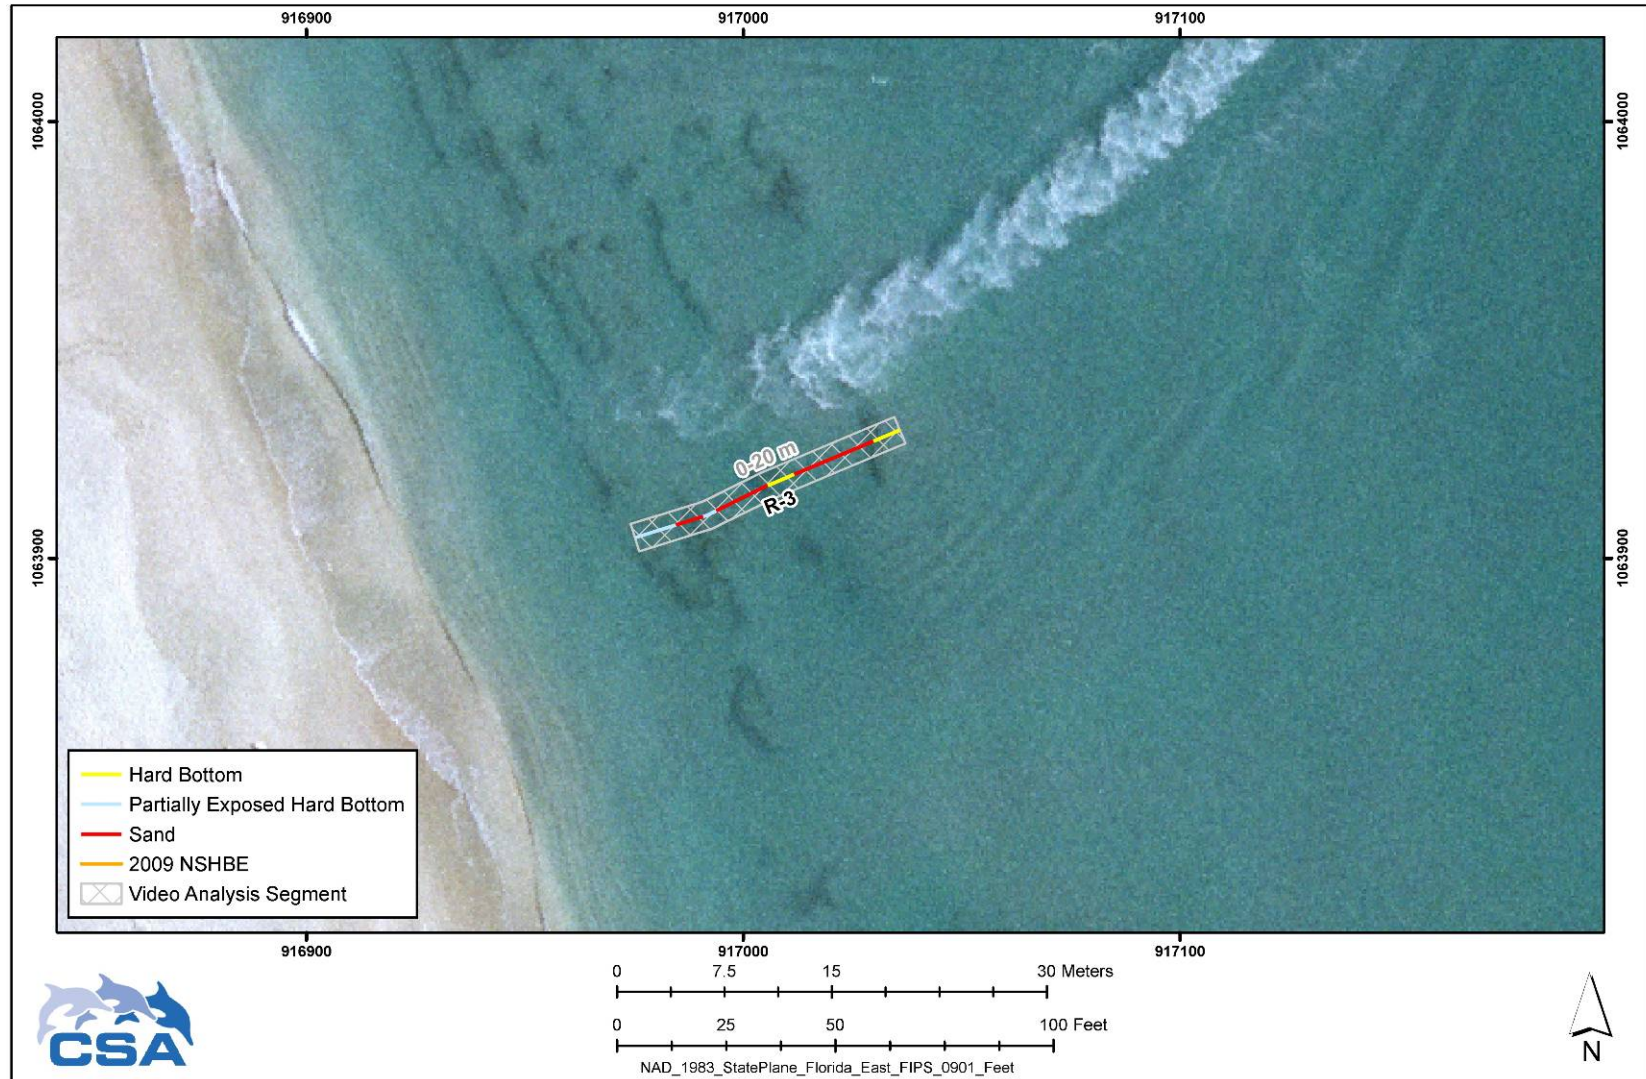
Figure D-22. Transect R-3 established during the Baseline Nearshore Hard Bottom Characterization Survey for the St. Lucie County South Beach Project. Yellow lines denote hard bottom, blue lines denote partially exposed hard bottom, red lines denote sand and/or shell hash gaps, and orange line denotes mapped nearshore hard bottom edge (NSHBE). Box indicates the transect segment selected for video analysis. Hard bottom survey conducted 15 August 2009.

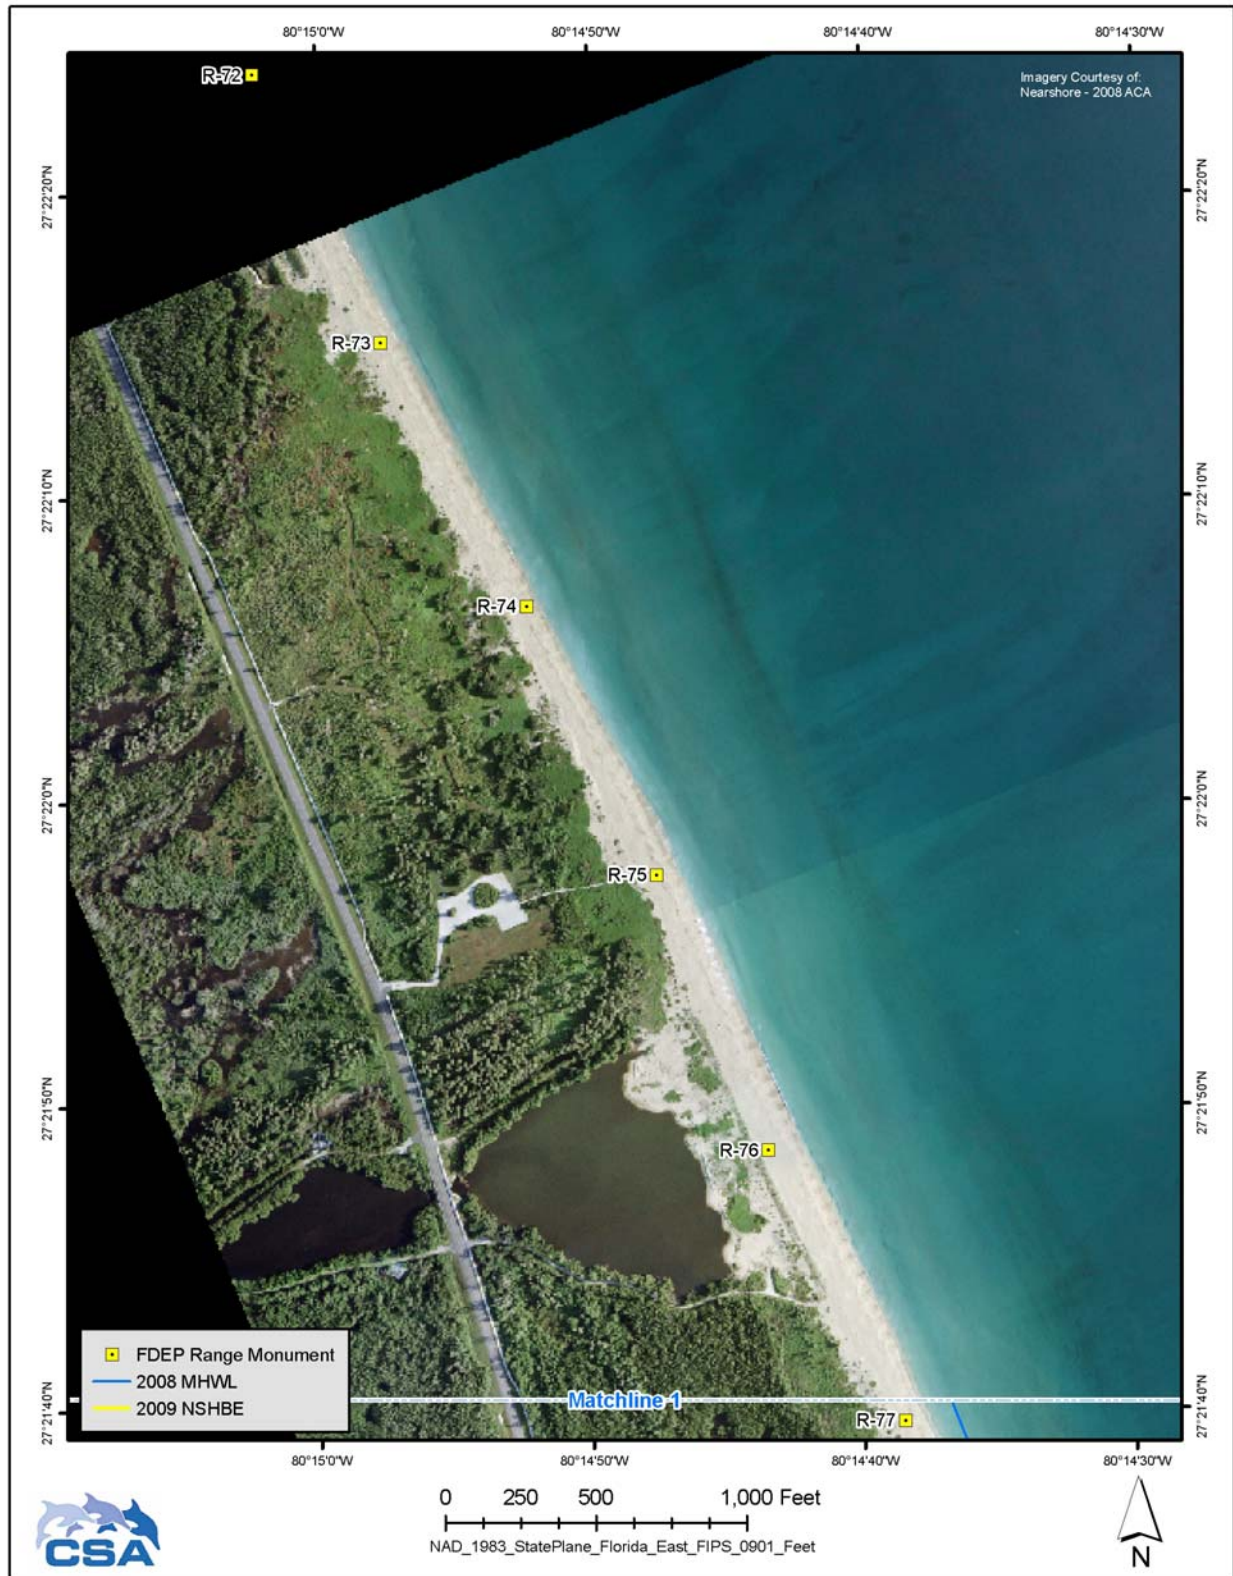
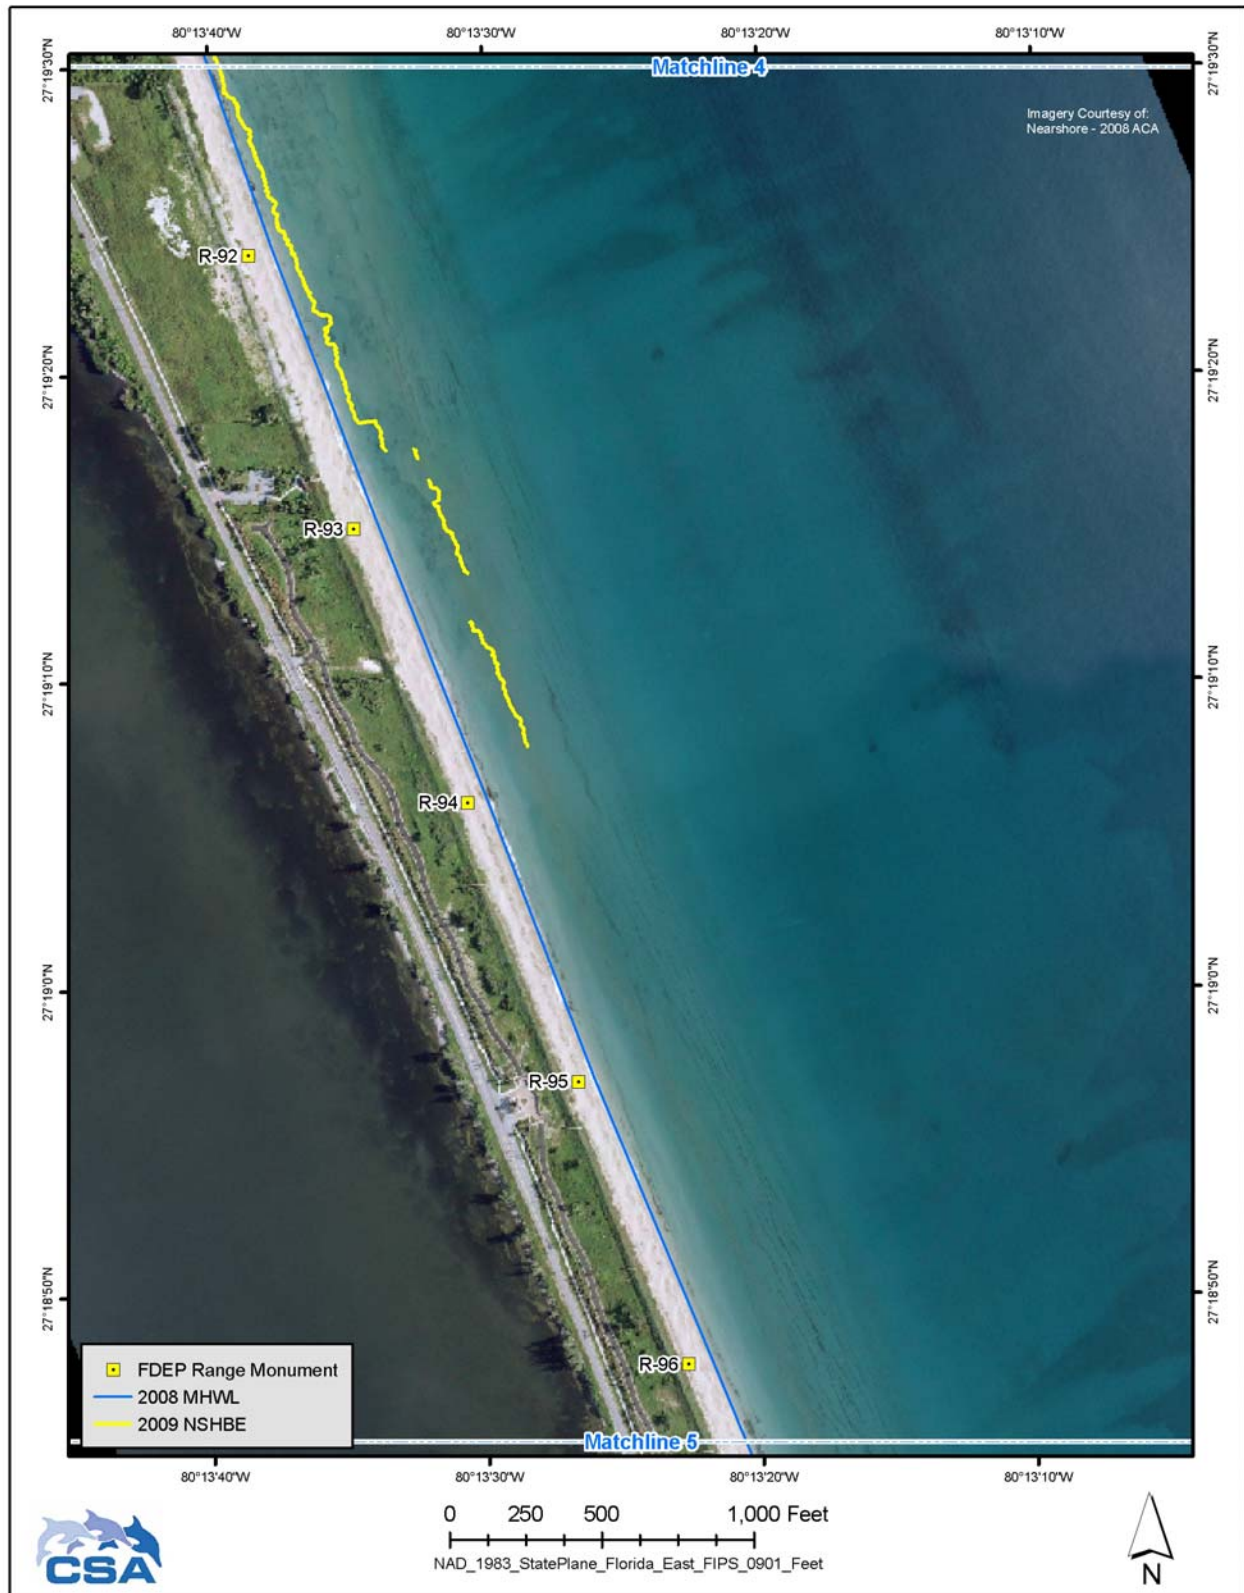
Figure D-23. Overview of the nearshore hard bottom edge (NSHBE) between FDEP Range Monuments R-73 and R-77 mapped during the Baseline Nearshore Hard Bottom Characterization Survey for the St. Lucie County South Beach Project.

Figure D-24. Overview of the nearshore hard bottom edge (NSHBE) between FDEP Range Monuments R-77 and R-81 mapped during the Baseline Nearshore Hard Bottom Characterization Survey for the St. Lucie County South Beach Project.

Figure D-25. Overview of the nearshore hard bottom edge (NSHBE) between FDEP Range Monuments R-82 and R-86 mapped during the Baseline Nearshore Hard Bottom Characterization Survey for the St. Lucie County South Beach Project.

Figure D-26. Overview of the nearshore hard bottom edge (NSHBE) between FDEP Range Monuments R-87 and R-91 mapped during the Baseline Nearshore Hard Bottom Characterization Survey for the St. Lucie County South Beach Project.

Figure D-27. Overview of the nearshore hard bottom edge (NSHBE) between FDEP Range Monuments R-92 and R-96 mapped during the Baseline Nearshore Hard Bottom Characterization Survey for the St. Lucie County South Beach Project.

Figure D-28. Overview of the nearshore hard bottom edge (NSHBE) between FDEP Range Monuments R-97 and R-101 mapped during the Baseline Nearshore Hard Bottom Characterization Survey for the St. Lucie County South Beach Project.

Divers mapped the nearshore hard bottom edge in the survey area between FDEP Range Monuments R-77 and R-2 (**Appendix D, Figures D-23 to D-32**). Marine conditions during the mapping process were ideal with seas less than 0.3 m (1 ft) and underwater visibility ranging from 1.0 to 3.0 m (3.0 to 10.0 ft).

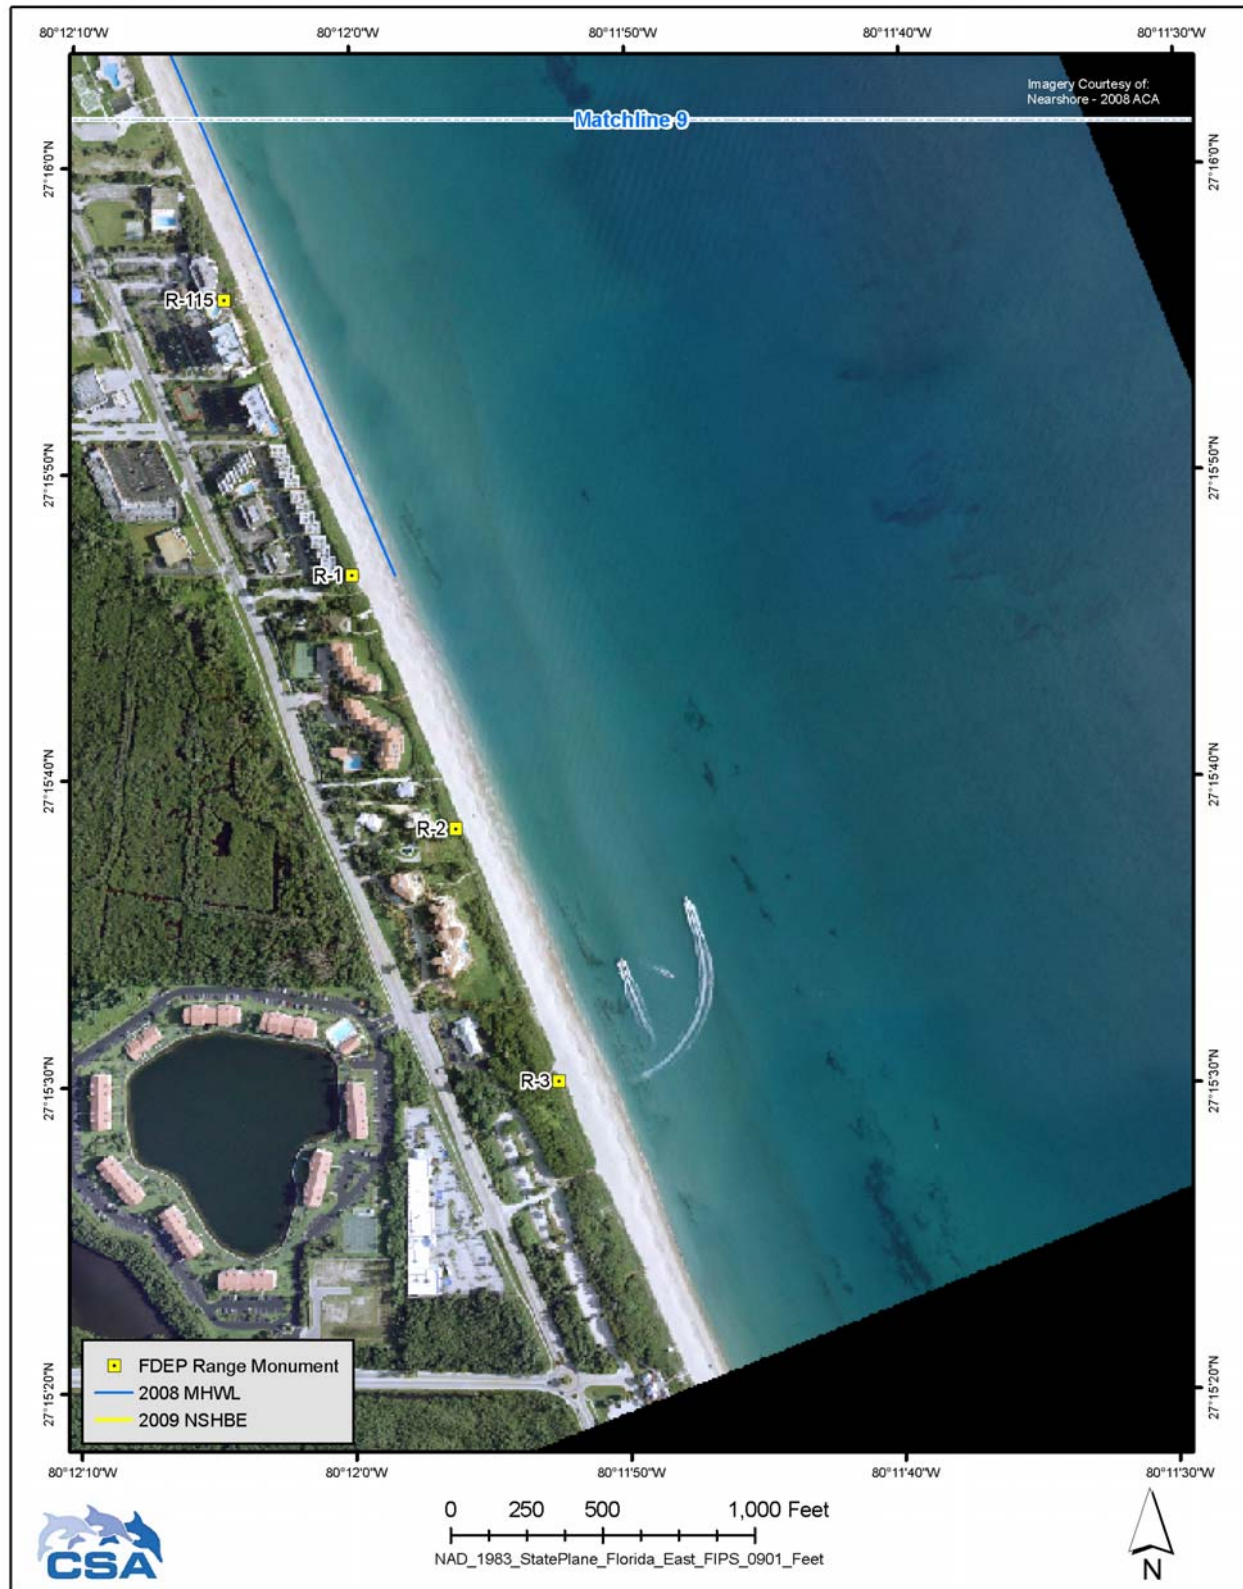
Figure D-29. Overview of the nearshore hard bottom edge (NSHBE) between FDEP Range Monuments R-101 and R-105 mapped during the Baseline Nearshore Hard Bottom Characterization Survey for the St. Lucie County South Beach Project.

Figure D-30. Overview of the nearshore hard bottom edge (NSHBE) between FDEP Range Monuments R-106 and R-109 mapped during the Baseline Nearshore Hard Bottom Characterization Survey for the St. Lucie County South Beach Project.

Figure D-31. Overview of the nearshore hard bottom edge (NSHBE) between FDEP Range Monuments R-110 and R-114 mapped during the Baseline Nearshore Hard Bottom Characterization Survey for the St. Lucie County South Beach Project.

Figure D-32. Overview of the nearshore hard bottom edge (NSHBE) between FDEP Range Monuments R-115 and R-3 mapped during the Baseline Nearshore Hard Bottom Characterization Survey for the St. Lucie County South Beach Project.

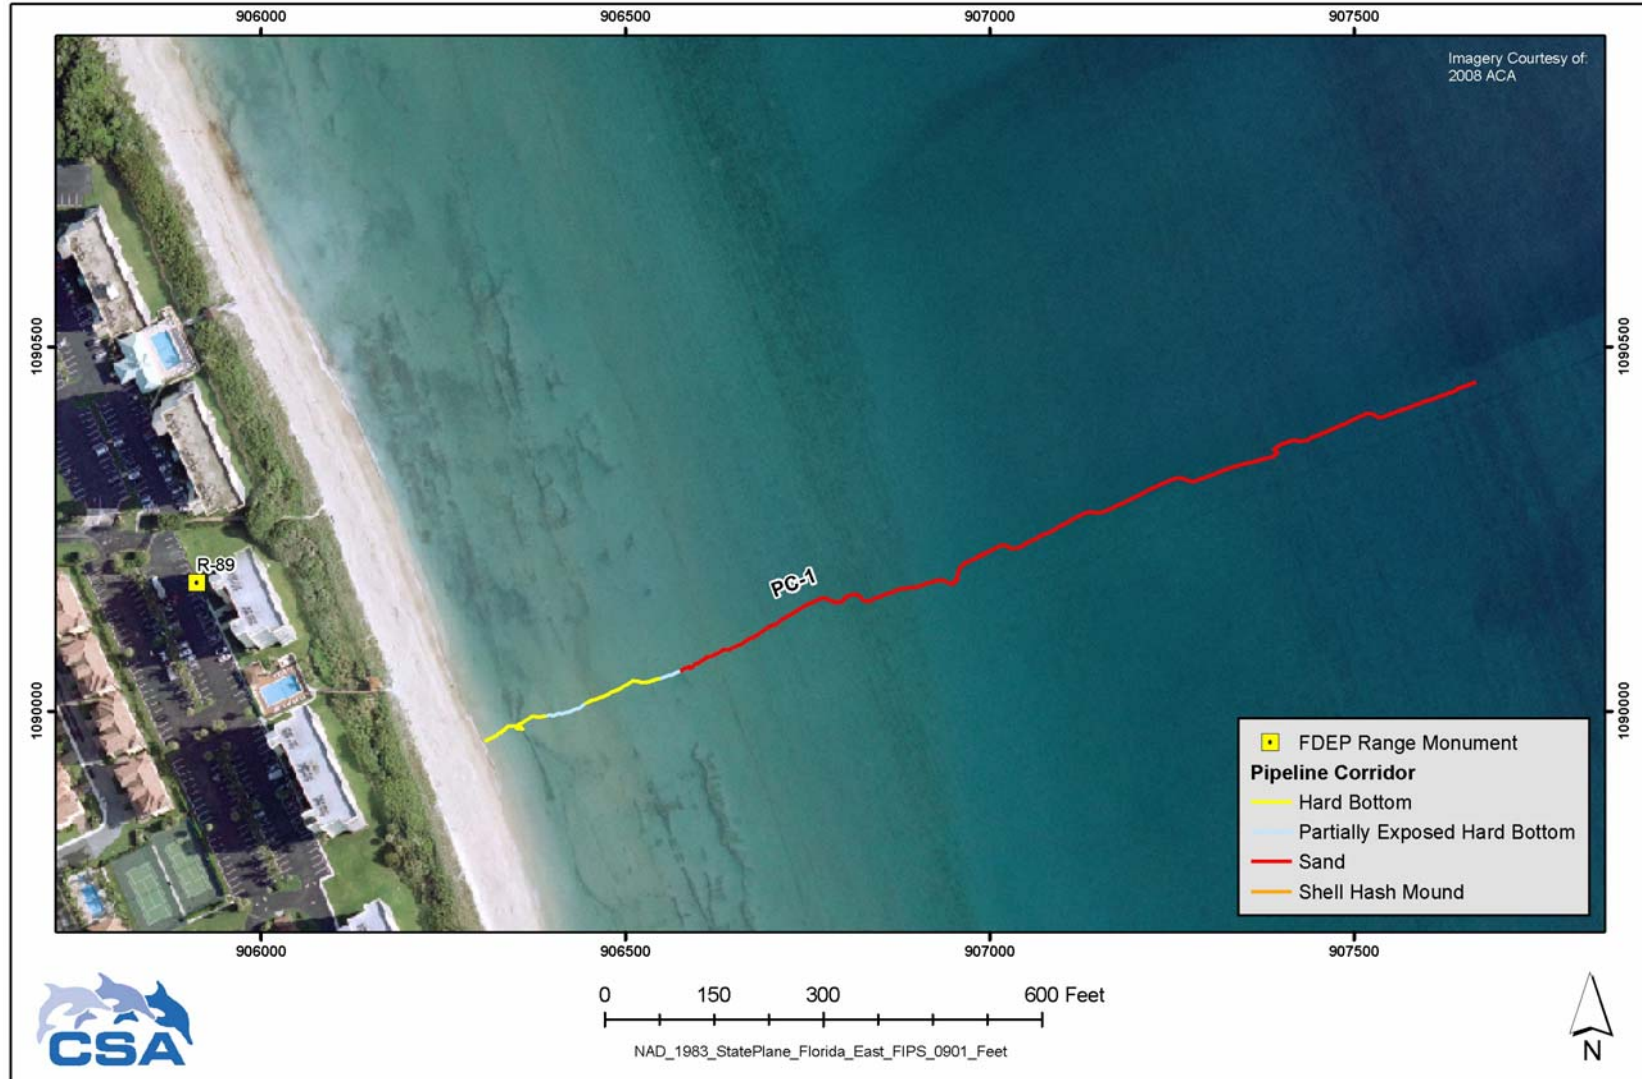
Figure D-33. Potential pipeline corridor PC-1 near FDEP Range Monument R-89 mapped during the Baseline Nearshore Hard Bottom Characterization Survey for the St. Lucie County South Beach Project. Yellow lines denote hard bottom, blue lines denote partially exposed hard bottom, and red line denotes sand. Geo-referenced qualitative video data were collected along the entire proposed pipeline corridor. Survey conducted 16 July 2009.

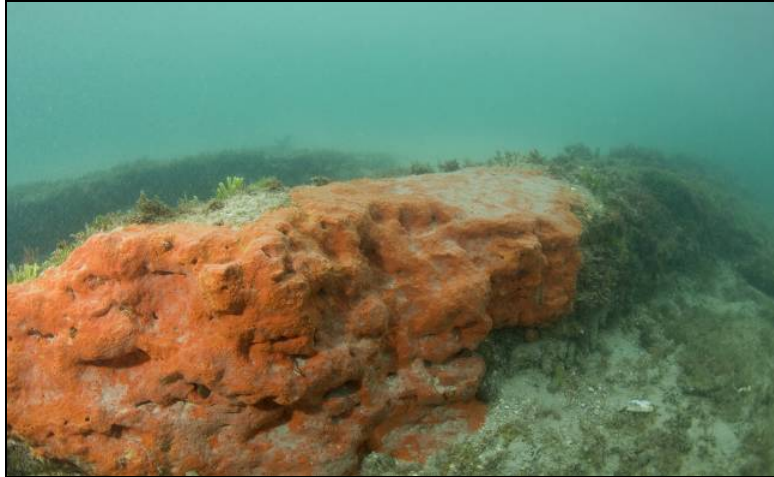
Photo 1. Hard bottom feature along Transect R-85.

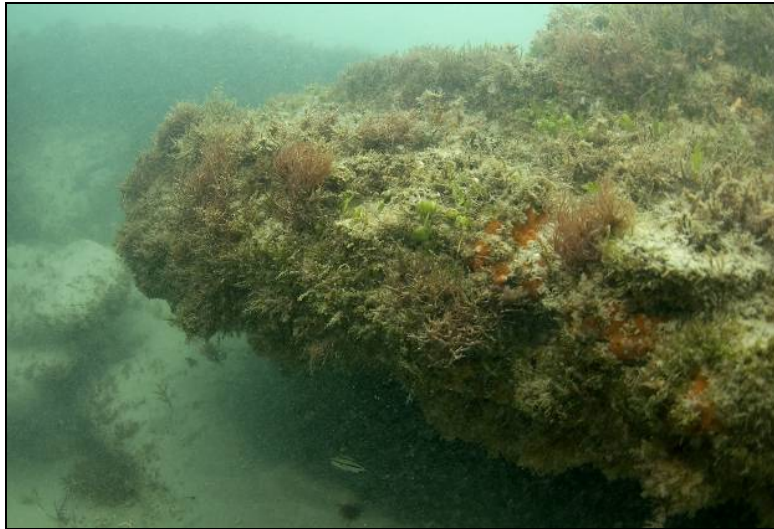
Photo 2. Hard bottom ledge along Transect R-85.
