### **BASELINE NEARSHORE HARDBOTTOM CHARACTERIZATION REPORT**

# Baseline Nearshore Hard Bottom Characterization Survey for the St. Lucie County South Beach Project

January 2010

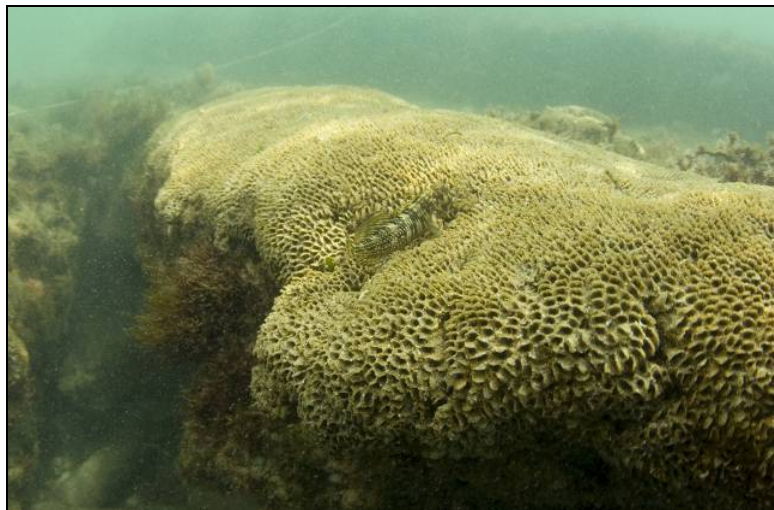
Photo 3. Wormrock reef growing on hard bottom substrate along Transect R-85.

Measurements made along the survey transects used to characterize habitat structure included mean relief, hard bottom width, distance from mean high water level (MHWL) to the inshore edge of the hard bottom feature, and water depth (**Figure 2**). Mean relief measurements did not exhibit any consistent patterns and varied considerably among the survey transects, ranging from 6 to 26 cm (**Figure 2(A)**). Examples of hard bottom features from the area are depicted in **Photos 1** and **2**. Greatest width of the hard bottom feature occurred along the segment from FDEP Monuments R-85 to R-92 (**Figure 2(B)**). Hard bottom width did not show any particular trends along the project area shoreline. Distances from MHWL to the inshore edge of hard bottom were greatest for survey transects located at the southern (FDEP Monuments R-109.2 to R-112) and northern (FDEP Monuments R-77.7 and R-78.7) ends of the project area (**Figure 2(C)**); at these transects, distances from MHWL to the inshore edge of hard bottom exceeded 150 m. Water depth was obviously related to the distance between MHWL and the inshore hard bottom edge, with the deepest survey transects occurring at the southern and northern ends of the project area. In several areas along survey transects, wormrock (*Phragmatopoma lapidosa*) augmented the structural complexity of the hard bottom (**Photo 3**).

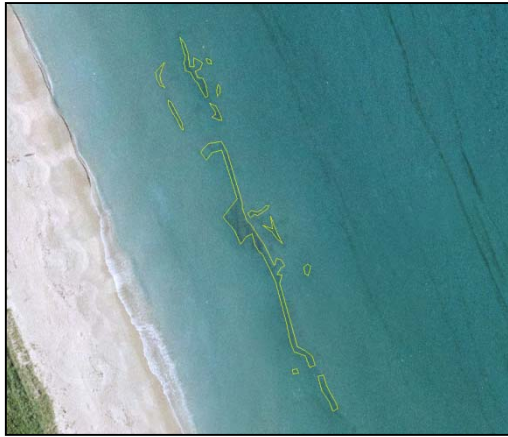
A). Example of combined manual and computer interpretation techniques to generate polygons encompassing hard bottom features (2008 aerial) – 0.078816 acres of hard-bottom.

The combined manual and computer approach is designed to help eliminate the disadvantages associated with each of the interpretation techniques and produce a product that realistically depicts the features of interest, both spatially and visually. This combined approach addresses common manual errors such as undershoots, overshoots, omissions, spikes, and double counting that often overestimate or underestimate areal estimations. The figure below presents combined manual and computer processing (left) and manual only processing (right) results for a visual comparison.

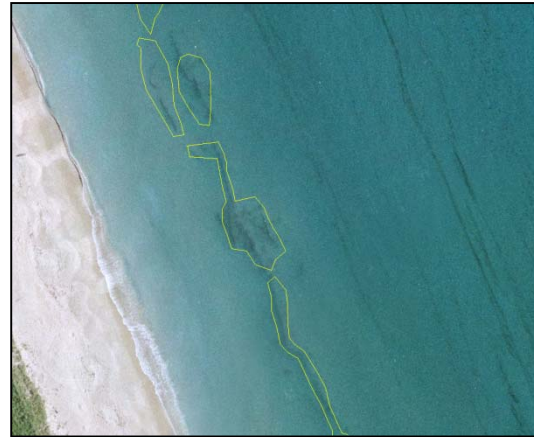
B). Example of manual-only technique (FDEP) to generate polygons encompassing hard bottom (2008 aerial) – 0.287999 acres of hard bottom.
