# R-46 PROFILES

PALM BEACH  
 PROGRAM SUPPORT GIS  
 DIVISION OF WATER RESOURCE MANAGEMENT  
 FLORIDA DEPARTMENT OF ENVIRONMENTAL PROTECTION

RANGE: R-46  
 EST DATE: JUN1989  
 SURVEY DATE: 29NOV18  
 AZIMUTH: 75.0

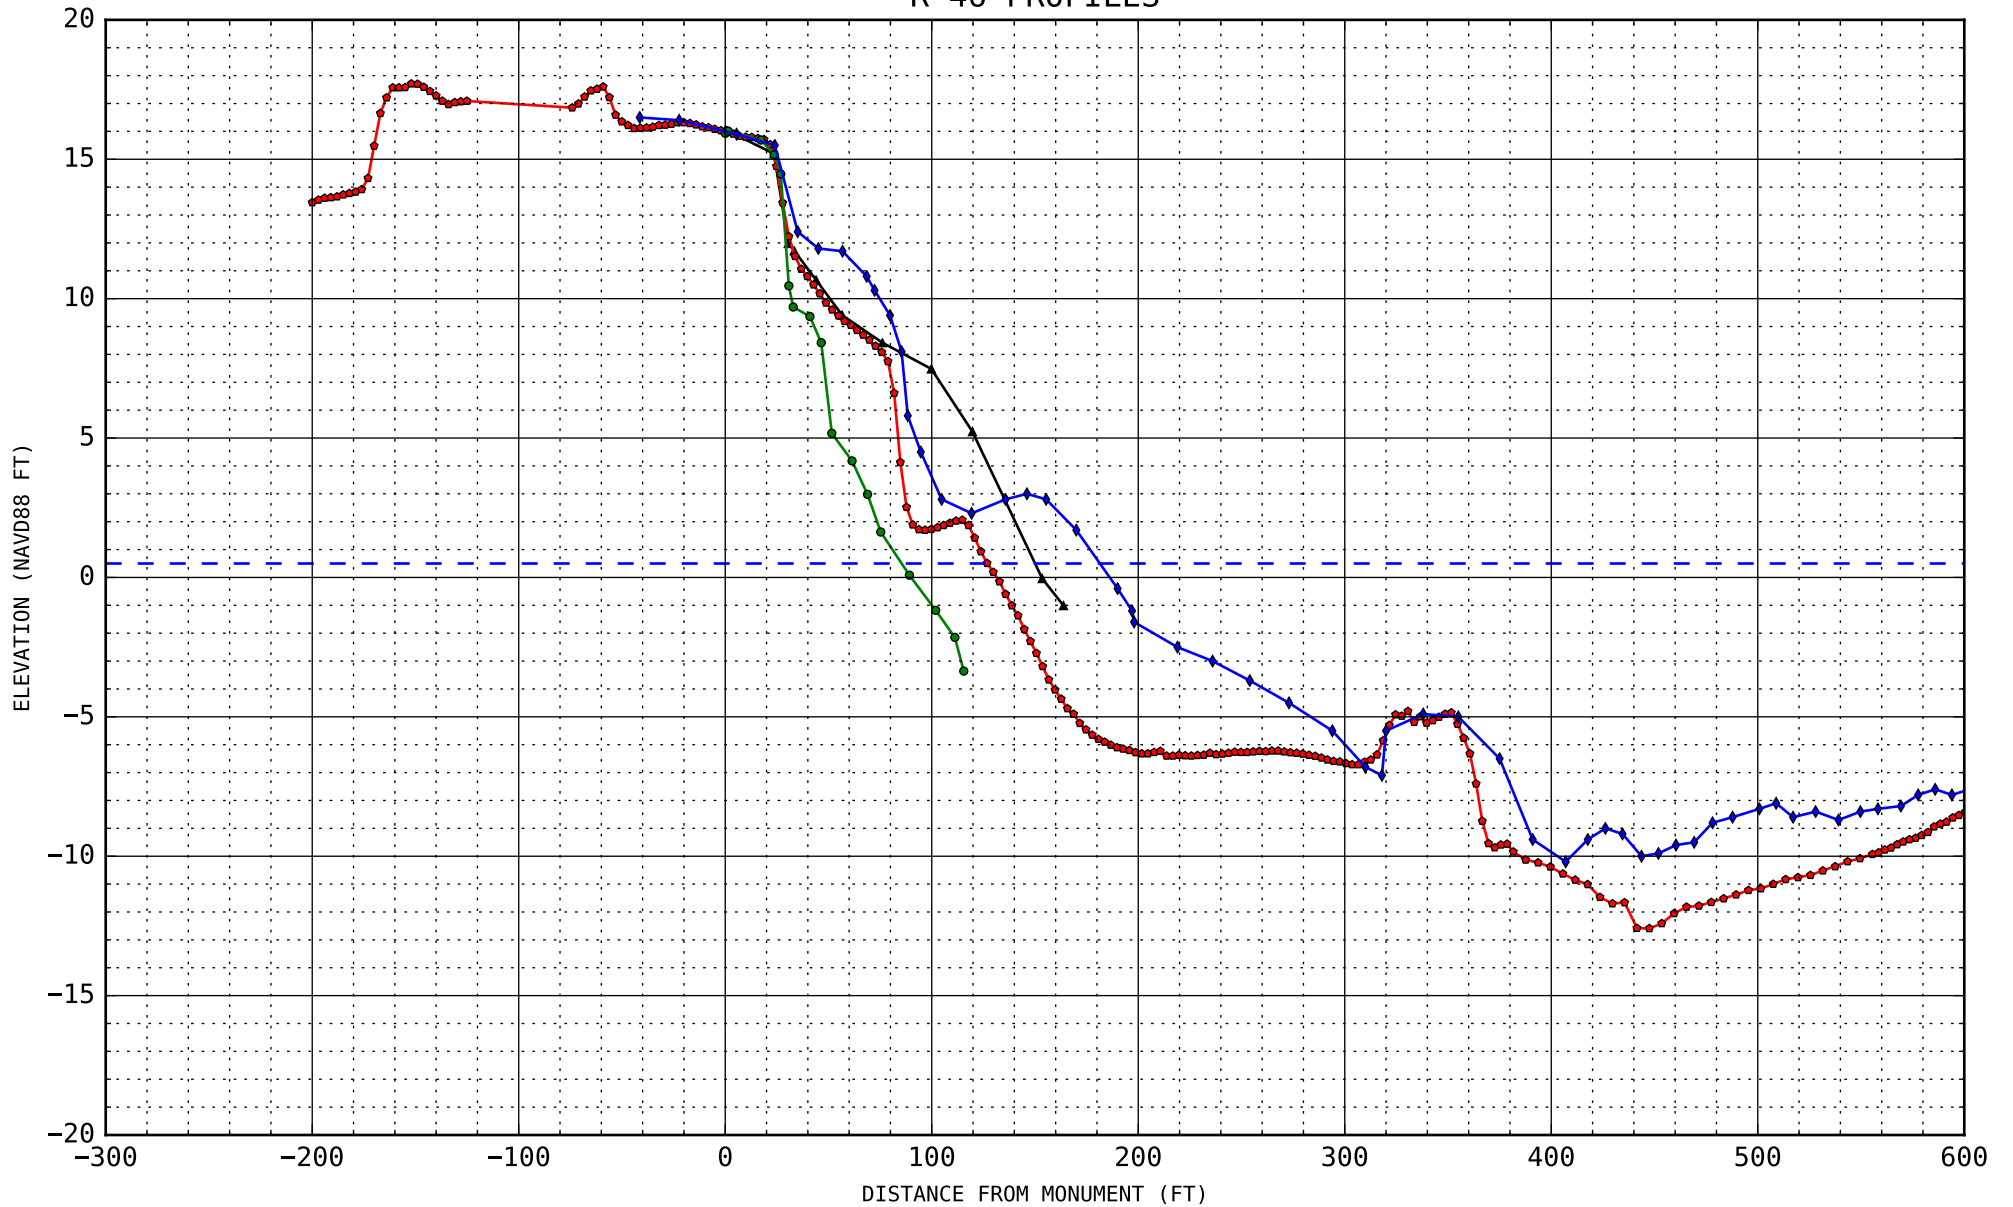
- ▲ 2018-NOV CONDITION BY DEP
- 2018-JUN MONITORING BY NGS-LIDAR
- 2016-MAY MONITORING BY DEP
- ◆ 2010-OCT MONITORING BY SDI
- - - MHW CONTOUR (0.5 FT)

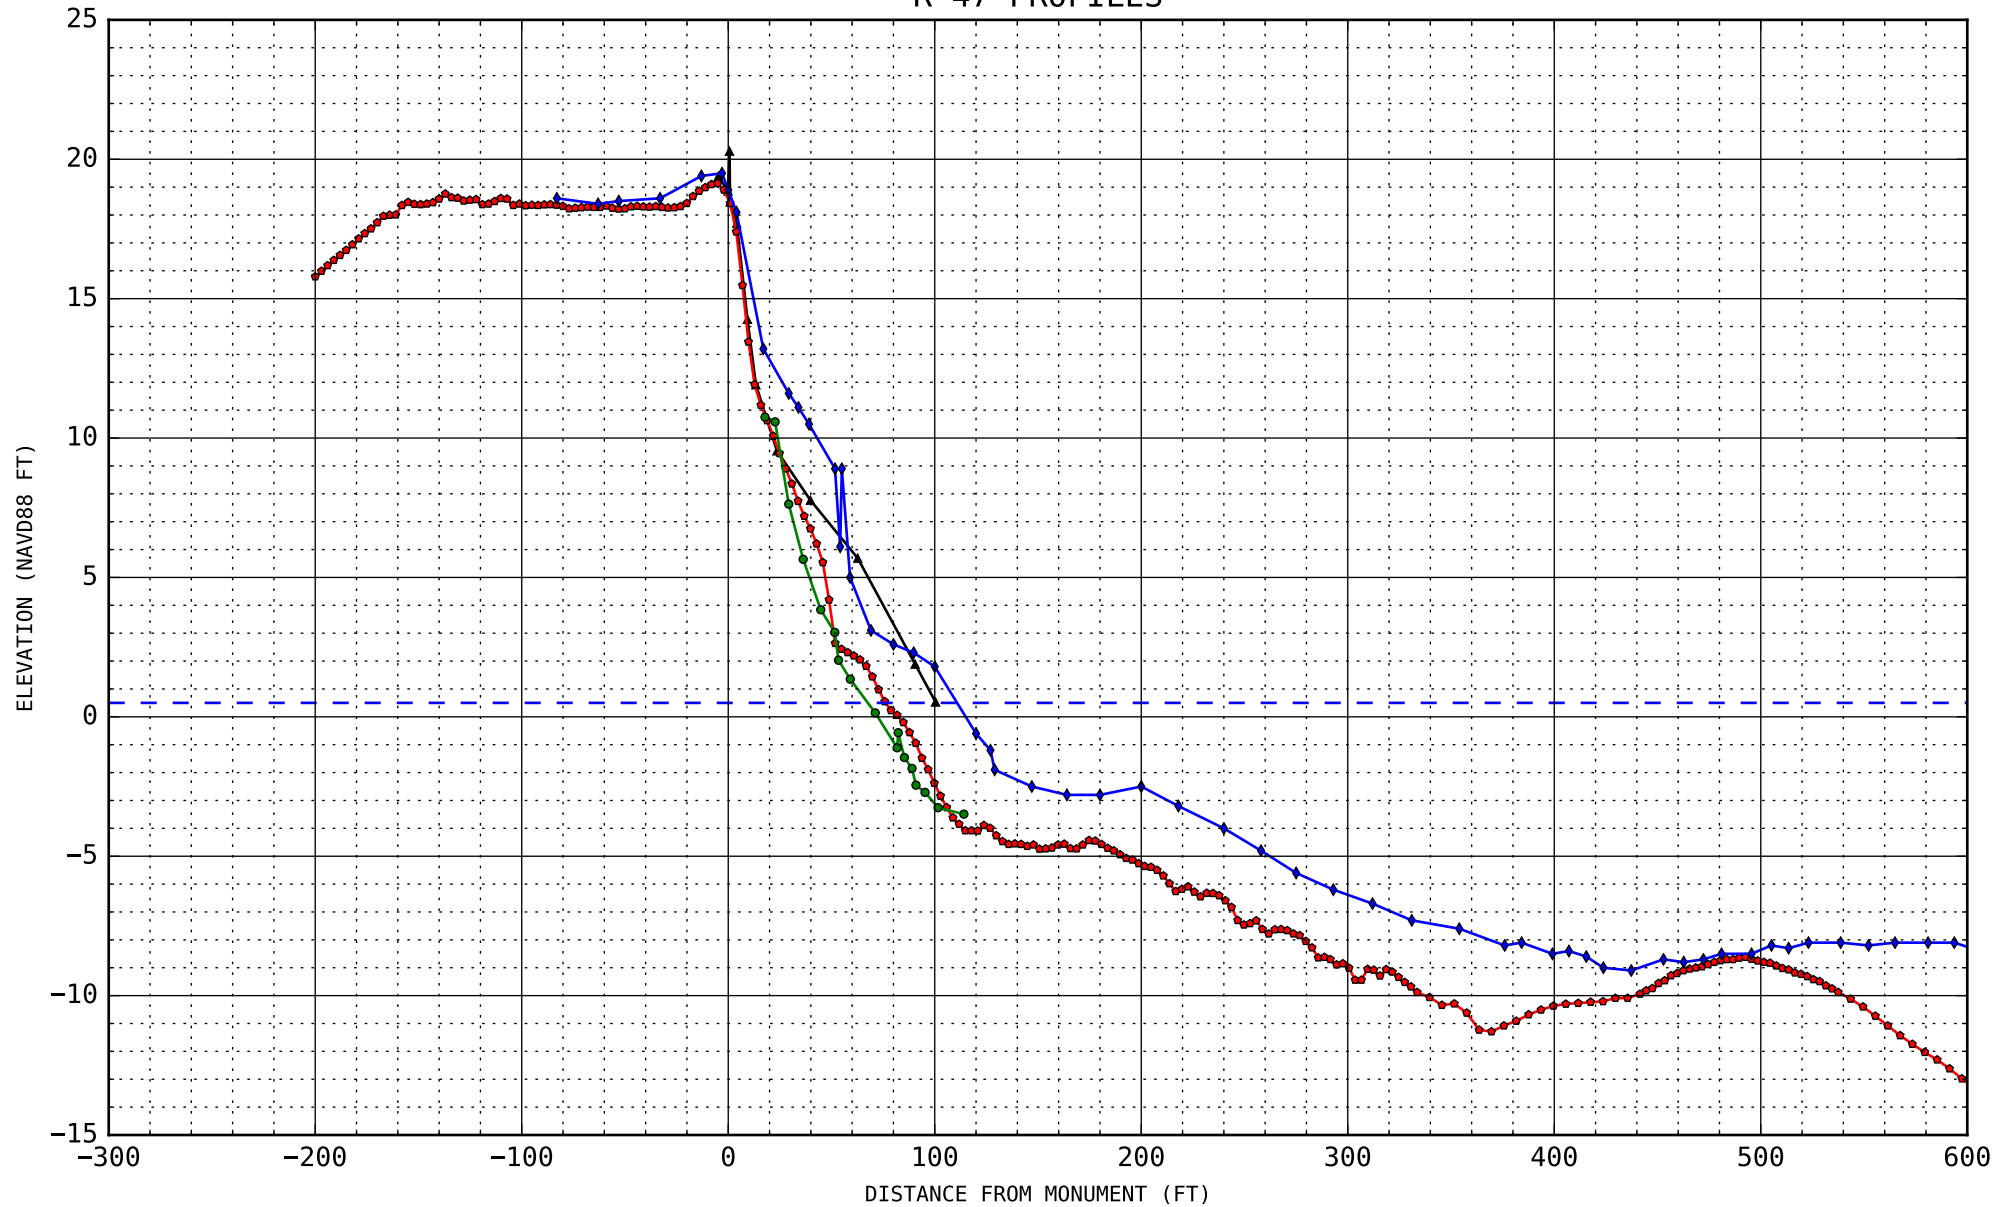
# R-47 PROFILES

- ▲ 2018-NOV CONDITION BY DEP
- 2018-JUN MONITORING BY NGS-LIDAR
- 2016-MAY MONITORING BY DEP
- ◆ 2010-OCT MONITORING BY SDI
- - - MHW CONTOUR (0.5 FT)

RANGE: R-47  
EST DATE: MAR1974  
SURVEY DATE: 29NOV18  
AZIMUTH: 80.0

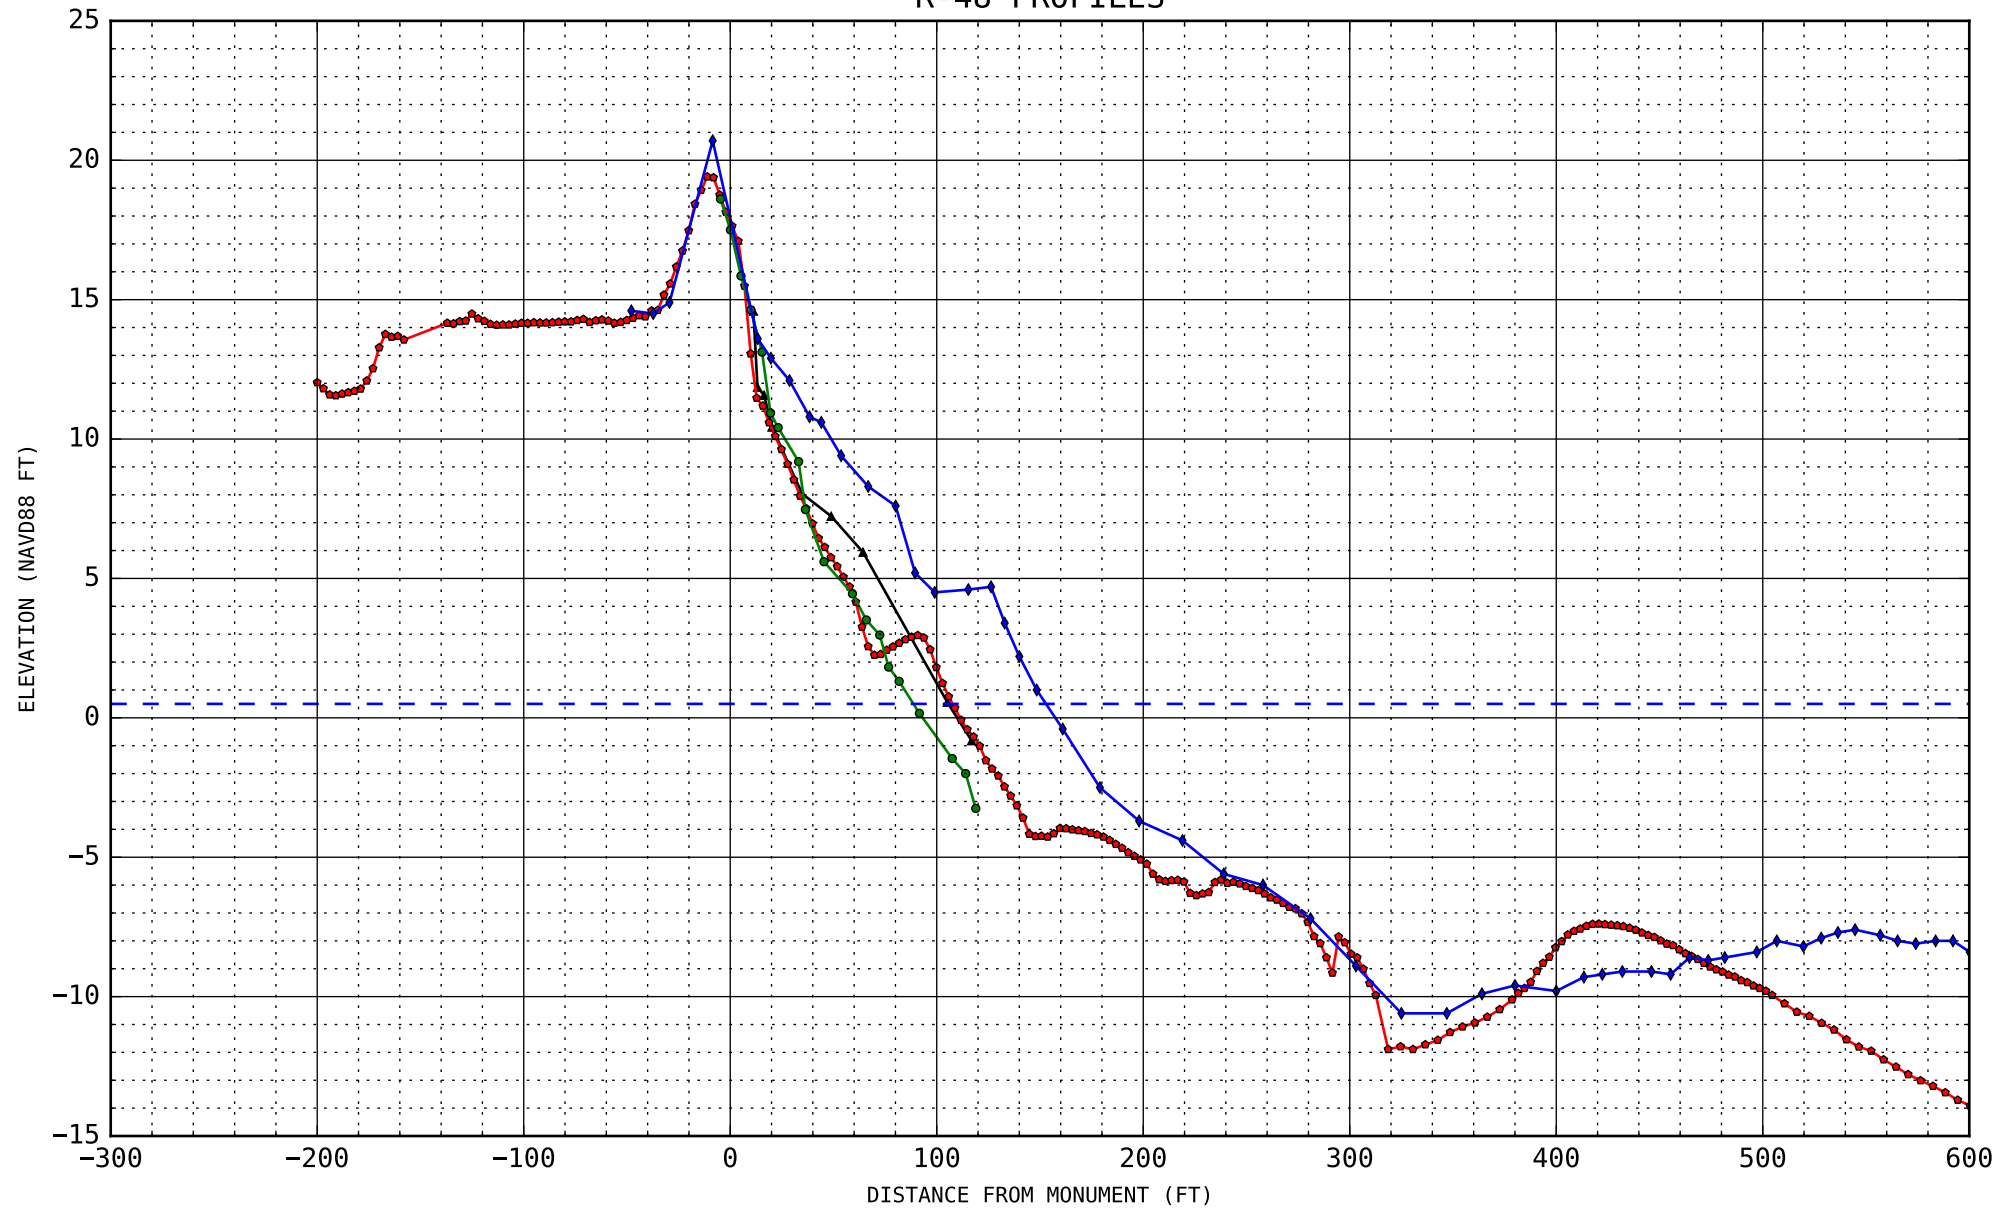
# R-48 PROFILES

- ▲ 2018-NOV CONDITION BY DEP
- 2018-JUN MONITORING BY NGS-LIDAR
- 2016-MAY MONITORING BY DEP
- ◆ 2010-OCT MONITORING BY SDI
- - - MHW CONTOUR (0.5 FT)

RANGE: R-48  
EST DATE: JUN1989  
SURVEY DATE: 29NOV18  
AZIMUTH: 75.0

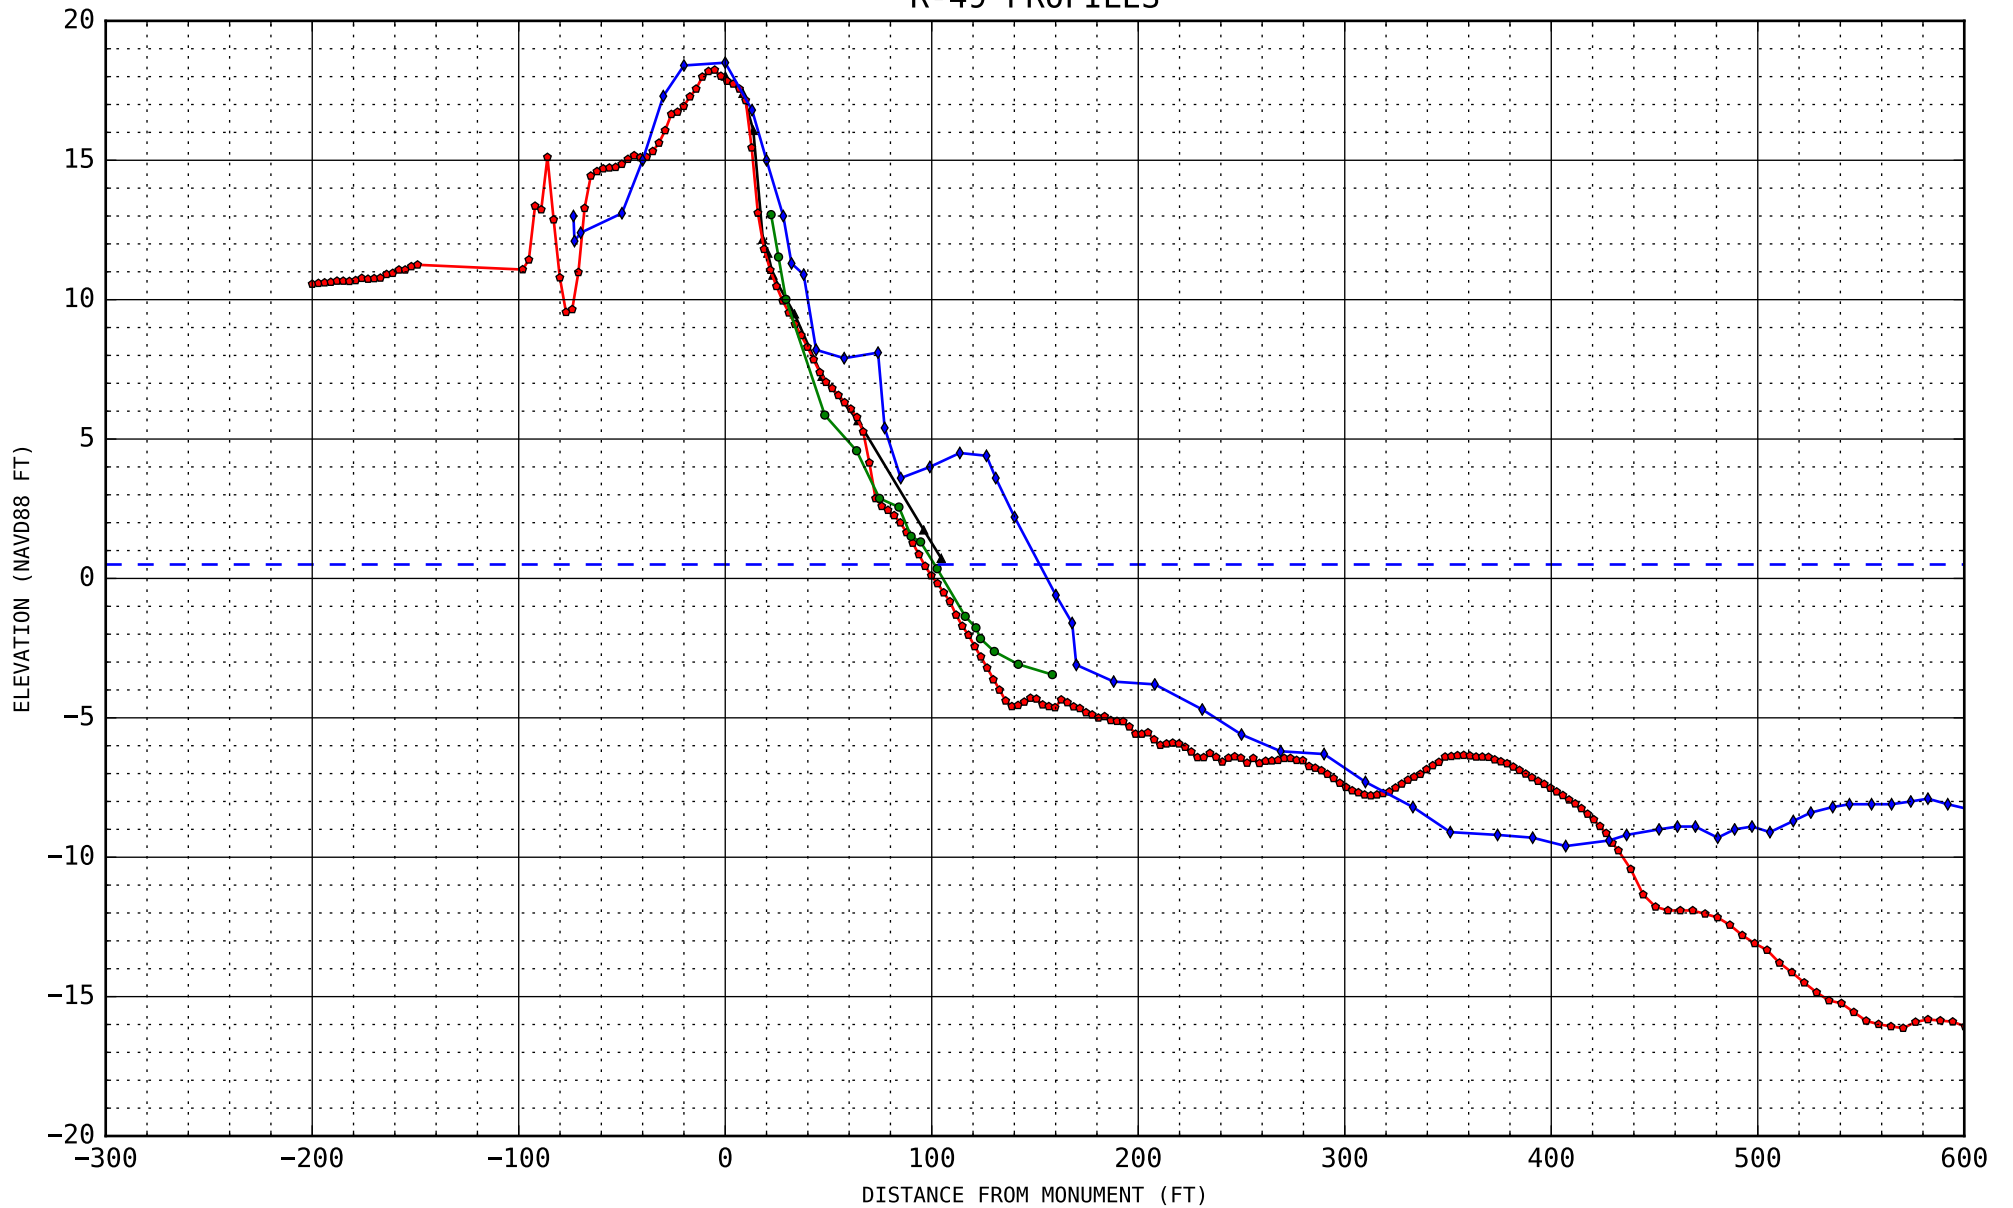
# R-49 PROFILES

- ▲ 2018-NOV CONDITION BY DEP
- 2018-JUN MONITORING BY NGS-LIDAR
- 2016-MAY MONITORING BY DEP
- ◆ 2010-OCT MONITORING BY SDI
- - - MHW CONTOUR (0.5 FT)

RANGE: R-49  
 EST DATE: JUN1989  
 SURVEY DATE: 29NOV18  
 AZIMUTH: 75.0

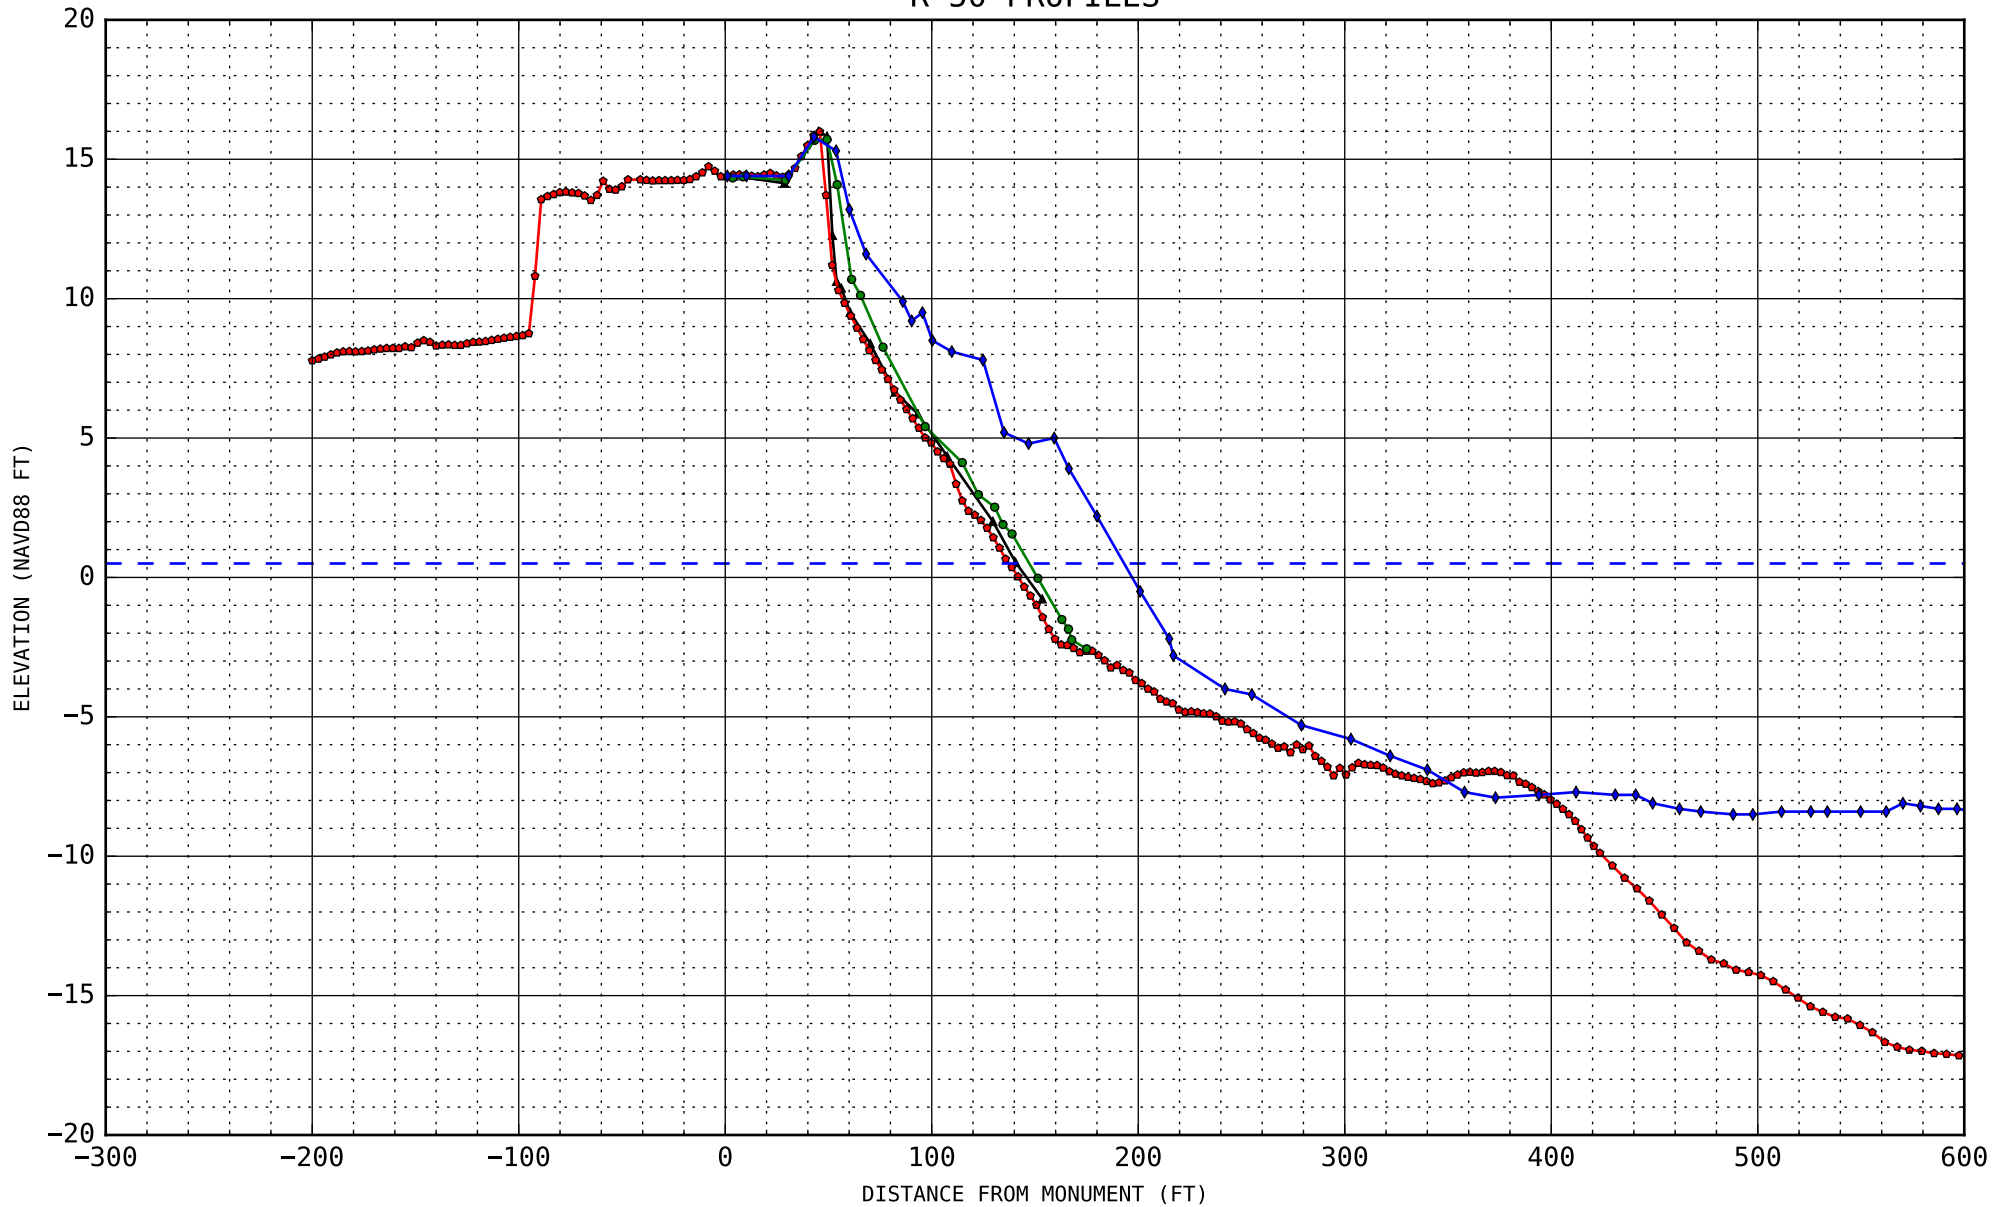
# R-50 PROFILES

- ▲ 2018-NOV CONDITION BY DEP
- 2018-JUN MONITORING BY NGS-LIDAR
- 2016-MAY MONITORING BY DEP
- ◆ 2010-OCT MONITORING BY SDI
- - - MHW CONTOUR (0.5 FT)

RANGE: R-50  
 EST DATE: FEB1975  
 SURVEY DATE: 29NOV18  
 AZIMUTH: 75.0

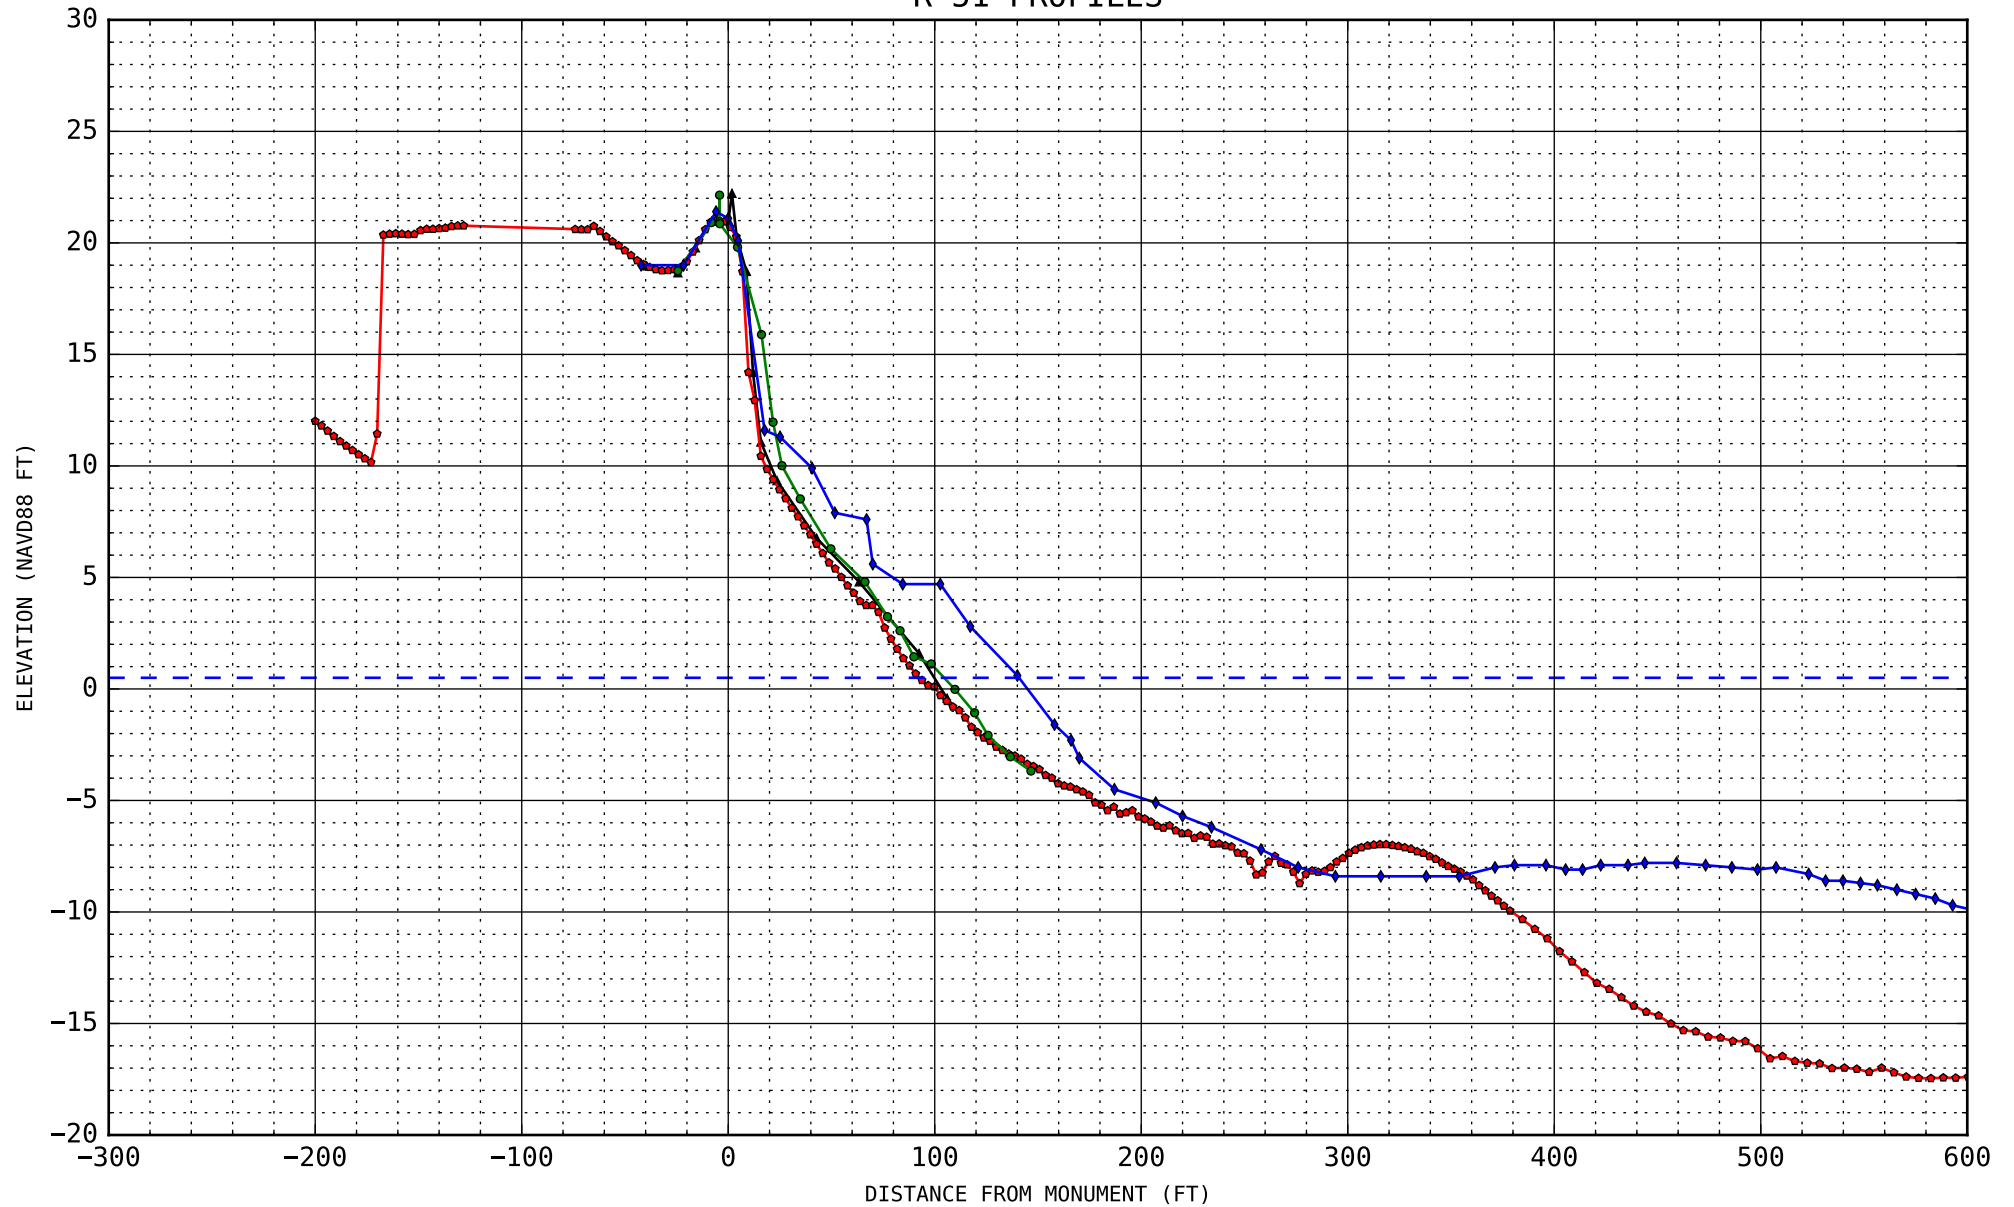
# R-51 PROFILES

- ▲ 2018-NOV CONDITION BY DEP
- 2018-JUN MONITORING BY NGS-LIDAR
- 2016-MAY MONITORING BY DEP
- ◆ 2010-OCT MONITORING BY SDI
- - - MHW CONTOUR (0.5 FT)

RANGE: R-51  
EST DATE: MAR1974  
SURVEY DATE: 29NOV18  
AZIMUTH: 75.0

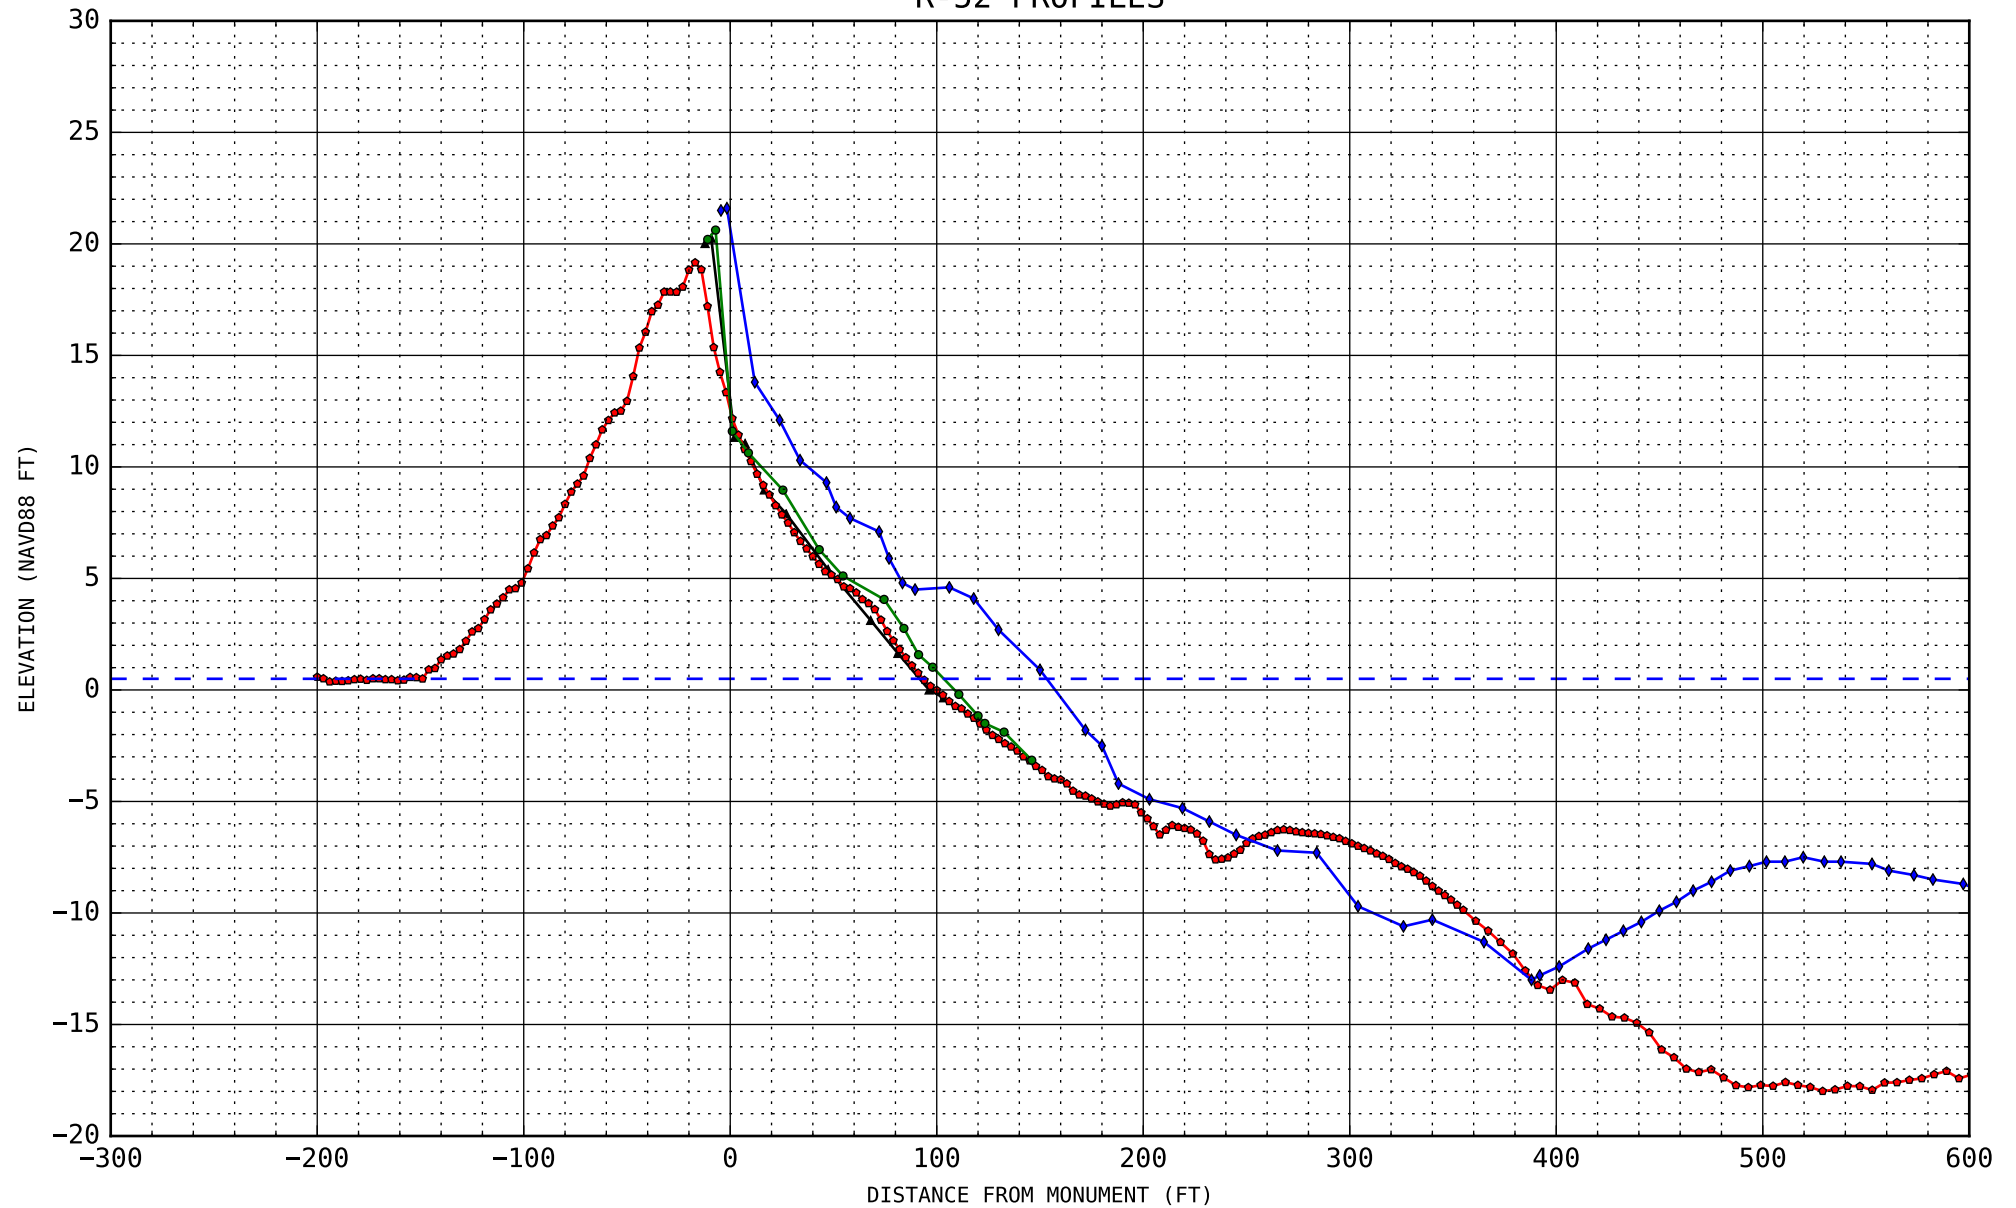
# R-52 PROFILES

- ▲ 2018-NOV CONDITION BY DEP
- 2018-JUN MONITORING BY NGS-LIDAR
- 2016-MAY MONITORING BY DEP
- ◆ 2010-OCT MONITORING BY SDI
- - - MHW CONTOUR (0.5 FT)

RANGE: R-52  
EST DATE: MAR1974  
SURVEY DATE: 29NOV18  
AZIMUTH: 70.0

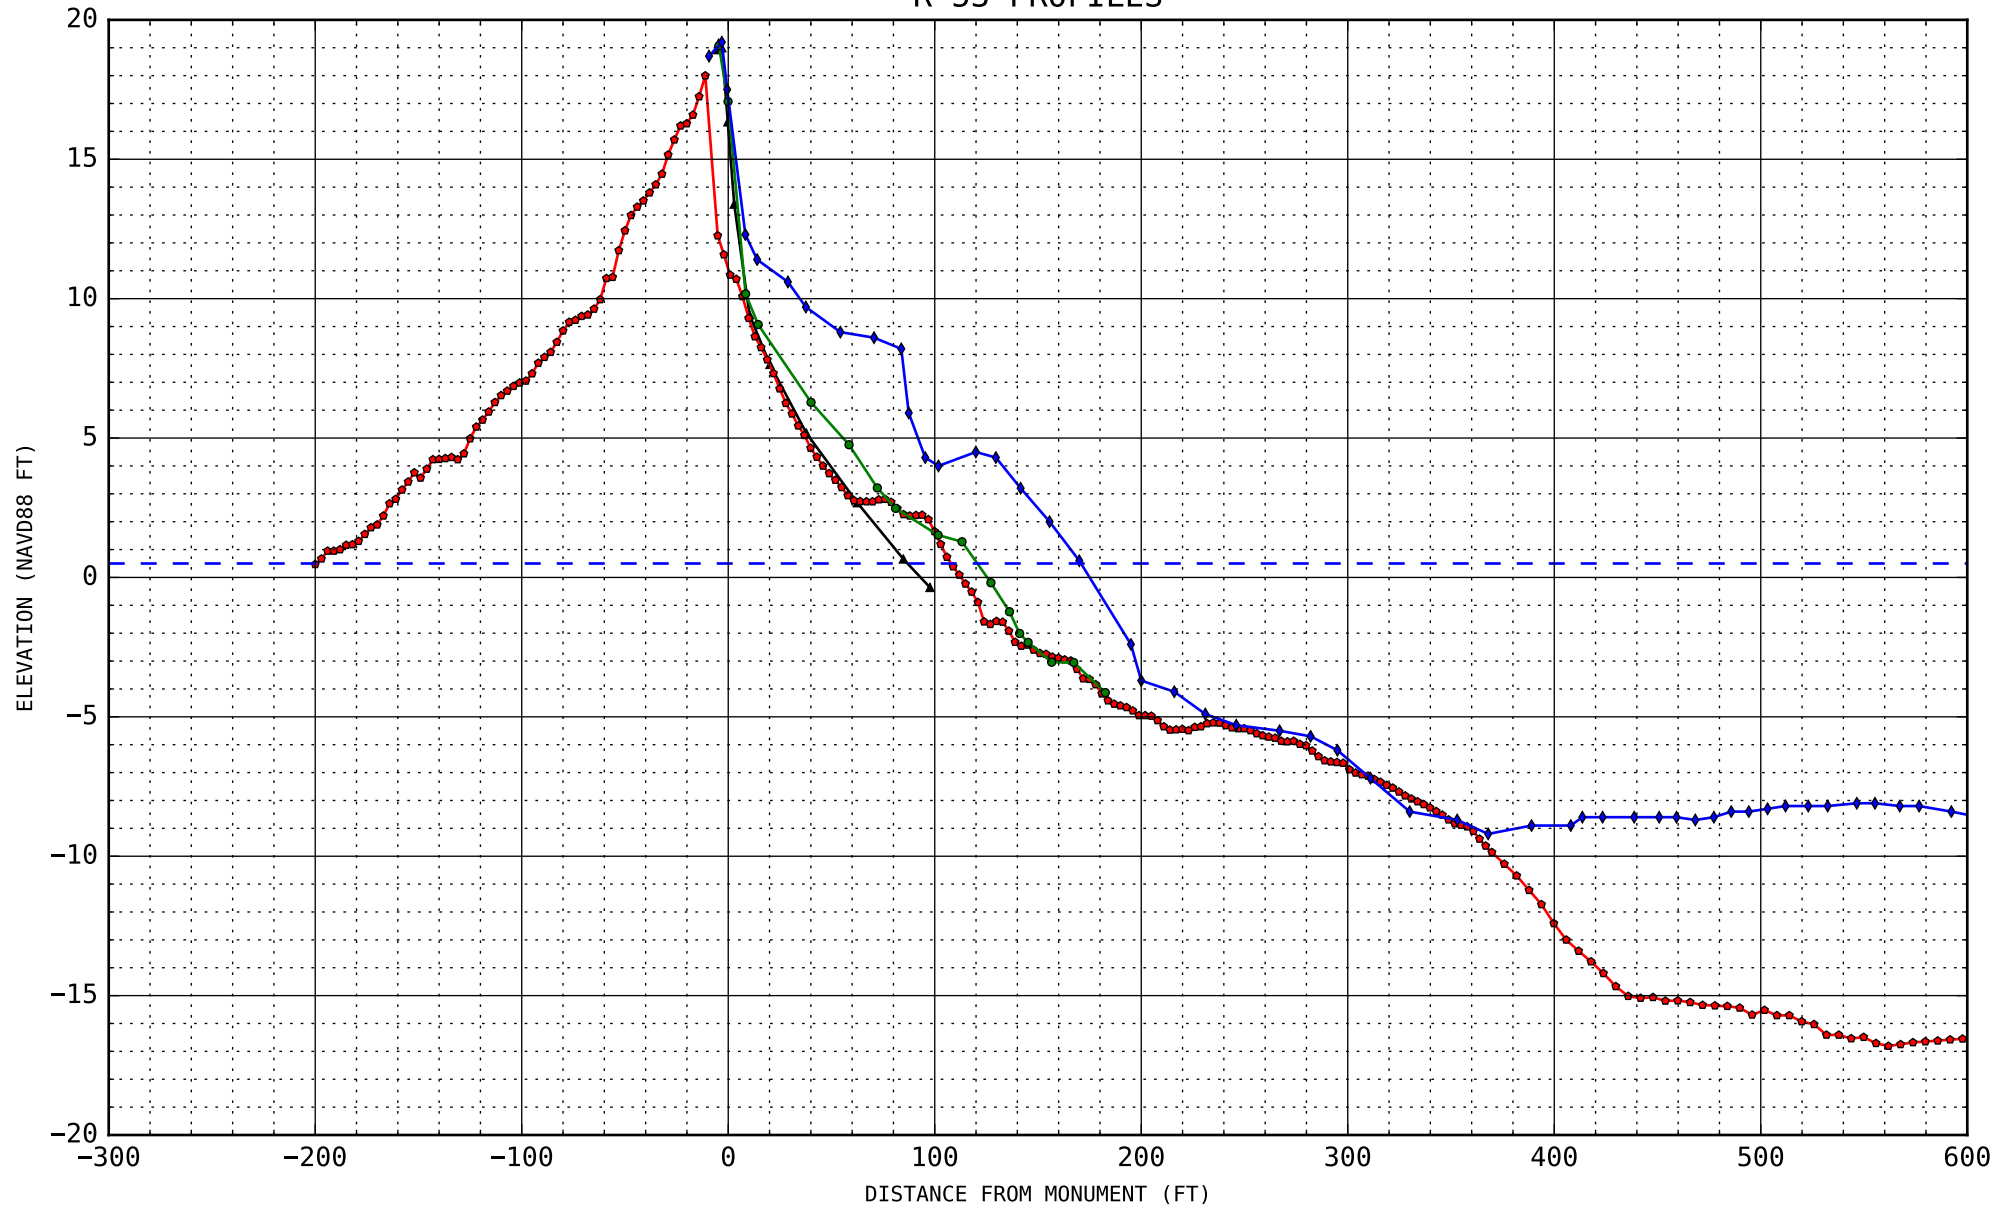
# R-53 PROFILES

- ▲ 2018-NOV CONDITION BY DEP
- 2018-JUN MONITORING BY NGS-LIDAR
- 2016-MAY MONITORING BY DEP
- ◆ 2010-OCT MONITORING BY SDI
- - - MHW CONTOUR (0.5 FT)

RANGE: R-53  
 EST DATE: MAR1974  
 SURVEY DATE: 29NOV18  
 AZIMUTH: 75.0

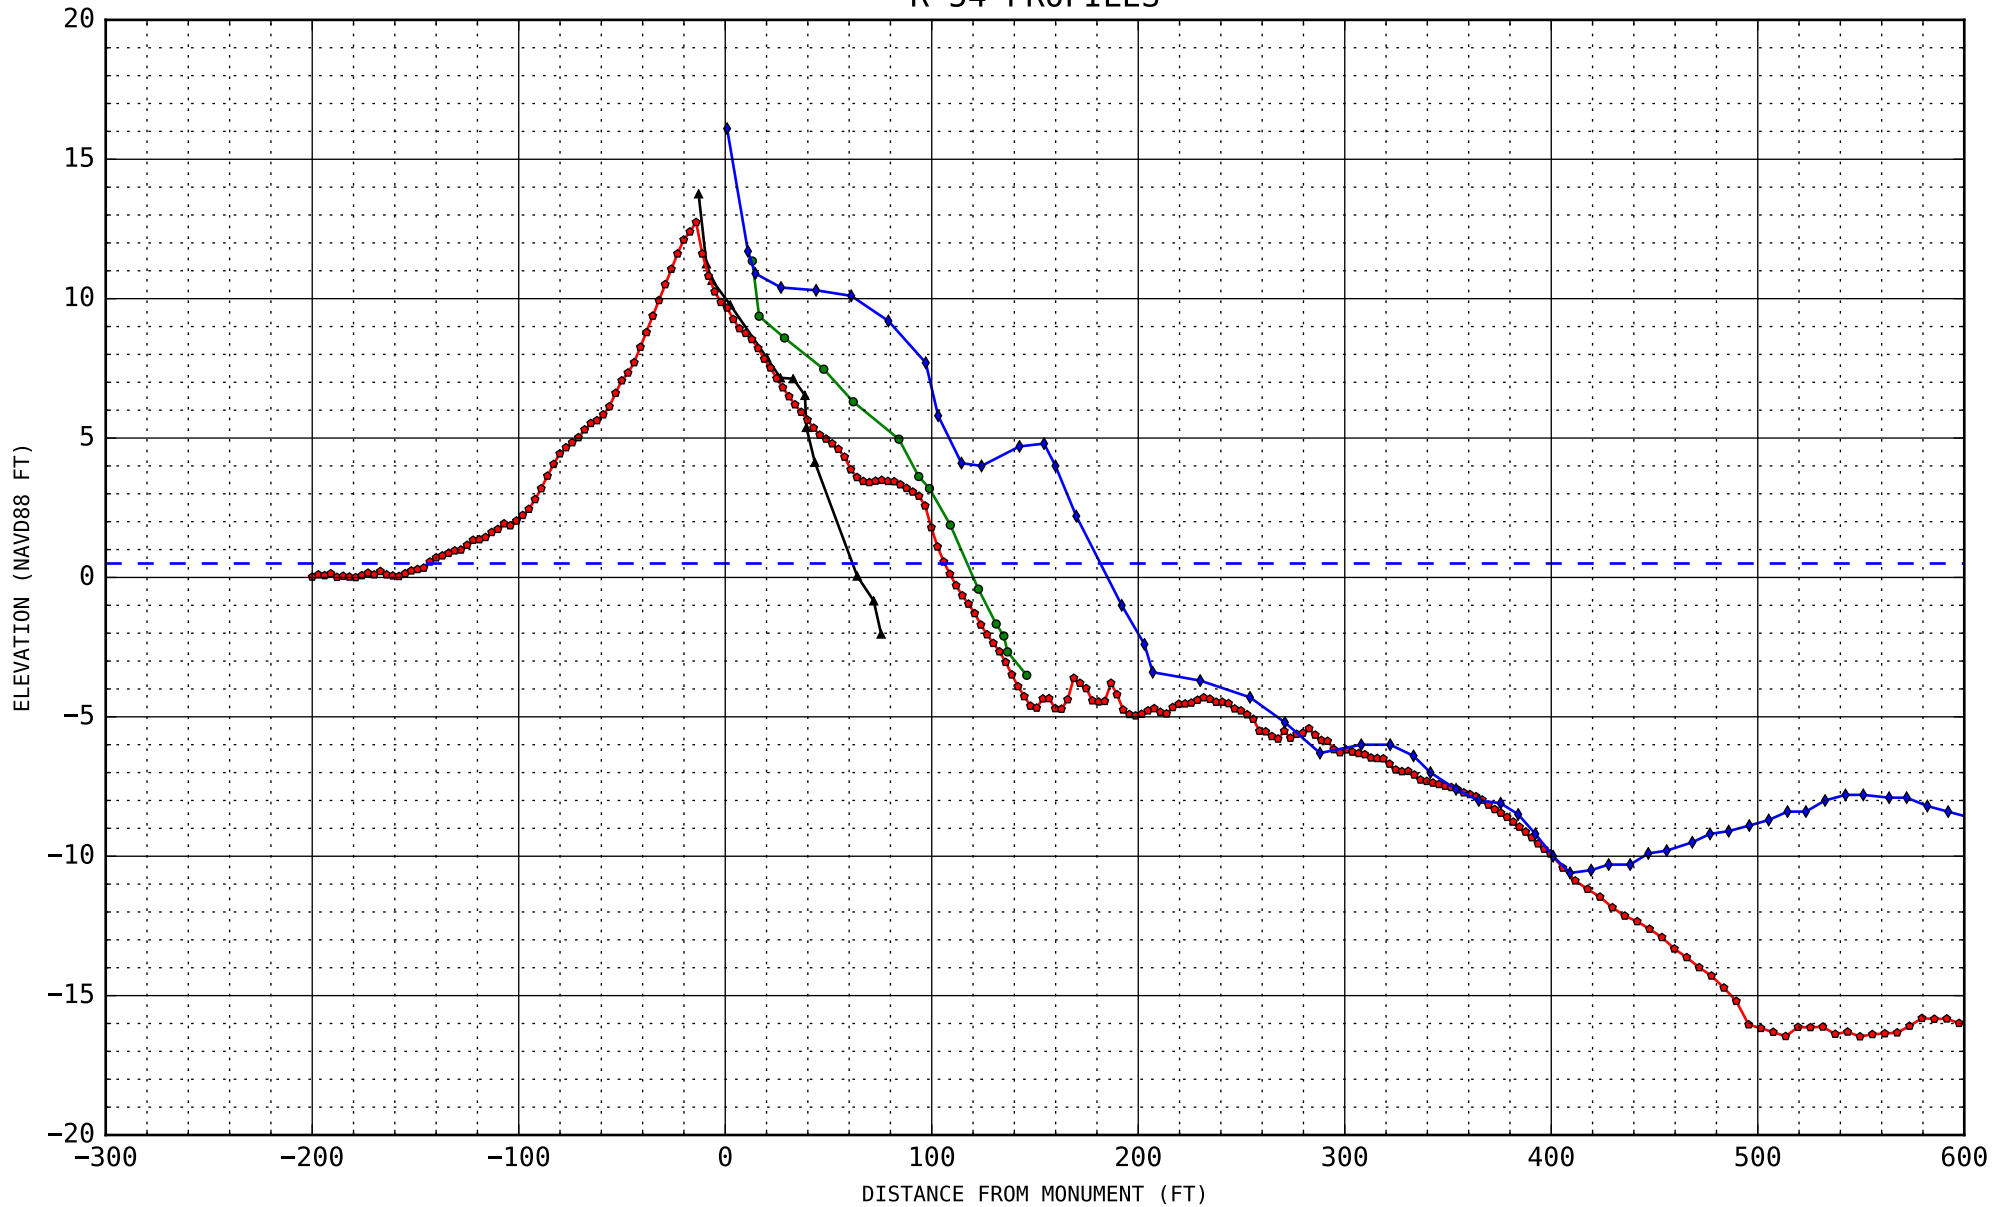
# R-54 PROFILES

- ▲ 2018-NOV CONDITION BY DEP
- 2018-JUN MONITORING BY NGS-LIDAR
- 2016-MAY MONITORING BY DEP
- ◆ 2010-OCT MONITORING BY SDI
- - - MHW CONTOUR (0.5 FT)

RANGE: R-54  
EST DATE: MAR1974  
SURVEY DATE: 29NOV18  
AZIMUTH: 75.0
