# R-46 PROFILES

PALM BEACH  
 PROGRAM SUPPORT GIS  
 DIVISION OF WATER RESOURCE MANAGEMENT  
 FLORIDA DEPARTMENT OF ENVIRONMENTAL PROTECTION

RANGE: R-46  
 EST DATE: JUN1989  
 SURVEY DATE: 29NOV18  
 AZIMUTH: 75.0

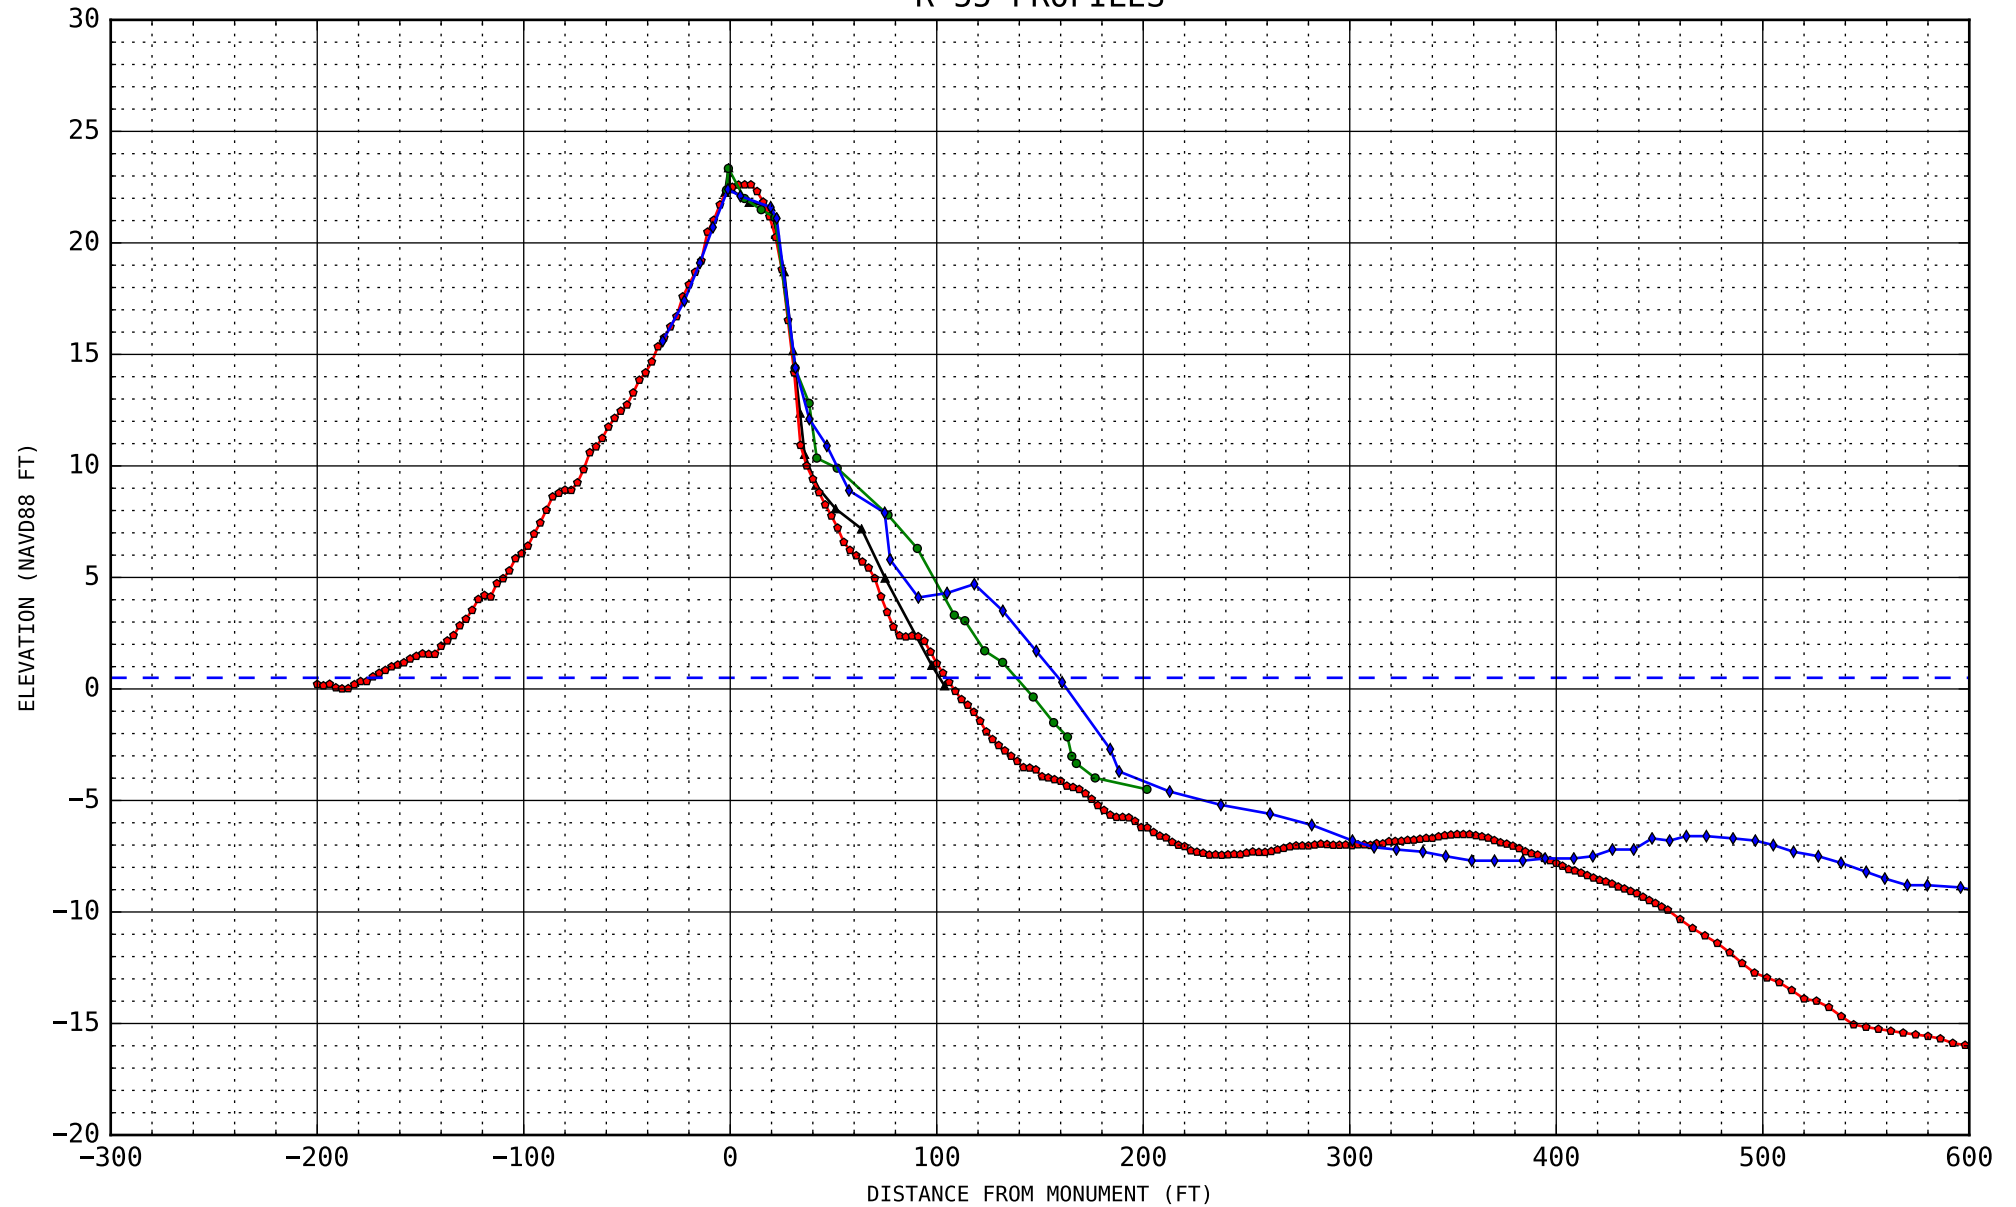
# R-55 PROFILES

- ▲ 2018-NOV CONDITION BY DEP
- 2018-JUN MONITORING BY NGS-LIDAR
- 2016-MAY MONITORING BY DEP
- ◆ 2010-OCT MONITORING BY SDI
- - - MHW CONTOUR (0.5 FT)

RANGE: R-55  
EST DATE: JUN1989  
SURVEY DATE: 29NOV18  
AZIMUTH: 75.0

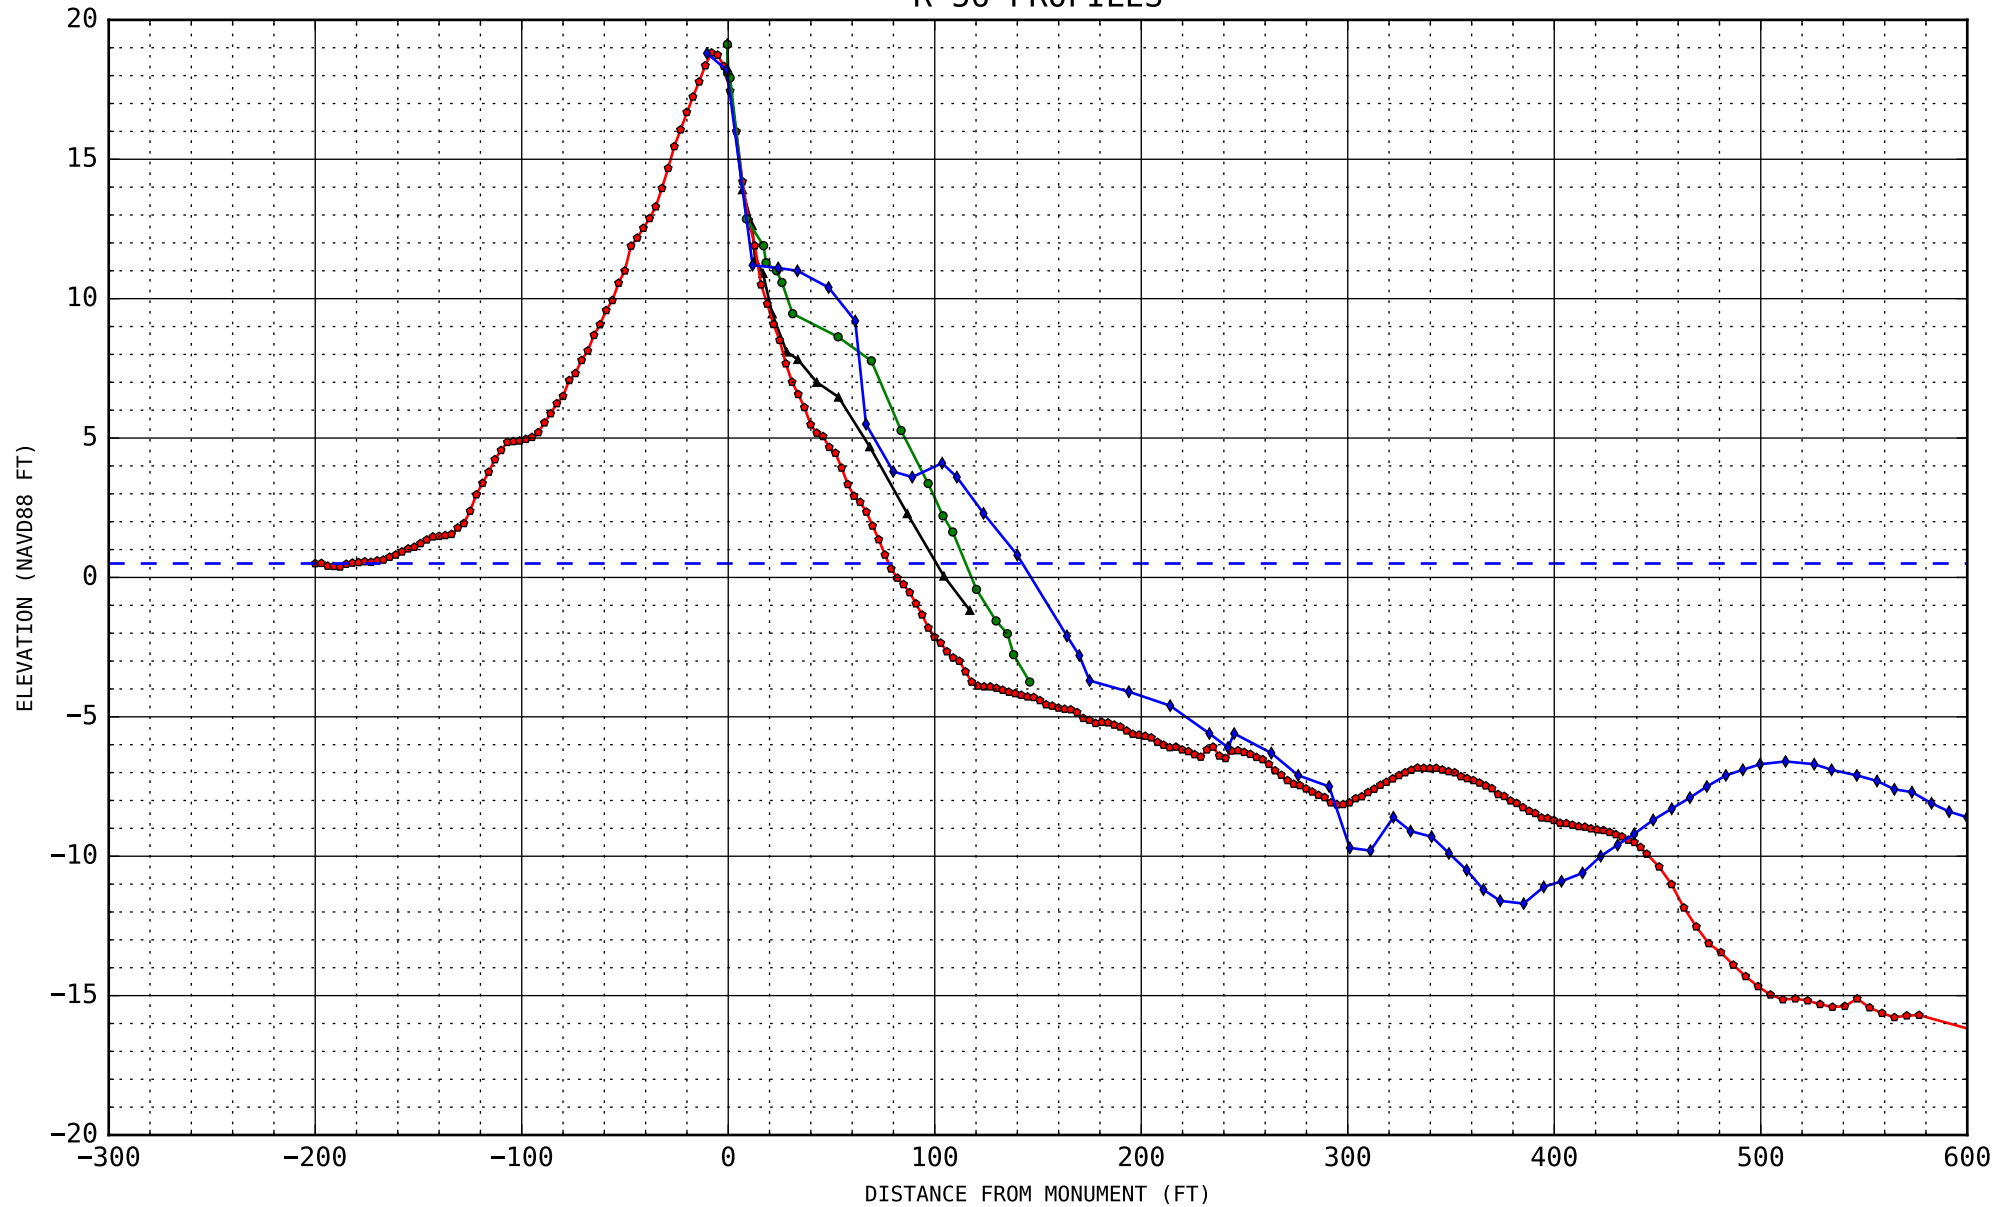
# R-56 PROFILES

- ▲ 2018-NOV CONDITION BY DEP
- 2018-JUN MONITORING BY NGS-LIDAR
- 2016-MAY MONITORING BY DEP
- ◆ 2010-OCT MONITORING BY SDI
- - - MHW CONTOUR (0.5 FT)

RANGE: R-56  
EST DATE: MAR1974  
SURVEY DATE: 29NOV18  
AZIMUTH: 75.0

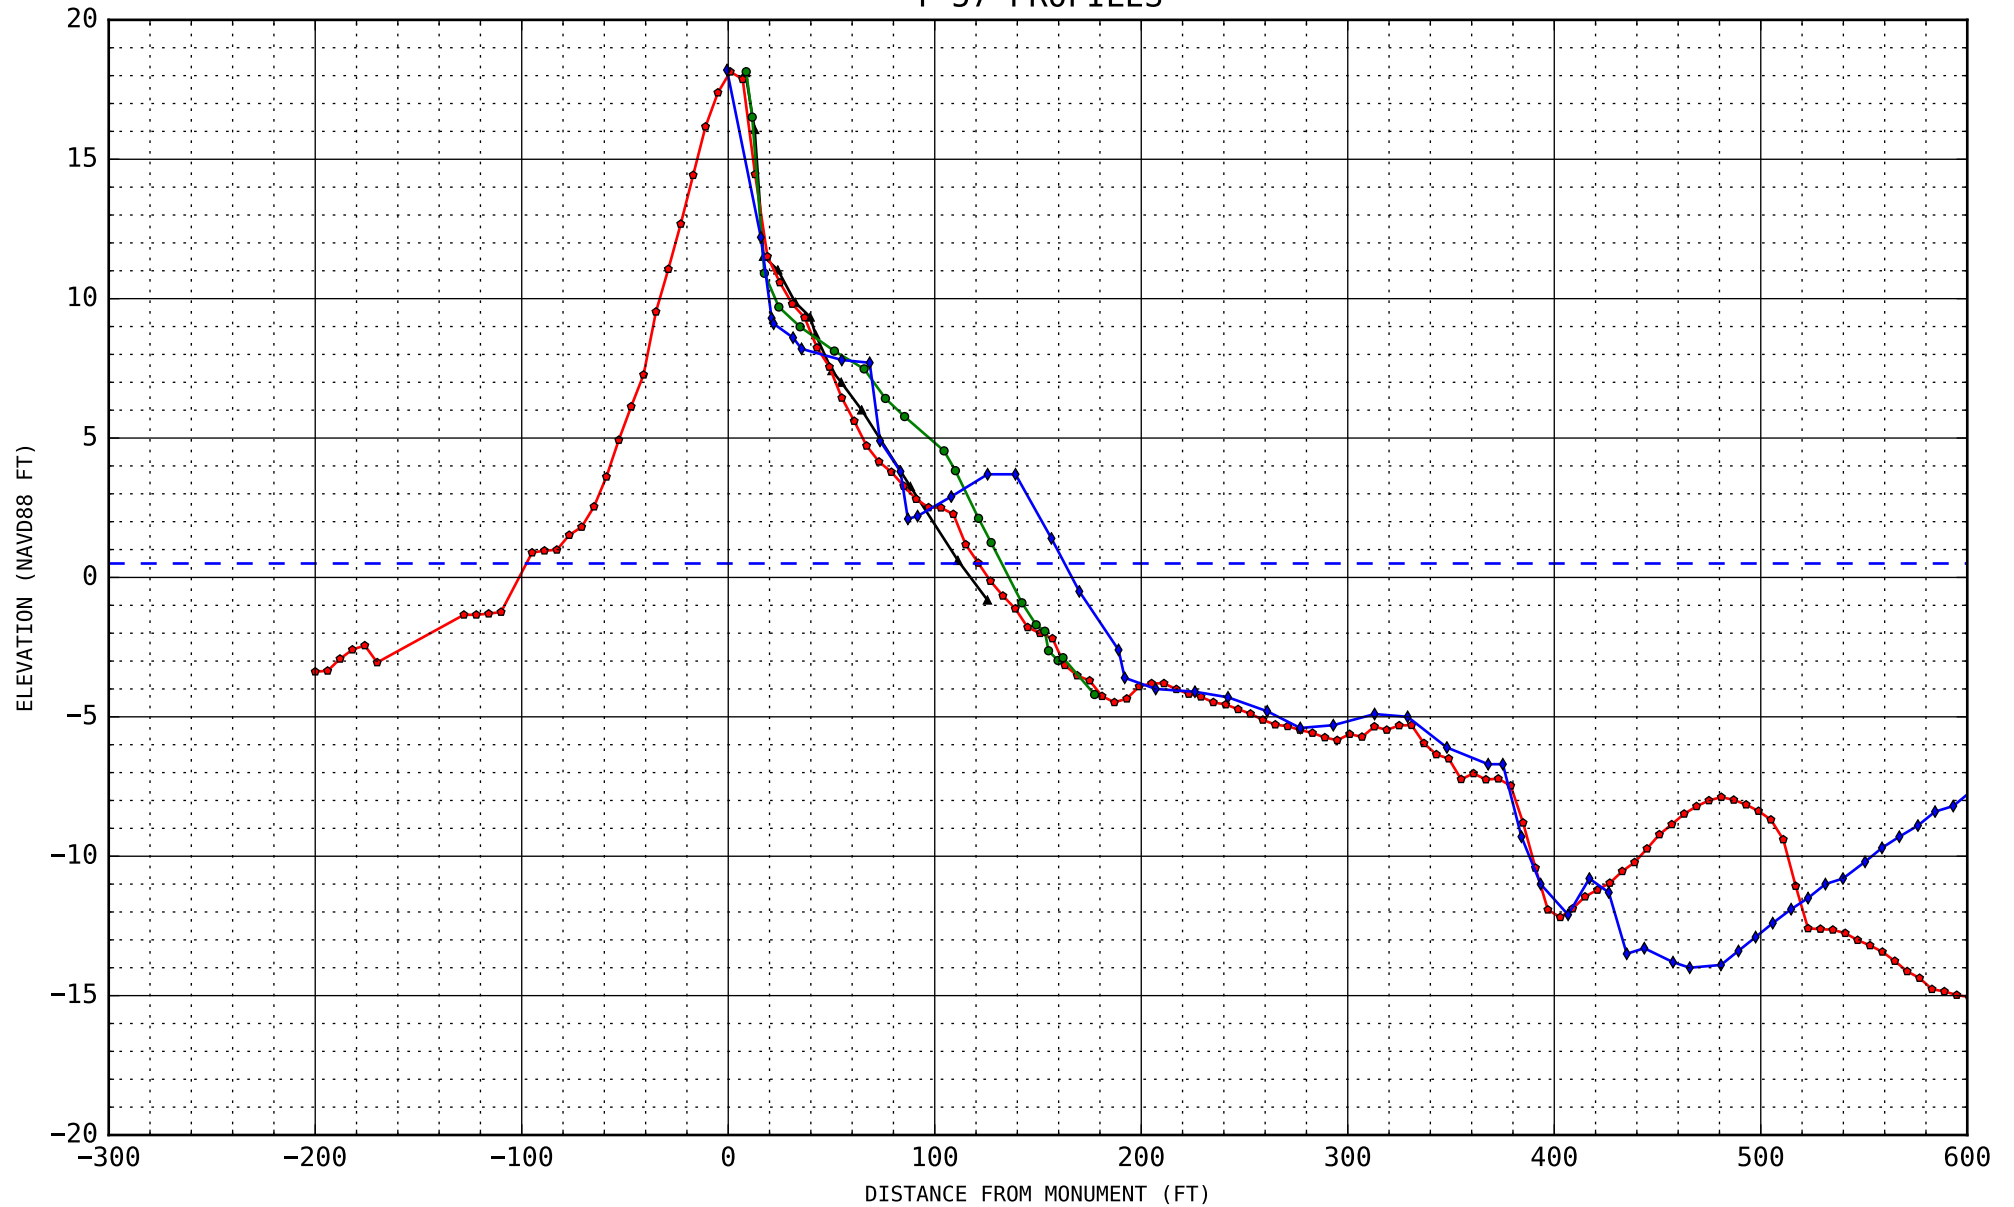
# T-57 PROFILES

- 2018-NOV CONDITION BY DEP
- 2018-JUN MONITORING BY NGS-LIDAR
- 2016-MAY MONITORING BY DEP
- 2010-OCT MONITORING BY SDI
- - - MHW CONTOUR (0.5 FT)

RANGE: T-57  
 EST DATE: OCT1977  
 SURVEY DATE: 29NOV18  
 AZIMUTH: 75.0

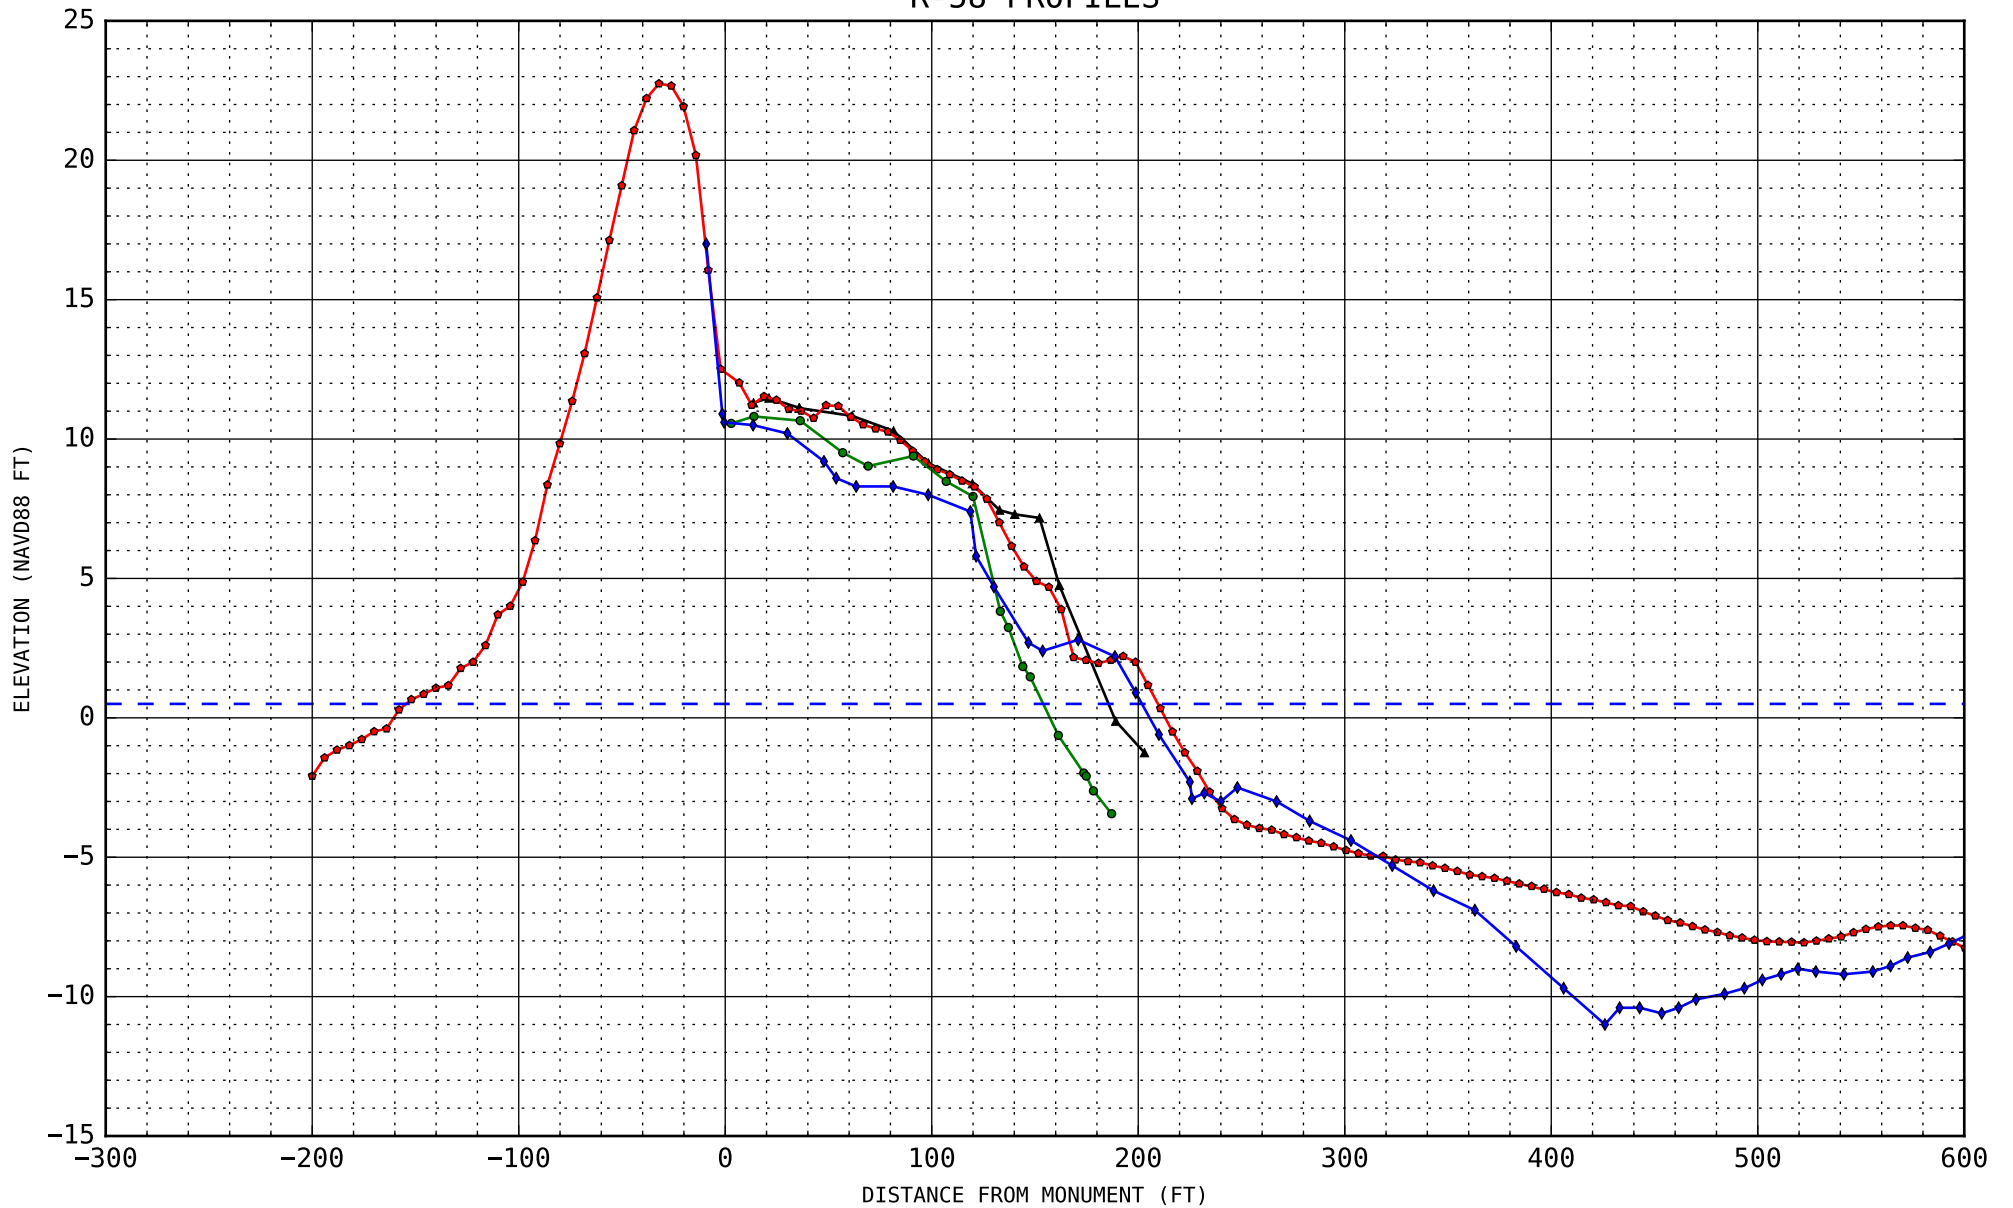
# R-58 PROFILES

- ▲ 2018-NOV CONDITION BY DEP
- 2018-JUN MONITORING BY NGS-LIDAR
- 2016-MAY MONITORING BY DEP
- ◆ 2010-OCT MONITORING BY SDI
- - - MHW CONTOUR (0.5 FT)

RANGE: R-58  
 EST DATE: JUN1989  
 SURVEY DATE: 29NOV18  
 AZIMUTH: 75.0

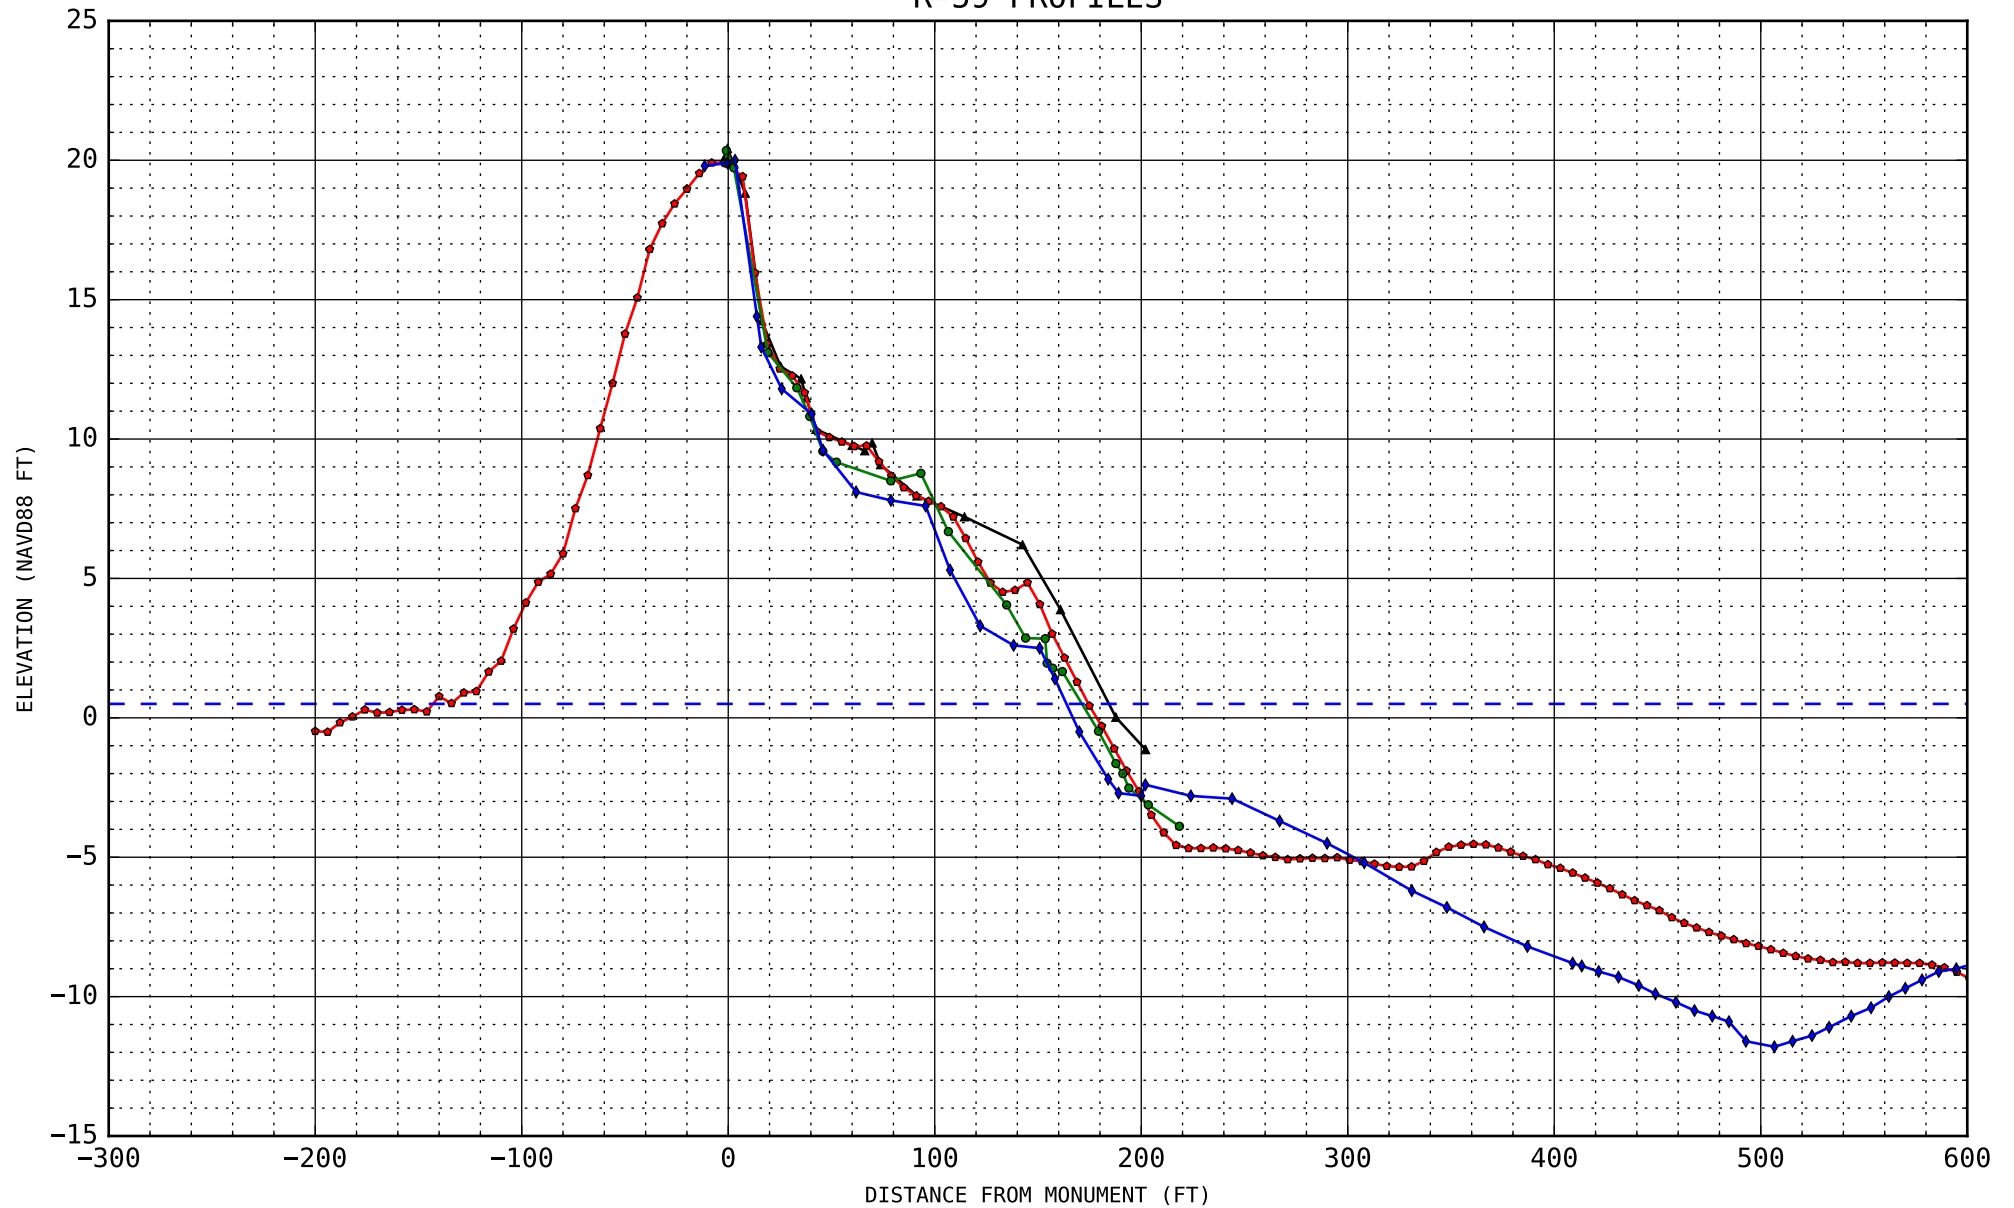
# R-59 PROFILES

- ▲ 2018-NOV CONDITION BY DEP
- 2018-JUN MONITORING BY NGS-LIDAR
- 2016-MAY MONITORING BY DEP
- ◆ 2010-OCT MONITORING BY SDI
- - - MHW CONTOUR (0.5 FT)

RANGE: R-59  
EST DATE: MAR1974  
SURVEY DATE: 29NOV18  
AZIMUTH: 70.0

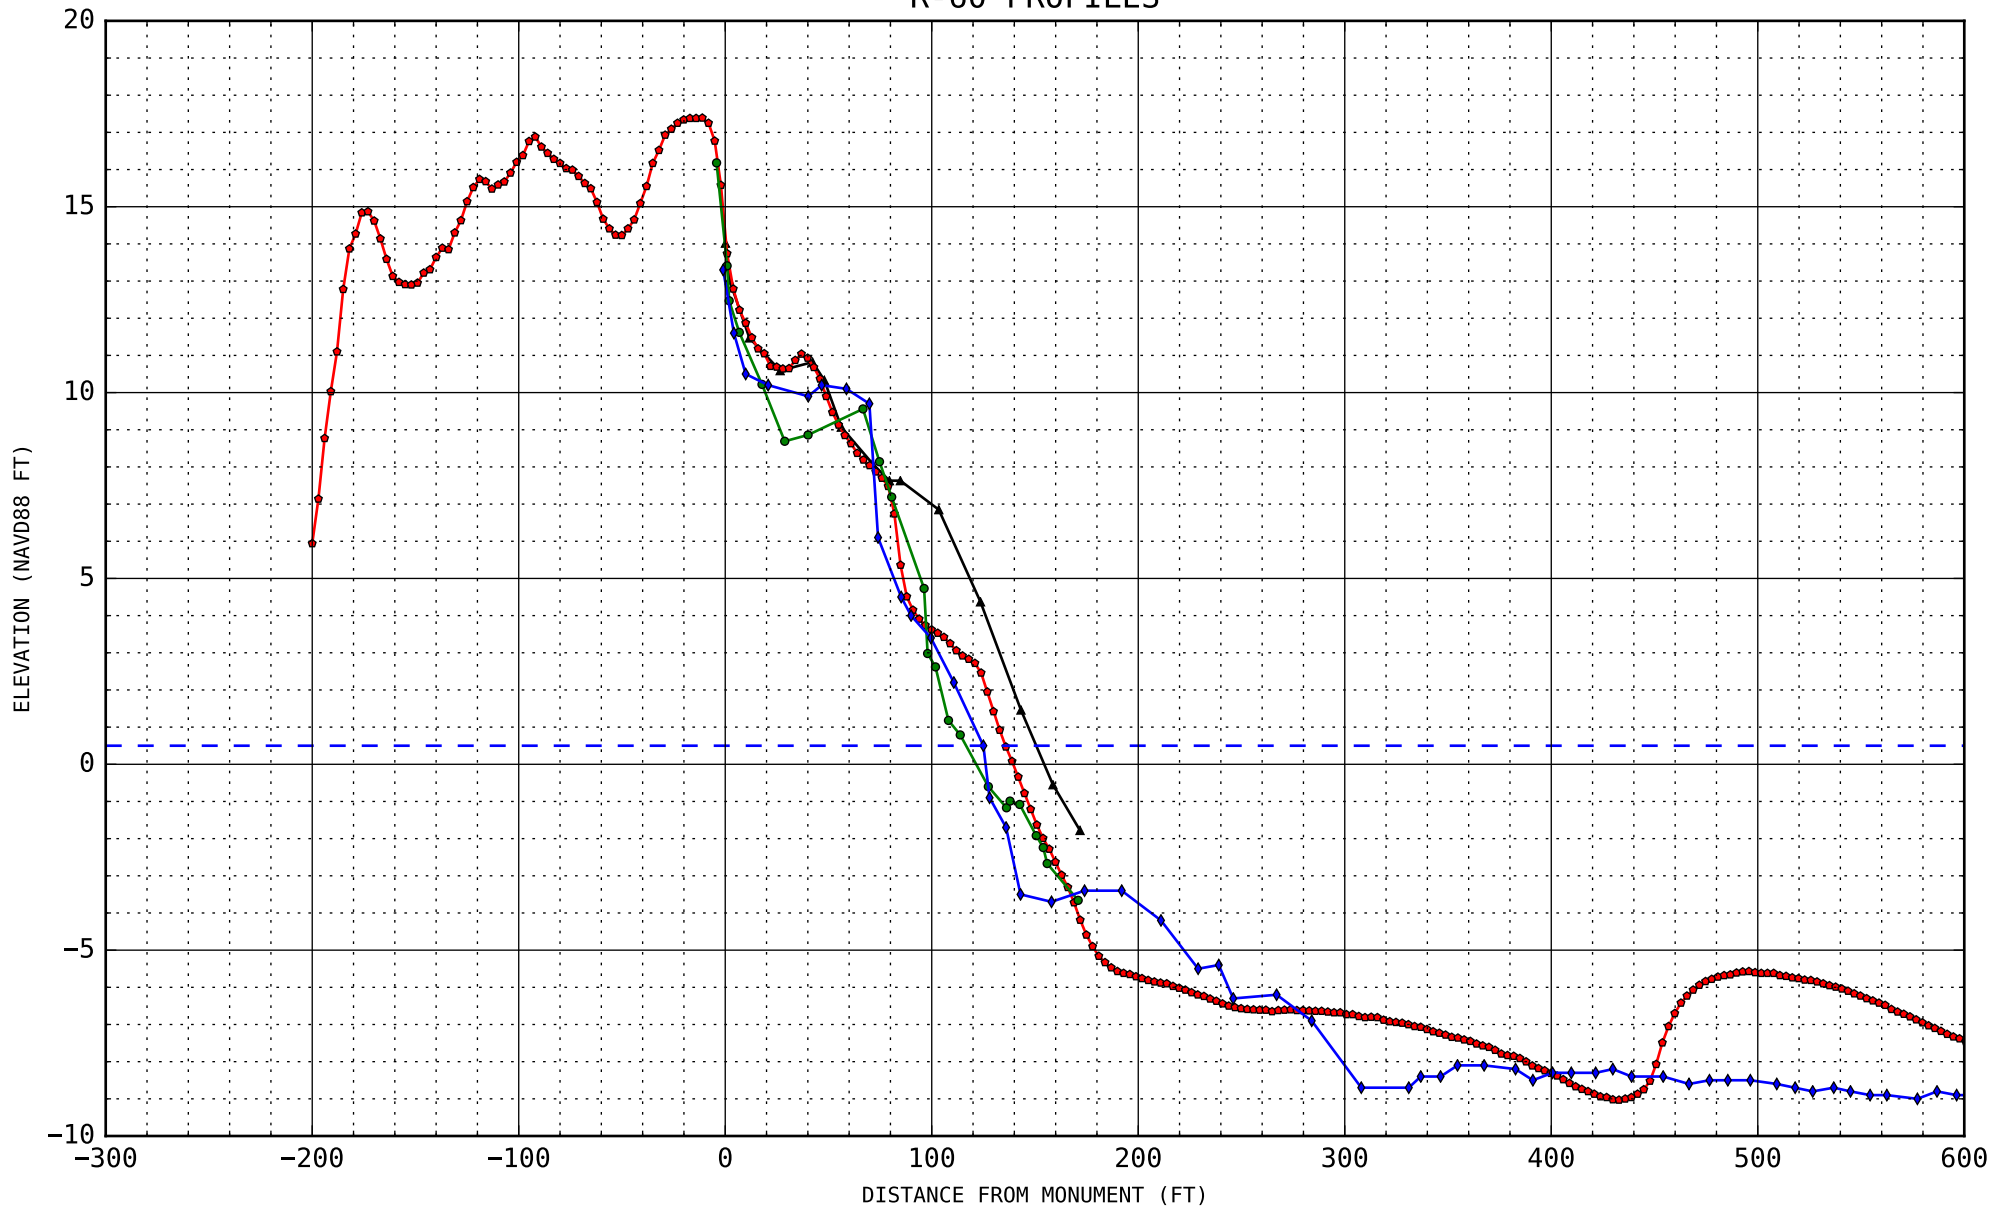
# R-60 PROFILES

- ▲ 2018-NOV CONDITION BY DEP
- 2018-JUN MONITORING BY NGS-LIDAR
- 2016-MAY MONITORING BY DEP
- ◆ 2010-OCT MONITORING BY SDI
- - - MHW CONTOUR (0.5 FT)

RANGE: R-60  
EST DATE: M&E2000  
SURVEY DATE: 29NOV18  
AZIMUTH: 70.0
