# EcoSummary

Major Lake in Washington County  
August 29, 1995

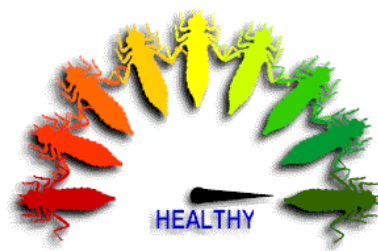
Lake Condition Index: A developmental biological assessment tool used by FDEP biologists to indicate ecosystem health and identify impairment in Florida Lakes.
