# EcoSummary

BioRecon Report

## Mt. Sinai Branch above Eglin Road 412, Walton County August 10, 2000

BioRecon: A rapid, cost-effective screening mechanism for identification of biological impairment

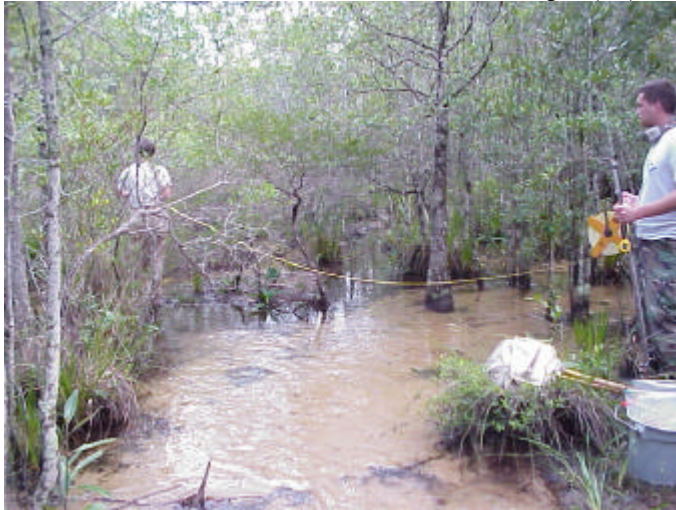
Lack of habitat from a sediment filled channel limited fish and wildlife productivity in this stream reach. A depth of only a few inches prevented fish larger than mosquito fish (no darters or shiners observed) from inhabiting this stream reach. The stream's sediment filled pools and its average depth of only a few inches precluded most fish propagation. Stream habitats were smothered by sand/silt (97%) from historical silvicultural practices and probably erosion from the inactive Wagner Field's runoff. The Road 412 culvert and fill material used to span the stream and riparian zone acted as a dam to exacerbate the smothering. Mt.Sinai Branch was over 18 meters wide above the culvert crossing as a result of the hydrologic modification.. The undersized culvert (0.5 meter diameter) in effect dammed the stream. This flooded the riparian zones, killing or stunting the trees. The paved road approach had eroded to form 2 gullies at the culvert crossing. Fire had burned to both stream banks and the remaining stunted riparian trees and shrubs provided little shade and habitat cover.

Removing road fill and replacing with a bridge spanning Mt.Sinai Branch and its floodplain would help restore the stream's natural morphological characteristics. Adding habitat such as large woody debris, along with stream bank protection and channel restoration would enhance fish and wildlife productivity and diversity. Proper placement of large pine logs along the stream bank would enhance riffle/pool habitat (velocity and depth) for the darters and other stream wildlife. Riparian buffer zones greater than 18 meters should be maintained. The buffer zones provide the shade, food, habitat (woody debris/leaf fall) and filtration necessary for the propagation of Mt.Sinai Branch biota. Restoring the stream's natural hydrology (i.e. increase depth/width ratio) and riparian forests buffer zones (replanting native Atlantic white cedars, allowing streamside native tree growth) would benefit the watershed's fish and wildlife including the endangered Okaloosa darter. **For more information, contact Donald Ray, FDEP Northwest District, 160 Governmental Center, Pensacola, FL 32501 (850) 595-8300 x1126 or SC 695-8300**
