## Bear Creek below Interstate 10 near Mile Marker 78, Walton County October 3, 2000

BioRecon: A rapid, cost-effective screening mechanism for identification of biological impairment

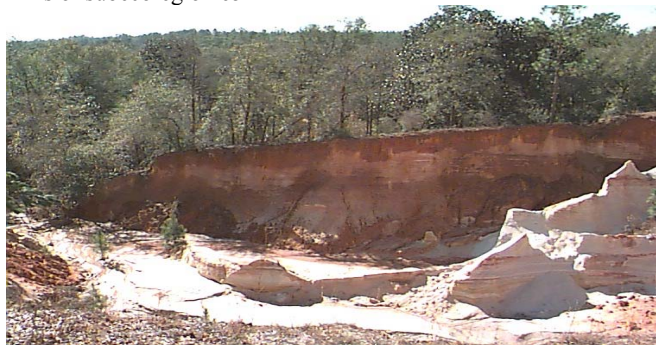
The stream community was severely limited by sediments from the severely eroded hillsides in its headwaters. These sediments smothered almost 100% of the aquatic habitats, which eliminated the stream's wildlife diversity and productivity. Sediments filled the stream channel to a depth of at least 1.5 meters in the upper sample reach. This left a water depth averaging less than 0.02 meters, much too shallow to support a fish population. The creek was severely braided from sediments filling the stream channel. Iron bacteria were common and iron is a contributor for red tide blooms in marine waters. Erosion and smothering from the hillside sediment runoff had killed much of Bear Creek's wetland forest riparian buffer zone. These buffer zones provide the shade, food, habitat (woody debris/leaf fall/roots) and filtration necessary for the continued propagation of Creek's biota. Mountain Laurel now rare in North Florida was still present in non-eroded hillside area. The western panhandle of Florida experiences severe erosion. Soft sandy soil, intense rainfall, and steep topographical relief make Bear Creek highly susceptible to erosion after removal of vegetative cover. Note the obvious example

demonstrated in photo on the left.

Restore the stream's natural hydrology (i.e. depth/width ratio), maintain a >18 meter riparian forest buffer zone and eliminate sediment runoff to allow the watershed's fish and wildlife habitat (woody debris, leaf packs, undercut banks, roots, and aquatic vegetation) to return. However, first the former borrow pit used for the construction of Interstate 10 should be stabilized and replanted with native streamside vegetation including mountain laurel. Also, the highway runoff, which caused the gully erosion, needs to be directed into sand filters simulating rainfall percolating through the area's hillsides forming headwater springs of local streams. **For more information, contact Donald Ray, FDEP Northwest District, 160 Governmental Center, Pensacola, FL 32501 (850) 595-8300 x1126 or SC 695-8300**
