BioRecon Report

## Juniper Creek above Eglin Air Force Base Clay Pit B-43, Okaloosa County January 18, 2000

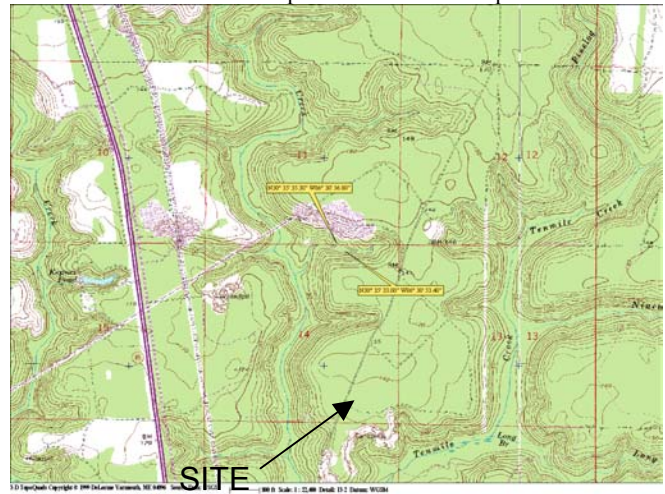
Feral pig rooting along the stream channel affected the stream community. Recent erosion caused by the hogs was observed and those eroded soils were deposited in the stream, which created braided channels. Half of the University of Florida sediment study plots were uprooted at this control site. Sediment deposition, which included erosion impacts from fire baring riparian zone soils, was moderate. Because of the burning, young plants, dominated by a pioneer community of titi and briars, had replaced the climax blackgum/sweetbay riparian forest community. Mature riparian buffer zones

provide the shade, food, habitat (woody debris/leaf fall/roots) and filtration necessary for the continued propagation of a healthy stream biota. Despite the recent and historical impairments, the benthic habitat assessment rated a low optimal score of 68%, a considerable improvement of the 35% found downstream in the NPS affected area. The water depth was 0.5 meters or less which enabled a limited fish population. This was also much greater than the 0.2 meters found downstream of the sediment plume from the mine pit.

Restore the stream's natural hydrology (i.e. depth/width ratio), maintain a >18 meter riparian forest buffer zone and eliminate sediment runoff to allow the watershed's fish and wildlife habitat (woody debris, leaf packs, undercut banks, roots, and aquatic vegetation) to return to a healthy ecological status. Eglin Air Force Base had initiated a plan to eliminate feral pigs illegally placed on the base. Also, land management included buffer zones that follow Best Management Practices to protect riparian vegetation along the streams on Eglin Air Force Base. The Jackson Guard was continuing restoration study at this site. **For more information, contact Donald Ray, FDEP Northwest District, 160 Governmental Center, Pensacola, FL 32501 (850) 595-8300 x1126 or SC 695-8300**
