# EcoSummary

Pate Lake, Washington County

March 11, 1994

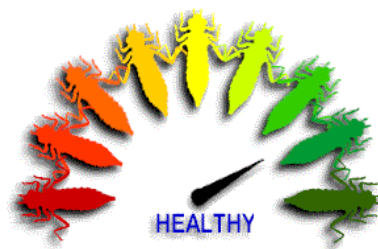
Lake Condition Index: A developmental biological assessment tool used by FDEP biologists to indicate ecosystem health and identify impairment in Florida Lakes.
