# **ECOSUMMARY**

## **A Biorecon Assessment**

### **Surface Water Assessment & Monitoring Program South District**

### **Prairie Creek at State Road 31, De Soto Co.**

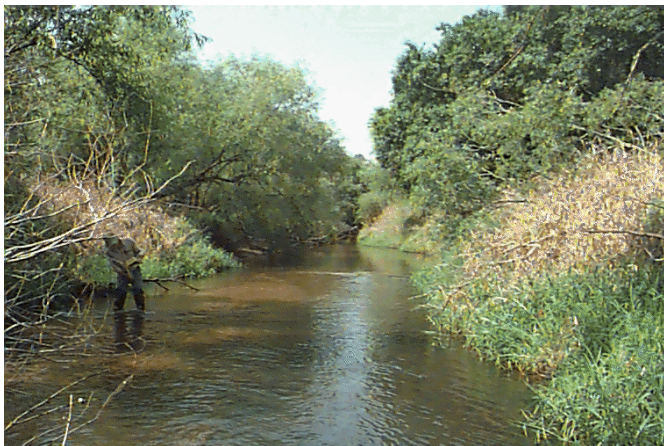
**Prairie Creek**

The drainage basin for Prairie Creek includes orange groves, forest, and improved and native pasture. Major land uses in the area include agriculture, grazing, and rural residential. The creek supplies drinking water for Punta Gorda and flows into the Peace River.
