# EcoSummary

BioRecon Report

## Big Escambia Creek below Fanne Road in Escambia County

22 July 1998

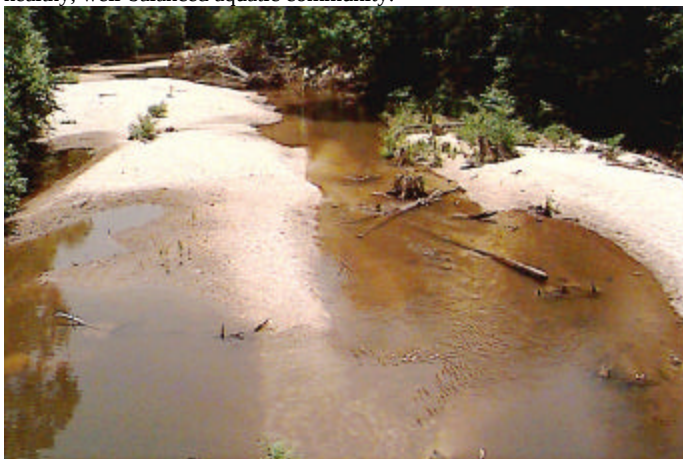
Big Escambia Creek below Fanne Road showing sand and gravel point bars from upstream sedimentation in excess of maximum loading capacities.

The habitat assessment of the site was 58% of the % similarity to the reference score. A score of 65% is an interim biometric threshold. Habitat smothering rated poor from 96% coverage of habitats with 10% sand, 42% gravel, and 40% mud/muck/silt. The available substrates were covered with a thick layer of silt. The stream banks were unstable with recent raw, eroded areas with bank sloughing. The riparian zone had some invasion of Chinese privet along with kudzu near the bridge.

Big Escambia Creek passed all three BioRecon metrics, indicating a healthy condition at this site. However, habitat smothering was observed an anthropogenic disturbance. Sediment sources include sand and gravel mining, agriculture, silviculture, urban, and dirt road runoff. Coliform bacteria sources include agriculture and urban runoff. The presence of coliform bacteria and turbidity were rainfall dependent. This sample was collected after a record drought so sediment and bacteria concerns were not adequately monitored for this watershed. It is recommended that Big Escambia Creek be monitored during and after significant rainfall events. This would determine sediment and bacteria effects on recreational activities for Escambia River and shellfish harvesting in Escambia Bay's Class II waters.
