# Applied Polymer Systems, Inc.

## Innovations

### Clover Bar Ravine Clean Up, Edmonton, Alberta

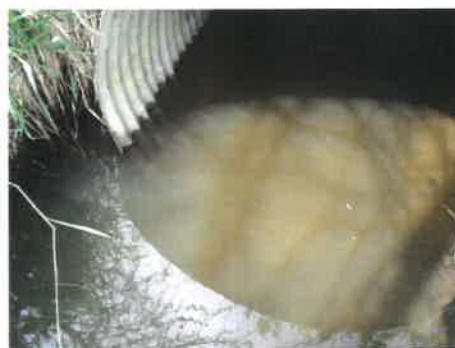
**Left: Water before treatment with Floc Logs.**

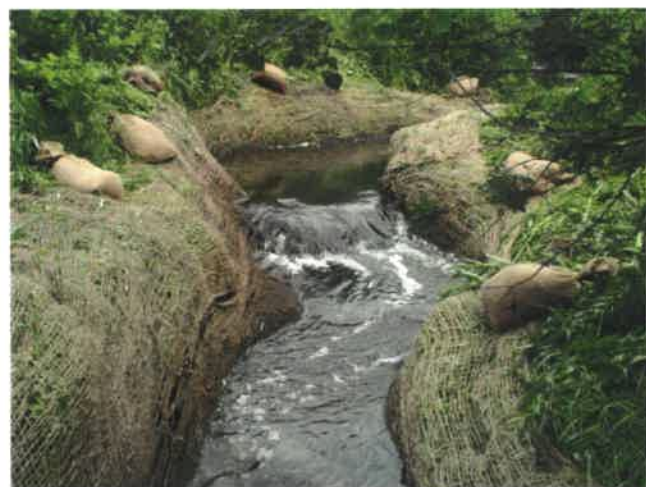
**Below: Jute matting was installed along the stream bed and banks.**

The passive treatment system was installed in June 2007. The treatment system was designed with 34 Floc Logs® placed along the creek bed beginning at the outfall. Before the logs were installed, the streambed was lined with an open-weave jute matting to prevent further erosion and work as an area of attachment for flocculated particulate. The logs were placed 10 feet apart alternating between APS 703d#3 and 706b Floc Logs®. Sand bags were placed in the channel and the Floc Logs® were tied off to them. The sand bags kept the logs in place as well as increased the turbulence of the water flowing over and around the logs, increasing mixing which in turn improved the reaction and performance of the system. The only maintenance required for this passive treatment system was simple monitoring of the banks to ensure they were not washing out. The biodegradable jute matting was not removed; new layers were simply applied directly on top of existing layers.

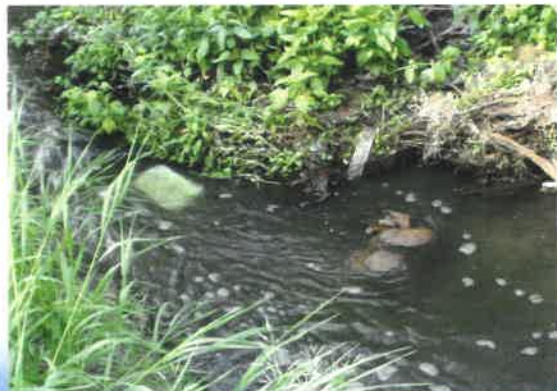
**Left: Floc Logs were attached to sand bags, which added extra turbulence.**

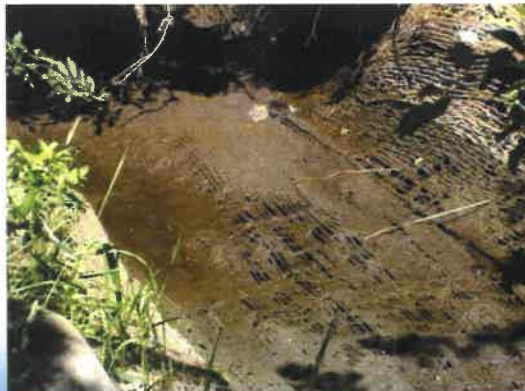
**Right: Jute lining the creek bed and banks captured flocculated metals and sediment, preventing them from discharging into the stream and river.**

These flocs are heavy and settle quickly out of the water column. Natural fiber matting, such as jute, is used in conjunction with Floc Logs® to provide an area of attachment for the polymer charged particles as well as added erosion control. Floc Logs® are composed of anionic, negatively charged, polyacrylamides. This charge repels against the negatively charged gill mucous of fish and other aquatic organisms, making them nontoxic even at high dosages and safe for use in the open aquatic environment, unlike cationic (positively charged) polyacrylamides or chitosan that can cause detrimental effects to aquatic organisms.

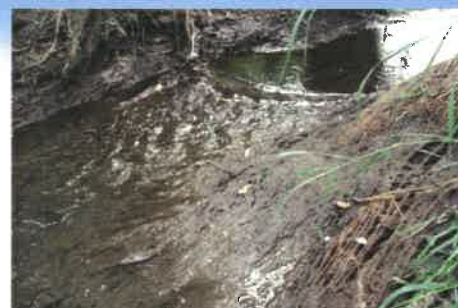
Above: Flocculated sediment and metals attached to jute matting result in clear water discharging from the treatment train.

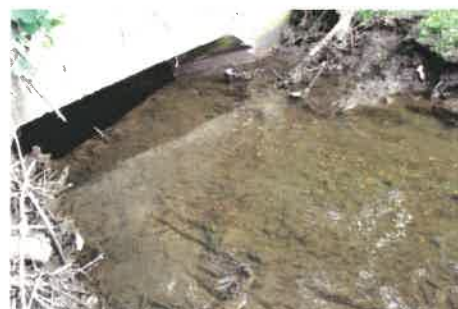
Above: Success is evident with clear water exiting.

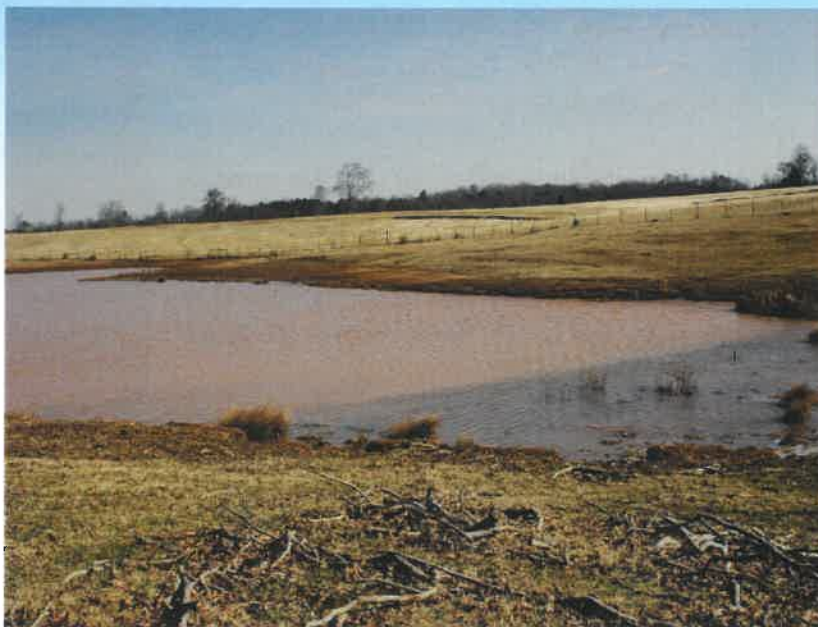
**Above:** Rolling M Ranch pond before treatment, turbidity level over 900 NTU

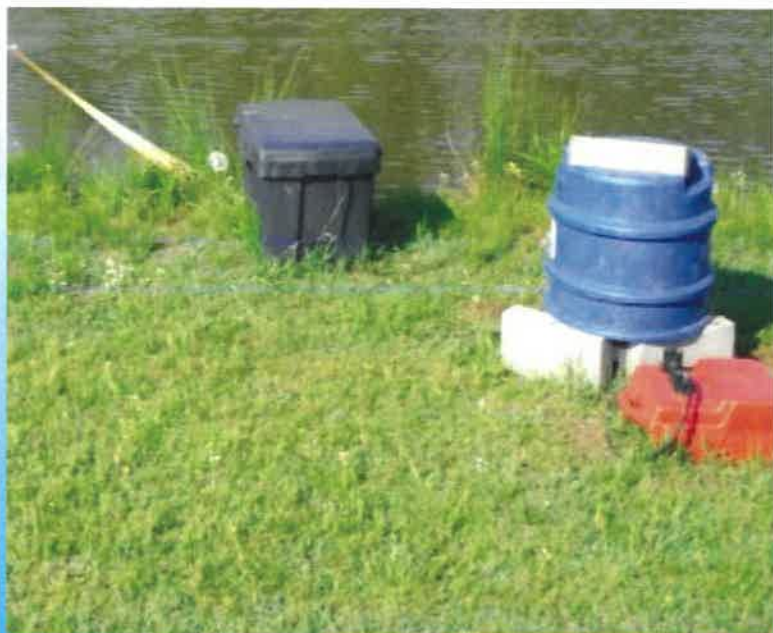
**Below:** The L.I.P.V.A.C. System from Eco Pond Rescue installed at Rolling M Ranch.

Erosion Tech's first idea was to use a dewatering ditch, lined with Floc Logs, to treat the water and discharge it back into the pond. Then they thought about trying the new L.I.P.V.A.C.S with Applied Polymer Systems, Inc. Floc Logs which successfully flocculate and remove phosphorous and nonliving nutrients.

This particular pond required the 703d#3 and 706b Floc Logs to clarify the water. The pond contained approximately 18 million gallons of water, which would require 18 of each Floc Log to successfully treat the system. The 706b and 703d#3 L.I.P.V.A.C Logs, and two (2) L.I.P.V.A.C.S. were installed in late March.

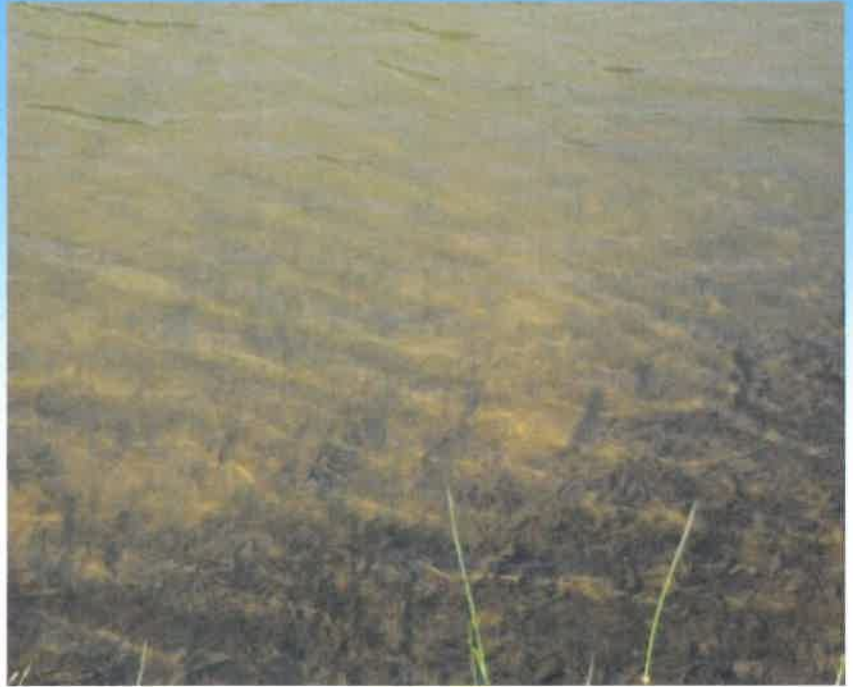
**Above:** The turbidity level of the pond has been reduced dramatically and now the bottom of the pond is visible in places.

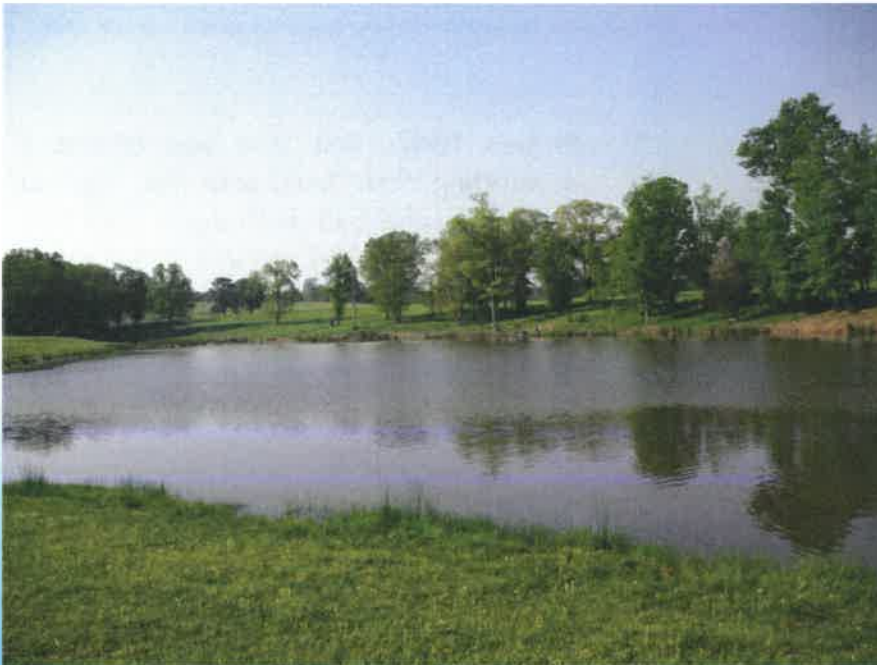
**Below :** After treatment with L.I.P.V.A.C. System and Logs, the turbidity level of the pond is now below 15 NTU.

The L.I.P.V.A.C.S. ran for approximately 24 hours a day for about 30 days. After treatment the pond's NTU had been reduced from 967 to 14.

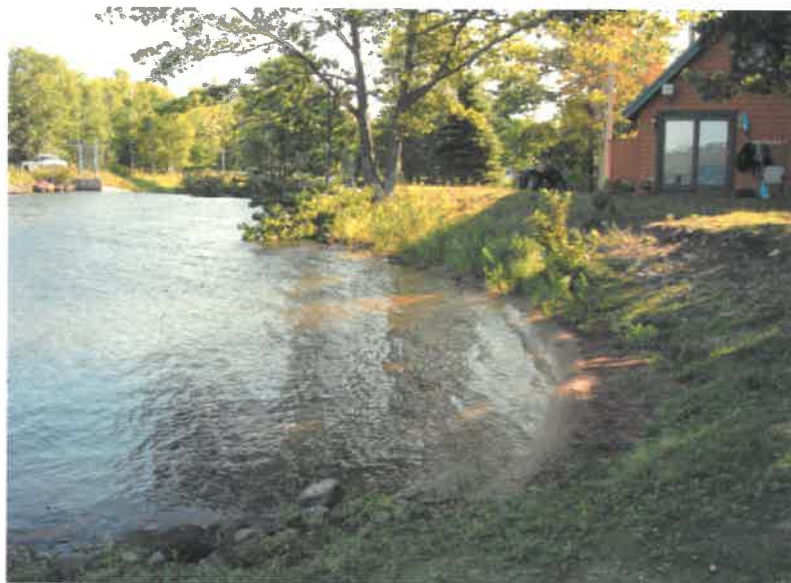
Erosion of the shoreline is clearly visible in the bank along the right side of this photograph. The dam is seen on the upper left-hand corner of the photo.

Through the years, substantial erosion has been occurring along the banks adjacent to the dam. Sand bagging was the normal practice to prevent scouring and channelization around the dam. It was feared that should erosion continue, the water would eventually cut a path around the dam, rendering it useless, and essentially draining the lake. This would alter the ecosystem as well as severely diminish property values along the lake.

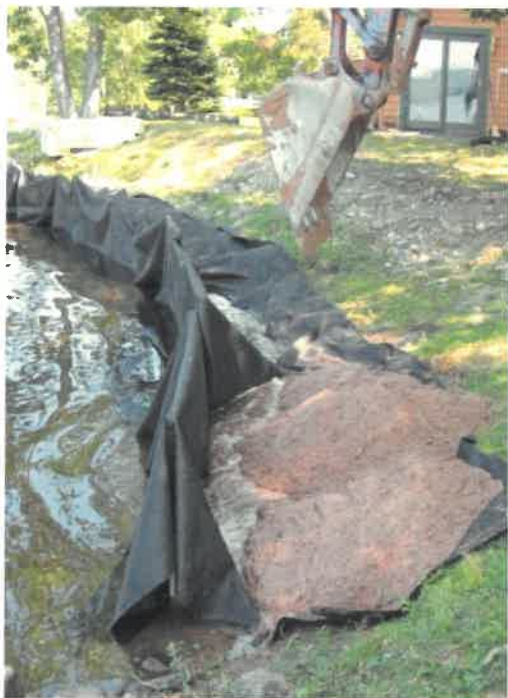
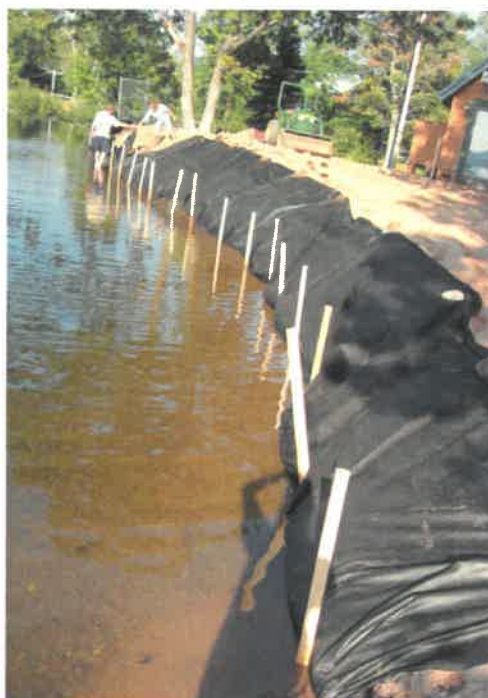
The photo to the left shows the geosynthetic fabric laid on the bank and the sand beginning to be deposited. The photo to the right shows the excess fabric being pulled over the sand and fortified with rock, forming a containment for the sediment.

The area was cleared of tall grasses and shrubs, and wooden stakes were placed at the low water line to establish a boundary. A non-woven geosynthetic fabric was then laid across the slope with enough overlap so it could be pulled over the soon to be added sand/soil material, forming a containment and preventing the fine material from washing into the lake. Once the sand was brought in and the geosynthetic fabric stretched over it, medium sized rock was used to fortify the newly contoured bank.

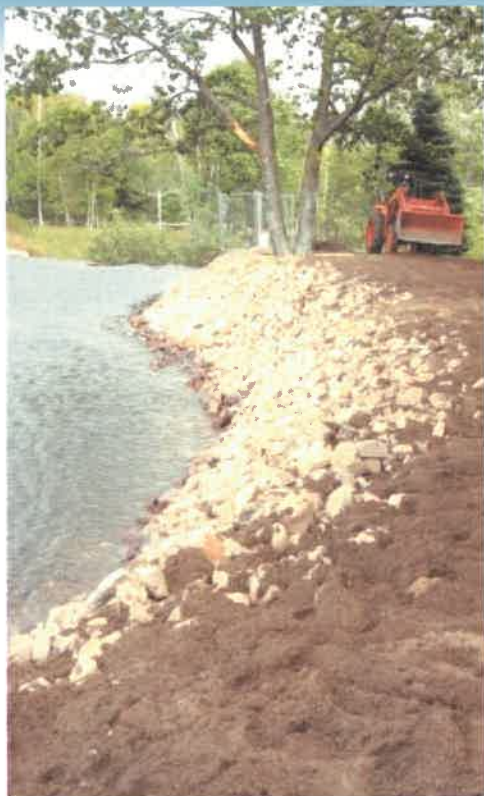
**Left: Completed bank structure consisting of sand, rock, and top soil.**

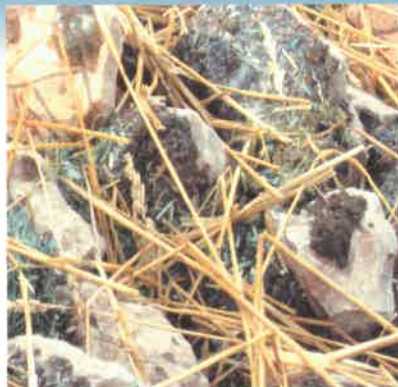
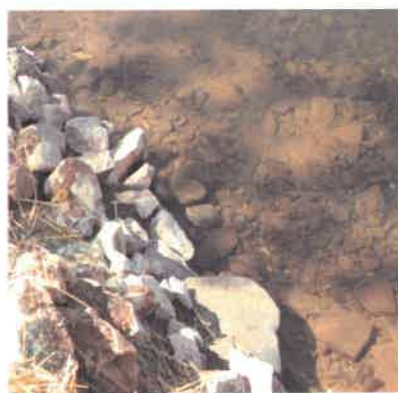
**Right Top: Polymer, seed mix, mulch, and straw matrix spread over rock.**  
**Right Bottom: Clear lake water directly below newly stabilized bank.**

Next, a mixture of seed, mulch, and polymer was added to the rock bank. Establishing vegetation in rock and sand is very difficult. This was achieved using a seed mix of clover, perennial rye, tall fescue, and millet. The clover was used to produce nitrogen without the use of fertilizers. A site tested polymer, APS 705 powder, was used to bind all the materials together with the soil to form a matrix, keep it in place, and allow for a vegetative cover to be established.

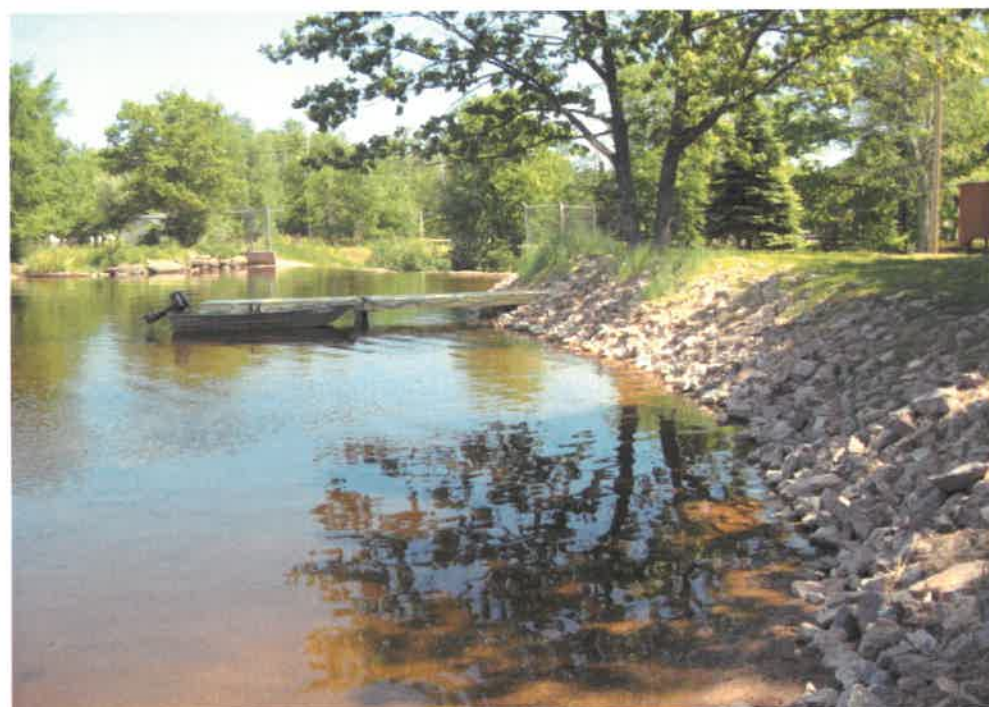
**The following spring the bank was visually appealing and permanent. Note the grass growing between the rocks and the clarity of the water seen in the reflection of the tree..**

The project took about two weeks to complete and the different types of grasses came up from within 3 days to 2-3 weeks. After a year, in the following spring, the grass continued to grow once again.

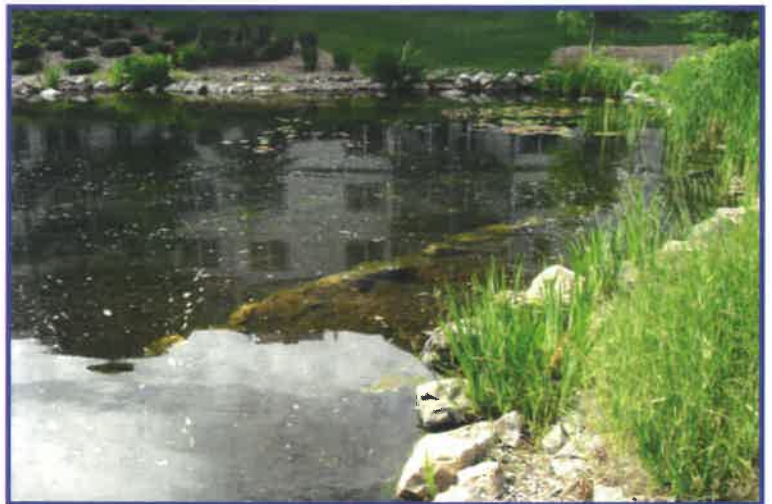
**Above:** Nutrient rich pond promotes excess algae growth and results in cloudy water and algal covering of rocks in the pond.

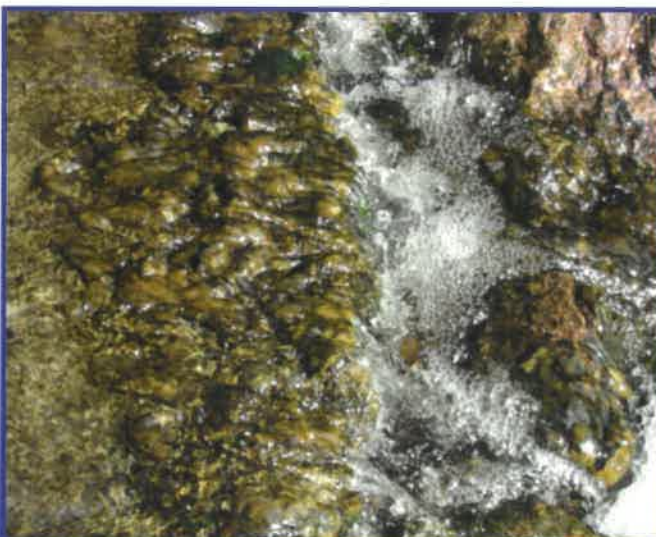
**Below:** Close up of dense algal mats covering the rock surfaces within the pond.

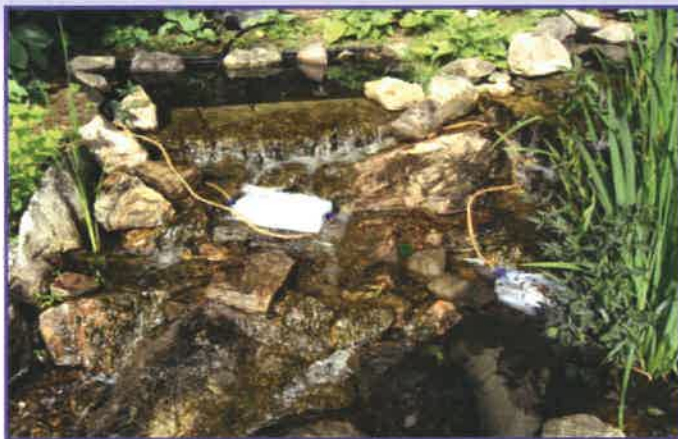
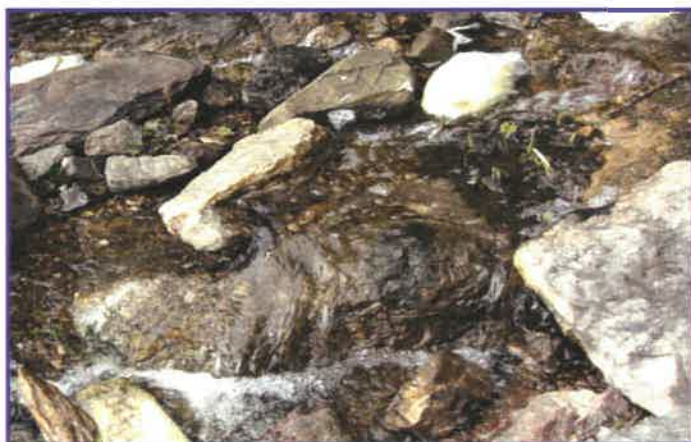
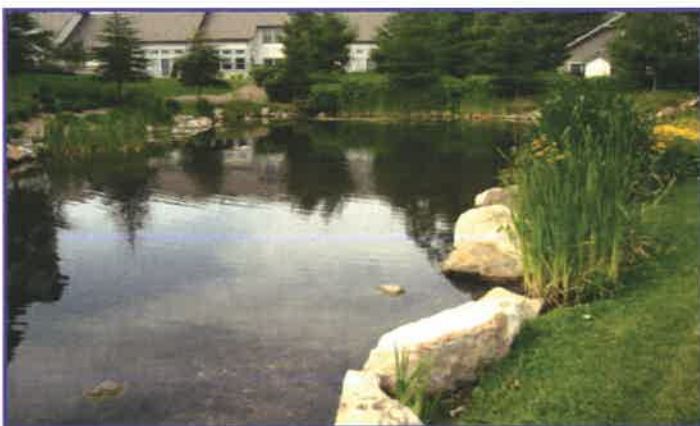
After installation of the logs in the waterfalls (first photo), results were noticeable within the first month and Lakeshore Condominiums have been using the system for nearly two years. The logs are replaced about once a month (except in winter due to freezing of the ponds). The method is very simple, requiring little to no maintenance, with excellent quality water as an outcome. The rocks (second photo) after treatment are nearly clear of algal buildup, and the pond water itself (last photo) is clear and beautiful.

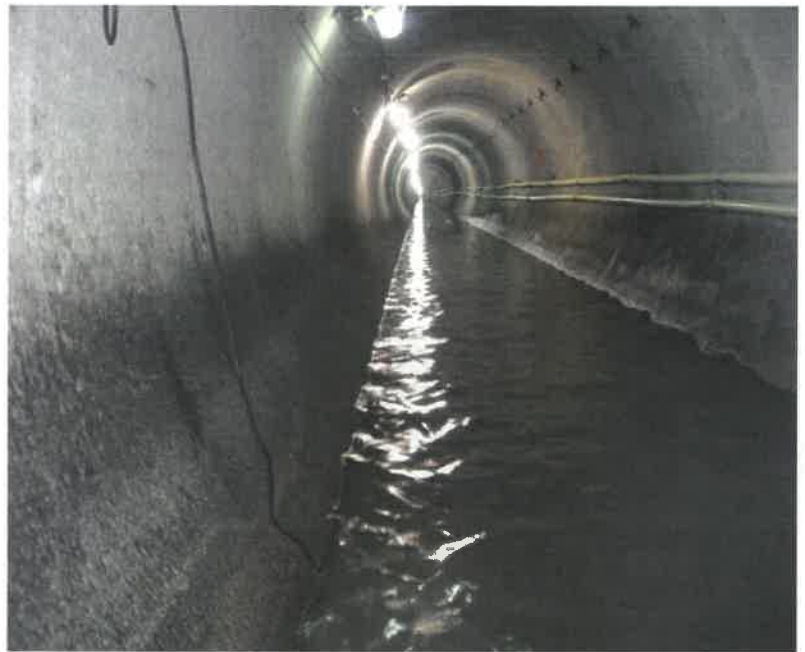
Photo of the tunnel dug by Mole Constructors in Gwinnet County, Georgia.

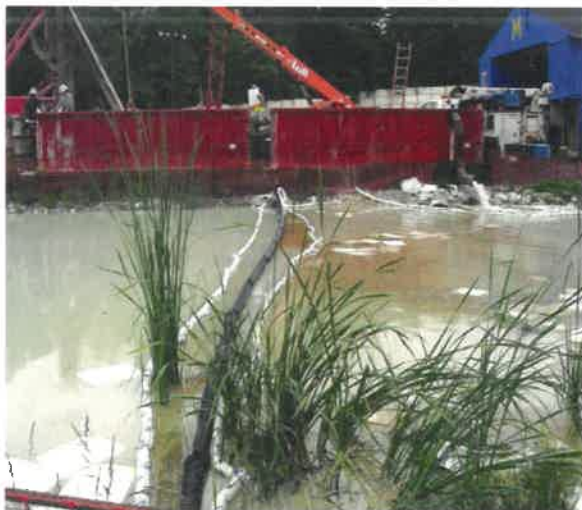
Three tanks make up the system and involve the use of Floc Logs and particle curtains to treat incoming water and remove sediments before discharge.

The system that Mole created was comprised of a mixing launder, three (3) tanks, and particle curtains. The mixing launder is a split pipe that sits on top of the three tanks.

The launder followed the perimeter of the tanks on three sides and then discharged into the first tank. The first tank was used to capture the large particulate, while the second and third tanks contained particle curtains which work to capture finer particulate that has not settled to the bottom.

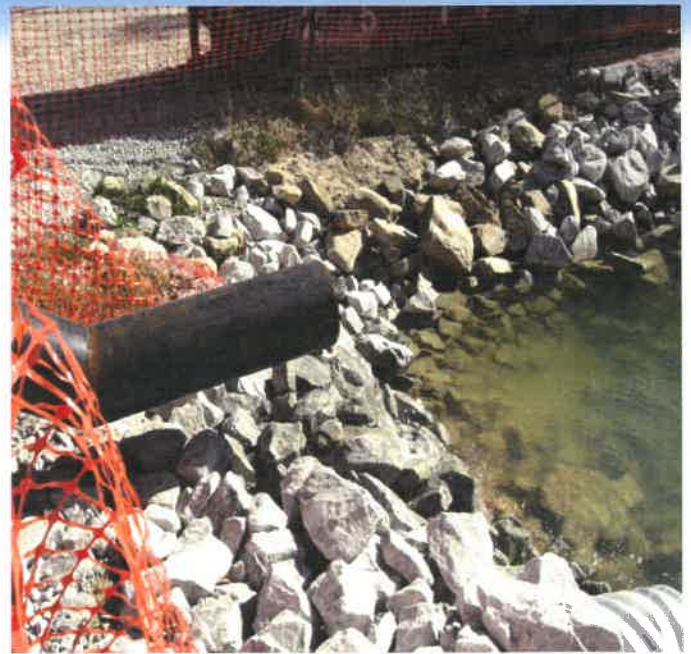
**Above:** Particle curtain strategically placed to catch the particles that did not settle out by gravity.

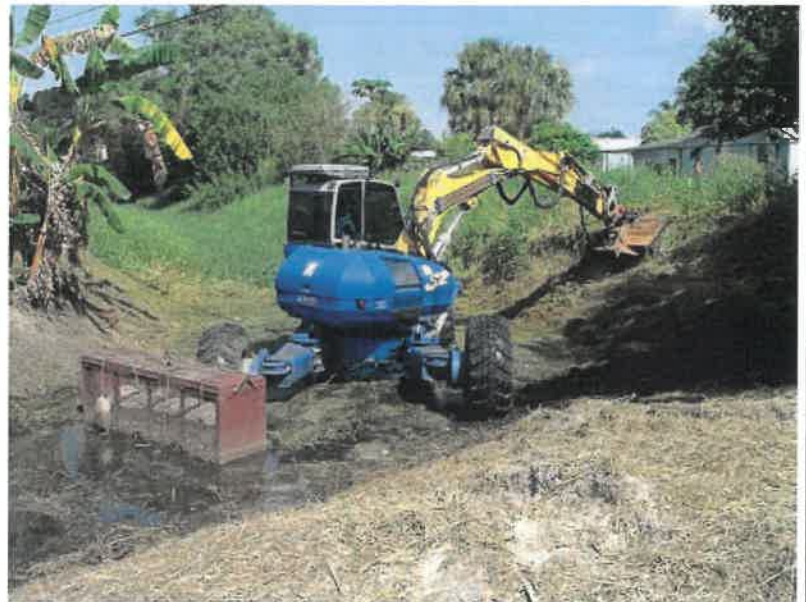
**Design:** A movable metal box was designed for ease of mobility and mixing of the Floc Logs. Note the Floc Logs placed within the metal box.

A metal box was designed and constructed to provide a movable mixing zone for the Floc Logs. Several were attached to this box and to the Water Spyder to allow agitation and current flow to dissolve the APS product for turbidity treatment. Particle curtains, made of PVC pipe and jute were constructed and placed downstream to capture fine flocculent material that did not gravity settle.

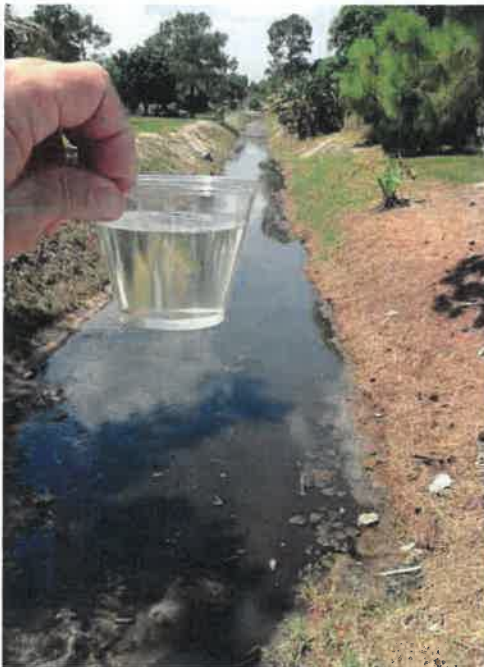
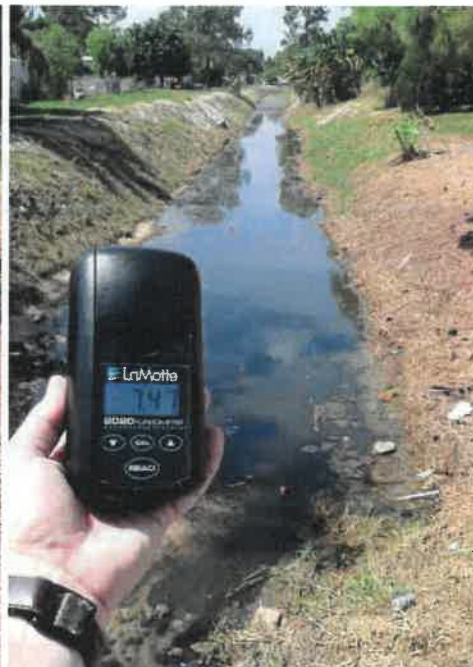
**Clarity:** The actual NTU value of the discharge water was read at about 7.5 NTU. The clarity and color of the water speaks for itself.

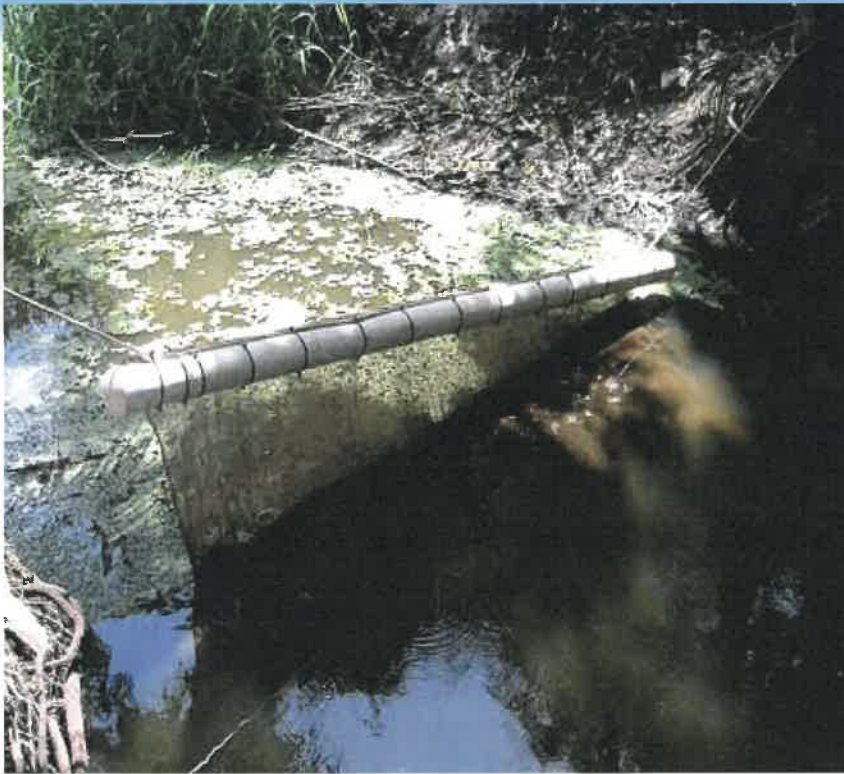
**Above:** Particle curtain strategically placed to catch the particles that did not settle out by gravity.

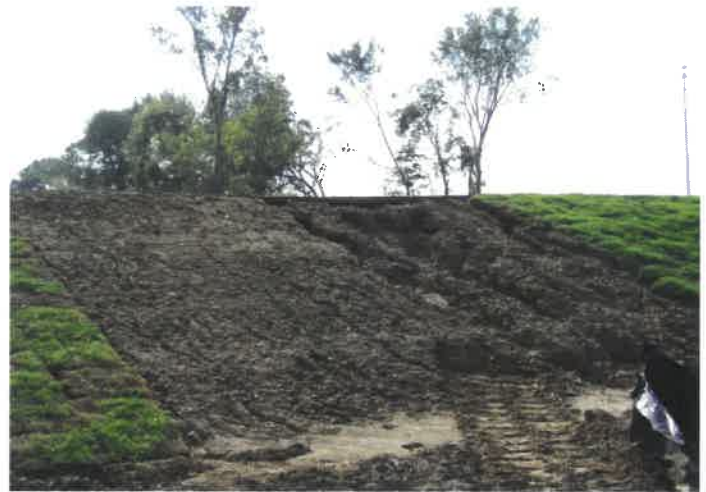
The test slope had previously been stabilized with sod, but a portion of it had been undercut, the sod had failed and washed away. Massive rills and gullies had formed in the exposed slope. After consulting with Jason Painter of Jen Hill, it was decided to try a Soft Armoring application to repair the slope.

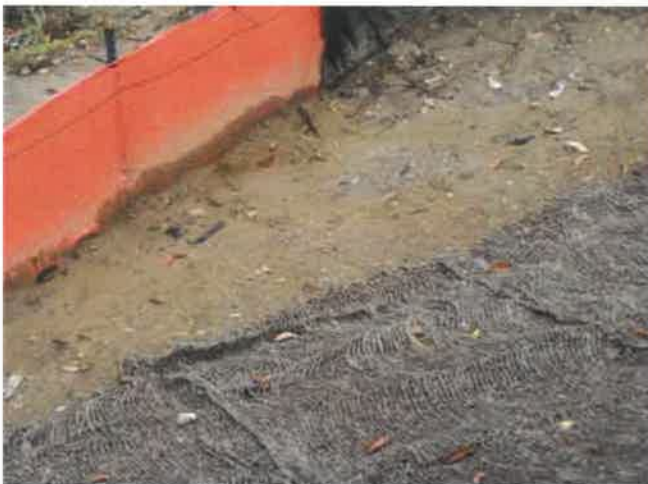
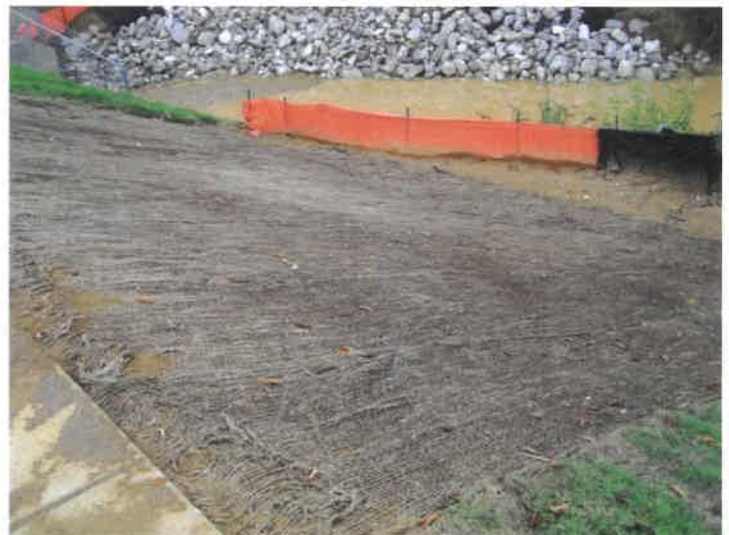
As shown in the photos below, even before the grass had germinated the slope is stabilized and showing no erosion or plumes of turbidity in the stormwater running through the silt fence and into the nearby stream.

Just 3 days after installation of the jute matting and application of seed and soil-specific polymer powder, a large rainstorm dropped over two inches of rain on the site.

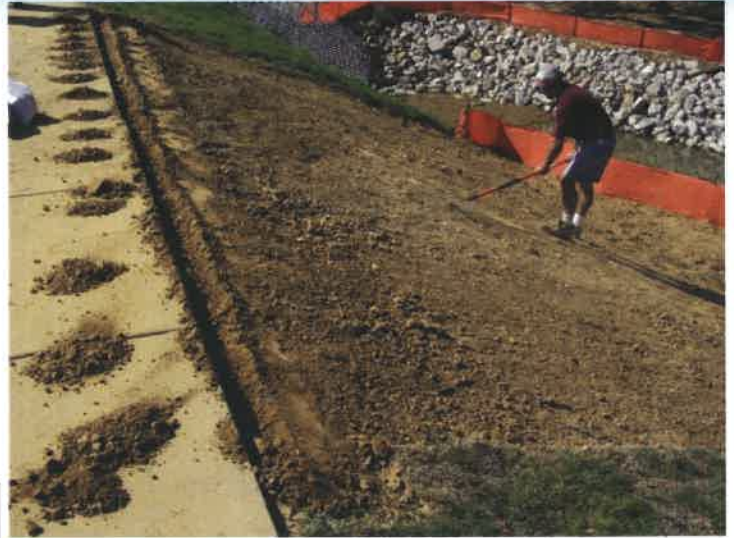
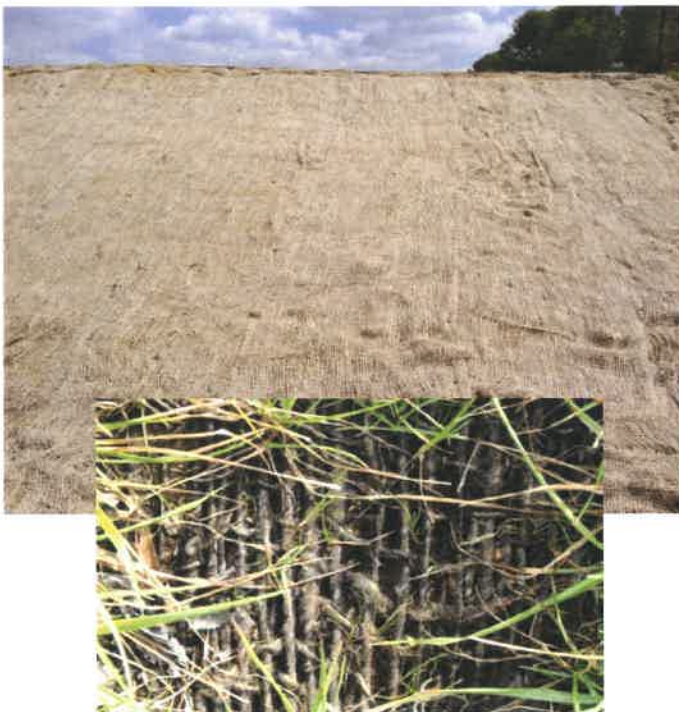
Over four months after the application, the grass in the area of soft armoring was well-established and showed no signs of erosion. The areas of sod on either side of the soft armoring had dried out and died. The polymer allows for better water penetration and retention in the soil, helping to ensure healthy, lush vegetation.

Preparation work on the site involved regrading the slope and filling in the rills. Since the area was very small, this was done by hand.

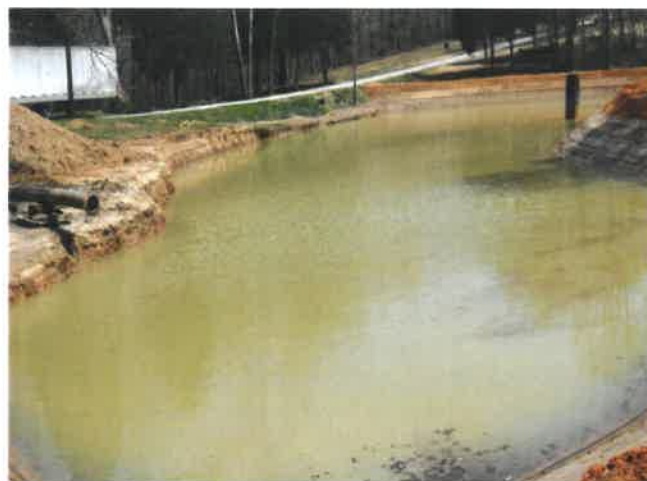
The dredge spoils discharged into the stilling pond through the pipe on the left and discharged through the riser pipe on the right.

The plan was to dredge out the cove and deposit the spoils into a large stilling pond where the sediment would settle out. The excess water would discharge from the pond, filter through a wooded area, and eventually return to the lake. The wooded land belonged to the Tennessee Valley Authority (TVA), and they had the project shut down over concerns of elevated sediment loads in the water returning to the lake as well as erosion through the woods due to the high volume and velocity of the discharged water.

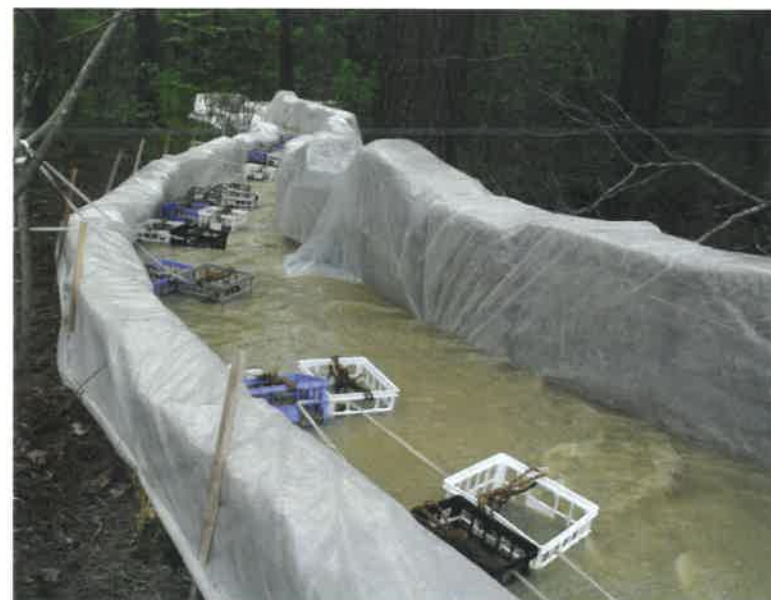
The soil-specific Floc Logs were secured into plastic crates in the mixing/reaction portion of the treatment system where the polymer would react with suspended sediment.

The site-specific Floc Logs were secured in plastic crates and placed in a series running down the treatment ditch. The turbulence caused by the narrow ditch and the high flow rate ensured that the turbid water could flow over and around the Floc Logs allowing for dissolution. The dissolving polymer mixed and reacted with the suspended sediment, binding together to cause large particulate to form. The turbulence along the ditchline increased the mixing which increased the particle size and pulling the fine sediment and swelling clays out of suspension.

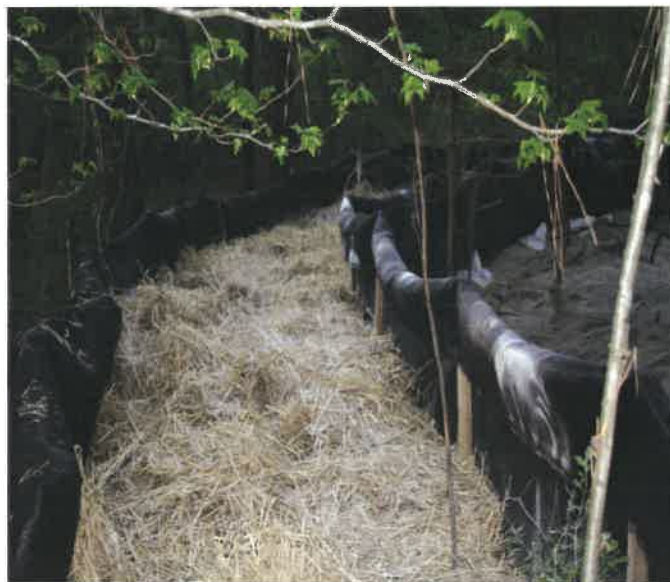
**The treated water passed across the jute dispersion field before passing through the sediment retention barrier filled with straw and polymer where final polishing occurred.**

The treatment system consisted of two parts. The first part was the mixing/reaction portion, where the polymer reacted with the suspended sediment and caused flocculation. The second part was the particle collection portion, where the flocculated particulate was collected and removed from the water. The water entered the treatment system after settling reduced the sediment loads of the dredge spoils. The water discharging from the stilling pond into the treatment ditch flowed at a rate of 3,500 gallons per minute, and needed to be treated as a continuous flow to allow work to continue on schedule.

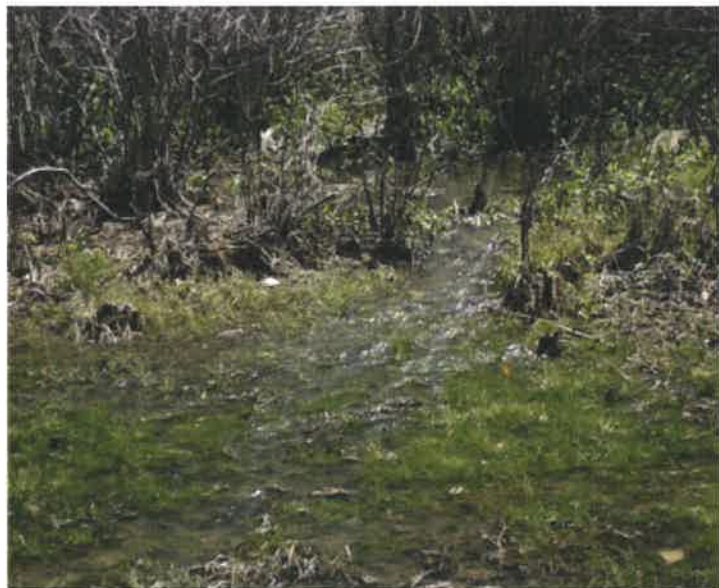
**The clarified water re-entered Kentucky Lake without any turbidity impacts.**

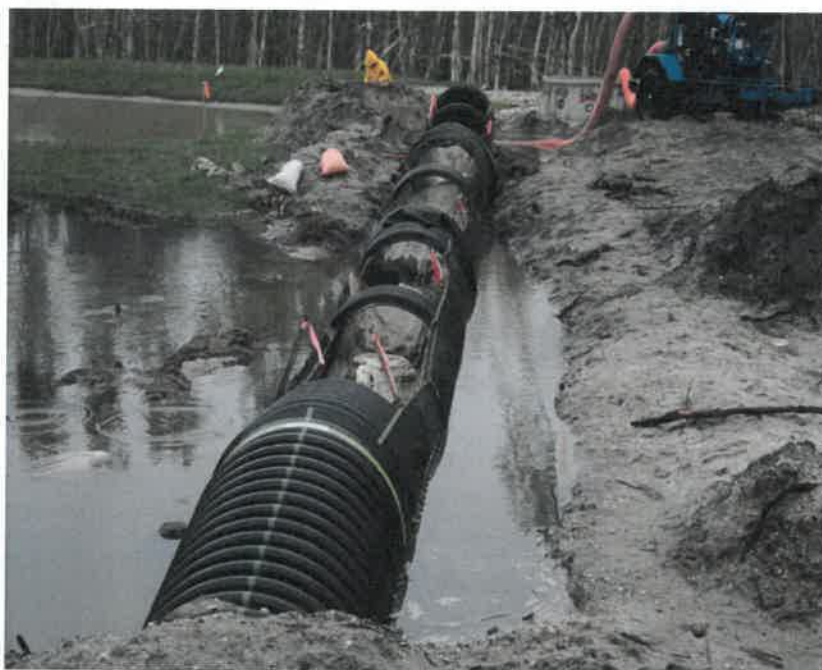
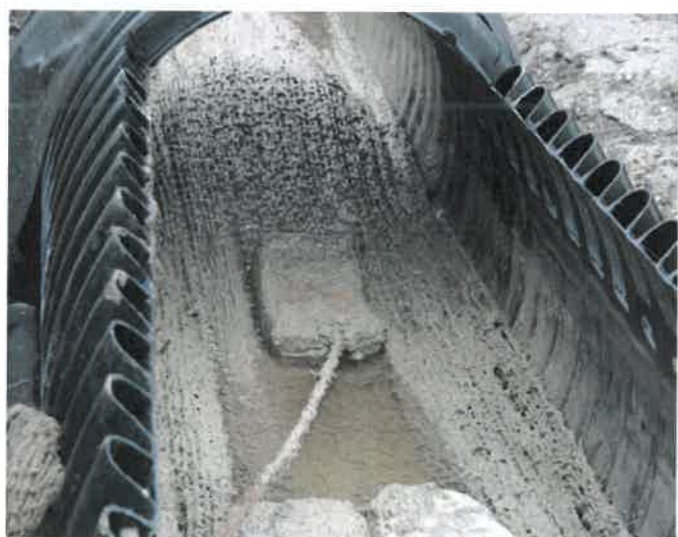
A split pipe treatment system was created using 36 inch HDPE pipe cut in half and lined with jute matting. The site-specific Floc Logs were installed inside.

Check dams made with rock bags were placed every 10 feet along the length of the split pipe; these checks helped increase the turbulence and create mixing conditions.

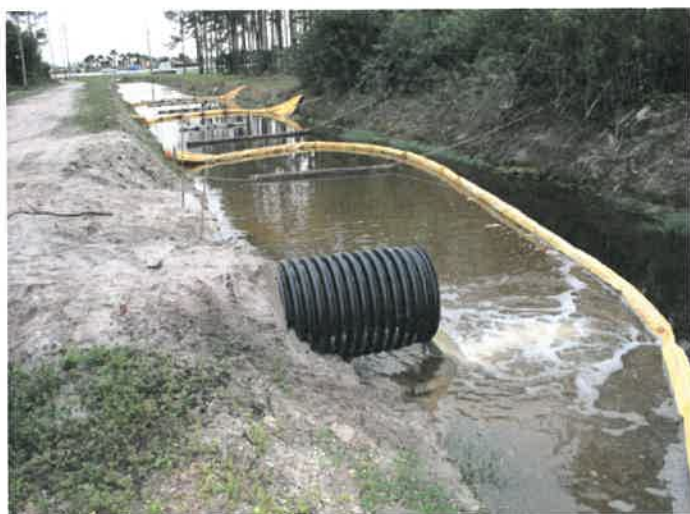
**Above, Right:** The sediment was reacted with the Floc Logs, binding the particles together and attaching them to the jute matting in the split pipe system.

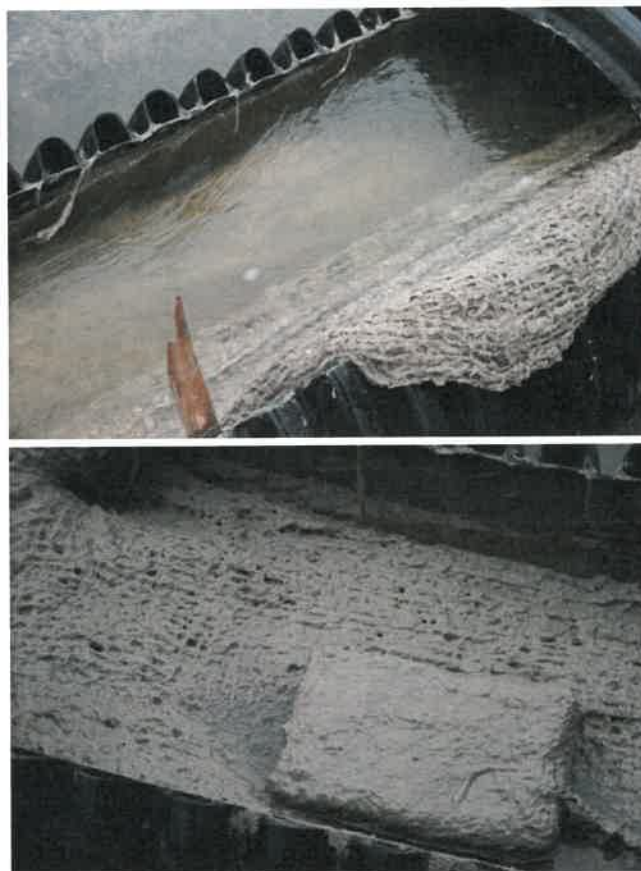
The split pipes were lined with jute matting, which provided surface area for the flocculated particulate to adhere to. The clarified water was then discharged off site.

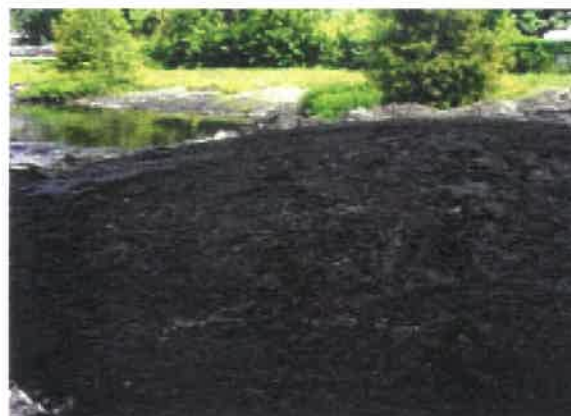
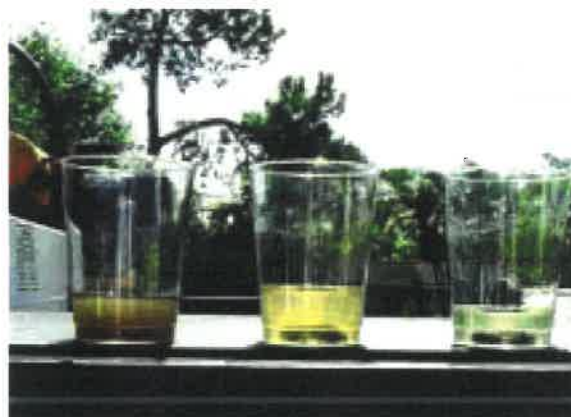
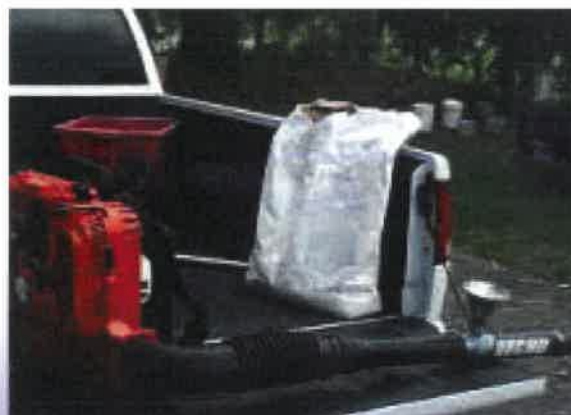
First, a soil specific test was performed by the APS testing lab to match the PAM blend to the site. Kevin decided to use a backpack leaf blower to disperse the powdered PAM blend across the muck. This technique allowed for continuous application on the work site as needed.

Once applied, the PAM generally reacted with the muck within 10-20 minutes untouched. Having the equipment operator blend the PAM and muck back and forth with the machine's bucket until it began to set-up speeded up this process. Once thickened, the muck could be removed like any other soil.

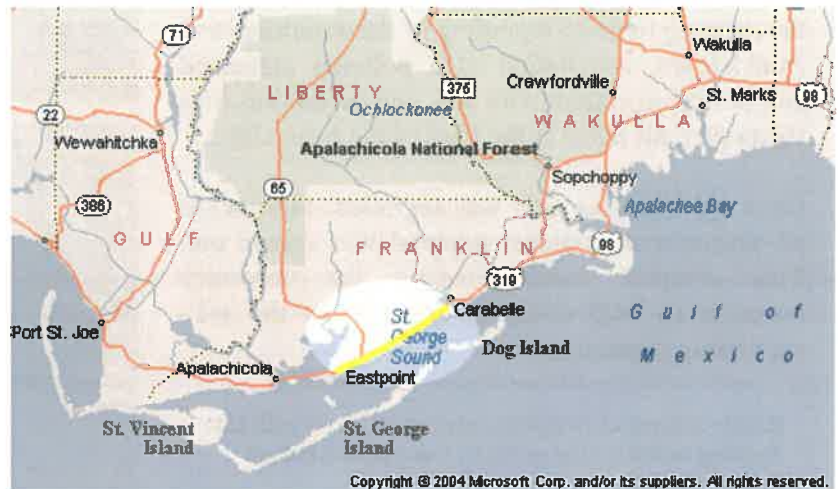
This 14 mile stretch of Highway 98 along the coast was the project area.

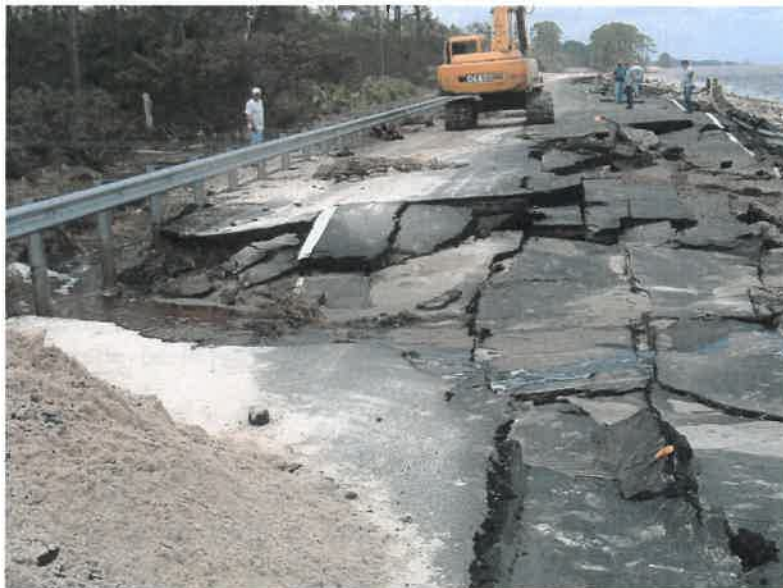
The movement of the highly erosive beach sands caused the roadway to collapse, in some places across the entire width of the two lane road.

Damage was severe on approximately 14 miles of US highway 98, ranging from erosion of the shoulder to buckling and subsidence of the entire roadway. Immediately after the storm, the Florida Department of Transportation (FDOT) took action to reconstruct and open traffic on the stretch of damaged highway, awarding a construction contract to complete emergency repairs within 14 days. The travel lanes were quickly reconstructed and traffic soon resumed; however, within a month shoulder erosion was reoccurring, threatening to again encroach on travel lanes.

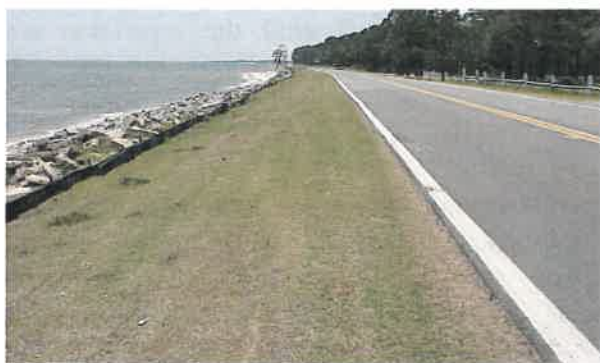
**Below:** A cross-section diagram of the soft armor application.

Over the layer of compost, open-weave jute matting and the correct soil-specific APS 705 Silt Stop powder was applied at a rate of 50 pounds per acre. Bermuda grass sod was laid over the jute matting. The jute matting provided an initial attachment surface for the polymer powder, which immediately bound to the surrounding soil and compost layers, instantly creating a highly erosion-resistant matrix that provided structural support while the vegetation was established.

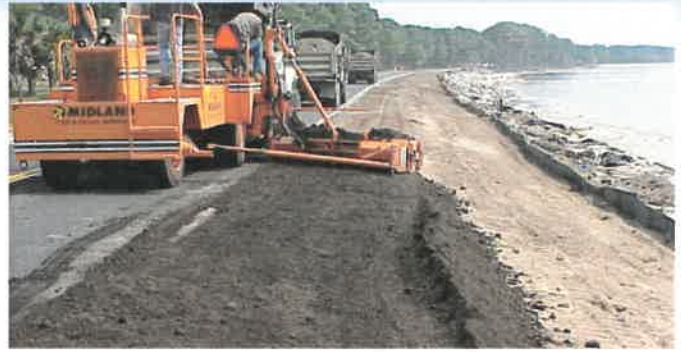
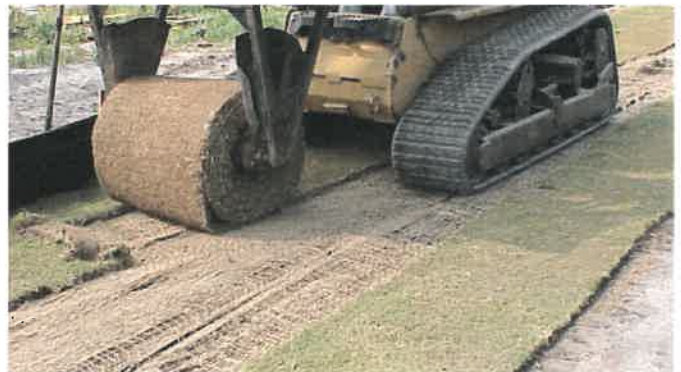
The shoulder of Highway 98, over 8 months after the application, is still stabilized and has held up to the extreme weather conditions of the Florida coast.

Over one year later, in August 2006, the soft armoring technique is still performing well, requiring little maintenance and successfully mitigating coastal erosion. The application sustained two major storm events, a category 1 hurricane as well as a tropical depression, with total survival of the road. This single application had added savings to FDOT because it prevented the road from having to be rebuilt or repaired after these storms.

Over time, the jute blanket has biodegraded and the sod vegetation has continued to establish root structure into the underlying topsoil. The shoulder areas along US Highway 98 are so well stabilized that they can now be used as access to the waterfront without fear of erosion. The level of performance of this type of soft armor application far surpassed the expectations of FDOT.
