**APPENDIX 10.7**

**MONITORING PROGRAMS**

# Cultural Resource Assessment Survey of the Duke Energy 2018 CC Parcel Citrus County, Florida

**Report Title:** Site Characterization and Preliminary  
Geotechnical Design Recommendations  
For Citrus County Combined Cycle Project  
Crystal River, Florida

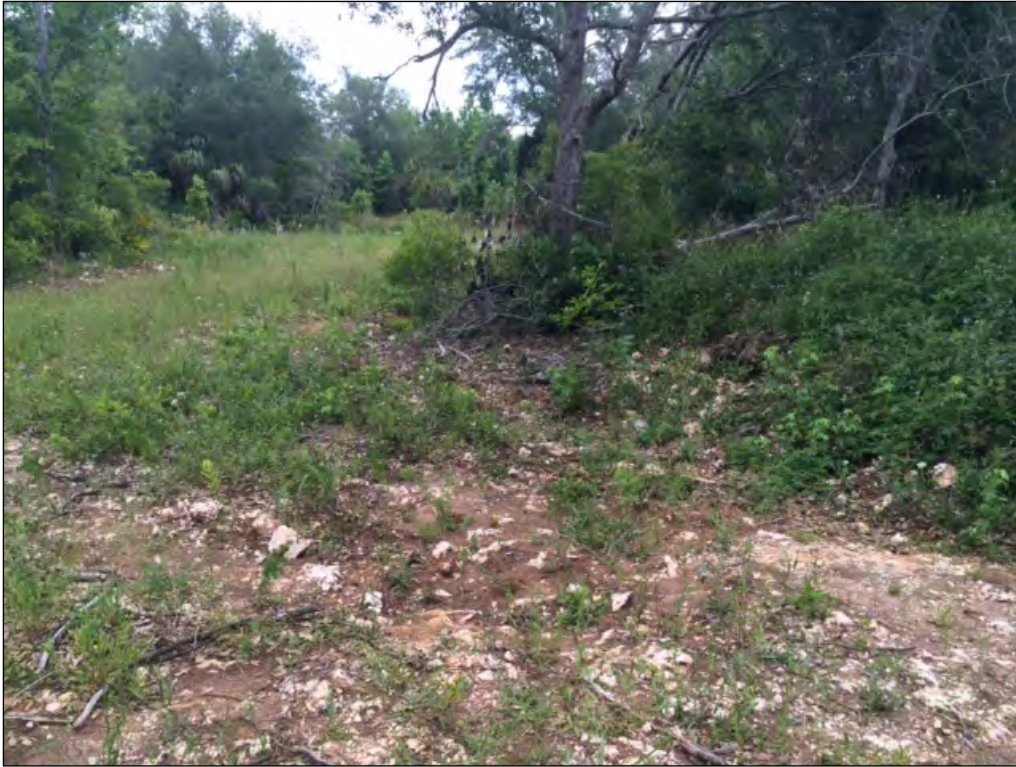
**Figure 2.5. Rock outcrop in the central portion of the DEF 2018 CC project area at ST 108.**

Much of the property has been modified by land-clearing activities. Undisturbed land within the project tract includes discrete areas comprised of native flatwoods (pine, palmetto) vegetation. The tract also includes multiple wetlands containing cypress, bay, and sweet gum, which appear to be largely unmodified. The understory varies and is characterized by scrub palmetto in the dryer portions of the project area and gallberry in the wetter zones. Limestone formations are visible on the surface in several areas. **Figures 2.3 through 2.6** depict representative views of current vegetation and activities within the project area.

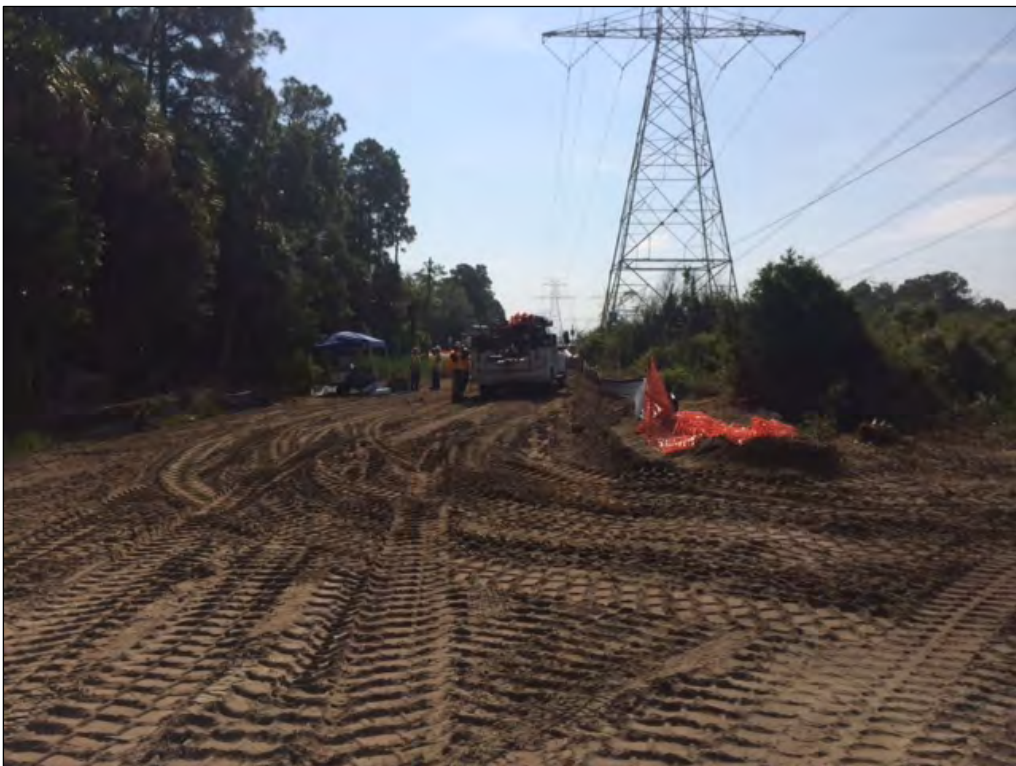
**Figure 2.6. Activities within the transmission line on the DEF 2018 CC project area.**

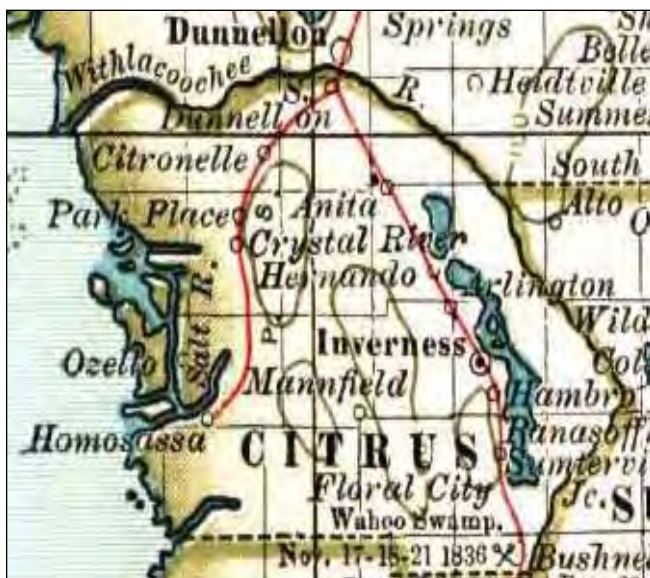
**Figure 3.2.** 1897 Century Atlas map showing the former SSO&G Railroad corridor taken over by the Plant System (red lines) in Citrus County. Source: Florida Center for Instructional Technology, University of South Florida.

through the county seat of Inverness before reaching the junction point of Pemberton in Hernando County. The SSO&G provided freight, passenger, and mail service to several Citrus County communities along the railroad corridor (Dunn 1977:30, 71). By the late 1890s, the SSO&G had been consolidated into Henry B. Plant's sprawling transportation network of railroads and steamboats known as the Plant System (**Figure 3.2**). In 1902, the Atlantic Coast Line acquired the Plant System and operated its railroads through Citrus County.

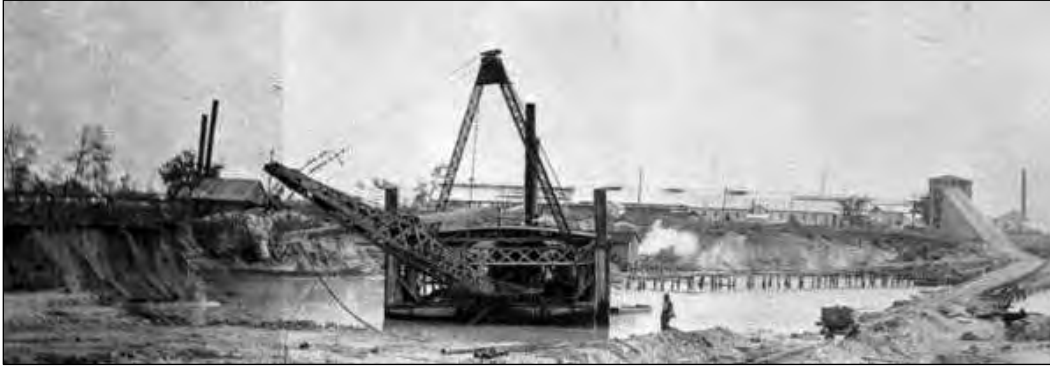
**Figure 3.6. Photograph depicting phosphate mining ca. 1910 in Citrus County with dredging machinery operated by Bradley Phosphate Company. Source: Florida Center for Instructional Technology, University of South Florida.**

This discovery coincided with similar finds around Hawthorne in Alachua County and around the Peace River in Polk and Hardee Counties. Recognizing the value of the mineral, Vogt bought up large tracts of land in eastern Citrus County, which he later sold to the phosphate tycoon John C. Dunn (Dunn 1977:117, 131). Phosphate mining became an important industry in the county, attracting new workers and residents into the area (**Figure 3.6**). By the early 1900s, much of the phosphate was exported to Europe. With the beginning of World War I, however, European demand for phosphate dried up, leading to the demise of the industry in Citrus County and a subsequent decline in population.

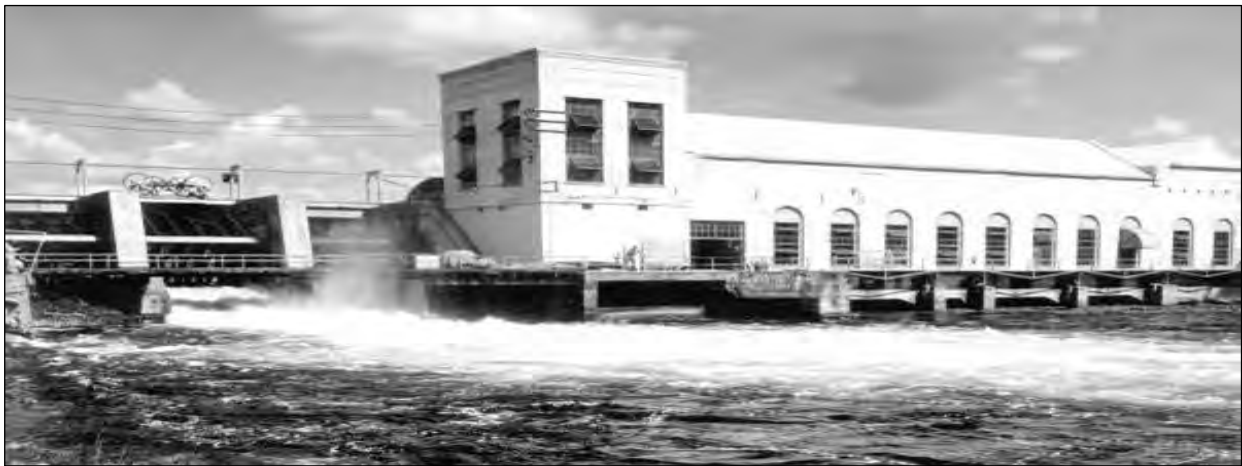
**Figure 3.8. 1955 photograph of the Dunnellon Dam and Hydro-Electric Power Plant.**  
Source: Florida Center for Instructional Technology, University of South Florida.

In 1926, the dam and property were acquired by the Florida Power Corporation. The new company upgraded the power-generating capabilities of the dam by installing three additional generating units to augment the original two (Dunn 1977:166–167). At the time, the power plant was the largest hydroelectric facility in Florida (**Figure 3.8**), providing service to Citrus, Marion, Sumter, Hernando, Pasco, and Pinellas Counties (Garnault 1925:37–45). The hydroelectric plant remained in operation until 1963, when Florida Power donated the dam and

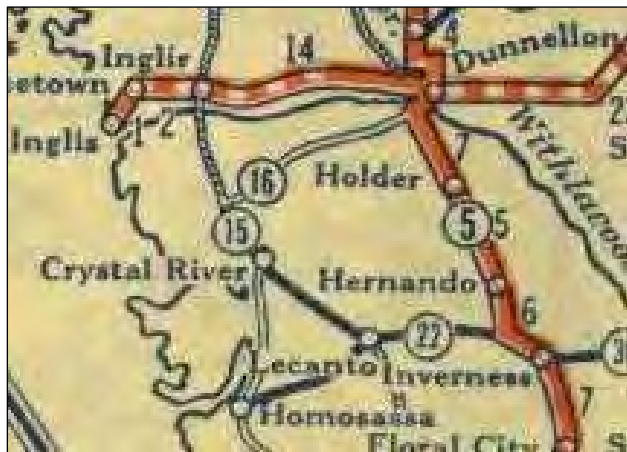
**Figure 3.9. Rand McNally Auto Map showing the state of Citrus County’s road development in 1927.**

Another infrastructural change welcomed by all throughout the county was a newly improved highway. In 1914, Citrus County had only one stretch of highway that could be considered, as one driver put it, “magnificent.” The segment stretched from Holder south to Floral City along present-day US 41 (Dunn 1977:226). Most of the secondary roads in Citrus County at that time were still in a poor or unimproved state, consisting mostly of sand. As late as 1925, State Highway 15 (present-day US 19 and US 98) from Inglis south through Red Level to Crystal River

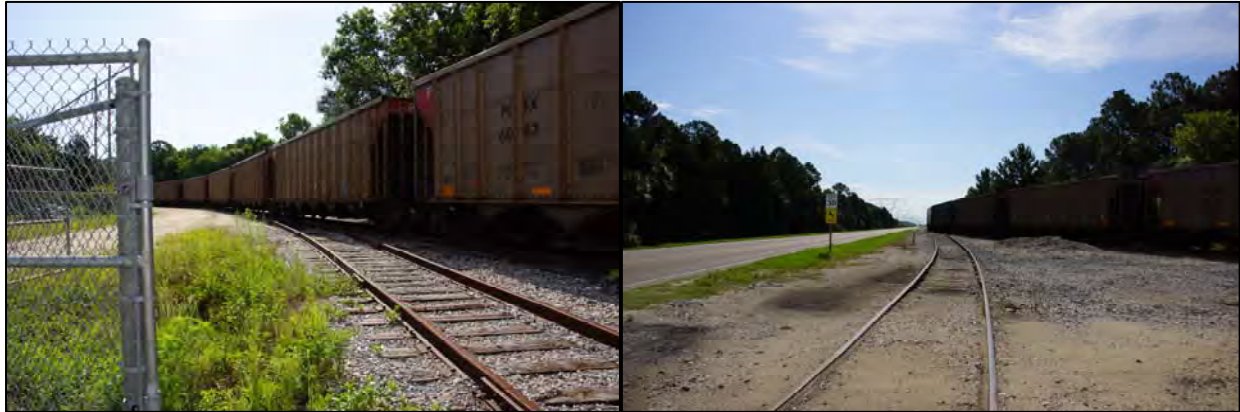
**Figure 5.4. Views of resource 8CI01455. Left: View northeast along the loop at the western end of the spur line; right: View east along West Powerline Street on the south parcel boundary.**

*Florida's Historic Railroad Resources*, the NRHP Multiple Property Nomination form, was used as a guide to evaluate 8CI01455 (Johnston and Mattick 2001). To be eligible for listing in the NRHP, Florida's roadbeds must have served a historic railroad transportation function and have been constructed during one of Florida's historic railroad periods. NRHP eligibility must also be supported by association with an important local historical event or person. Additionally, the railroad must retain its original appearance to a high degree (Johnston and Mattick 2001:67).

8CI01455 was built as a spur line solely to provide access to the Crystal River Nuclear Plant, never functioned as a major transportation corridor, and it was constructed during the mid-twentieth century, which is not considered a historic Florida railroad period (Johnston and Mattick 2001:6–10). Furthermore, the development of Resource 8CI01455 lacks association with any local historical event or individual. According to the nomination form, a rail roadbed is an F3 property type (Rail Structure: Roadbed), and would consist of ballast, cross ties, rails, and tie plates (Johnston and Mattick 2001:63), which are not all present in this section of 8CI01455. The section of the line within the current project area has been altered since it was originally constructed including the removal of the original rails and cross ties and the reconfiguration of the line to form a loop. Also, the line was not constructed during one of Florida’s historic railroad periods, and due to the lack of historical association and significance, it is the opinion of the Principal Investigator that this portion of the railroad corridor within the project area be recommended ineligible for listing in the NRHP.

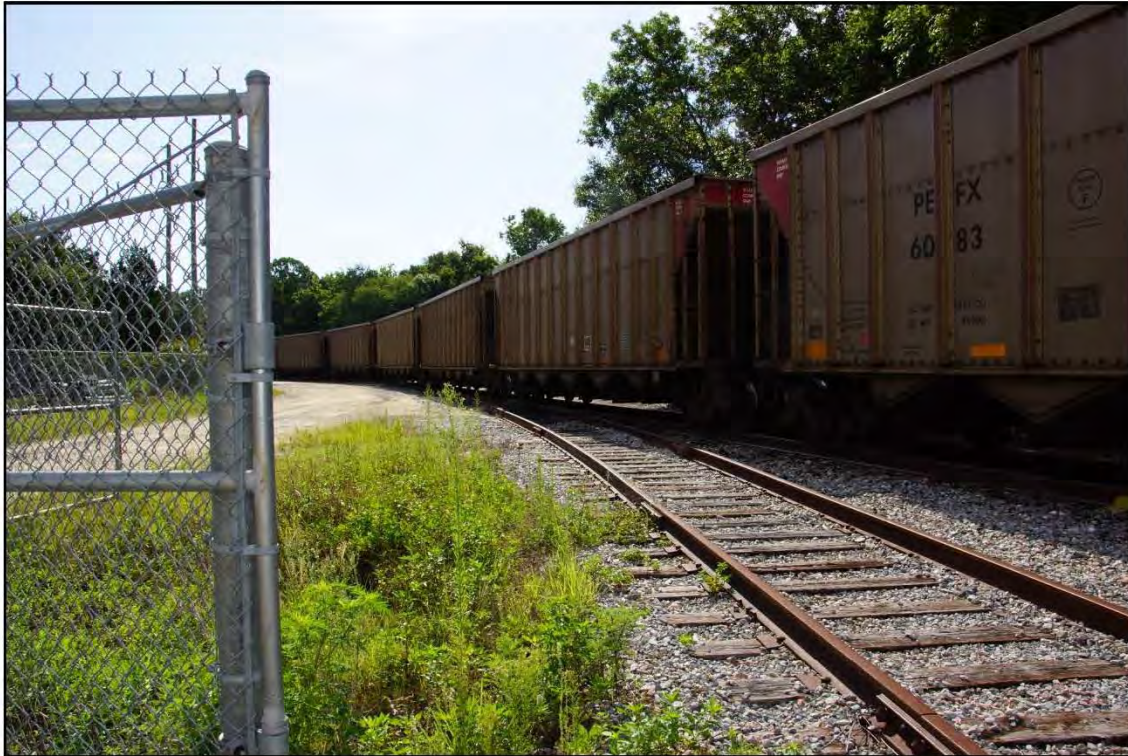
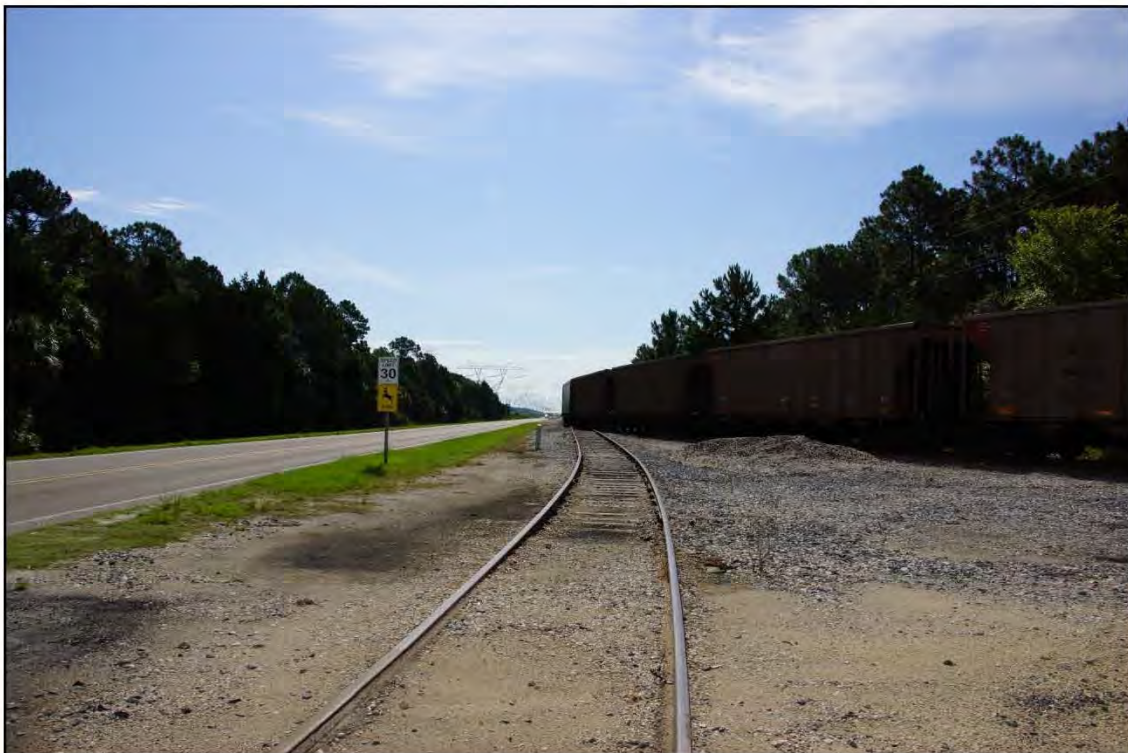
**Views of newly recorded Linear Resource CI01455, Seaboard Coast Line Railroad, within the Duke Energy 2018 CC Survey Area in Citrus County, Florida. Top: View northeast along the loop at the western end of the spur line; bottom: View east along West Powerline Street on the south parcel boundary.**

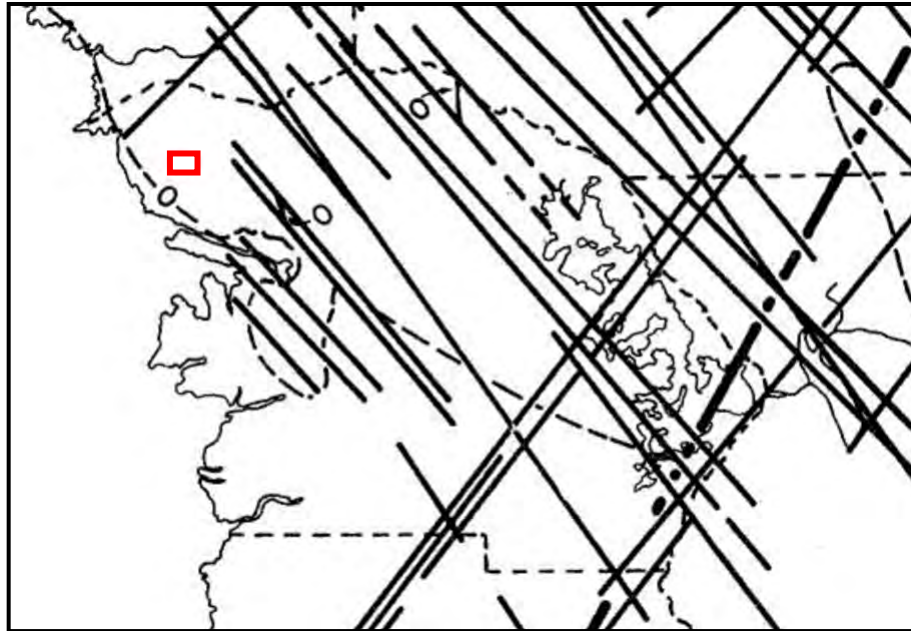
— Joints and possible faulting  
 - - - Contour of the Inglis mbr. over the Ocala Uplift  
 D Possible Post-Paleozoic graben fault  
 U boundary (after Paul Applin)

Fracture Pattern of the Northern Portion of the Florida Peninsula  
 Taken from: Geology of Citrus and Levy Counties, Florida by R. O. Vernon  
 Published by Florida Geological Survey, 1951

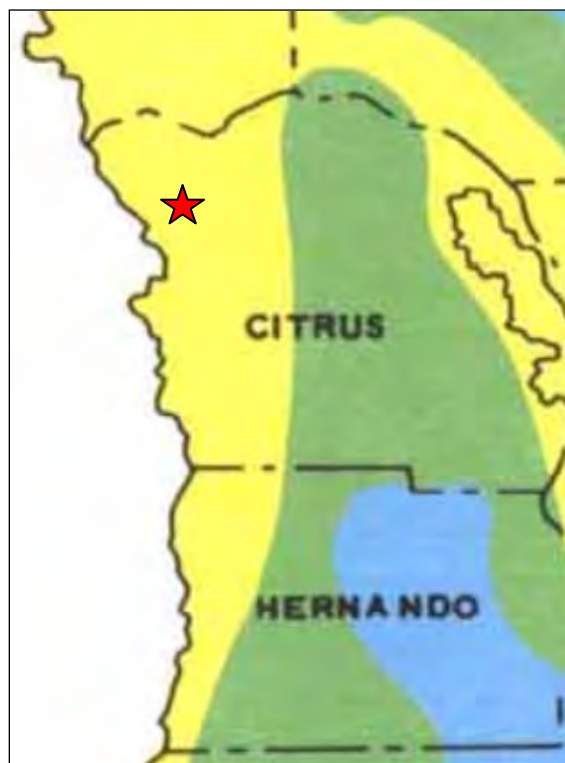
- AREA I. BARE OR THINLY COVERED LIMESTONE**  
Sinkholes are few, generally shallow and broad and develop gradually. Solution sinkholes dominate
- AREA II. COVER IS 30 - 200 FEET THICK**  
Consists mainly incohesive and permeable sand. Sinkholes are few, shallow of small diameter and develop gradually. Cover-subsidence sinkholes dominate
- AREA III. COVER IS 30 - 200 FEET THICK**  
Consists mainly cohesive clayey sediments of low permeability. Sinkholes are most numerous, of varying size, and develop abruptly. Cover-collapse sinkholes dominate
- AREA IV. COVER IS MORE THAN 200 FEET THICK**  
Consists of cohesive sediments interlayered with discontinuous carbonate beds. Sinkholes are very few, but several large-diameter, deep sinkholes occur. Cover-collapse sinkholes dominate

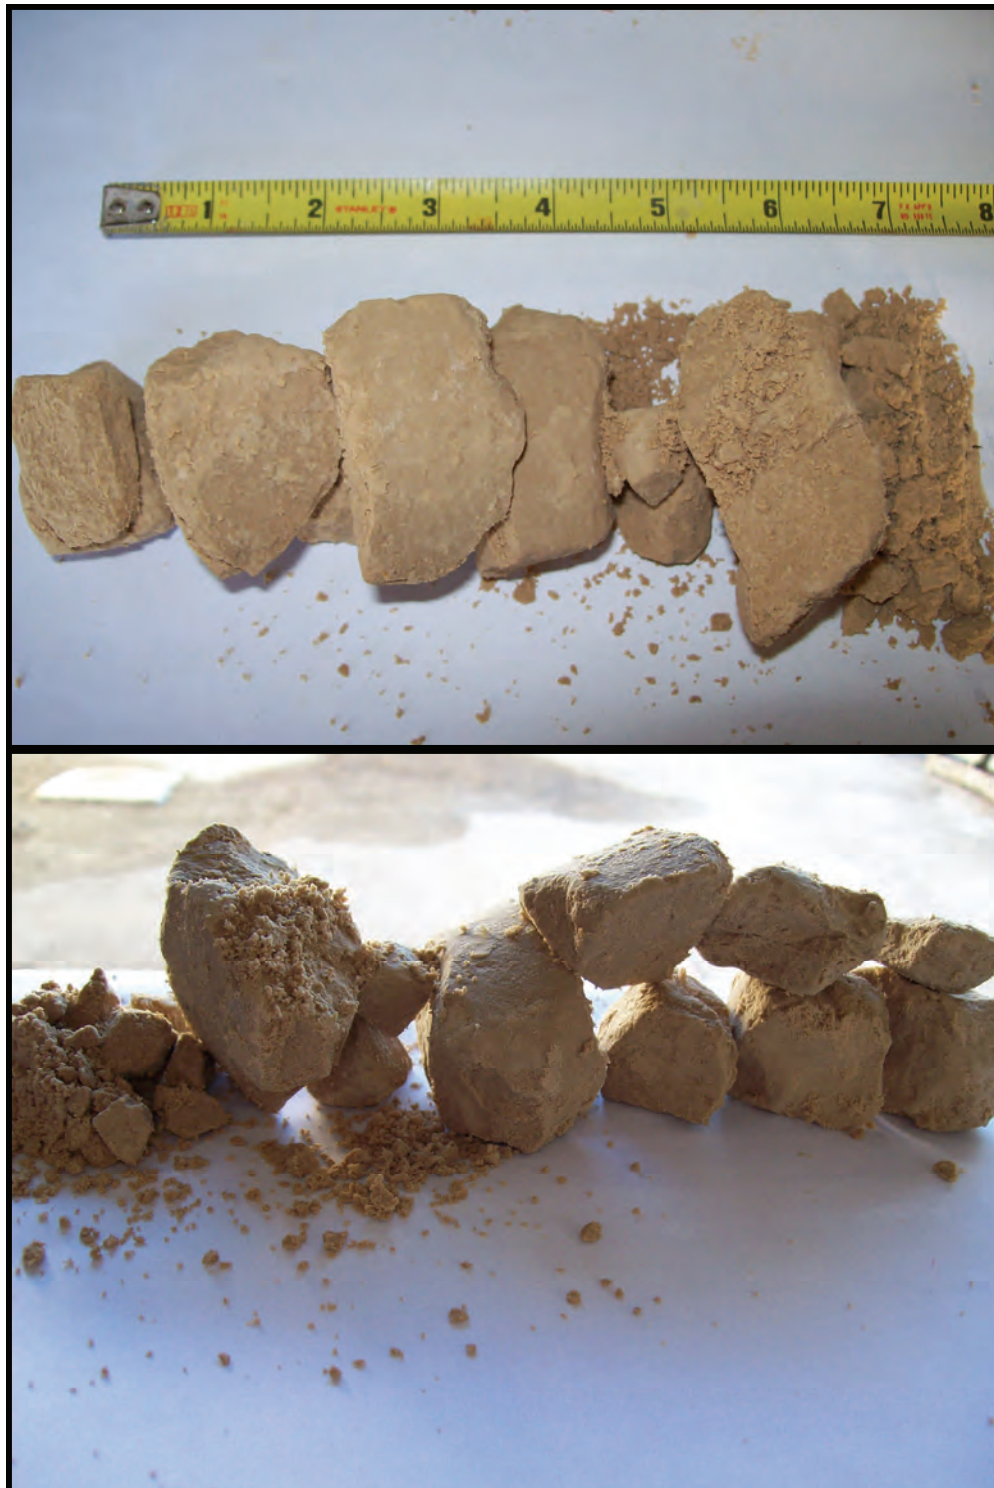
**Photograph #1: Limestone Core RC-1, Boring B-19.**  
**Core Length Attempted: 6-in; Recovery: 4-in**  
**Consistency: Very dense (SPT N = 50/4" and 50/3" for the spoons above and below RC-1),**  
**but friable LIMESTONE**

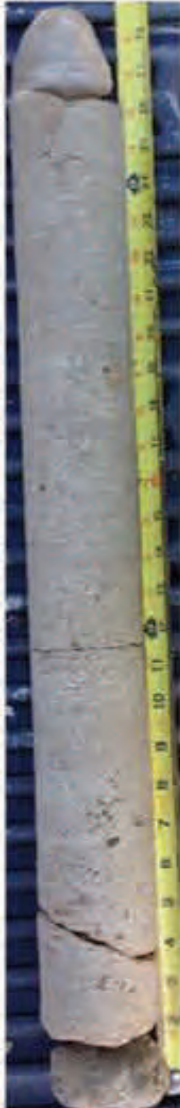
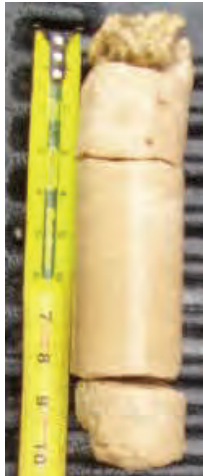
| | B-04 RC5<br>62.5 to 64.5 ft | B-04 RC6<br>65 to 70 ft | B-05 RC1<br>24 to 29 ft |
| Attempted | 24-in | 60-in | 60-in |

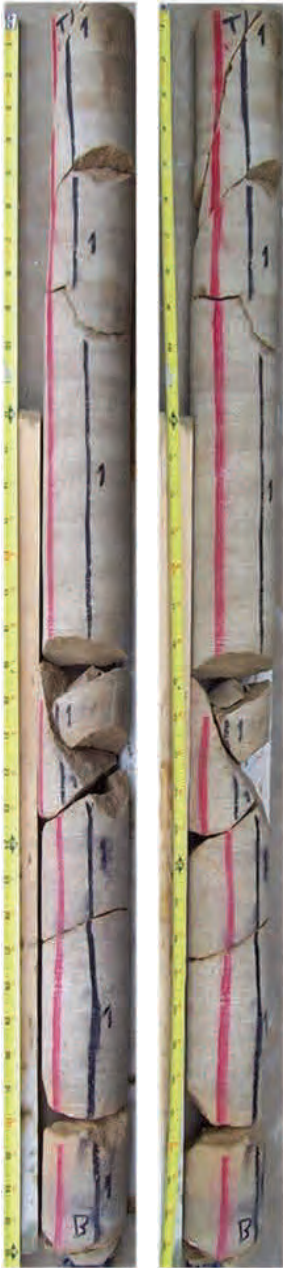
| | B-09 RC1<br>62 to 67 ft | B-09 RC2<br>67 to 69.8 ft | B-09 RC3<br>70 to 73 ft |
| Attempted | 60-in | 32-in | 36-in |

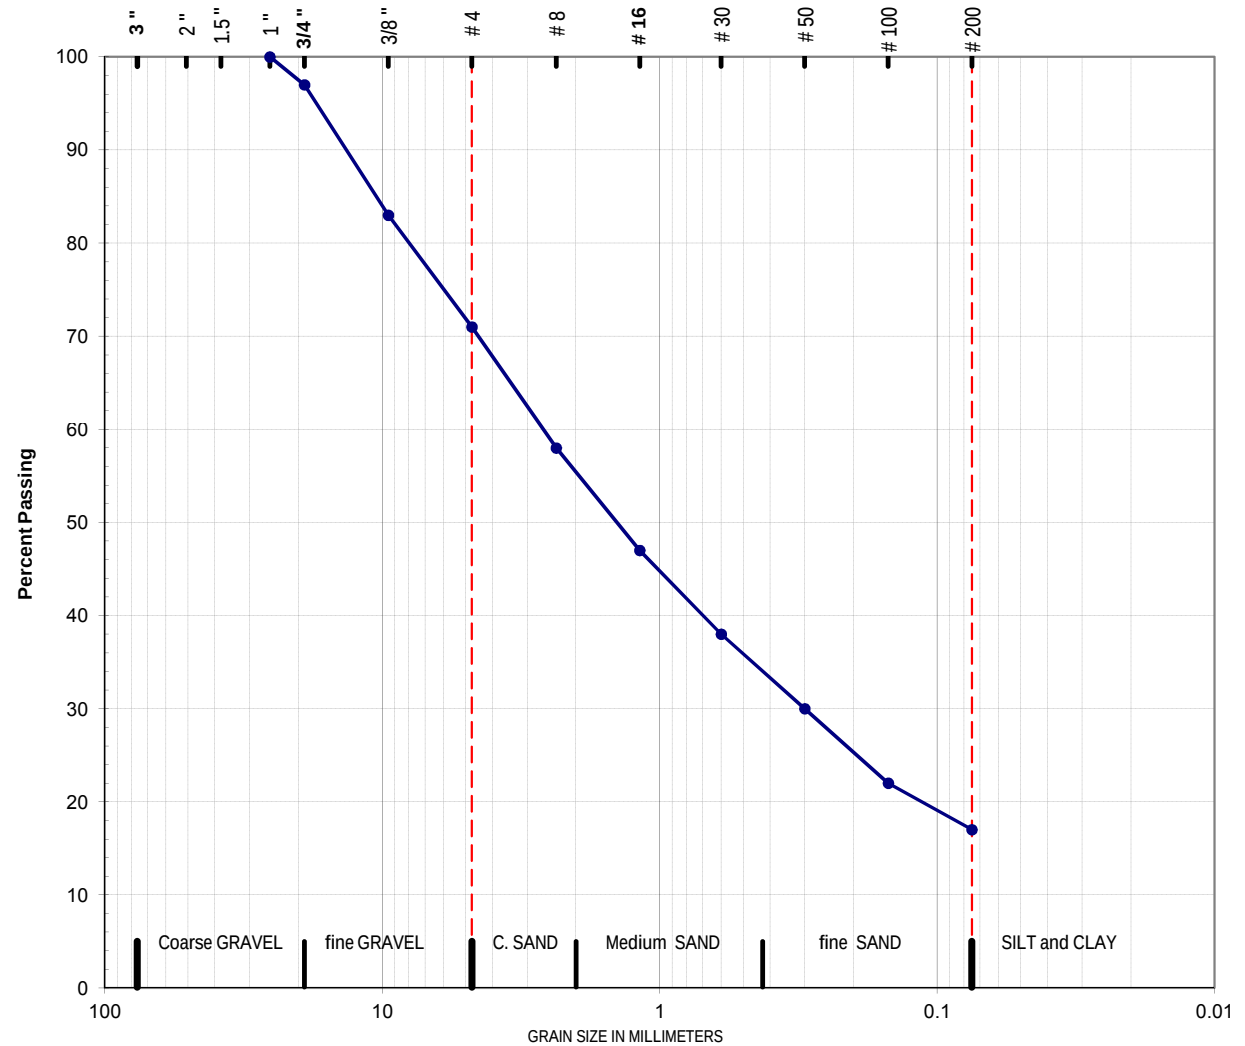
Bore Hole #: B-19 Sample ID SS3 Depth (ft) 4.0 USCS:  
 Description: Pale yellowish brown LIMESTONE, sand to gravel-grained size % Moisture: 16.4  
 Date Tested: 11/7/13

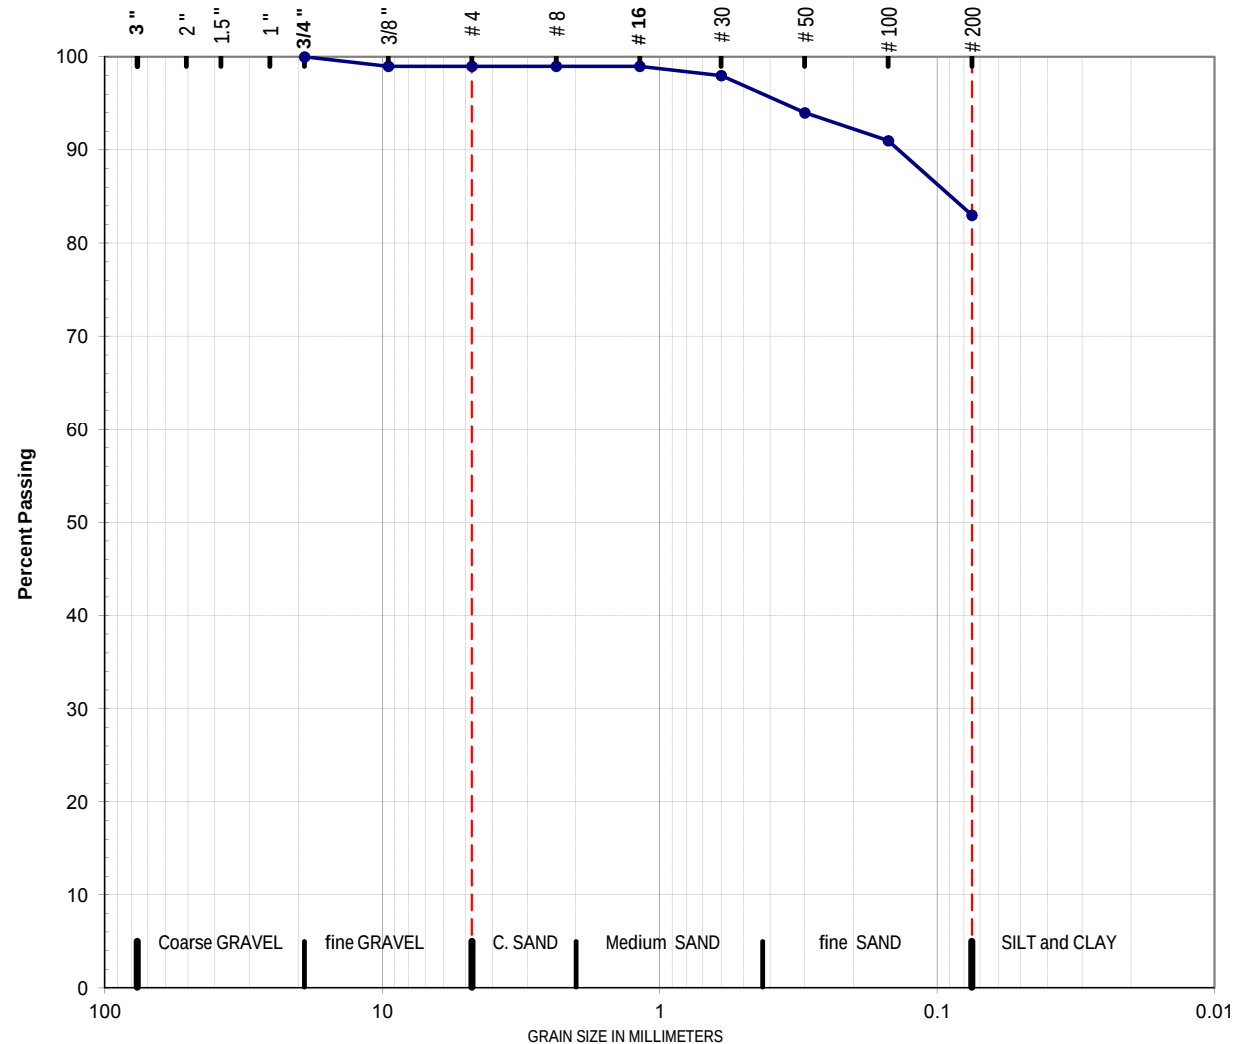
Bore Hole #: B-19 Sample ID RC1 Depth (ft) 15.0 USCS:  
 Description: Pale brown LIMESTONE, silt-grained size, friable % Moisture: 11.0  
 Date Tested: 11/7/13

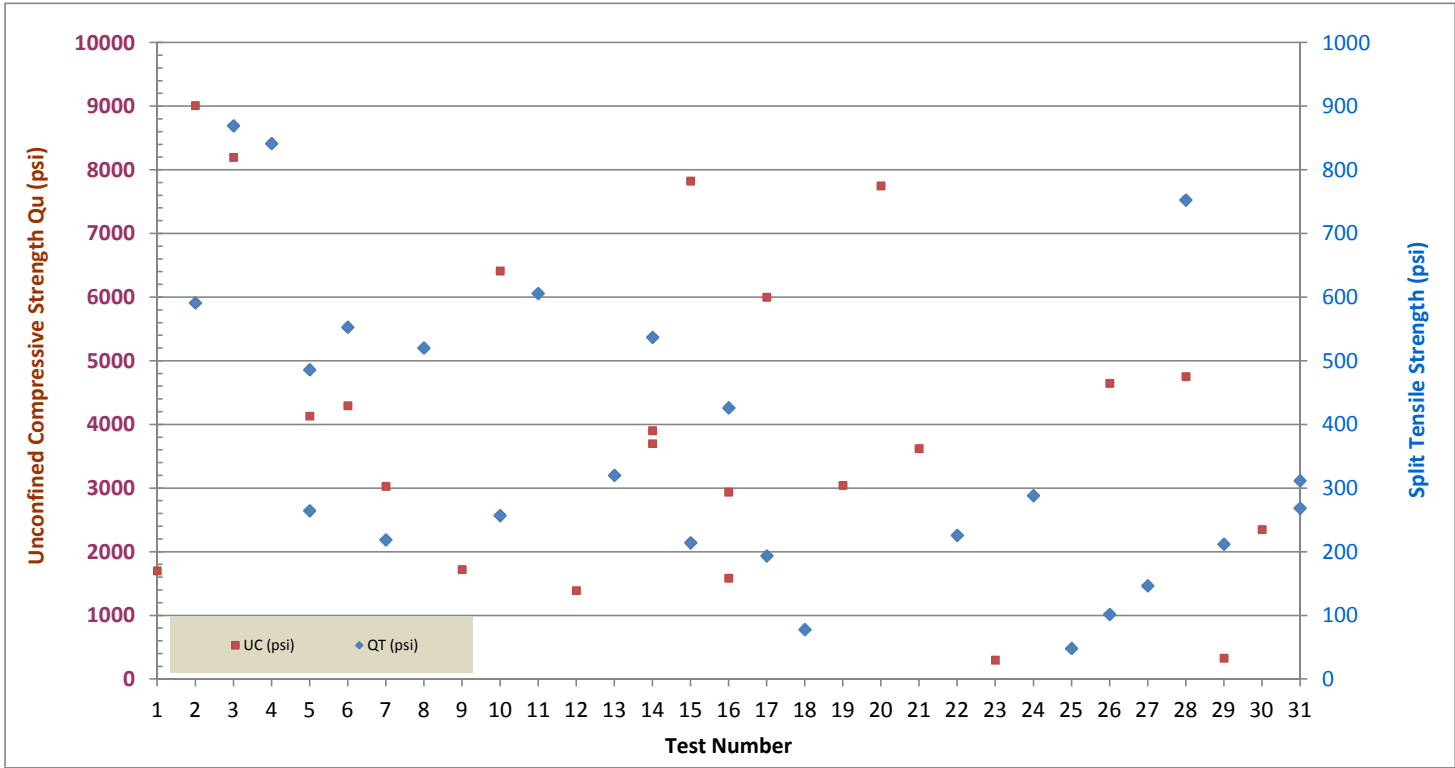
LIMESTONE LABORATORY TEST RESULTS

- \* Unconfined Compressive Strength of Rock Cores (ASTM D 7012)
- \* Split Tensile Testing of Rock Cores (ASTM D 3967)
