# Summary of Results

## **Walk the WBID Exercise for Gottfried Creek (WBID 2049)**

**September 2015**

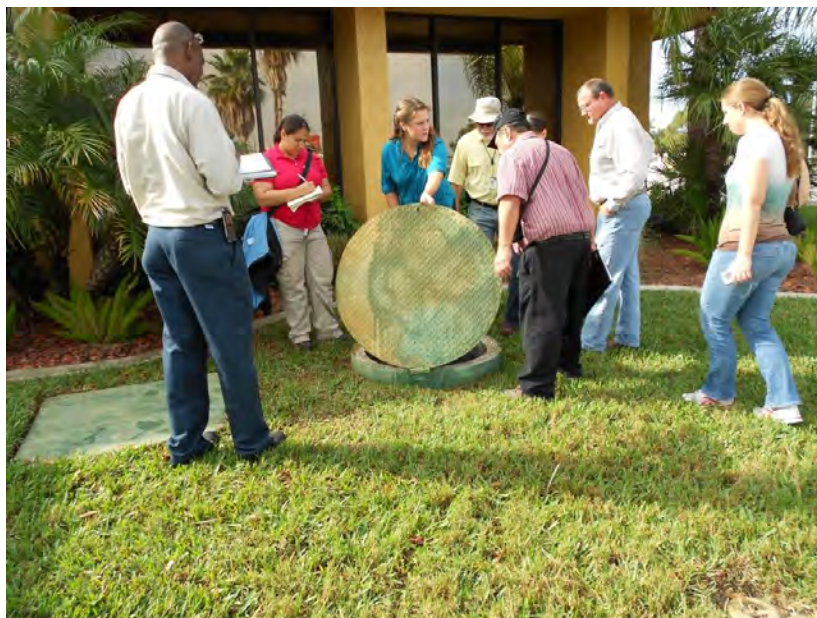
**Figure 2. Private Lift Station – Provision Eye Center.**

WTW Team inspecting lift station.

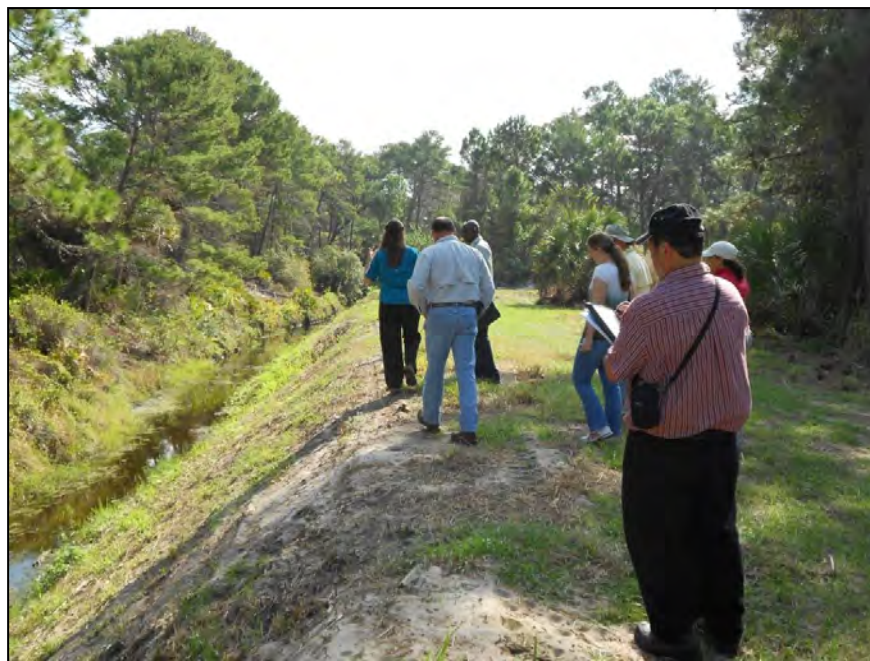
**Figure 6. WTW Team inspecting open stormwater canal.**

Canal is well maintained, open to UV light, and flows at low velocity except during significant rainfall events. No action item was necessary.

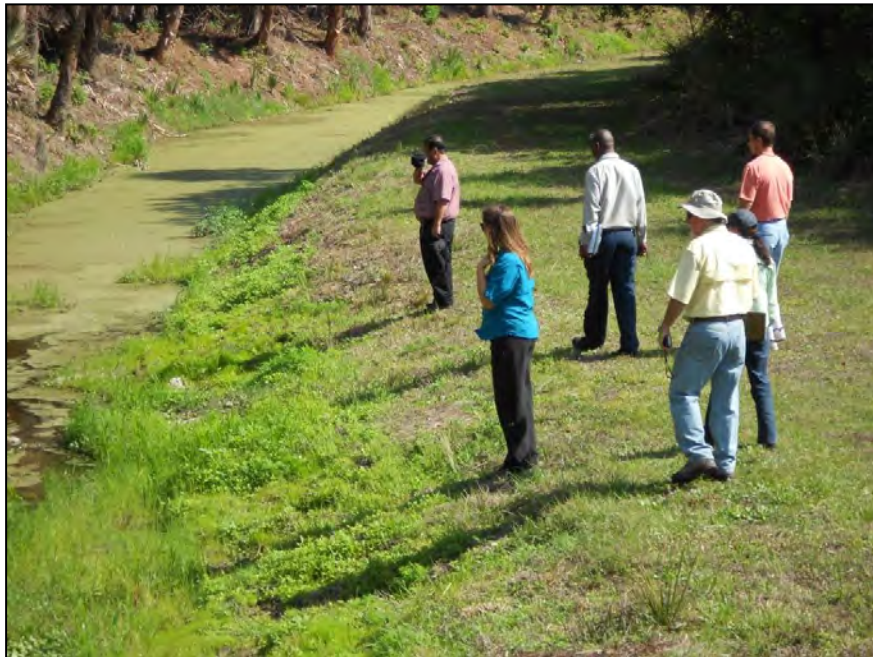
**Figure 12. WTW Team Inspecting Englewood Lateral.**

The community, previously serviced by a package plant, was connected to the EWD central sanitary sewer system in 2001. No issues were observed. No action item was necessary.

- Figures 15, 20, 21, 22, 26, 47, 48, 50, 56, 66, 67, and 68 show evidence of wildlife in close proximity to the Gottfried Creek watercourse, including: raccoon prints, waterfowl, feral hogs, and feces.
- Bacterial re-growth is probable in ditches and natural watercourses given the sediments observed. See Figures 18, 20, 21, 22, 25, 64, 66, 69, 70, and 71.
- Natural canopy cover is not a contributor, but does prevent UV rays from reaching the water column. UV rays kill pathogens and fecal coliforms. See Figures 23, 25, 31 and 32.
- Natural tannins from decomposing plant material in the water also shade out UV rays. See Figures 10, 11, 12, 16, 23, 25, and 32.

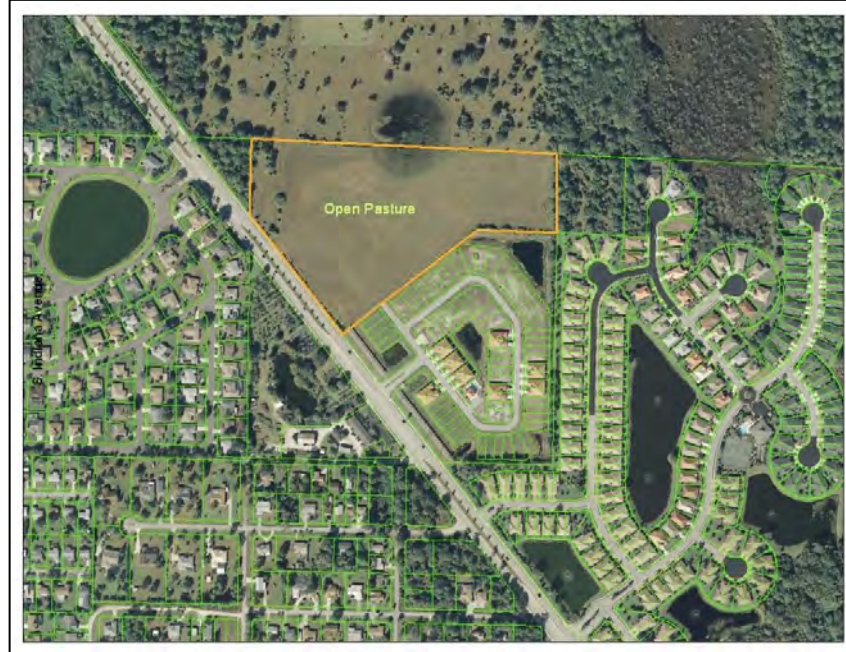
**Figure 13. Open Pasture – N. Indiana Avenue – Aerial View.**

No cattle present; cattle routinely rotated to other pastures; property bermed; no cow patties observed.  
Action Item: Determine if runoff flows to Gottfried Creek.

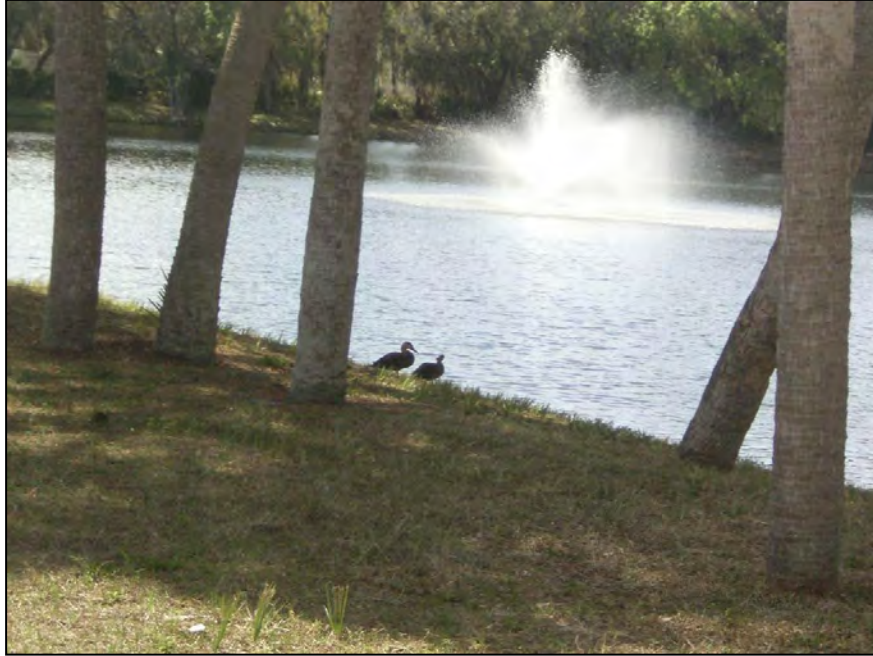
**Figure 15. Foxwood Stormwater Pond.**

Ducks and wading birds observed in and around pond.

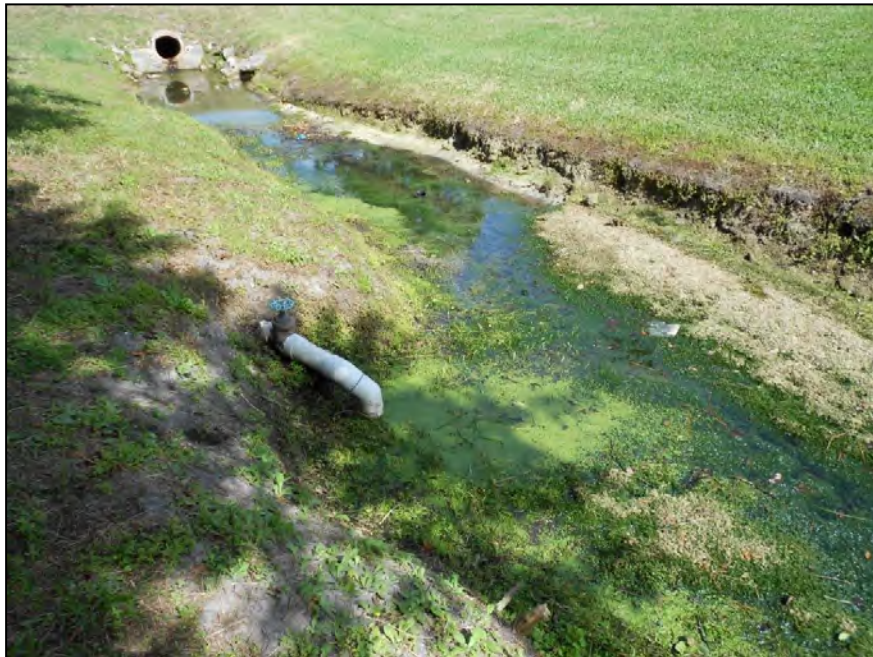
**Figure 16. Foxwood Stormwater Ditch – View Toward Upstream.**

The stormwater pond overflows into the ditch; irrigation pipes observed (foreground).

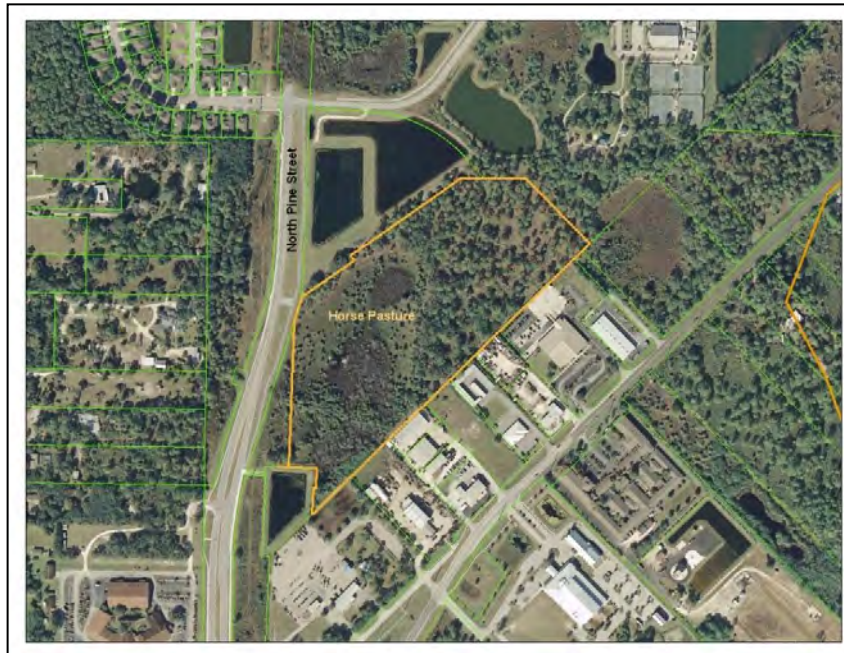
**Figure 36. Horse Pasture on North Pine Street – Aerial View.**

Improper manure disposal could impact Gottfried Creek.  
Action Item: Determine if runoff could flow to the creek.

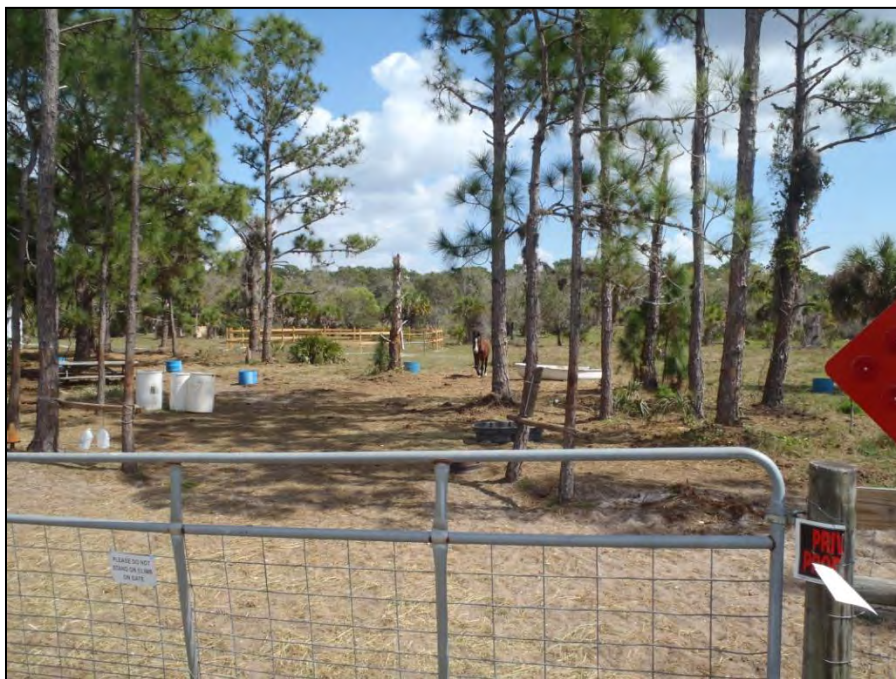
**Figure 37. Horse Pasture on North Pine Street.**

Overview of Pasture – View to East

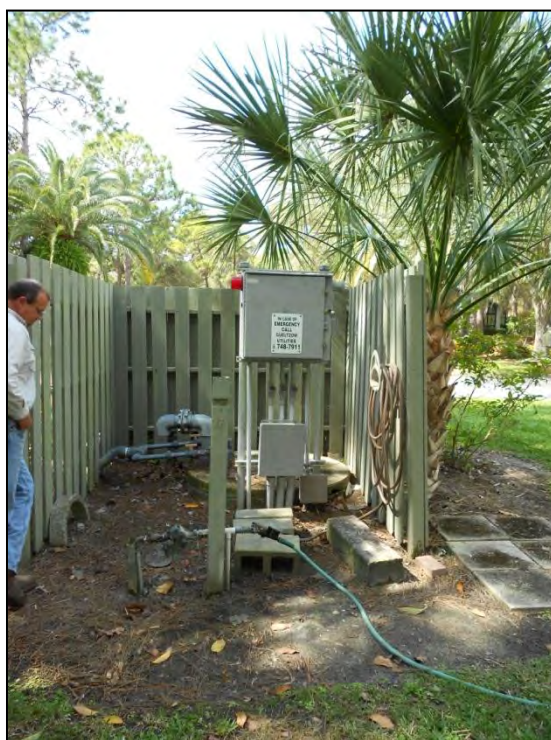
**Figure 44. Gasparilla Condominium – Private Lift Station.**

No Violations Noted.

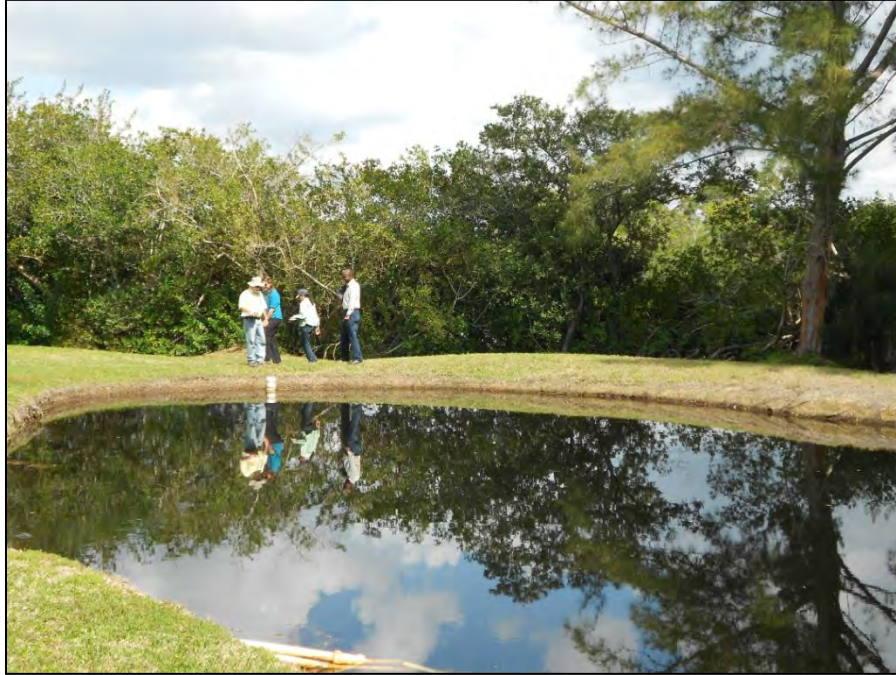
**Figure 45. Gasparilla Condominium Stormwater Pond.**

WTW Team Inspecting Berm Around Pond.

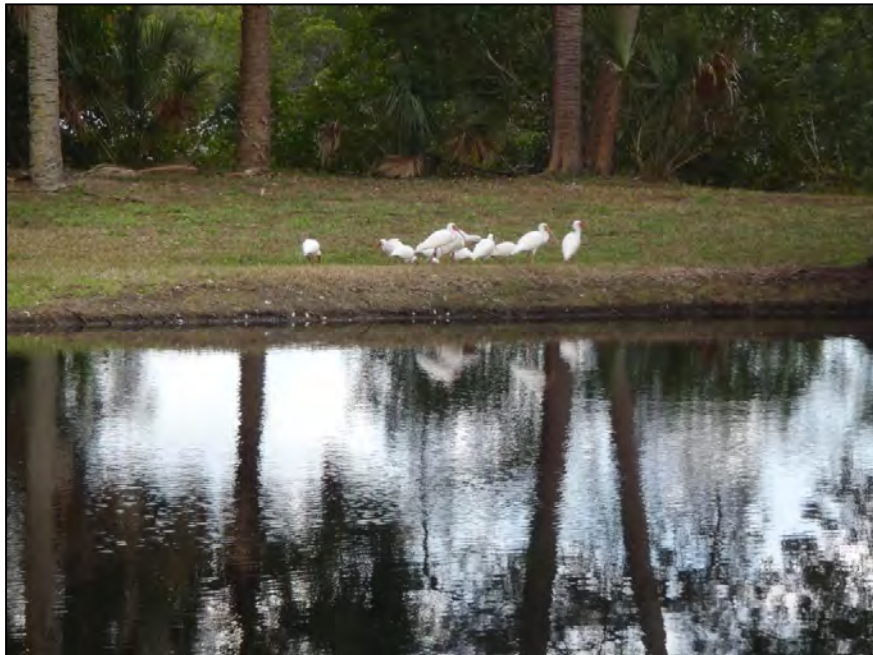
***Figure 48. Gasparilla Condominium Stormwater Pond.***

Flock of White Ibis on Pond Berm  
No issues observed. No Action Item necessary.

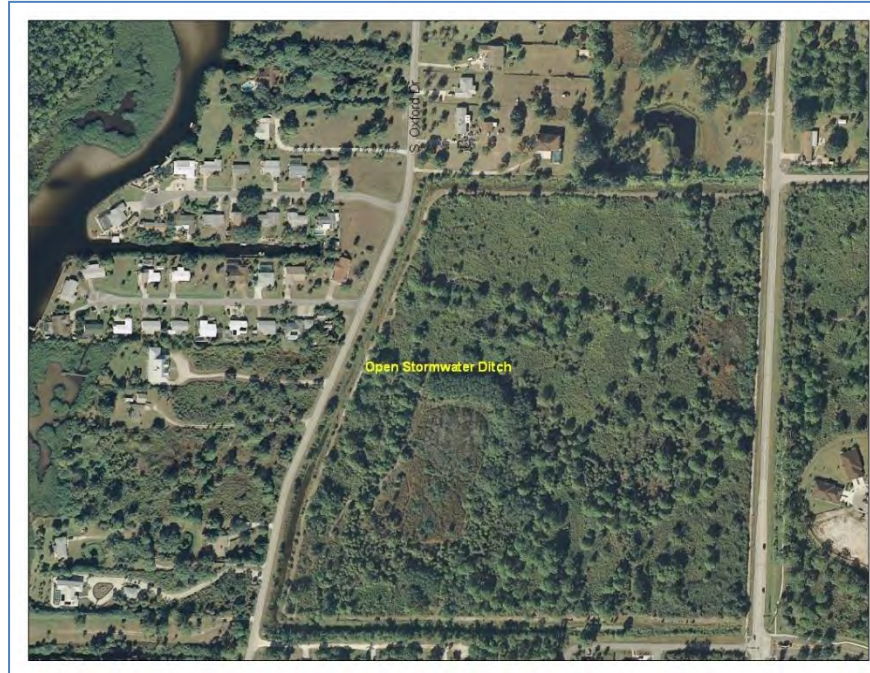
**Figure 49. South Oxford Stormwater Ditch.**

Ditch runs parallel to S. Oxford then flows west to Gottfried Creek

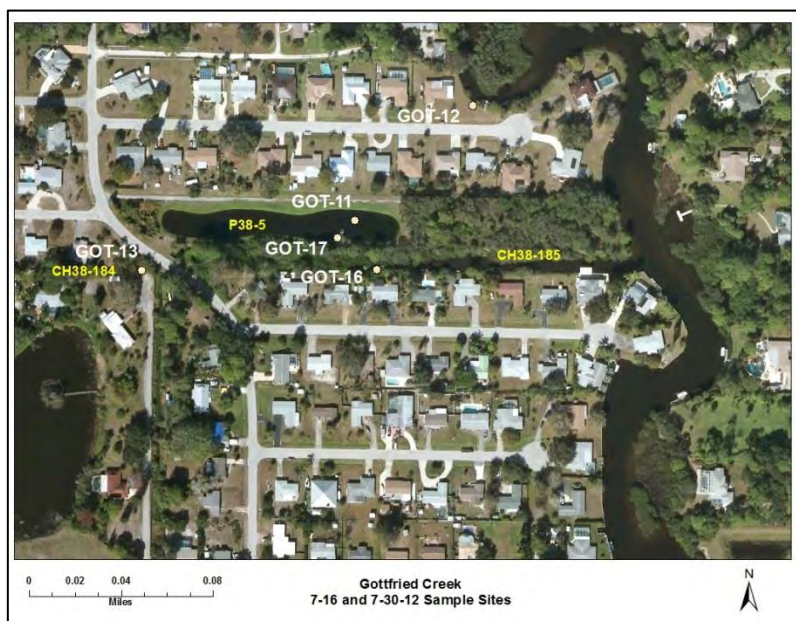
**Figure 101. Gottfried Creek Sample Sites 7-16 and 7-30-2012.**

Figures 98-107 include photos of the sample site location. The water level in the pond (Figure 101) was low and aquatic vegetation, including hydrilla, an exotic invasive aquatic plant, had almost completely overtaken the pond bottom. The surface was covered with duck weed, which is indicative of high nutrient low flow conditions. A number of wading birds that included 2 Great Blue Herons, 1 Little Blue Herons, 2 Glossy Ibis, and 12 (4 adults and 8 juveniles) moorhens inhabited the pond. No alligators or other wildlife were observed. Sample GOT-12 was taken directly from the creek (Figure 107) upstream of the volunteer station. The water level in the ditch (Figure 98) was very, and there was little flow. The west end of the canal is completely shaded and overgrown with heavy, entangled vegetation that consists mostly of Brazilian Pepper. A resident also reported that the canal was home to a large alligator that could be a contributor by stirring up bacteria laden sediments.

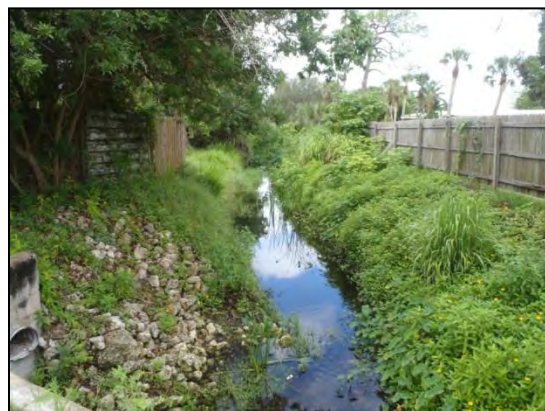
**Figure 102. Stormwater Ditch DP38-184.**

Sample Site GOT-13
