# Summary of Results

## Walk the Waterbody Exercise for Hopkins Creek (WBID 2266)

***Florida Department of Environmental Protection  
Division of Environmental Assessment and Restoration  
Bureau of Watershed Restoration  
Tallahassee, FL 32399***

**August 2011**

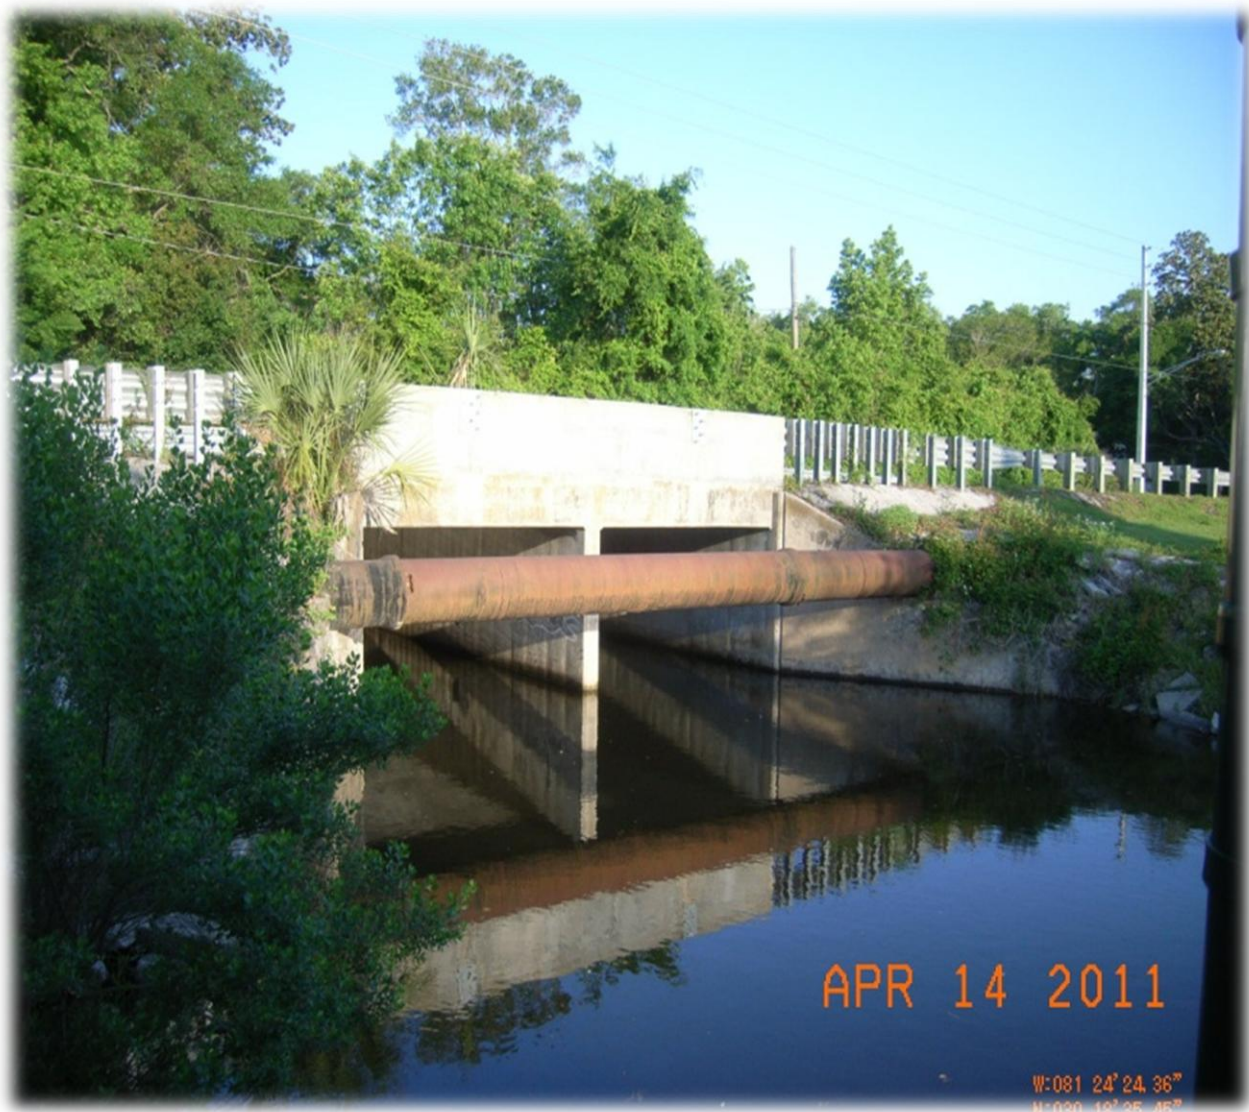
**Figure 3. Point 24: Neptune Beach, Penman Rd. (FDOT ditch).**

**FIELD NOTES:** A possible drip witnessed off the WWTP effluent pipe could be from air condensation or a leak. The pipe was thought to belong to the city of Jacksonville Beach, and this needs to be confirmed. Low velocity was observed in the channel.

**POST FIELD NOTES:** Jacksonville Beach followed the field event with an inspection of the pipe and saw no drip from the pipe.

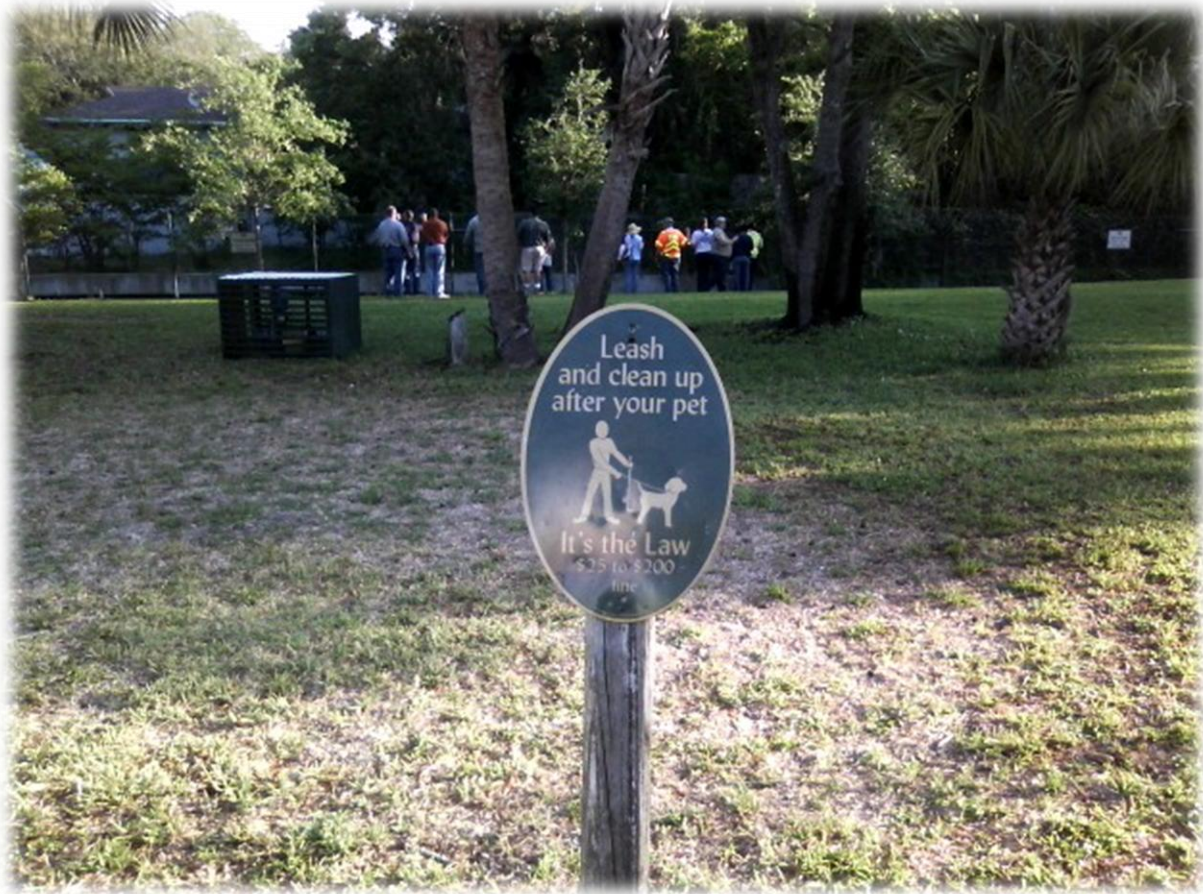
**Figure 4. Point 24: Neptune Beach, Penman Rd. (FDOT ditch).**

**FIELD NOTES:** The team observed dog waste in an irrigation area adjacent to the ditch, and a “clean up after pet” sign was posted next to the playground.

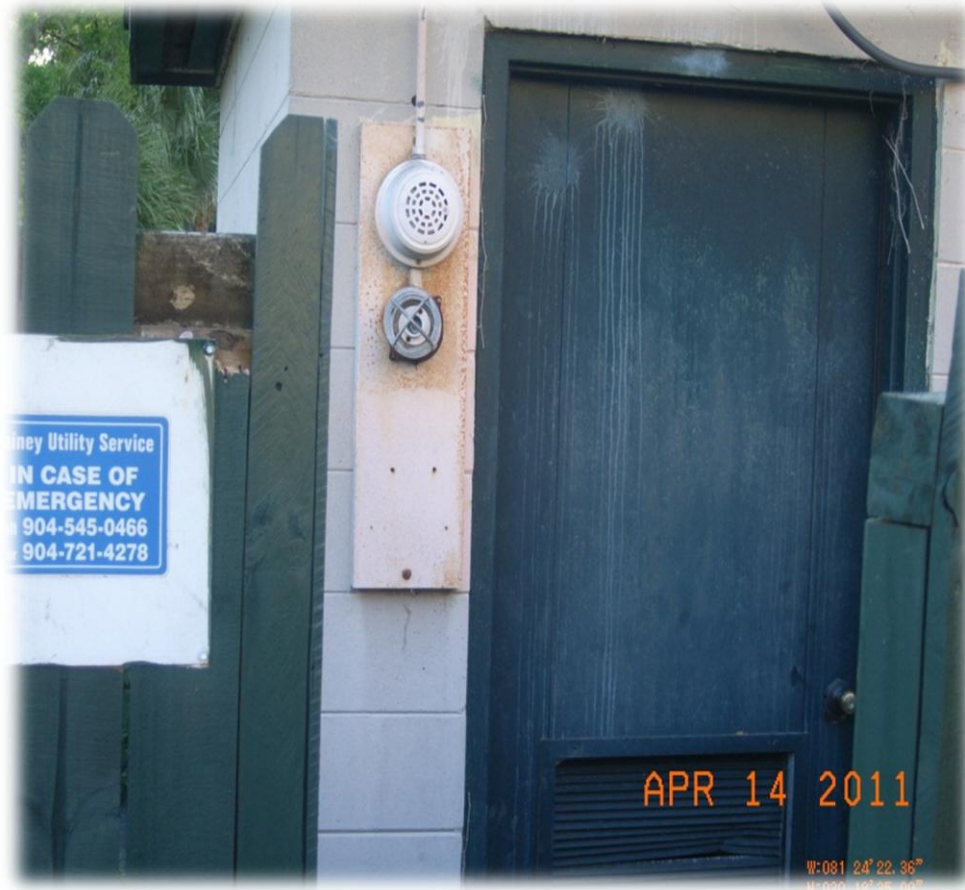
**Figure 5. Point 24: Neptune Beach, Penman Rd. (FDOT ditch).**

**FIELD NOTES:** The private lift station at Ocean Oaks Apartments was missing a warning light. The posted emergency contact was Gainey Utility Service at (904) 545-0466. Neptune Beach will pass this information on to the city of Jacksonville for follow-up. Also, there was no lock on the wet well, a bleach bottle was found next to the irrigation well, and irrigation water was observed landing on the nearby pavement.

**POST-FIELD NOTES:** The City of Jacksonville EQD inspected the lift station on 7-27-11.

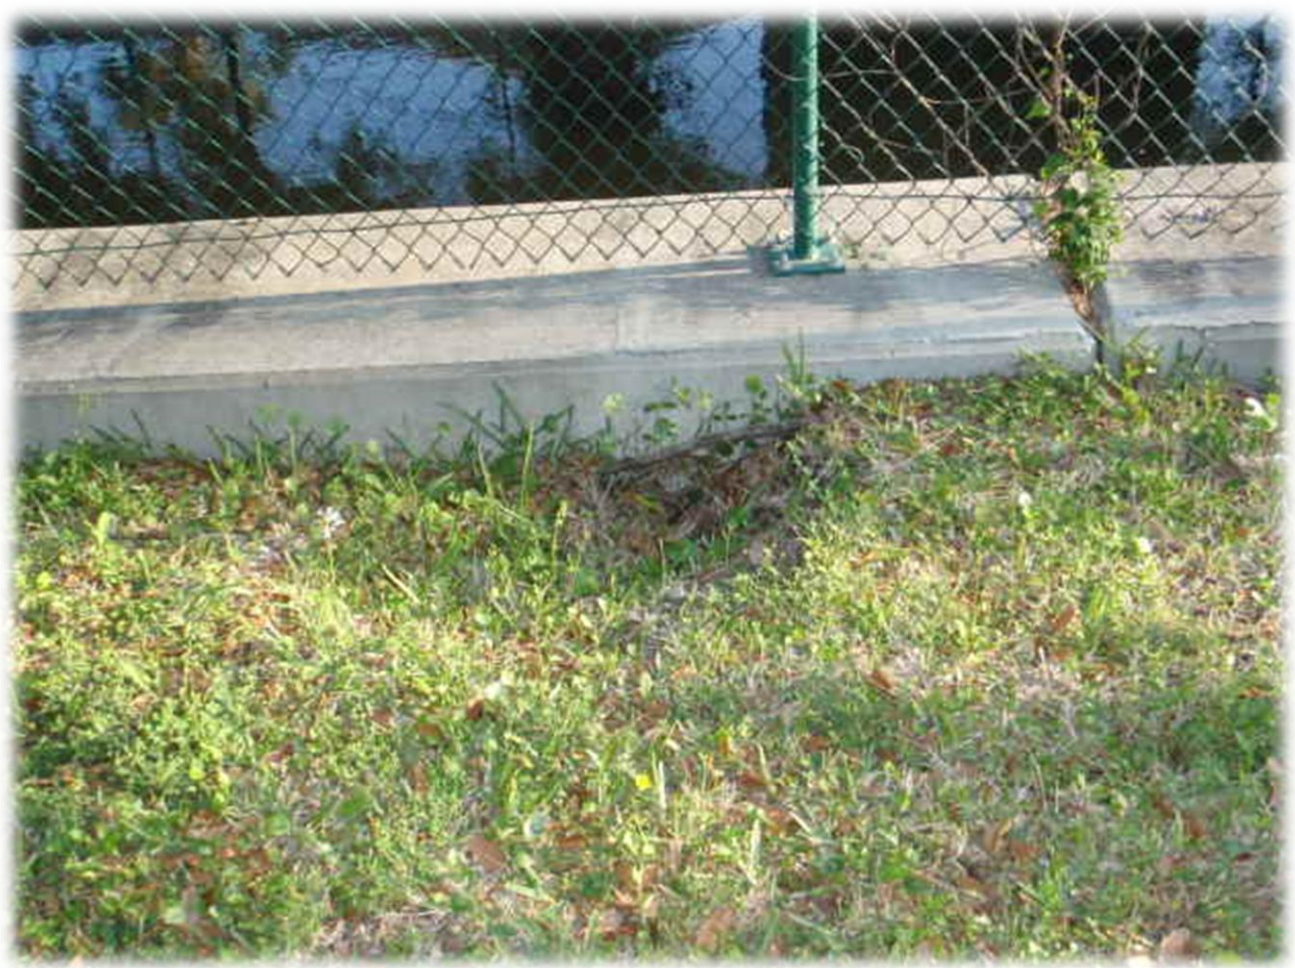
**Figure 7. Point 24: Neptune Beach, Penman Rd. (FDOT ditch).**

**FIELD NOTES:** The team observed erosion at the apartment side of the wall.

**POST-FIELD NOTES:** FDOT contractors August 4<sup>th</sup>, filled the hole and will look at it the area after the next rain. If the hole does not reappear, they will place sod over the dirt.

| Related Figure(s) | Action Item | Entity | Date Initiated/Completed | Outcome |
|---|---|---|---|---|
| 6, 7, 8 | Point 24: Neptune Beach, Penman Rd. (FDOT ditch). Remove vegetation from the fence at this section of the 8th St. Ditch, repair erosion at the apartment side of the wall, weed-eat the area, secure it, and thin the vegetation along the ditch bank to expose the ditch to sunlight. | FDOT contractor | 6- Completed<br>7-Scheduled for Aug 4 <sup>th</sup> , 2011<br>8-Scheduled for end of Aug. 2011. | FDOT has asked its contractors to carry out this work. |

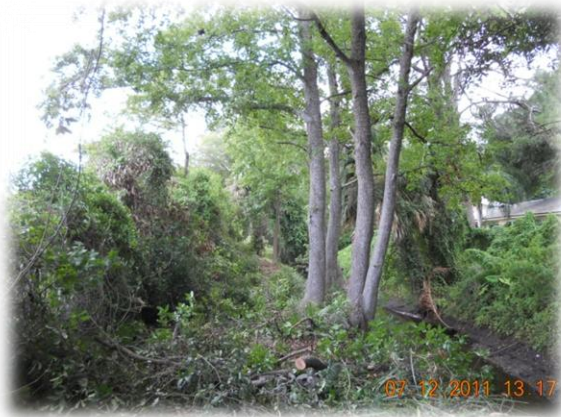
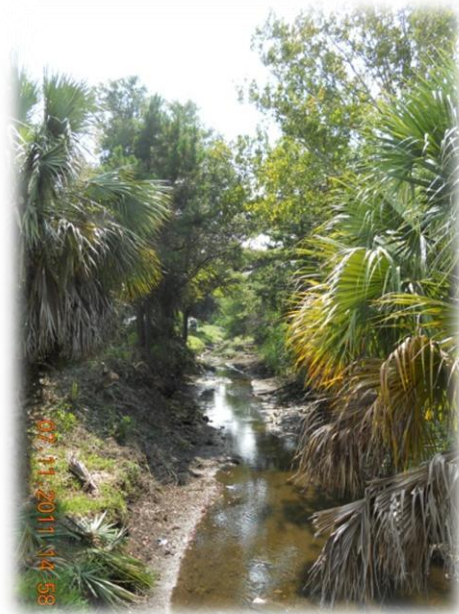
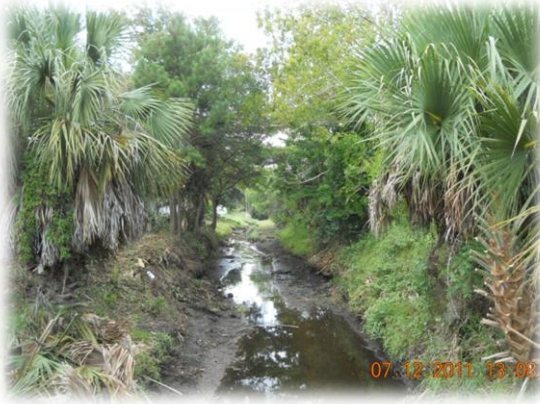
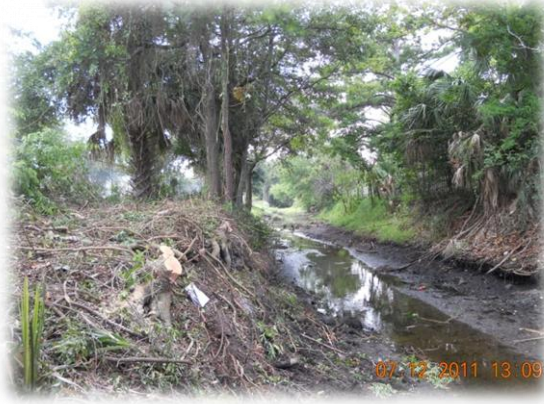
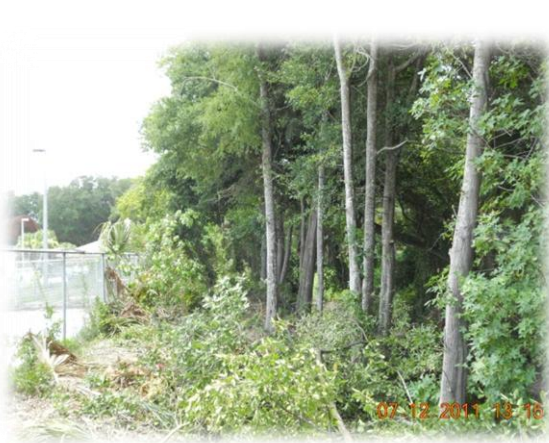
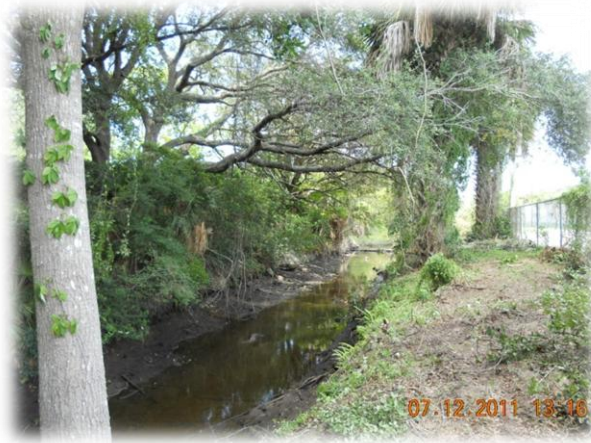
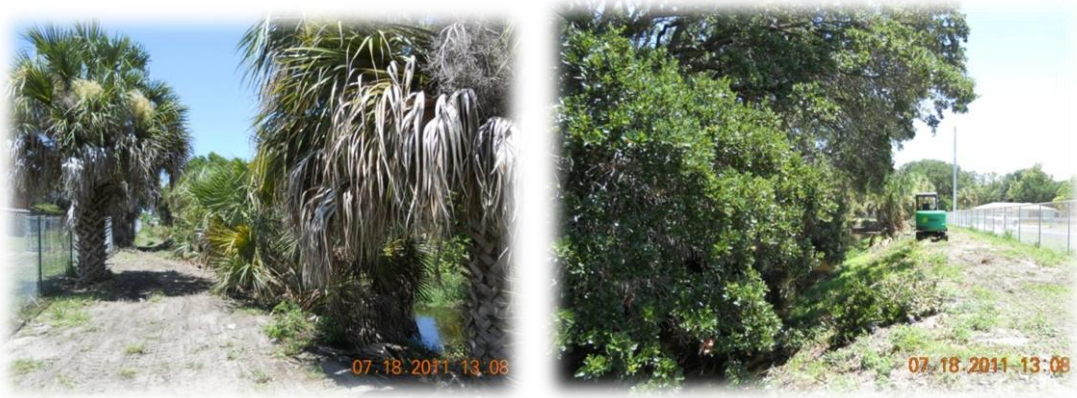
**FIELD NOTES:** This stretch of the ditch is overgrown.

**POST-FIELD NOTES:** FDOT asked its contractors to weed-eat the area starting at 8<sup>th</sup> St next to the High School, secure it, and thin the vegetation along the ditch bank to expose the ditch to sunlight. This area will be maintained on a regular mowing cycle. Expect this to be finished the end of August.

*These two pictures are taken adjacent to the High School in Neptune Beach. The brush has been removed and tree trimming has been mostly completed. The contractors will perform additional tree trimming. The vegetation along the ditch has been widened so equipment can return to mow. Invasive plants and trees have been removed, and future inspections will be made to ensure invasive have not returned.*

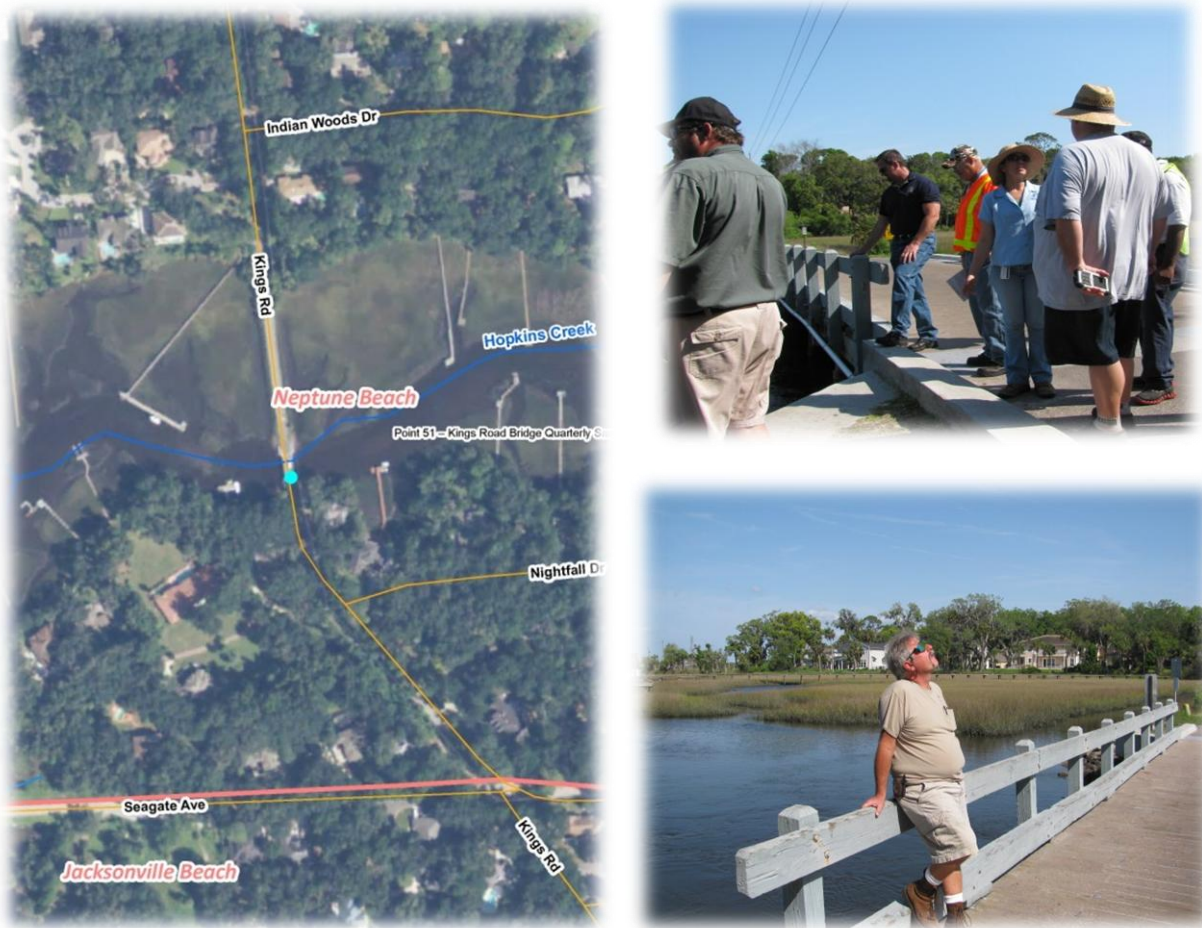
**Figure 9. Point 51: Neptune Beach, Kings Rd. Bridge.**

**FIELD NOTES:** The nearby neighborhood is on septic systems and has historically had numerous repair permits. High salinity could cause fecal coliform die off. The dark water and silty bottom could aid the regrowth of fecal coliform. Dog waste was observed by the bridge.

**POST-FIELD NOTES:** On May 23, 2011, Braden Ward, Florida Department of Health Inspector, met with Neptune Beach Public Works representatives and followed up with a low-tide boat trip to look for PICs in the septic area near the bridge, and no PICs were found. FDOH surveyed 49 properties in the area served by septic systems. One property was found to have a collapsed septic tank lid, which has since been replaced by the homeowner. As a side note, permitting records show 10 permitted repairs of failed septic systems within the 49 properties over the last 16 years.

| Related Figure(s) | Action Item | Entity | Date Initiated/Completed | Outcome |
|---|---|---|---|---|
| 9 | Point 51: Neptune Beach, Kings Rd. Bridge. Carry out a door-to-door check on septic tanks in the summer. | Duval County Health Department (DCHD) | Completed June 2011 | FDOH completed the survey and found 2 broken tank lids in the area. |

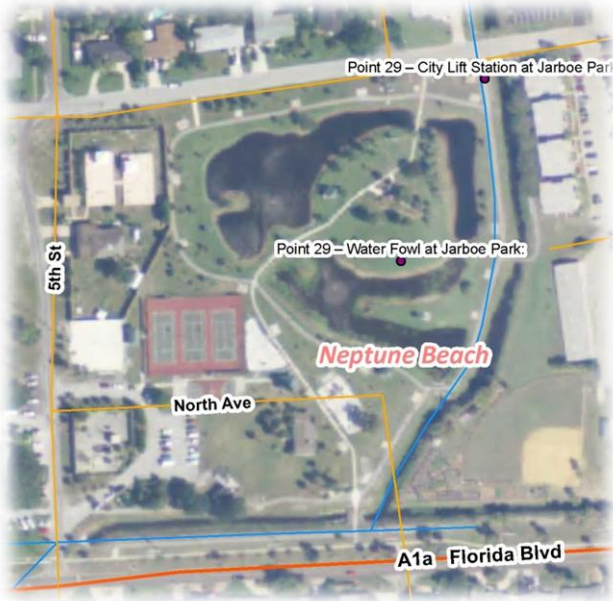
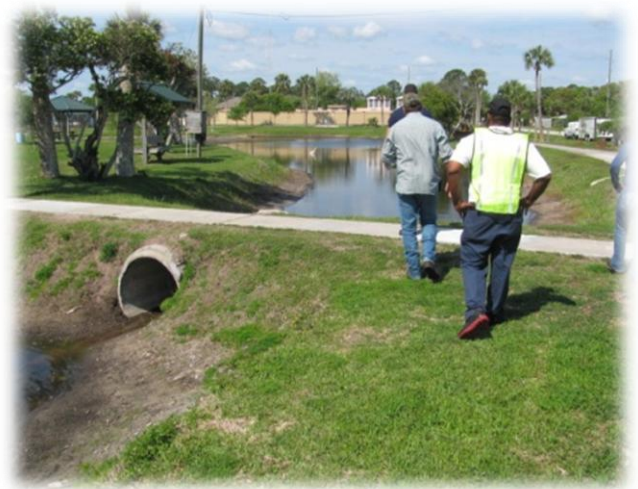
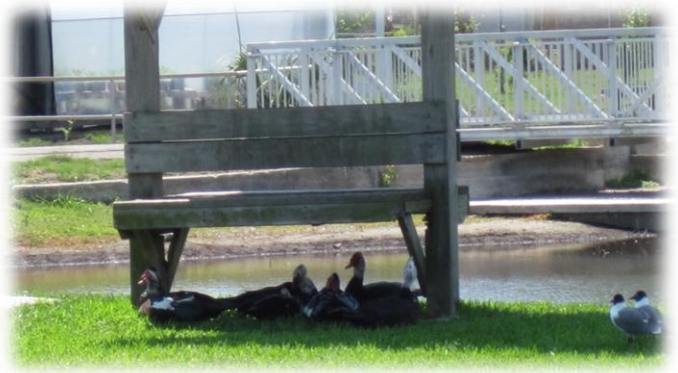
**Figure 10. Point 29: Neptune Beach, Jarboe Park.**

**FIELD NOTES:** The aerial photo shows the area of Jarboe Park. The team observed ducks, seagulls, and other waterfowl in the park, as well as fish, tadpoles, and turtles.

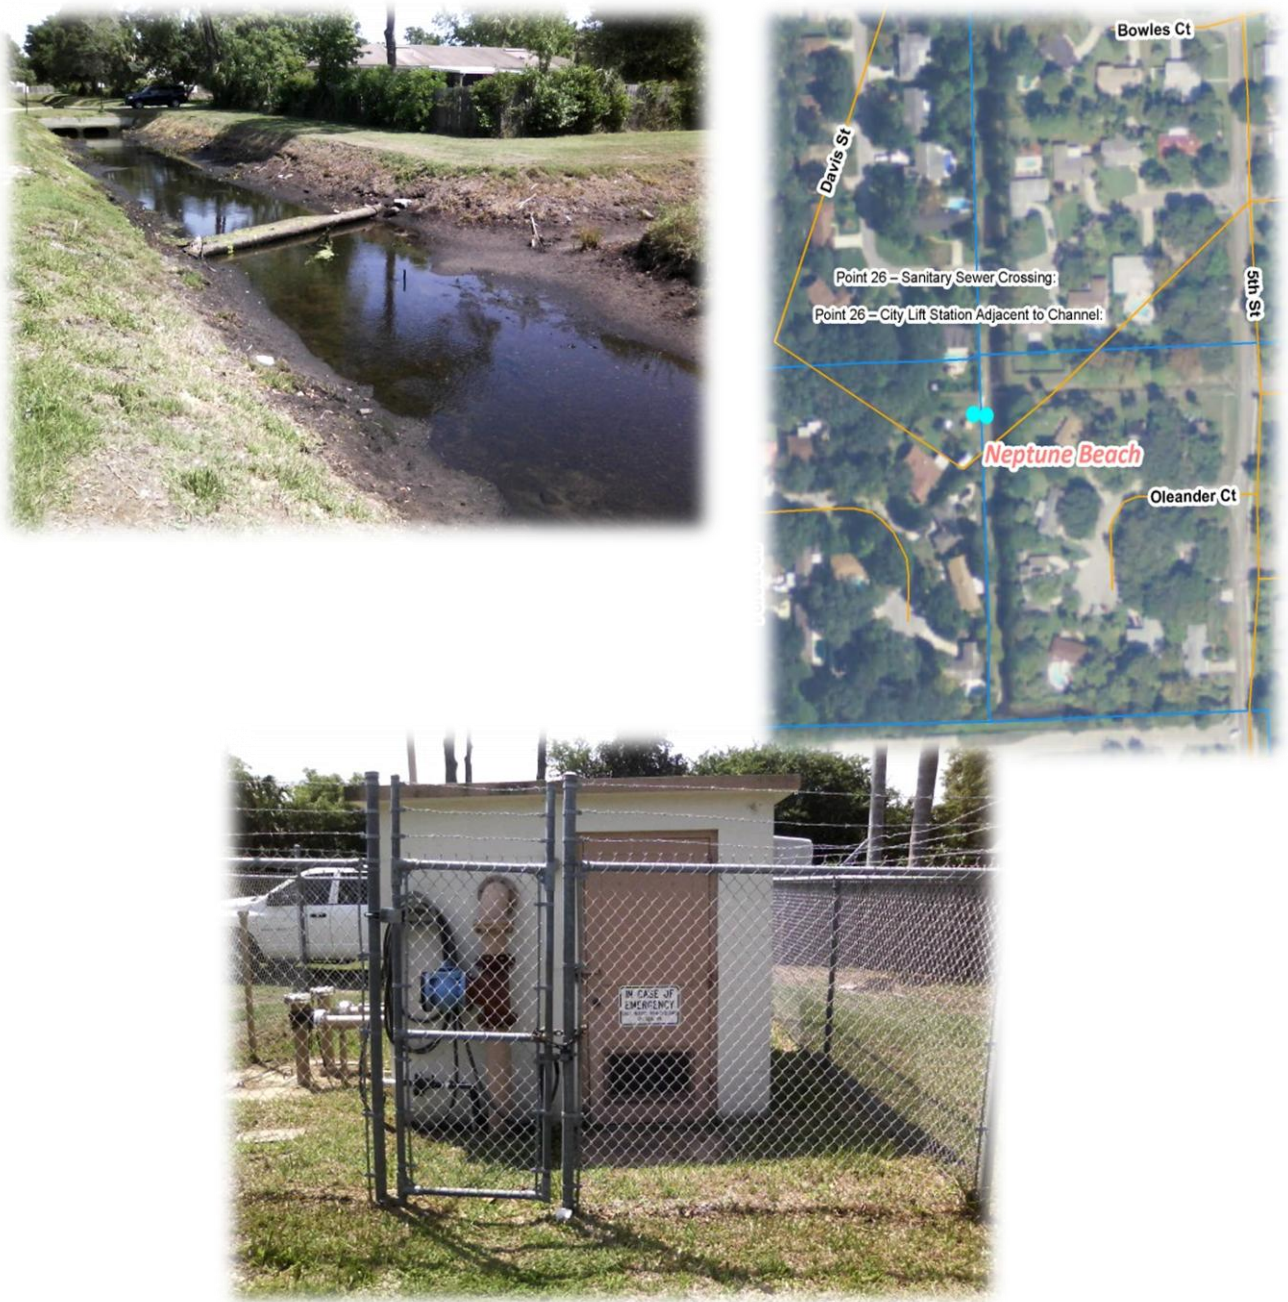
**Figure 11. Point 26: Neptune Beach, Davis St. Ditch.**

**FIELD NOTES:** There are 2 gravity sewer lines crossing the creek (top photo), and the overflow to the old Fletcher Lift Station (bottom photo) is plugged. The lift station, which is adjacent to the ditch, was locked. An emergency contact sign was posted. A sample taken at this location showed fecal coliform levels of 72 colony-forming units per 100 milliliters (cfu/100mL).

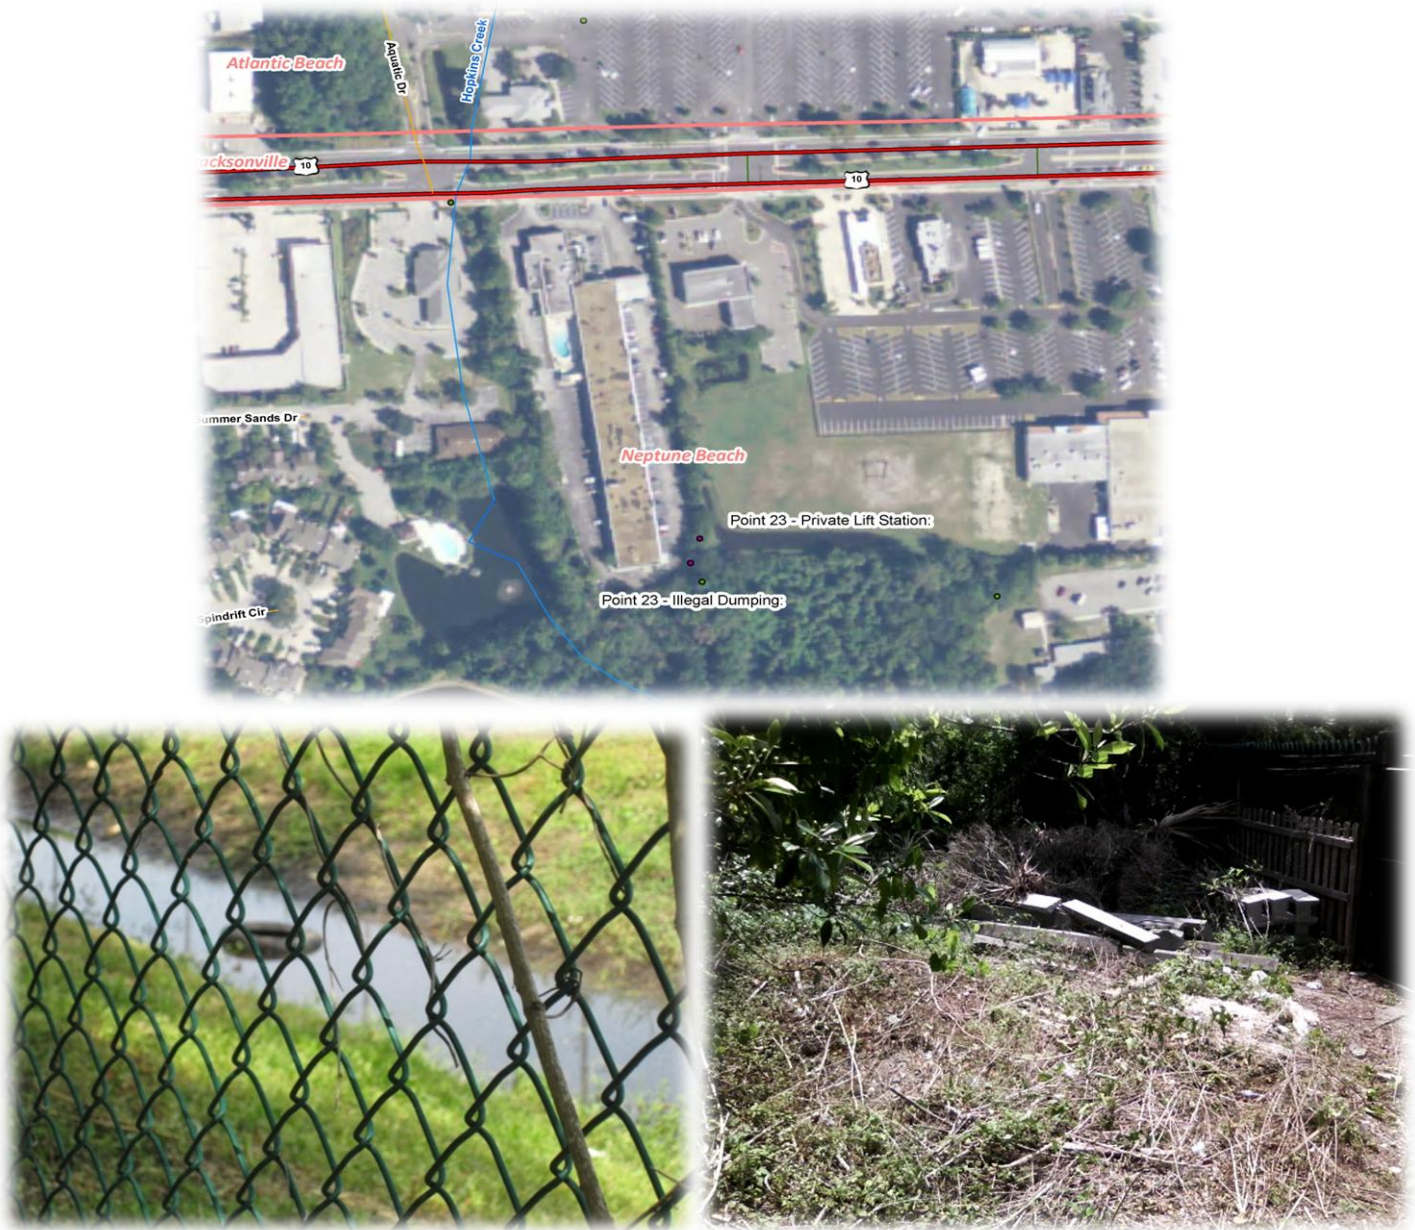
**Figure 12. Point 23: Neptune Beach, private hotel and grocery store dumpsters.**

**FIELD NOTES:** A code enforcement issue was observed, with trash piles behind the Days Inn lift station (top photo). Tires were found in the adjacent Winn Dixie stormwater pond (bottom photo).

**POST-FIELD NOTES:** Neptune Beach Code Enforcement followed up, and the trash and tires were removed in April 2011. The 4 pictures below show the cleaned up areas.

| Related Figure(s) | Action Item | Entity | Date Initiated/Completed | Outcome |
|---|---|---|---|---|
| 15 | Point 23: Neptune Beach, private hotel. Follow up on the missing lock at the wet well at the Days Inn lift station. | City of Jacksonville | 7-21-11 | City of Jacksonville EQD inspected the facility. |
| 15 | Point 23: Neptune Beach, private hotel. Anita Nash will call Neptune Beach Code Enforcement to find out if the lift station at this location was leaking. | FDEP | June 2011 | No leaking witnessed, but there was obvious degradation of the lift station. Maintenance was required. Possible evidence of |

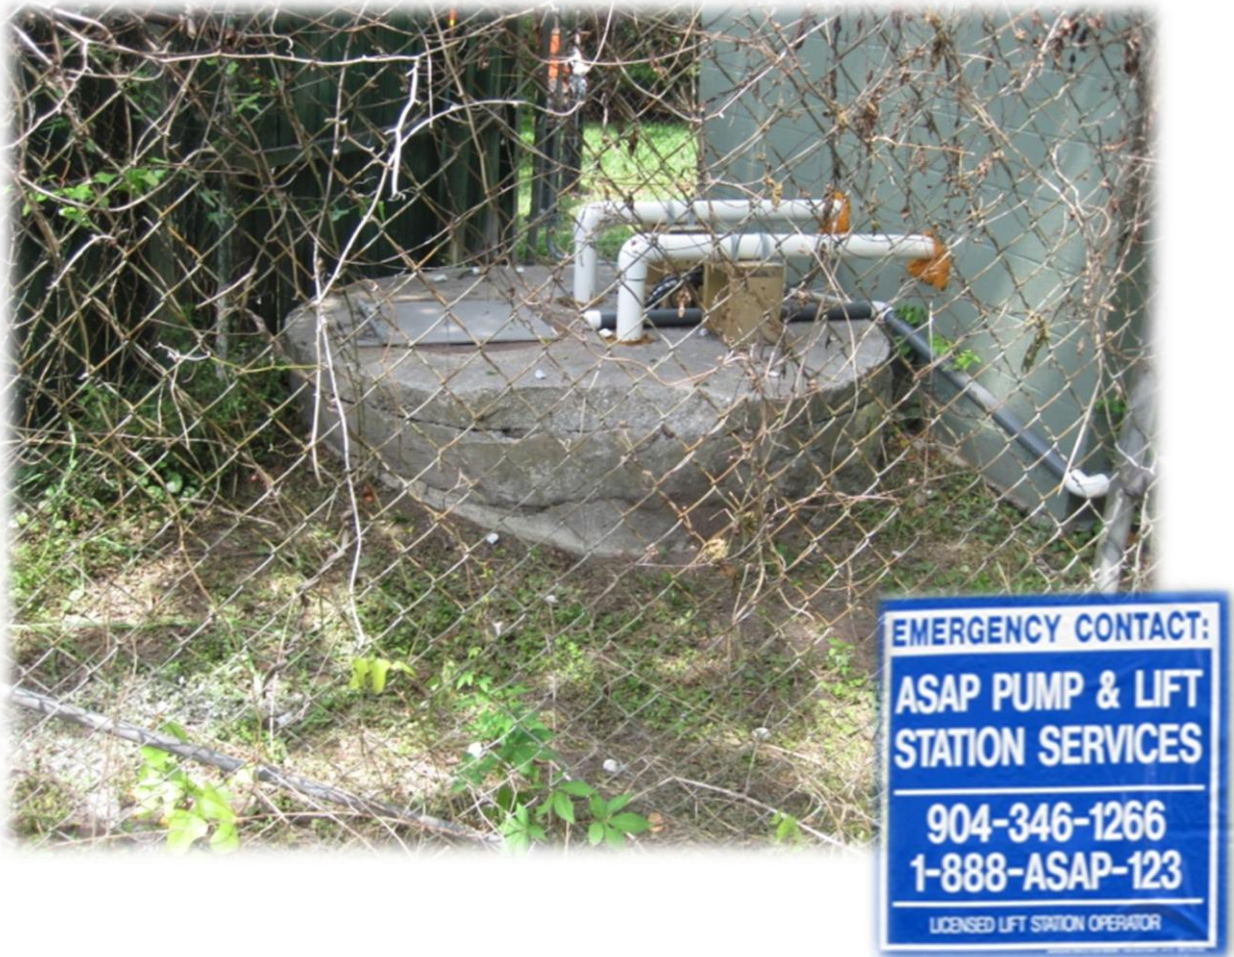
**Figure 15. Point 23: Neptune Beach, private hotel.**

**FIELD NOTES:** There was no lock on the wet well at the Days Inn lift station (top photo). An emergency contact was posted (bottom photo).

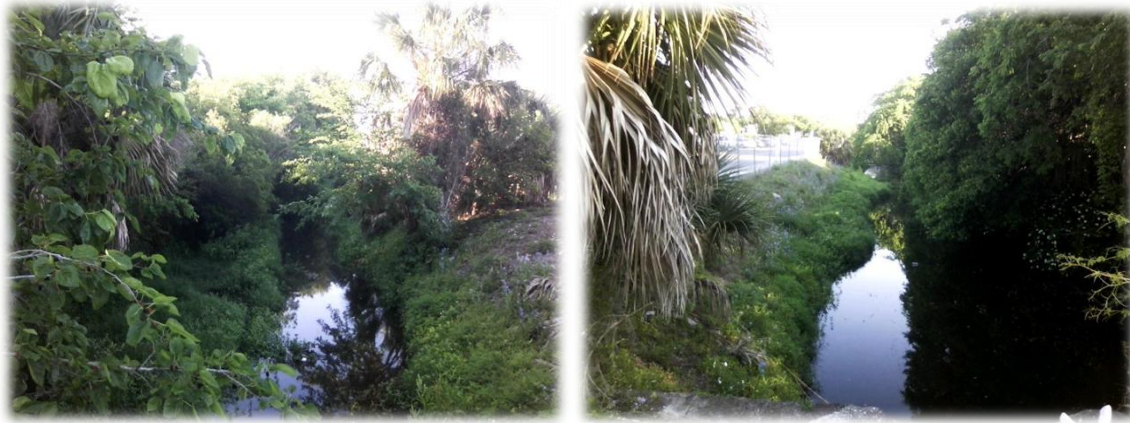
**Figure 17. Point 35: Border of Jacksonville and Neptune Beach, FDOT ditch at Seagate Ave.**

**FIELD NOTES:** Canopy cover prevents ultraviolet (UV) light from reaching the ditch. There is slow flow and little flushing unless heavy rainfall occurs. Wildlife live in the ditch, and a turtle was observed. This location is a Jacksonville Beach sampling point (during wet and dry weather).

**POST-FIELD NOTES:** A sample taken at this point during the field event showed fecal coliform concentrations of 280 cfu/100mL. The first sample of the day was labeled Point 53 on the lab results page, but it appears that the numbers were transposed.

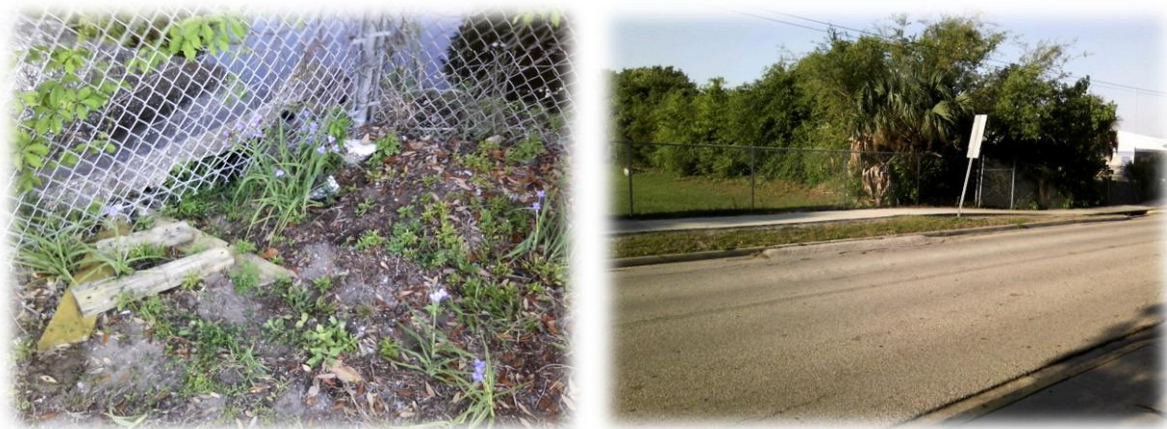
**Figure 18. Point 35: Border of Jacksonville and Neptune Beach, FDOT ditch at Seagate Ave.**

**FIELD NOTES:** There is erosion occurring behind the concrete flume belonging to DOT.

DOT plans to repair the flume after vegetation removal is complete. DOT plans to look at all DOT flumes and repair as necessary.

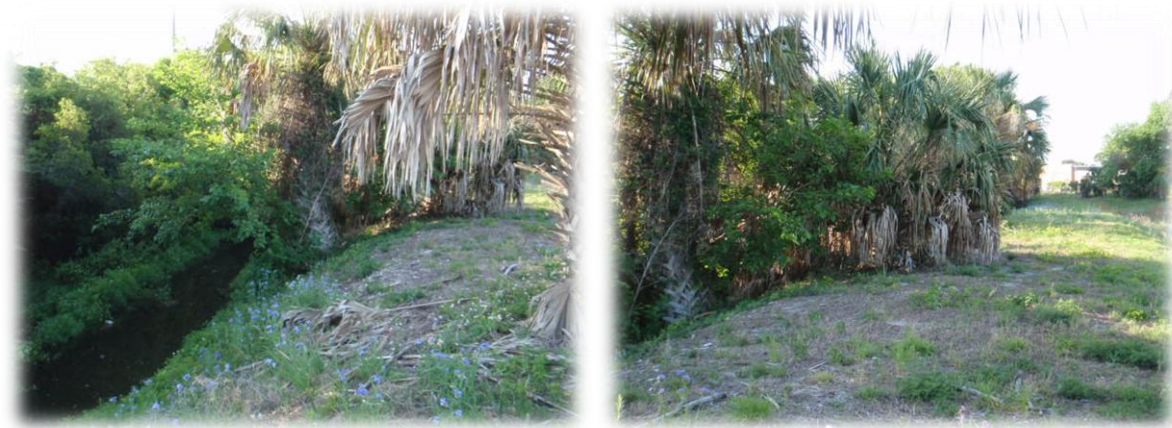
**Figure 19. Point 35: Border of Jacksonville and Neptune Beach, FDOT ditch at Seagate Ave.**

**FIELD NOTES:** *This area is heavily overgrown, blocking UV penetration to the ditch.*

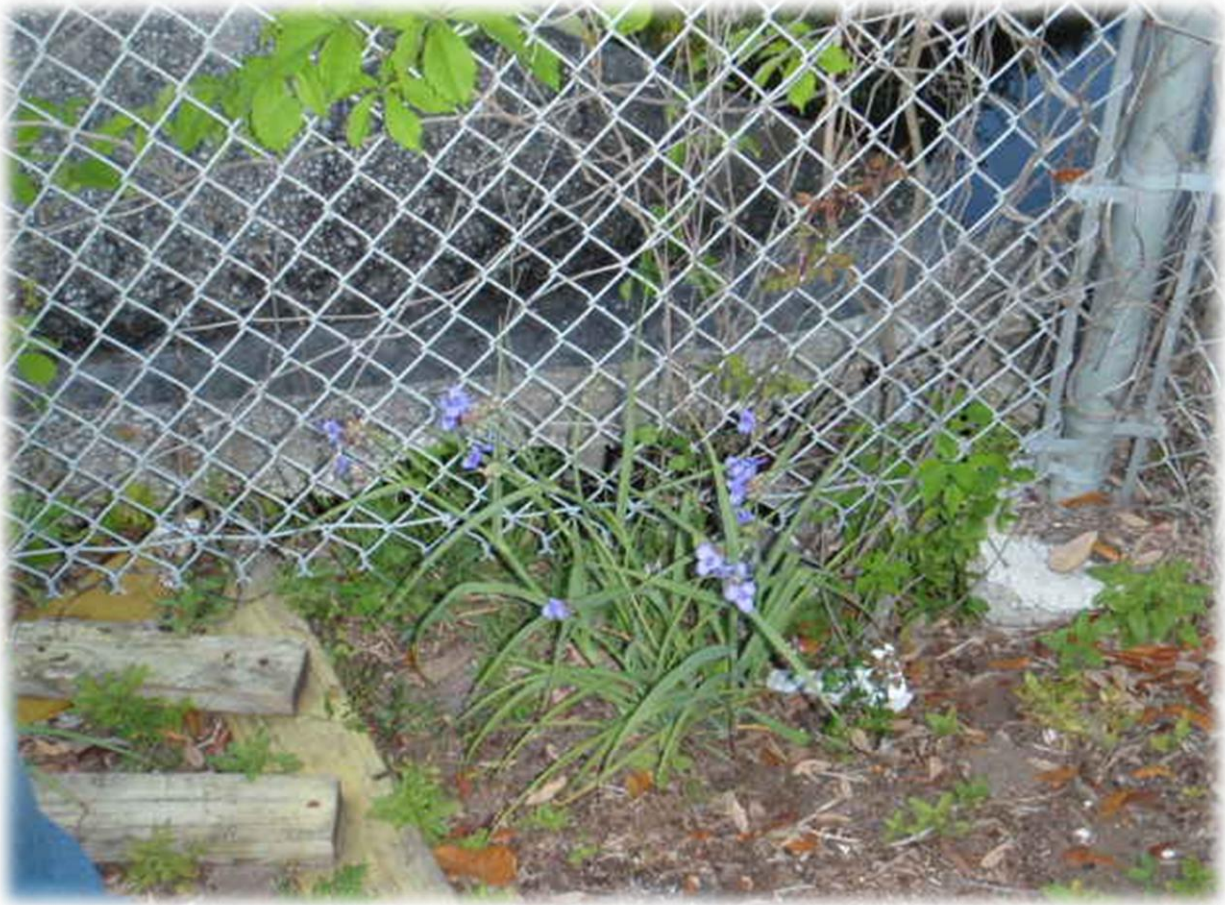
**Figure 21. Point 35: Border of Jacksonville and Neptune Beach, FDOT ditch at Seagate Ave.**

**FIELD NOTES:** The team observed erosion along the fence.

**POST-FIELD NOTES:** FDOT has asked its contractors to repair the eroded area. This will be accomplished once the majority of the tree trimming is complete. Tree trimming began on this ditch in July, 2011.

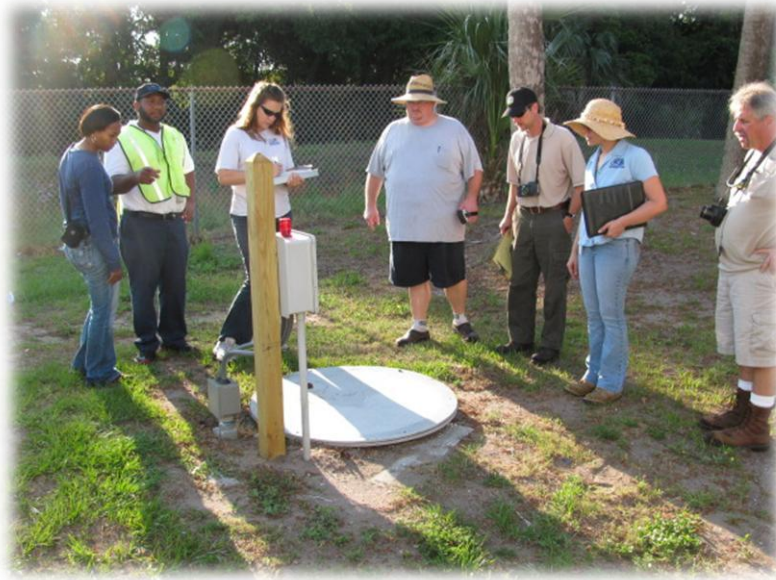
**Figure 22. Point 37: Jacksonville Beach, Boys and Girls Club.**

**FIELD NOTES:** The vent was rusted open on the private lift station at the Boys and Girls Club. No emergency contact number was provided.

**POST-FIELD NOTES: Reported Tenant Fletcher High School 06/28/2011:** Private lift station (point 37 – Boys and Girls club) has been inspected by the City of Jacksonville, FL environmental compliance Dept. See attached PDF copy of email from Mr. Bob Fegan, COJ inspector, and photo.

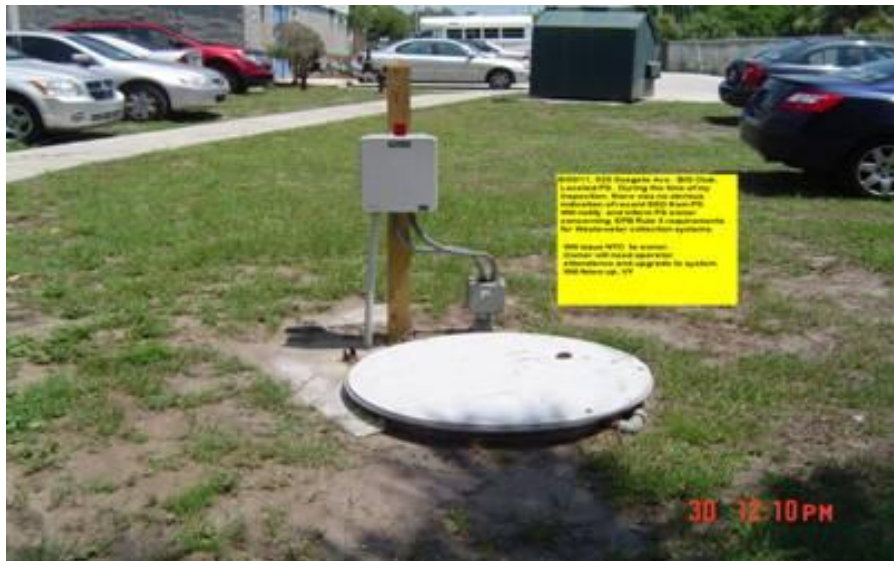
On 6/30/11, I responded to a complaint concerning possible contamination to Hopkins Creek.

The station will need monthly operator attendance. After contracted with an operator, upgrade to system will be required. We will require a sign posted with operators information and a monthly log of PS activity. Station will be secured and both audible and visible alarms should be activated at high level.

NTC# VY11-34 will start EQD enforcement actions.

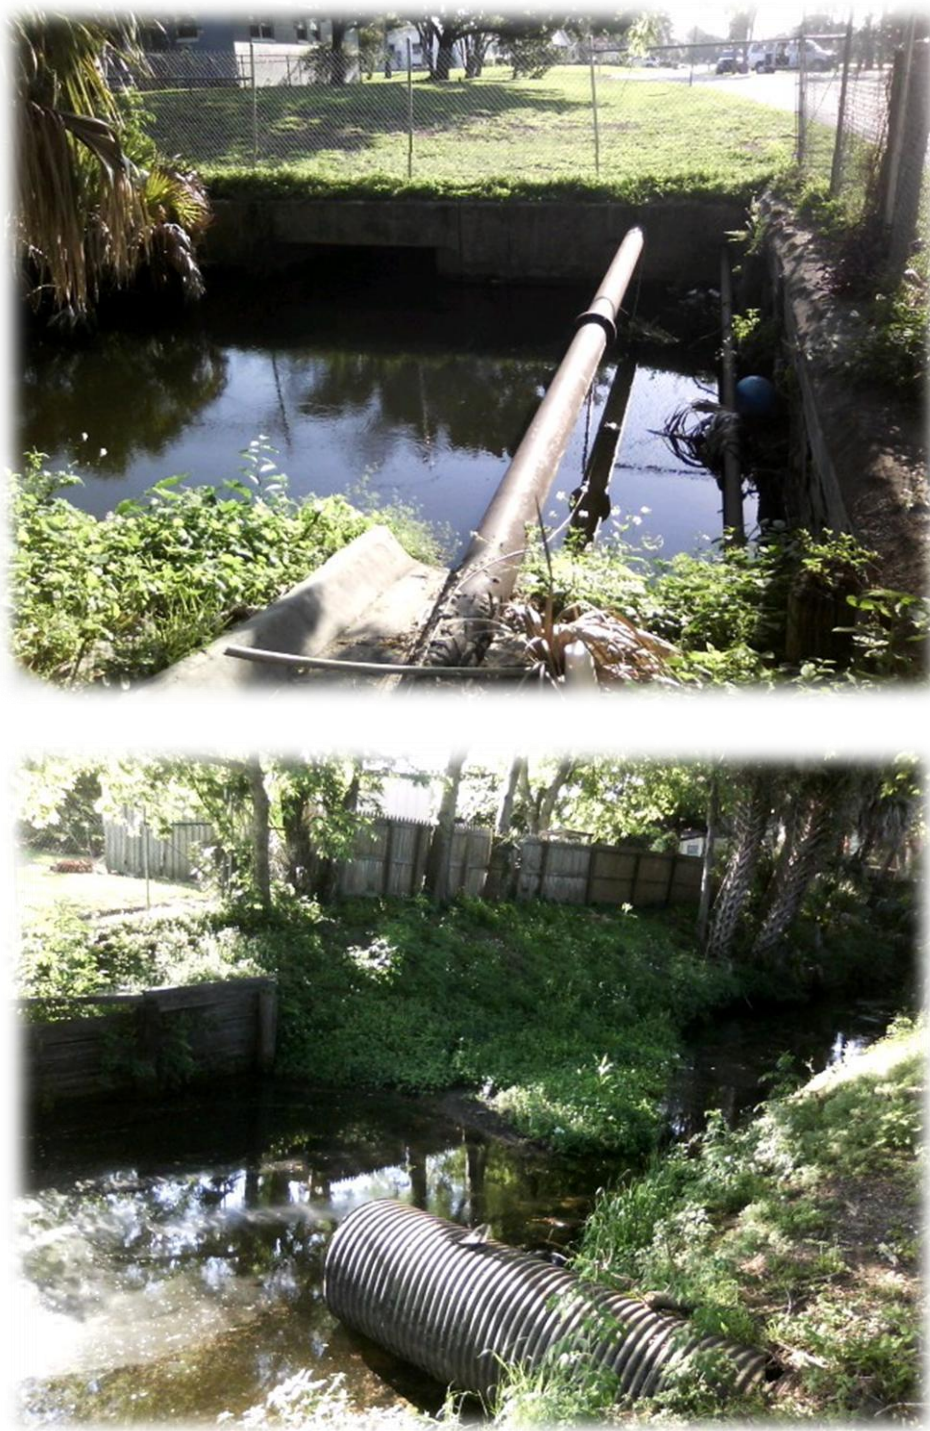
**Figure 24. Point 41: Jacksonville Beach at 15<sup>th</sup> Ave. N. (FDOT ditch).**

**FIELD NOTES:** The top photo faces north, and the bottom photo faces south. A sanitary sewer pipe crossing, outfalls, and a lift station are located nearby. This is a Jacksonville Beach monthly TMDL sampling station during wet and dry weather.

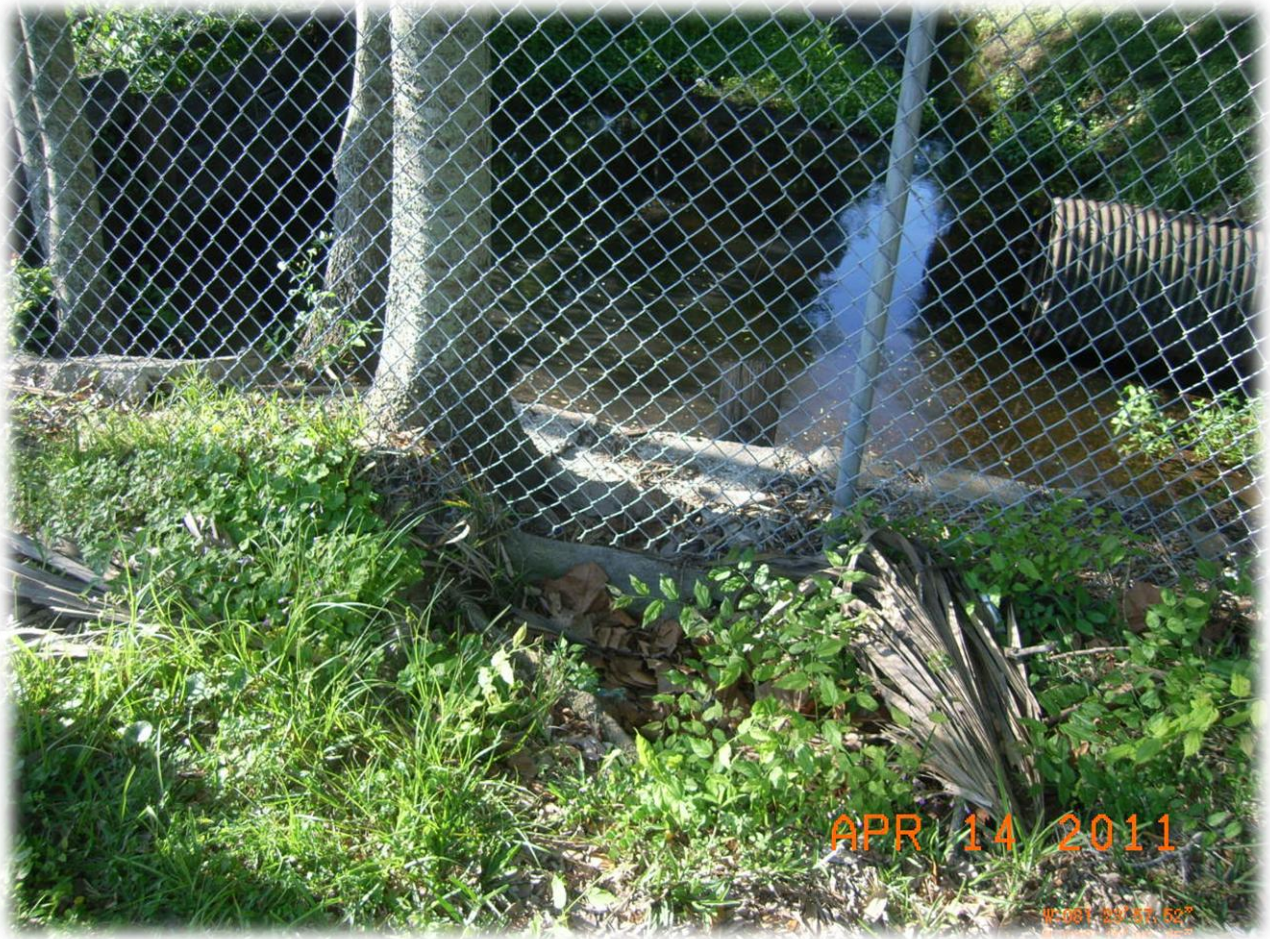
**Figure 25. Point 41: Jacksonville Beach at 15<sup>th</sup> Ave. N. (FDOT ditch).**

**FIELD NOTES:** The overgrowth of vegetation at this location prevents UV penetration. Because the upstream portion of the ditch is piped, UV light cannot penetrate the water. There is slow flow and little flushing unless heavy rainfall occurs.

**POST-FIELD NOTES:** DOT contractors informed DOT that the 8<sup>th</sup> St Ditch is subject to rise and fall of about 2 to 3 feet daily during tidal events, slowing progress of clearing vegetation. Work began in July 2011 on this ditch.

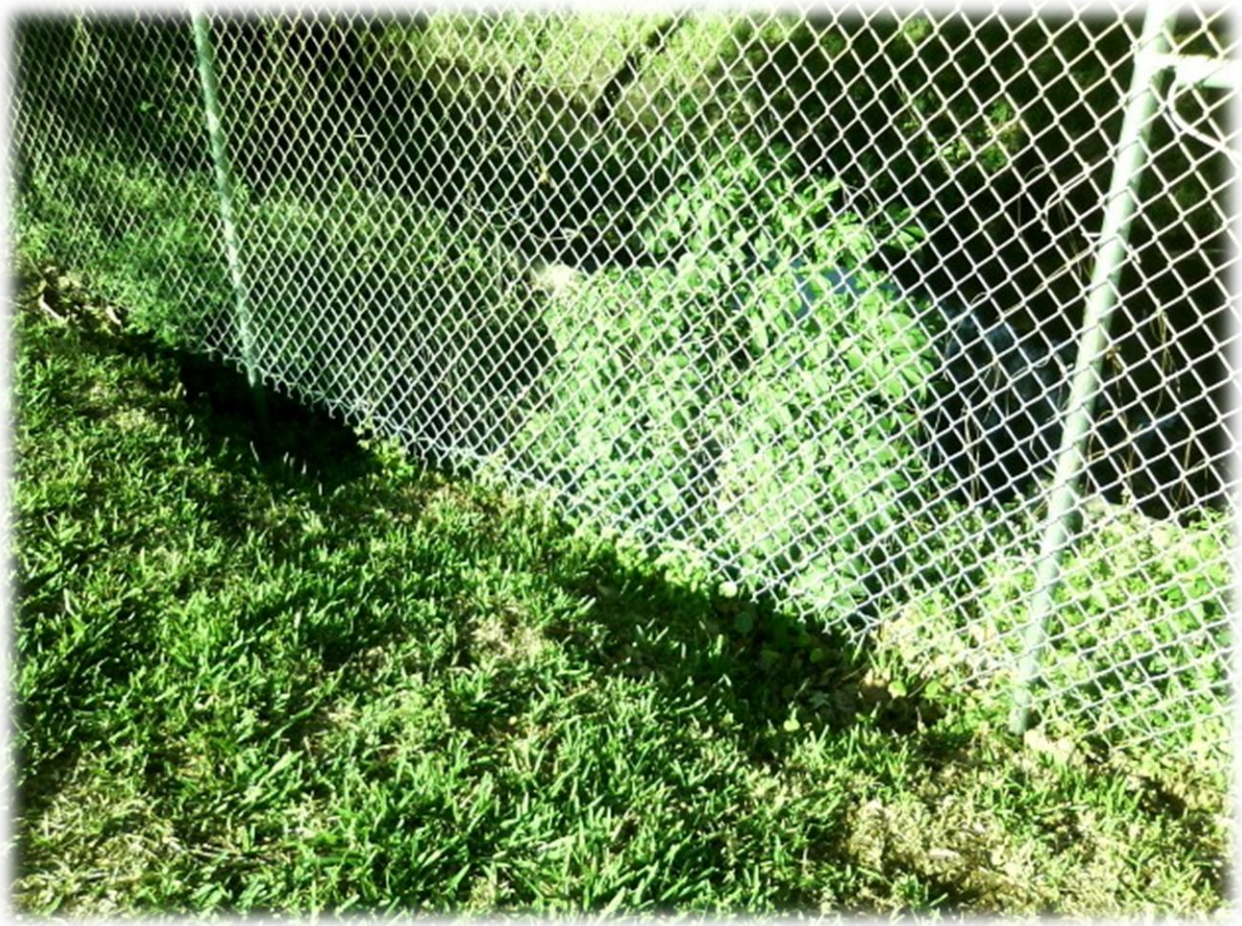
**Figure 26. Point 41: Jacksonville Beach at 15th Ave. N. (FDOT ditch).**

**FIELD NOTES:** *Erosion has occurred on the south side of the road.*

**POST-FIELD NOTES:** Scheduled to be repaired when tree trimming operation nearing completion. Tree trimming began July 2011.
