# Summary of Results

## Walk the Waterbody Exercise for Hopkins Creek (WBID 2266)

***Florida Department of Environmental Protection  
Division of Environmental Assessment and Restoration  
Bureau of Watershed Restoration  
Tallahassee, FL 32399***

**August 2011**

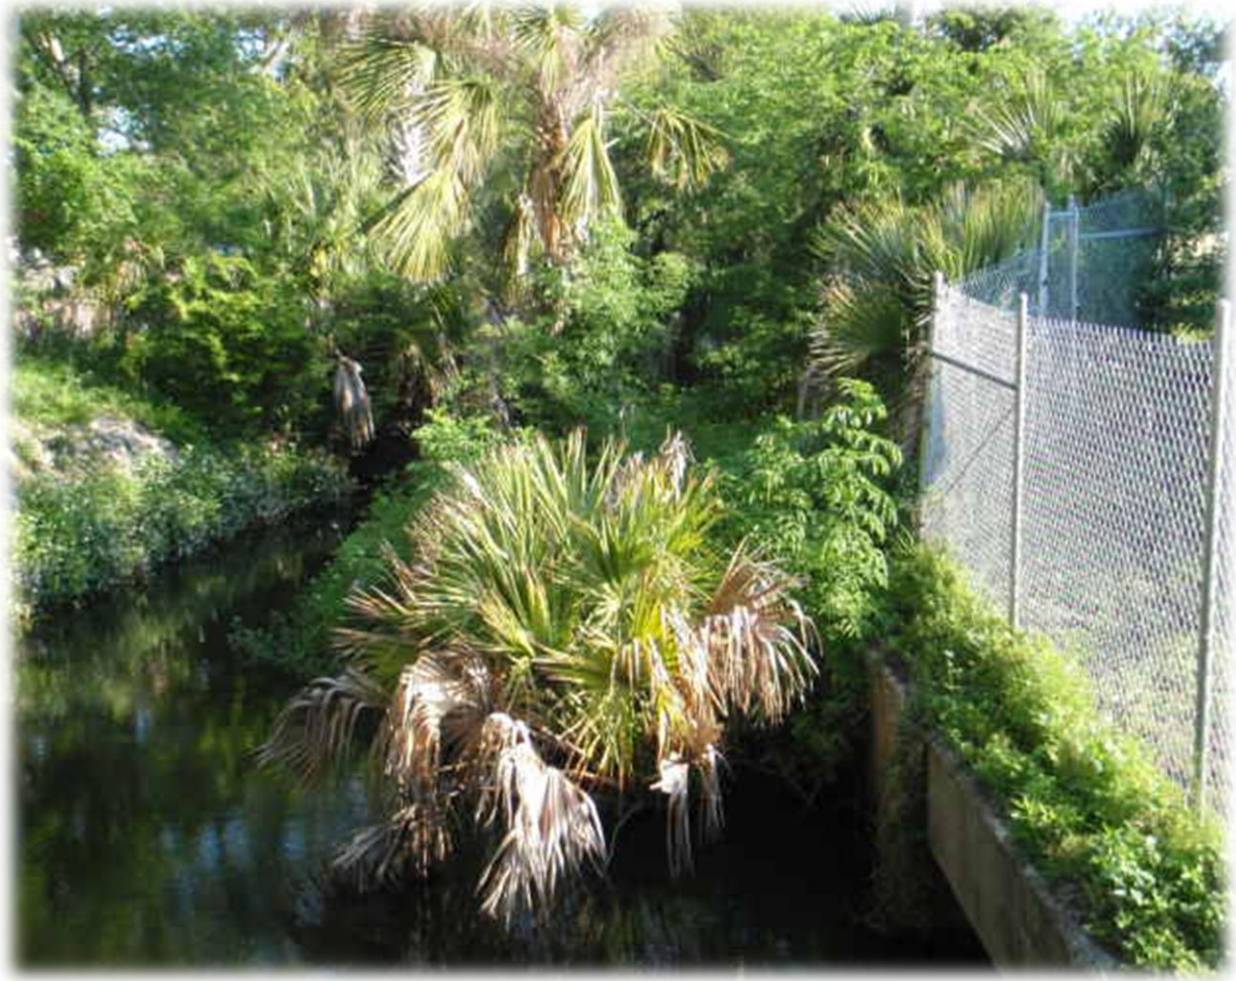
**Figure 27. Point 41: Jacksonville Beach at 15th Ave. N. (FDOT ditch).**

**FIELD NOTES:** The area is heavily overgrown.

**POST-FIELD NOTES:** FDOT has asked its contractors to thin vegetation to expose the ditch to sunlight and remove any debris from the flow line of the ditch. This is one of the challenging areas our DOT Contactor is facing but will accomplish. Scheduled to begin September, 2011.

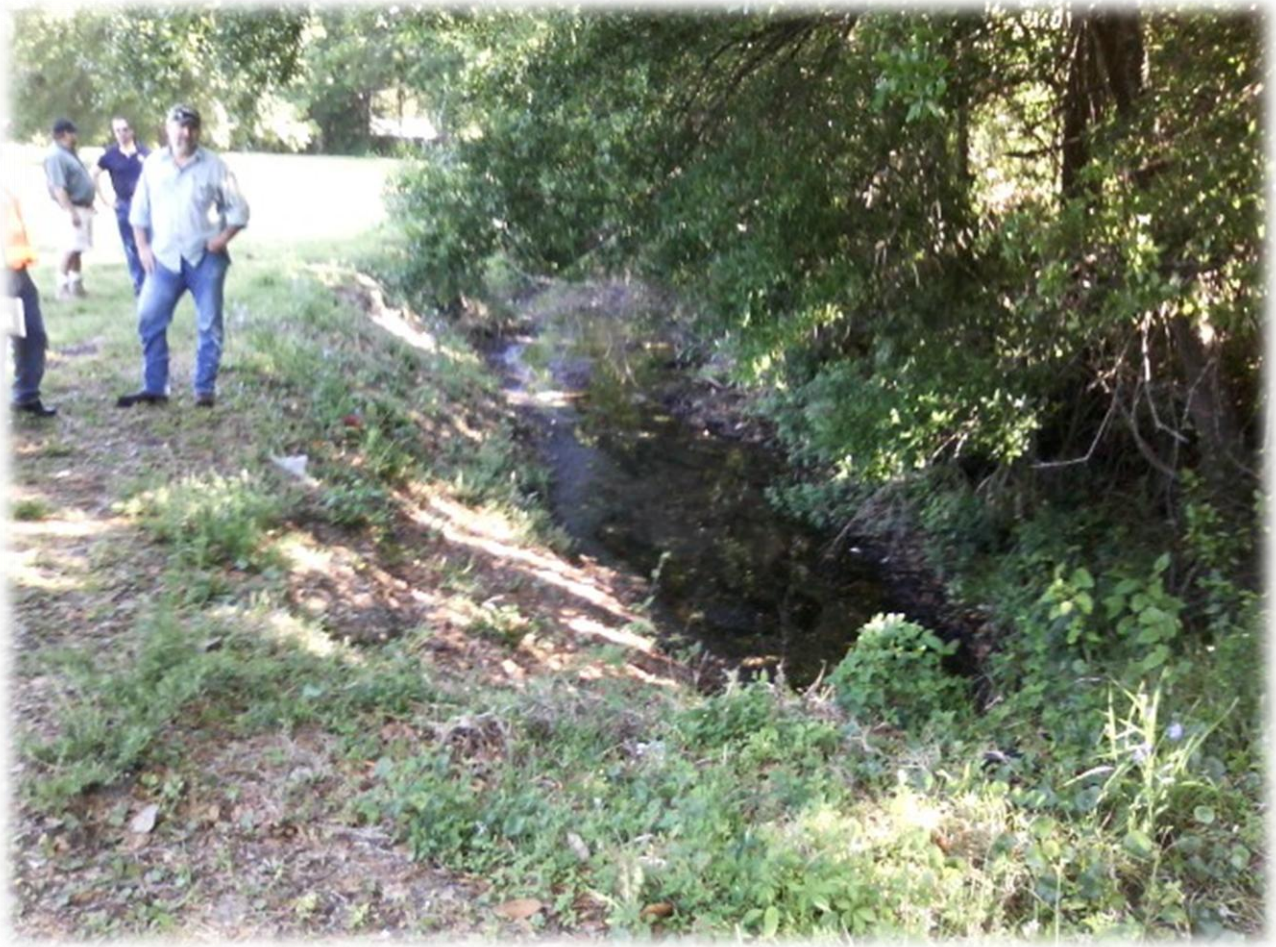
**Figure 30. Point 59: Jacksonville Beach.**

**FIELD NOTES:** A sample was taken at 12<sup>th</sup> Ave. South; the results showed 36 cfu/100mL of fecal coliform. The manhole cover was pulled; no bats were found. Bats have been observed in this manhole in the recent past. This part of the creek has slow velocity and canopy cover, and is piped upstream.

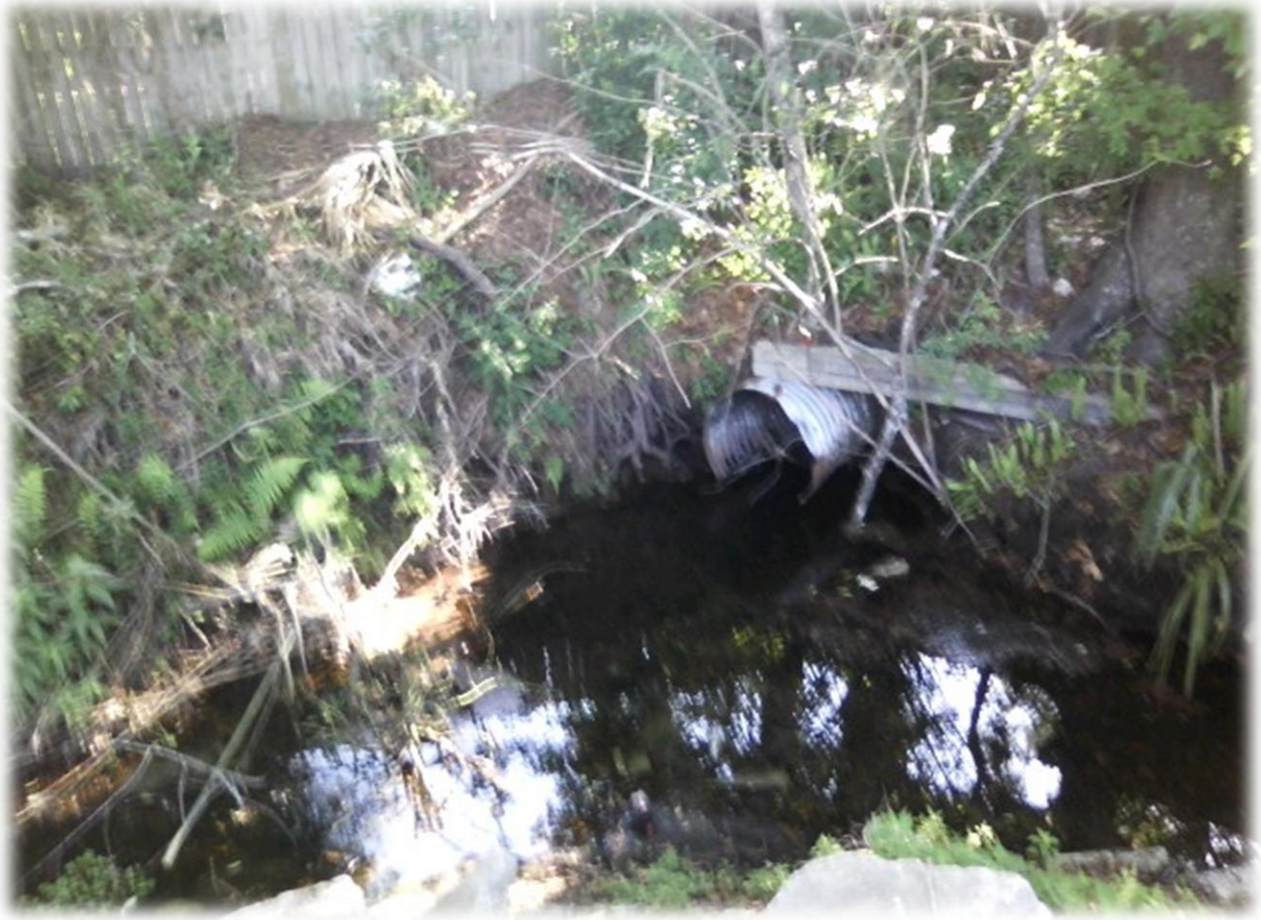
**Figure 31.** Jacksonville Beach, just downstream of Point 59.

**FIELD NOTES:** The team observed piles of illicitly dumped yard waste.

**POST-FIELD NOTES:** Jacksonville Beach Code Enforcement will follow up. Referred week of 06/27/2011 7/1/2011 COJB PW Streets Division employees went door to door to speak with residents about illicit dumping into our storm water system and ditches. They passed out 82 public information and educational materials to the local residents who live near the SW ditch.

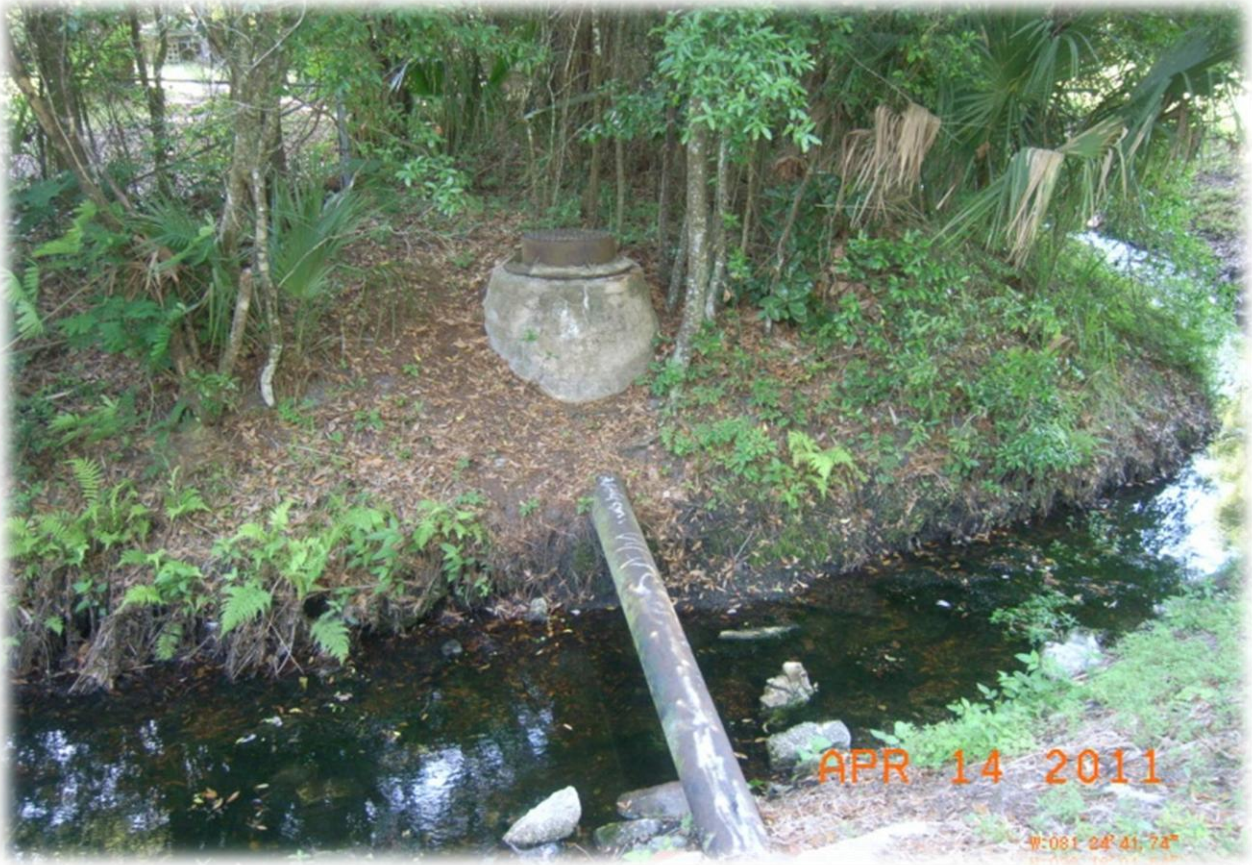
**Figure 32. Point 39: Jacksonville Beach, upstream from Pinewood Rd.**

**FIELD NOTES:** There are piped outfalls and sanitary sewer crossings. Some corrosion pitting was observed on the sewer crossing.

**POST-FIELD NOTES:** Jacksonville Beach inspected the pitting and has stated that the corrosion is not bad enough to take any action at this time.

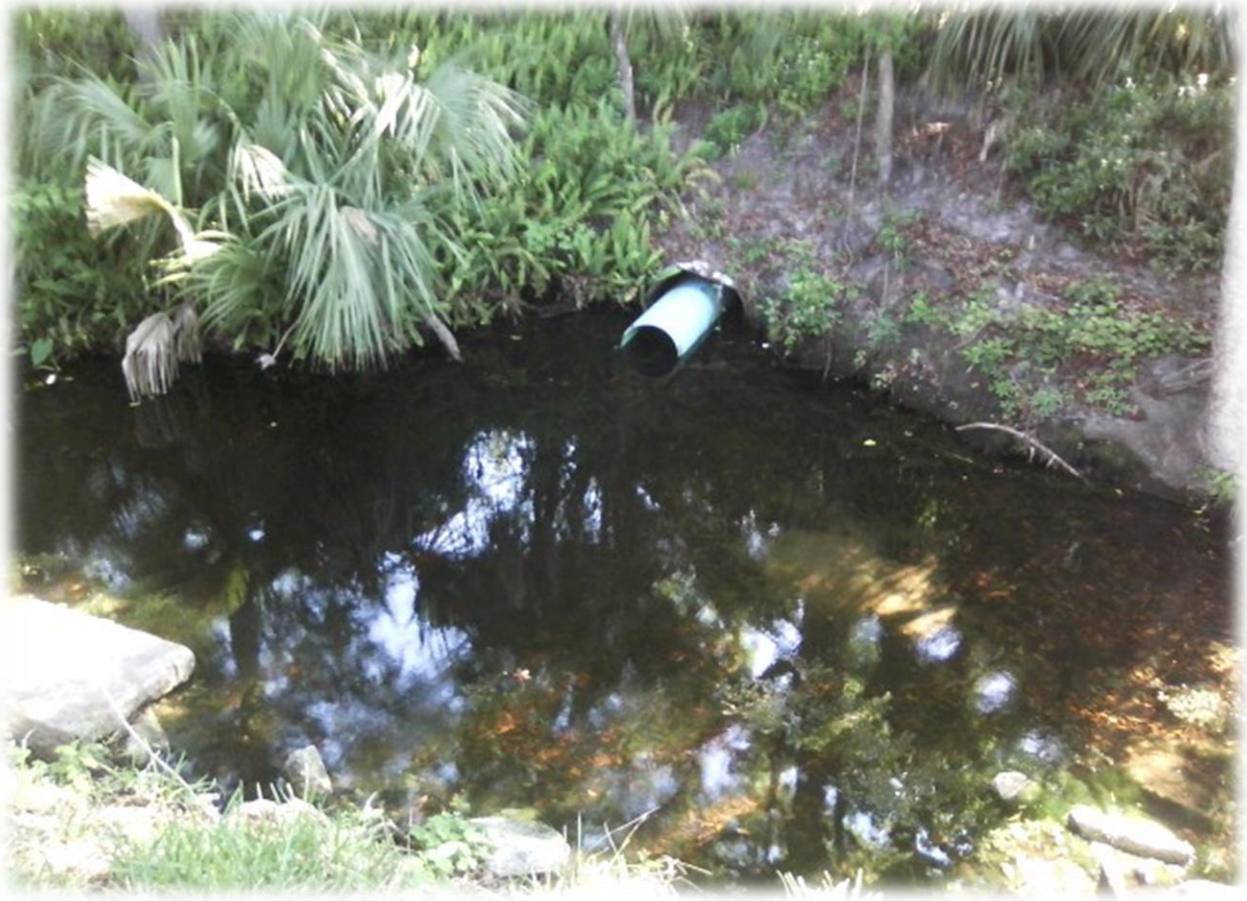
**Figure 33.** *Near Point 40: Jacksonville Beach, near Oakwood.*

**FIELD NOTES:** *The crossing collapsed one and a half years ago, and subsequently PVC pipe was inserted inside the old corrugated pipe.*

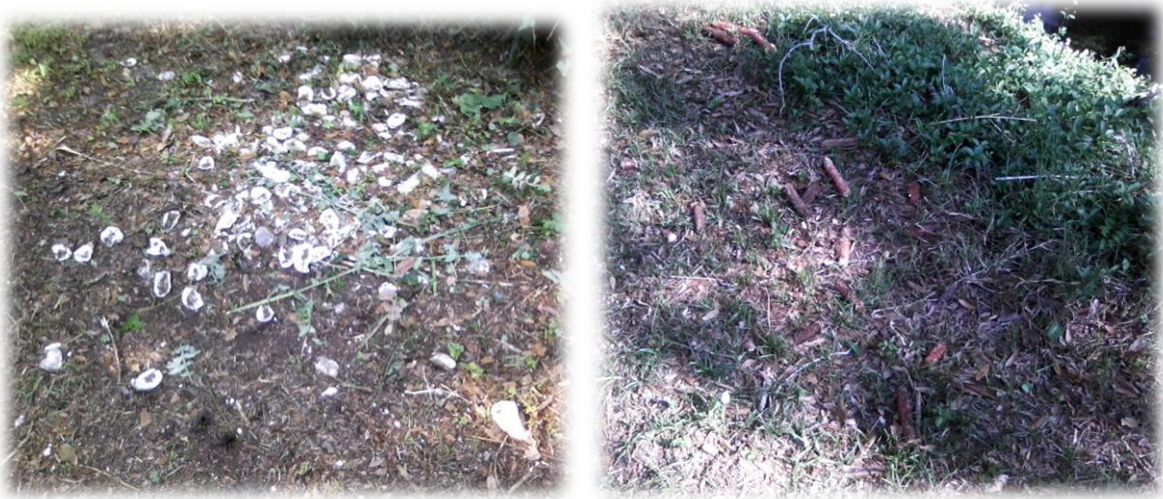
**Figure 34.** Near Point 40: Jacksonville Beach, downstream of Pinewood Rd.

**FIELD NOTES:** Yard waste was dumped behind a home above the ditch line, around the corner from, due north of sampling Point 59 at 12<sup>th</sup> Ave. North (left photo). Cobs of field corn were observed on the bank and may indicate that residents are feeding wildlife (right photo).

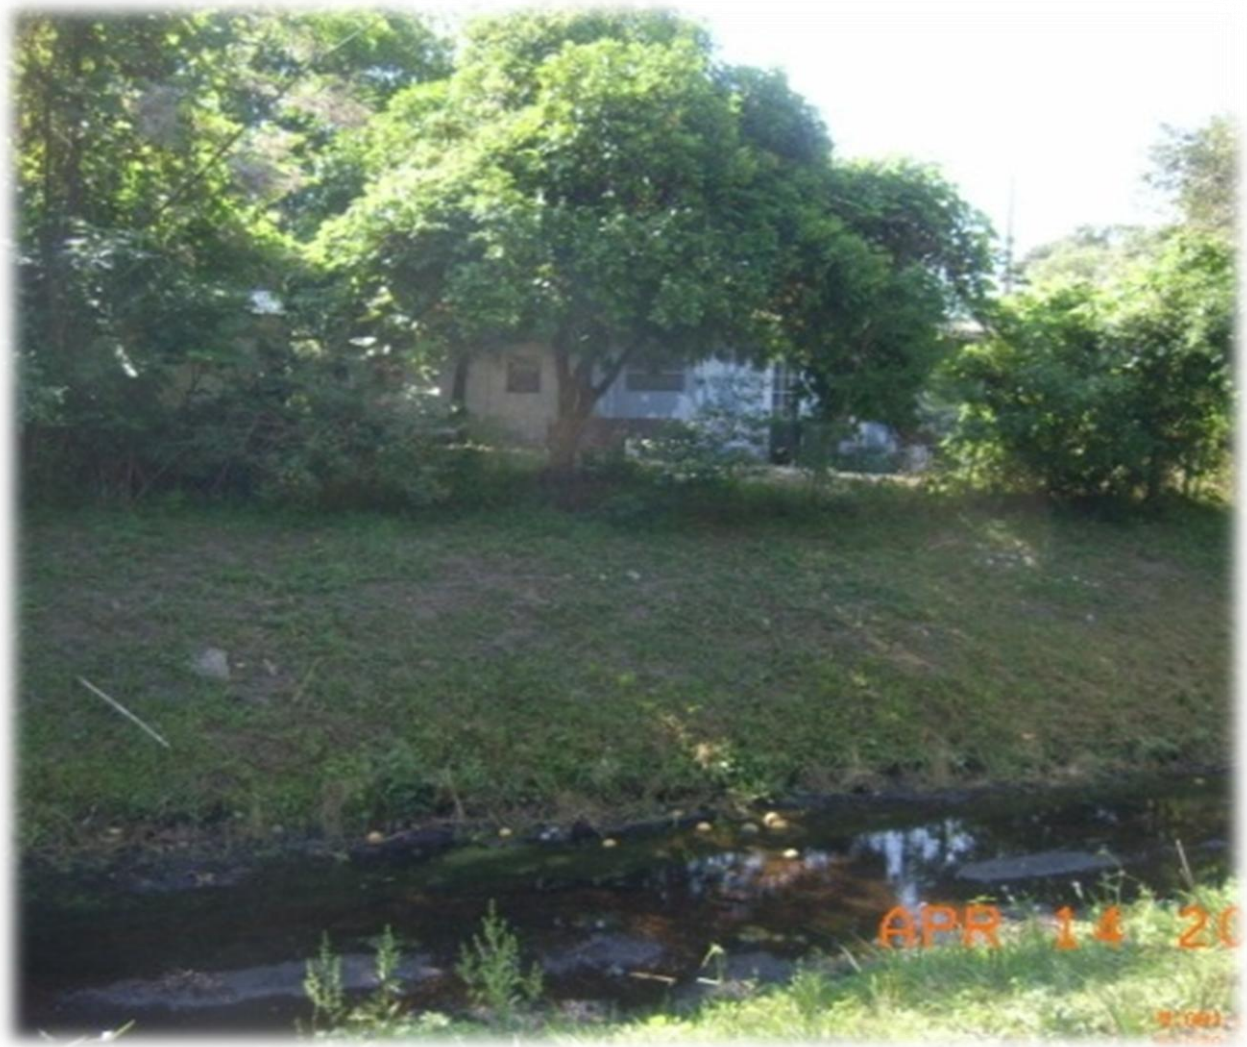
**Figure 35.** *Near Point 40: Jacksonville Beach, downstream of Pinewood Rd.*

**FIELD NOTES:** *A fruit tree was dropping fruit into the ditch.*

**POST-FIELD NOTES:** *The rotting fruit can host *Citrobacter*, which can cause a positive lab result for fecal coliform, falsely indicating fecal contamination.*

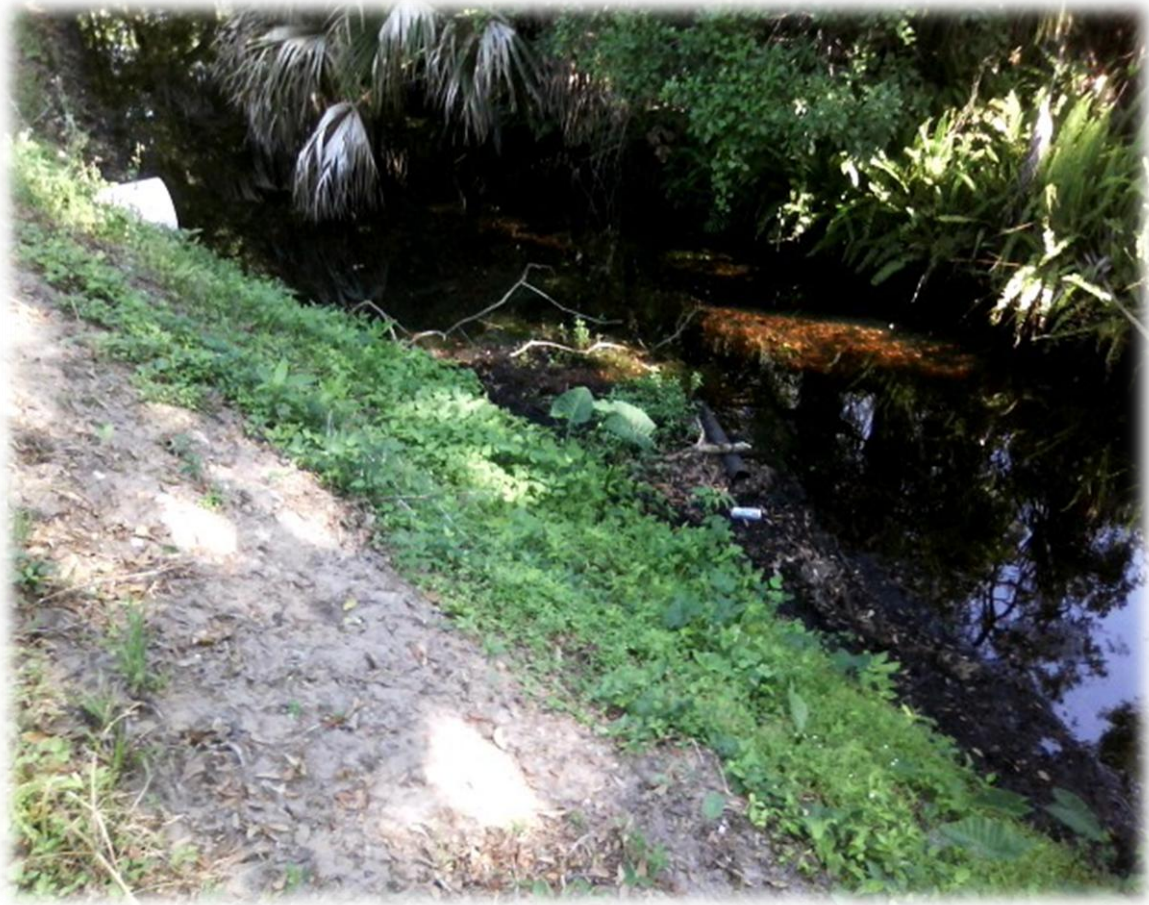
**Figure 36. Point 40: Jacksonville Beach, south of Pinewood Rd.**

**FIELD NOTES:** Debris was observed in the ditch, and the city of Jacksonville Beach put in a work order to clean it up.

**POST-FIELD NOTES:** The trash was picked up 06/21/2011.

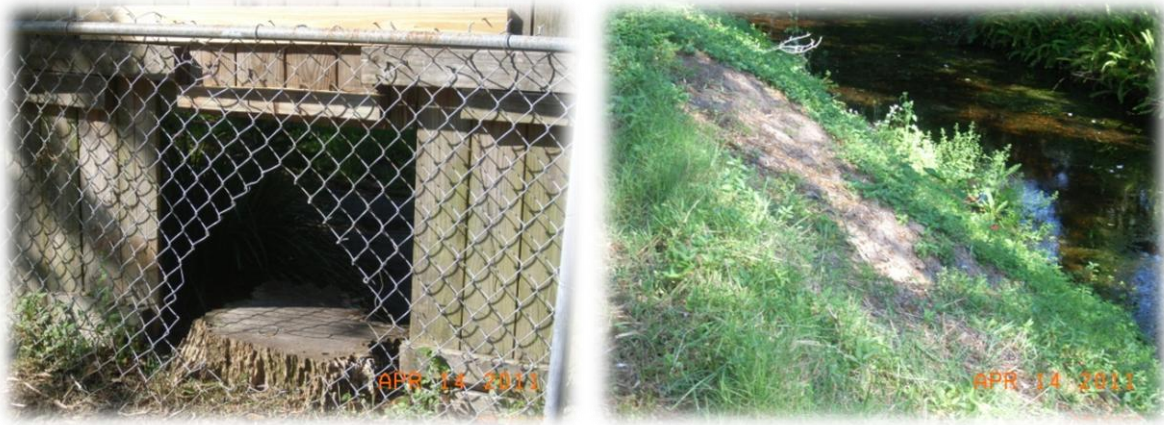
**Figure 37.** Near Point 40: Jacksonville Beach, downstream from Pinewood Rd.

**FIELD NOTES:** A “cat entrance” through the fence was observed between private property and the ditch in line with an animal trail to the water.

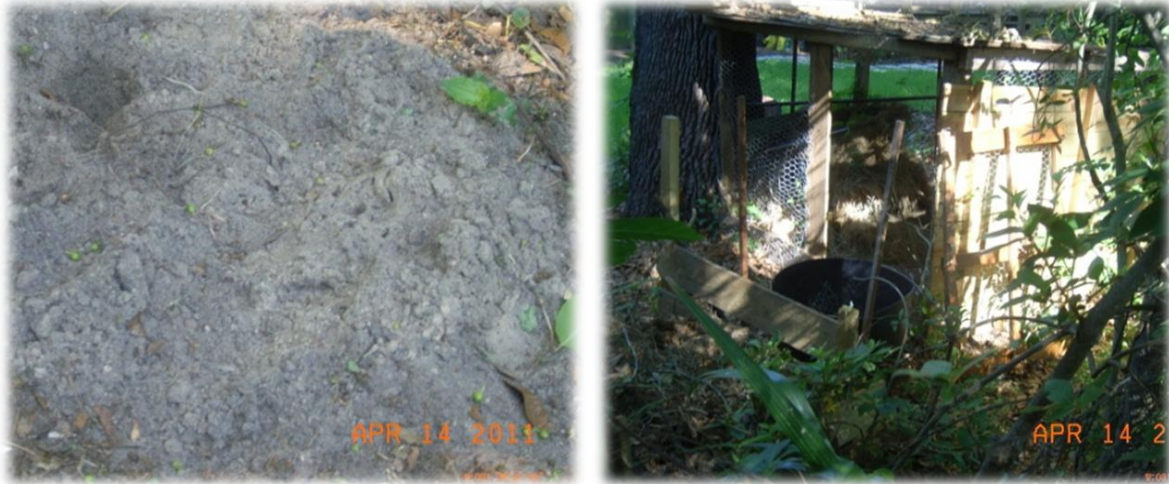
**Figure 38. Near Point 40: Jacksonville Beach, downstream from Pinewood Rd.**

**FIELD NOTES:** A large population of cats is running loose in the area, and tracks were observed during the field event. A possible animal cage was located along the fence, but no animals were observed in it during the walk.

**POST-FIELD NOTES:** Monitoring initiated 10/01/2010 no feral cats indicated north of Beach Blvd and west of Penman Road. Raccoon and Opossum nocturnal traffic is below normal w/1 raccoon and 2 opossum deaths. No indication of feeding today. Observations ongoing.

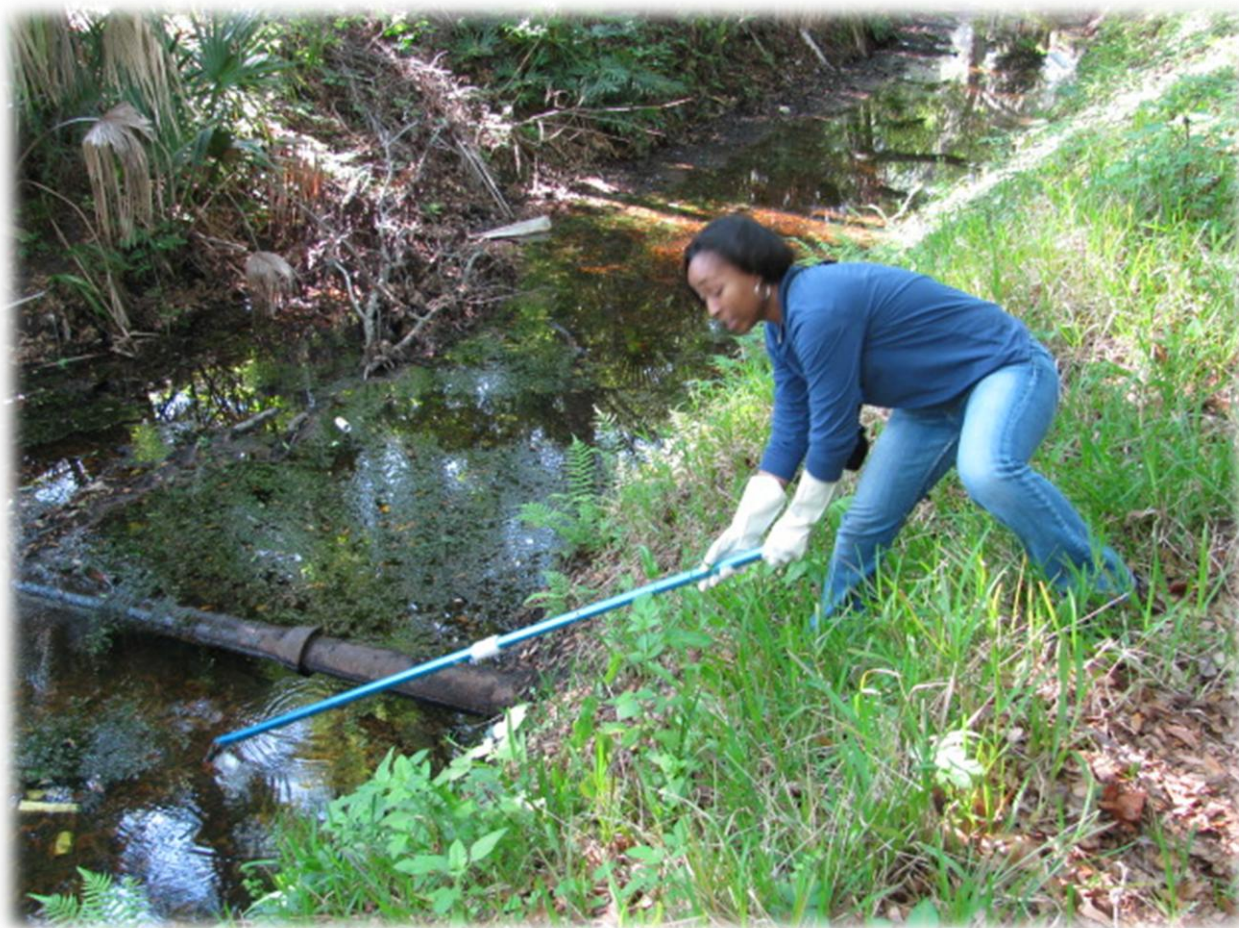
**Figure 39. Point 38: Jacksonville Beach.**

**FIELD NOTES:** A sample was taken downstream of the submerged sanitary sewer pipe; the results showed fecal coliform concentrations of 880 cfu/100mL.

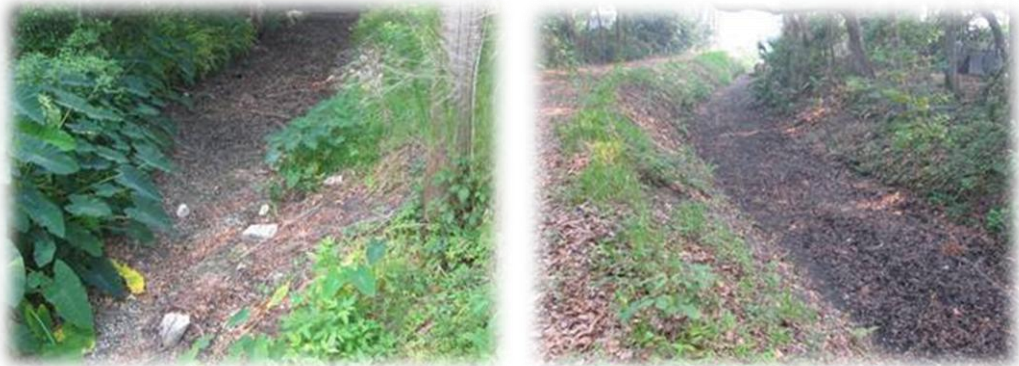
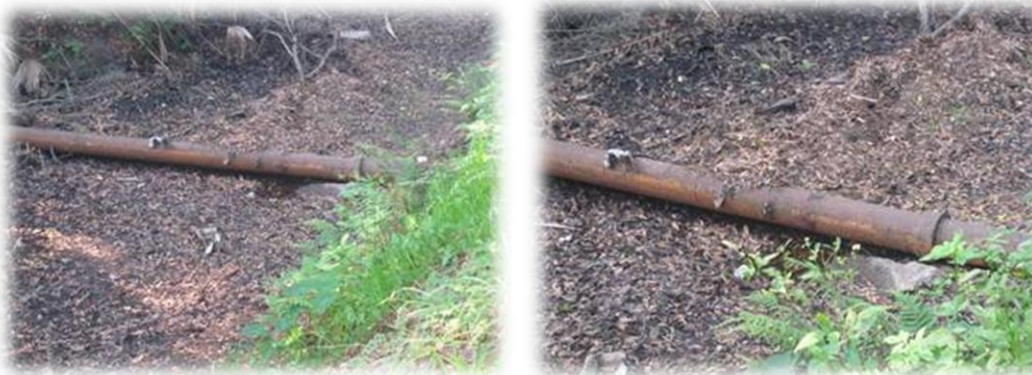
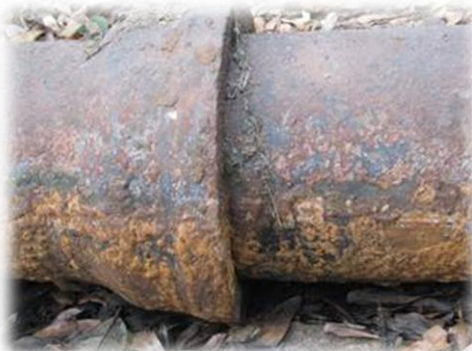
Hi Anita, I tried Tuesday (6/21/11) morning to take SW ditch samples (upstream and downstream of submerged sewer pipe) at point 38. The SW ditch was dry. I will wait until after we get some rain and re-schedule another sample time. While the ditch was dry, I inspected the sewer pipe. **There were no signs of any leaks or smell from the pipe. The pipe was dry.** I will continue to monitor and inspect the sewer piping routinely. I moved some leaves from under the piping for a better visual inspection. I only found a small amount of surface water. Photo's below.

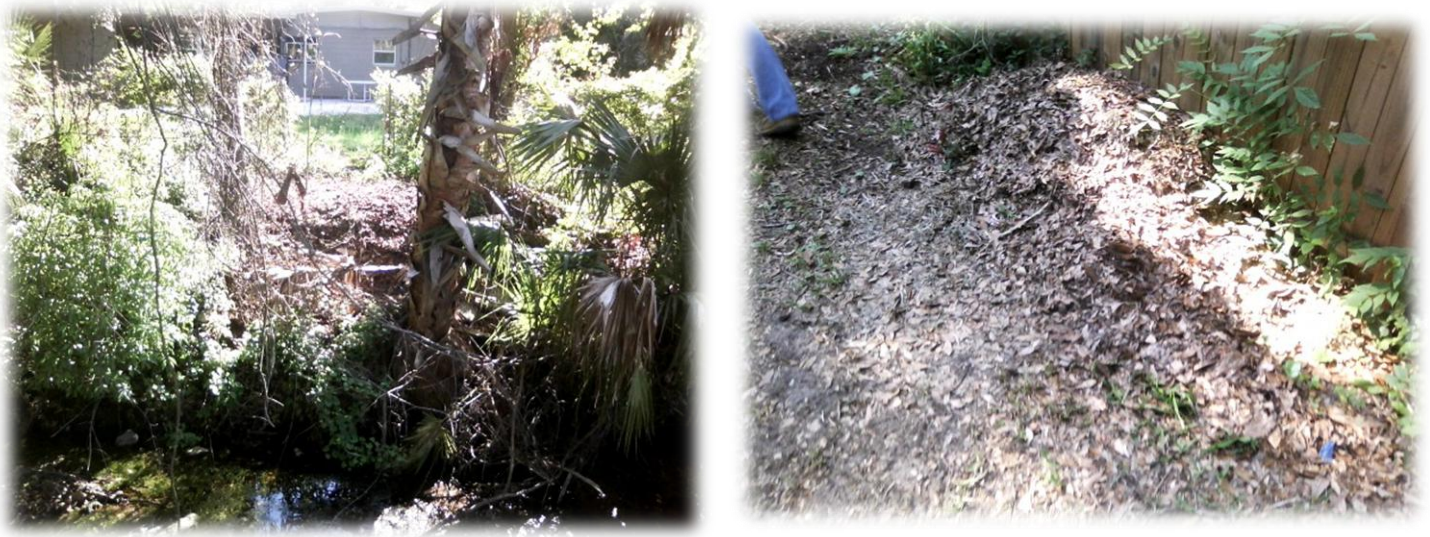
**Figure 40.** Near Point 40: Jacksonville Beach, downstream from Pinewood Rd.

**FIELD NOTES:** Piles of illicitly dumped yard waste were observed along the ditch. Jacksonville Beach will follow up.

**POST-FIELD NOTES:** COJB performed a complete clean up along the entire Pinewood Ditch

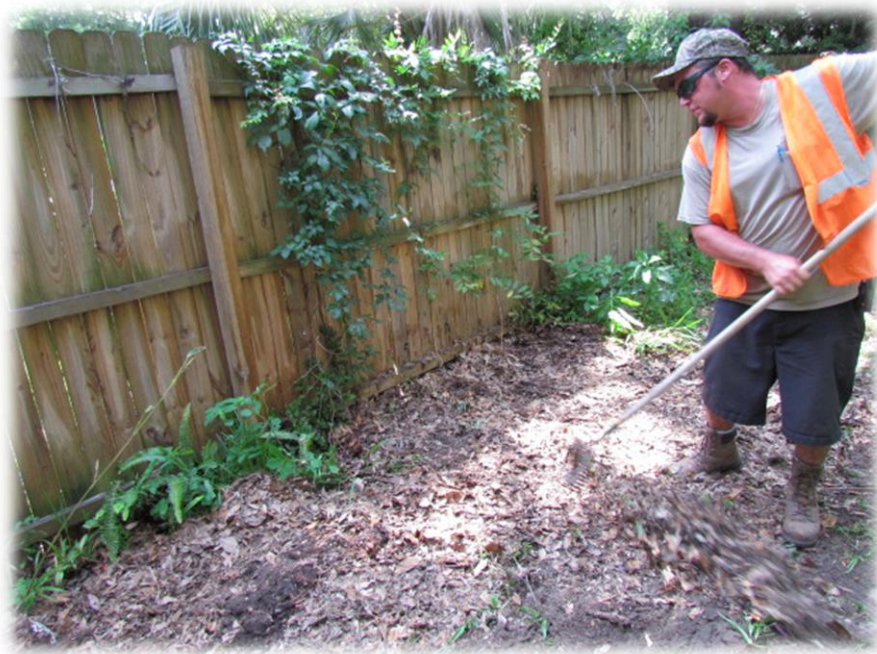
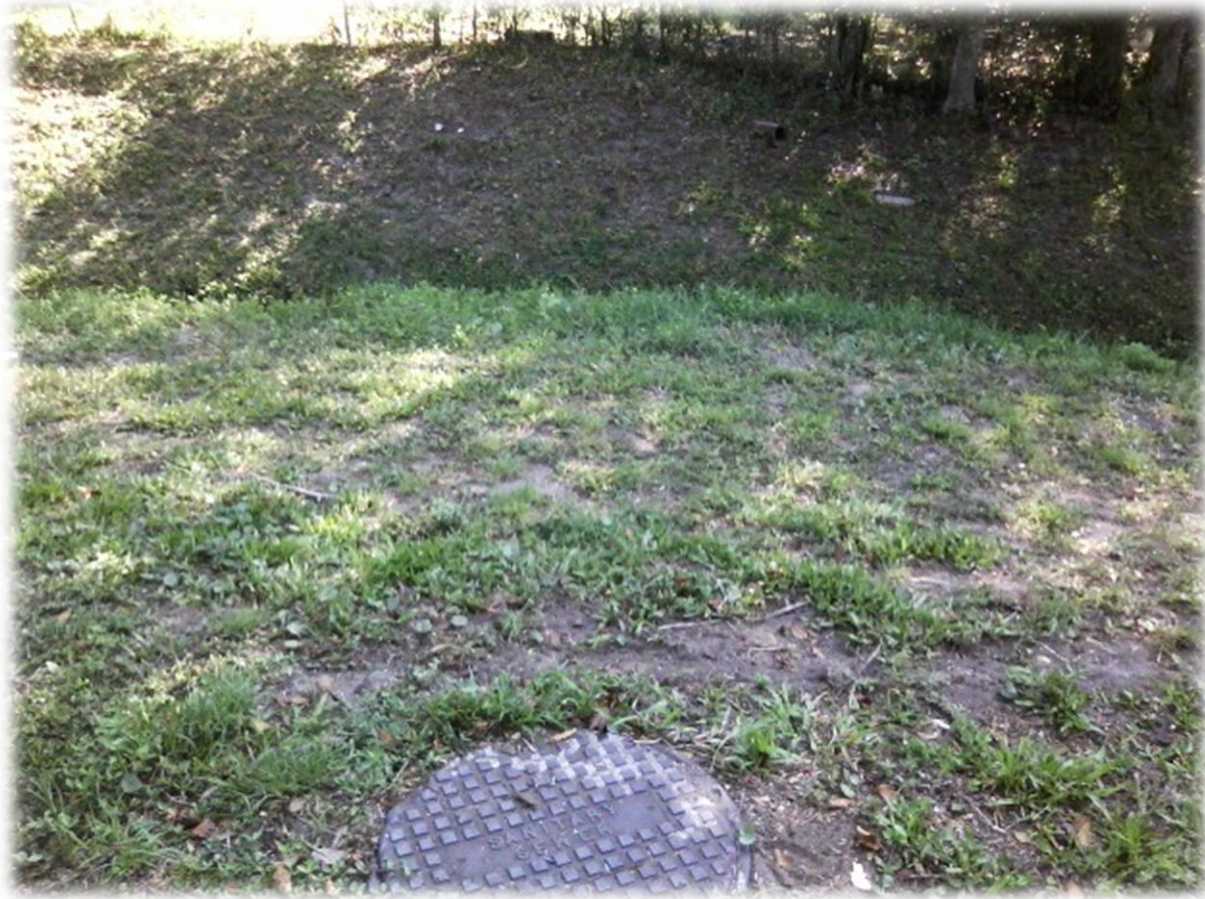
**Figure 41.** *Between Points 39 and 40: Jacksonville Beach, downstream from Pinewood Rd.*

**FIELD NOTES:** *There is a sewer crossing below grade.*

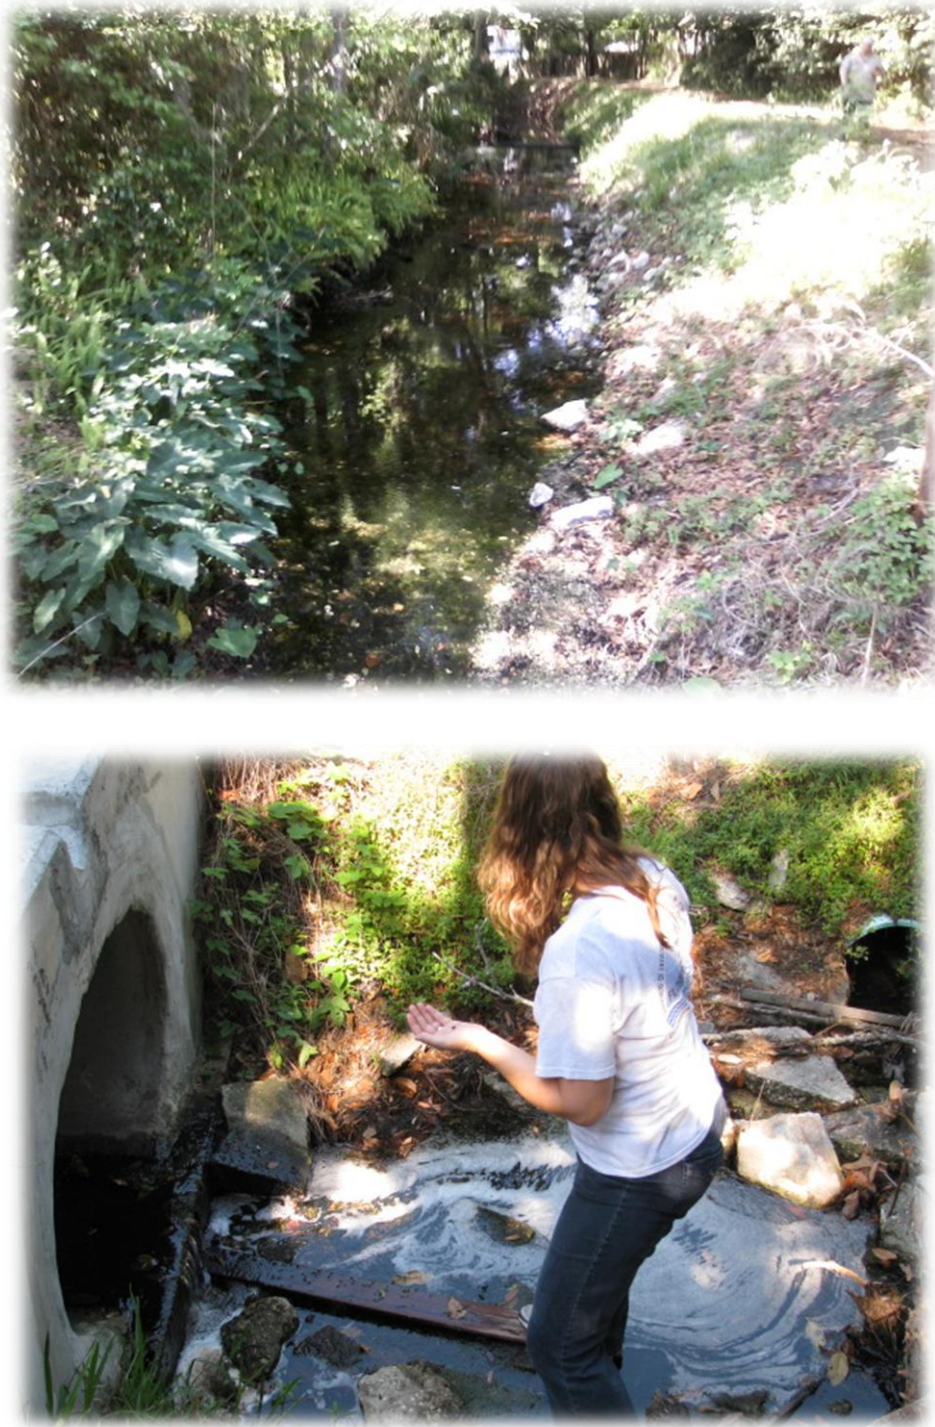
**Figure 42.** Point 38: Jacksonville Beach, Tallwood Rd. crossing.

**FIELD NOTES:** The team noticed a slight methane and/or sulfur smell. An abundance of snails were observed at the culvert at Pinewood Rd. There is a canopy cover in this part of the creek, and the water is foamy.

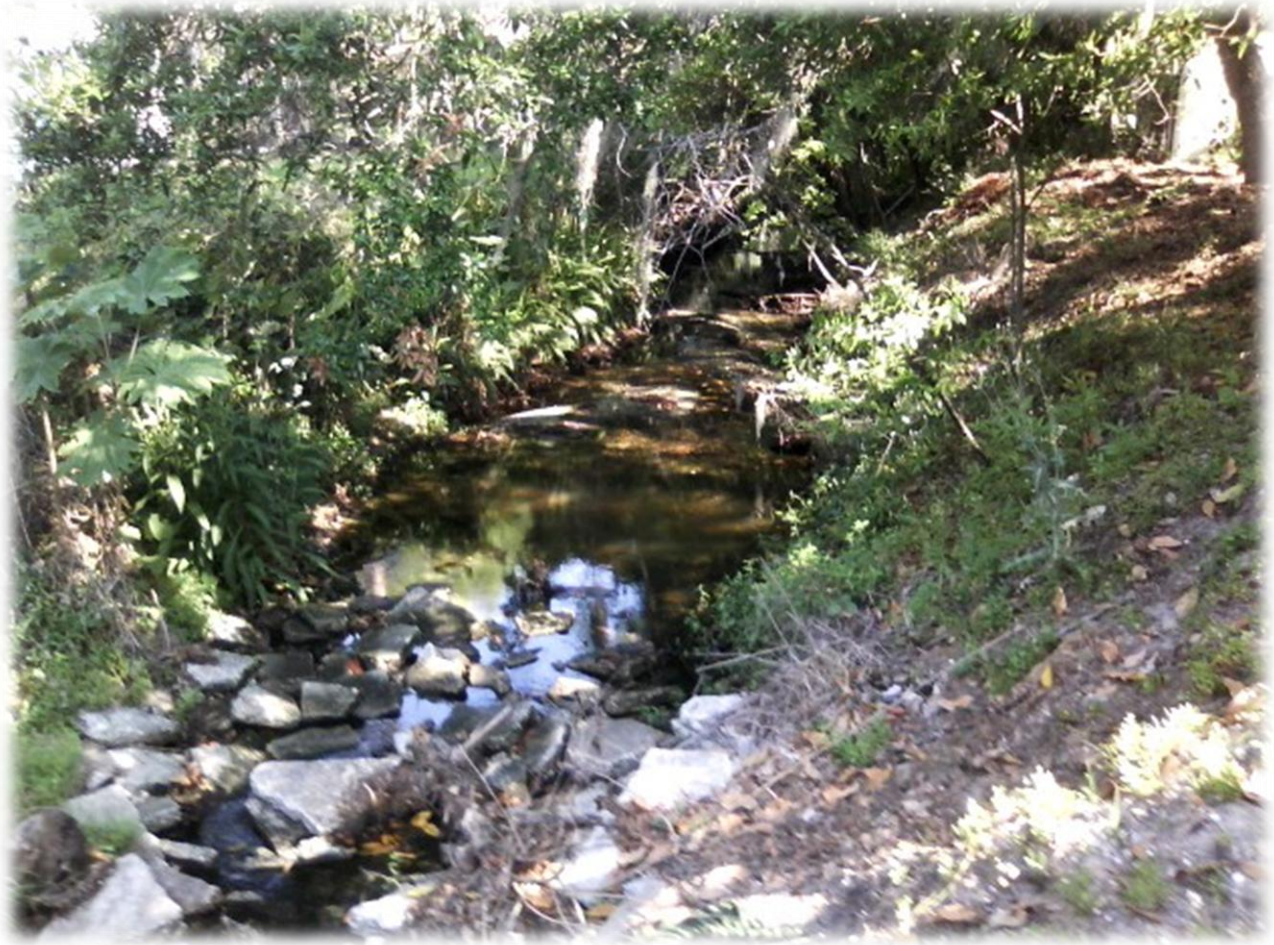
**Figure 43. Point 38: Jacksonville Beach, Tallwood Rd. crossing.**

**FIELD NOTES:** There is a dense canopy cover in this stretch of the creek. This is a Jacksonville Beach TMDL sampling station. The station is tidal and flows both directions.

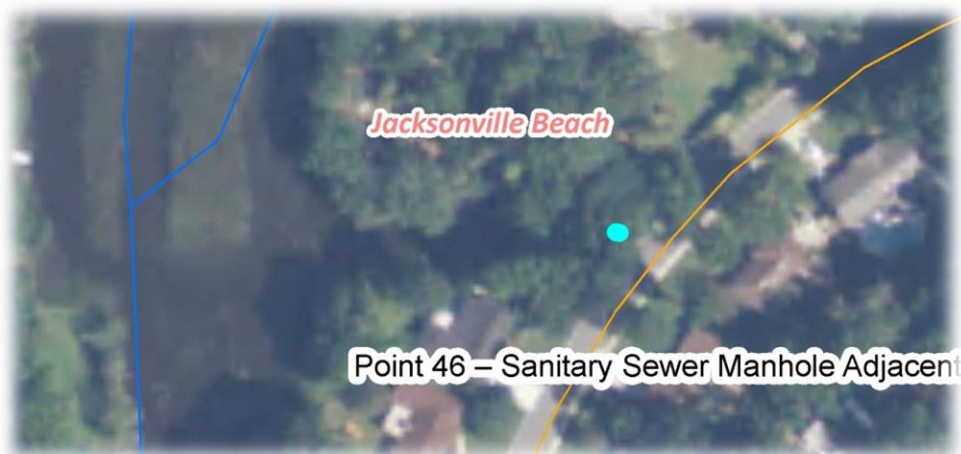
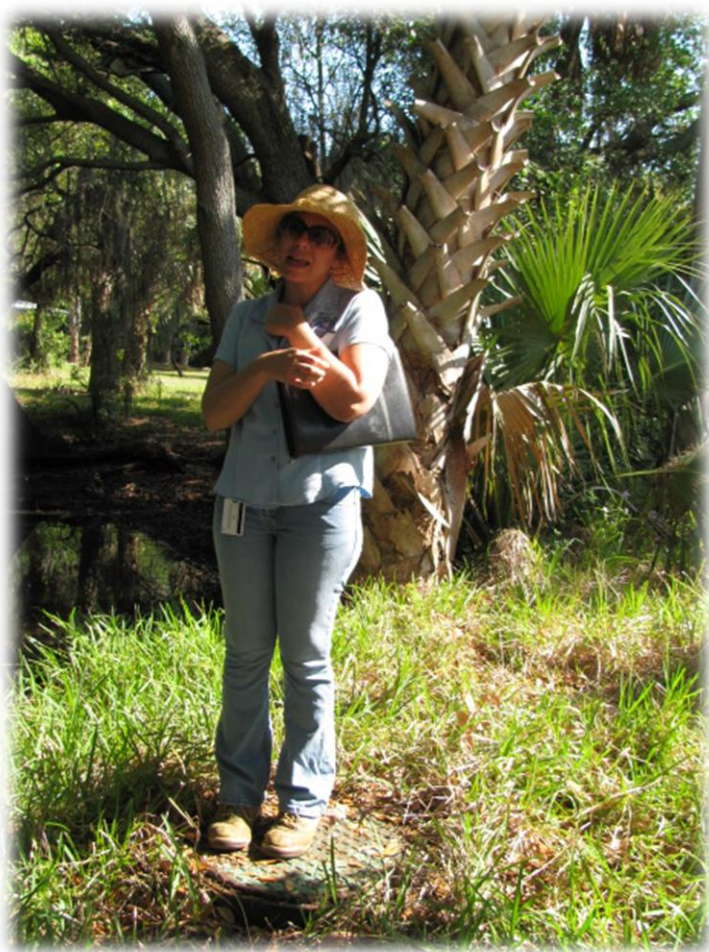
**Figure 44. Point 46: Jacksonville Beach, Arden Way.**

**FIELD NOTES:** The top photo shows the field notes taken during the walk. There is a lift station near the creek. Jacksonville Beach will review the history of the manhole near the creek (bottom photo).

**POST-FIELD NOTES:** The manhole was refurbished, and flow re-routed, pipe lined 2009. Per Distribution & Collection CJB 06/28/2011

Contacted Pam Morgan Supervisor COJB Waste Water Treatment Plant. There **have not been any sewer over flows at this location** in the history of the outfall.

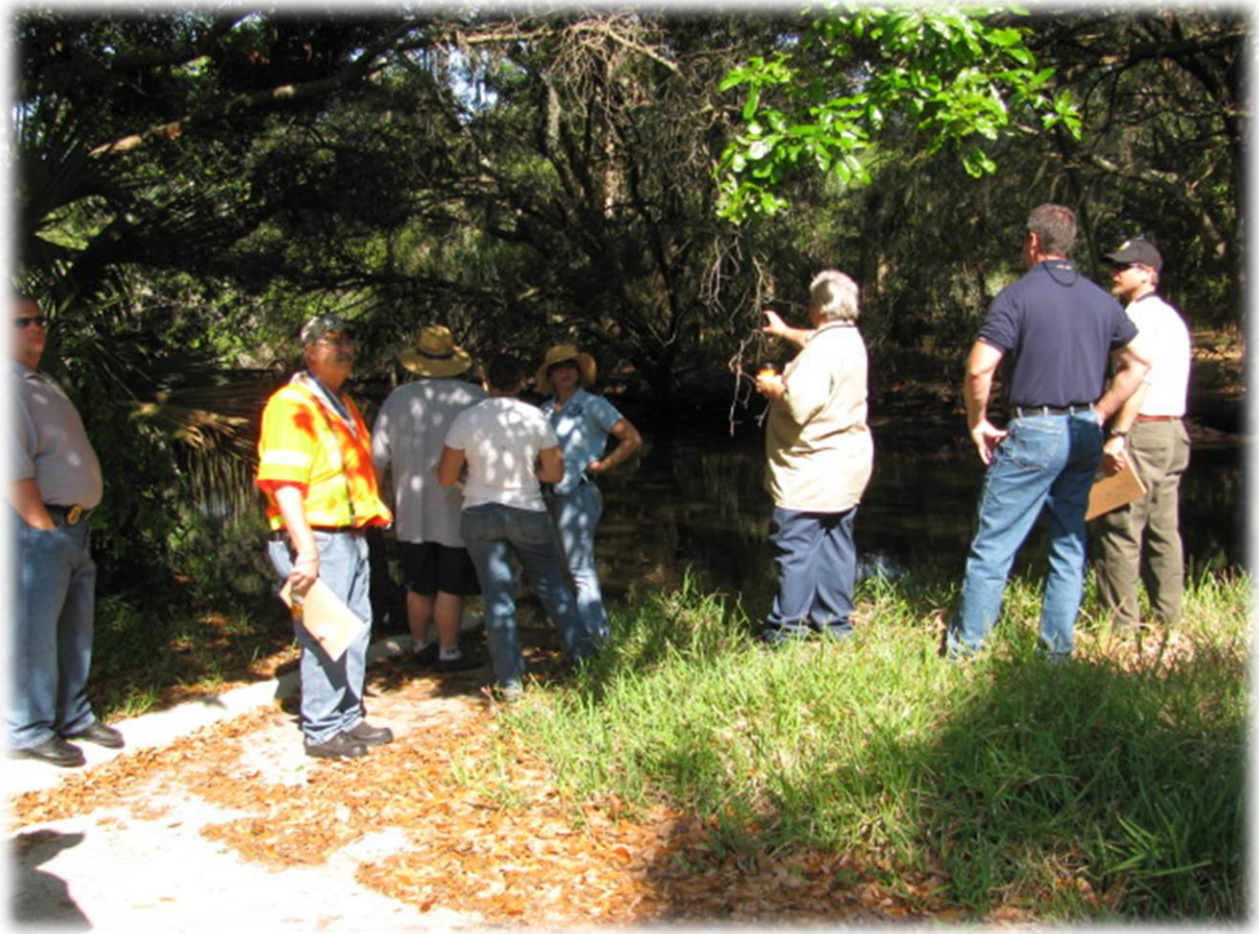
**Figure 45. Point 46: Jacksonville Beach, Arden Way.**

**POST-FIELD NOTES:** *At this location, the ditch has low to no velocity and heavy canopy cover.*

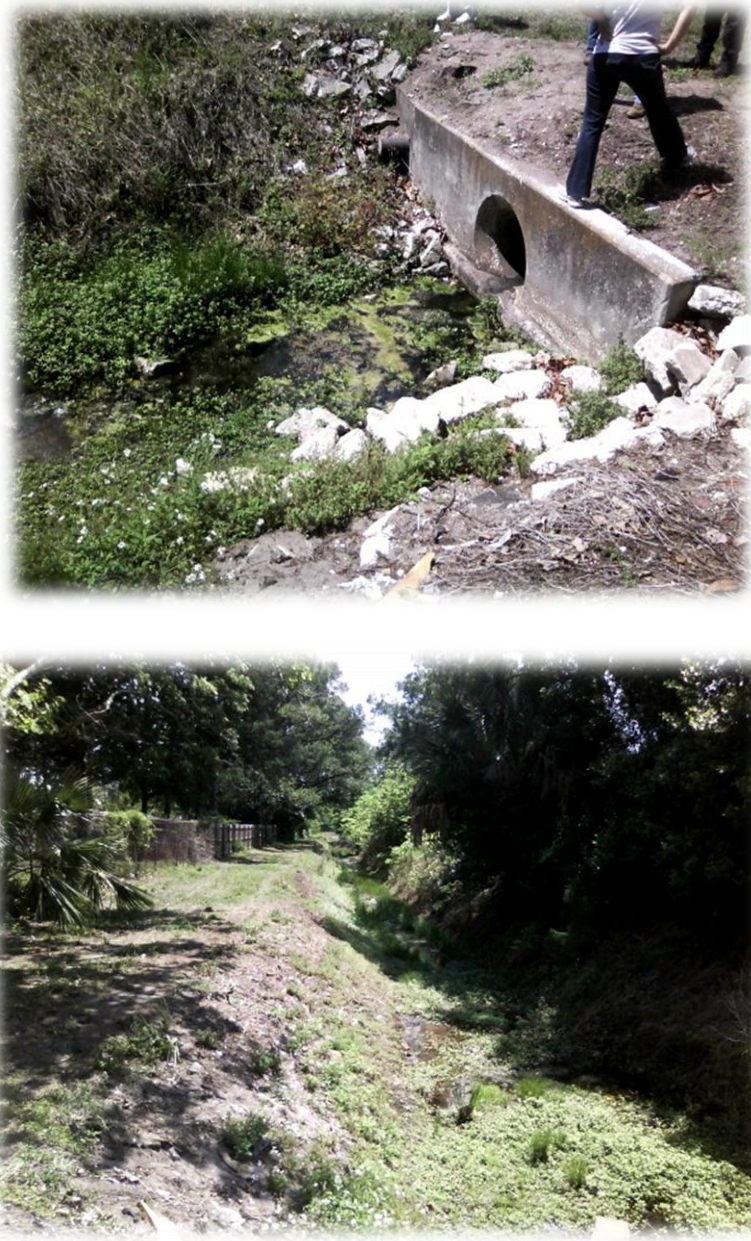
**Figure 47. Point 52: Atlantic Beach, Mayport Rd. and Saratoga Ditch (FDOT ditch).**

**FIELD NOTES:** Algae are growing in still water. A city lift station is adjacent to this location. The ductile iron pipe on the far edge of the wall is grouted shut (top photo), and there is heavy canopy cover and vegetation in the ditch (bottom photo).

**POST-FIELD NOTES:** July 28, 2011, FDOT's contractors thinned vegetation in the ditch next to the lift station exposing the ditch to sunlight and to repaired erosion and removed debris from the flow line. See photos below.

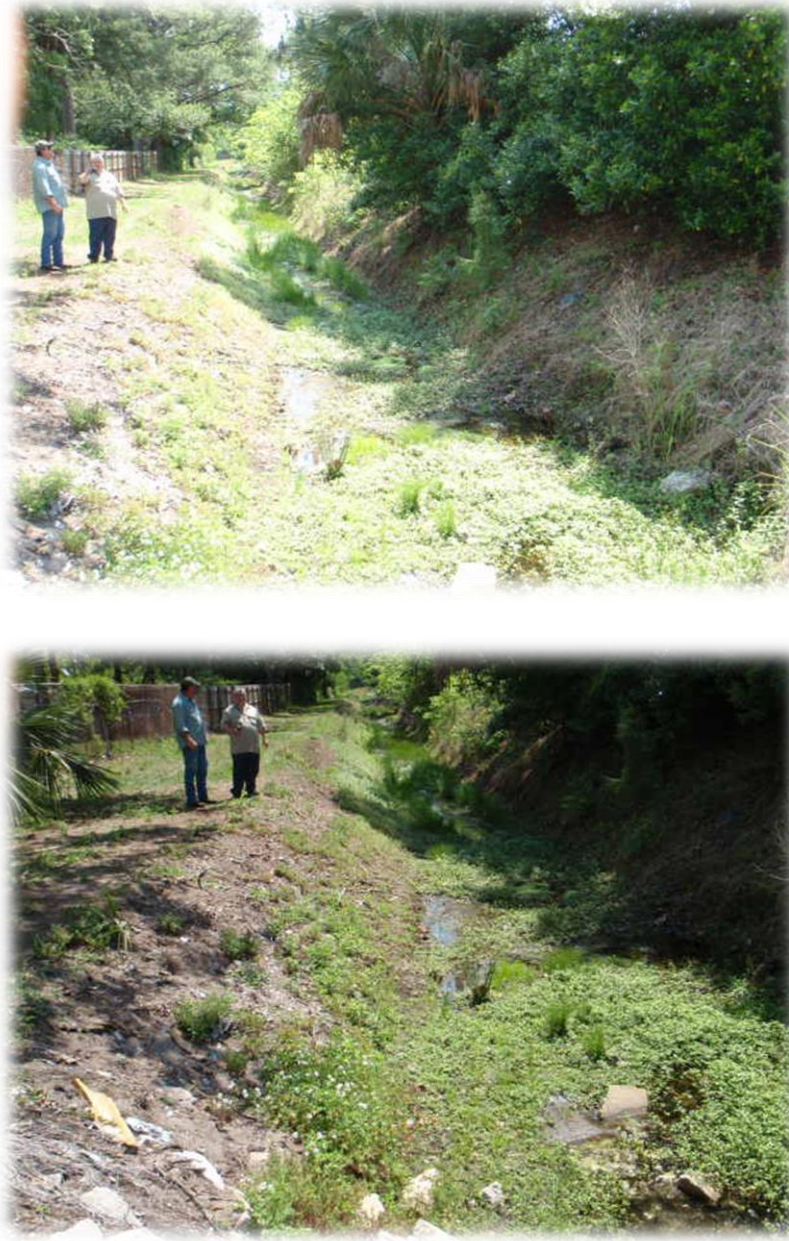
**Figure 48. Point 52: Atlantic Beach, Mayport Rd. and Saratoga Ditch (FDOT ditch).**

**FIELD NOTES:** The area is heavily overgrown.

**POST-FIELD NOTES:** July 28, 2011, FDOT's contractors thinned vegetation in the ditch next to the lift station exposing the ditch to sunlight and to repaired erosion and removed debris from the flow line. See photos below.
