# Summary of Results

## Walk the Waterbody Exercise for Hopkins Creek (WBID 2266)

***Florida Department of Environmental Protection  
Division of Environmental Assessment and Restoration  
Bureau of Watershed Restoration  
Tallahassee, FL 32399***

**August 2011**

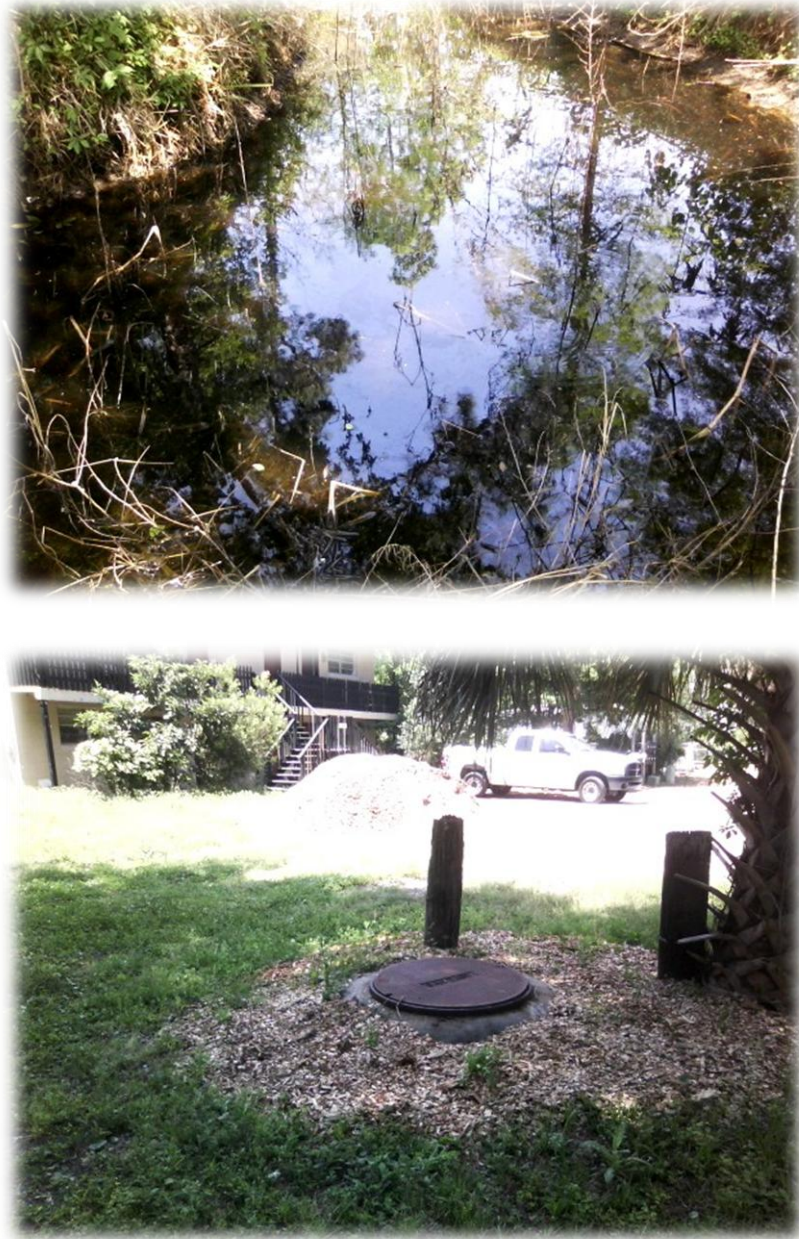
**Figure 50. Point 12: Atlantic Beach, at the end of Stanley Rd.**

**FIELD NOTES:** In the headwaters, the team observed a sheen on the surface of the water resembling petroleum product (top photo). This could be pesticides from spraying the previous week. The manhole near the creek has mulch around it near the ditch, possibly indicating overflows (bottom photo).

**POST-FIELD NOTES:** Atlantic Beach staff went back a few days after the field event and said the sheen was gone. The ditch was checked several times more. However, the ditch was dry due to the drought. Atlantic Beach will check the history of manhole overflows at this location.

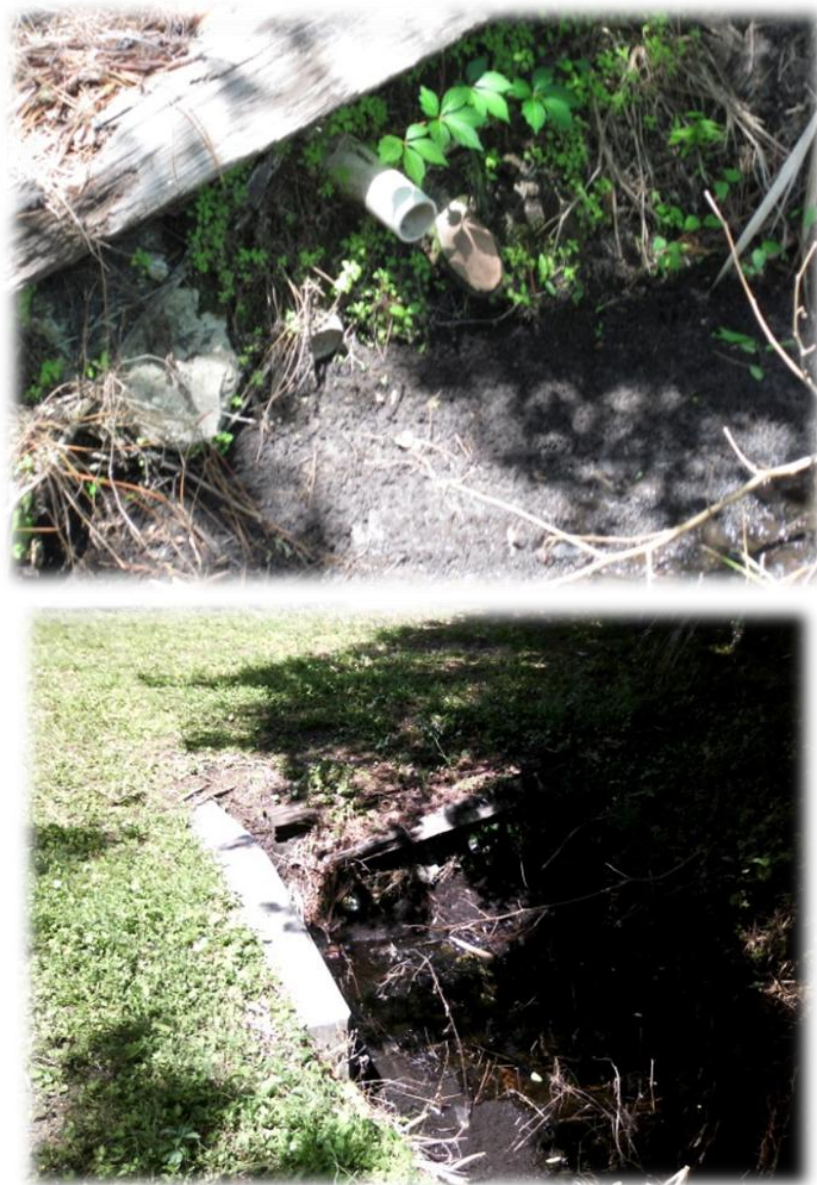
**Figure 52. Point 12: Atlantic Beach, at the end of Stanley Rd.**

**FIELD NOTES:** A potential illicit discharge was observed (a 2-inch pipe) (top photo). Although it was stated by AB staff that the pipe was capped at the homeowner's end years ago. A sample taken during the field event showed fecal coliform concentrations of 27 cfu/100mL. Piles of yard rakings, mainly pine needles, were observed on the bank and in the ditch (bottom photo).

**POST-FIELD NOTES:** Follow-up by Atlantic Beach indicated that the pipe has been capped at the ditch end and was not connected to anything as was noted in the field. Atlantic beach staffspoke with the land owners about not dumping yard clippings/rakings along the ditch.

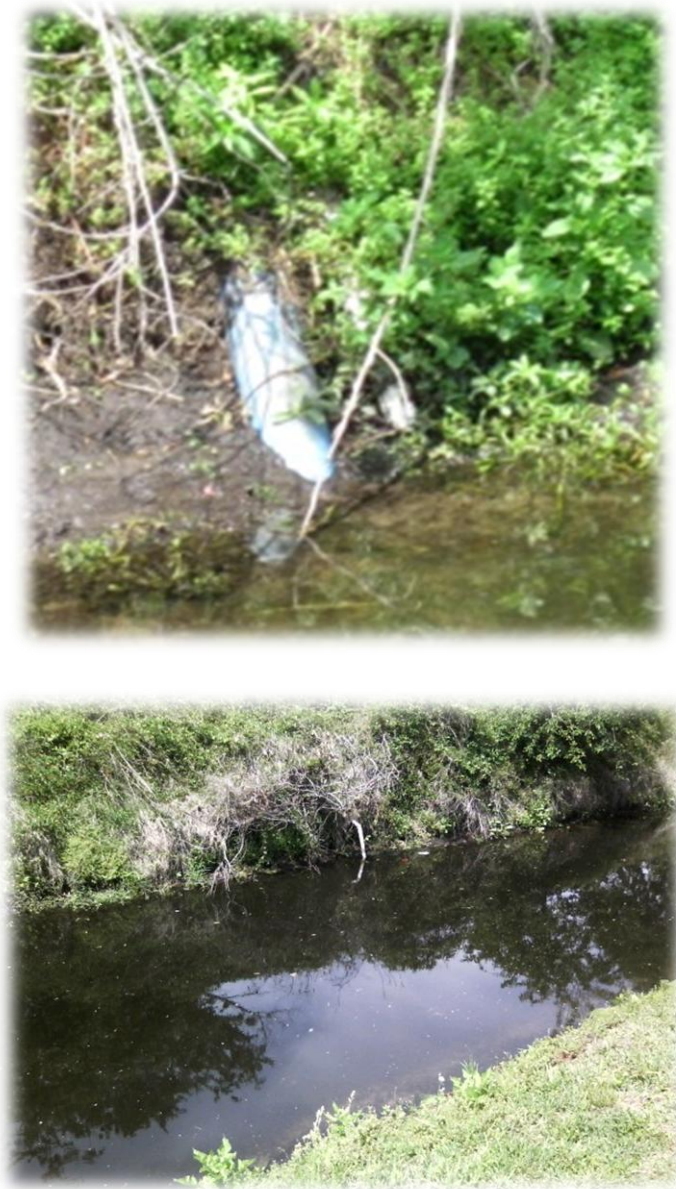
**Figure 54. Point 6: Atlantic Beach.**

**FIELD NOTES:** Three PICs were observed at the beginning of this stretch.

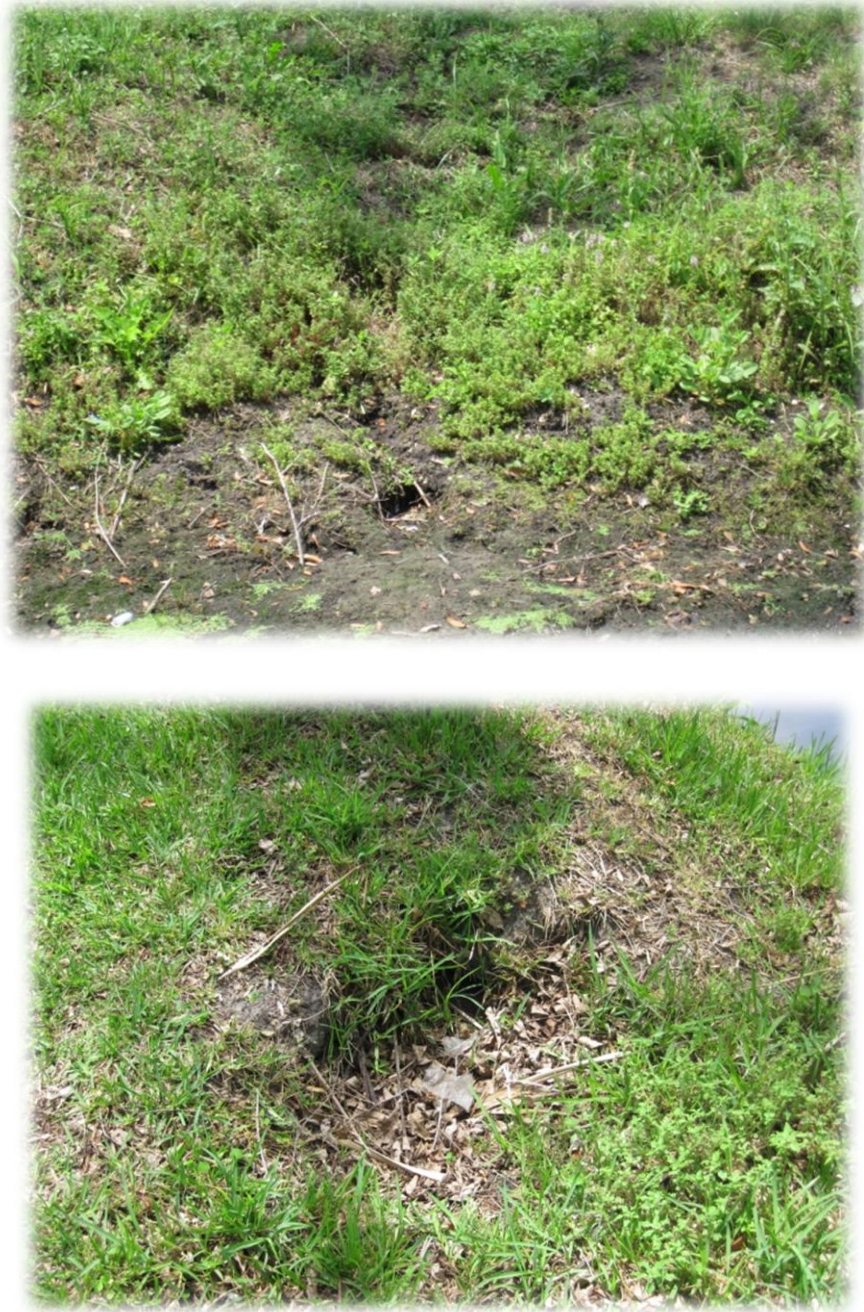
**Figure 55. Point 6: Atlantic Beach.**

**FIELD NOTES:** Two more discrete PICs (eroded flow paths) were observed in this stretch. The source was a roof drain on an adjacent building.

**POST-FIELD NOTES:** Atlantic Beach will investigate whether anything can be done about the roof drain, but this is unlikely.

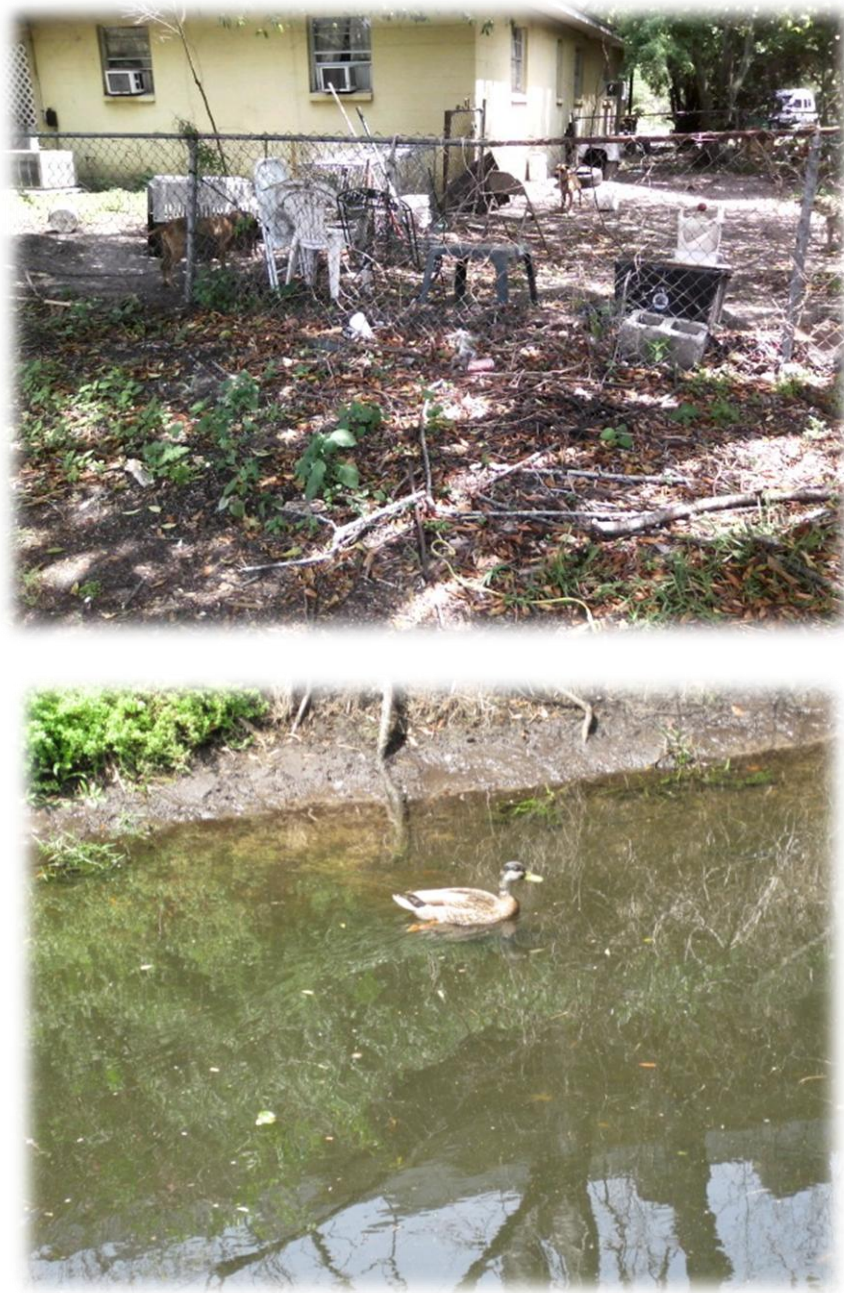
**Figure 56. Point 6: Atlantic Beach.**

**FIELD NOTES:** Dog waste was observed in neighboring yards (top photo), as well as waterfowl and turtles in the ditch (bottom photo). There is very low flow in this stretch.

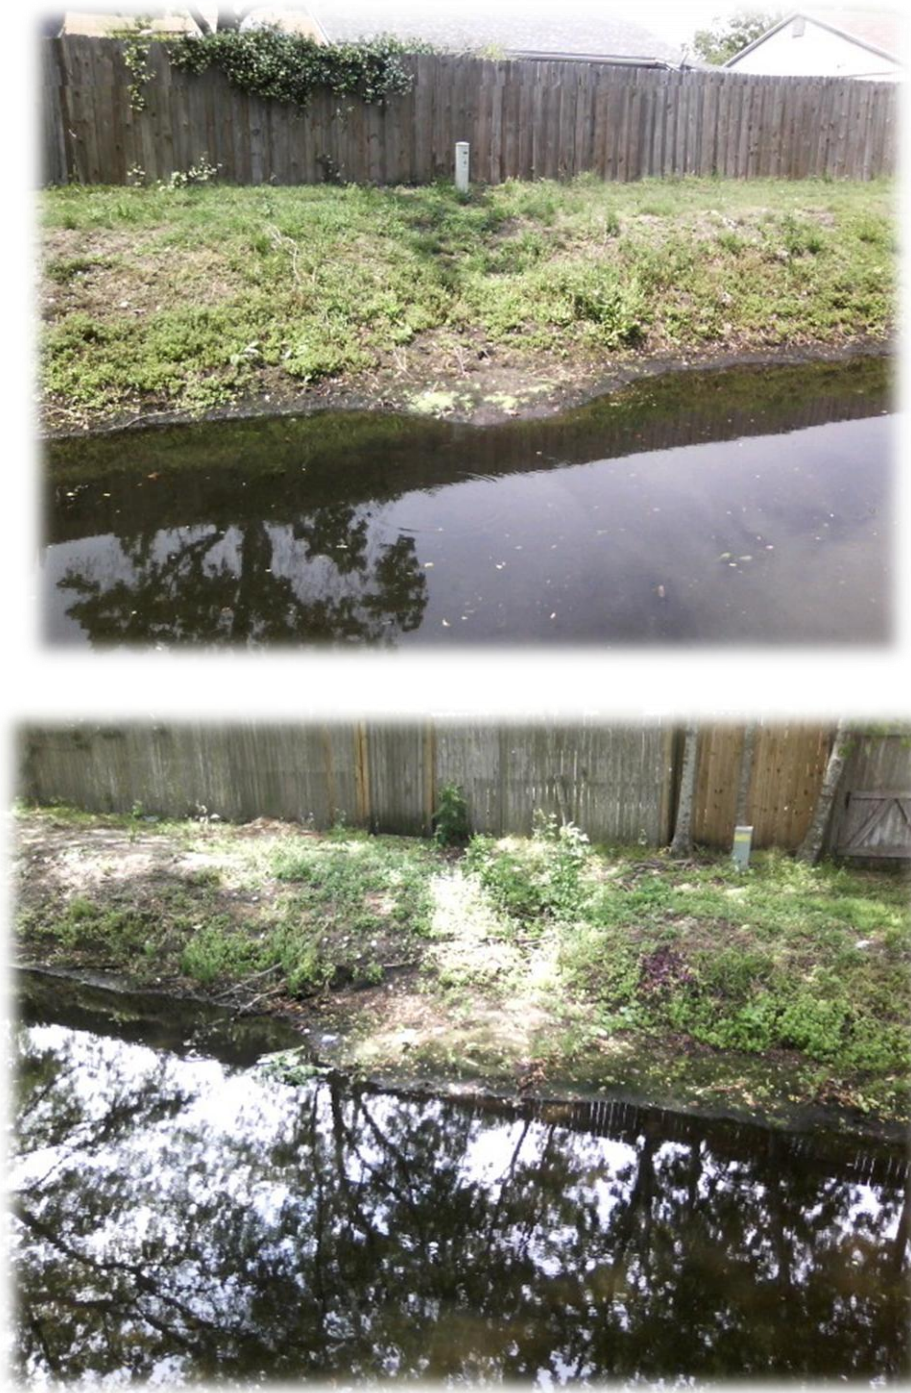
**Figure 57. Point 6: Atlantic Beach.**

**FIELD NOTES:** The team observed erosion from backyard runoff, caused by a natural low spot in the adjoining yards.

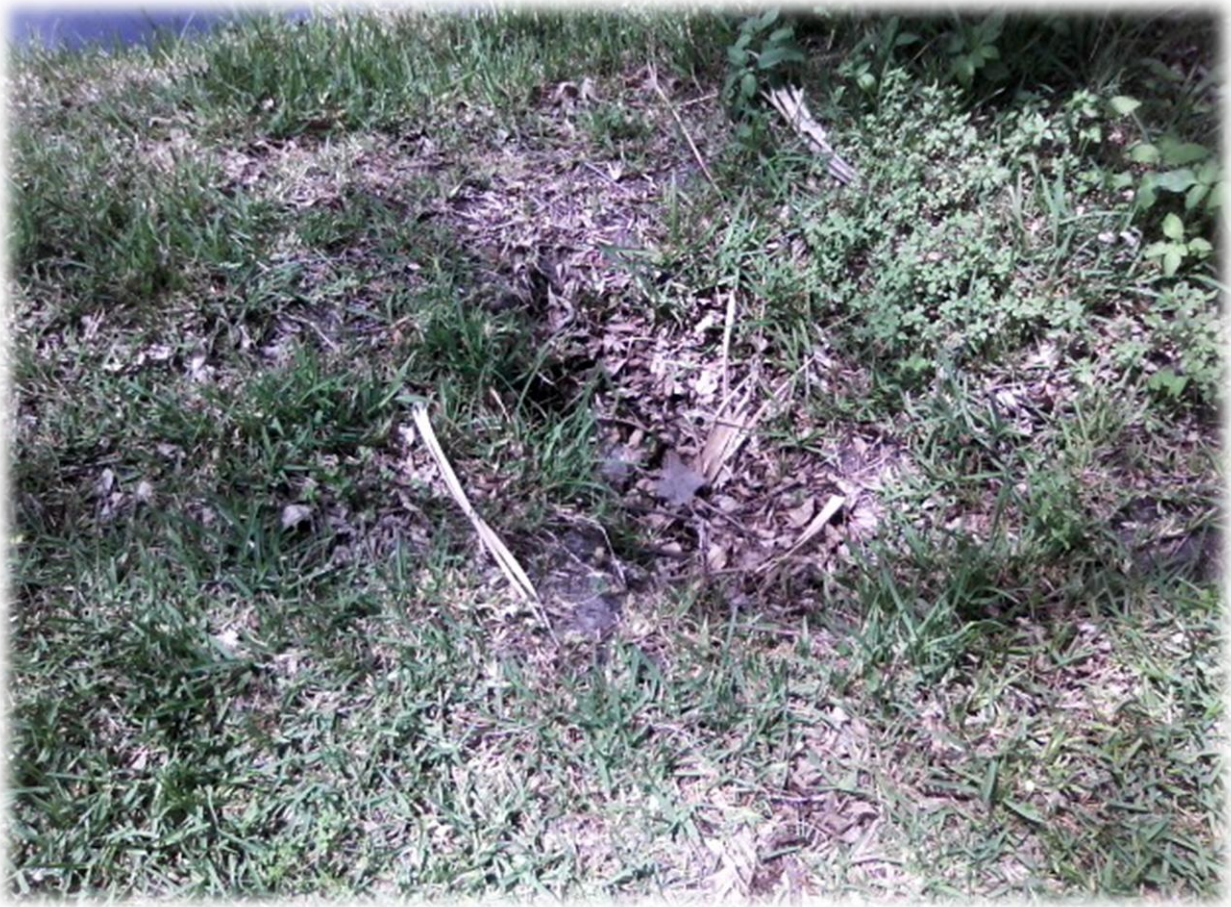
**Figure 58. Point 6: Atlantic Beach.**

**FIELD NOTES:** A hole was observed along the ditch.

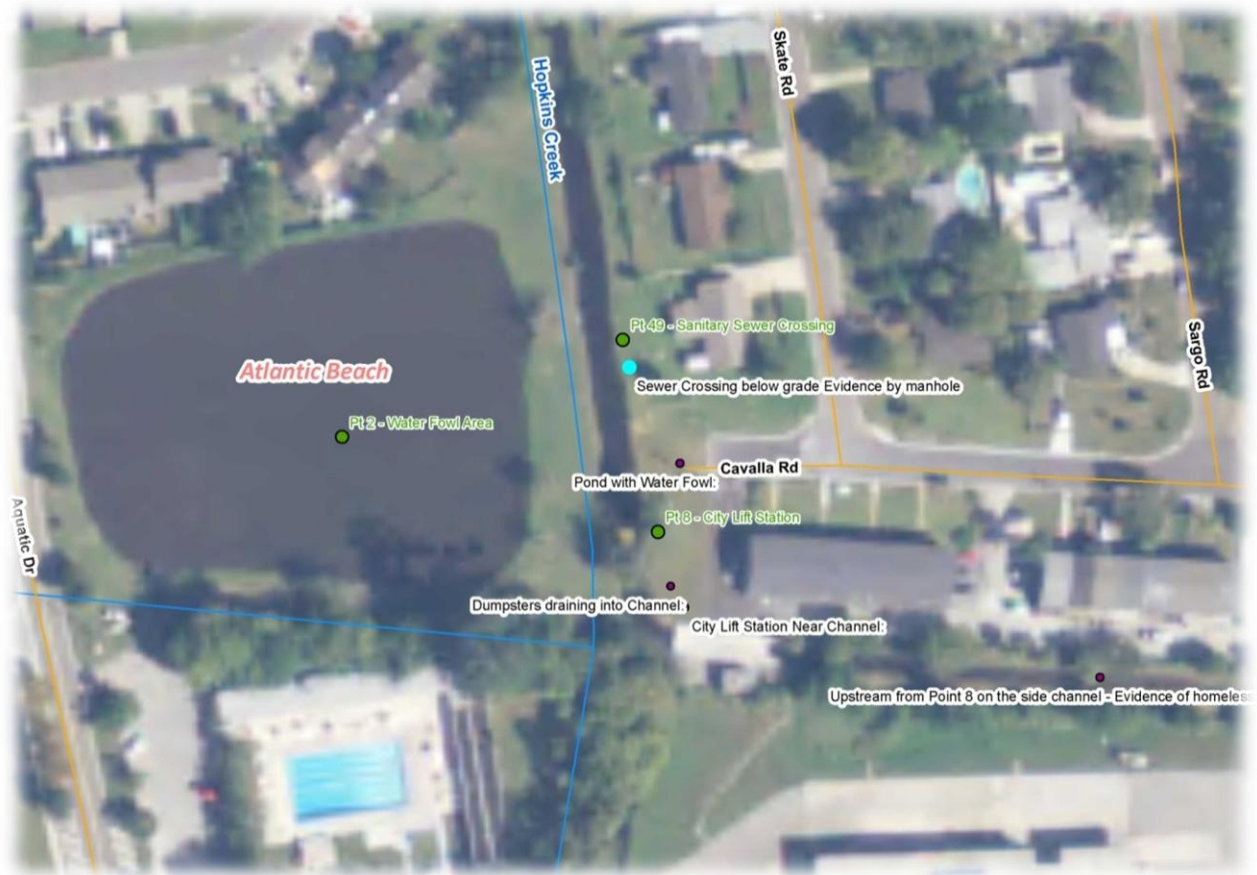
**Figure 59. Point 49: Atlantic Beach.** The aerial photo shows the field notes taken during the walk. There is a sewer crossing below grade.

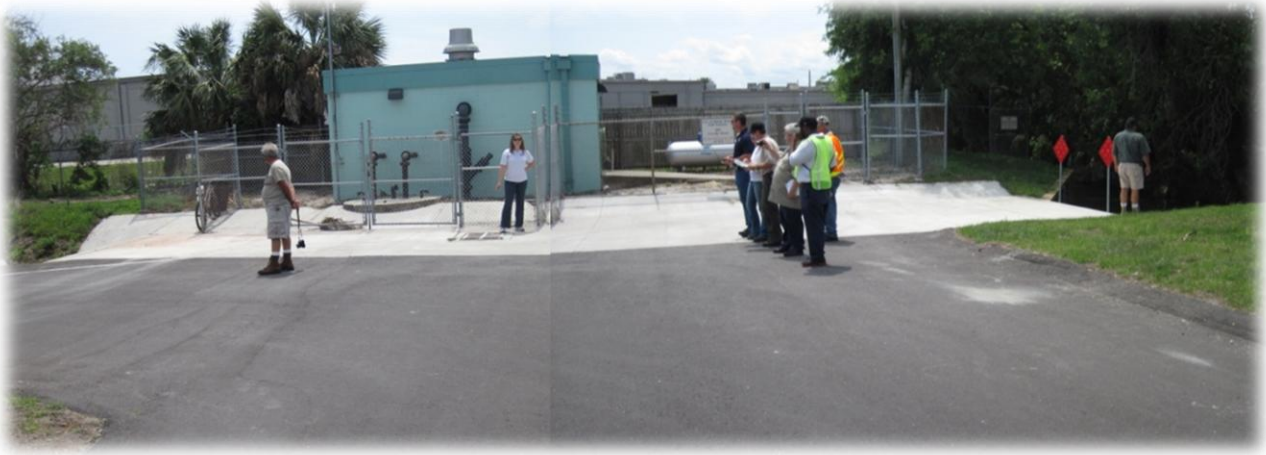
**Figure 61. Point 8: Atlantic Beach.**

**FIELD NOTES:** There is a well-maintained lift station on the Skate Road Ditch. Since there is no berm or catchment, an overflow could potentially flow directly into the creek.

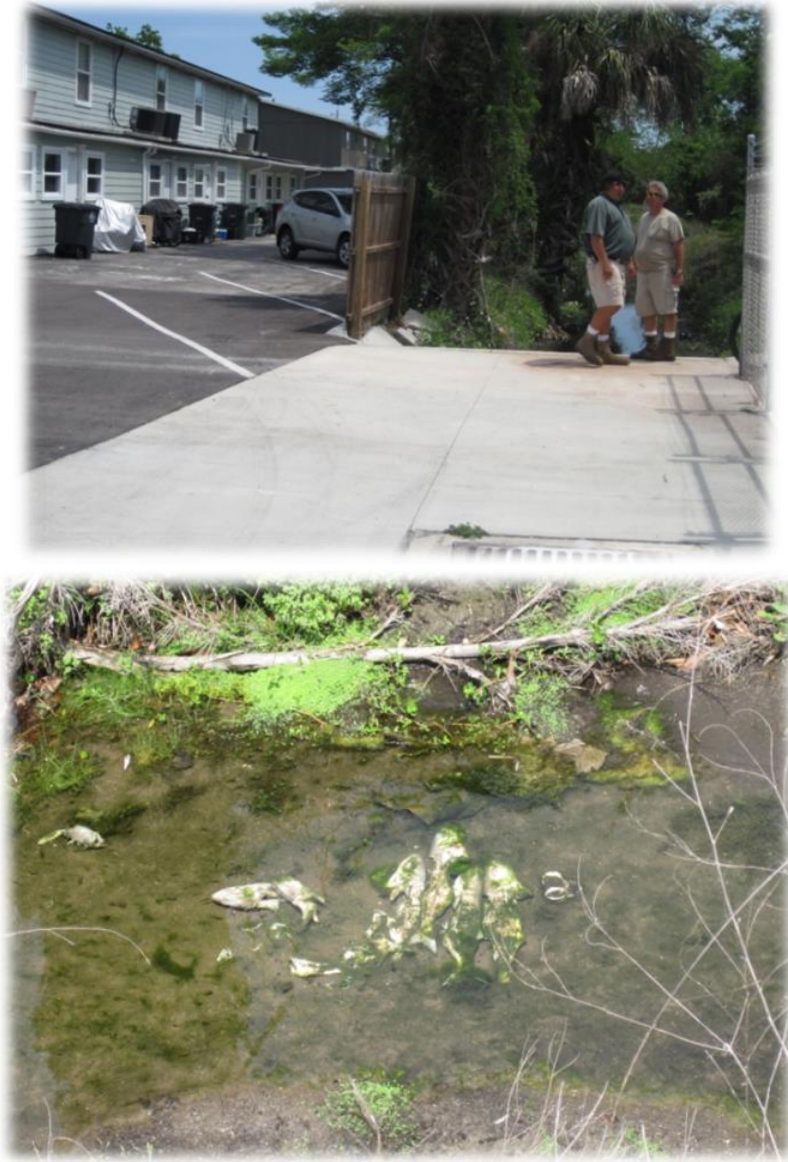
**Figure 62. Point 8: Atlantic Beach.**

**FIELD NOTES:** Residential runoff from the Royal Palm complex runs directly to the ditch (top photo). The team observed filleted fish carcasses dumped into the ditch (bottom photo).

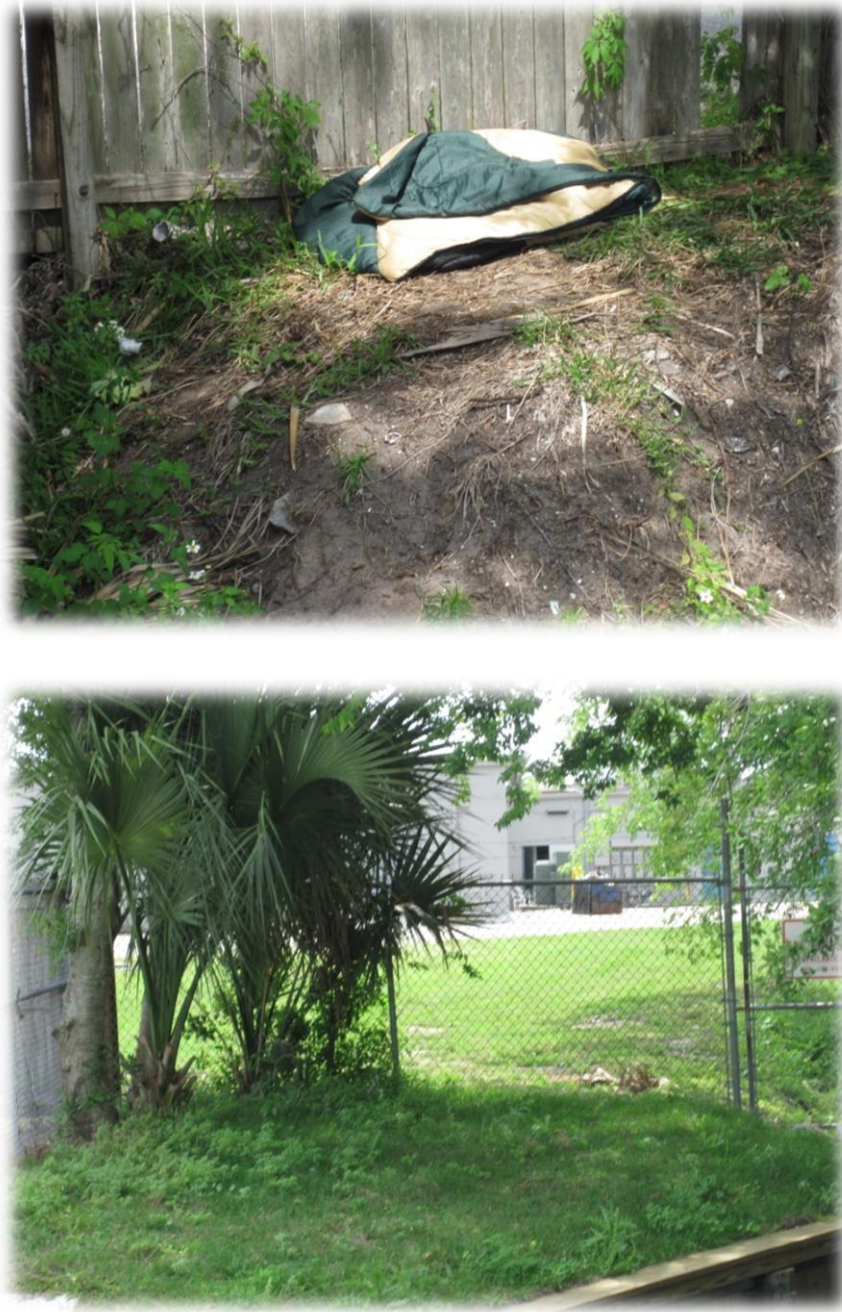
**Figure 63. Point 8: Atlantic Beach.**

**FIELD NOTES:** There may be homeless people staying along the ditch. The team noticed a sleeping bag (top photo) and 2 chairs behind the fence on the ditch side. Overflowing dumpsters also drain to the ditch (bottom photo).

**POST-FIELD NOTES:** Atlantic Beach will follow up to see if the homeless individuals return and will keep an eye on the dumpsters for overflow.

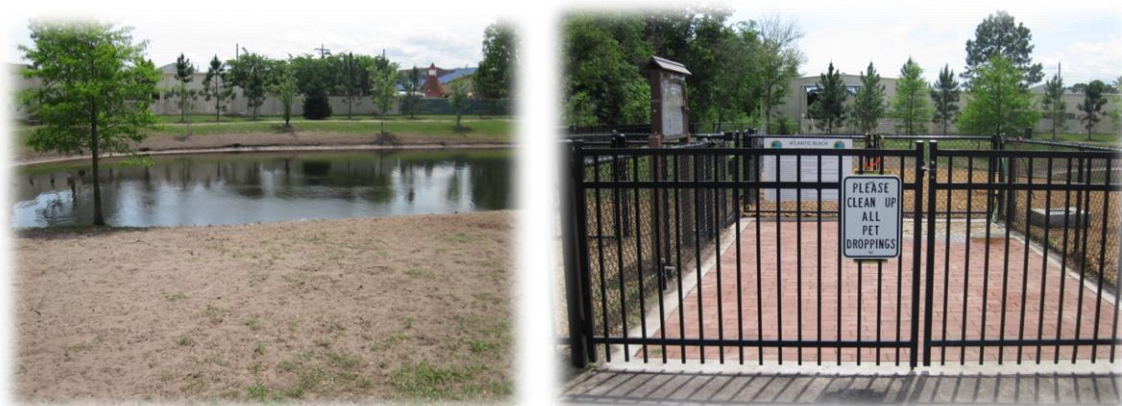
**Figure 65. Point 1: Atlantic Beach, Dog Park.**

**FIELD NOTES:** The photos show a dog park around the stormwater pond. An adjacent property, Point 10, has been known to be a homeless camp in the past, but no signs of recent activity were observed.
