# USGS-SWFWMD Cooperative Funding Study

## Streamflow Losses through Karst Features in the Upper Peace River Hydrologic Area, Polk County, Florida, May 2002 to May 2003

# **Effect of Karst Development on Peace River Flow**

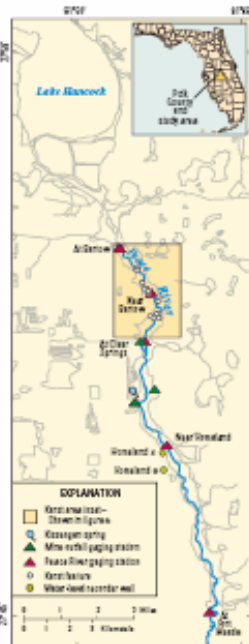
Figure 1. Upper Peace River Hydrologic Area, Polk County, Florida.

In October 2001, the U.S. Geological Survey (USGS) in cooperation with the Southwest Florida Water Management District (SWFWMD) began a study to evaluate the distribution, timing, and volume of surface-water to ground-water exchange in the Upper Peace River Hydrologic Area in Polk County, Florida (fig. 1). Historically, ground-water levels in
