# St. Joseph Peninsula Beach Nourishment Project Gulf County, Florida

## *Post-Construction Monitoring Report 2023*

This information is provided in partial fulfillment of the monitoring requirements in JCP Permit No. 0342057-001-JC, Gulf County, Florida for the St. Joseph Peninsula Beach Nourishment and Environmental Enhancement Project and the T.H. Stone Memorial St. Joseph Peninsula State Park Project

November 30, 2023  
MRD Project No. 23-210.009

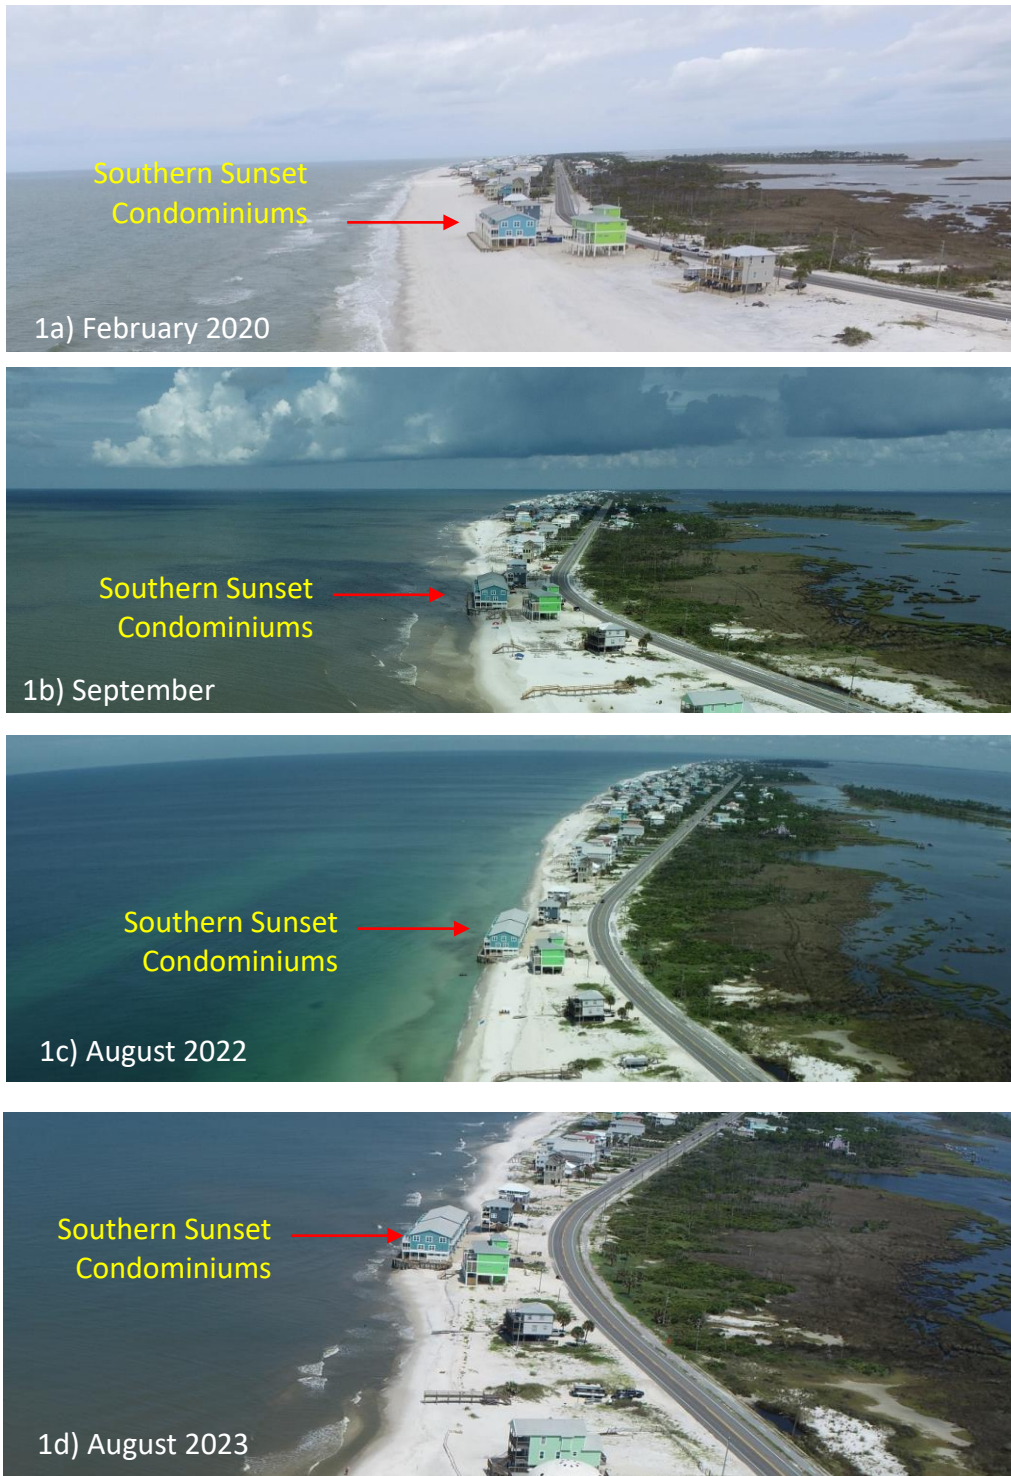
**Photo 1 (a-d.)** Shoreline evolution in the vicinity of the Southern Sunset Condominiums in (a) February 2020 (post-construction), (b) September 2021, (c) August 2022, and (d) August 2023 looking from south to north.

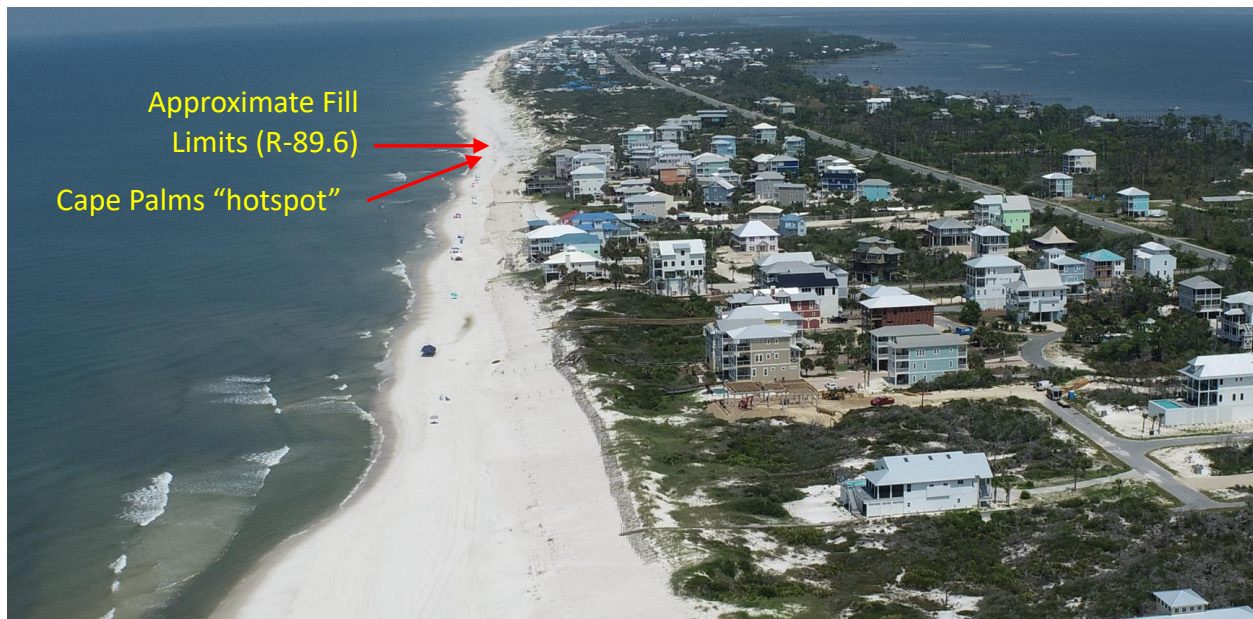
Additionally, following the construction of the 2008 Project, a "hotspot" was identified at Cape Palms Park between R-89 and R-90 (MRD, 2014). During Hurricane Michael, the townhomes (Cape Shoals) immediately to the north of Cape Palms were destroyed and were demolished prior to

the construction of the 2019 Project. Since the construction of the 2019 Project, there has been significant erosion observed at the Cape Palms Park between R-90 and R-90.5 (**Photo 2**).

**Photo 2.** Observed “hotspot” erosion at Cape Palms in August 2023. Photo looking from south to north.
