Beach Management Funding Assistance Program  
Local Government Funding Request  
Fiscal Year 2025/2026  
Beach Projects Application

## Bonita Beach Groin Repair

# BONITA BEACH TERMINAL GROINS DAMAGE REPORT FOR HURRICANE IAN; LEE COUNTY, FLORIDA.

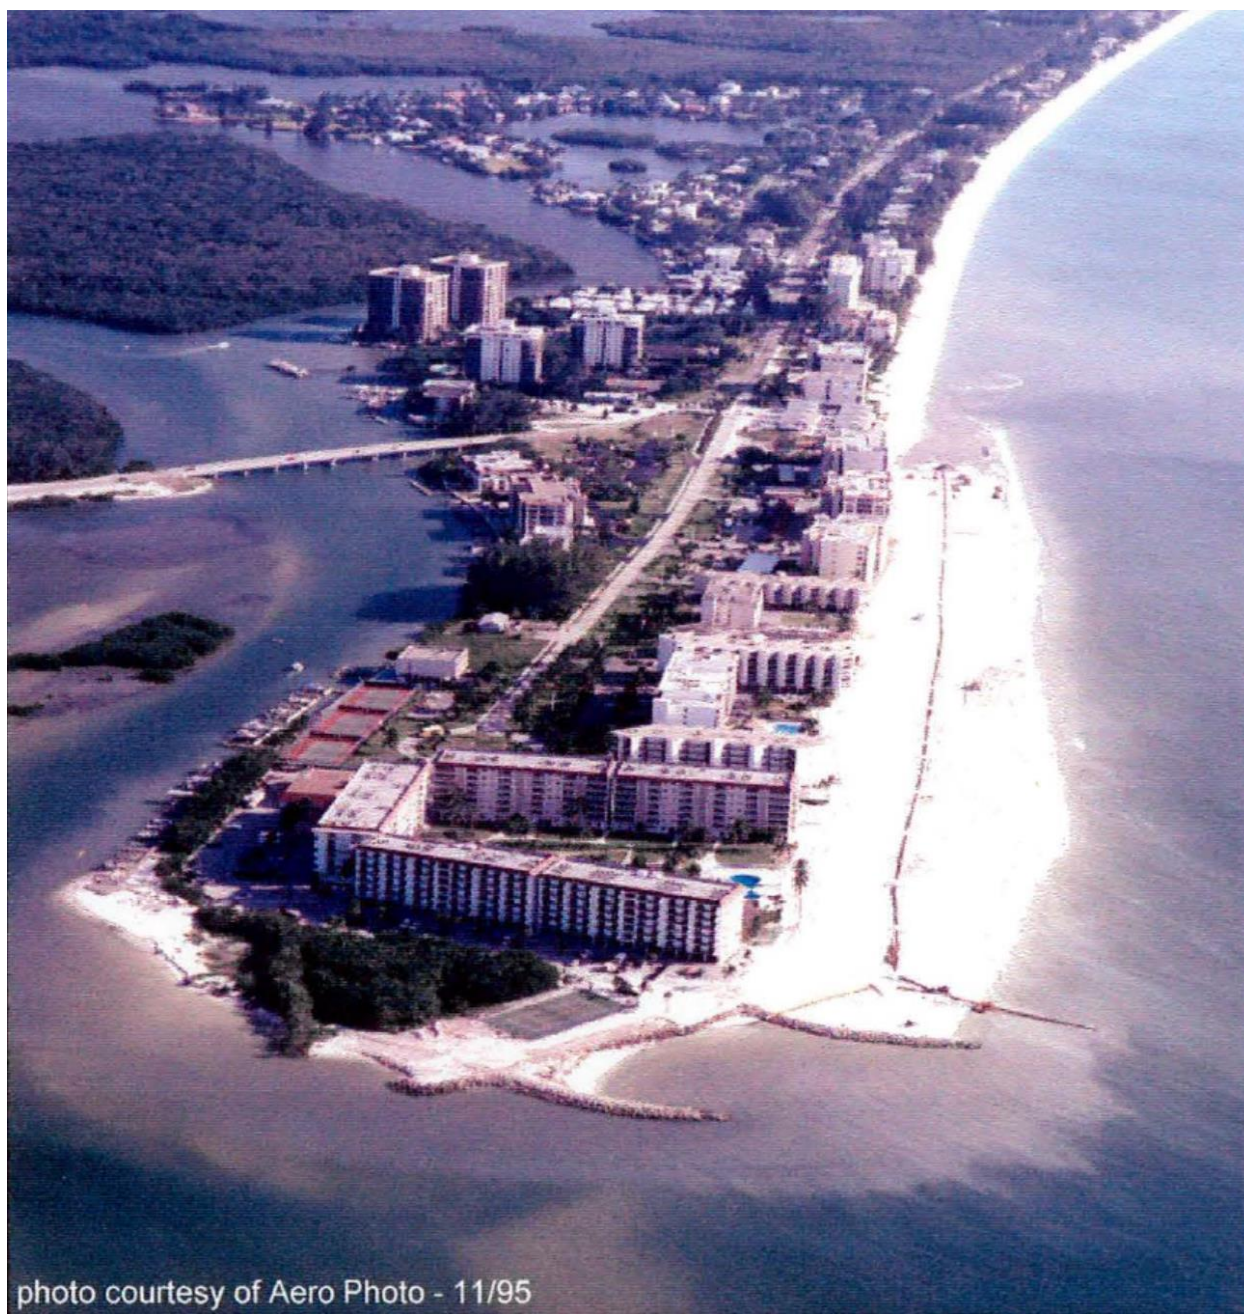
**Figure 2. Photo of 1995 Construction Project (from Olsen, 1996).**

The original Bonita Beach restoration project was completed in November 1995 and included the placement of approximately 217,000 cubic yards (cy) of sand and the construction of two terminal rock groins at the northern end of the project (Olsen, 1996). The construction of the project resulted in an initial seaward advancement of the shoreline along the project length of 120 to 160 feet, tapering to 0 feet along the southern 1,500 feet of the project length. The groins extended approximately 200 feet seaward (Figure 2).

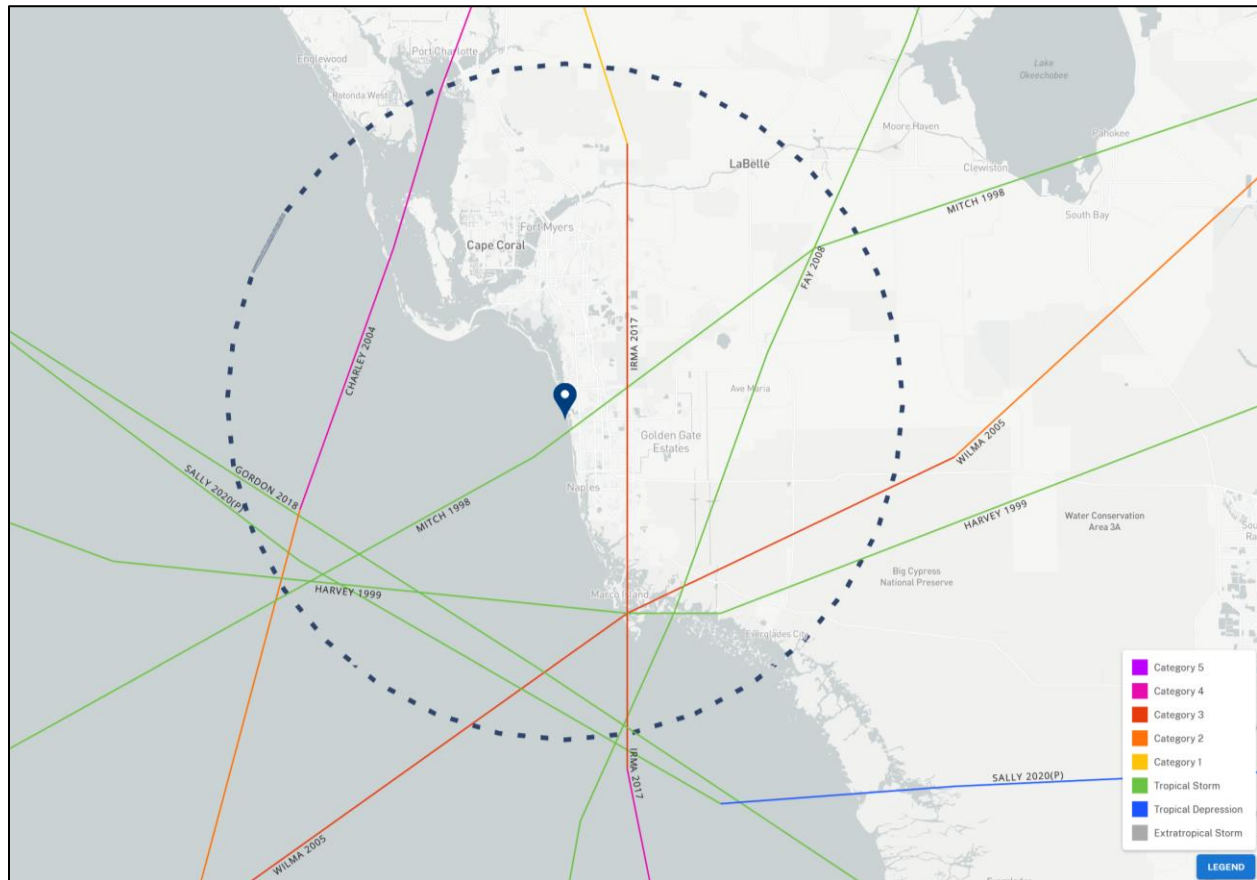
**Figure 3. 1995-2020 Storm Events within 50-mile Radius.**

CEC reviewed historical storm data that potentially impacted the Project area since its initial construction in 1995. A total of nine (9) storm events were identified ranging in strength from Tropical Storm to Category 4 Hurricane which occurred within 50 miles from Bonita Beach between 1995 and 2020 noting that Tropical Storm Gabriel (2001) was approximately 70 miles from the area but caused damage to the groins resulting in a FEMA funded repair project and for this reason was also included. These storms are presented in Figures 3 and 4 and Table 2.

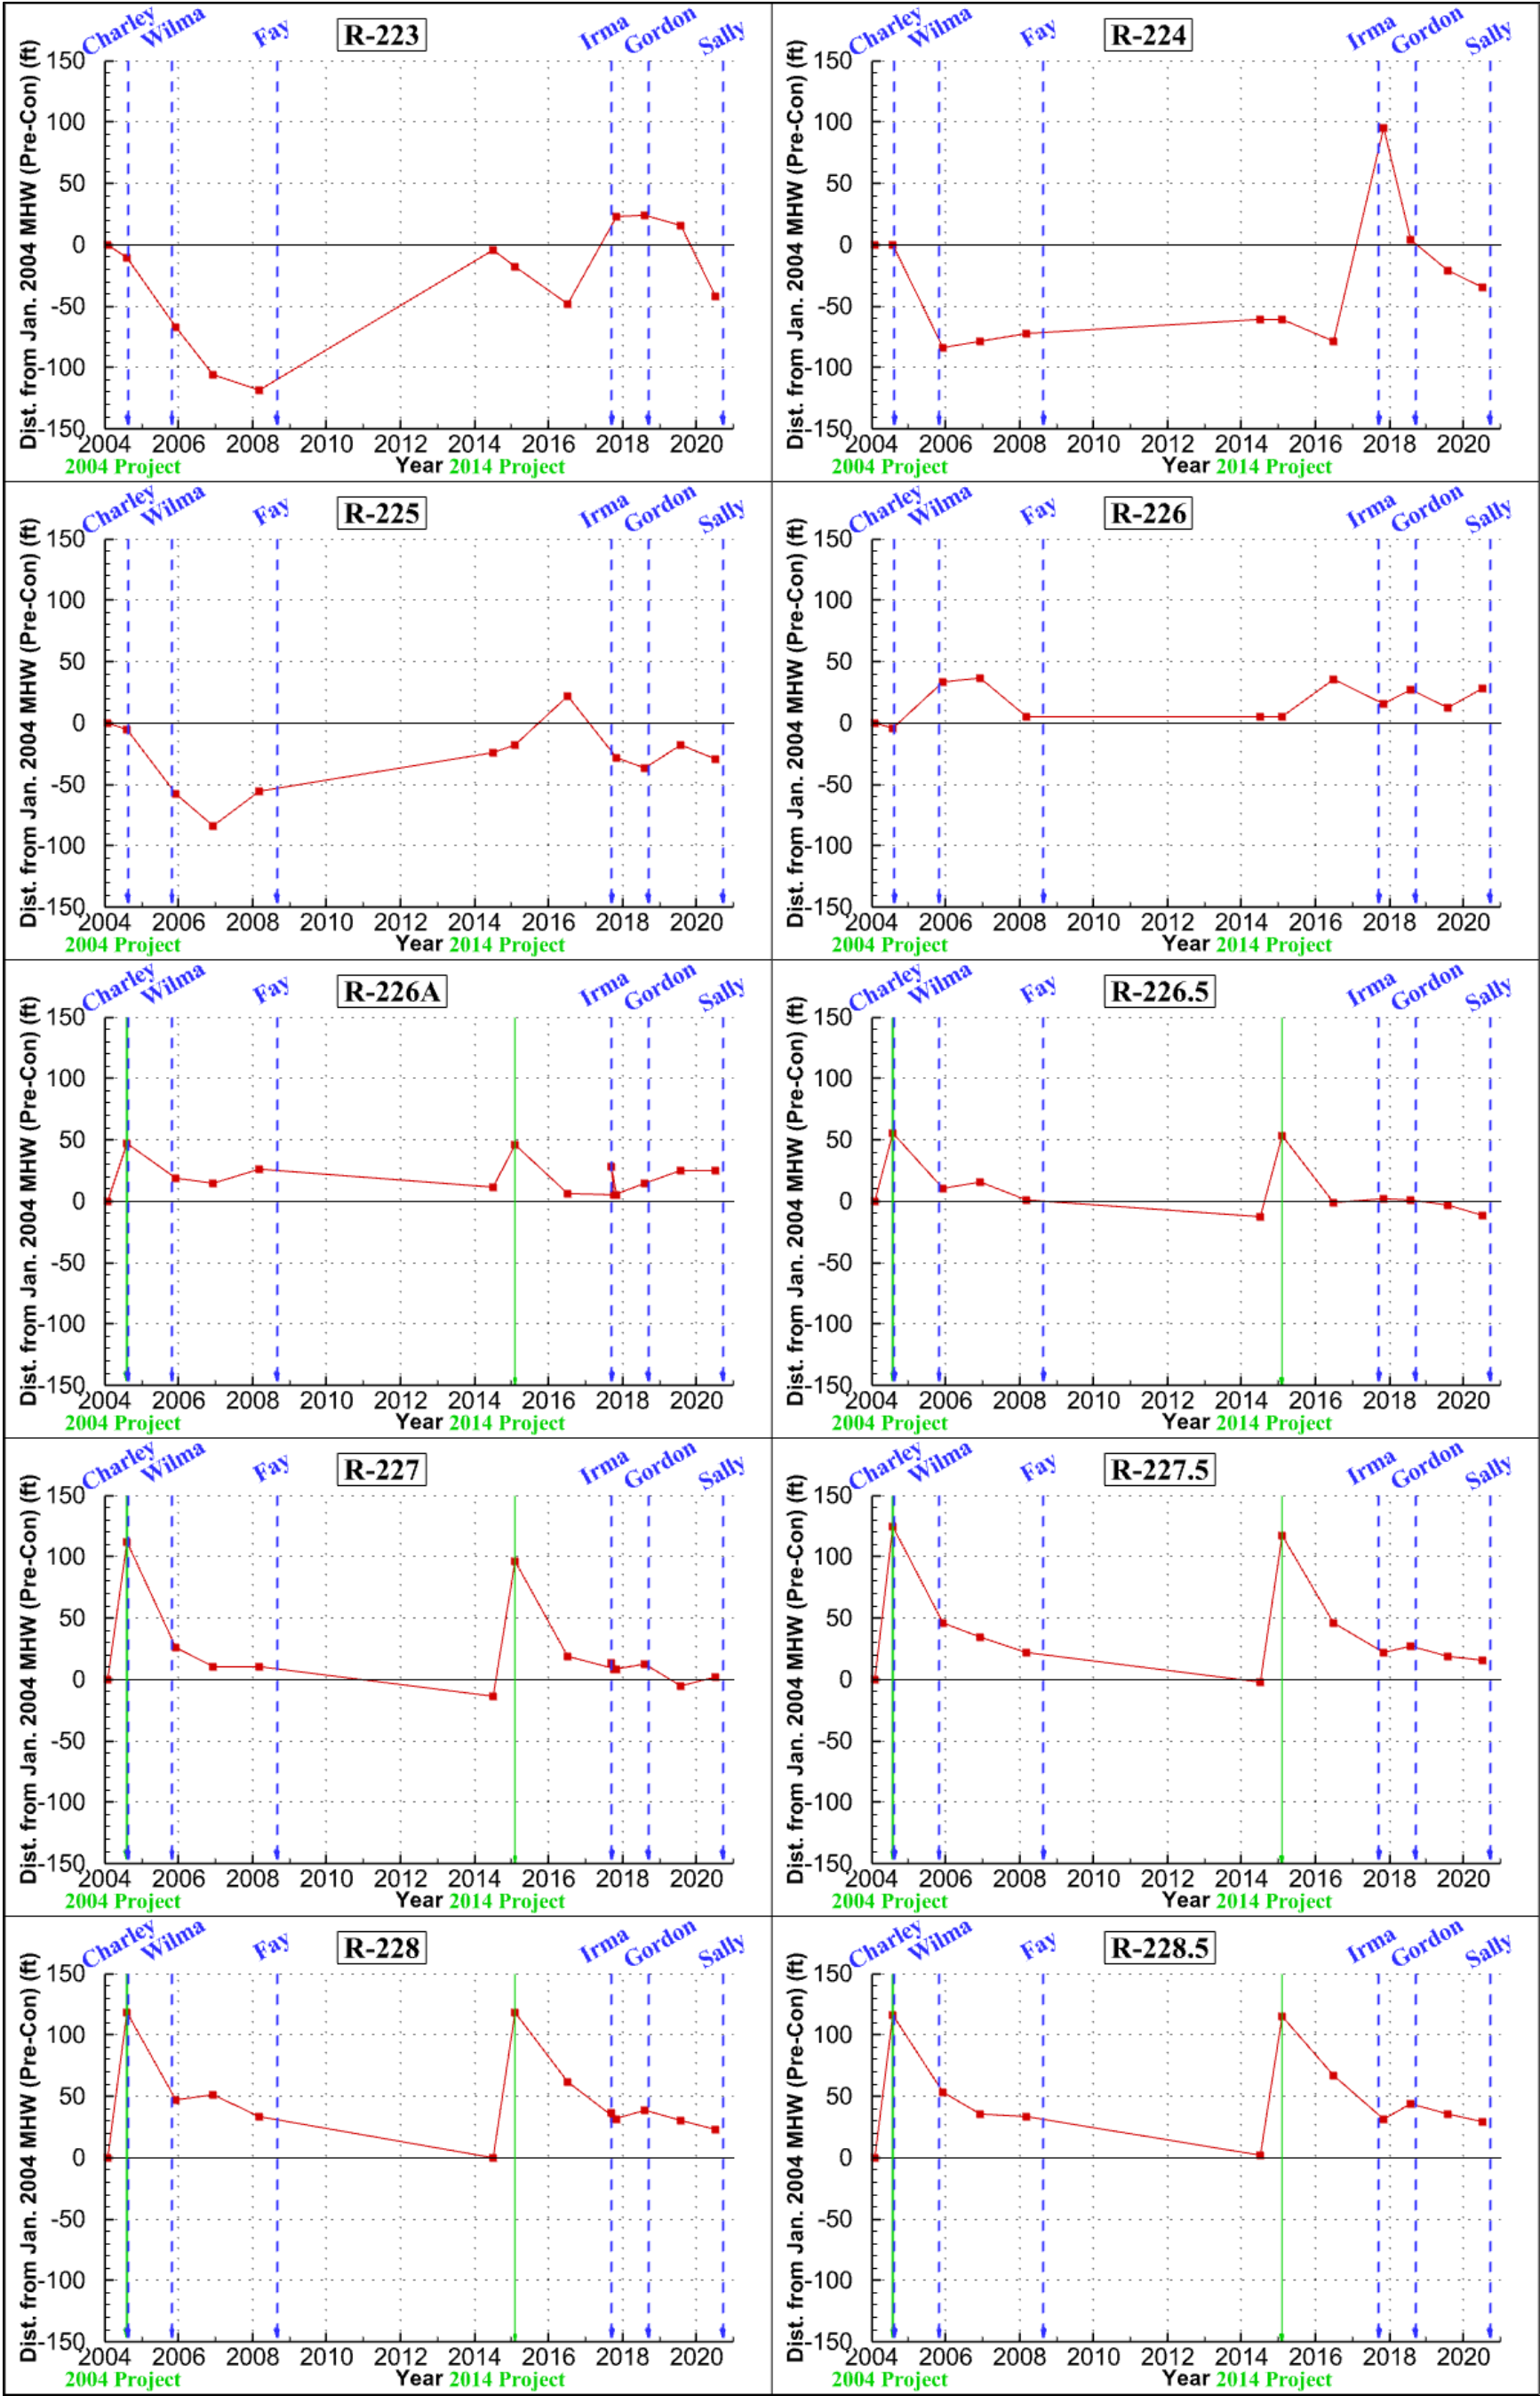
Figure 5. Shoreline Evolution Since 2004, R-223 – R-228.5.

To further interpret how the restoration projects performed over time, CEC created graphics visualizing how shoreline positions evolved over time since the 2004 pre-construction conditions at each R-monument spanning the shoreline segment from R-223 on Big Hickory Island to the north of the Project area to R-235 to the south and at each half-R-monuments within the fill area between R-226A and R-230. These graphics are presented in Figures 5 and 6 and also depict restoration and storm events.

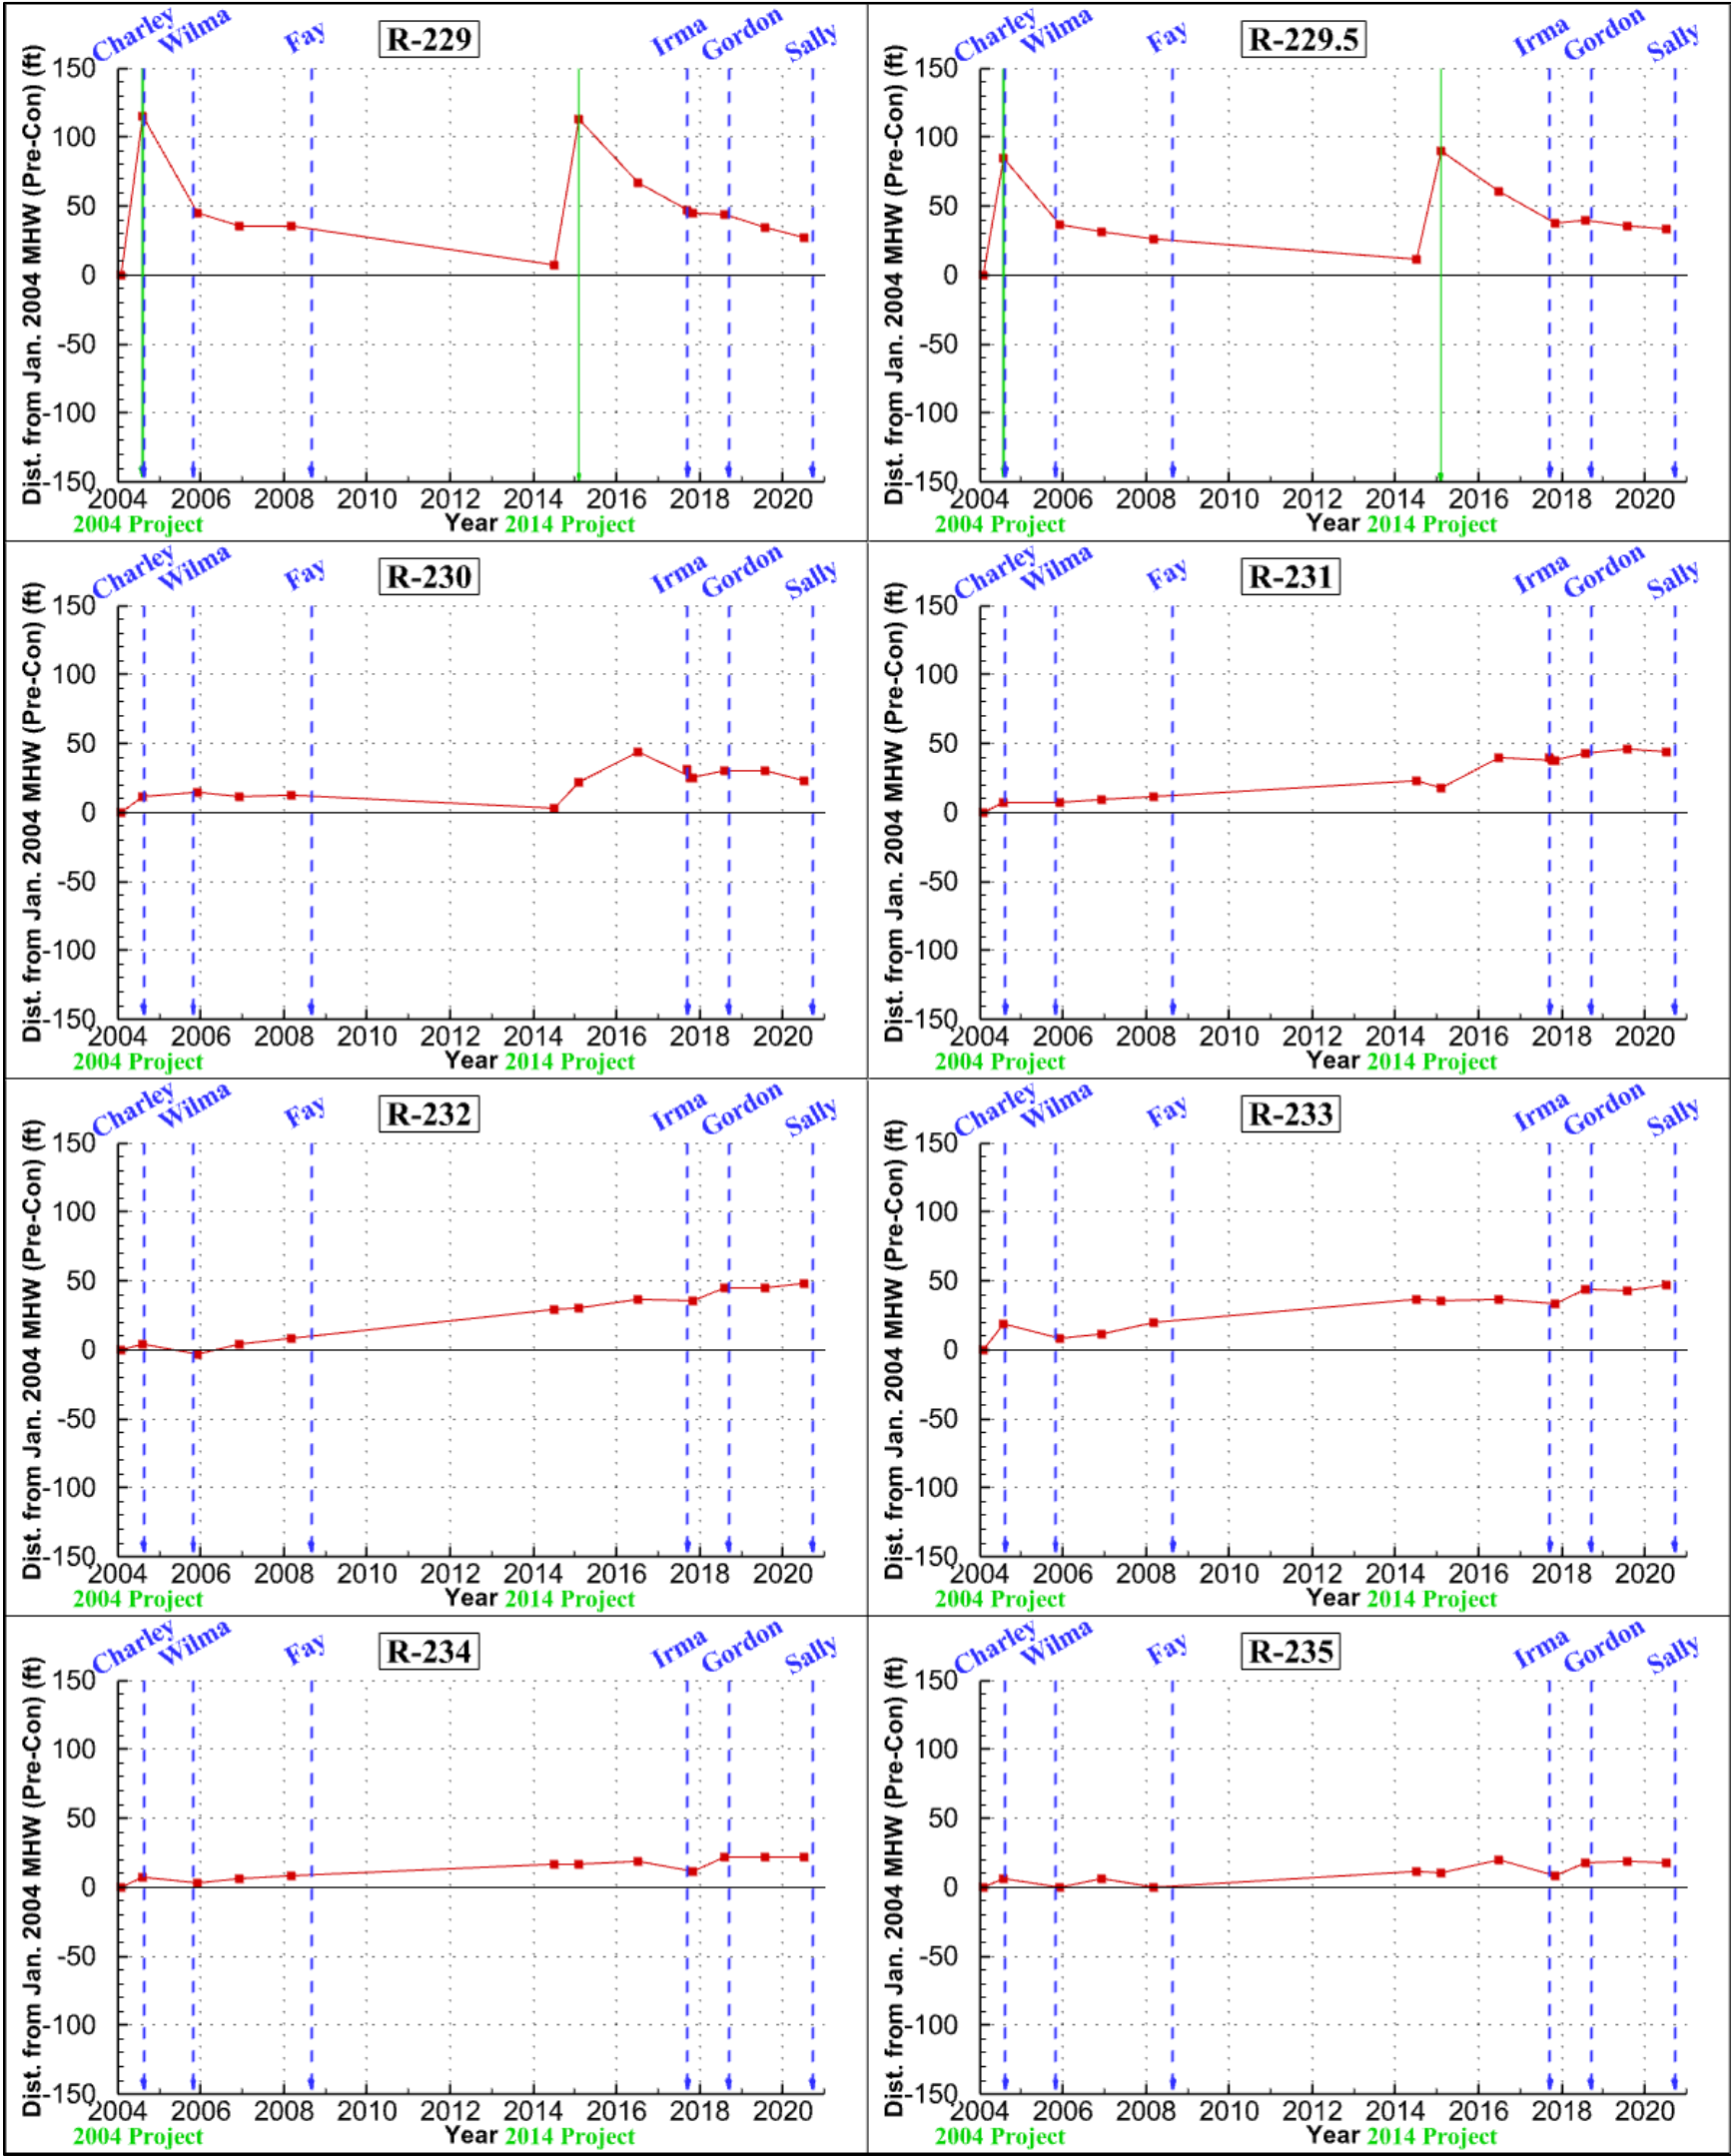
Figure 6. Shoreline Evolution Since 2004, R-229 – R-235.

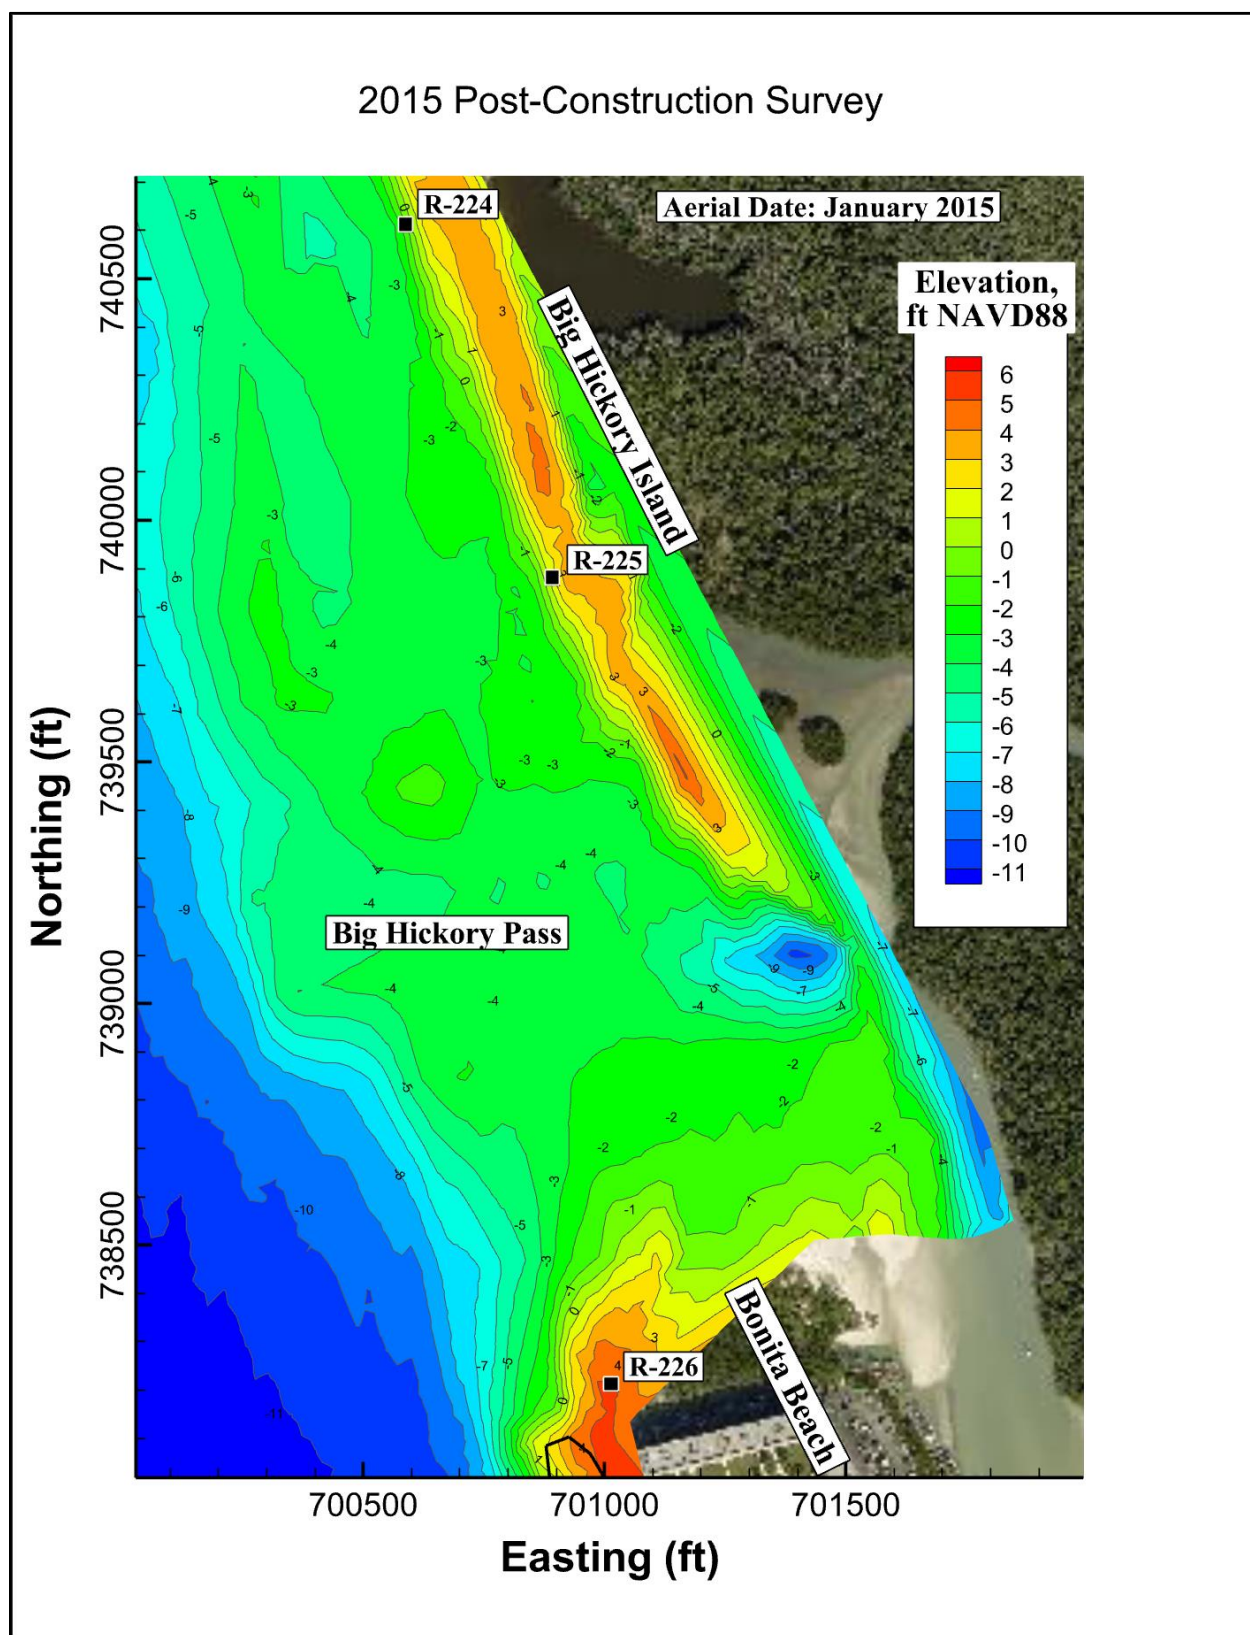
Figure 7. January 2015 Big Hickory Pass Survey.

A morphologic change analysis was completed utilizing the 2015 post-construction survey (Figure 7) and 2020 annual monitoring survey (Figure 8) to examine the changes in Big Hickory Pass. Figure 9 depicts the morphologic changes over 5.5 years. Significant gains are observed as sand transported north of the terminal groins and into the pass. Using the 2015 MHW shoreline at the pass throat and the +2-foot shoaling contour line as limits for measuring infill volume changes, a volume gain of 26,200 cy over the 5.5-year period was computed, equating to an annualized shoaling rate of 4,760 cy per year.

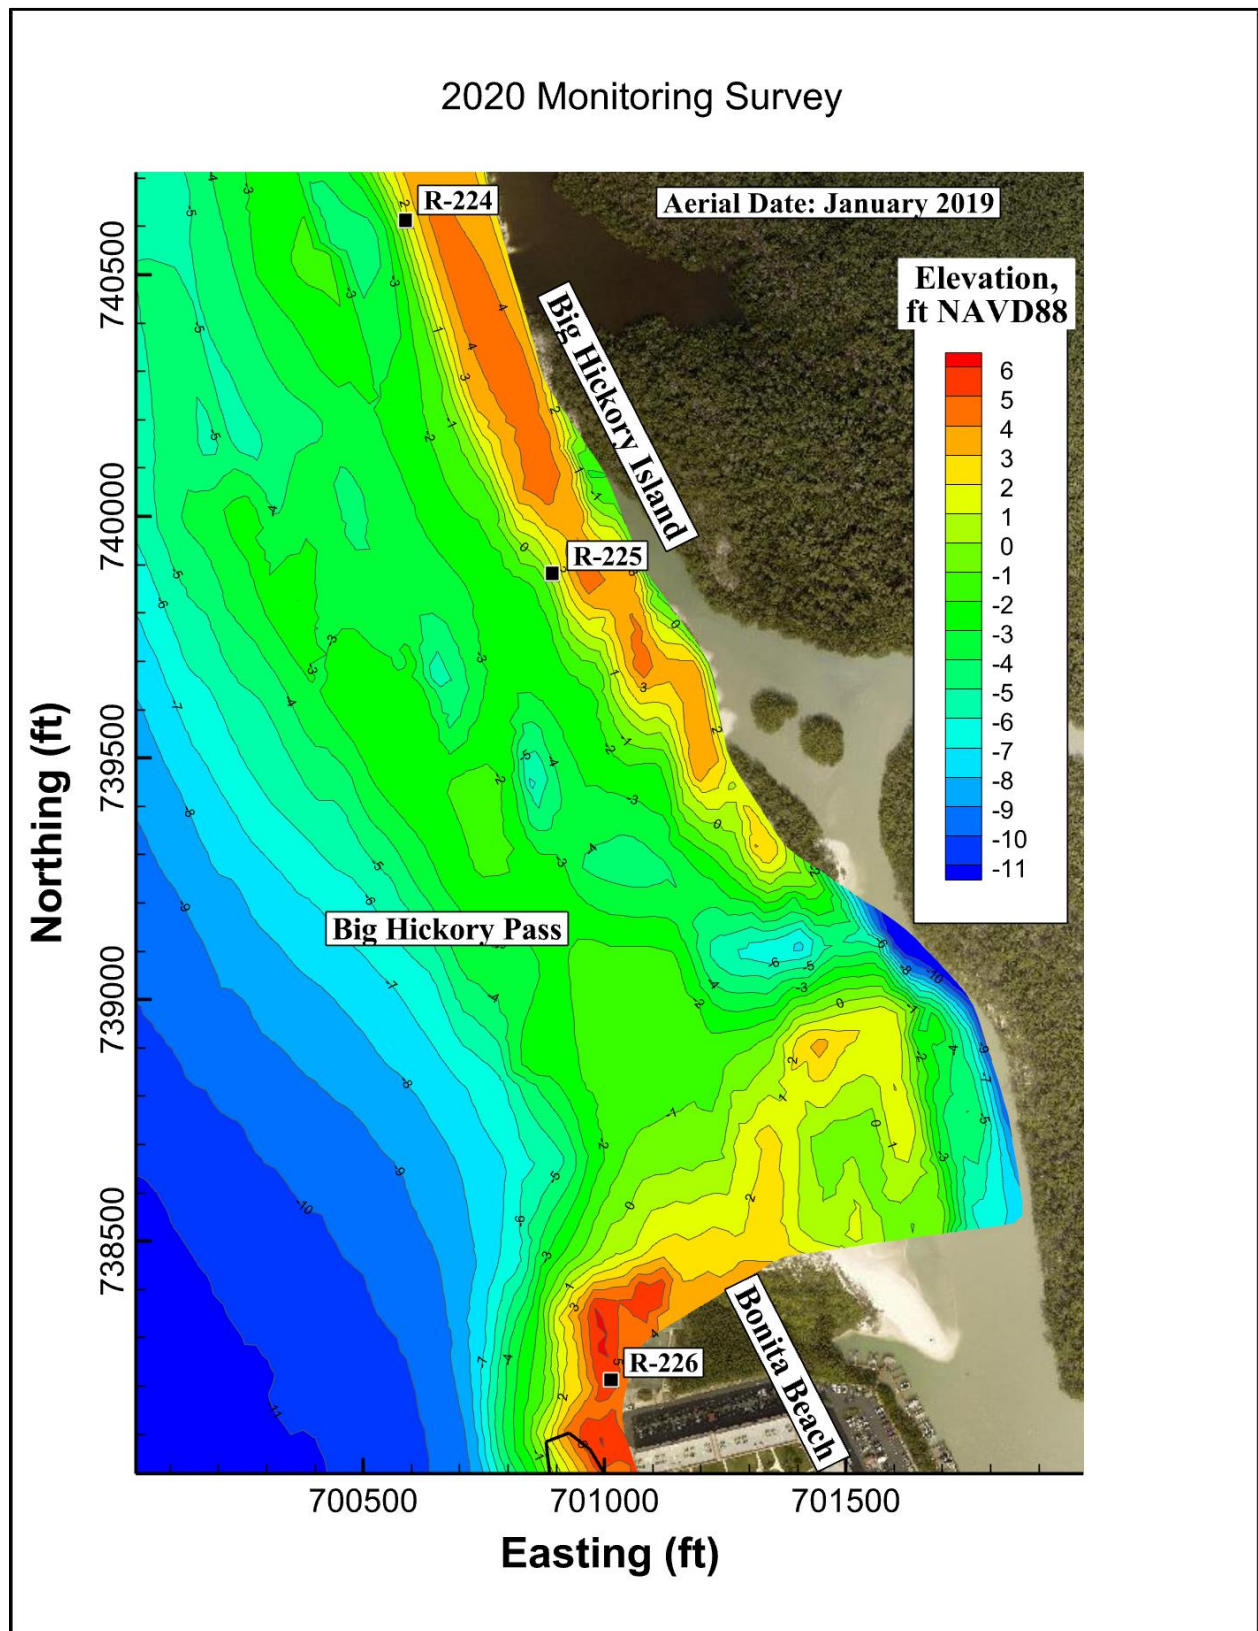
Figure 8. June 2020 Big Hickory Pass Survey.

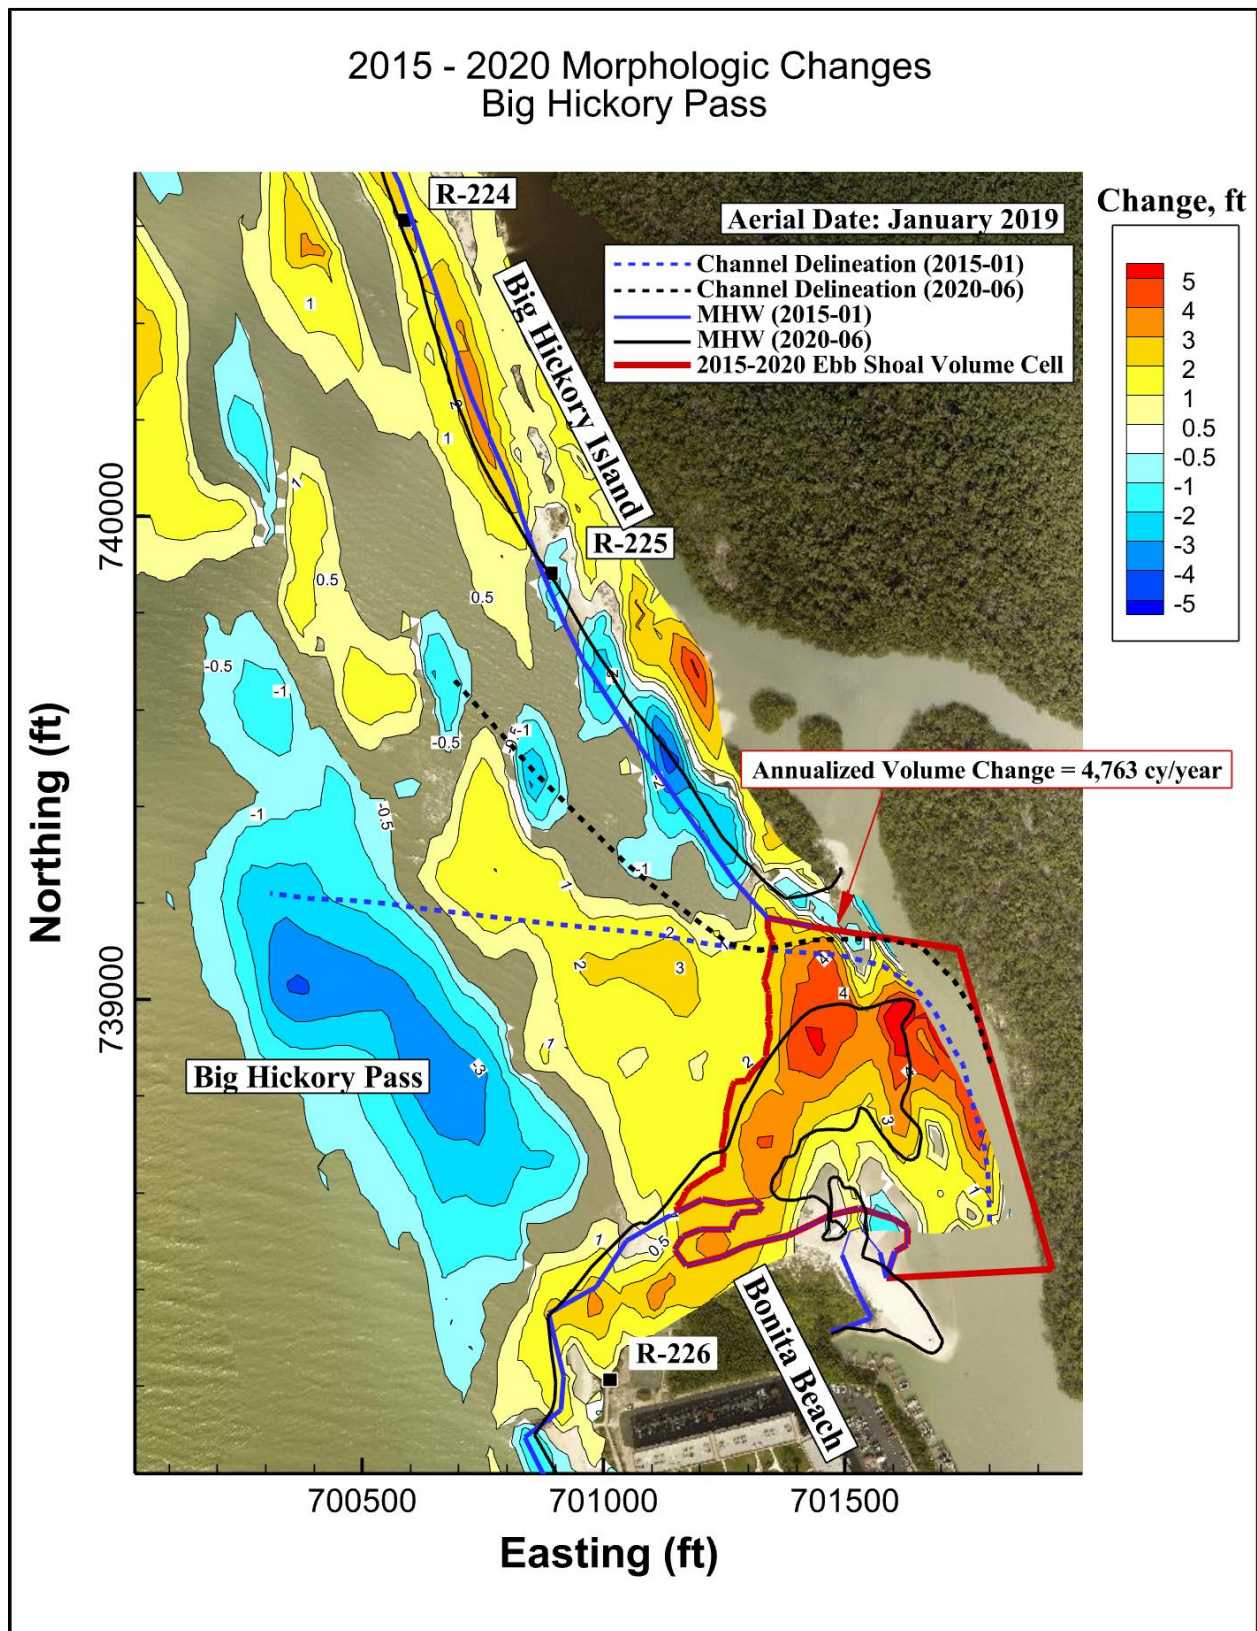
Figure 9. 2015-2020 Big Hickory Pass Morphologic Changes.

Channel deflection was also observed from 2015 to 2020. In 2015 the channel was due west, while in 2020 the channel was due northwest and parallel to the Big Hickory Island shoreline (Figure 9).

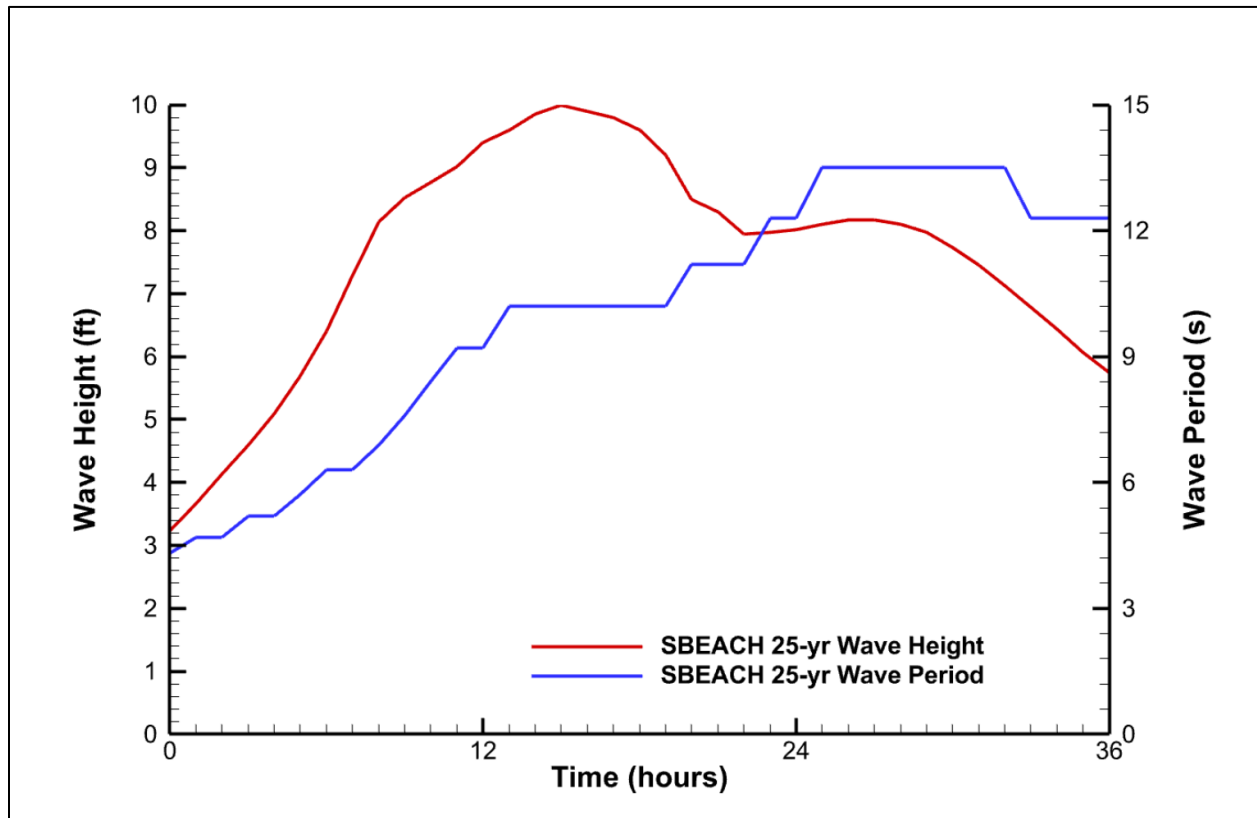
**Figure 10. SBEACH 25-Year Storm Wave Height and Period Input.**

To generate the 25-year storm wave parameters, the Wave Information Studies (WIS) database (<http://wis.usace.army.mil/>) was utilized to analyze wave conditions specific to the Project Area. WIS produces a high-quality online database of hindcast, nearshore wave conditions covering U.S. coastlines. The time interval of the data was one hour. Wang and Manausa (2015) recommended using a 10-foot high and 10-second long wave for simulating a 25-year storm event. Figure 10 presents a 36-hour time series of wave height and period used in the SBEACH simulations. The peak wave height and period reach 10 feet and 10 seconds, respectively, at hour 15.

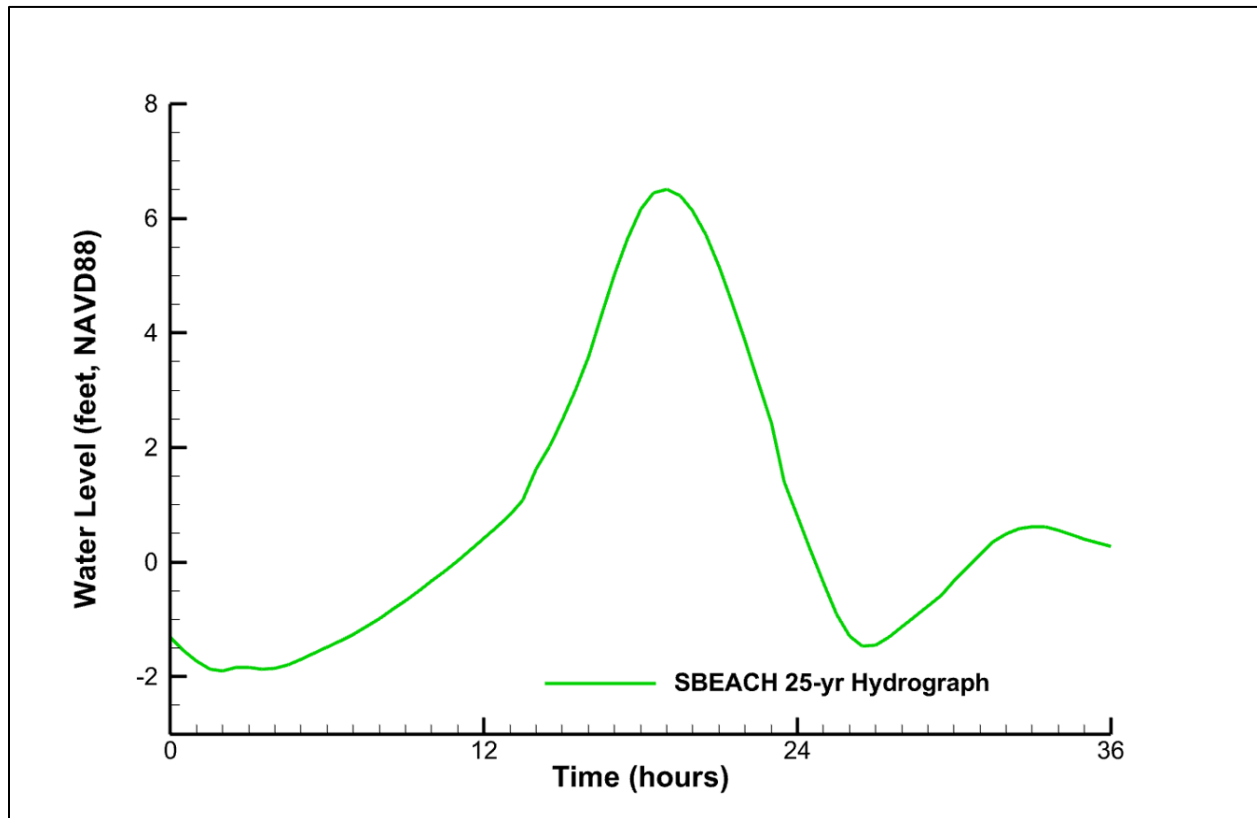
**Figure 11. SBEACH 25-Year Storm Hydrograph Input.**

According to Wang and Manausa (2015), the 25-year peak storm elevation for Bonita Beach is approximately 8.7 feet NAVD88. It includes contributions of wind stress, barometric pressure, wave setup, and tides. Because SBEACH accounts for wave setup internally, the wave setup component of the peak storm elevation had to be excluded from the SBEACH hydrograph. The recommended 25-year storm hydrograph is presented in Figure 11 and has a peak elevation of 6.5 feet NAVD88. It should be noted that due to variability in beach profile characteristics (e.g., slope, berm width and elevation), the modeled peak elevation using the recommended hydrograph varied within  $\pm 0.2$  feet from 8.7 feet depending on profile location. In order to achieve the recommended 8.7-foot peak for all profiles, the recommended hydrograph was adjusted through iterations until the model predicted the maximum storm elevation of 8.7 feet NAVD88. Overall, four (4) hydrographs were generated.

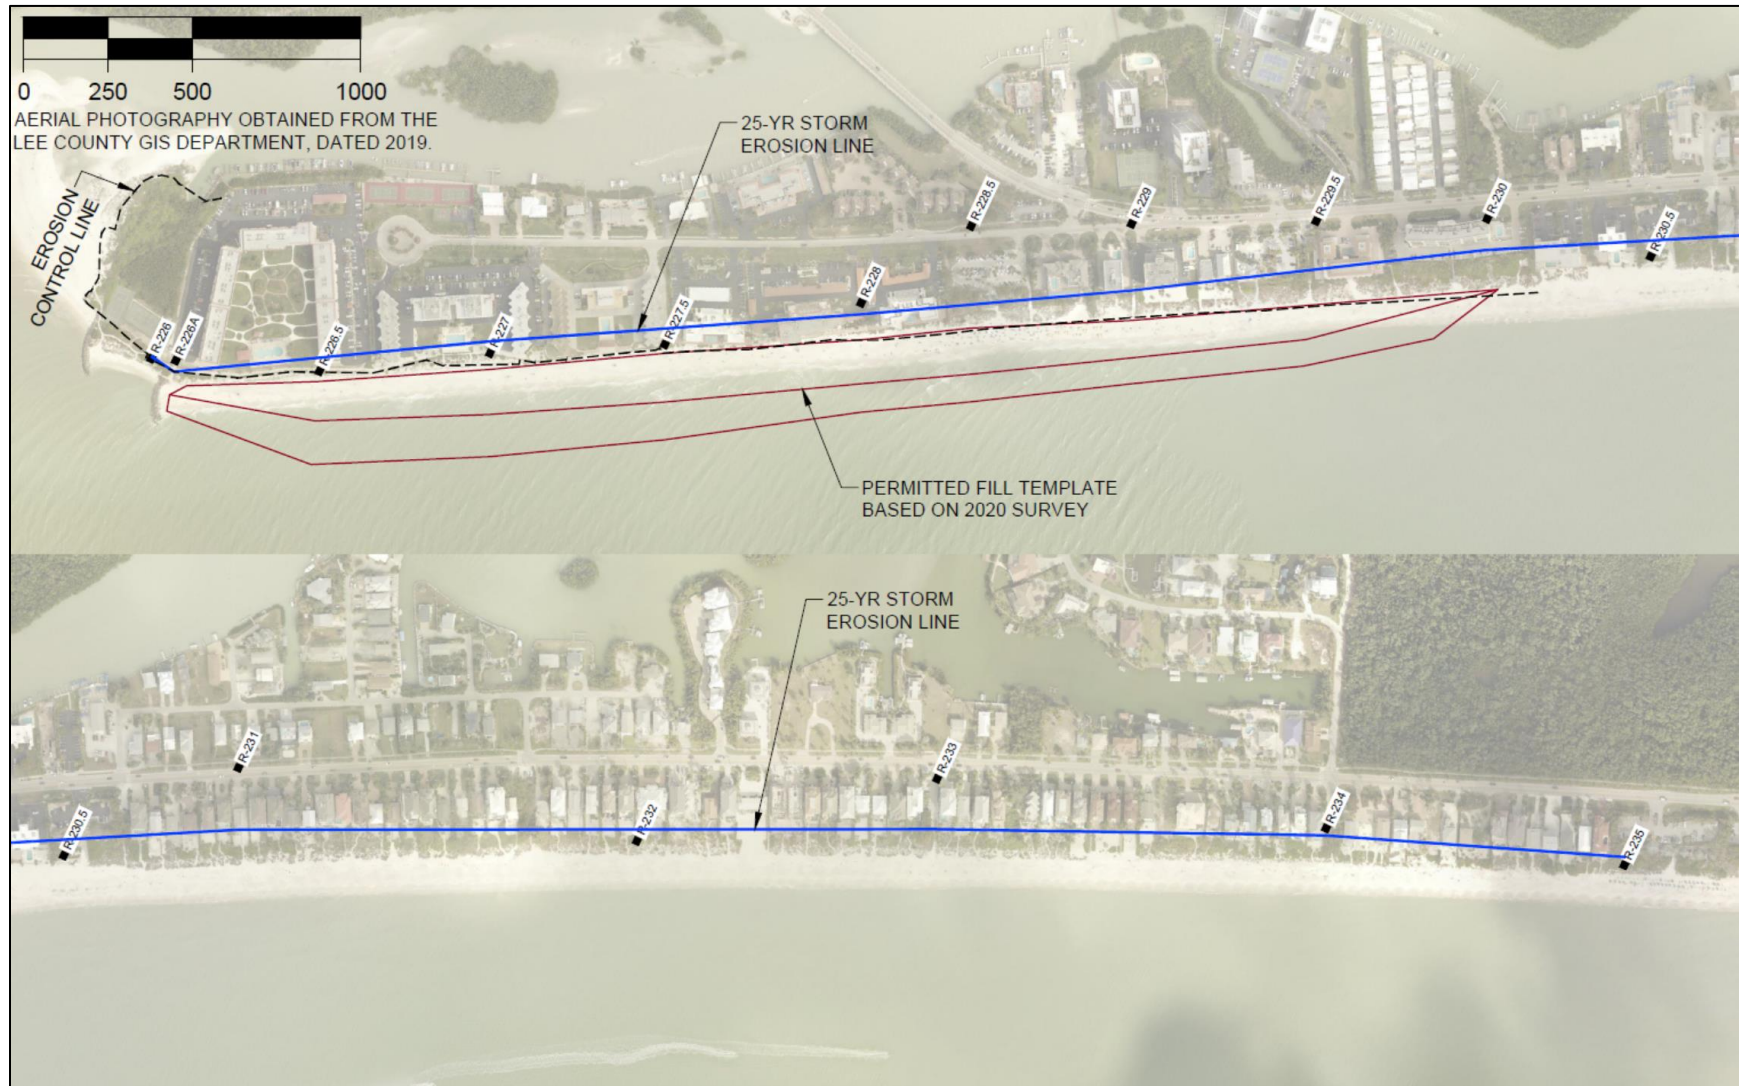
Figure 23. Erosion Predicted by SBEACH after 25-Year Storm Event.

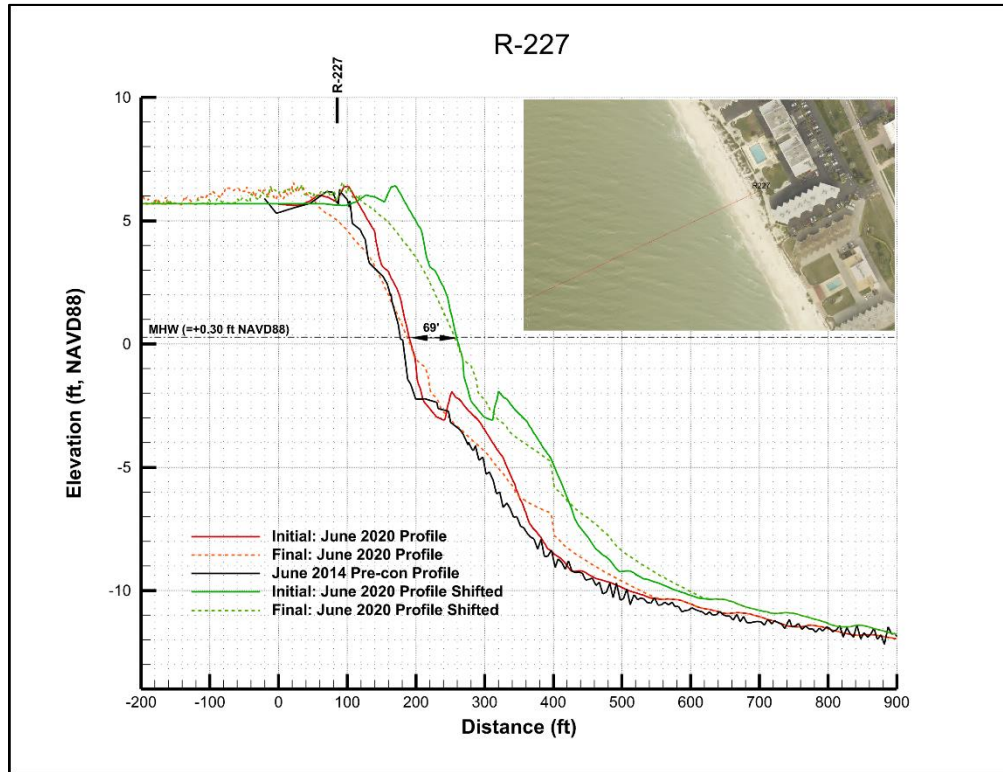
**Figure 24. SBEACH Model Results R-227.**
