Beach Management Funding Assistance Program  
Local Government Funding Request  
Fiscal Year 2025/2026  
Beach Projects Application

## Bonita Beach Groin Repair

# BONITA BEACH TERMINAL GROINS DAMAGE REPORT FOR HURRICANE IAN; LEE COUNTY, FLORIDA.

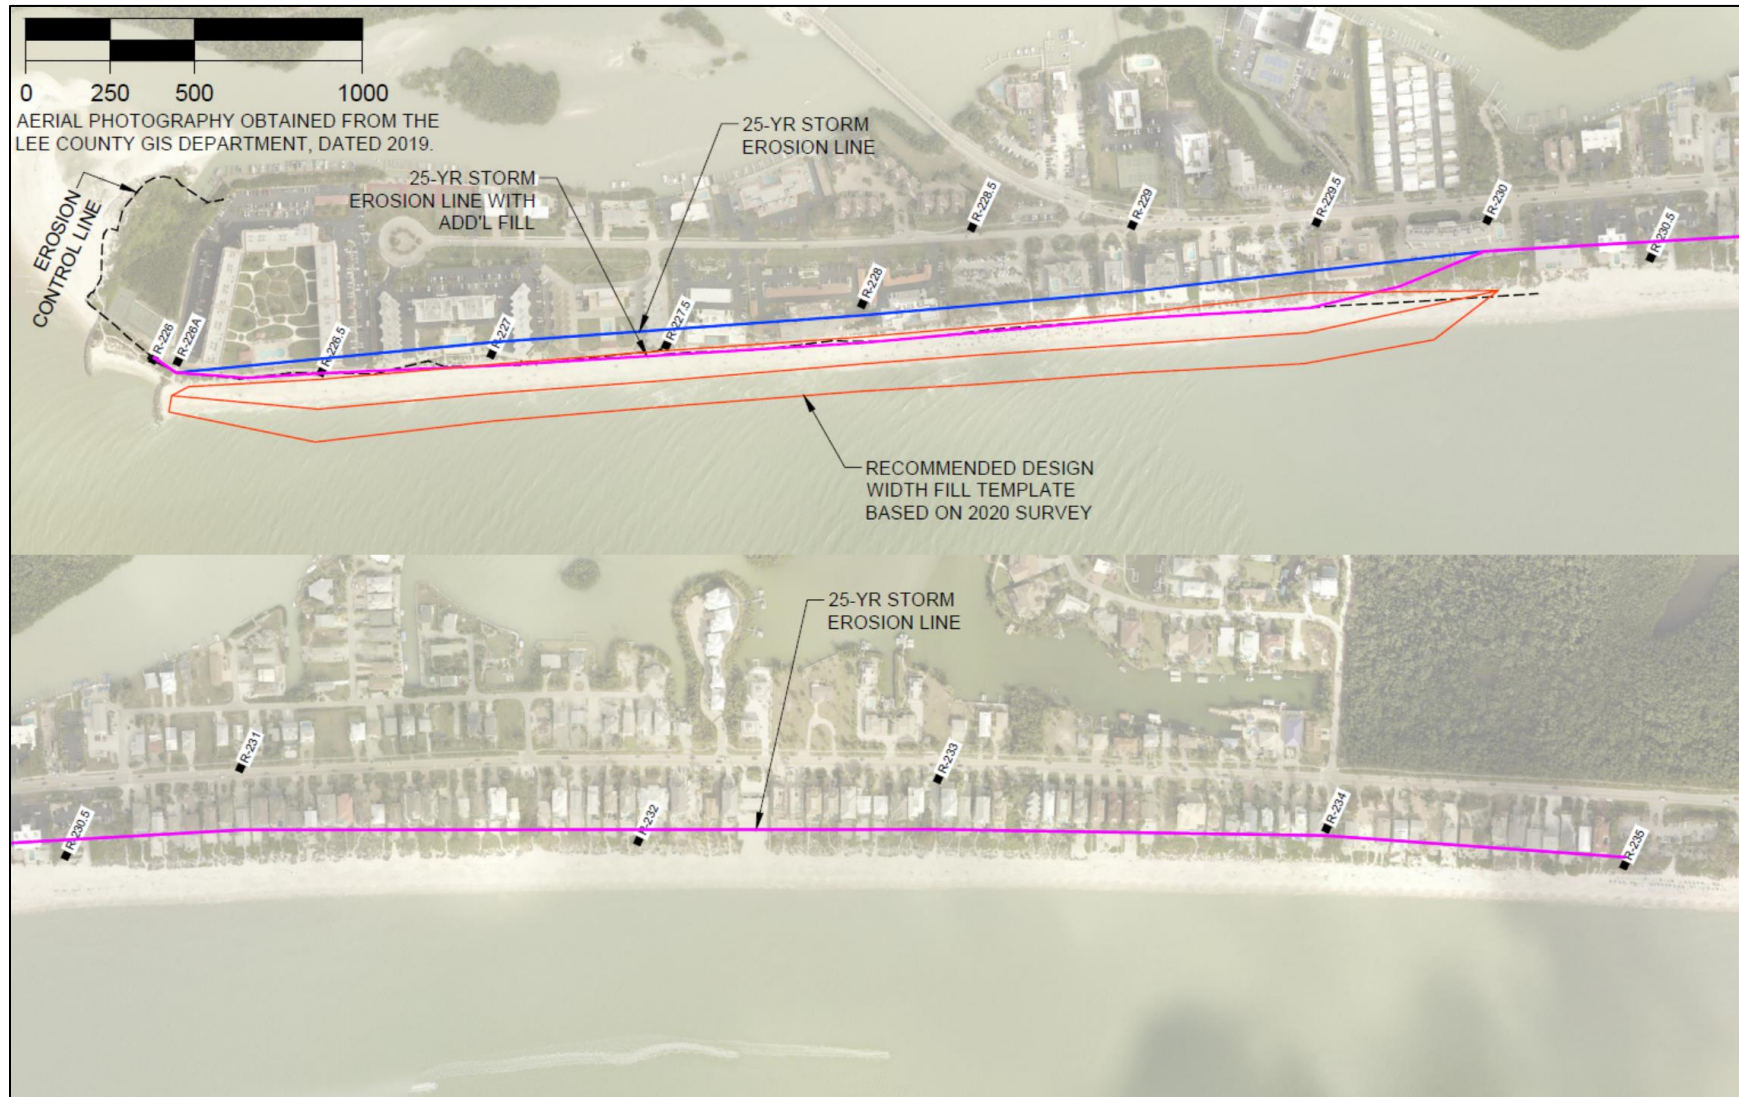
**Figure 27. Erosion Predicted by SBEACH after 25-Year Storm Event for Recommended Fill Design.**

The new erosion limits were mapped out in a plan view by connecting the erosion limits predicted by the model between the R-monuments, which are presented in Figure 27. The new erosion limits are aligned with the ECL and the structures along the shoreline within the fill segment are landward of the erosion limits. The figure also depicts the limits of the recommended design width fill template.

The average value of the seaward shift for the three R-monuments is approximately 75 feet. CEC recommends this value as design width at MHW for future renourishment projects to provide storm damage reduction benefits to the upland structures from a 25-year storm event.

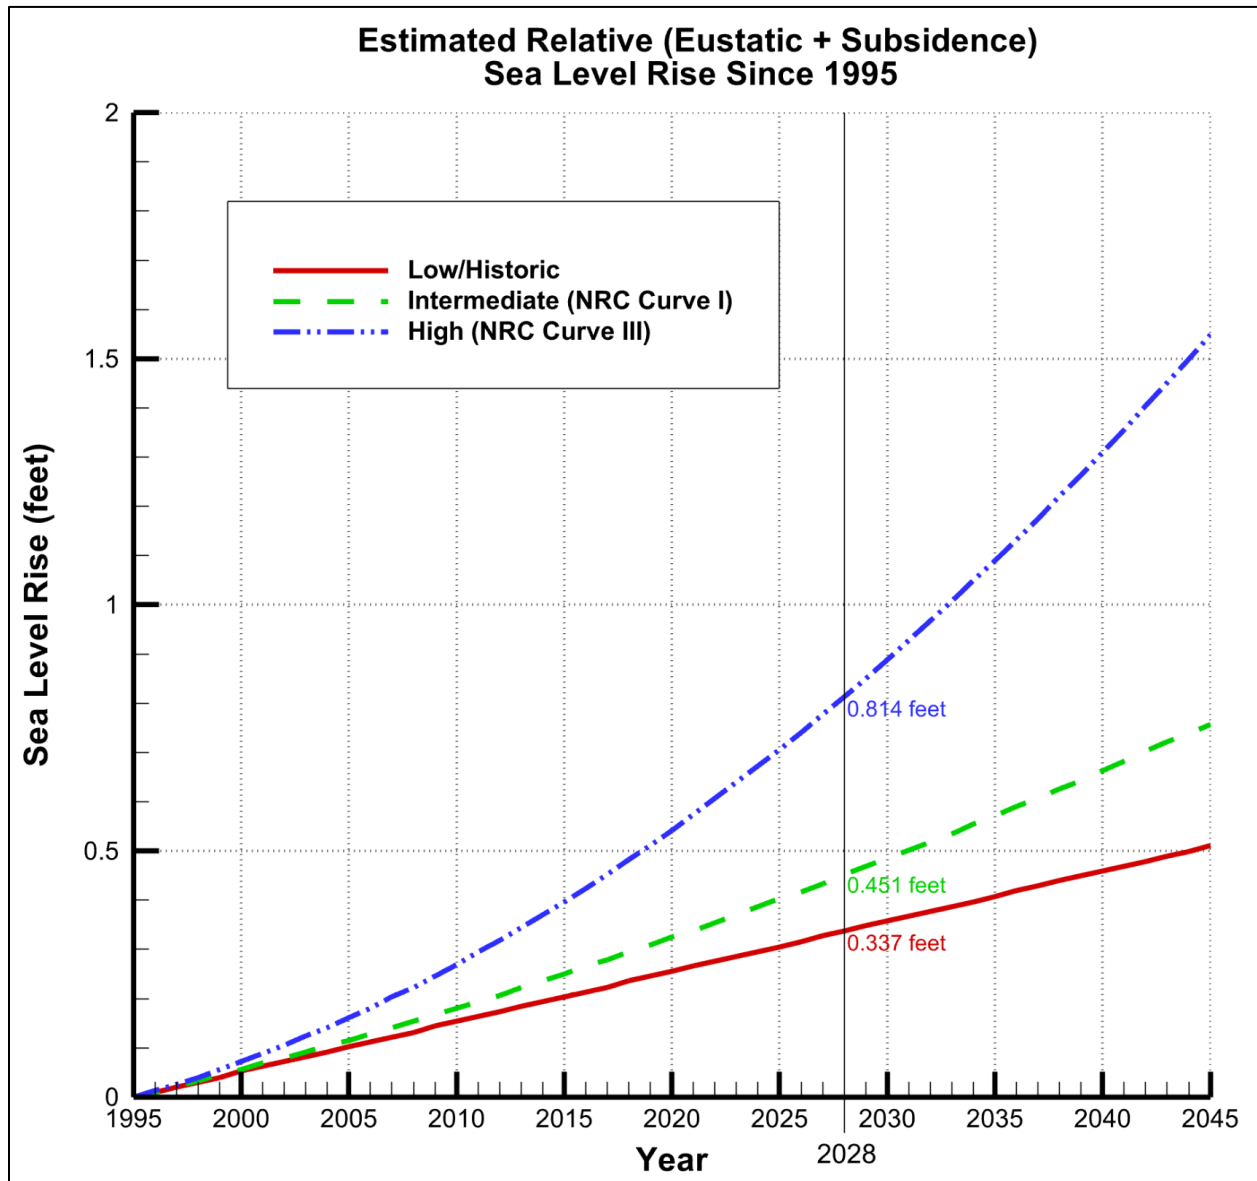
Figure 30. Estimated Relative Sea Level Rise since 1995 based on USACE Methodology.

Based on the analysis, the estimated sea level rise to the Year 2028 is 0.337 feet, 0.451 feet, and 0.814 feet, for the low/historic, intermediate and high curves, respectively. CEC recommends a value of 0.6-foot, which falls between the intermediate and high sea-level rise estimates, as the design criteria for sea level change through 2028, the expiration year of the current permit.

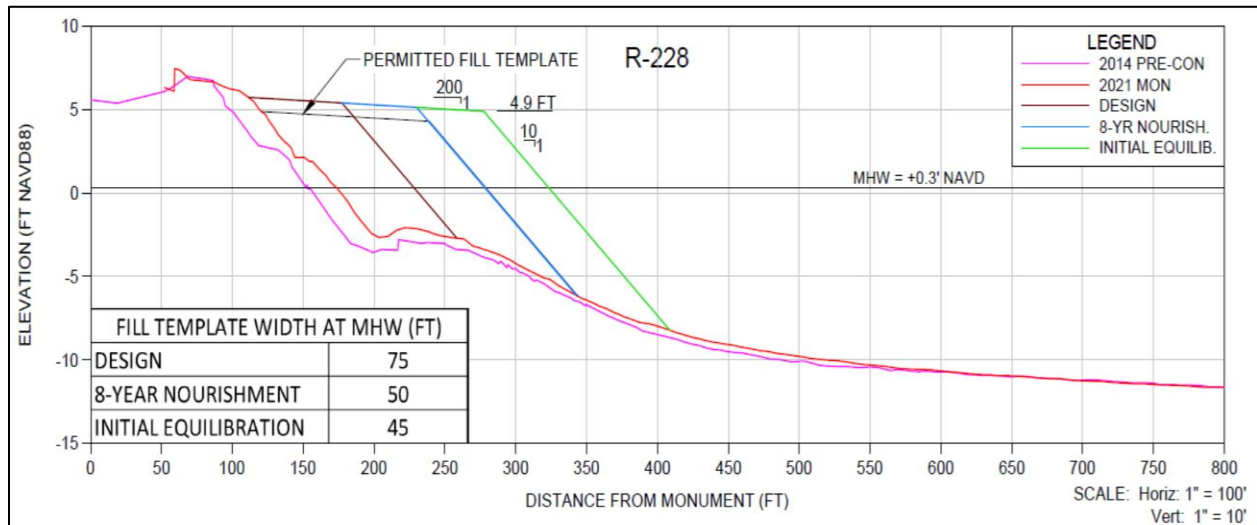
The recommended beach fill template developed for R-228 is presented in Figure 31. The permitted fill template is shown in comparison to the recommended template noting the

recommended advanced nourishment line (blue) fall approximately on the same position. Comparing the two, the berm width is approximately 45 feet wider and the berm crest is approximately 0.6 feet higher.

**Figure 31. Recommended Beach Fill Template for Future Renourishment Projects.**

Based on the 2020 survey, the fill volume required to build the permitted fill template is approximately 102,000 cy and the volume to build the recommended fill template is approximately 196,000 cy.

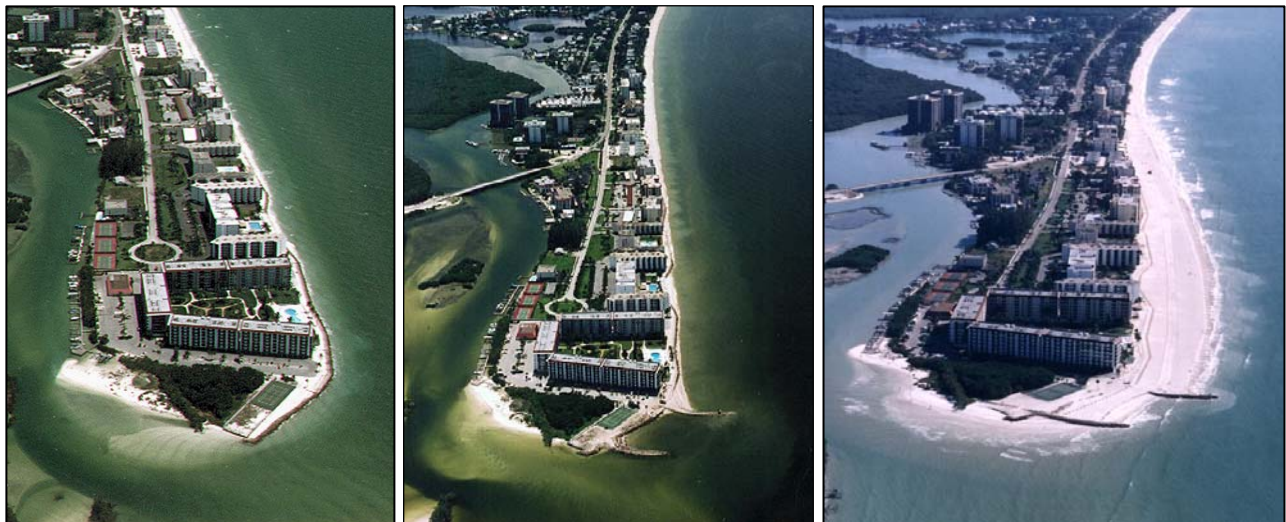
**Figure 1:** North end of Bonita Beach before construction of the terminal groins (*left*), after construction of the terminal groins (*middle*), and after placement of 217,000 cy of sand<sup>3</sup> (*right*).

The groins were designed such that the northernmost groin “steps-down” the beach width from the project shoreline to the inlet. Before the construction of the rock groins and the initial beach nourishment in 1995, there was little to no sand beach along this shoreline; and the north end of the project area (at the groins’ location) featured only a seawall with no dry beach. **Figure 1** shows photographs of the north end of Little Hickory Island before construction of the initial nourishment (*left*), after construction of the groins (*center*), and after placement of the initial 217,000 cubic yards of beach fill nourishment (*right*).

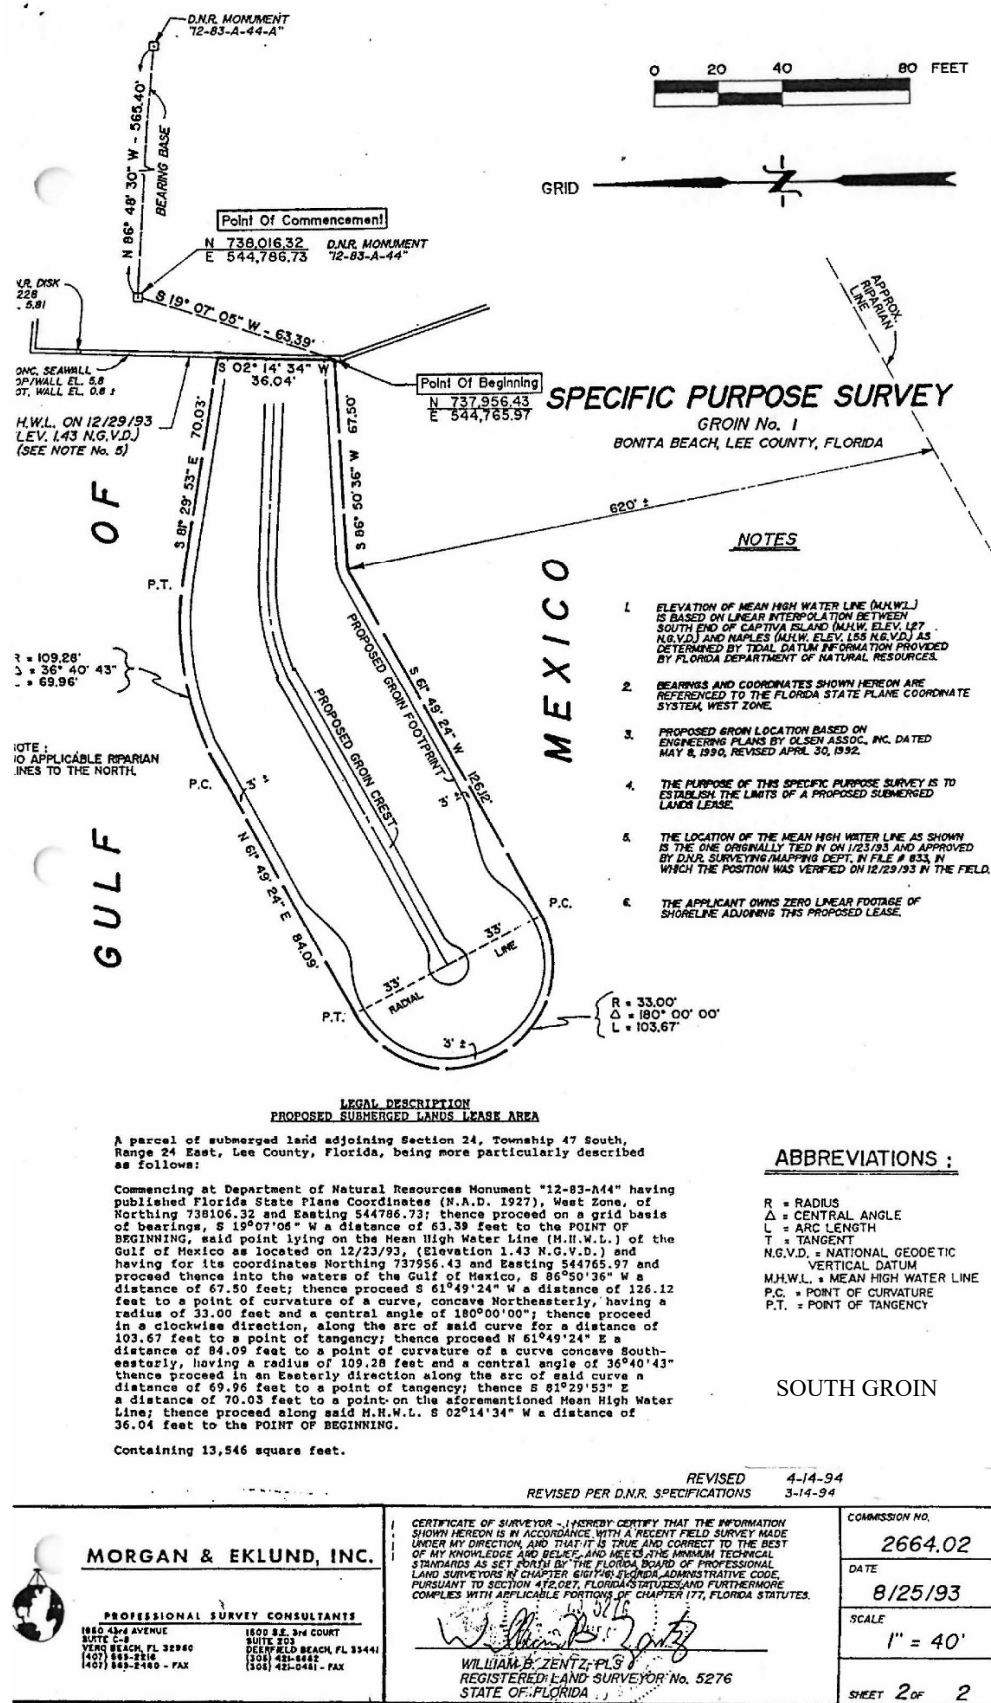
Figure 4 (continued): Specific purpose survey and submerged lands easement for South Groin.  
Extracted from permit DBS900263 LE.

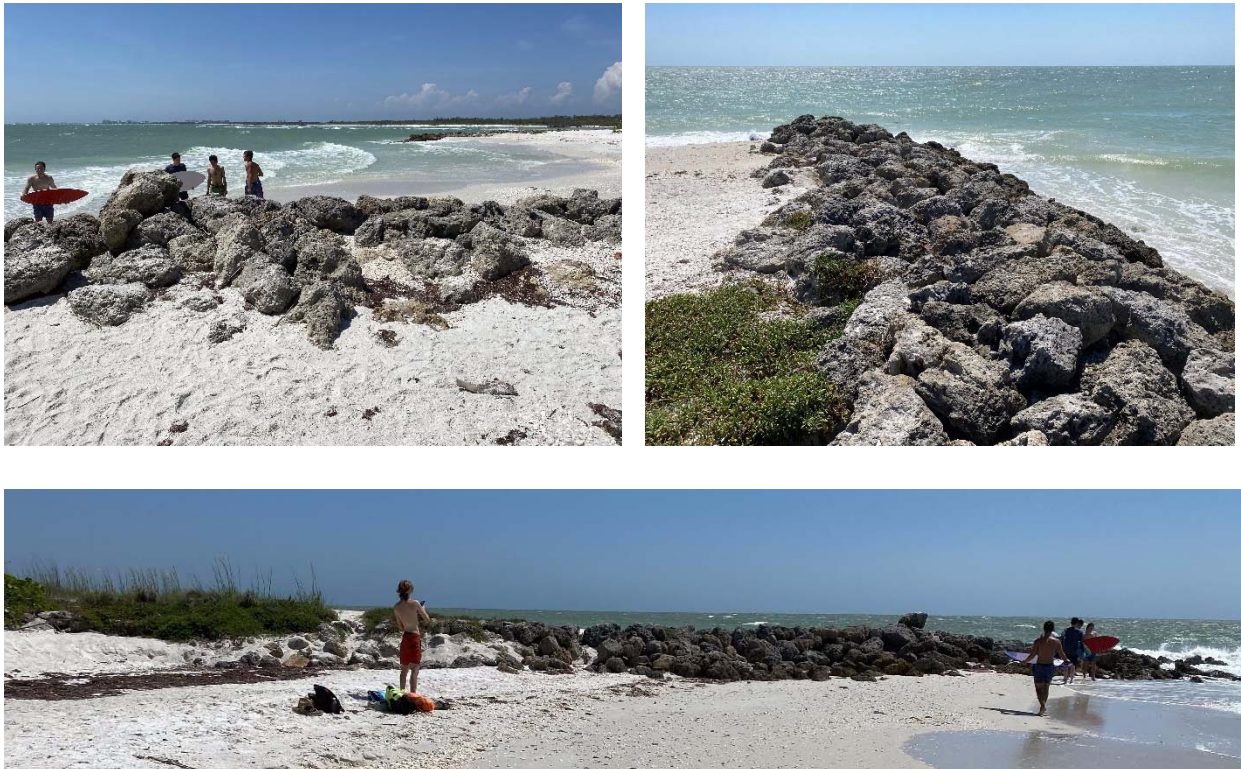
**Figure 5:** Left – South groin. Right – North groin. Lower – South groin. Pre- Hurricane Ian; 4 May 2021. Photos by Vadim Alymov (Coastal Engineering Consultants, Inc.).

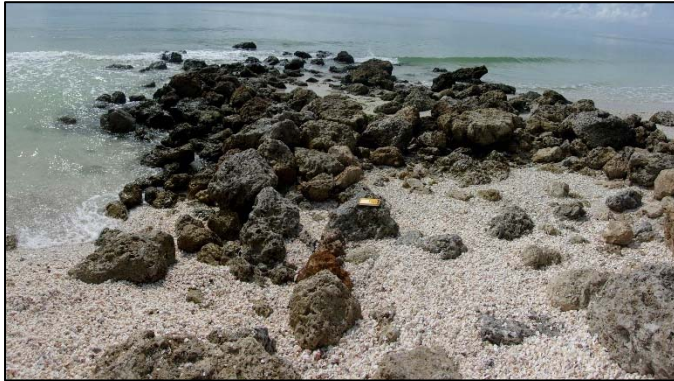
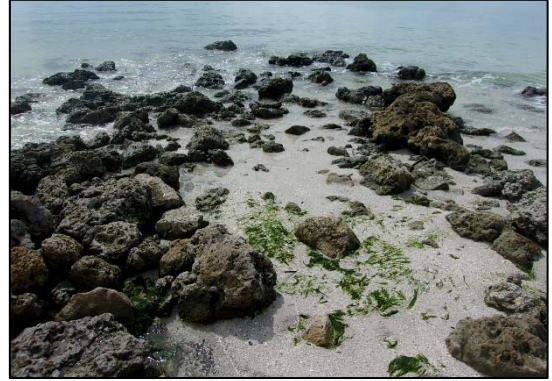
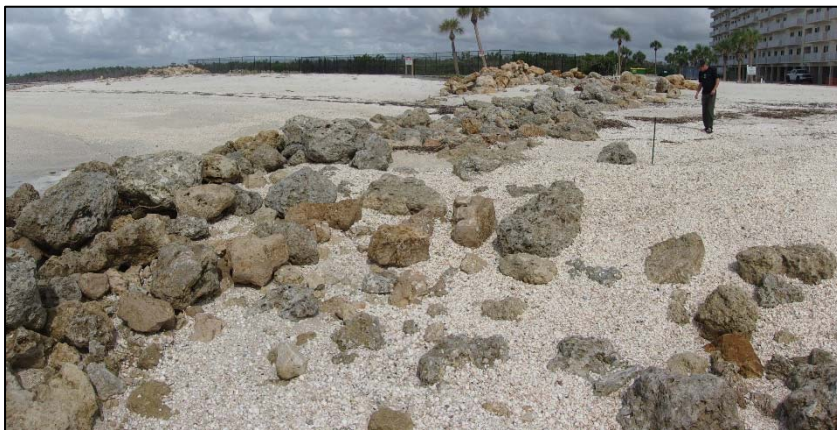
**Figure 6:** South groin (photo - 9/26/2023), 1 year after Hurricane Ian. At top: seaward end. At left: central stem and landward end.

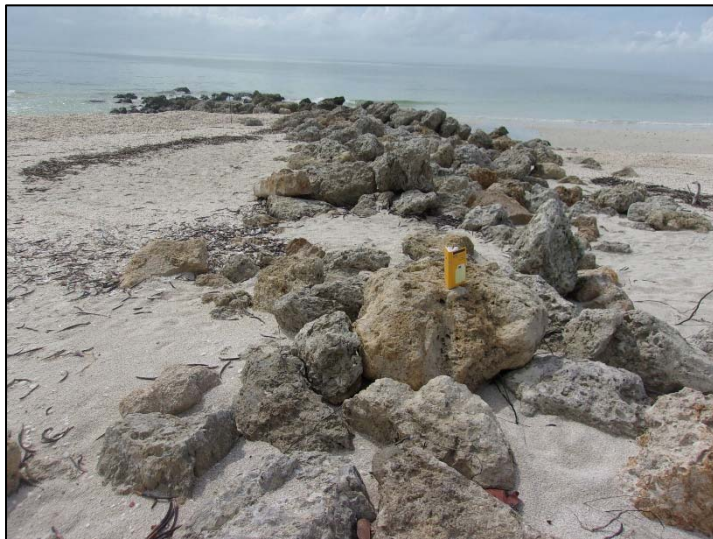
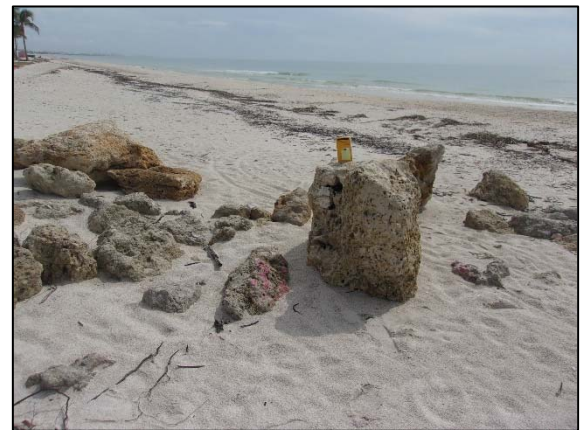
Left – South Groin, central & seaward end.  
Above – South Groin, landward end.

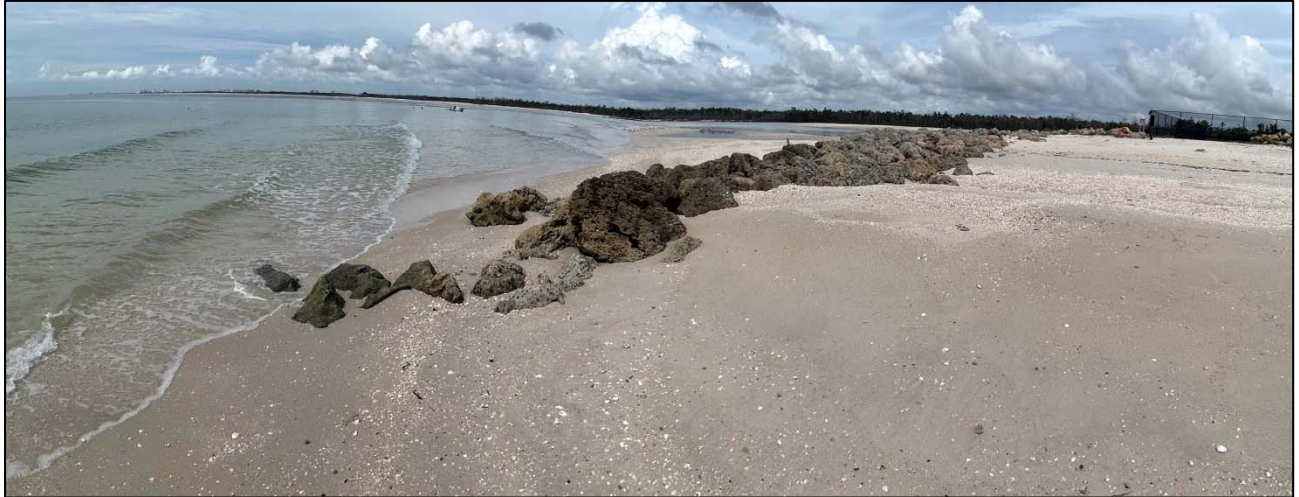
North Groin – Seaward End (9/26/2023).

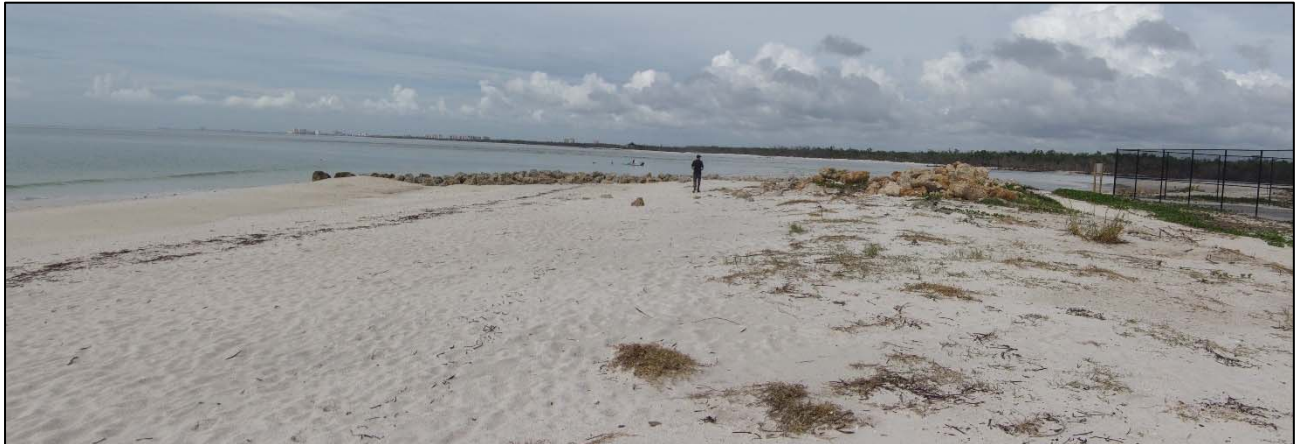
North Groin – Profile (9/26/2023), with scattered rock stockpiled along the beach berm at right. [The deposition of a low sand berm along the shoreline, evident in the photograph above, is a residual result of Hurricane Idalia in late August 2023.]

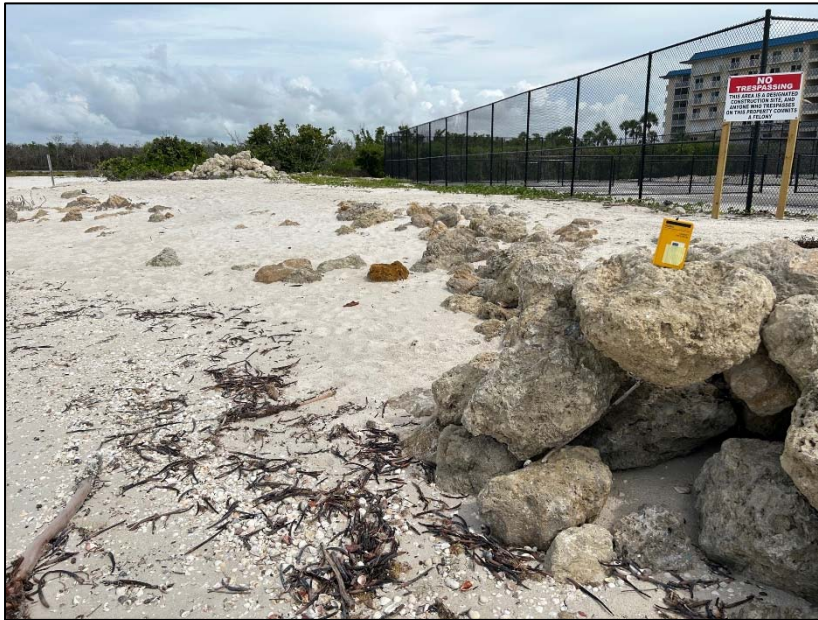
Left – Landward end of North Groin at beach berm.

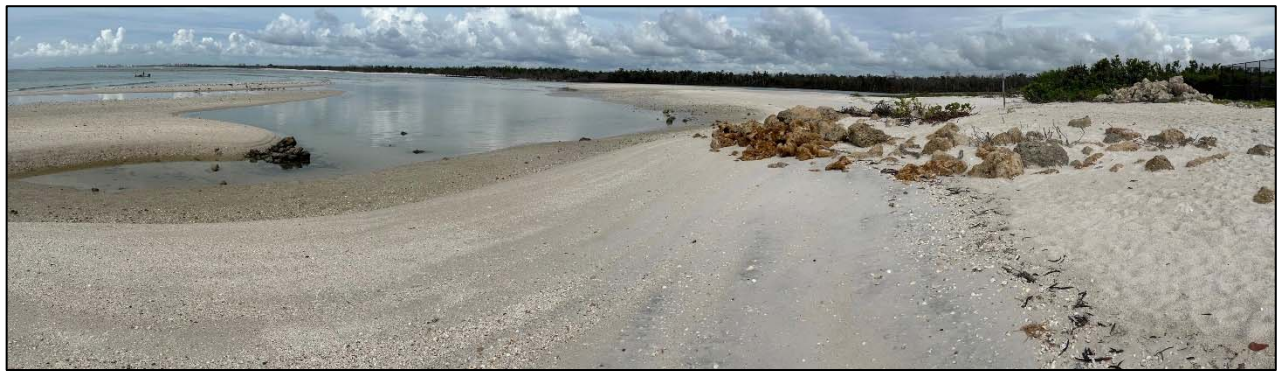
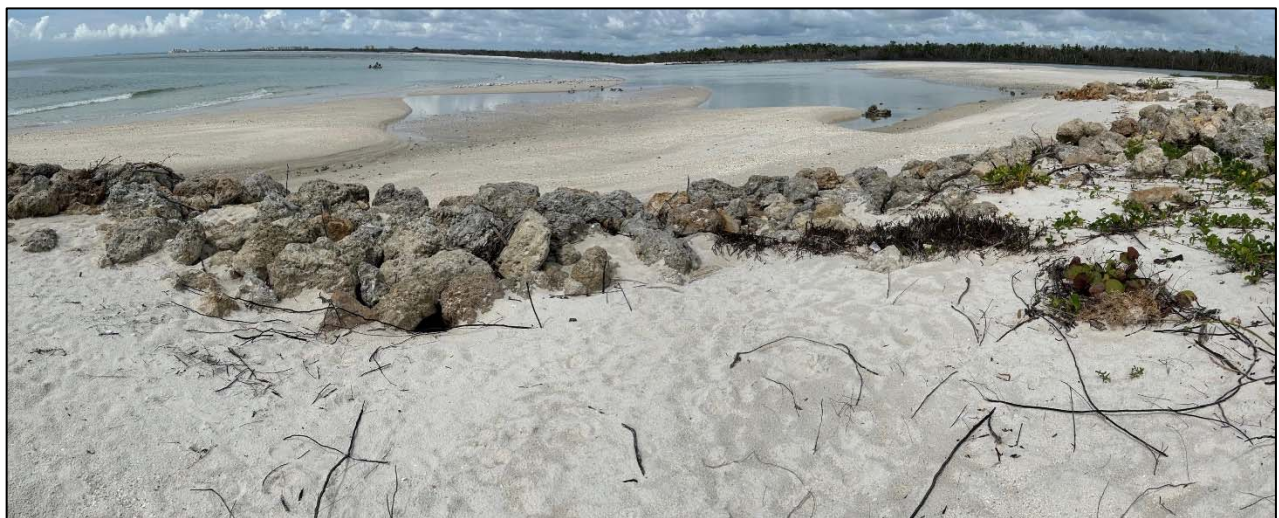
Below (middle): Landward extension of North Groin looking east into Big Hickory Pass.

Below (bottom): Landward end of North Groin looking southeast toward Big Hickory Island, with Big Hickory Pass to center & right (composited images).

**Figure 6:** Photographs of the Bonita Beach terminal groins on 26 September 2023, one year after Hurricane Ian, continued from prior pages. **Figure 6** is concluded on next page.

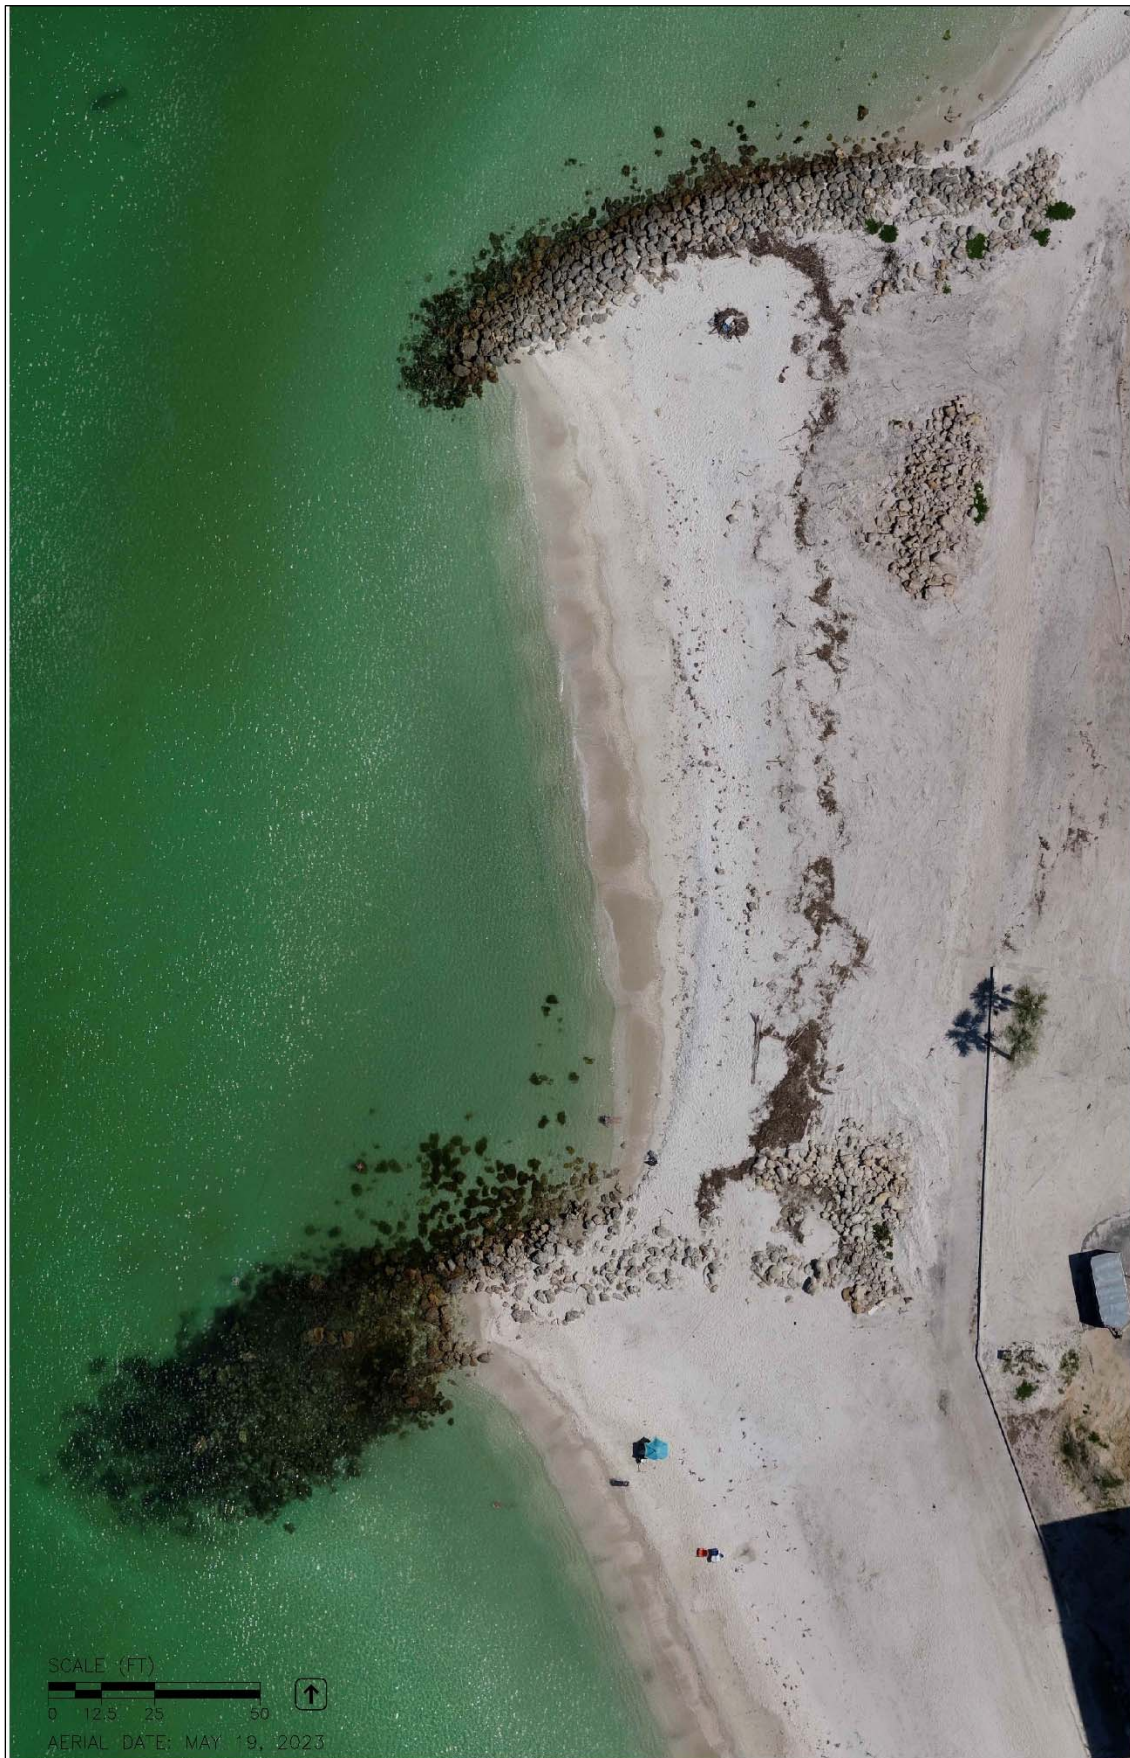
**Figure 6 (concluded):** Aerial photograph of the terminal groins from 19 May 2023.

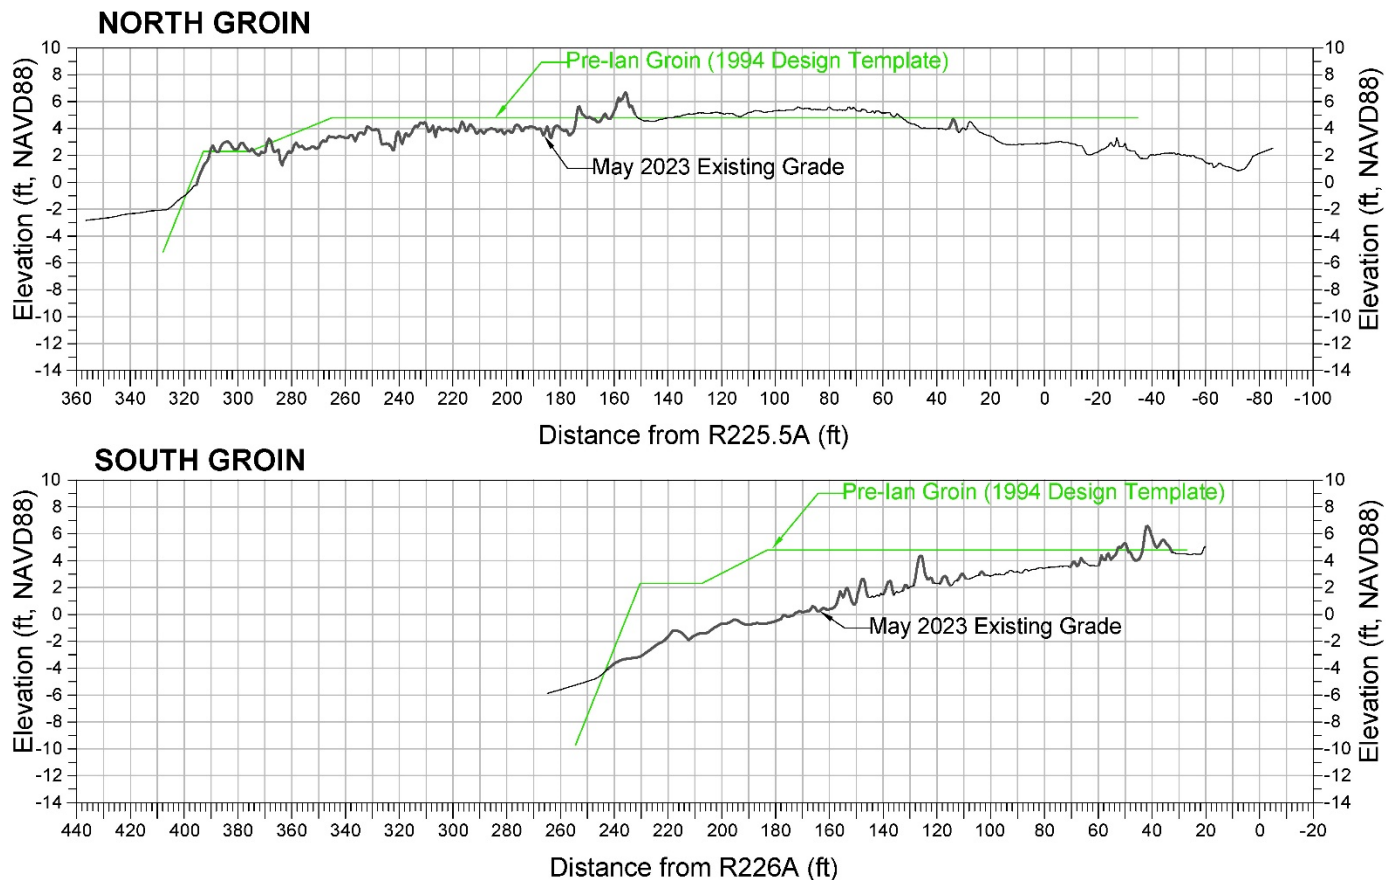
**Figure 7:** Cross-shore profile of the groins' centerlines. The distance is projected from the adjacent monument locations, R-225.5A (North Groin) and R-226A (South Groin). The pre-Ian profile is represented by the 1994 design profile with green lines. The existing conditions along each groin (May 2023) are indicated by the black lines. The thicker black line is exposed rock.

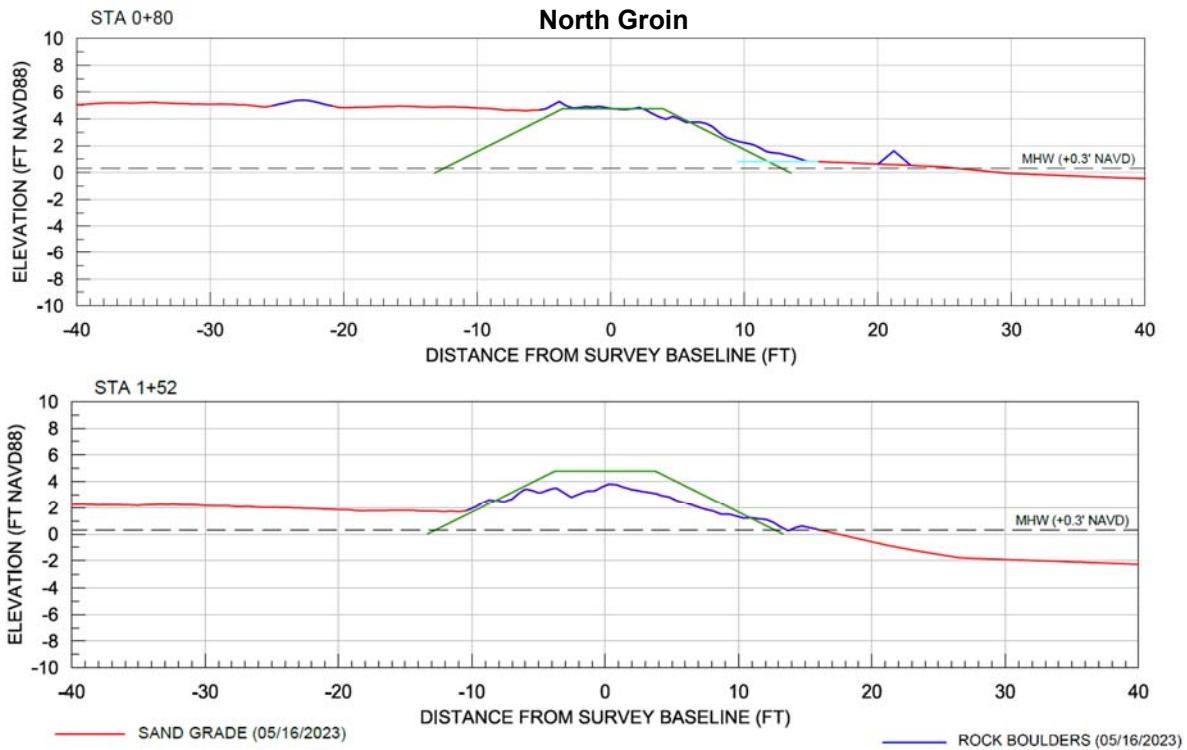
**Figure 8:** Representative cross-sections of the **North Groin** with May 2023 existing grade and rock boulders (red and blue line, respectively) and 1994 groin plan (green line).

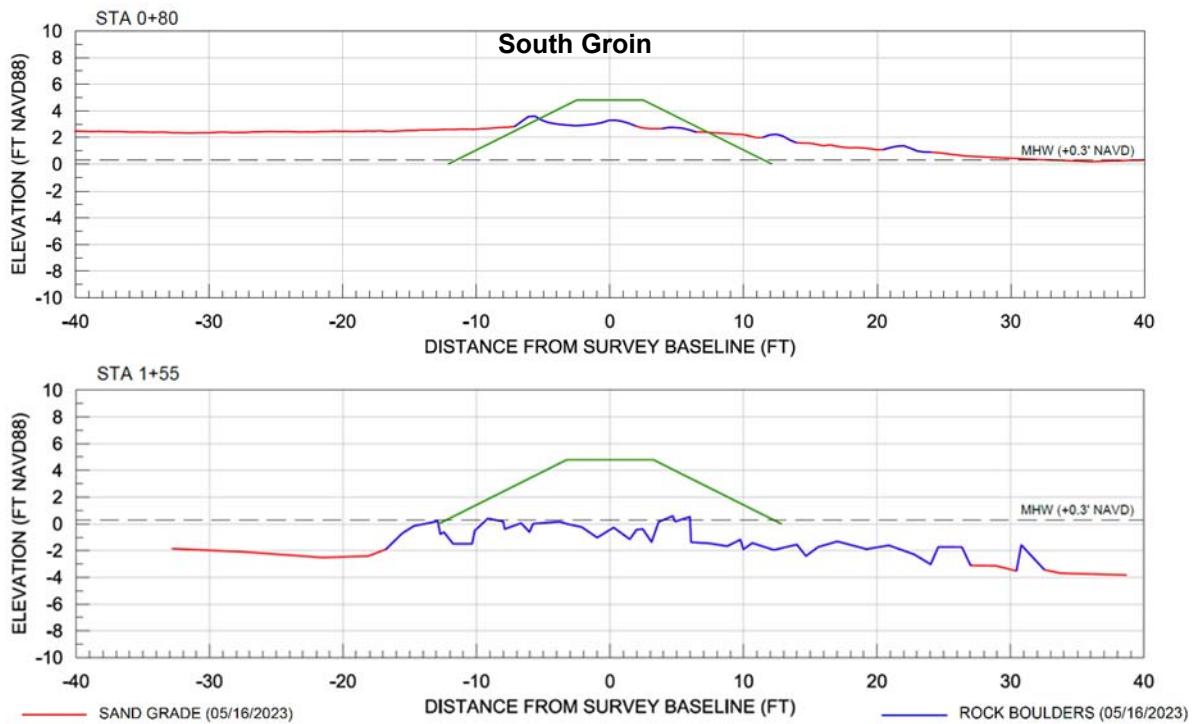
**Figure 9:** Representative cross-sections of the **South Groin** with May 2023 existing grade and rock boulders (red and blue line, respectively) and 1994 groin plan (green line).

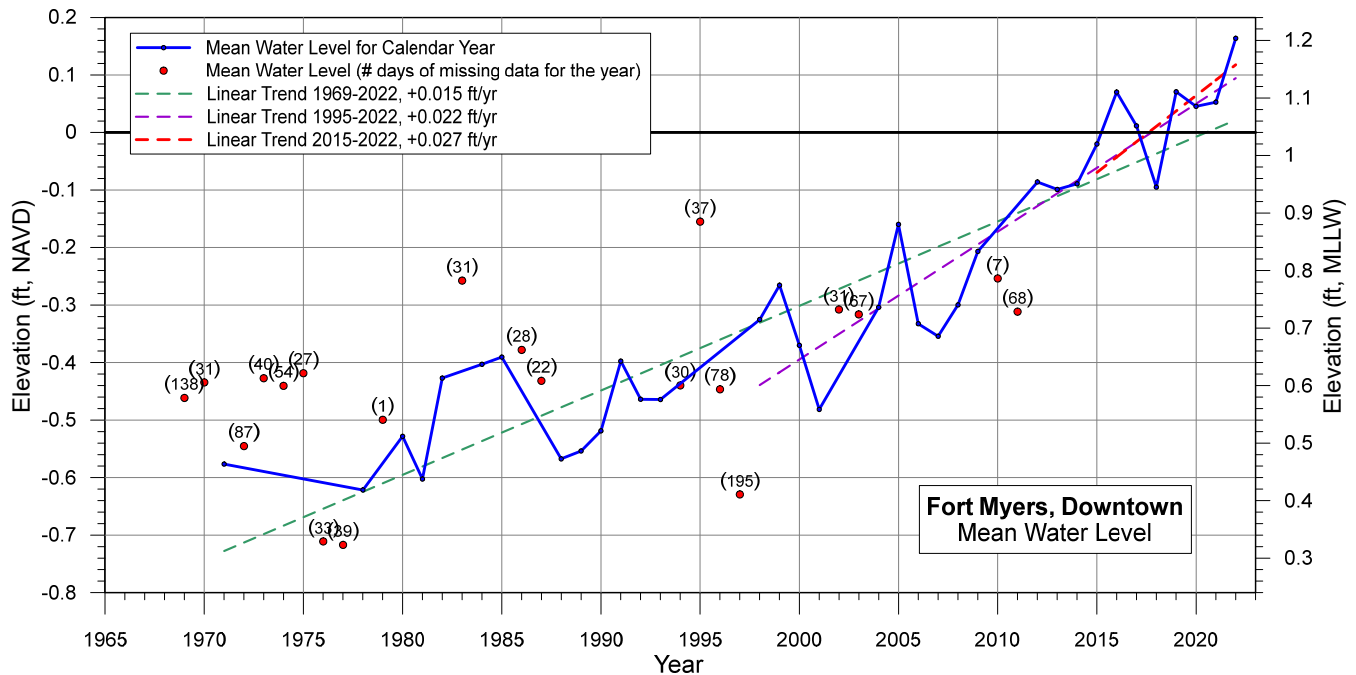
**Figure 10:** Annual mean sea level as measured in Fort Myers (NOAA Station 8725520).

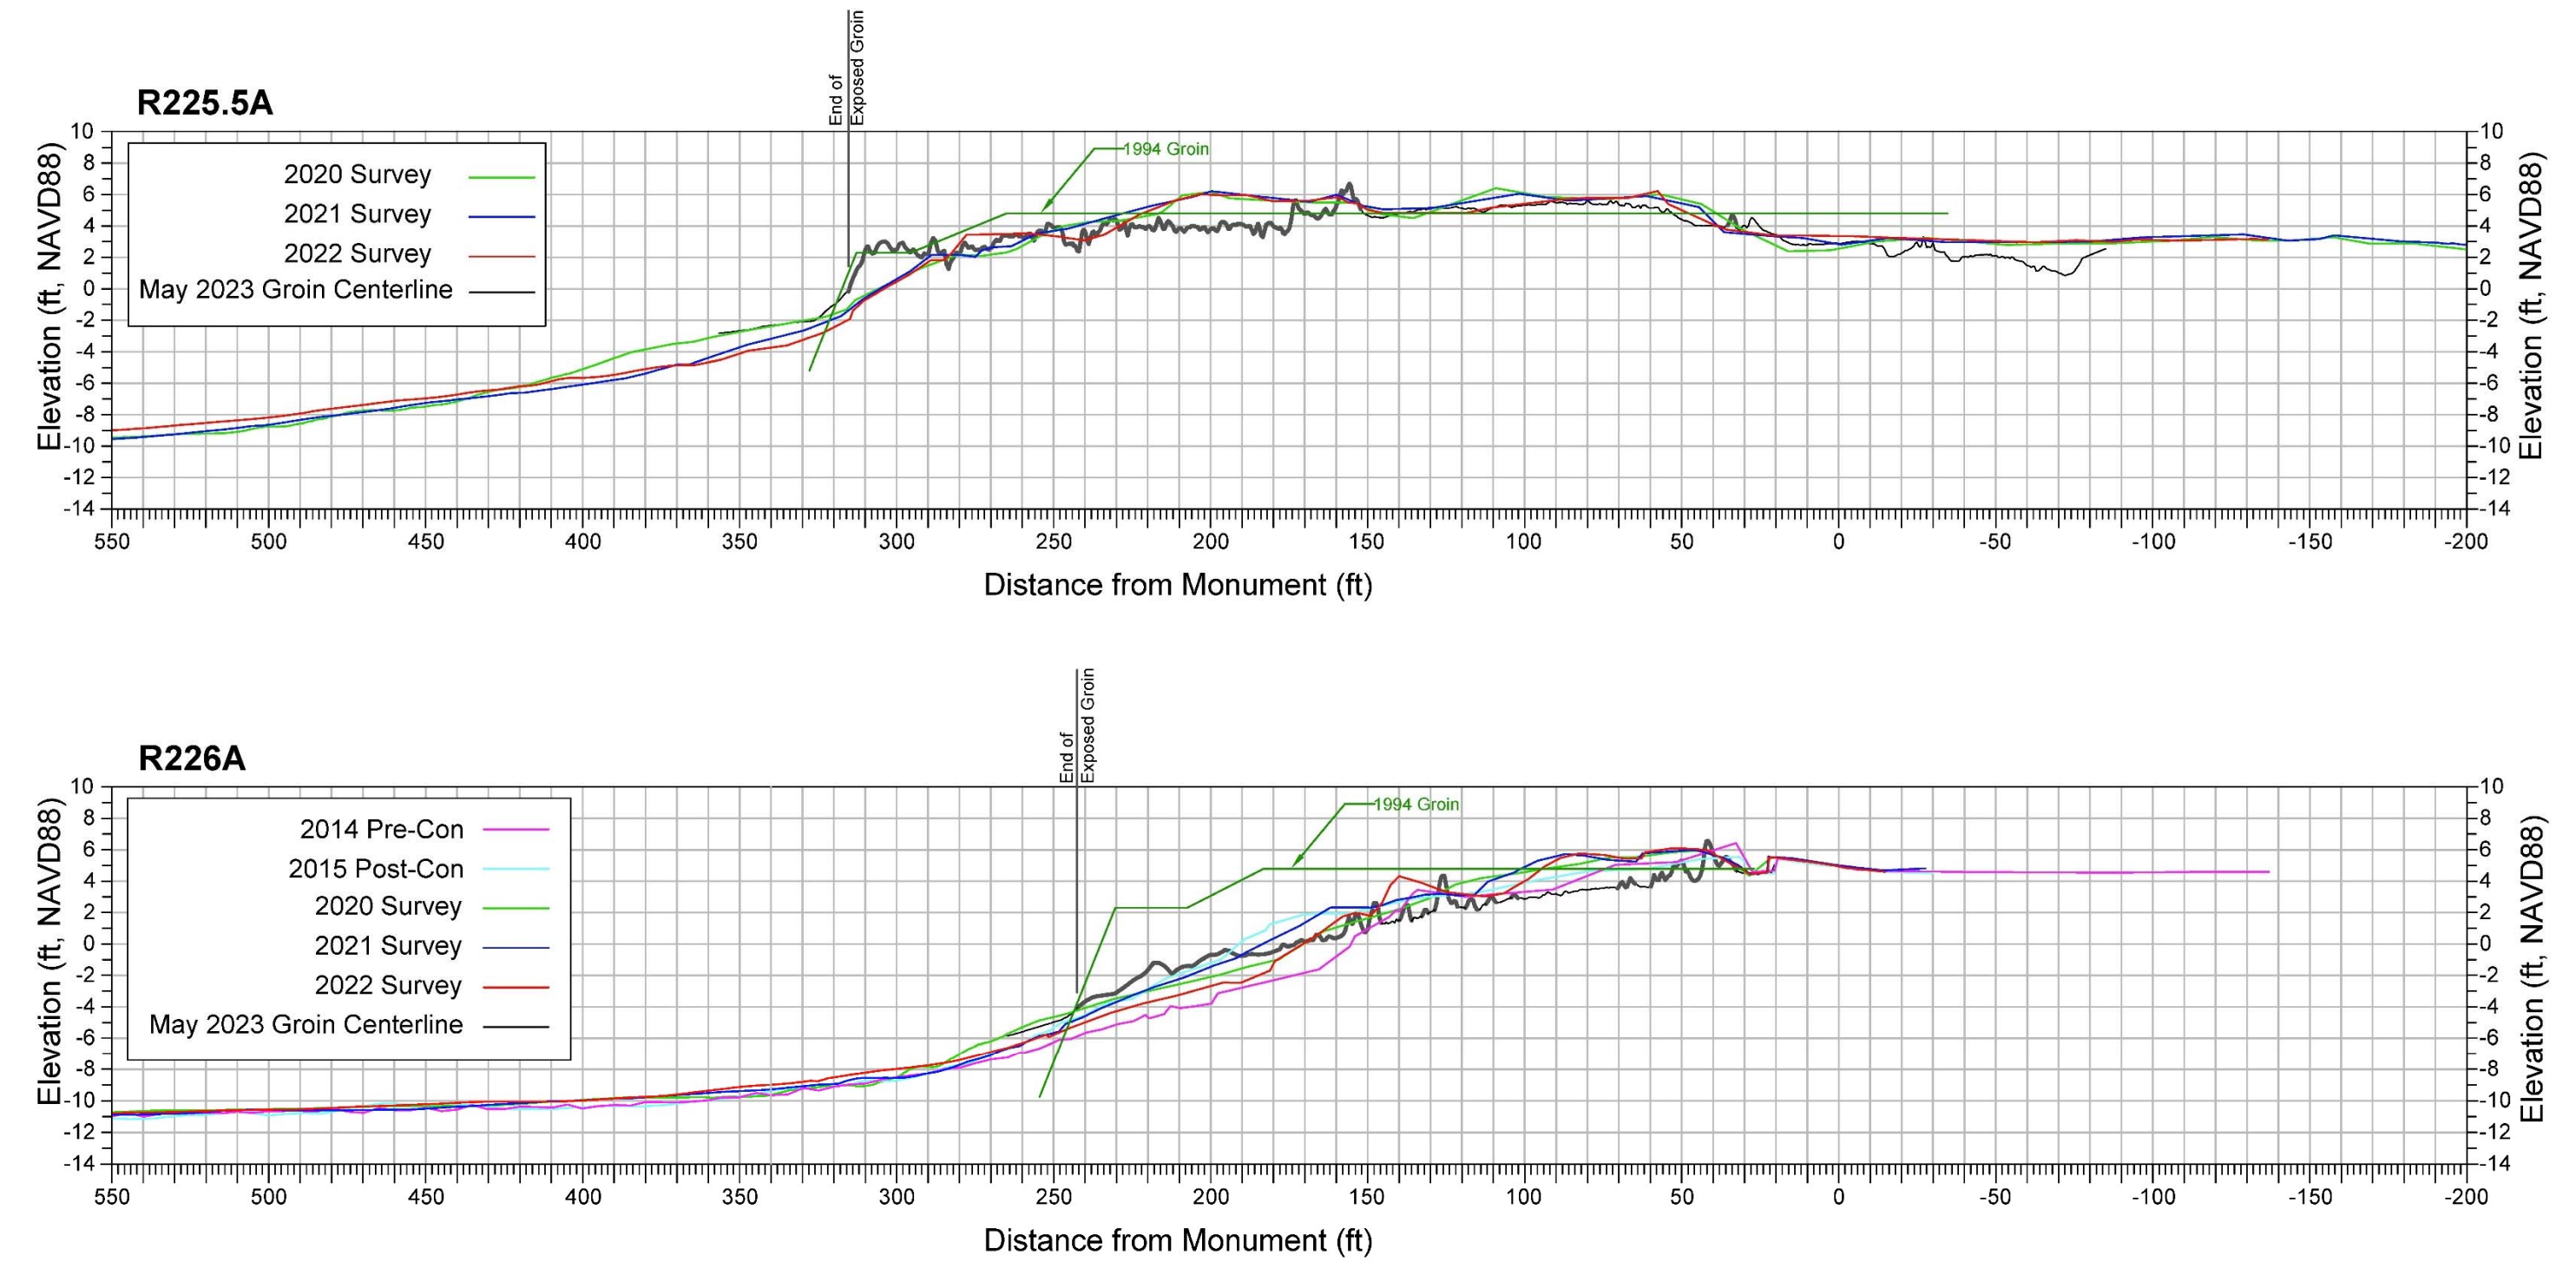
**Figure 11:** Beach profile plots at R-225.5A, North Groin (top); and R-226A, South Groin (bottom). The distance is from the R-monuments. The approximate 1994 design profile for each groin is indicated by the dark green lines. The existing conditions along each groin (May 2023) are indicated by the black lines, with exposed rock indicated by the thicker line.

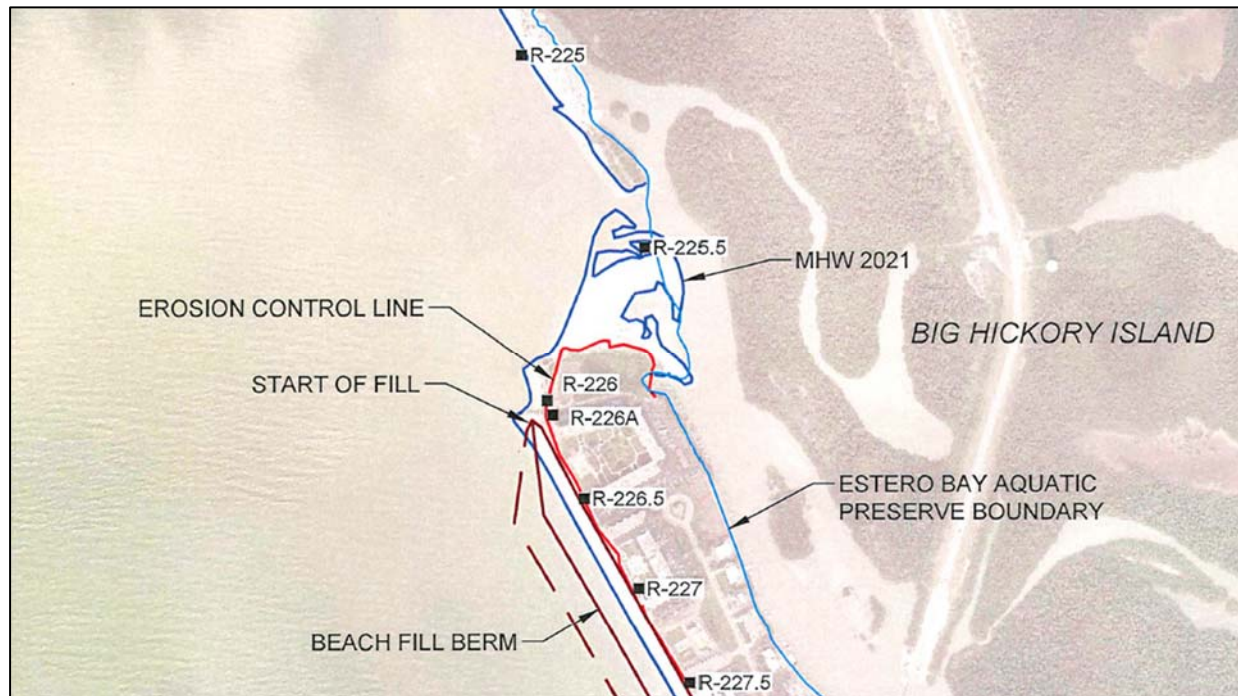
**Figure 12:** Beach fill template along the north end of Little Hickory Island as drawn by Coastal Engineering Consultants. Image extracted from permit drawings by CEC<sup>4</sup>.
