Beach Management Funding Assistance Program  
Local Government Funding Request  
Fiscal Year 2025/2026  
Beach Projects Application

## Bonita Beach Groin Repair

# BONITA BEACH TERMINAL GROINS DAMAGE REPORT FOR HURRICANE IAN; LEE COUNTY, FLORIDA.

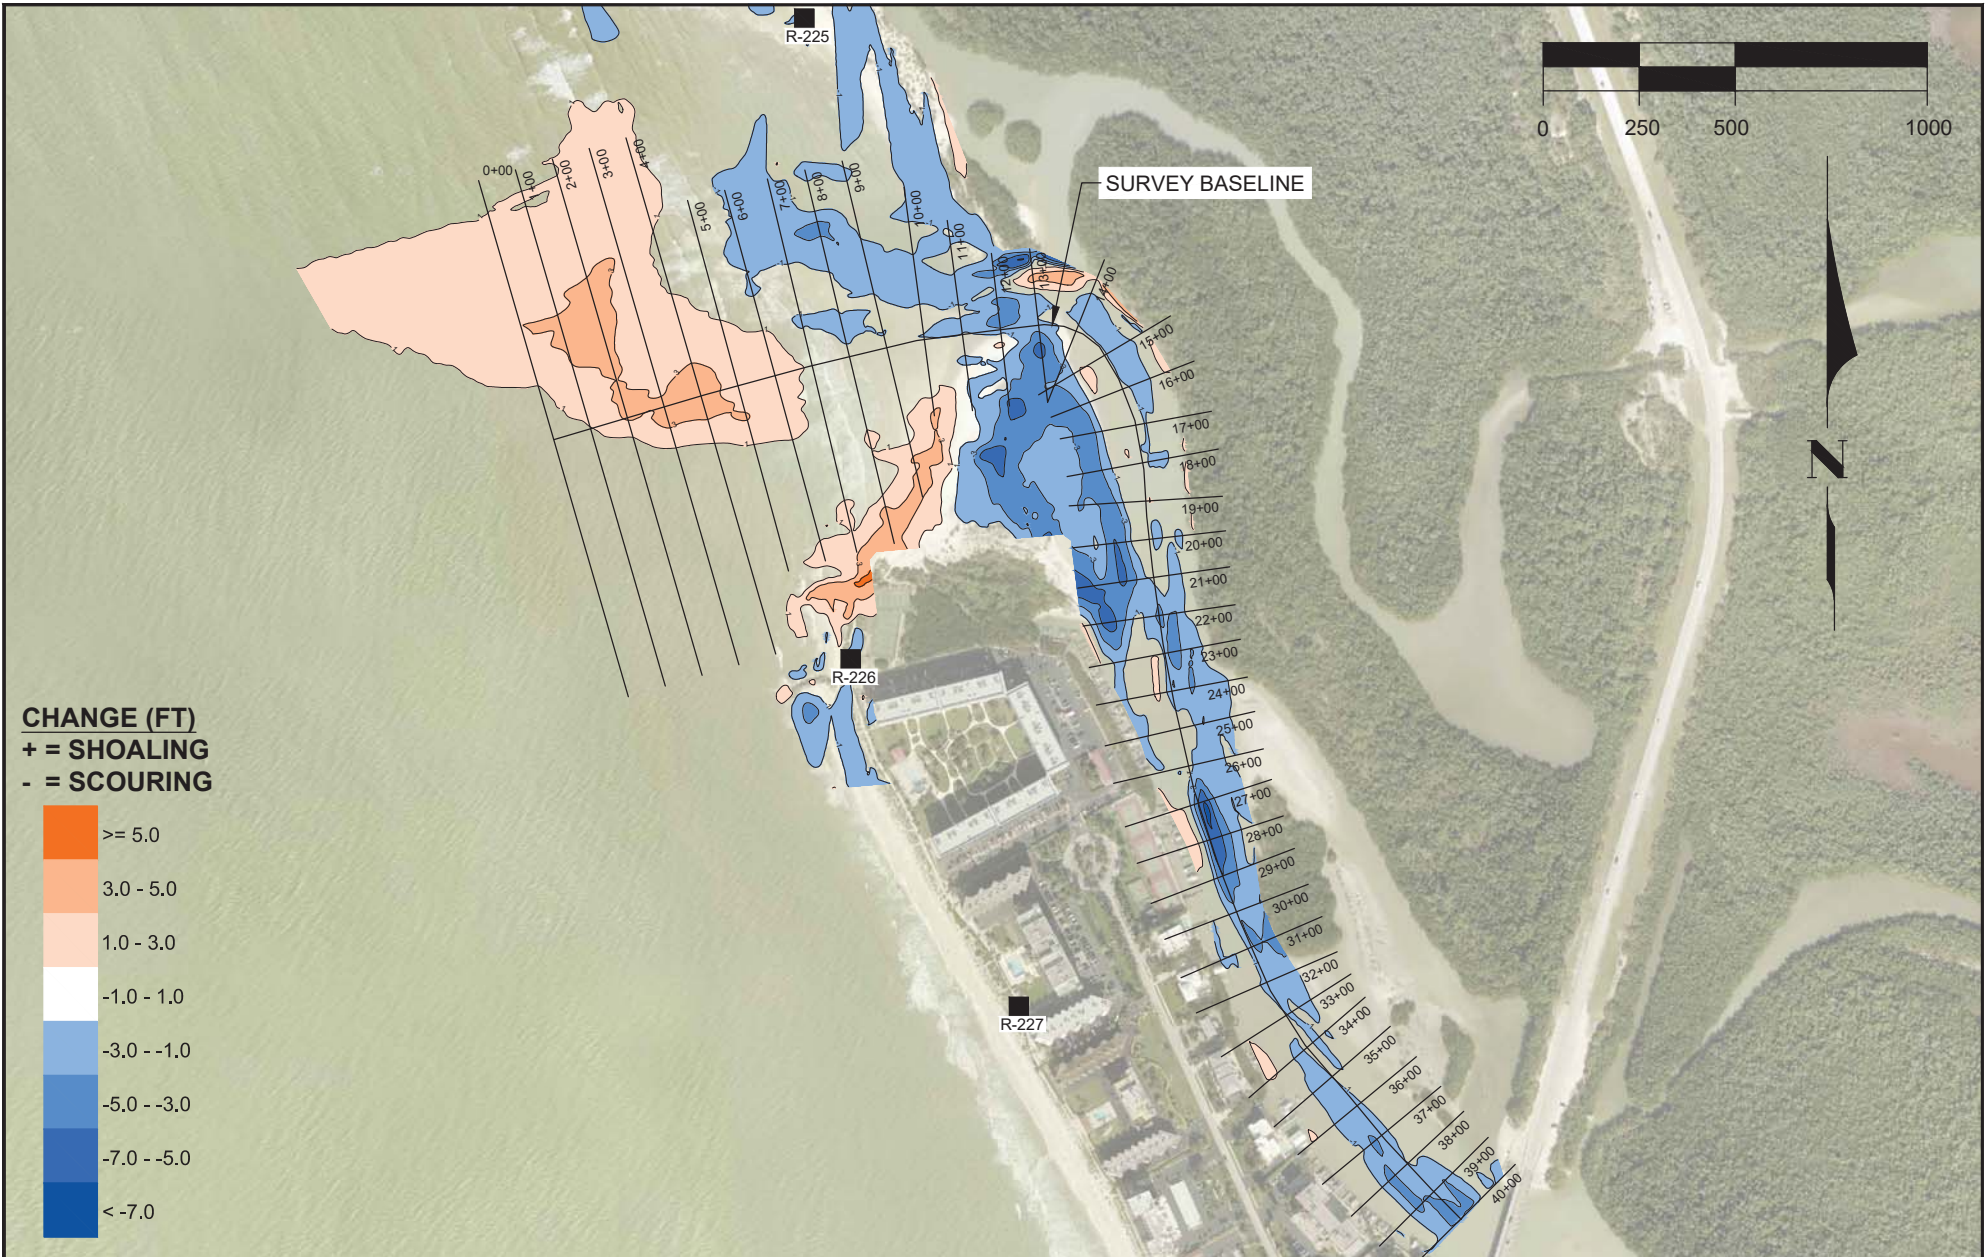
**CHANGE (FT)**  
**+** = SHOALING  
**-** = SCOURING

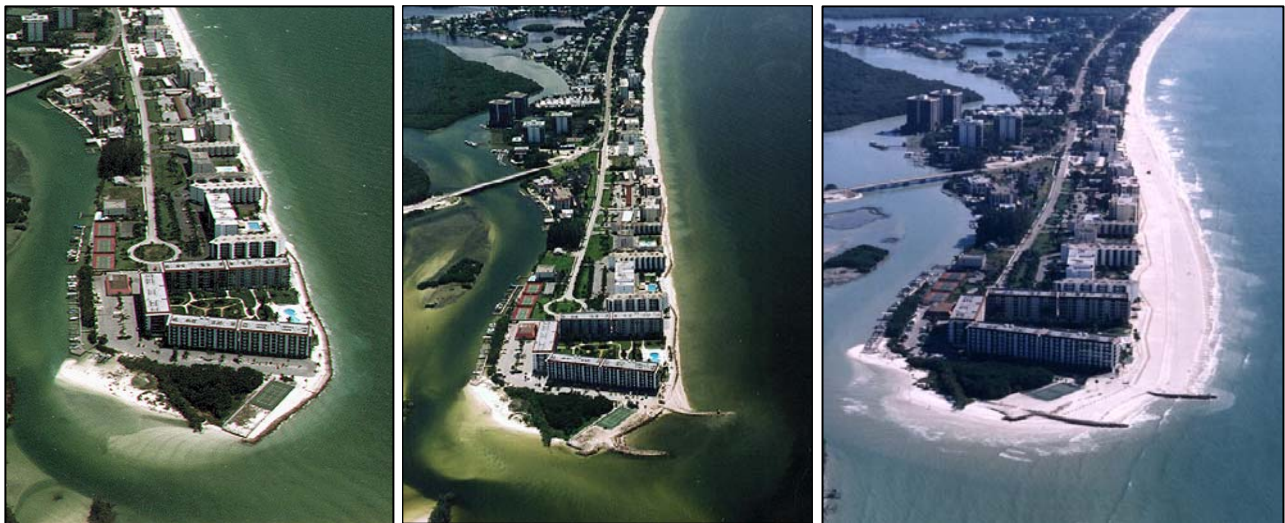
**Figure 1:** North end of Bonita Beach before construction of the terminal groins (left), after construction of the terminal groins (middle), and after placement of 217,000 cy of sand<sup>1</sup> (right).

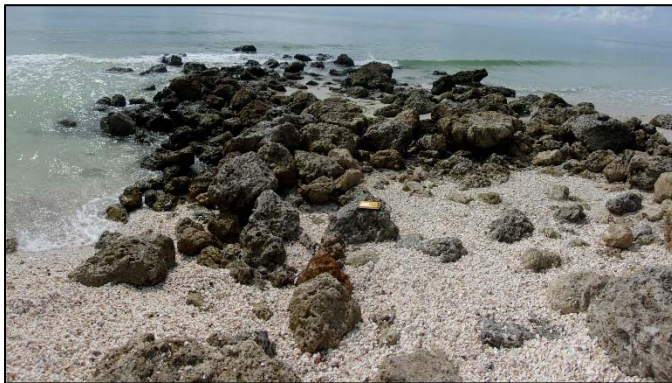
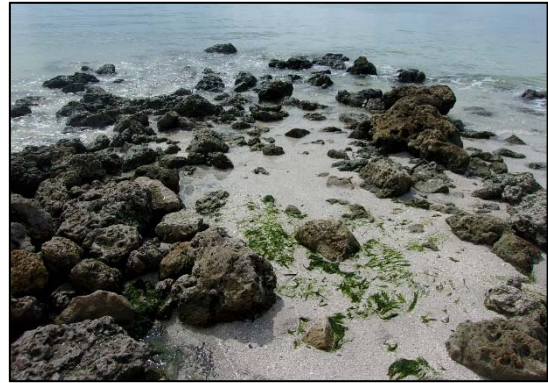
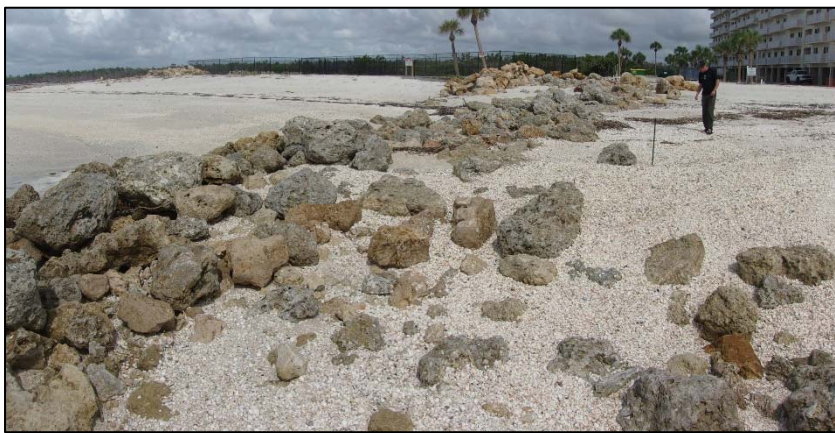
**Figure 2:** South groin (photo - 9/26/2023), 1 year after Hurricane Ian. At top: seaward end. At left: central stem and landward end.

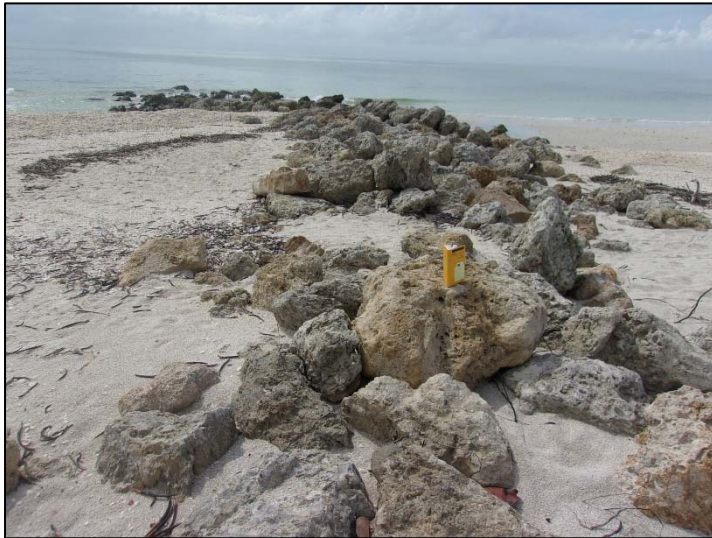
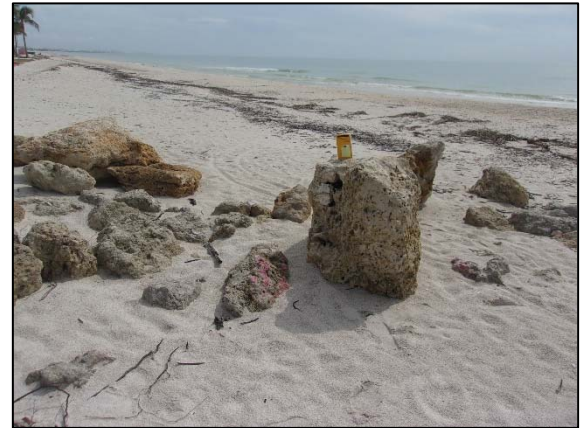
Hurricane Ian. On or about 25-26 September 2022, high waves and storm surge from Hurricane Ian caused severe beach erosion along all of Lee County and significant damage to the two rock groins at Big Hickory Pass. **Figure 2** shows representative photographs of the rock groins as of 26 September 2023.

Left – South Groin, central & seaward end.  
Above – South Groin, landward end.

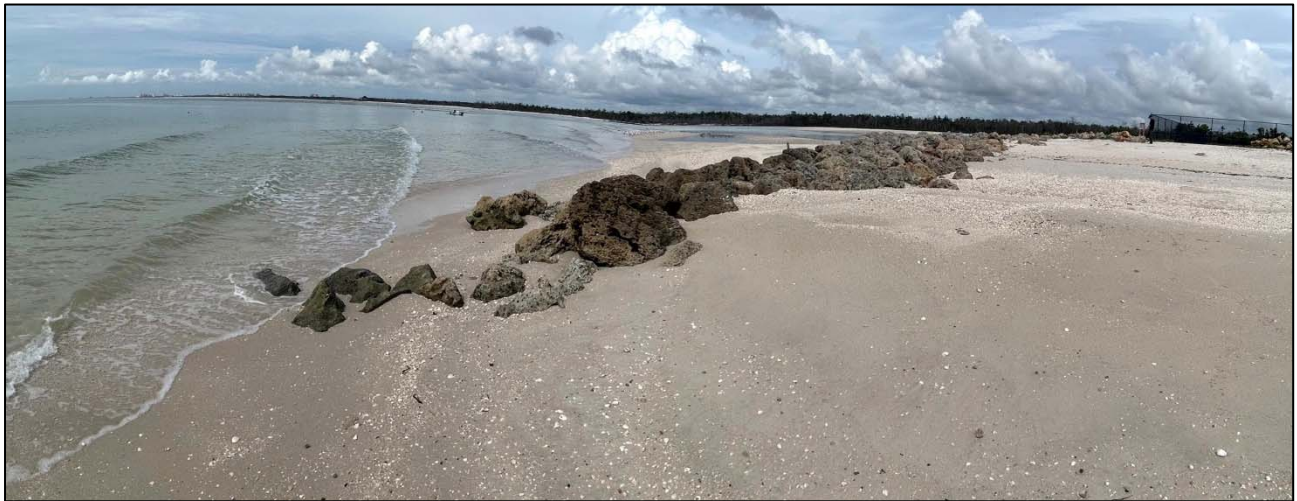
North Groin – Seaward End (9/26/2023).

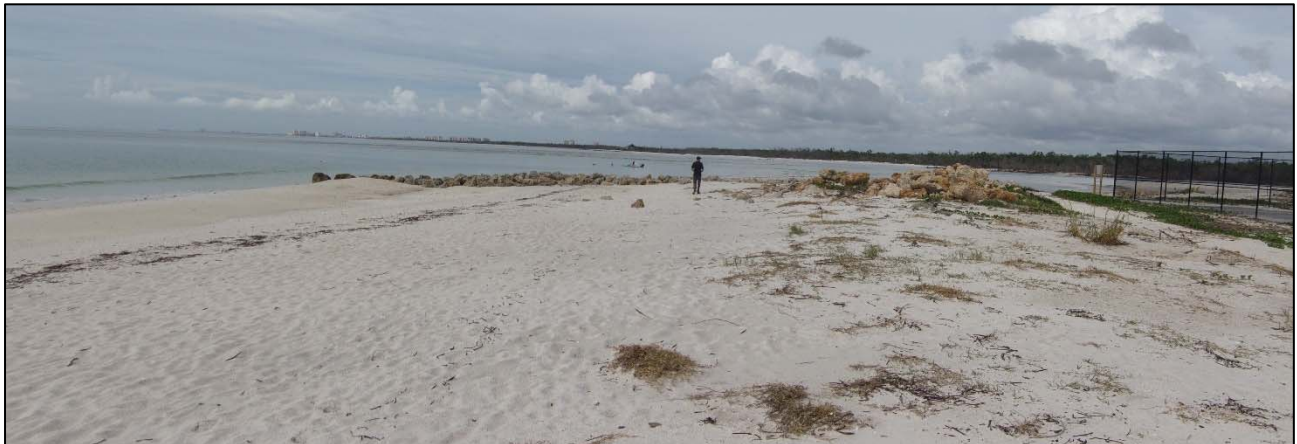
North Groin – Profile (9/26/2023), with scattered rock stockpiled along the beach berm at right. [The deposition of a low sand berm along the shoreline, evident in the photograph above, is a residual result of Hurricane Idalia in late August 2023.]

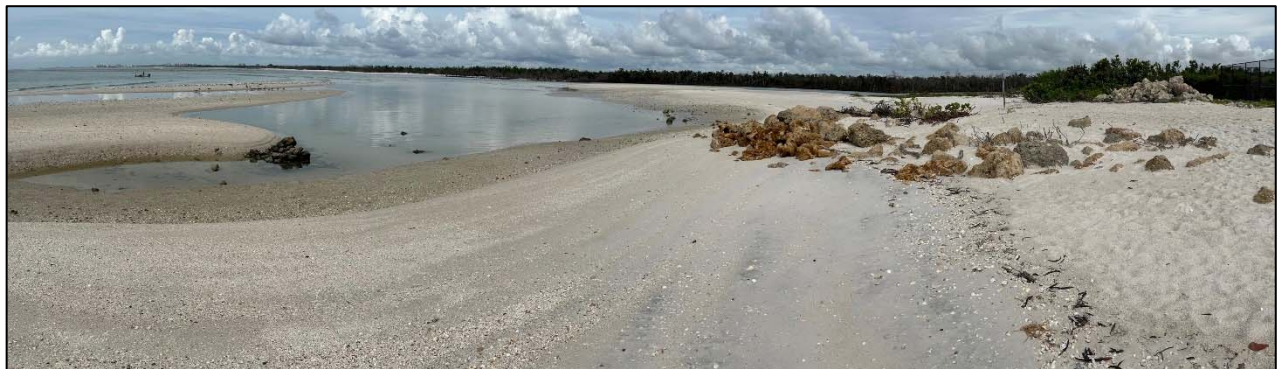
Below (middle): Landward extension of North Groin looking east into Big Hickory Pass.

Below (bottom): Landward end of North Groin looking southeast toward Big Hickory Island, with Big Hickory Pass to center & right (composited images).

**Figure 2:** Photographs of the Bonita Beach terminal groins on 26 September 2023, one year after Hurricane Ian, continued from Page 2. **Figure 2** is concluded on next page.

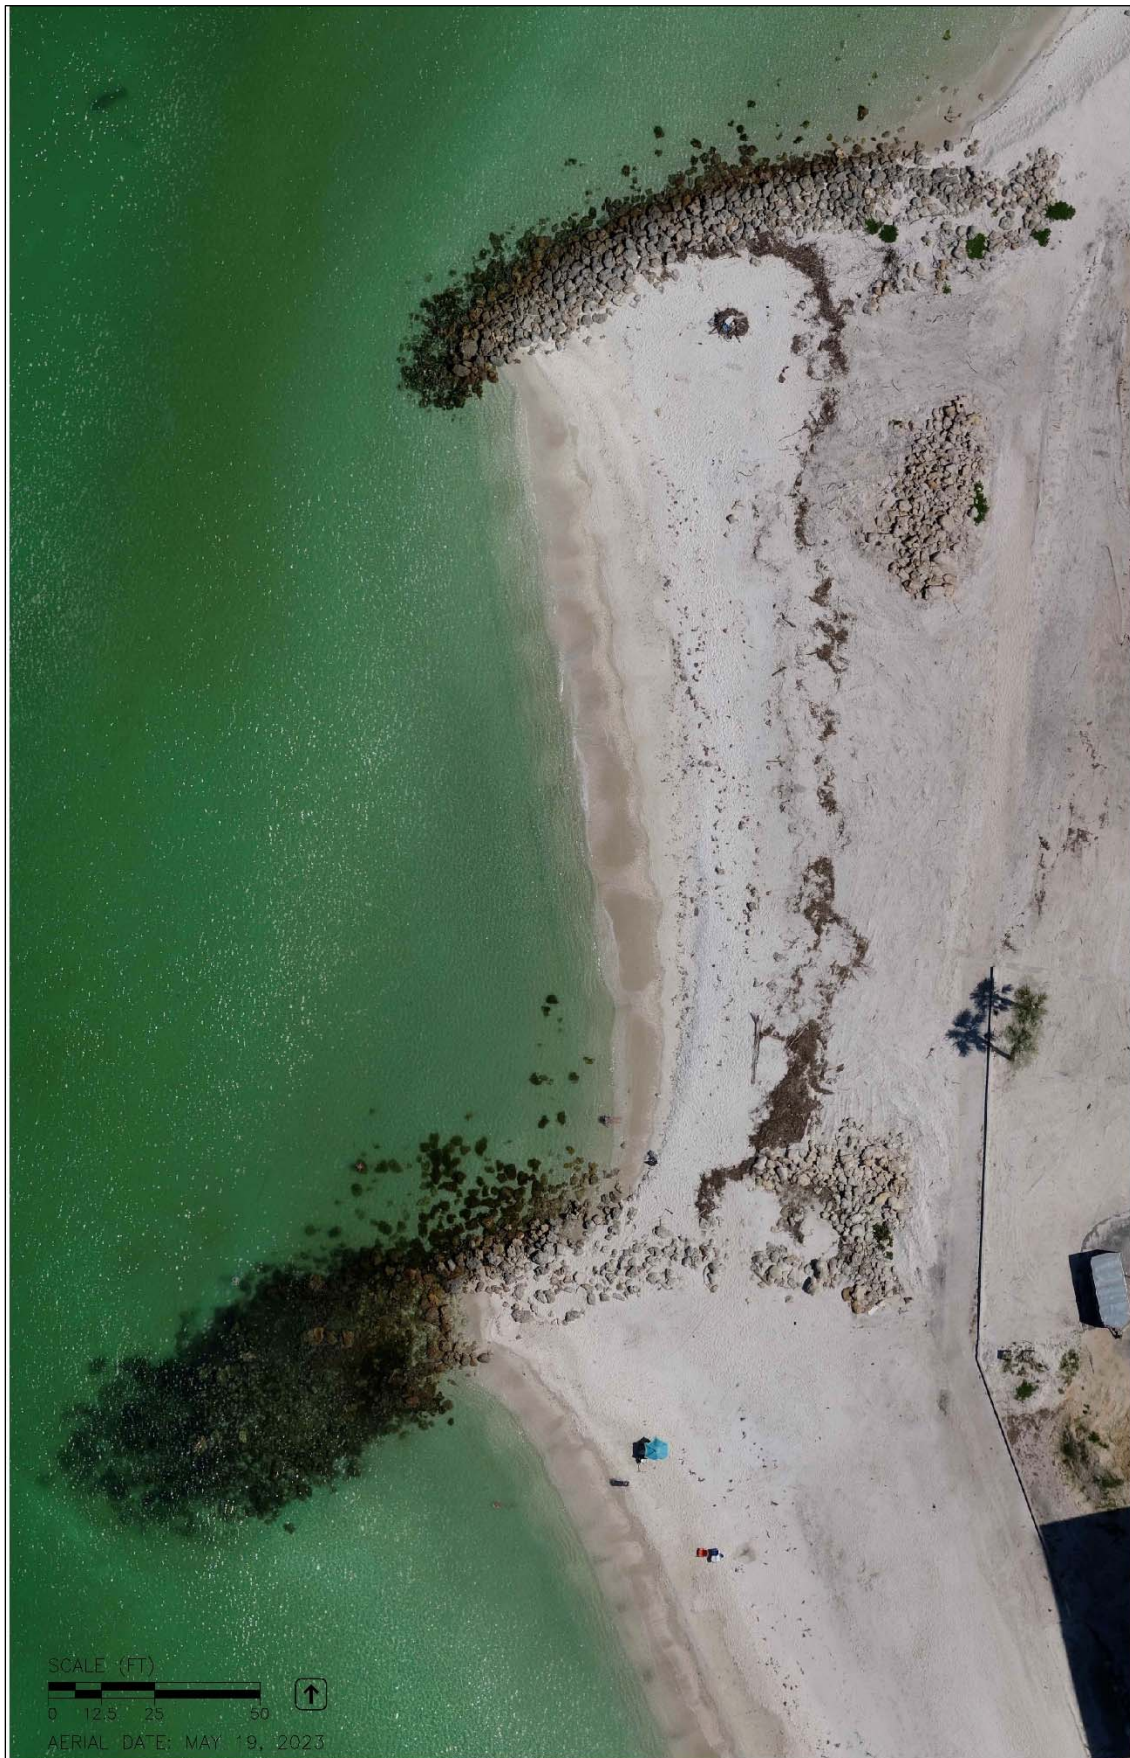
**Figure 2 (concluded):** Aerial photograph of the terminal groins from 19 May 2023.

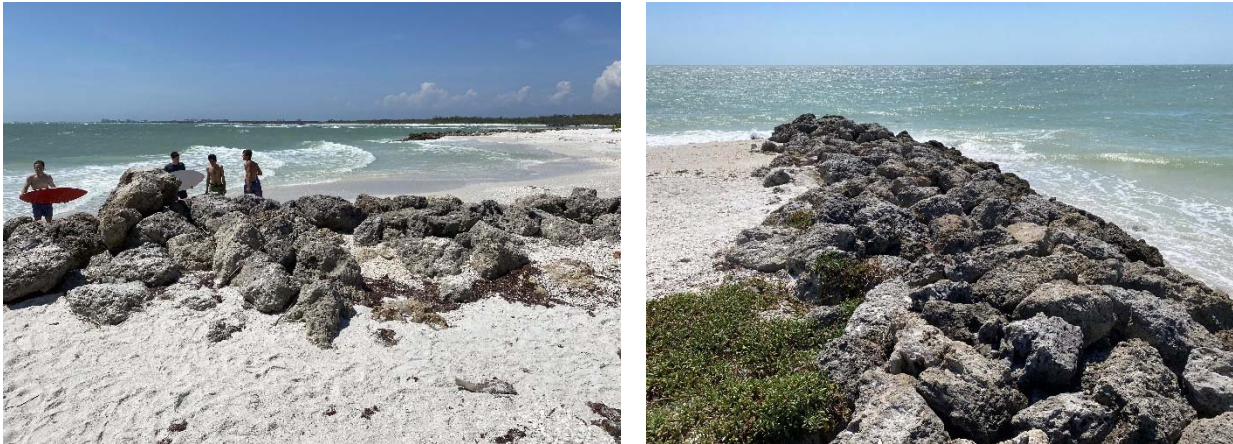
**Figure 3:** Left – South groin. Right – North groin. Pre-Ian. 4 May 2021. Photos by Vadim Alymov (Coastal Engineering Consultants, Inc.)

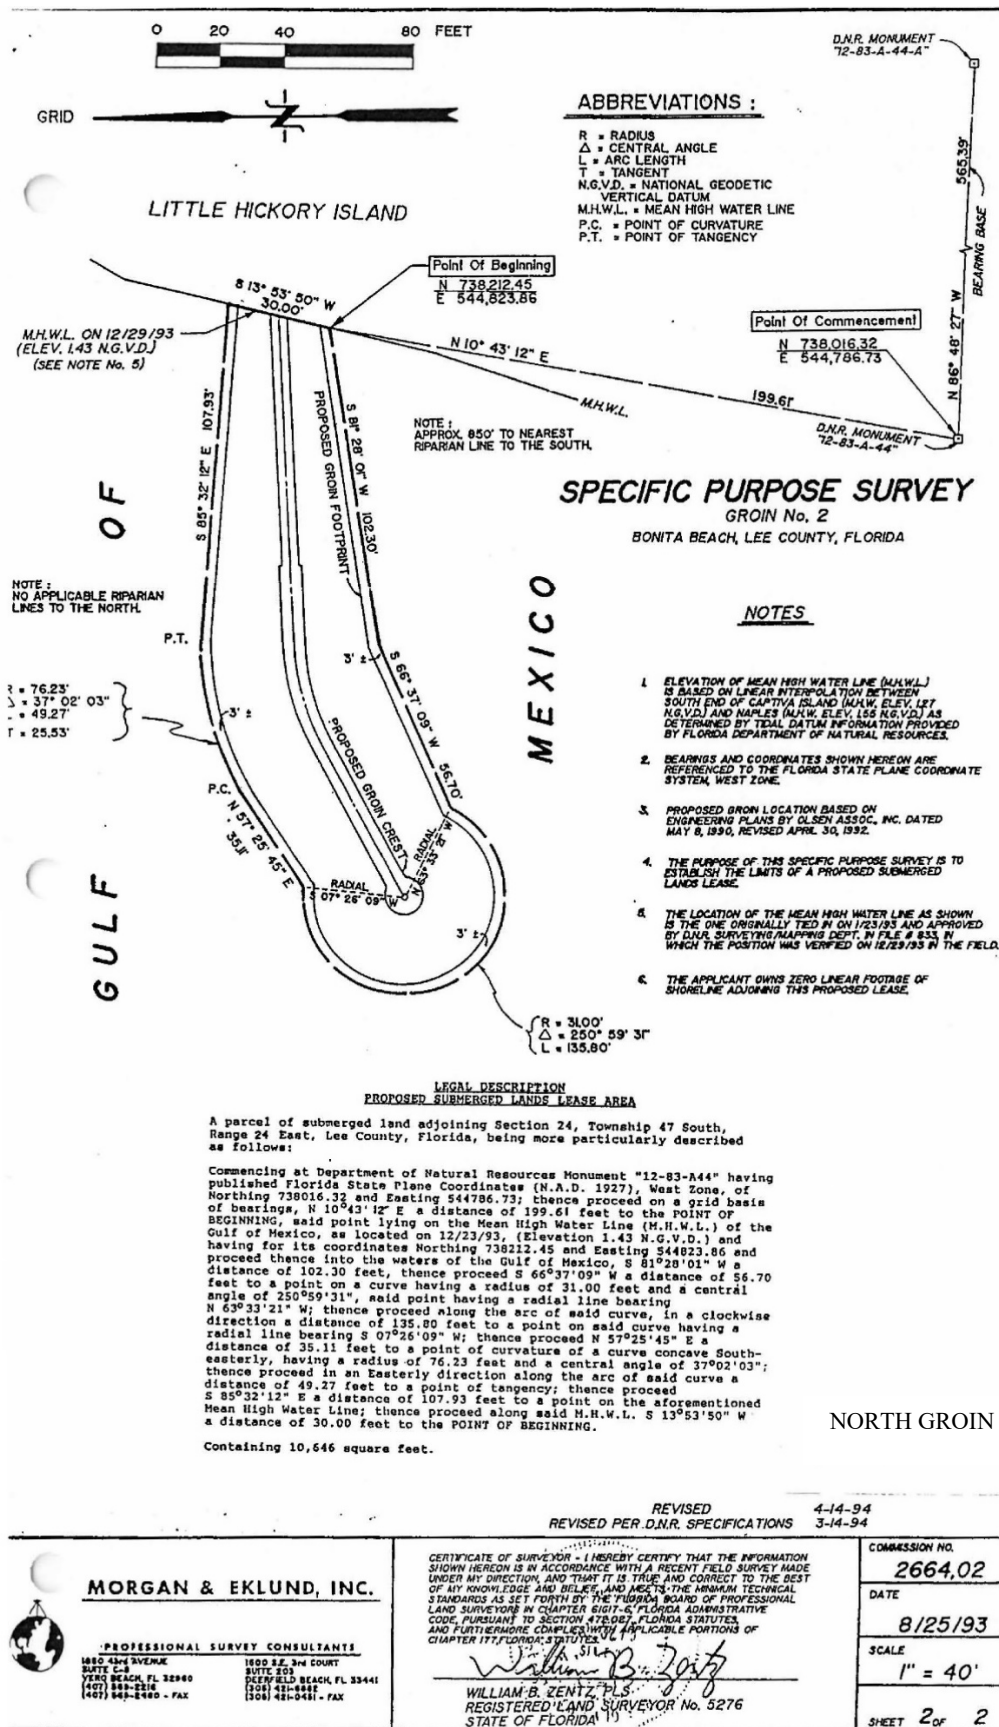
Figure 4: Specific purpose survey and submerged lands easement for North Groin. Extracted from permit DBS900263 LE.

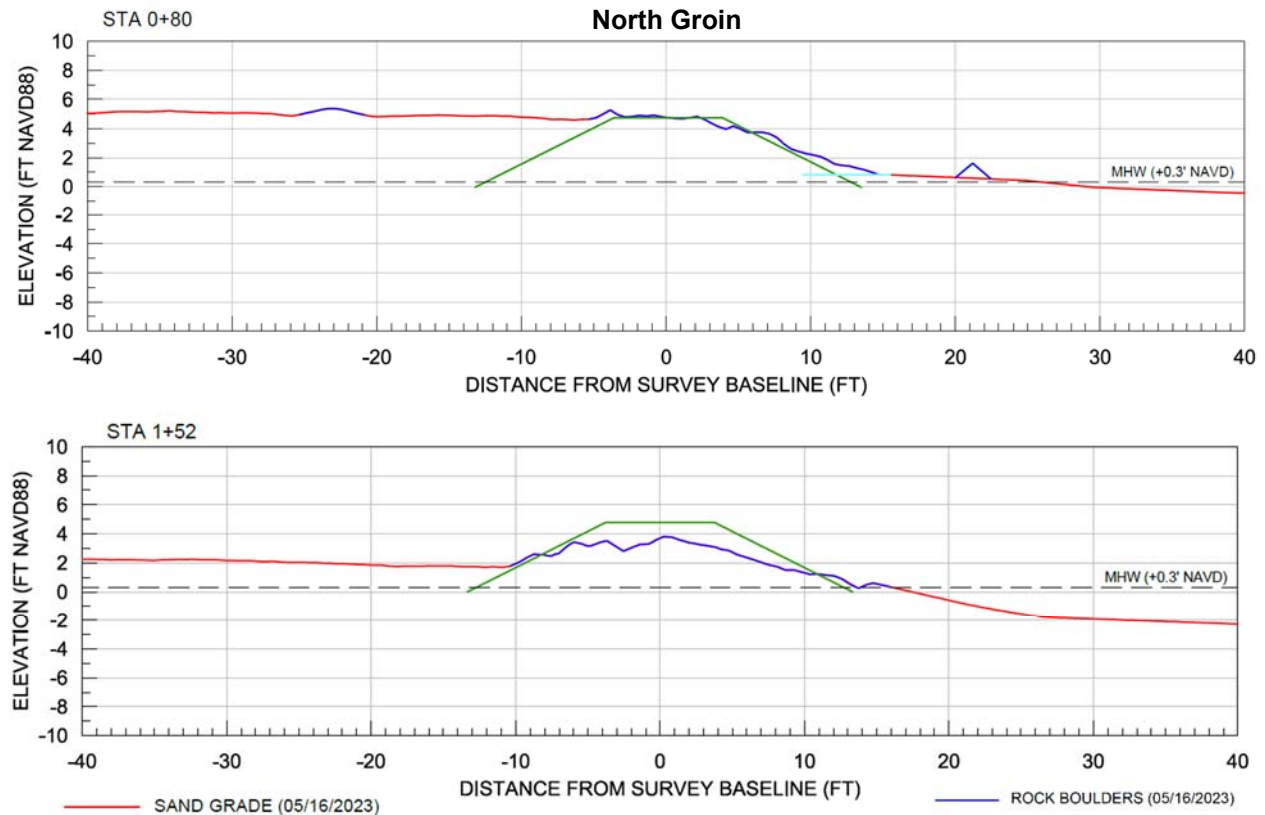
**Figure 8:** Representative cross-sections of the **North Groin** with May 2023 existing grade and rock boulders (red and blue line, respectively) and 1994 groin plan (green line).

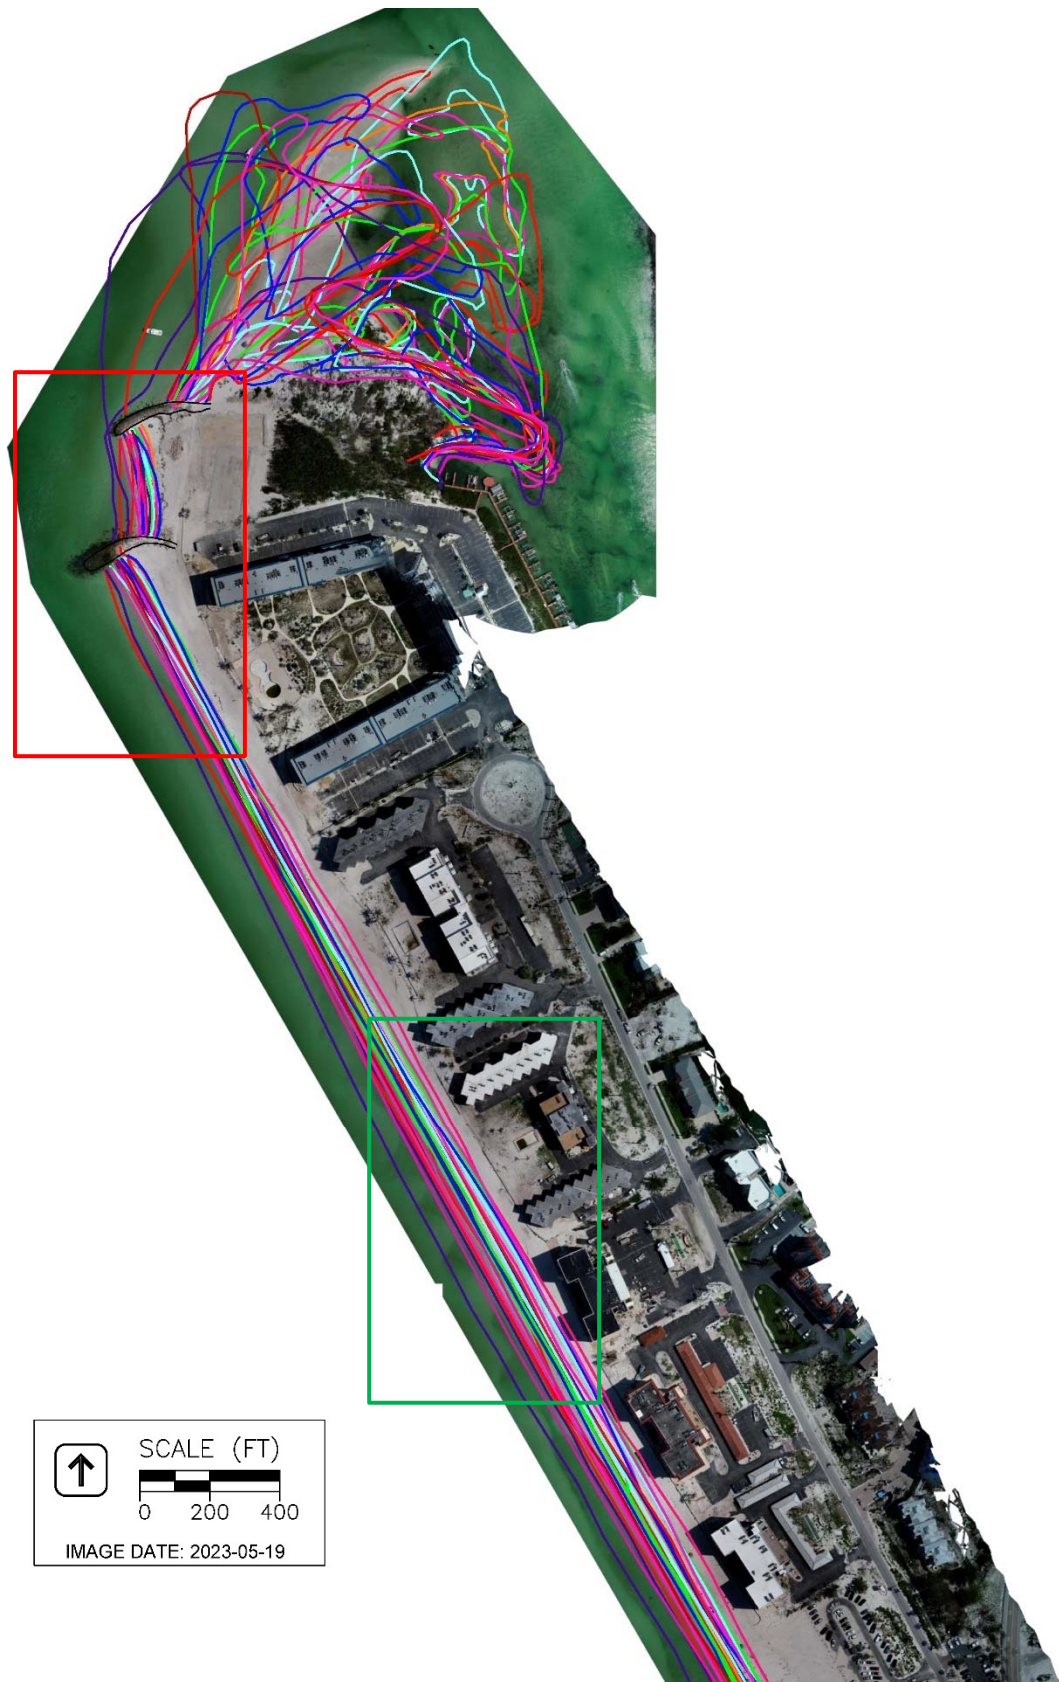
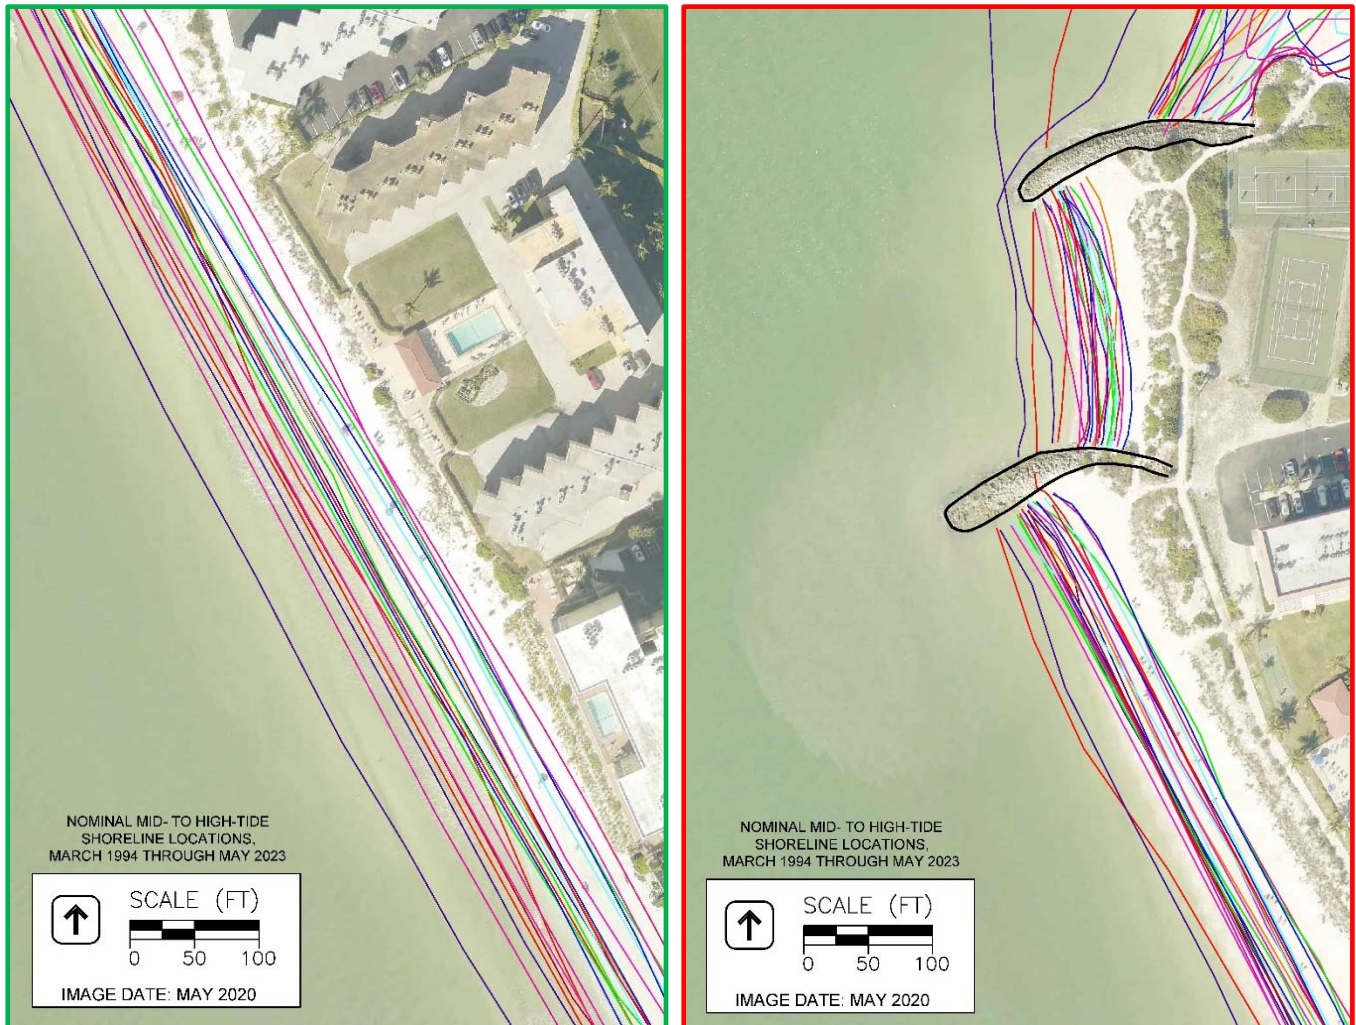
**Figure 10** (continued on next page): Comparison of the Bonita Beach shoreline as observed from aerial photographs from 1994 through 2023. Each line represents the Bonita Beach shoreline from a different aerial photograph (ranging from 1994 to 2023). Figure **adapted** from **Attachment B**.

**Figure 10** (Continued from prior page): Comparison of the Bonita Beach shoreline as observed from aerial photographs from 1994 through 2023. Each line represents the Bonita Beach shoreline from a different aerial photograph (ranging from 1994 to 2023). Figure adapted from **Attachment B**.

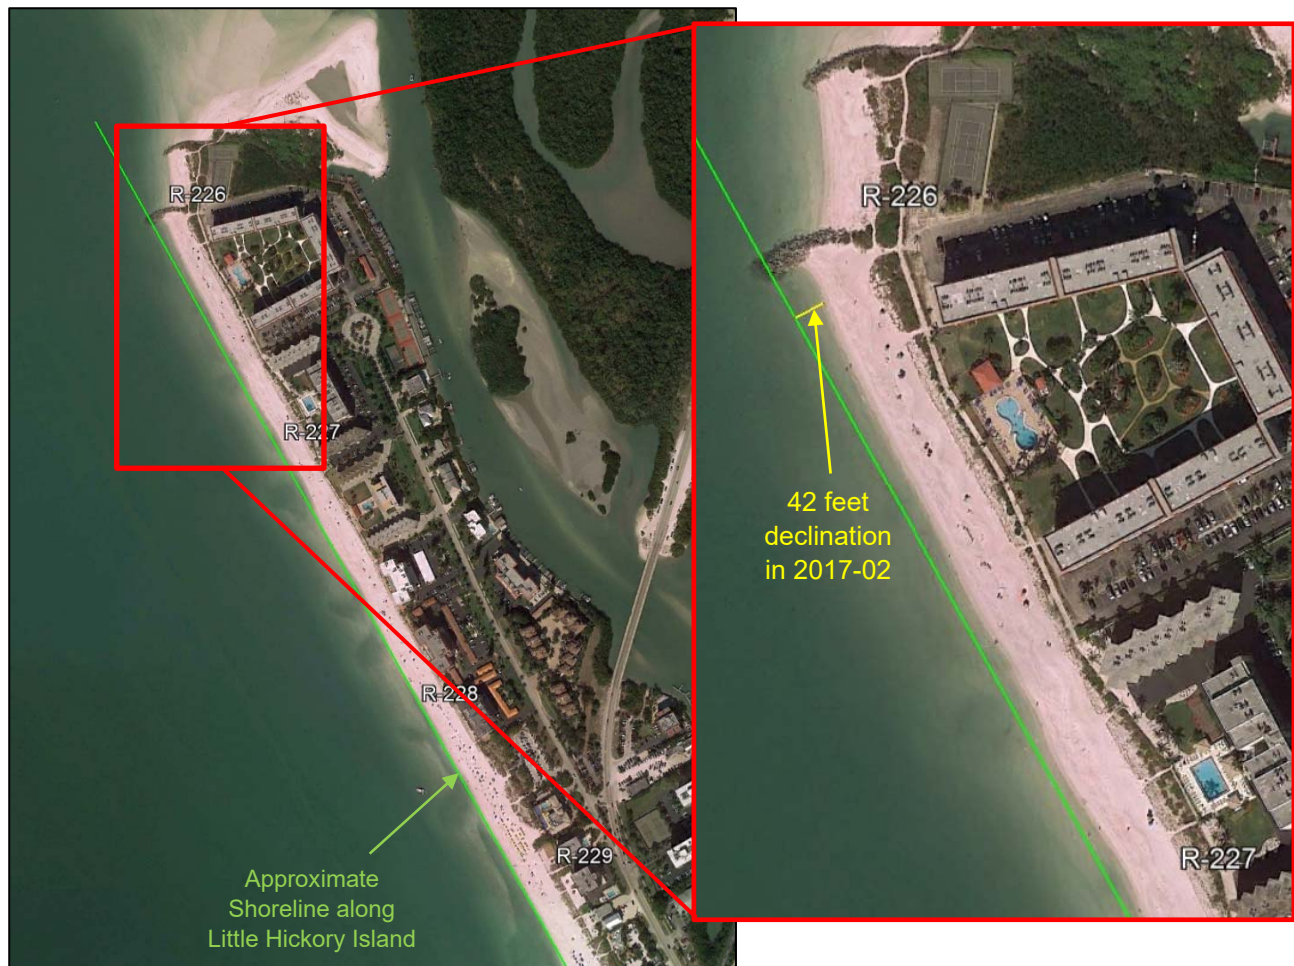
**Figure 11:** Aerial photograph of Little Hickory Island depicting a shoreline declination within 500–1,000 feet of the south groin. Aerial photograph dated February 2017 obtained from Google Earth. This landward declination of the shoreline, by 30 to 50 ft, is common to mostly all of the 2003-2023 aerial photographs.

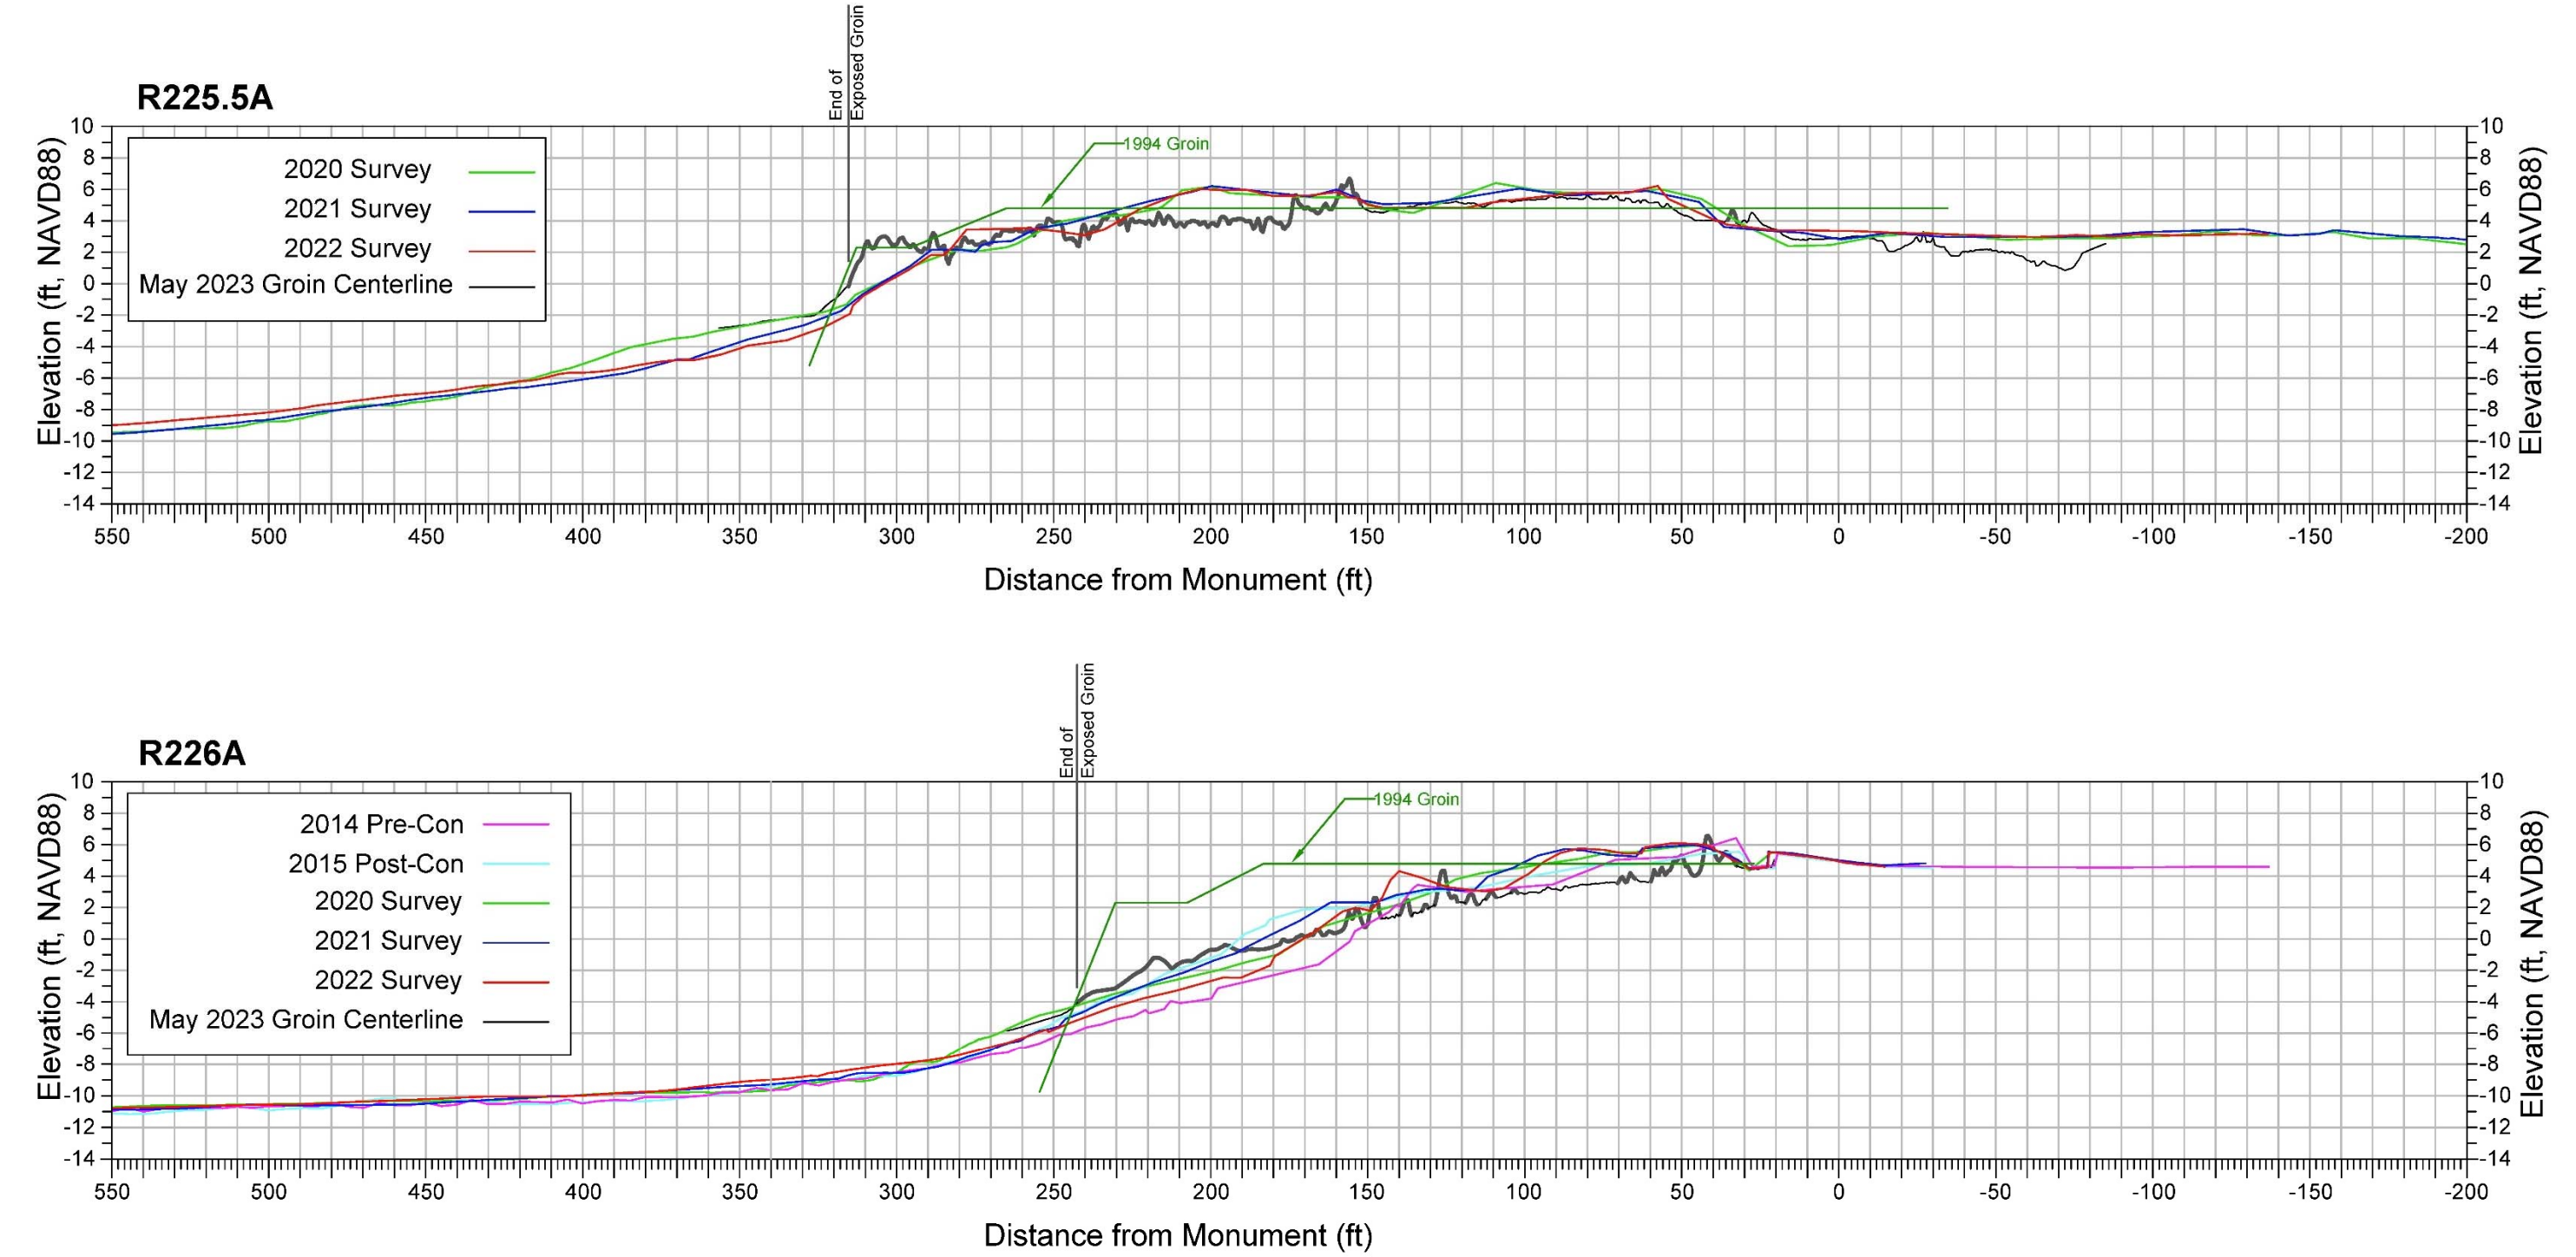
**Figure 12:** Beach profile plots at R-225.5A, North Groin (top); and R-226A, South Groin (bottom). The distance is from the R-monuments. The approximate 1994 design profile for each groin is indicated by the dark green lines. The existing conditions along each groin (May 2023) are indicated by the black lines, with exposed rock indicated by the thicker line.

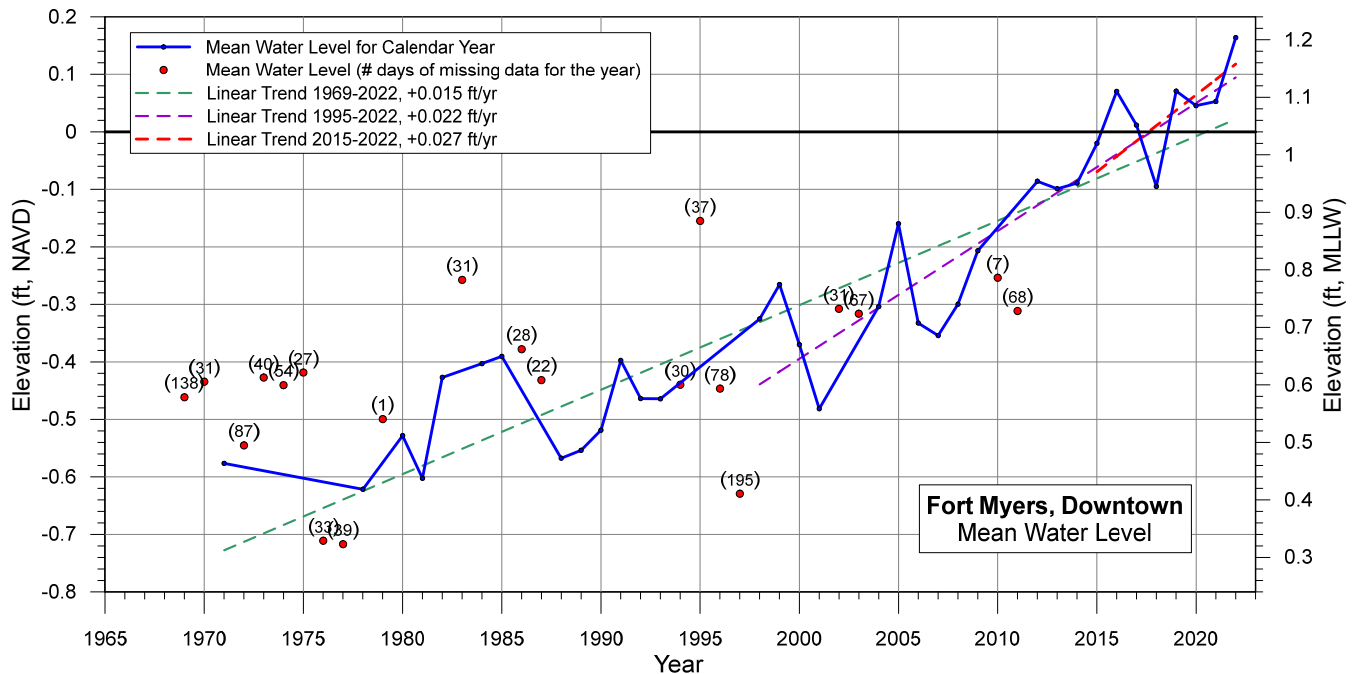
**Figure 15:** Annual mean sea level as measured in Fort Myers (NOAA Station 8725520). Annual mean water level as computed from hourly water levels. Red dots display the mean water level computed for years in which data was not available for all hours of the year. The number above the point indicates the equivalent days of data missing in that year. Linear trends were computed only using years with full data available, that is, without counting red points.
