Beach Management Funding Assistance Program  
Local Government Funding Request  
Fiscal Year 2025/2026  
Beach Projects Application

## Bonita Beach Groin Repair

# BONITA BEACH TERMINAL GROINS DAMAGE REPORT FOR HURRICANE IAN; LEE COUNTY, FLORIDA.

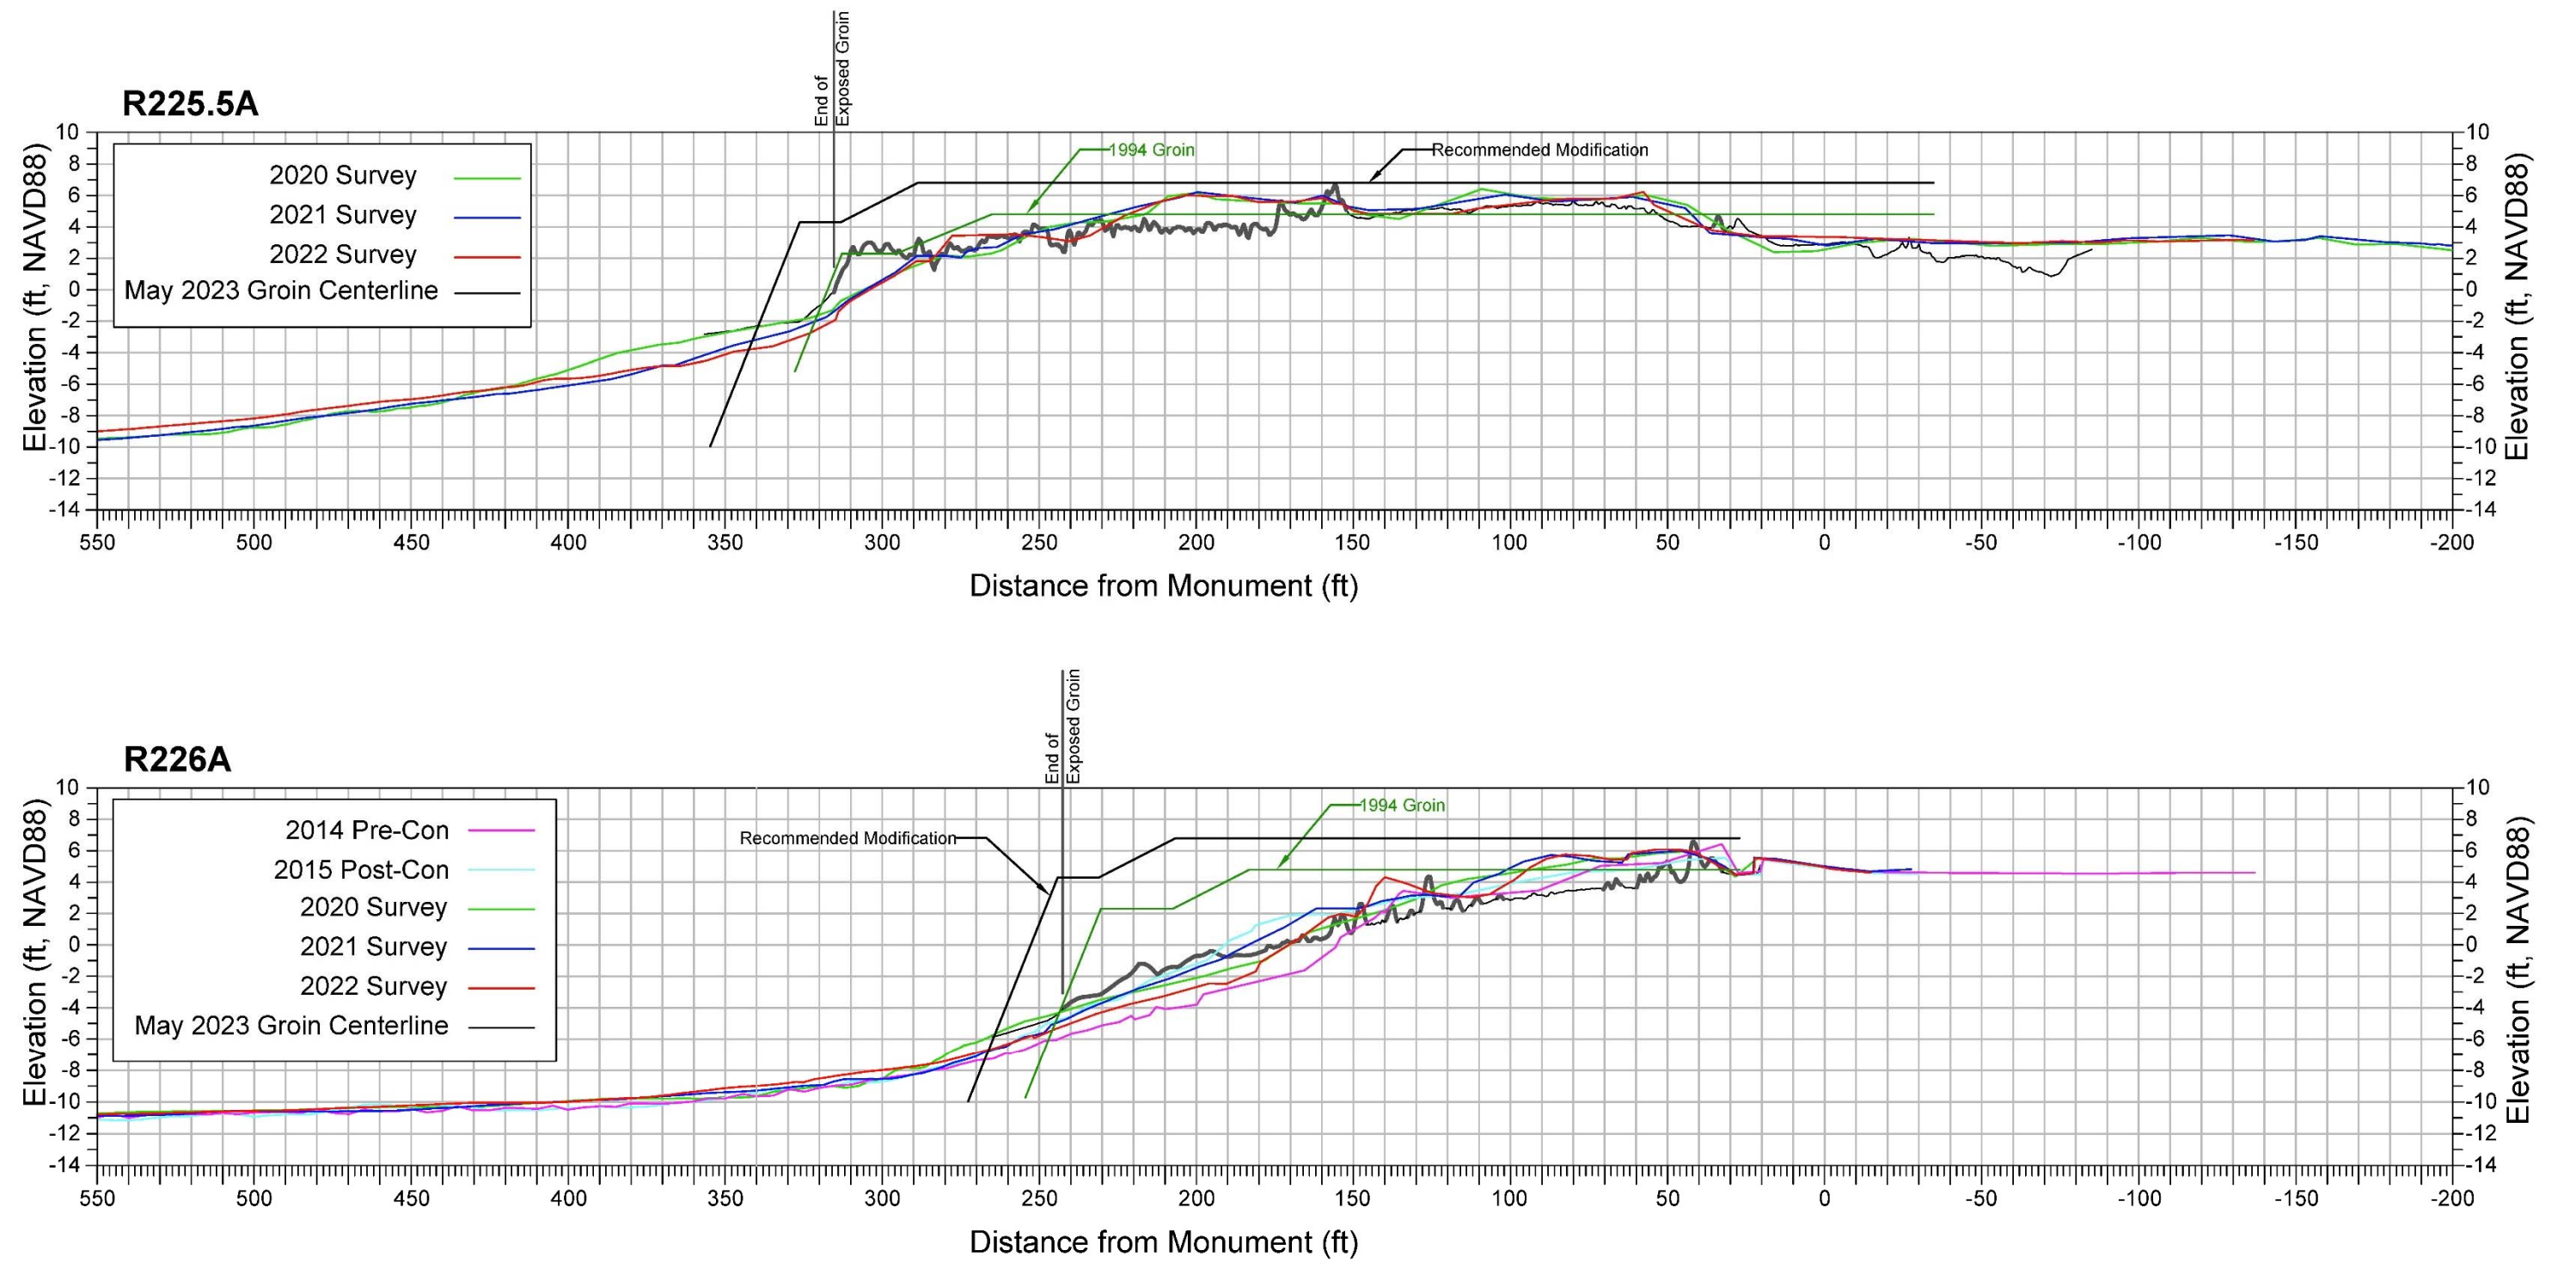
**Figure 16:** Beach profile plots from at R-225.5A (top) and R-226A (bottom) with the proposed recommendations and 1994 North Groin (top) and South Groin (bottom). Rock along the “May 2023 Groin Centerline” is indicated with thicker line.

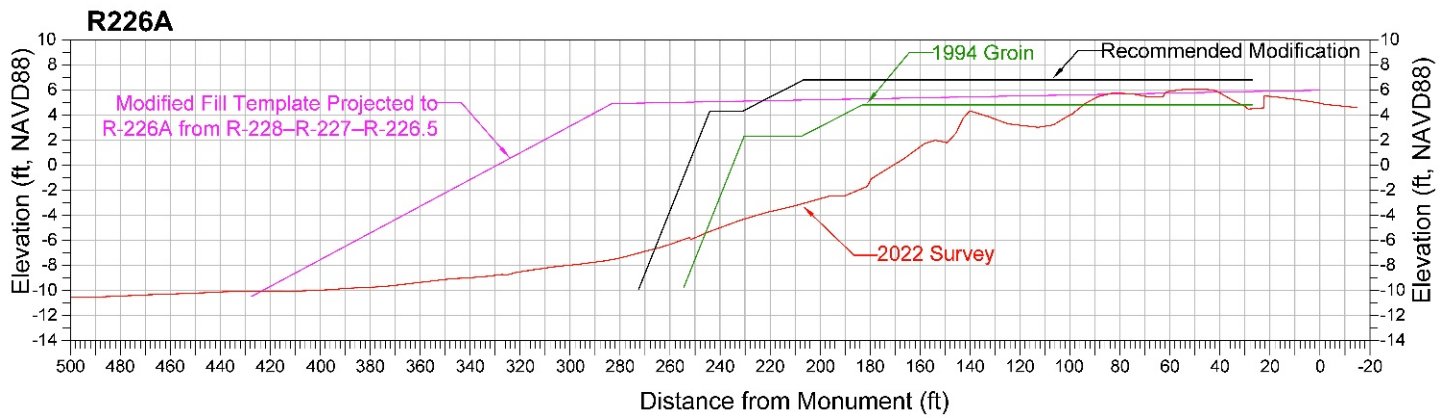
**Figure 17:** Beach profile plot at R-226A displaying the South Groin and the New Beach Fill Template with the recommended modification.

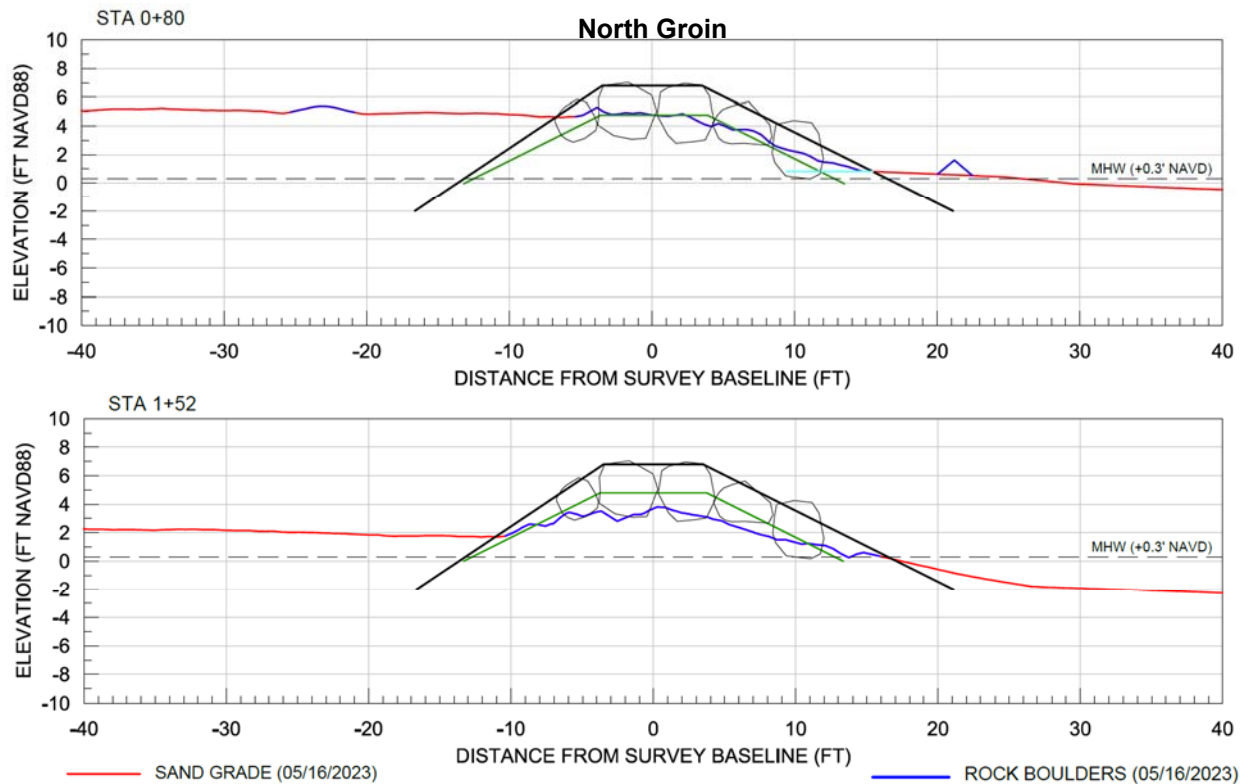
**Figure 18:** Representative cross-sections of the **North Groin** with May 2023 existing grade and rock boulders (red and blue line, respectively), recommended modification (black line) and 1994 groin plan (green line).

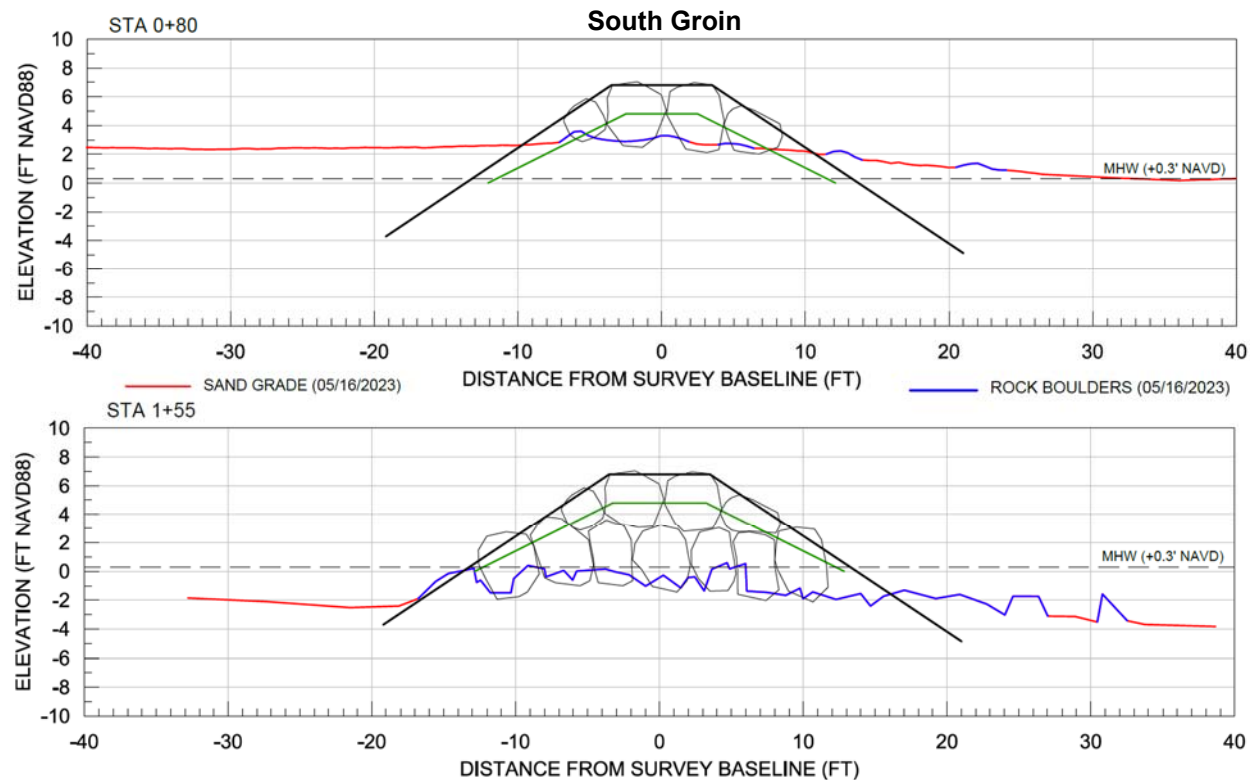
**Figure 19:** Representative cross-sections of the **South Groin** with May 2023 existing grade and rock boulders (red and blue line, respectively), recommended modification (black line) and 1994 groin plan (green line).
