## **2012 MONITORING REPORT**

**CITY OF GULF BREEZE DEADMAN'S ISLAND RESTORATION PROJECT**

**ESTUARY HABITAT RESTORATION PROGRAM**

**GULF BREEZE, SANTA ROSA COUNTY, FLORIDA**

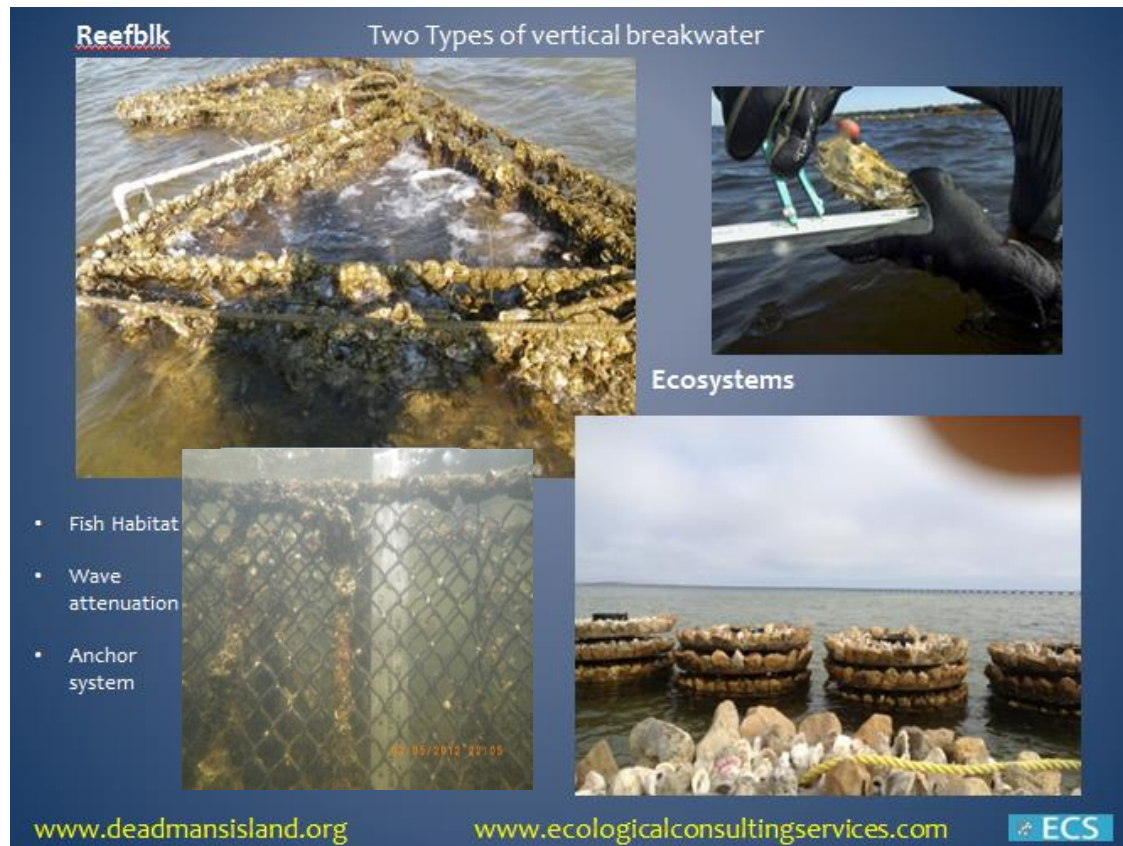
Figure 1- Two type of verticals wave attenuators placed at Deadman's Island

The Phase 1 breakwaters the Reefblks were oyster dependent breakwaters. The oysters in the phase 1 rebar breakwaters died off in 2011 and in 2012 lost almost all shell in the vertical bags, deeming the breakwater as non-functional. The Phase 2 breakwaters placed were two types, Ecodiscs Lilypads and Ecodisc Table Tops, made by Reefmaker and the prototype was created by students of Little Flower Elementary School by adding fossilized and recycled oyster shells. The difference between the two is the Lilly pads were stacked closer together with about a 4 inch gap between tiers. Each Lillypads has about six discs. Monitoring is difficult with the Lillypads because of the four inch gap. It is more difficult to count the marine organisms between a 4 inch by 1 foot wide and also needs the assistance of flashlights for counting. The Ecodisc Table Tops are also circular; however, they have three partitions on each disc, about 9 inches high. These partitions deflect the wave action more, and the spacing provides easier viewing and counting. However, the species abundance monitoring data shows smaller juveniles preferred the smaller gap of the Lillypads for habitat over the larger spaced Table Tops breakwater. Both designs showed functional wave attenuation. However, the table tops showed better wave attenuation than the Lillypads. In addition to the top design, various breakwaters have two types of footing. One footing model has a pad that deploys over the Pearson piling which rests on the sub tidal floor. The

other footing is without the pad, and only the piling is exposed. All units are secured by separate collars underneath the tiers. Although it is too early to tell, observations demonstrate the unit with a Pad on the bottoms tends to accrete sand, where the units on the bottom without a pad, tending to scour or leave the levels constant with neither scouring nor accretion. The annual professional survey should be a good long term indicator of the coastal processes occurring.

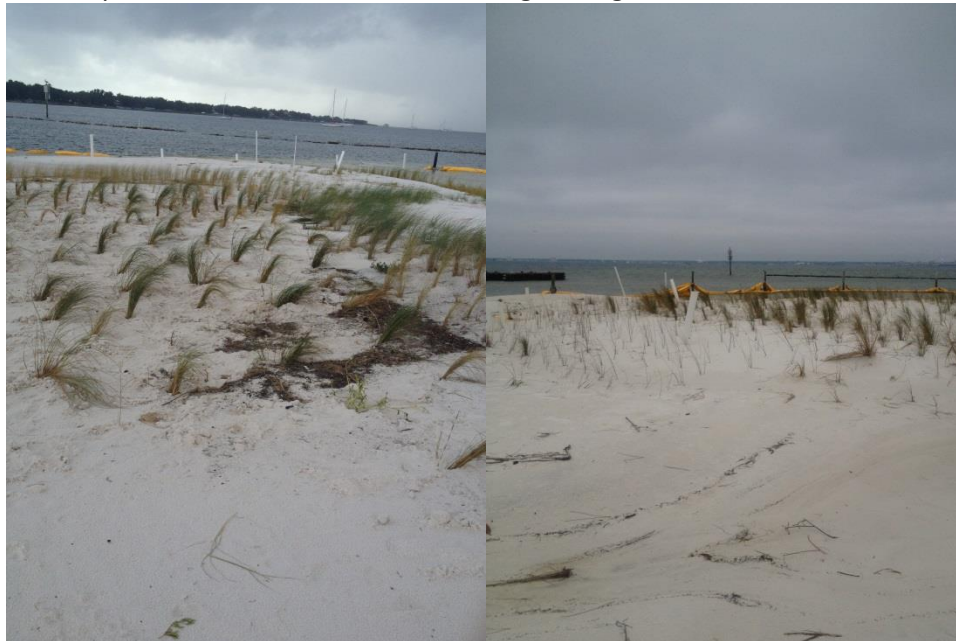
Issac Sept 2012

Rogue surges Nov 2012

Figure 2- after picture of the vegetation after Issac (Sept 2012)and and after picture of a rogue surge (not declared a storm) in Nov 2012. The roque surge caused more scouring and removed more plants than tropical storm Issac. In addition, more sand was deposited and buried a majority of the vegetation

The storm events did cause some damage to the shoreline, however; reviewing the tide data historically, there were several high tides which were above normal. The 2012 moon phases caused extremely high tides which created, unpredictable rogue surges. Rogue surges created the most damage to the entire area of Deadman's Island. Overall, 64% of the vegetation recovered from storm impact and being buried. The plants, as long as there is a small exposure to sunlight for photosynthesis, can recover or grow when buried underneath the sand.

The breakwaters which were above high tide, protected the area more than the submerged breakwater which acted as fringing reef which caused waves to break on the reef, and create more momentum for sand shifting.

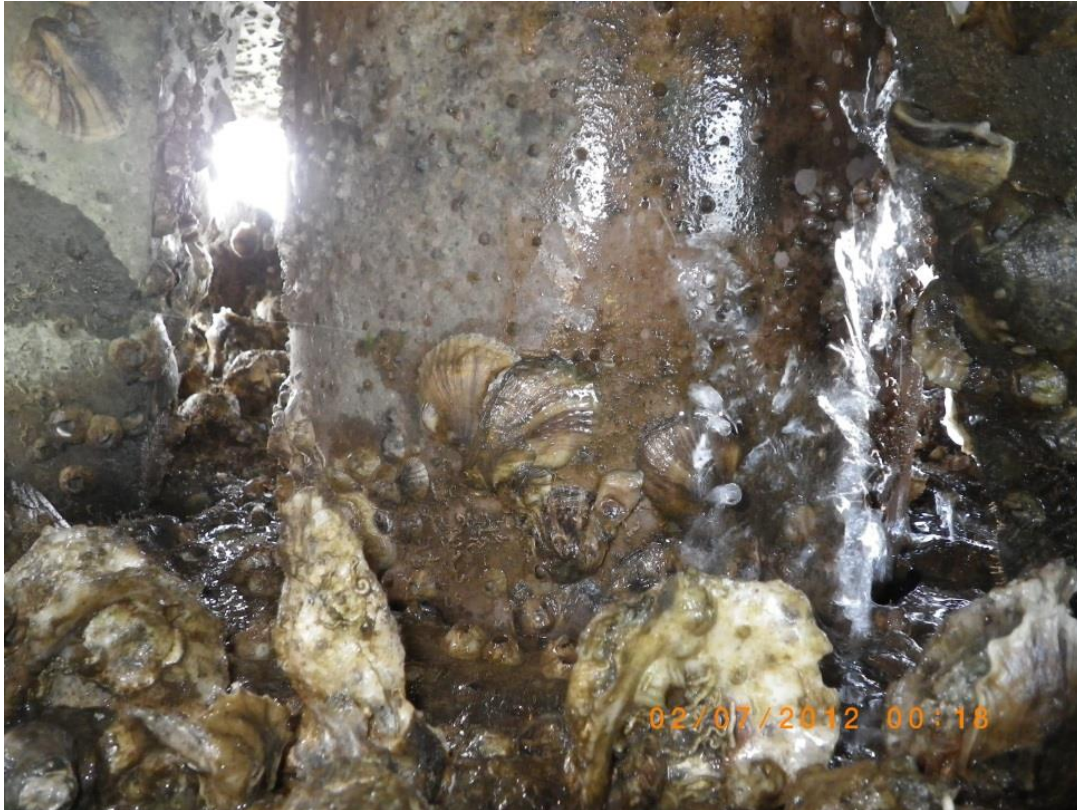
Figure 6-Spat and oyster settlement on the western reefs of Deadman's island

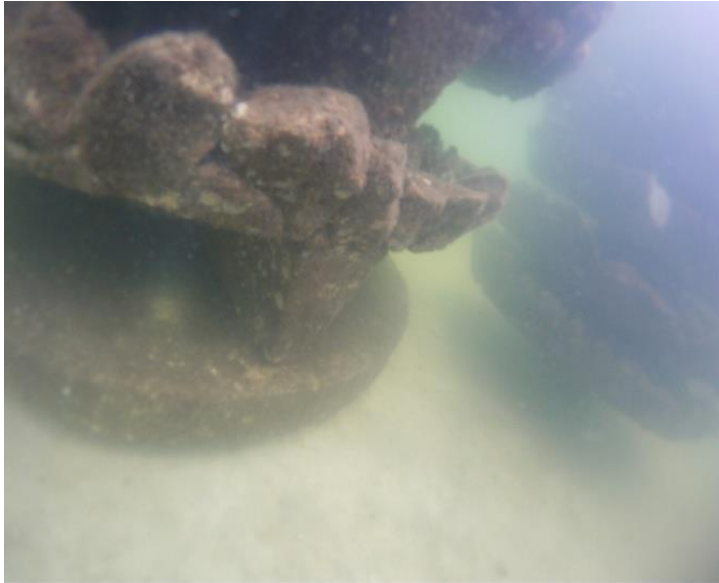
Figure 18-Two types of Ecodisc design- "Table Tops" (left) show a concrete pad stabilizing the units and the "Lillypads" with the piling exposed and secured by a collar underneath.

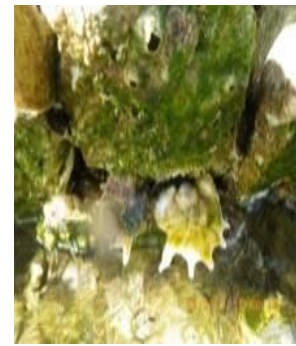
Figure 19 (Below) -Method of monitoring is a dual Hooka regulator system attach to SCUBA tanks.

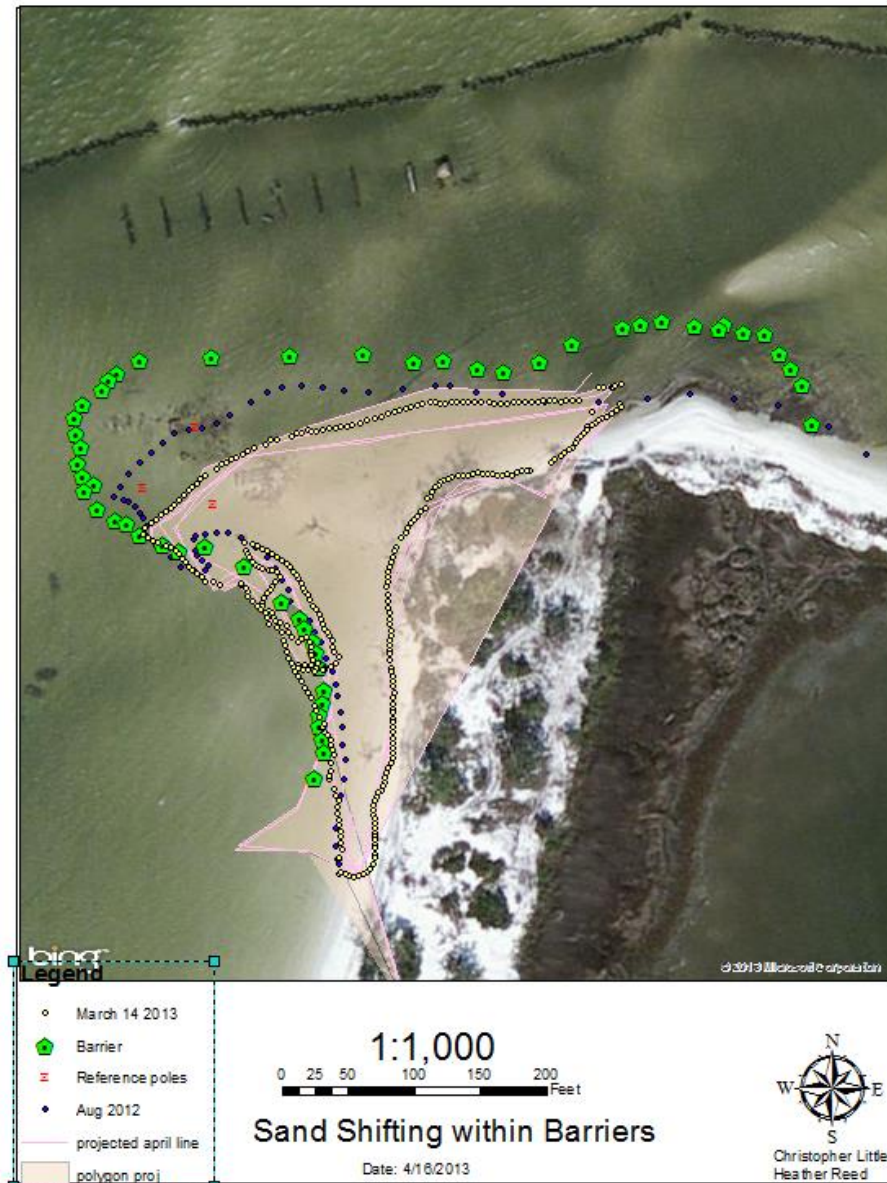
Figure 20-The barrier system (Green markers) was placed in May 2012. These markers are fixed reference points of anchoring for the barrier. The August 2012 after TS Issac points (blue points) show sand shifting and eroding back towards the peninsula. The March 20

Upon placement of the 16,000 cubic yards of sand, a barrier system, the shoreline change and also barrier system was monitored for three months. The barrier system needs constant maintenance, and the shoreline change is documented when a significant change is observed.

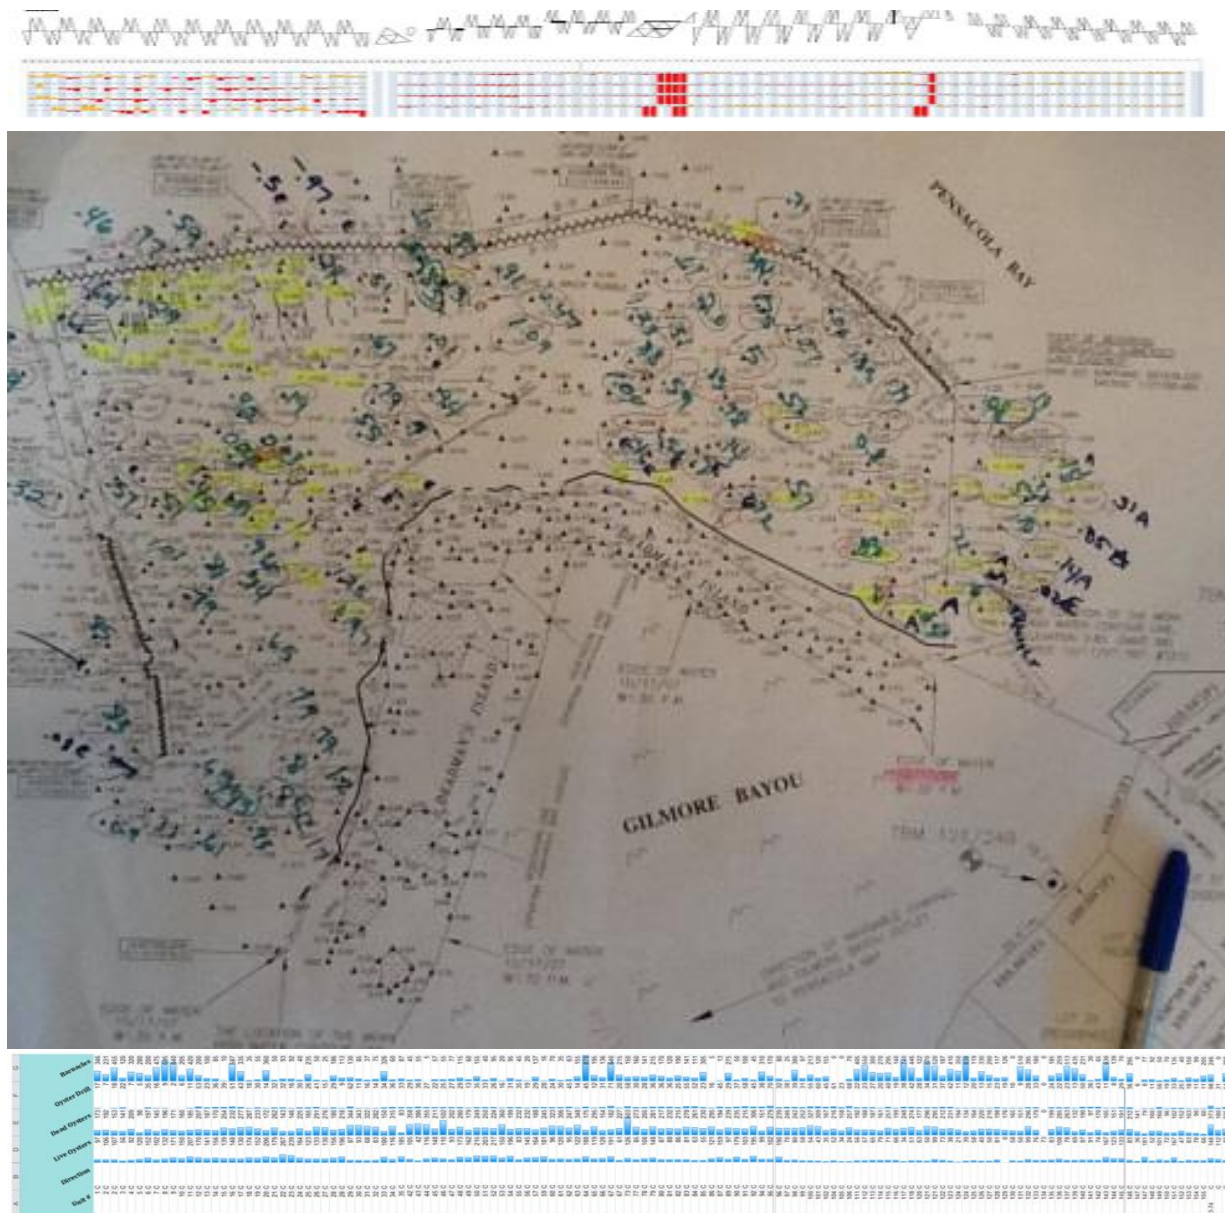
Figure 21- Bathymetric survey of the sub tidal floor in front and behind the wave attenuators of the Deadman's Island restoration project.

A bathymetric survey was taken by a professional surveyor with elevation points. The points were then compared to the 2007 bathymetric baseline survey. This comparison was performed by hand and excel input. Points from 2007, 2011 and 2012 which were close together on the map were put in placed an excel spreadsheet and also color coded on the map.

The analysis method involves highlighting each point and comparing the point data; to the previous years within a spreadsheet. It was found the data analysis was very time consuming and not as successful as hoped. However, ; the survey data is very important to have in this project. The method of analysis will have to be modified, hopefully, for the next report.
