**FINAL REPORT  
FOR  
CITY OF GULF BREEZE DEADMAN'S ISLAND RESTORATION PROJECT  
FLORIDA PANHANDLE COASTAL PROGRAM, U.S. FISH & WILDLIFE  
SERVICE  
Grant # F00AP005  
GULF BREEZE, SANTA ROSA COUNTY, FLORIDA**

**By Heather Reed  
Natural Resource Specialist and Habitat Restoration Project Manager  
Ecological Consulting Services, Inc.  
2013**

The City of Gulf Breeze Deadman's Island Restoration Project  
Final Report for the US Fish and Wildlife Service 11/01/13  
Heather Reed, Restoration Project Manager

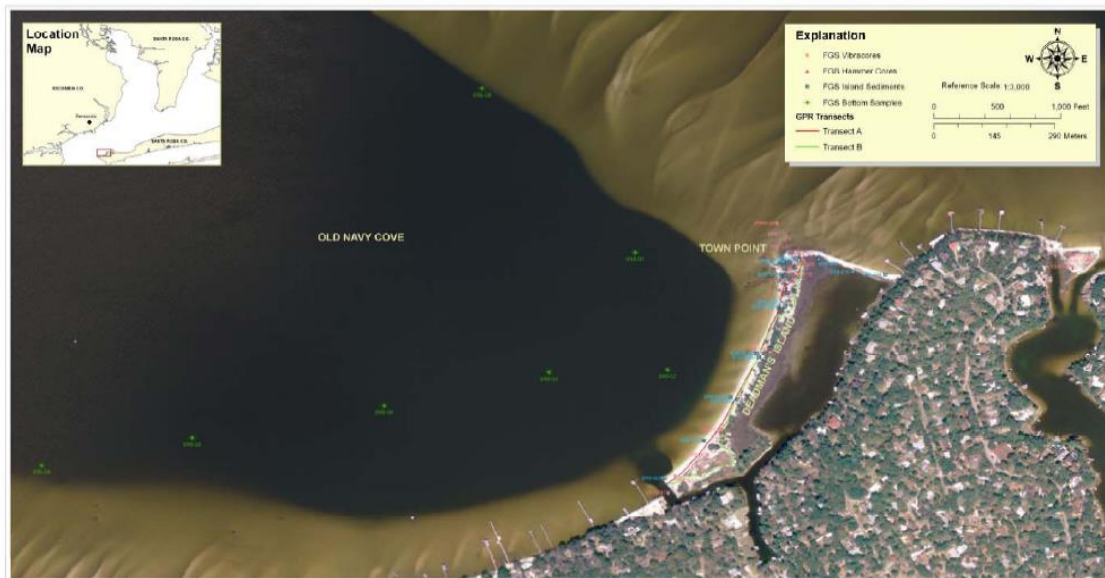
**Figure 1: FGS Baseline monitoring site map for GPR, Side scan sonar and bathymetry for Deadman's Island, Gulf Breeze, Florida.**

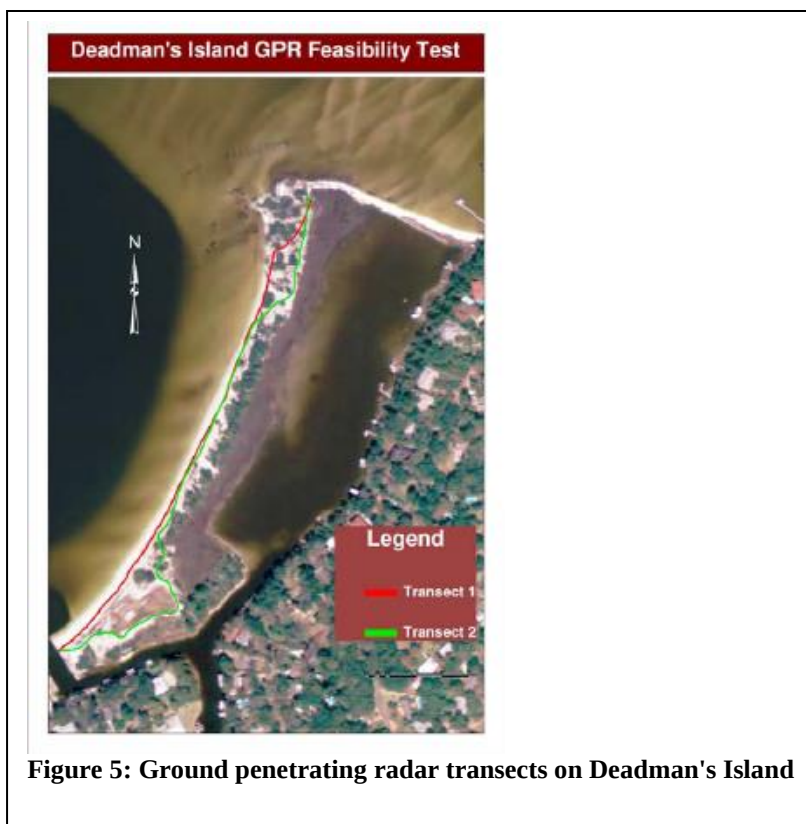
The GPR showed several anomalies in the area of the unmarked cemetery on Deadman's Island as well as several anomalies shaped in

**Figure 5: Ground penetrating radar transects on Deadman's Island**

which could be middens or additional graves (Fig 5). These areas were documented and placed in consideration of additional protection from erosion or avoidance.

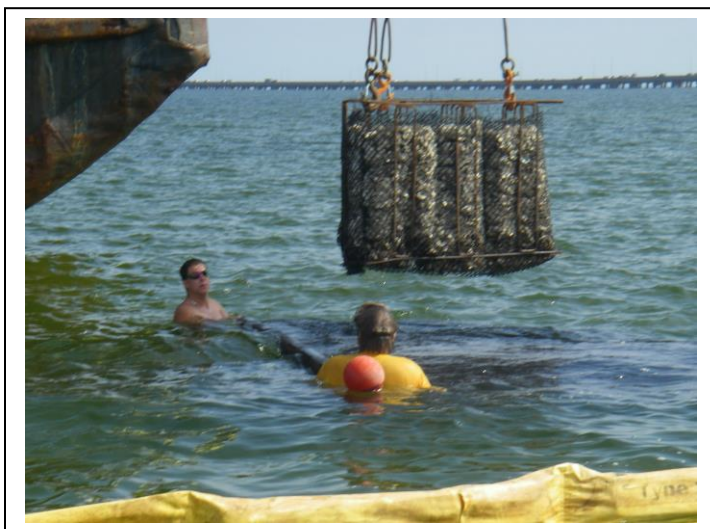
**Figure 13: These rebar breakwaters designed by Coastal Environments were required by the regulatory agencies, to be placed below mean high water as opposed to above mean high water as the later breakwater design**

unit and tamped to prevent settling. The shells in the bags settled as the crane lifted the unit and placed it in the water on the subtitle floor. This settlement caused a reduction in height of the breakwater. For example, 33 inch tall structure had a settlement on average from 3 to 6 inches. The bags expanded in width but lost height. Depending on the depth of the water the height would determine the effectiveness of wave attenuation. The shells in the bags settled as the crane picked up the unit and place it in the water on the subtitle floor. This settlement

caused a reduction in height of the breakwater. For example, 33 inch tall structure had a settlement on average from 3 to 6 inches. The bags expanded in width but lost height.

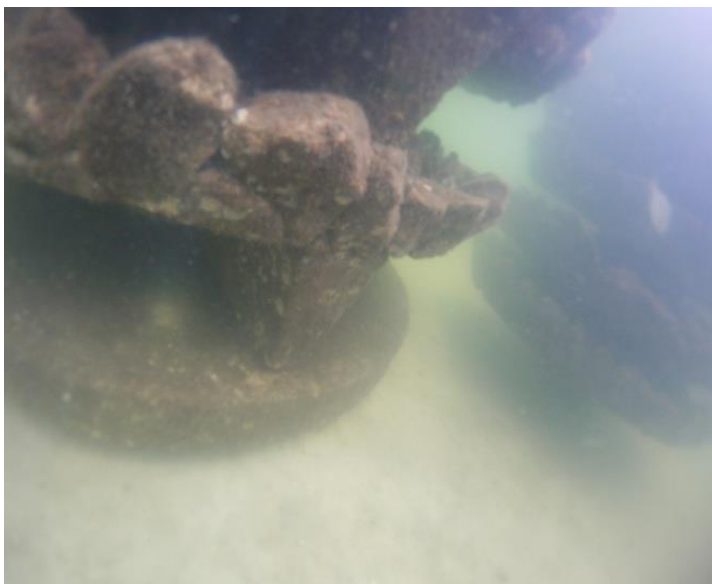
The permit was finally modified to include the east breakwater which were subjected to a high impact fast flow current system originating from the northeast. These discs were deployed September 2011 to stop the 12 mile fetch impacting Deadman's Island. The new "table top" ecosystems were placed, in addition to, the lilypad Ecodiscs. The monitoring events of 2012 are showing spat on the reef but not as abundant as the July West side Ecodiscs. This was expected. The West side area is only subjected to a four mile fetch and is more sheltered than the East side discs being exposed to the 12 mile fetch. Accretion is slow and is building but only around the structure units with the flat pad on the subtidal floor. The Ecosystems with the piling only has not shown any accretion nor scouring. This design would be ideal for Gulf Sturgeon concerns to reduce any chance of trapping fish behind the breakwaters.

**Figure 27: Two varieties of Ecosystems together- the left unit sits on the subtidal floor and the other system leaves the bottom exposed for better flow through and overhang fish habitat.**

The 2013 monitoring events show an increase to 80% oyster coverage, a 90% increase in adults and juvenile fish. The stone crabs which control the oyster drill population, were found on every unit, and the largest stone crabs were found underneath the ecosystems. These observations show the new ecosystems with the

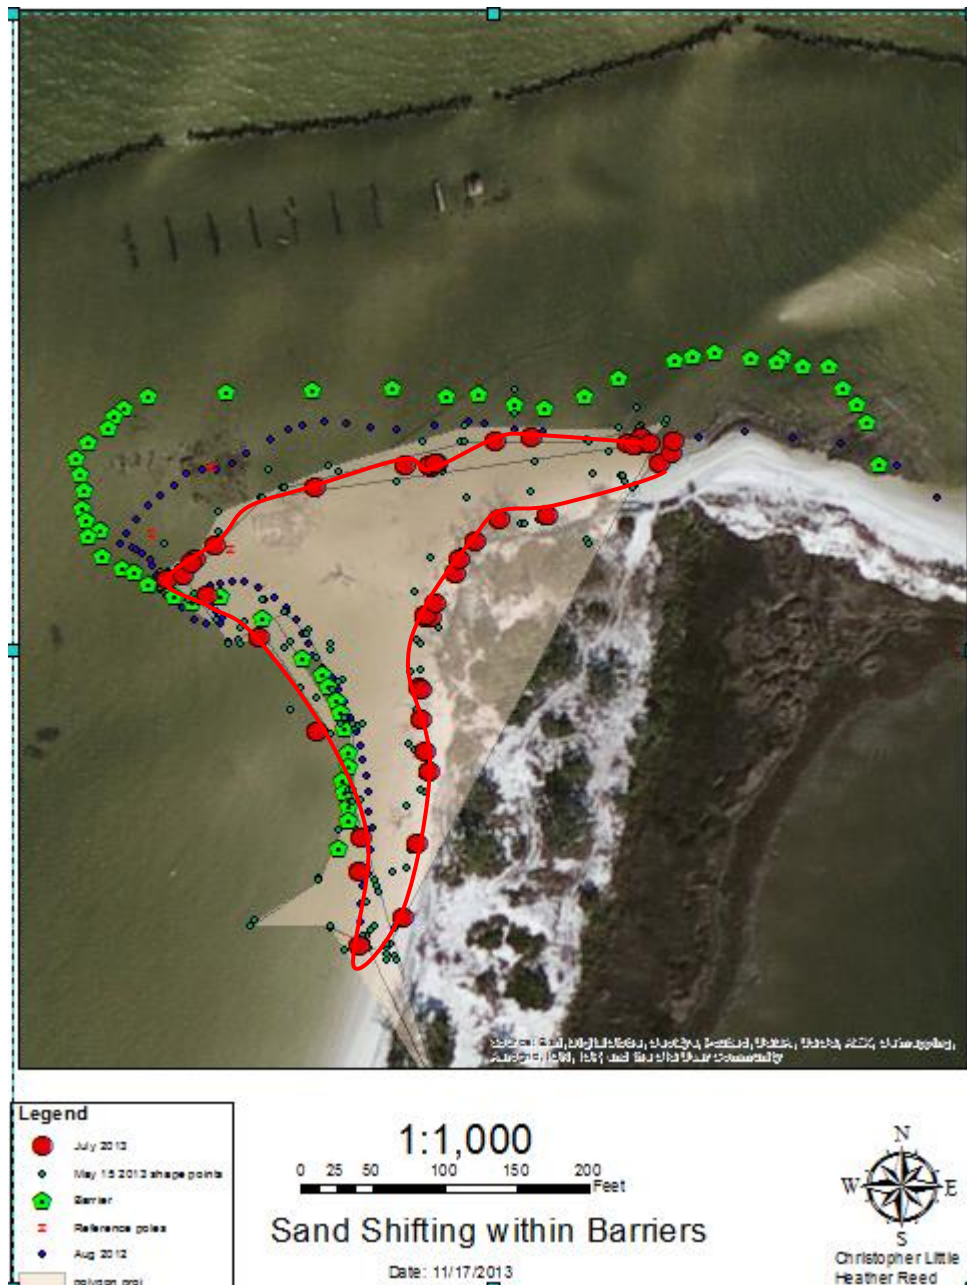
Figure 44: Sand shifting within the barriers of the fill site. The blue dots represent Aug 2012 and the red dots represent July 2013. The sand is shifting the south west and forming a small spit.
