**Living Shoreline and Oyster Reef Restoration  
in Pensacola Bay, FL  
Supplementary Information Document  
June 2012**

**Submitted by  
The Nature Conservancy  
Contact:  
Anne Birch  
Florida Marine Conservation Director  
The Nature Conservancy  
321-610-3892  
abirch@tnc.org**

## Supplementary Information Document

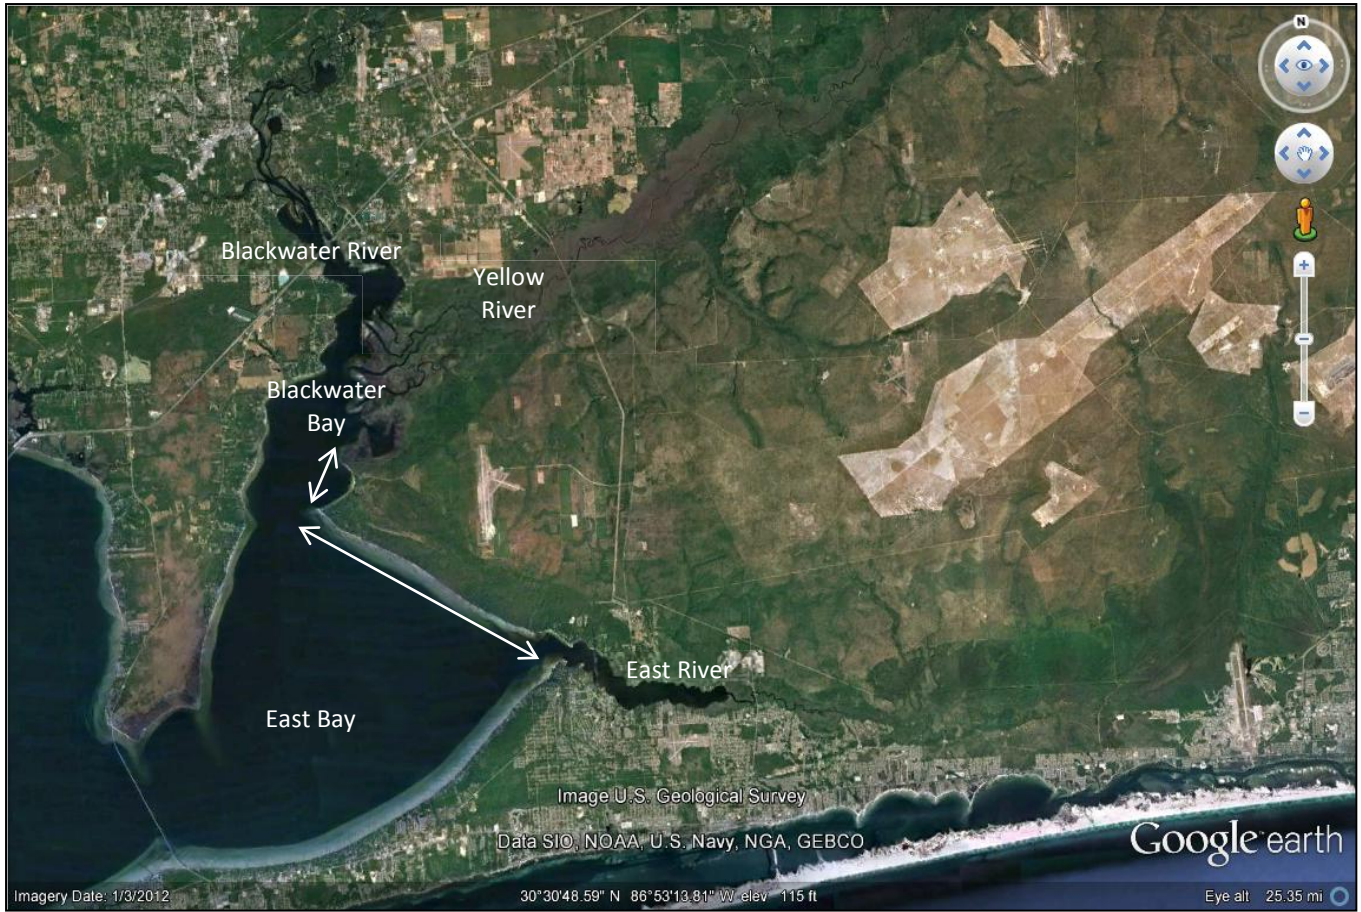
Figure 4: Map of conditionally approved (blue circle) and prohibited (red circle) shellfish harvesting areas in the project area

The project is **located in a “Conditionally Approved” shellfish harvesting area** (Fig. 4) as defined by the Florida Department of Agriculture and Consumer Services (FDACS) Division of Aquaculture. FDACS defines Conditionally Approved as *periodically closed to shellfish harvesting based on pollutional events, such as rainfall or increased river flow. The 14/43 standard must be met when the management plan parameter (rainfall, river stage, and/or river discharge) is less than the adverse pollution condition during all other adverse pollution conditions*. Salinity and water quality conditions are generally suitable for oyster settlement and growth and the limiting condition seems to be availability of suitable substrate (EPA 2004).

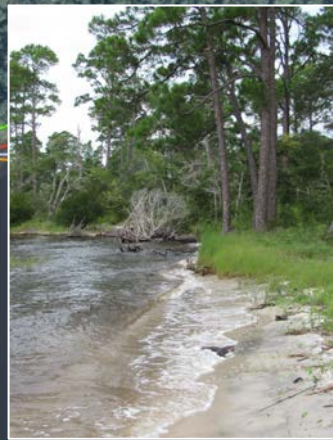
## East Bay - Sample Point #1 Project Site Map

- a. East Bay shoreline erosion profile sample point 1 with corresponding photo taken looking northwest along the shoreline.
- b. East Bay shoreline erosion profile sample point 2 with corresponding photo taken looking northwest along the shoreline.

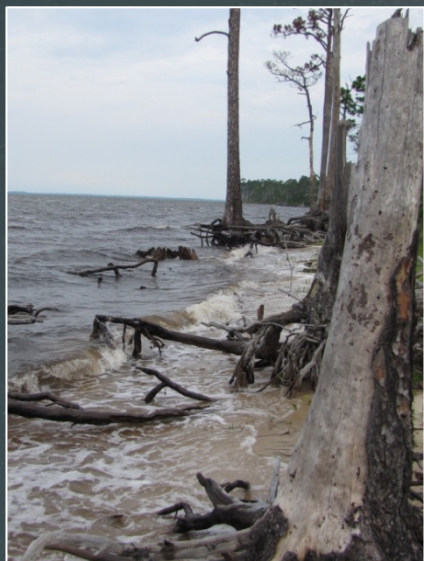
# Blackwater Bay - Sample Point #3B Project Site Map

The 2010 shoreline data was created by The Nature Conservancy, Alabama through field data collection and visual delineation using aerial photographs.

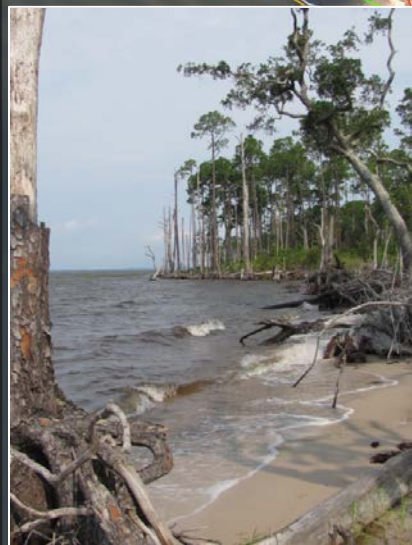
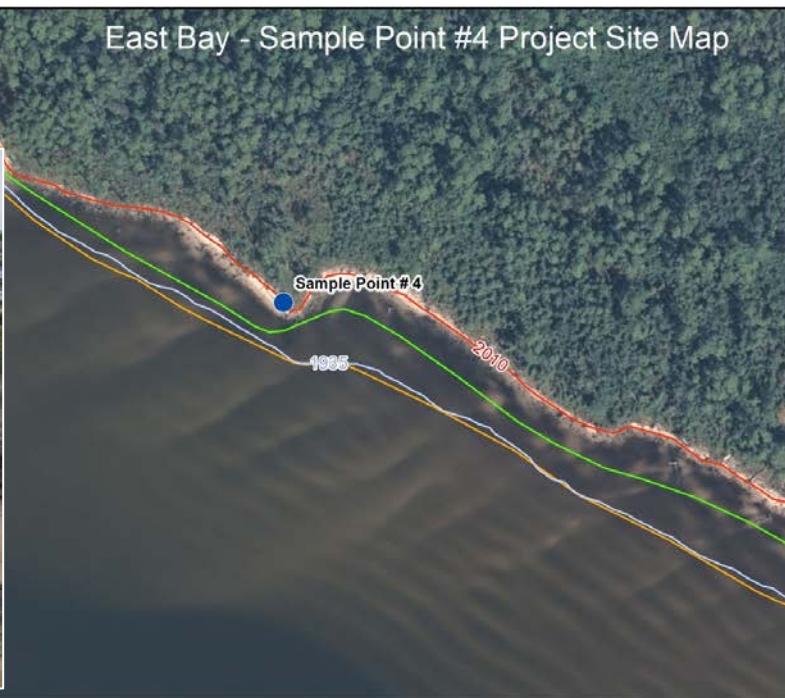
## East Bay - Sample Point #4 Project Site Map

- c. East Bay shoreline erosion profile sample point 3 with corresponding photo taken looking northwest along the shoreline
- d. East Bay shoreline erosion profile sample point 4 with corresponding photo taken looking northwest along the shoreline

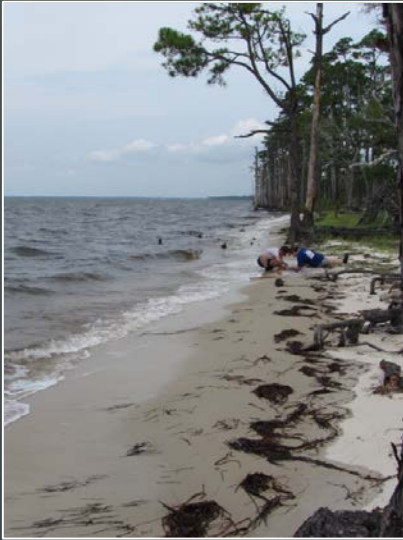
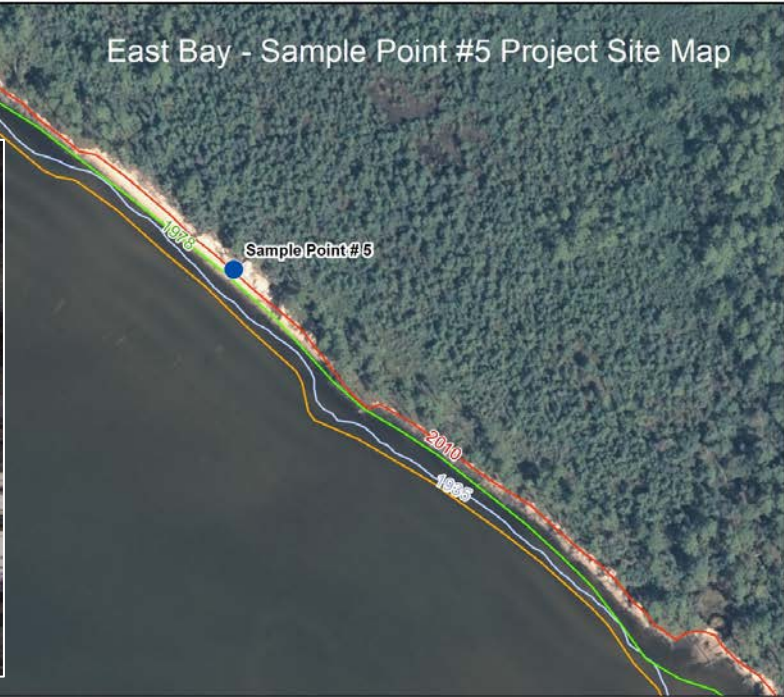
## East Bay - Sample Point #5 Project Site Map

- e. East Bay shoreline erosion profile sample point 5 with corresponding photo taken looking northwest along the shoreline
- f. East Bay shoreline erosion profile sample point 6 with corresponding photo taken looking northwest along the shoreline

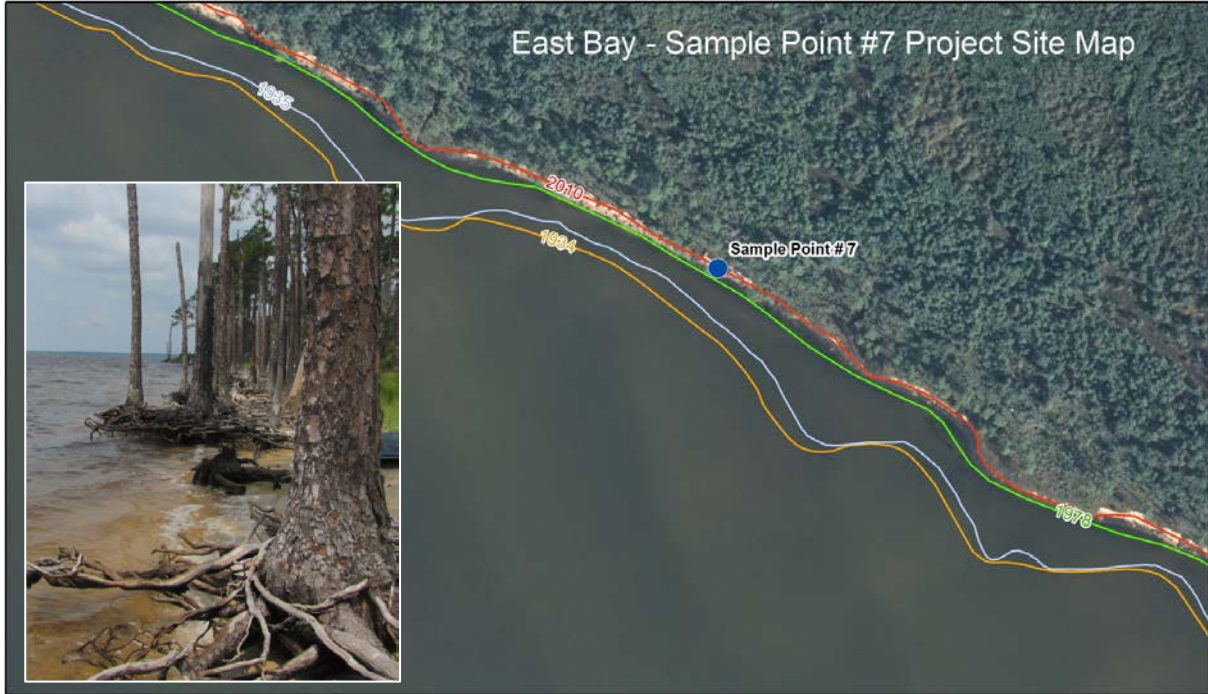
# East Bay - Sample Point #7 Project Site Map

- g. East Bay shoreline erosion profile sample point 7 with corresponding photo taken looking northwest along the shoreline.
- h. East Bay shoreline erosion profile sample point 8 with corresponding photo taken looking southeast along the shoreline

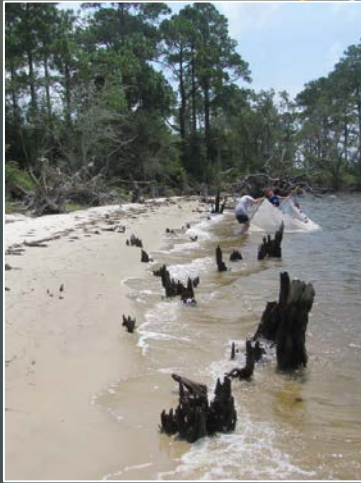
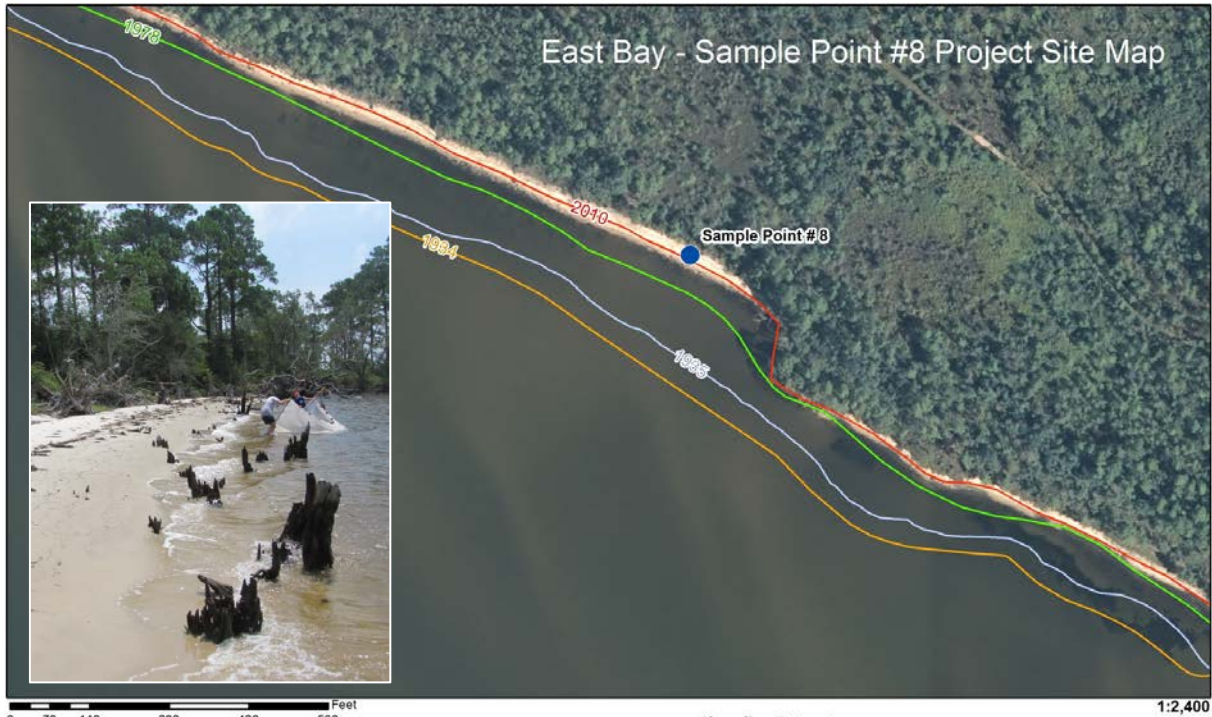
## East Bay - Sample Point #8 Project Site Map

**Shoreline Retreat**  
Distance from the 1934 line (meters)

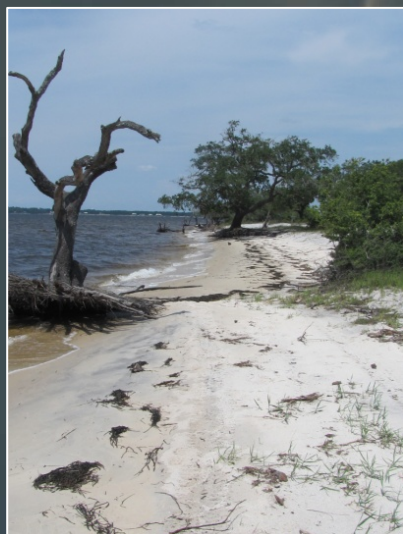
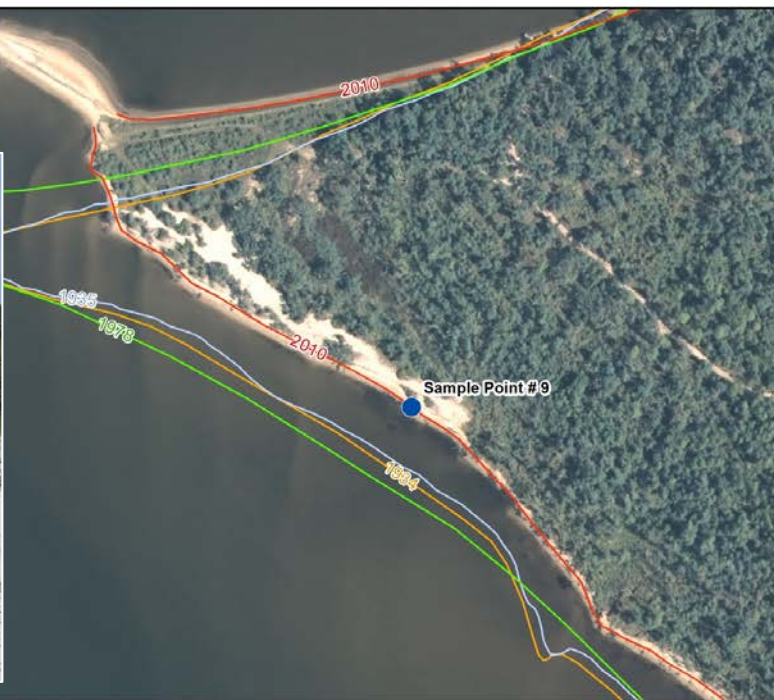
## East Bay - Sample Point #9 Project Site Map

- i. East Bay shoreline erosion profile sample point 9 with corresponding photo taken looking northwest along the shoreline

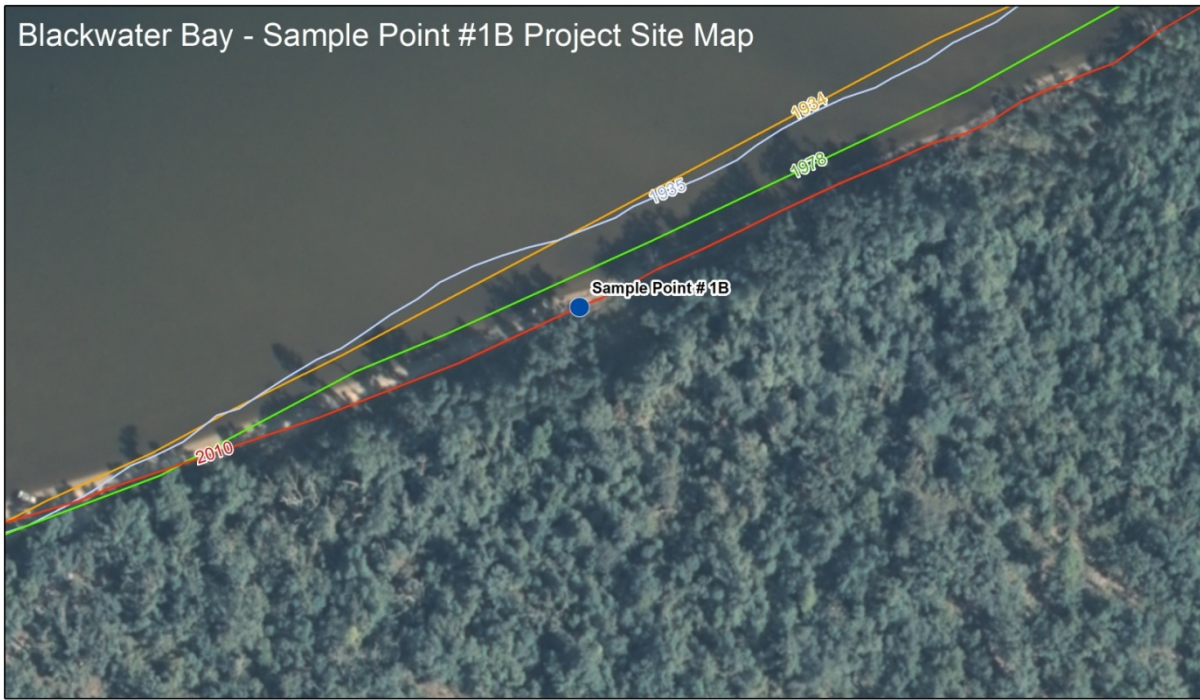
# Blackwater Bay - Sample Point #1B Project Site Map

- a. Blackwater Bay shoreline erosion profile sample point 1B
- b. Blackwater Bay shoreline erosion profile sample point 2B
- c. Blackwater Bay shoreline erosion profile sample point 3B
- d. Blackwater Bay shoreline erosion profile sample point 4B
- e. Blackwater Bay shoreline erosion profile sample point 5B
- f. Blackwater Bay shoreline erosion profile sample point 6B
- g. Blackwater Bay shoreline erosion profile sample point 7B
