# HYDROLOGIC DATA MONITORING PLAN

## MK Ranch Hydrological Assessment and Restoration

**MK RANCH HYDROLOGICAL ASSESSMENT AND RESTORATION  
HYDROLOGIC DATA MONITORING PLAN**

Amec Foster Wheeler Project No: 600508

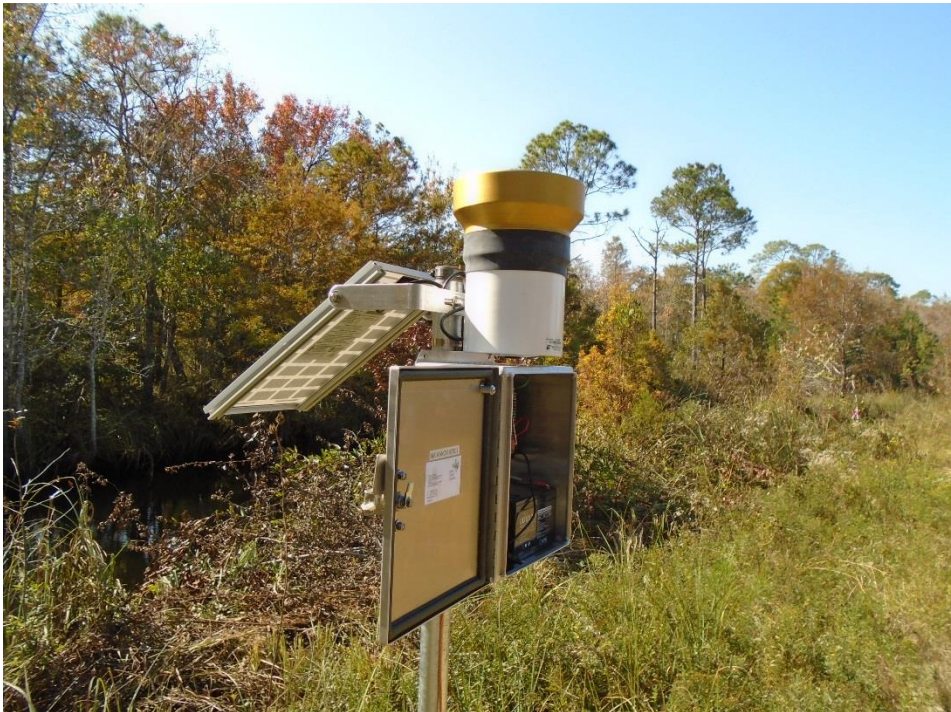
| <b>Photo No.:</b><br>Monitoring Station 1 | | |

| <b>Description:</b><br>View of MS-1 | | |

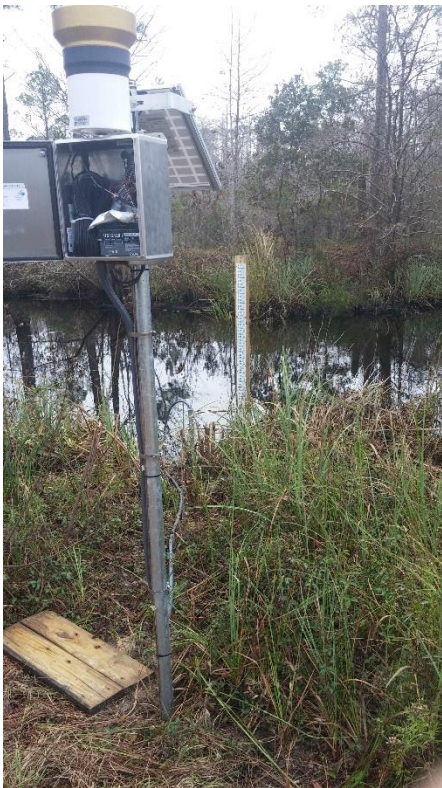
| <b>Photo No.:</b><br>Monitoring Station 1 | | |

| <b>Description:</b><br>View of Staff Gauge location at MS-2. | | |

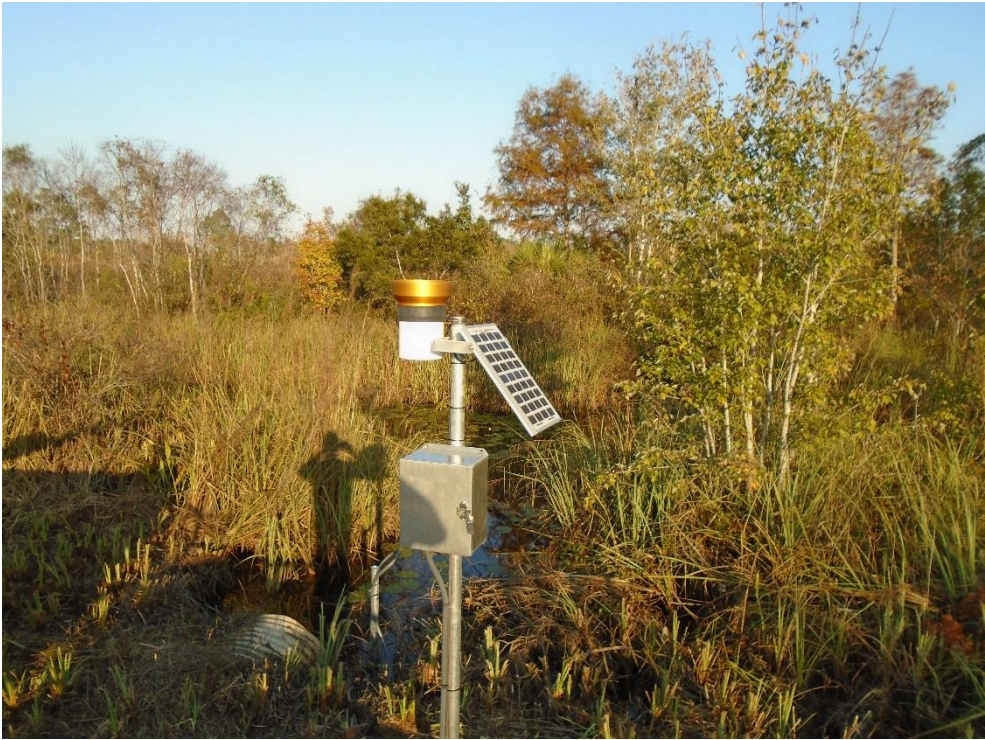
| <b>Photo No.:</b><br>Monitoring Station-2 | |

| <b>Description:</b><br>View of MS-2. | |

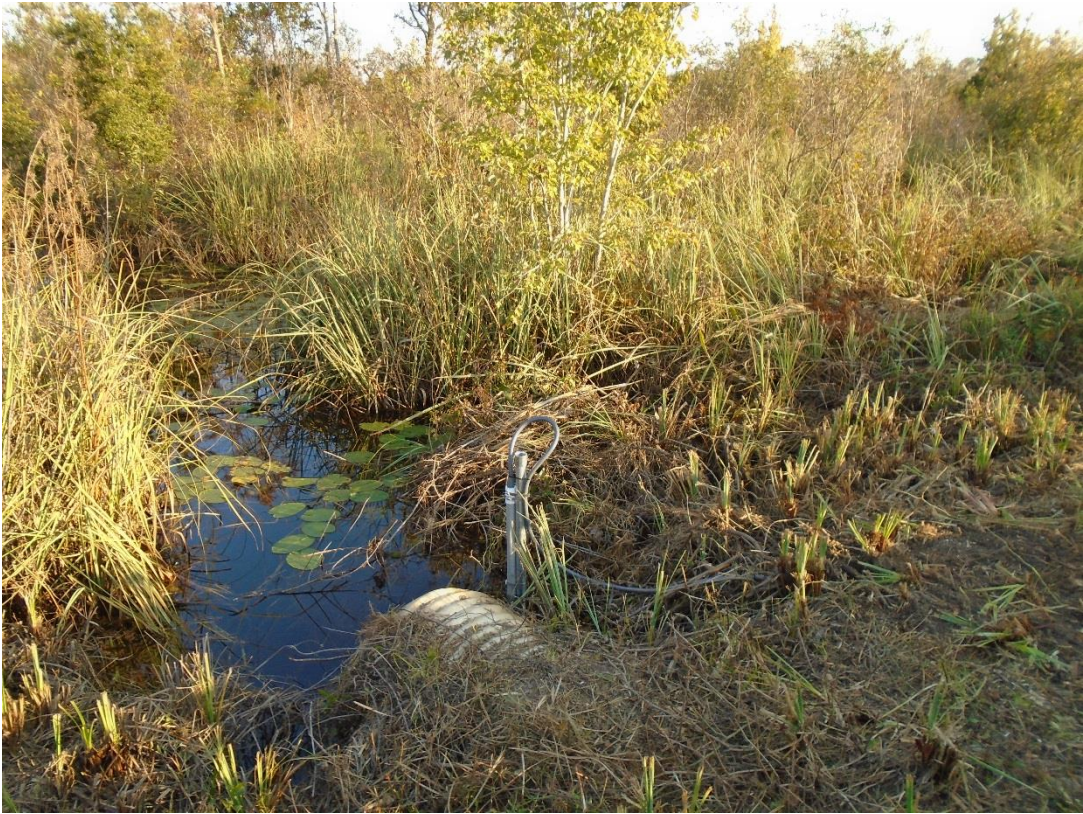
| <b>Photo No.:</b><br>Monitoring Station-2 | |

| <b>Description:</b><br>View of mounted transducer and thermistor submerged under water at MS-2. | |

The monitoring stations installed at MK Ranch consist of a Campbell Scientific CR300 data logger that is powered by a 12-volt battery and solar panel. The data logger collects data from a water level transducer and a thermistor that is mounted in a well screen below the water surface. In addition, three of the five monitoring stations are equipped with a tipping bucket rain gauge. All of the equipment is housed inside of a water-resistant stainless steel box that is mounted to a galvanized pole driven into the ground and leveled. Along with monitoring stations, five manual-read staff gauges were installed in the vicinity of the monitoring stations. The staff gauges are used to initially calibrate the monitoring stations and to check the integrity and community of the water level data being collected throughout the lifespan of the monitoring station.

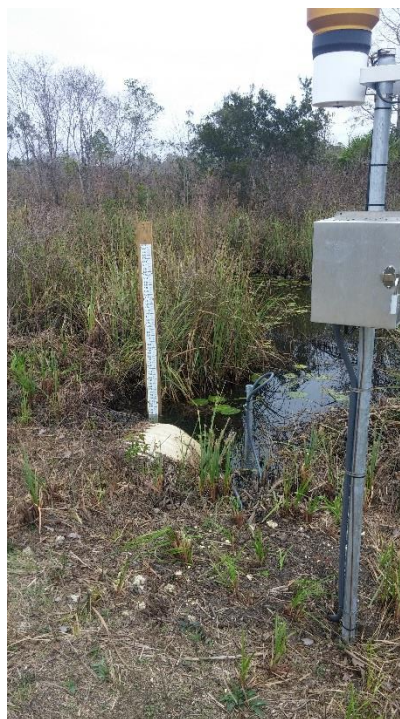
| <b>Photo No.:</b><br>Monitoring Station-2 | <b>Date:</b><br>12/20/2016 |

| <b>Description:</b><br>View of Staff Gauge location at MS-2. | |

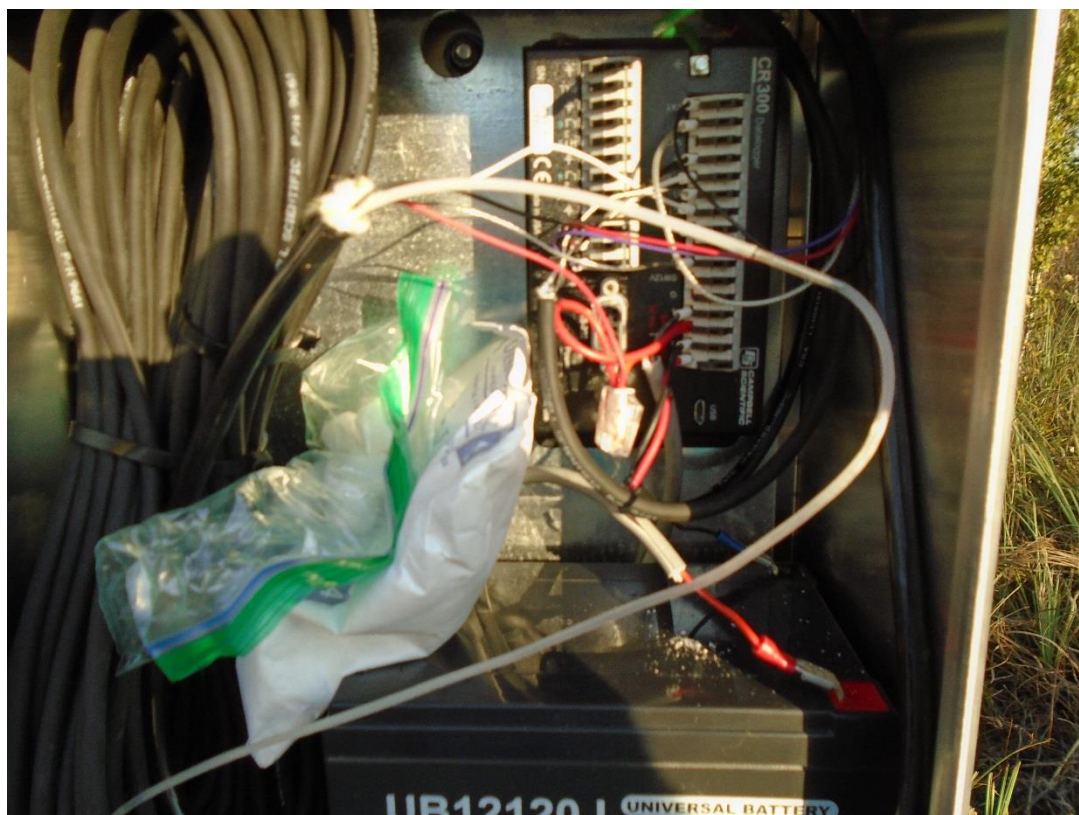
| <b>Photo No.:</b><br>Monitoring Station-2 | <b>Date:</b><br>11/15/2016 |

| <b>Description:</b><br>View of inside of stainless steel housing, monitoring station components typical with tipping bucket rain gauge. | |

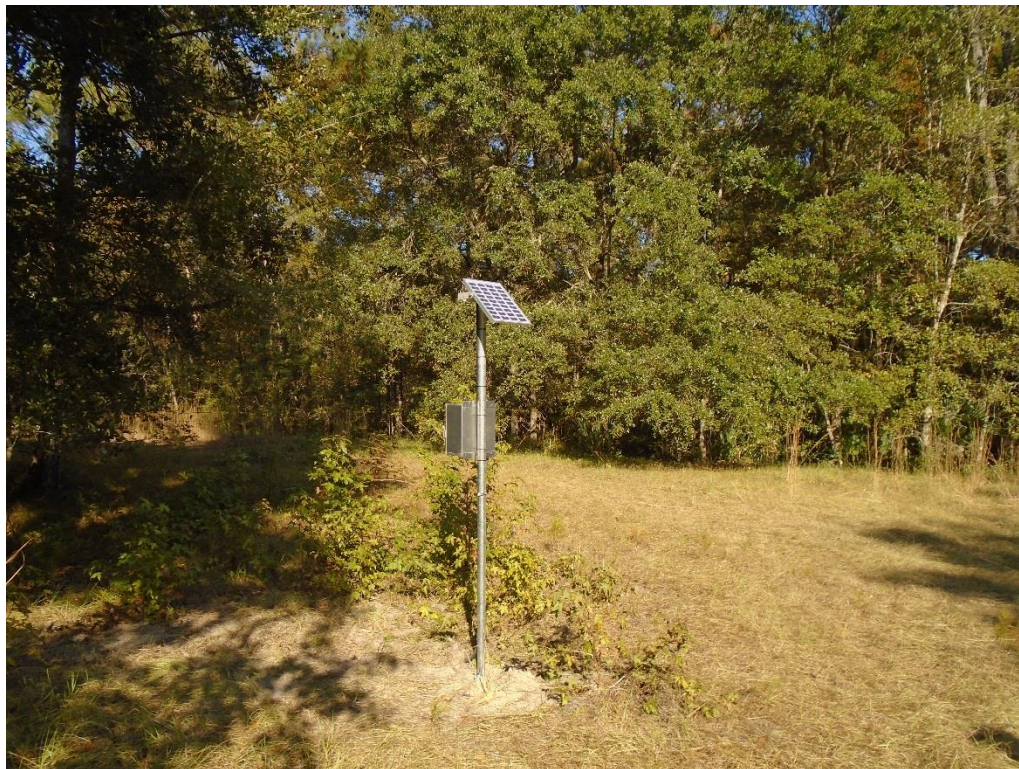
| <b>Photo No.:</b><br>Monitoring Station-3 | <b>Date:</b><br>11/15/2016 |

| <b>Description:</b><br>View of MS-3. | |

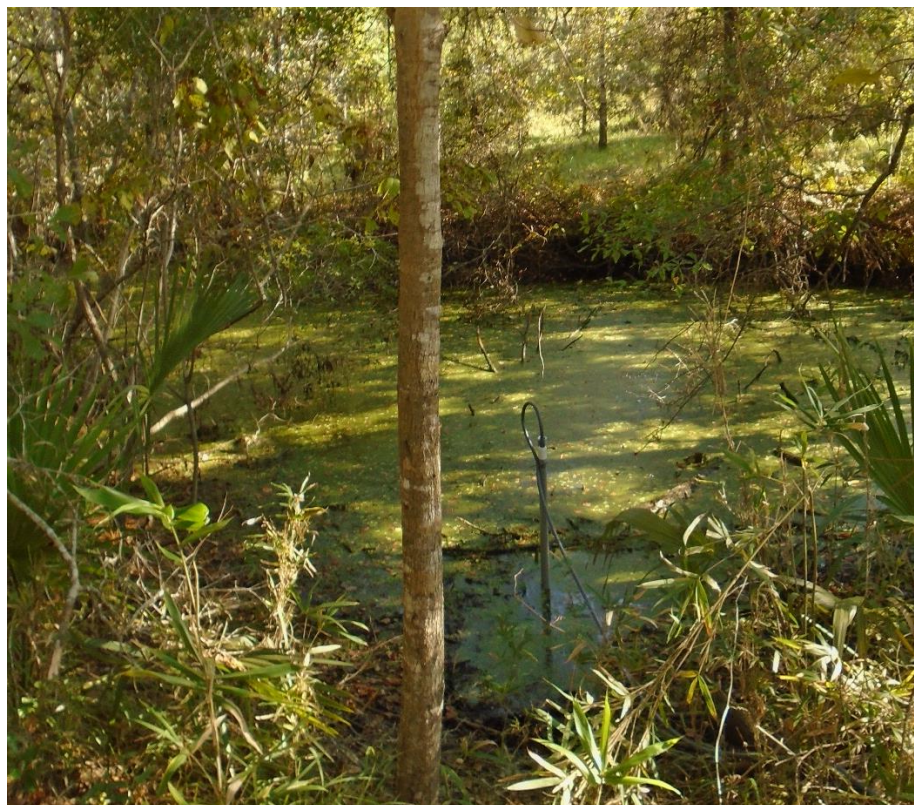
| <b>Photo No.:</b><br>Monitoring Station-3 | <b>Date:</b><br>11/15/2016 |

| <b>Description:</b><br>View of mounted transducer and thermistor submerged under water at MS-3. | |

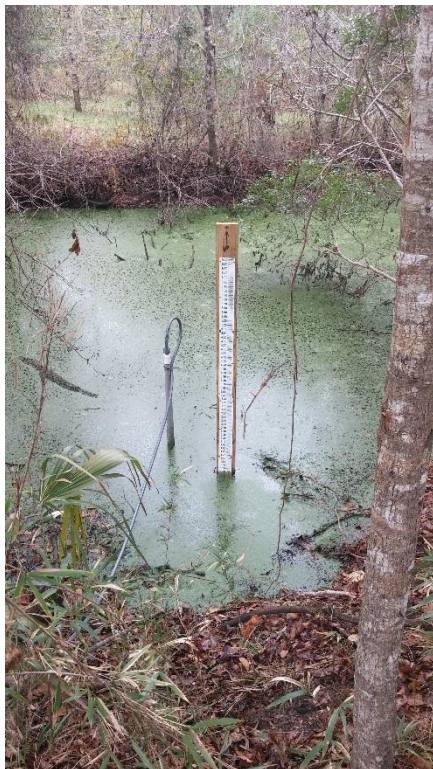
| <b>Photo No.:</b><br>Monitoring Station-3 | <b>Date:</b><br>12/20/2016 | |

| <b>Description:</b><br>View of Staff Gauge location at MS-3. | | |

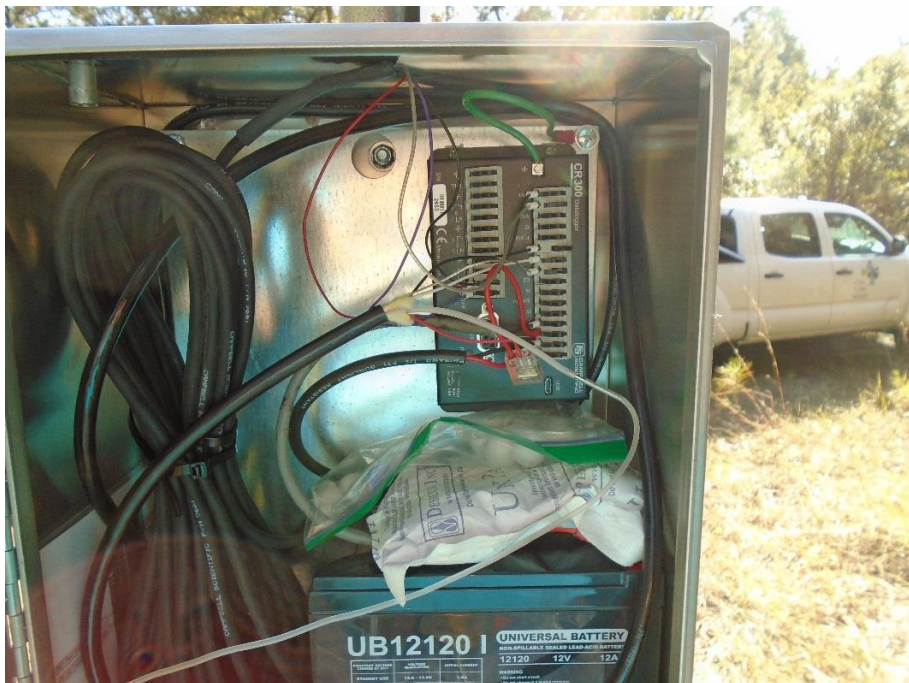
| <b>Photo No.:</b><br>Monitoring Station-3 | <b>Date:</b><br>11/15/2016 | |

| <b>Description:</b><br>View of inside of stainless steel housing, monitoring station components typical without tipping bucket rain gauge | | |

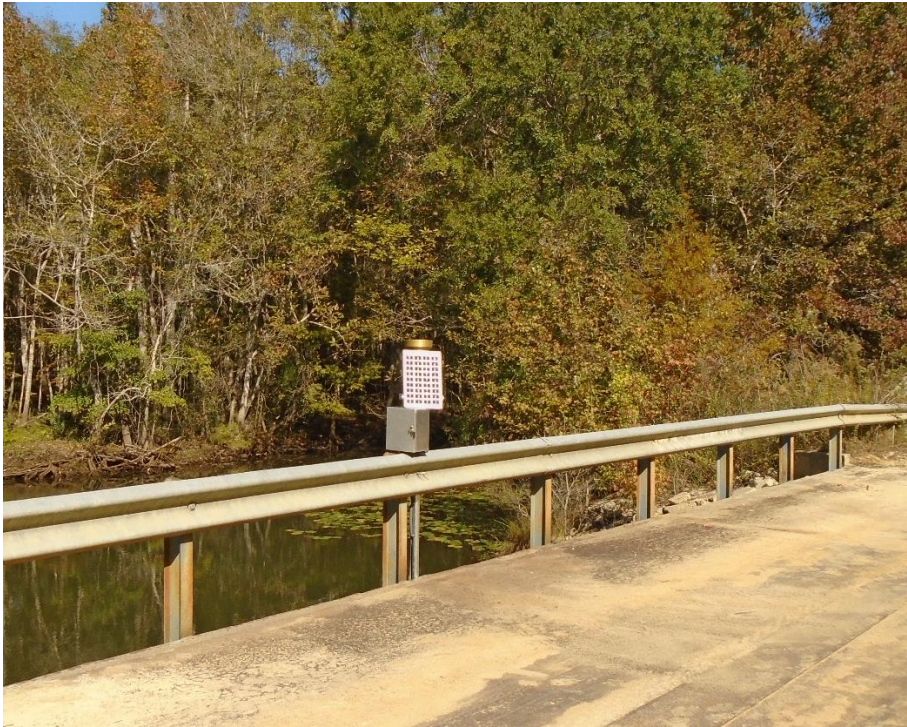
| <b>Photo No.:</b><br>Monitoring Station-4 | |

| <b>Description:</b><br>View of MS-4. | |

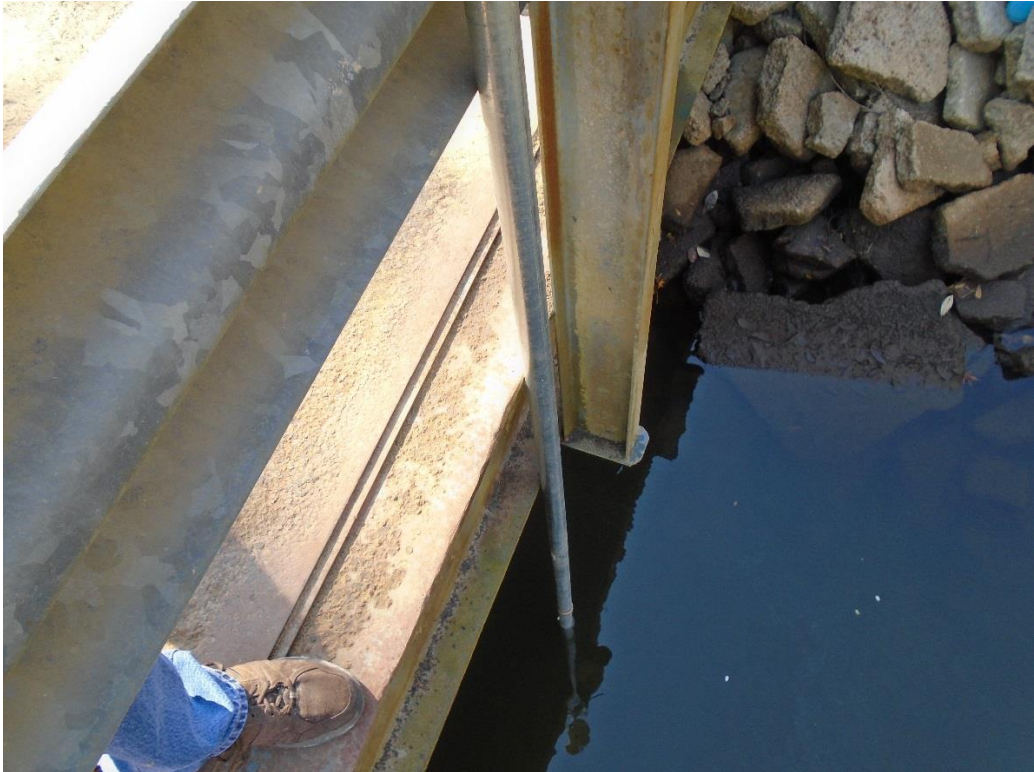
| <b>Photo No.:</b><br>Monitoring Station-4 | |

| <b>Description:</b><br>View of area where transducer and thermistor were mounted for MS-4. (Equipment and Well Screen not shown in Picture) | |

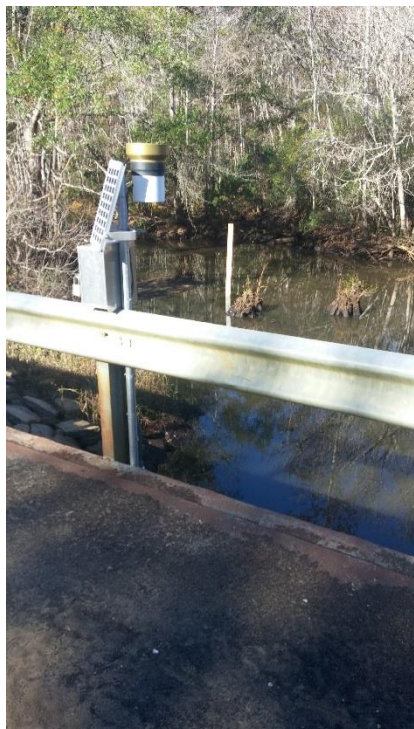
| <b>Photo No.:</b><br>Monitoring Station-4 | <b>Date:</b><br>12/20/2016 | |

| <b>Description:</b><br>View of Staff Gauge location at MS-4. | | |

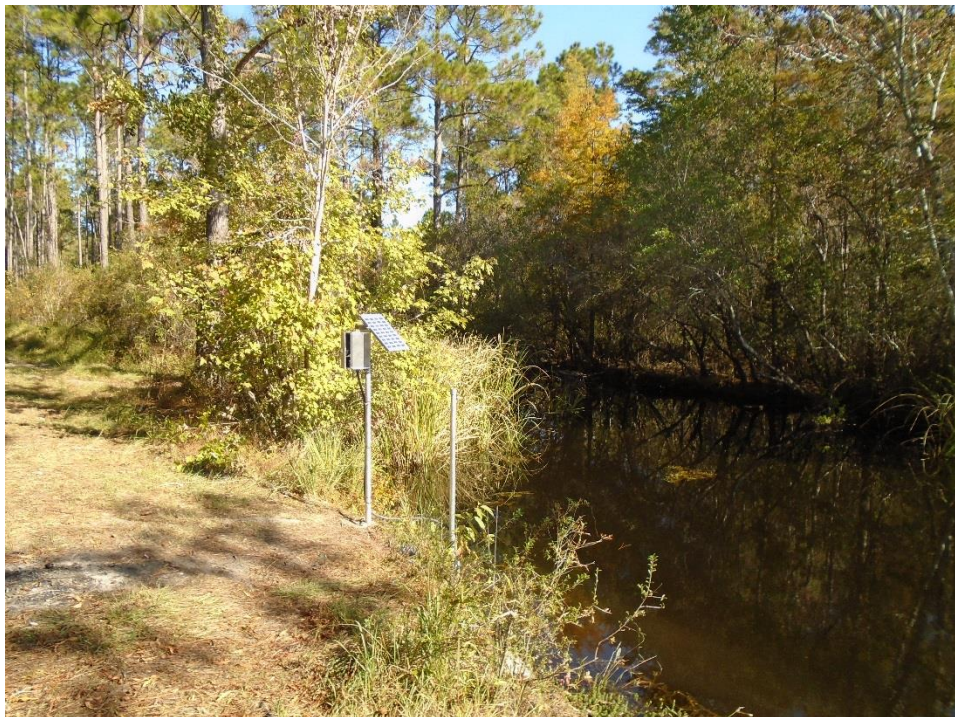
| <b>Photo No.:</b><br>Monitoring Station-5 | <b>Date:</b><br>11/15/2016 | |

| <b>Description:</b><br>View of MS-5. | | |

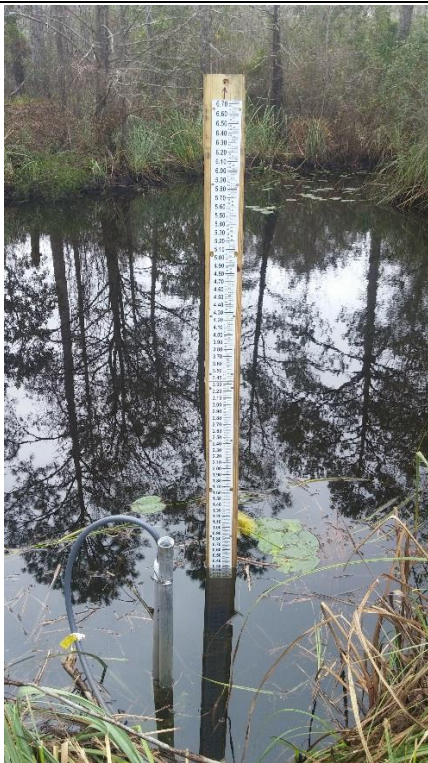
| <b>Facility:</b><br>MK Ranch<br><b>Photo No.:</b><br>Monitoring Station-5<br><b>Date:</b><br>12/20/2016<br><b>Description:</b><br>View of Staff Gauge location at MS-5. | |
