## INTRODUCTION

The Nature Conservancy (TNC) has hired Ecology and Environment, Inc. (E & E) and its team member, MRD Associates, Inc., to review alternatives to address problems associated with scour around the Black Lake Bridge. The project site is located in Escambia County, Florida (Figure 1) near the Perdido River. Prior to bridge construction in 2011, access across the creek was provided by a low earthen roadway. Water was conveyed under the roadway through large 60-inch-diameter corrugated metal culverts, with the roadway overtopped during infrequent high flow events. The roadway and culverts were removed, and a 24-foot-long bridge was constructed along with wooden abutment wing walls. The wing walls extended just below the mud line and did not have any protective armoring in front. Since the construction of the bridge, the wing walls have been undermined at least twice. The most recent event occurred during an exceptionally extreme event in late April 2014 which completely eroded the bank behind the south wing wall (Figure 2) and caused piping of material on the north wing wall (Figure 3). There is an approximate 24-foot gap between the bridge on its south end and the top

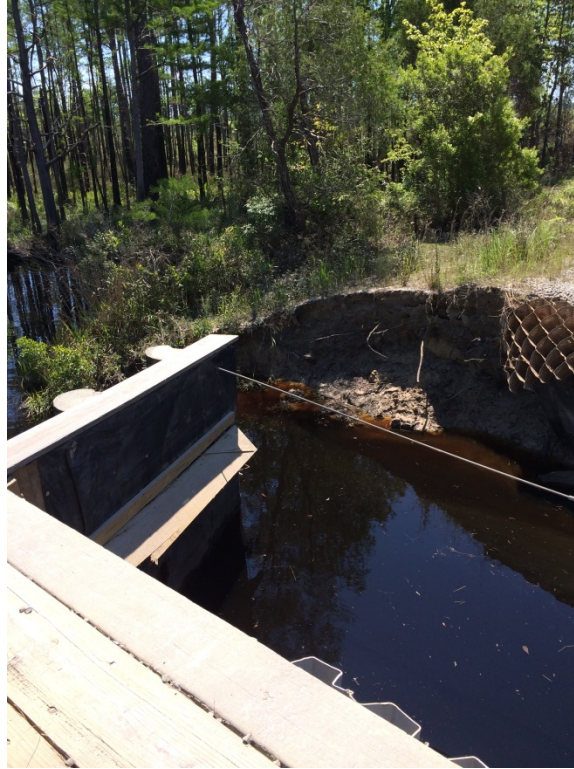
**Figure 2. Complete erosion of the bank behind the south wing wall occurred during an extreme event in April 2014.**

Access across the bridge is not possible due to extensive scour, particularly at the south abutment. Both abutments have inadequate levels of protection for scour. The south abutment is most vulnerable to scour since it is located on the outside bend of the creek channel where the highest water velocities occur.

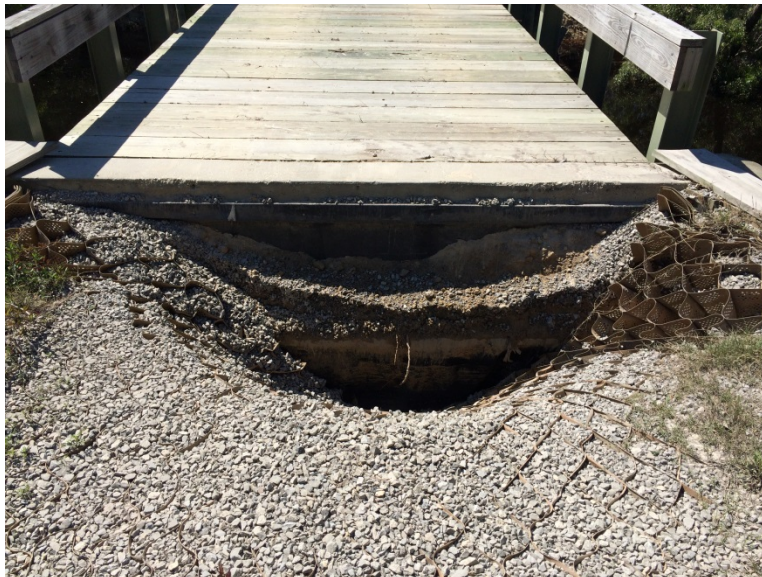
**Figure 3. The extreme event of April 2014 caused piping of material on the north wing wall.**
