# Seagrass Protection and Restoration Plan

## **Estero Bay Aquatic Preserve**

## **Florida Department of Environmental Protection**

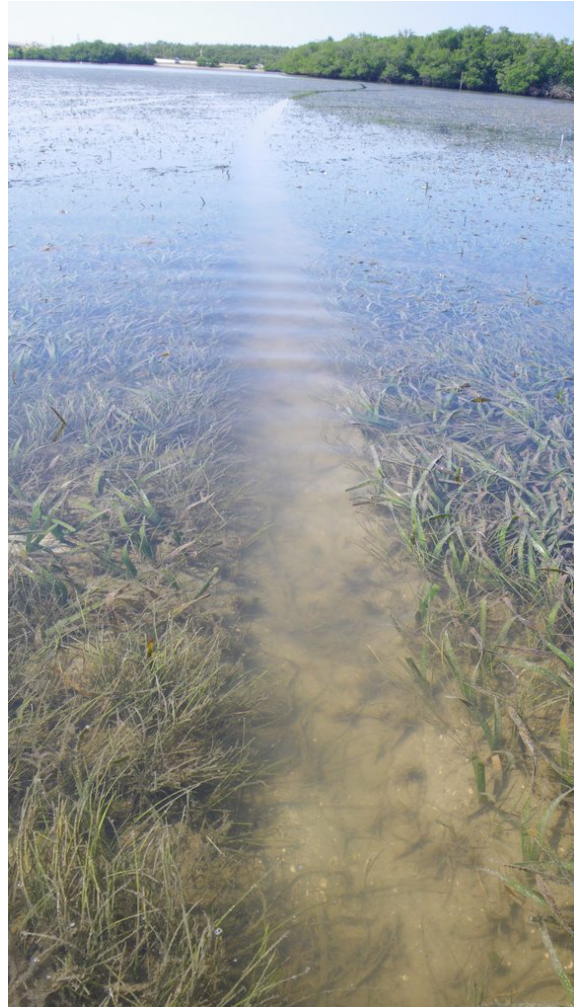
*Figure 3: Propeller Scar (prop scar) in a seagrass bed in Estero Bay (Photo Credit: FGCU Vester Marine Station)*

A propeller scar (prop scar) is a narrow, linear feature that is the direct result of a vessel's propeller moving through the seagrass bed (Zieman, 1976). Being in shallow waters, seagrass communities are especially vulnerable to prop scars by boats, and they are scarred as the boat passes through the community (Figure 3: Propeller Scar

(prop scar) in a seagrass bed in Estero Bay (Photo Credit: FGCU Vester Marine Station). Since propeller scarring mechanically injures the plants, the entire estuary is impacted (Sargent et al., 1995). Most of the large-scale estimates of vessel-induced seagrass damage have come from studies using aerial images. These aerial studies provide useful information regarding patterns and relative densities of scarring. Prop scars can take up to 10 years to heal, and this time period may be much greater in areas with poor water quality and where scarring is severe or frequent (Durako, Hall, Sargent, & Peck, 1992; Lewis & Estevez, 1988; Zieman, 1976). Also, the unstable sediments of a newly damaged seagrass bed are susceptible to erosion and this prevents the establishment of new plants.

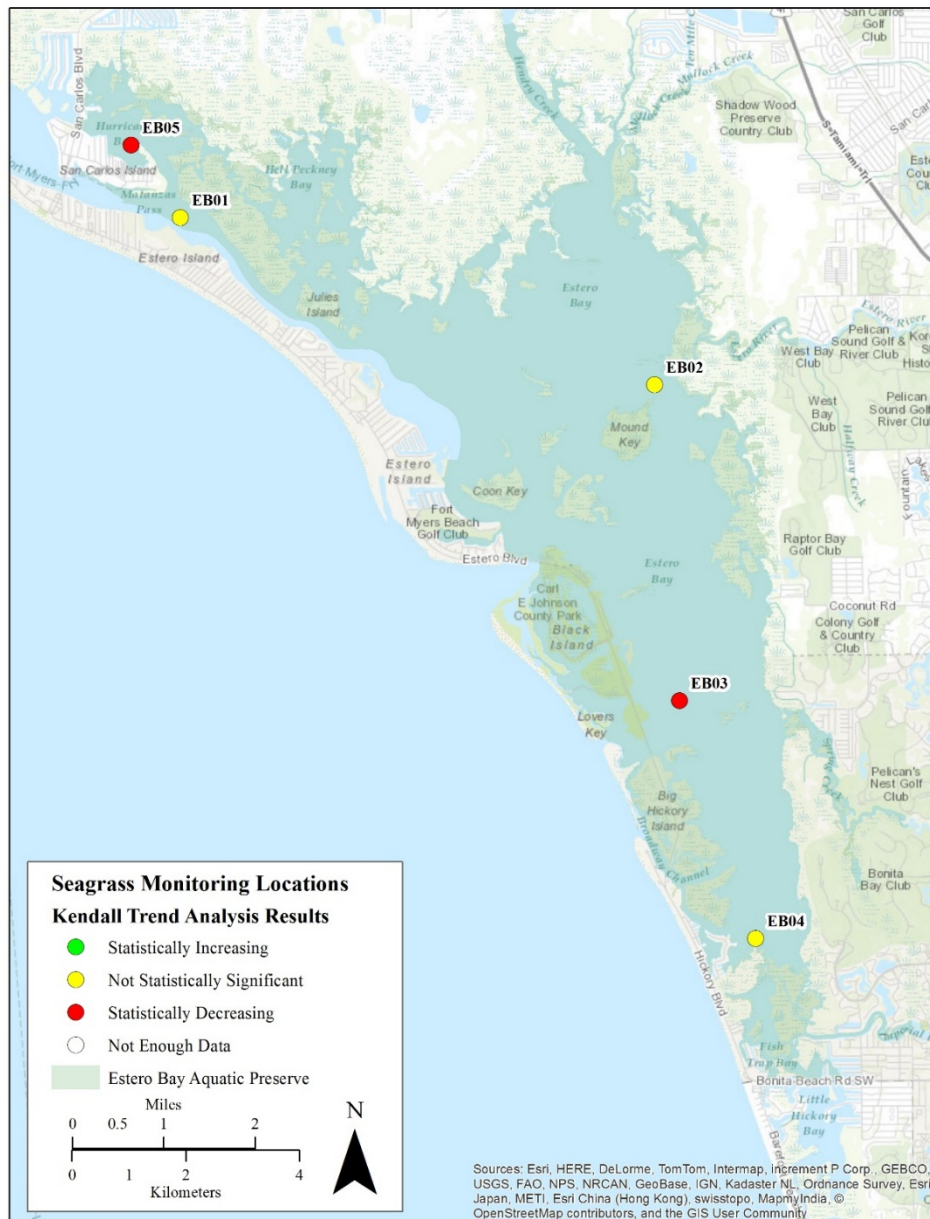
Map 7: Stations specific growing season mean total submerged aquatic vegetation abundance Braun-Blanquet score Kendall trend analysis results using data from 2006 to 2013.

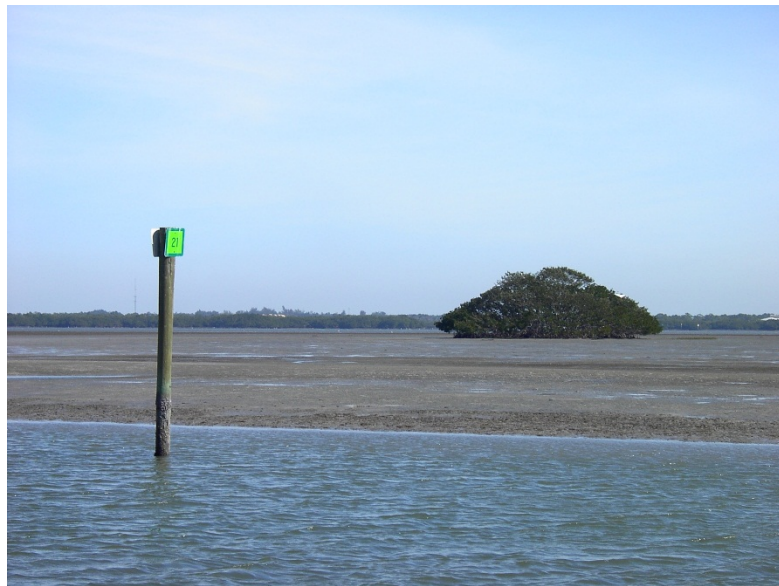
*Figure 6: New Pass NICMZ at low tide*

The two zones in EBAP encompass a total of 581 acres. The zones are strategically located in shallow water (Figure 6: New Pass NICMZ at low tide areas with heavy prop scars and that, when marked, are easily traversed (Map 11). The designation also considered vessel traffic patterns, visibility to boaters, enforceability, and ease of marking and regulating the zone. Once marked, NICMZs should prevent prop scarring and allow for the passive restoration of seagrass in these shallow, heavily propeller scarred areas. Non-motorized vessels, poling, and trolling are permitted within these zones. Monitoring efforts are to be conducted both before and after the establishment of NICMZ to evaluate their effectiveness.

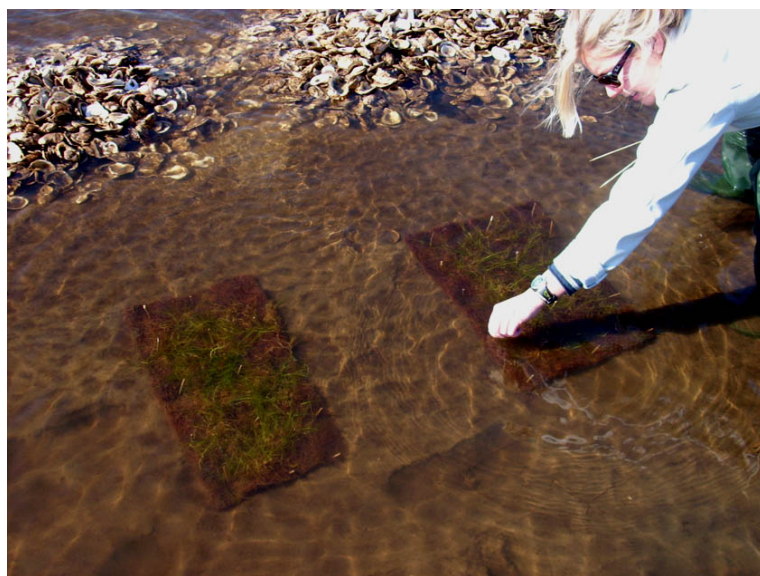
*Figure 7: Lab propagated widgeon grass coconut mats being secured on site (Photo Credit: DEP Northwest District).*

Anchoring the planting material to protect them from wave action also needs to be considered, and so, combining any of these planting methods with the placement of sediment tubes is necessary in order to bring the restoration site to grade. It is important to note that no planting material can be obtained from the sediments within the aquatic preserve (Rule 5B-64, FA.C).

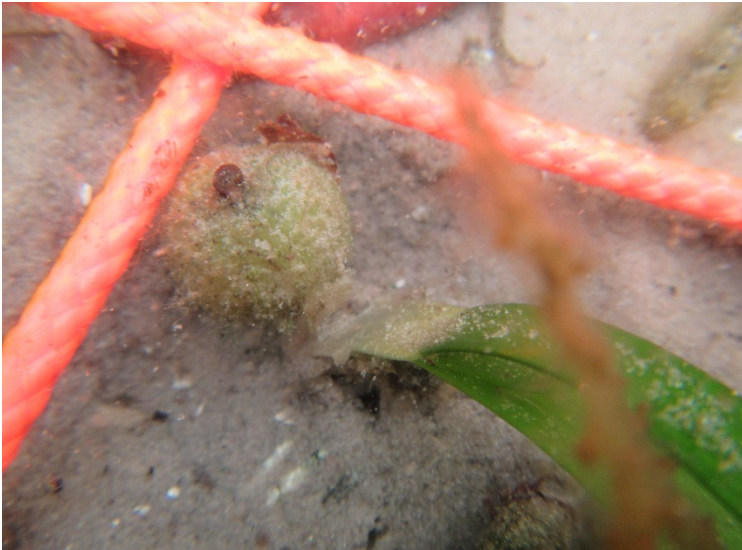
*Figure 8: Photograph of a turtle grass seed in Estero Bay.*

Seed distribution is only applicable in low energy areas so that the seeds can settle and germinate (Calumpong & Fonseca, 2001). Even though all of the seagrass species found in Estero Bay are documented to produce seeds, only Turtle grass (Figure 8) and widgeon grass have been documented to be found in a quantity sufficient

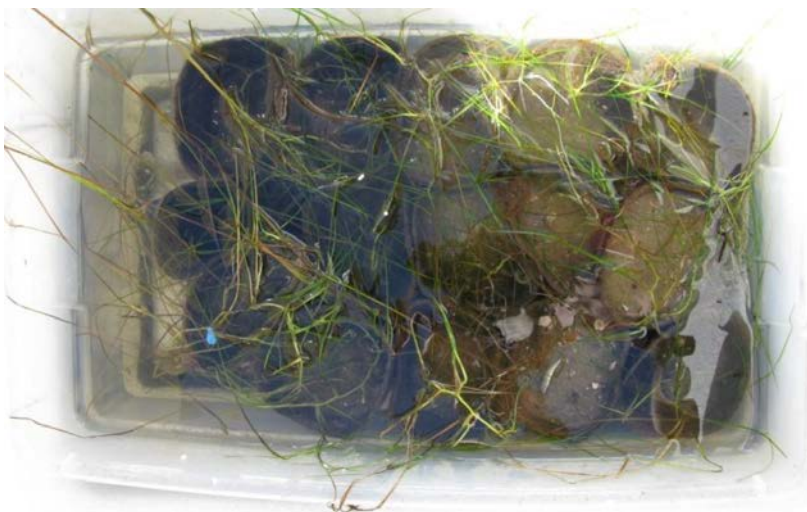
*Figure 9: Example of SCCF's peat pots before being transplanted on site (Photo Credit: Richard Bartleson, SCCF)*

2006). Pots with newly sprouted seeds with one short shoot (seedling) can be cultivated and planted in a restoration site (Figure 9). Durako & Moffler (1981) suggested that the use of the use of peat pots allows for greater anchoring ability than bare root seedlings. Regardless, a major problem with peat pots is that they are susceptible to being washed out during periods of high wave action (Treat & Lewis, 2006). A method used successfully by the Sanibel Captiva Conservation Foundation (SCCF) involves planting sprigs (seagrass fragments) into sediment in plastic containers, which are placed in an outdoor tank to grow into sods. Sods can be transplanted at the restoration sites.

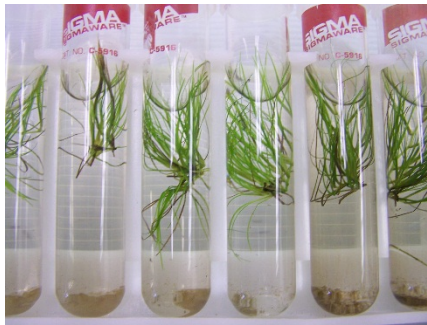
4. Place slant rack of selected plants in hood, as well as a rack of sterilized media, jar of alcohol with tweezers and scalpel, and sterilized Petri dishes wrapped in aluminum foil. Scalpel blade should be changed every other subdivision. Blades are found in drawer directly to right of flow hood. Scalpel and tweezers are found in cup on dish rack next to sink. Jar of alcohol on top of cabinet next to flow hood.

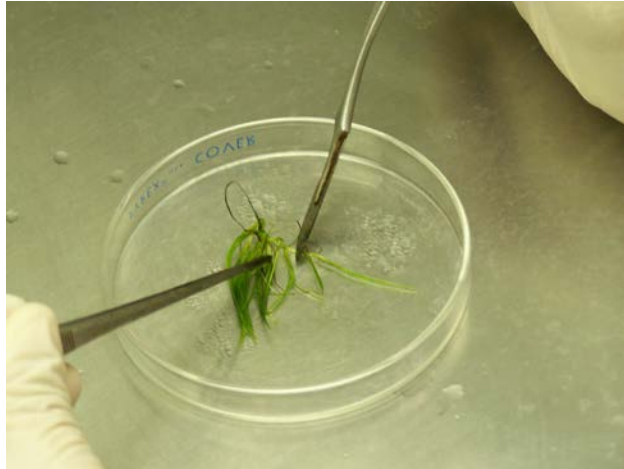
8. Sterilize tweezers again and scalpel.
9. Begin cutting *Ruppia*, making cuts every 2-3 nodes. Divide entire plant, cutting brown parts off and pushing to side.
