# Sebastian Inlet Channel Comprehensive Seagrass Mitigation Program Year 3 Monitoring Report

Sebastian Inlet District  
114 Sixth Avenue  
Indialantic, FL 32903

January 2011

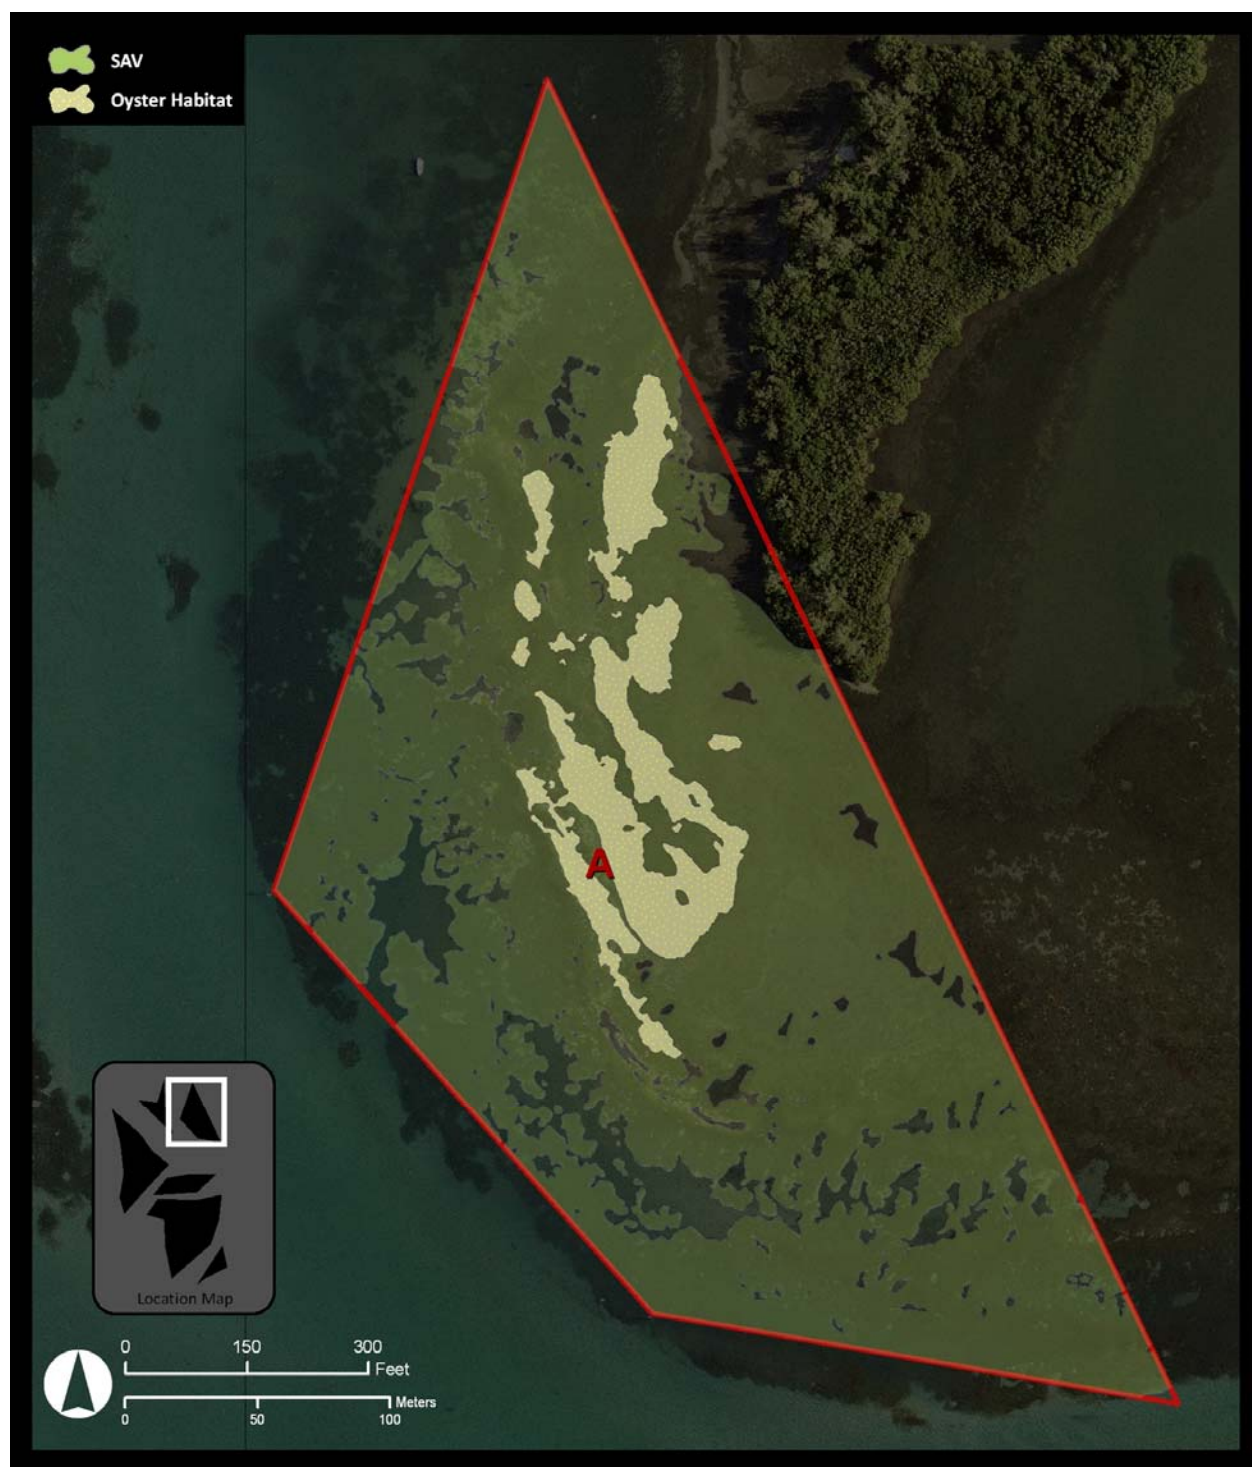
**Figure 3.** ESRI feature class depicting the estimated extent of seagrass and oyster habitat within Zone A in 2010.

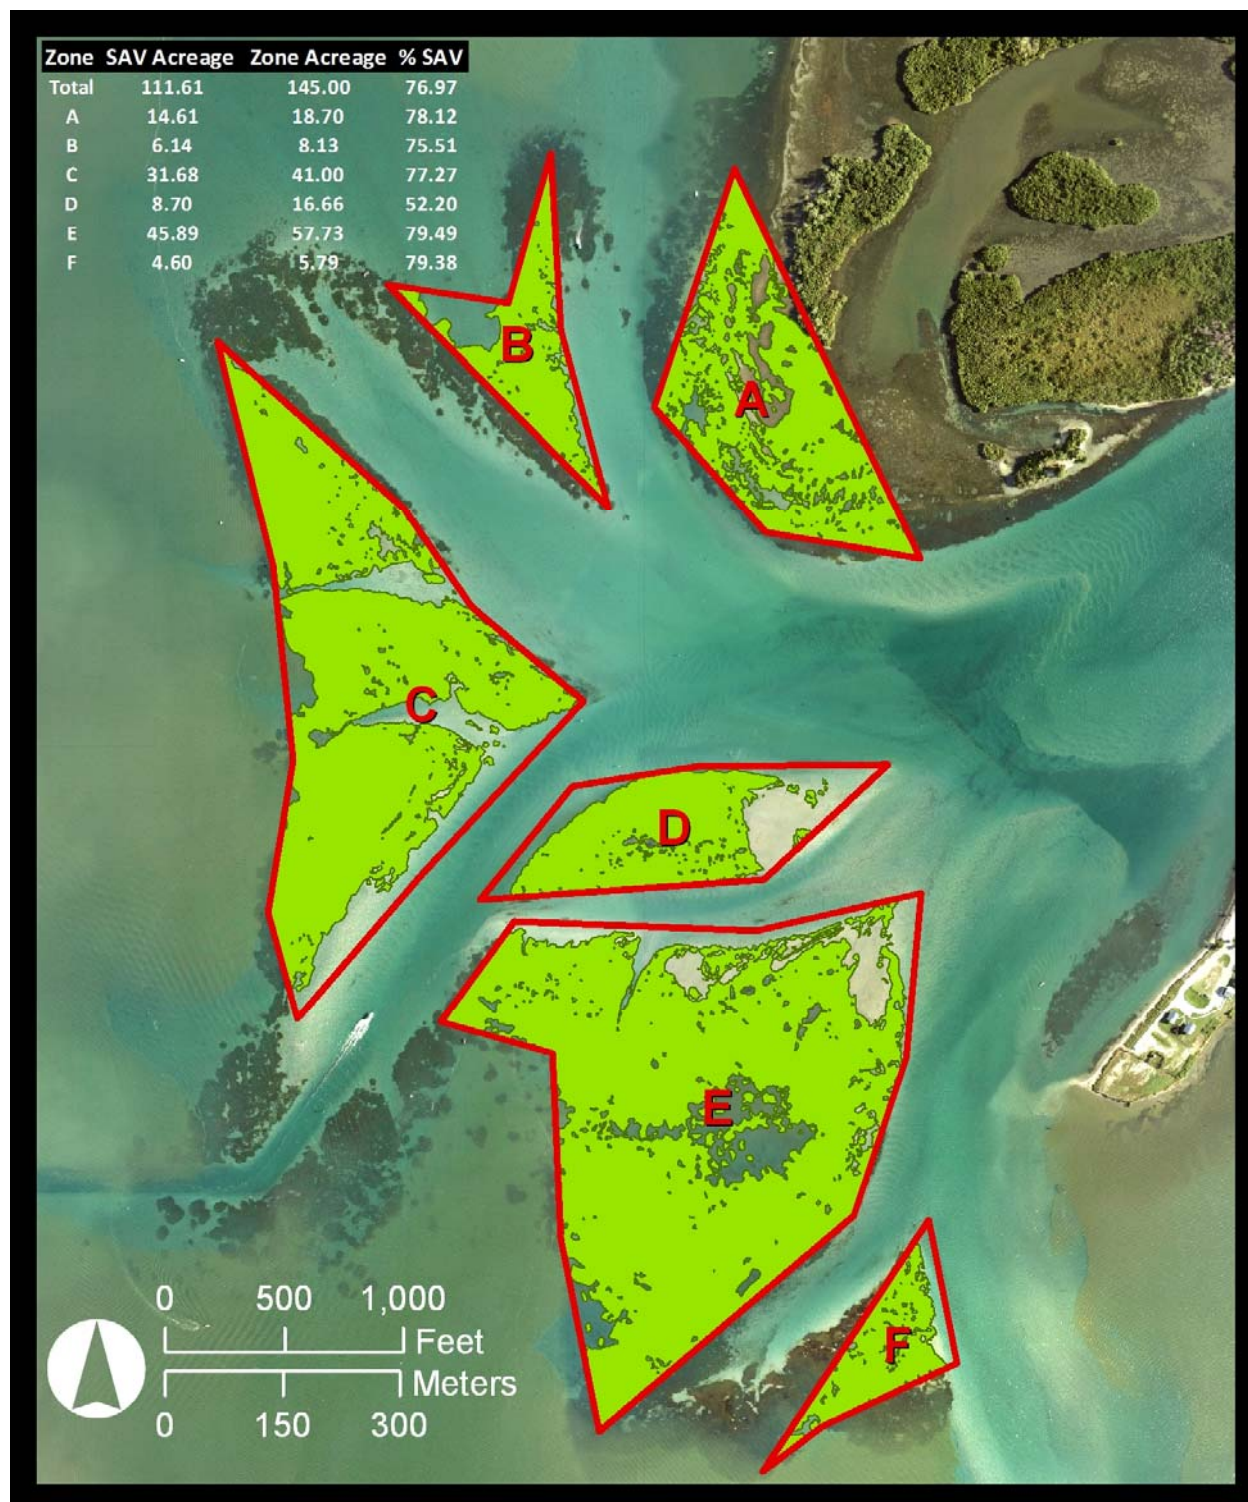
The finalized seagrass coverage feature class (post-groundtruthing) yielded 111.61 acres of seagrass, equivalent to 76.97% of the mitigation zone (Figure 4). Zone-specific seagrass acreage estimates ranged from 4.60 (Zone F) to 45.89 acres (Zone E) with percent cover values (i.e., the percentage of the zone area covered by seagrasses) from 52.20% (Zone D) to 79.49% (Zone E). A complete listing of zone values can be found in the inset table of Figure 4.

**Figure 4.** ESRI feature class depicting the estimated extent of seagrass within the mitigation area in 2010. The associated table summarizes area and percent coverages by Zone. Aerial image taken August 23, 2010.

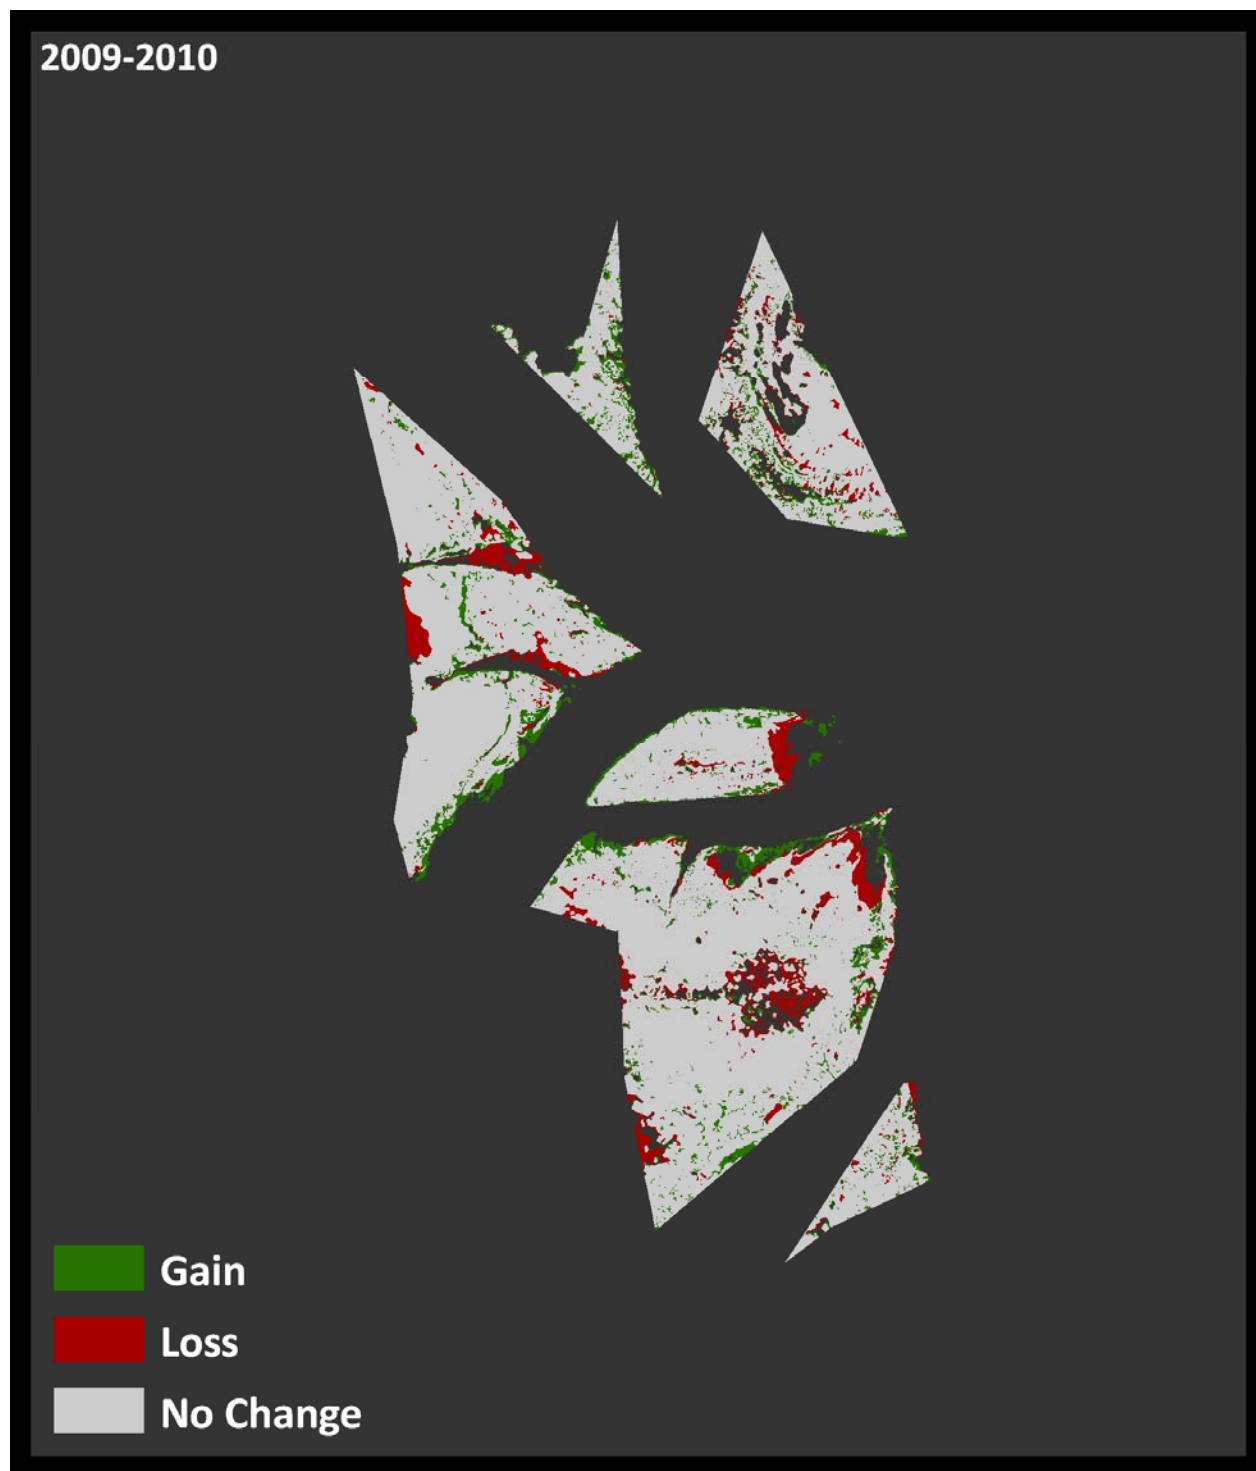
**Figure 5.** Spatial distribution of inter-year change in seagrass coverage within the mitigation boundaries. Gains are depicted as green, losses red, and areas consistent between years, gray. Analysis included 2009-2010 data. Zones A thru F are named in counterclockwise order originating from the upper right.

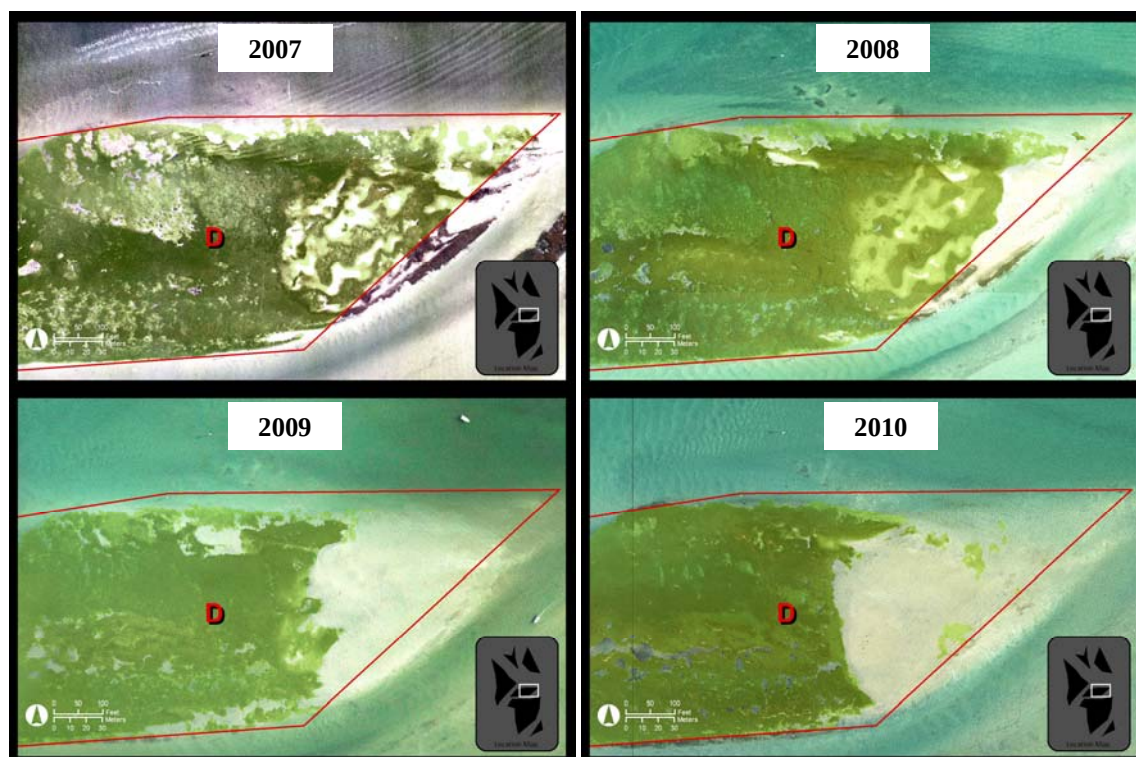
**Figure 9.** Graphics showing the westward retreat of the seagrass edge in Zone D from 2007 to 2010. Note that in the top graphic the edge of the seagrass bed in 2007 was at the eastern boundary of Zone D.

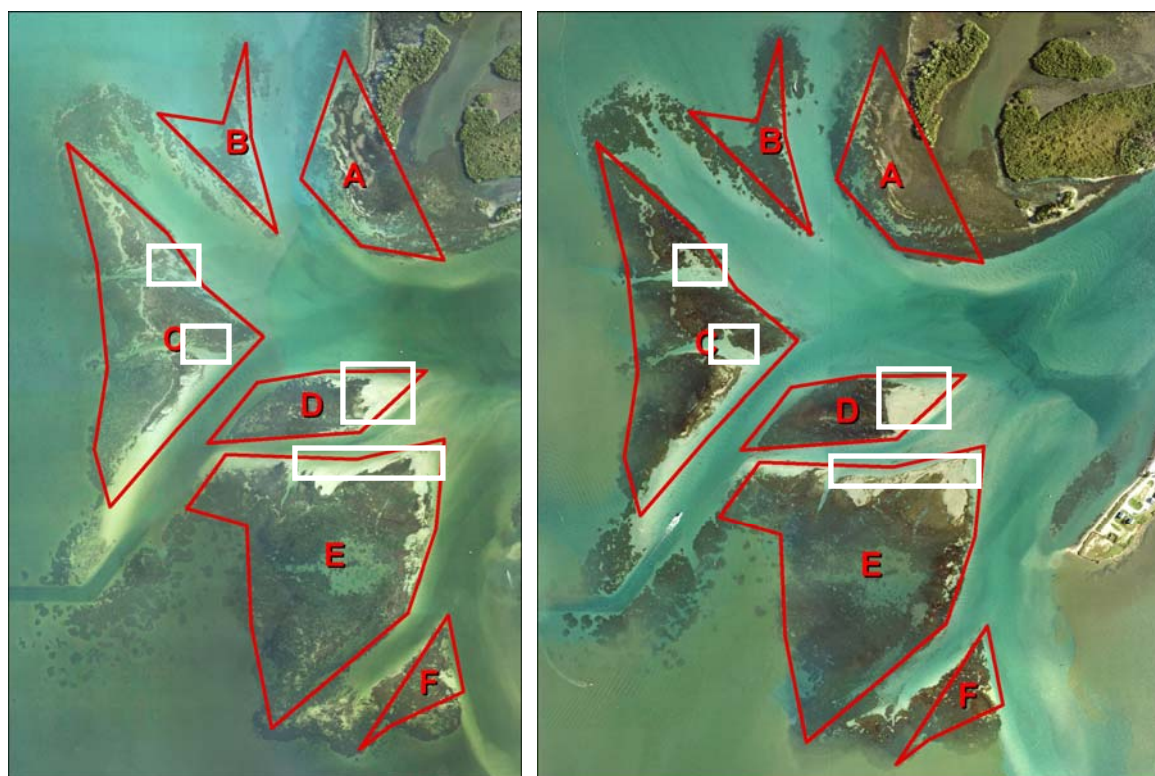
A quick qualitative assessment was performed on the aerial imagery collected in 2009 and 2010 (Figure 10). A notable decrease in seagrass coverage was observed within the interior channels of Zone C from 2009 to 2010. The eastern sides of these channels, previously occupied by *Halophila johnsonii* in 2009, were void of seagrasses in 2010 (Figure 10). This absence of *H. johnsonii* is likely due to the ephemeral nature of this species. In 2009 the aerial imagery was collected in June during peak growing season while the 2010 imagery was not successfully captured until late August. Notable changes were also observed on the eastern side of Zone D and the northern edge of Zone E. As in previous years, the seagrass edges continued to move toward the interior of the Zones; however, new seagrass growth was apparent near the zone boundaries from 2009 to 2010 (Figure 10).

**Figure 10.** Locations of noteworthy differences (white rectangles) between the 2009 (left) and 2010 (right) aerial images.

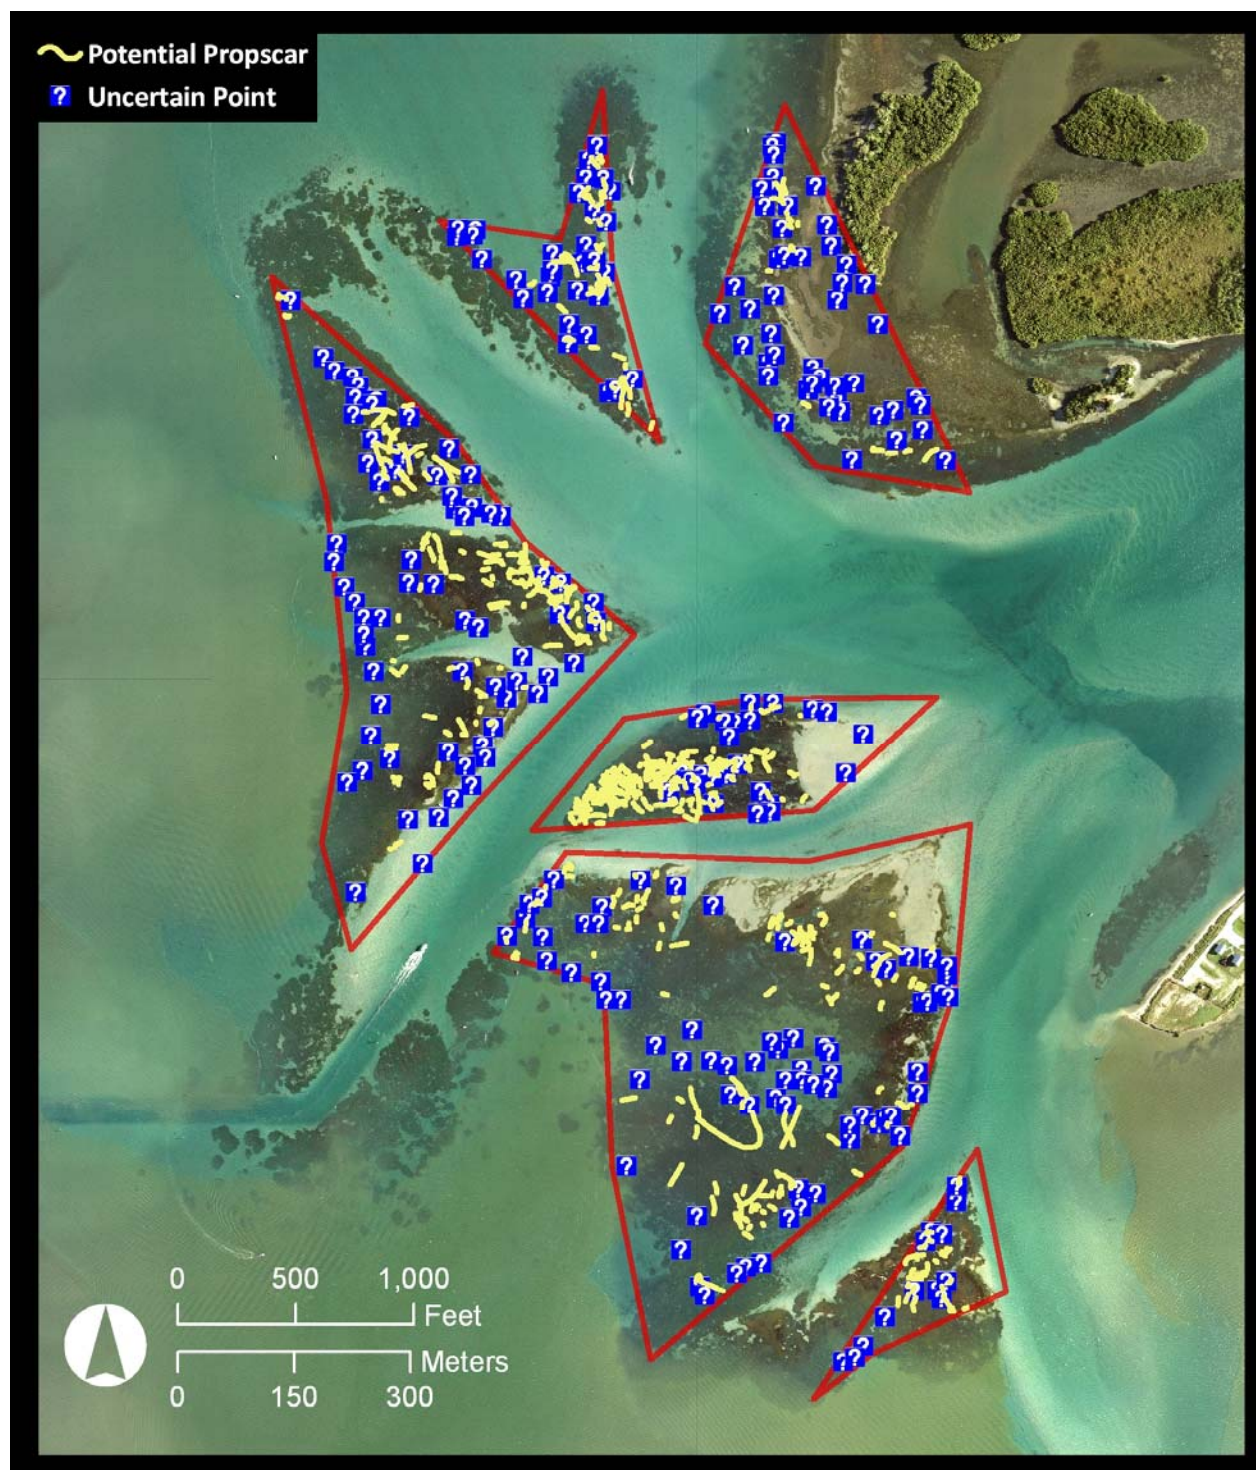
**Figure 11.** Location of potential propscars and points of uncertainty identified during the 2010 image analysis. Aerial photography provided by Aerial Cartographics of America, Inc, taken August 23, 2010.

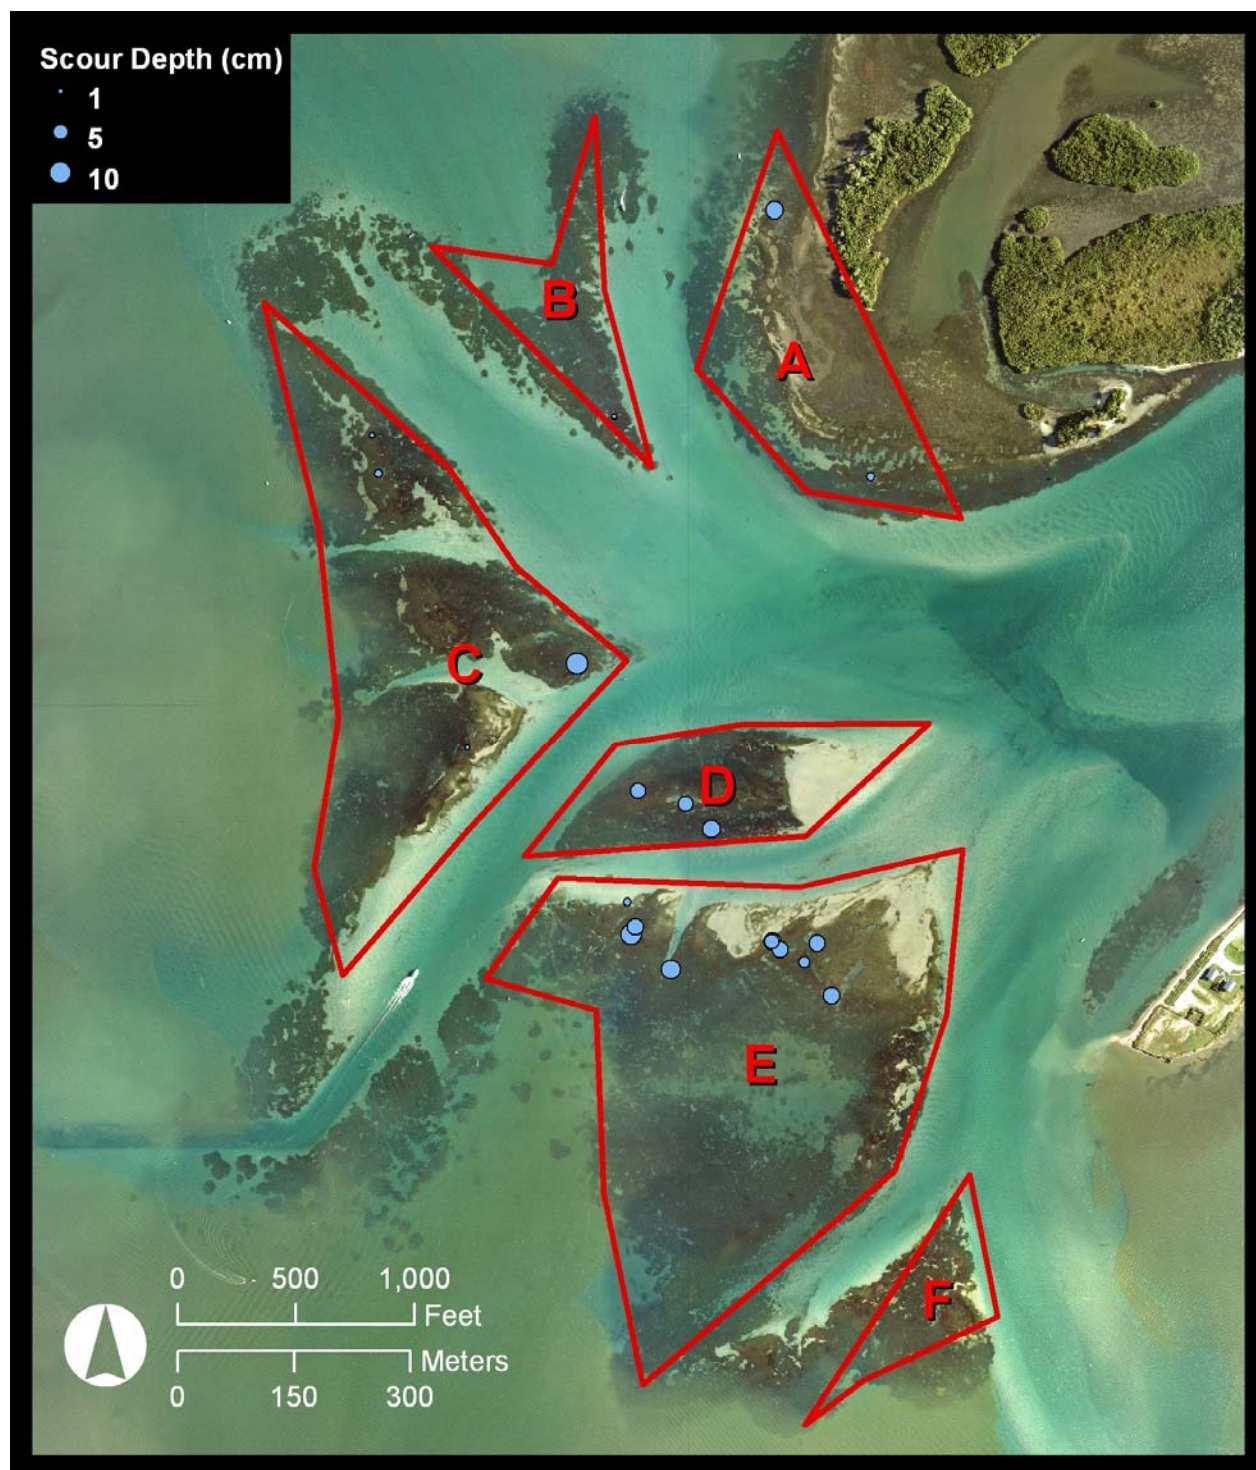
**Figure 17.** Scouring depth (cm) for Type III scarring observed within the mitigation area in 2010.

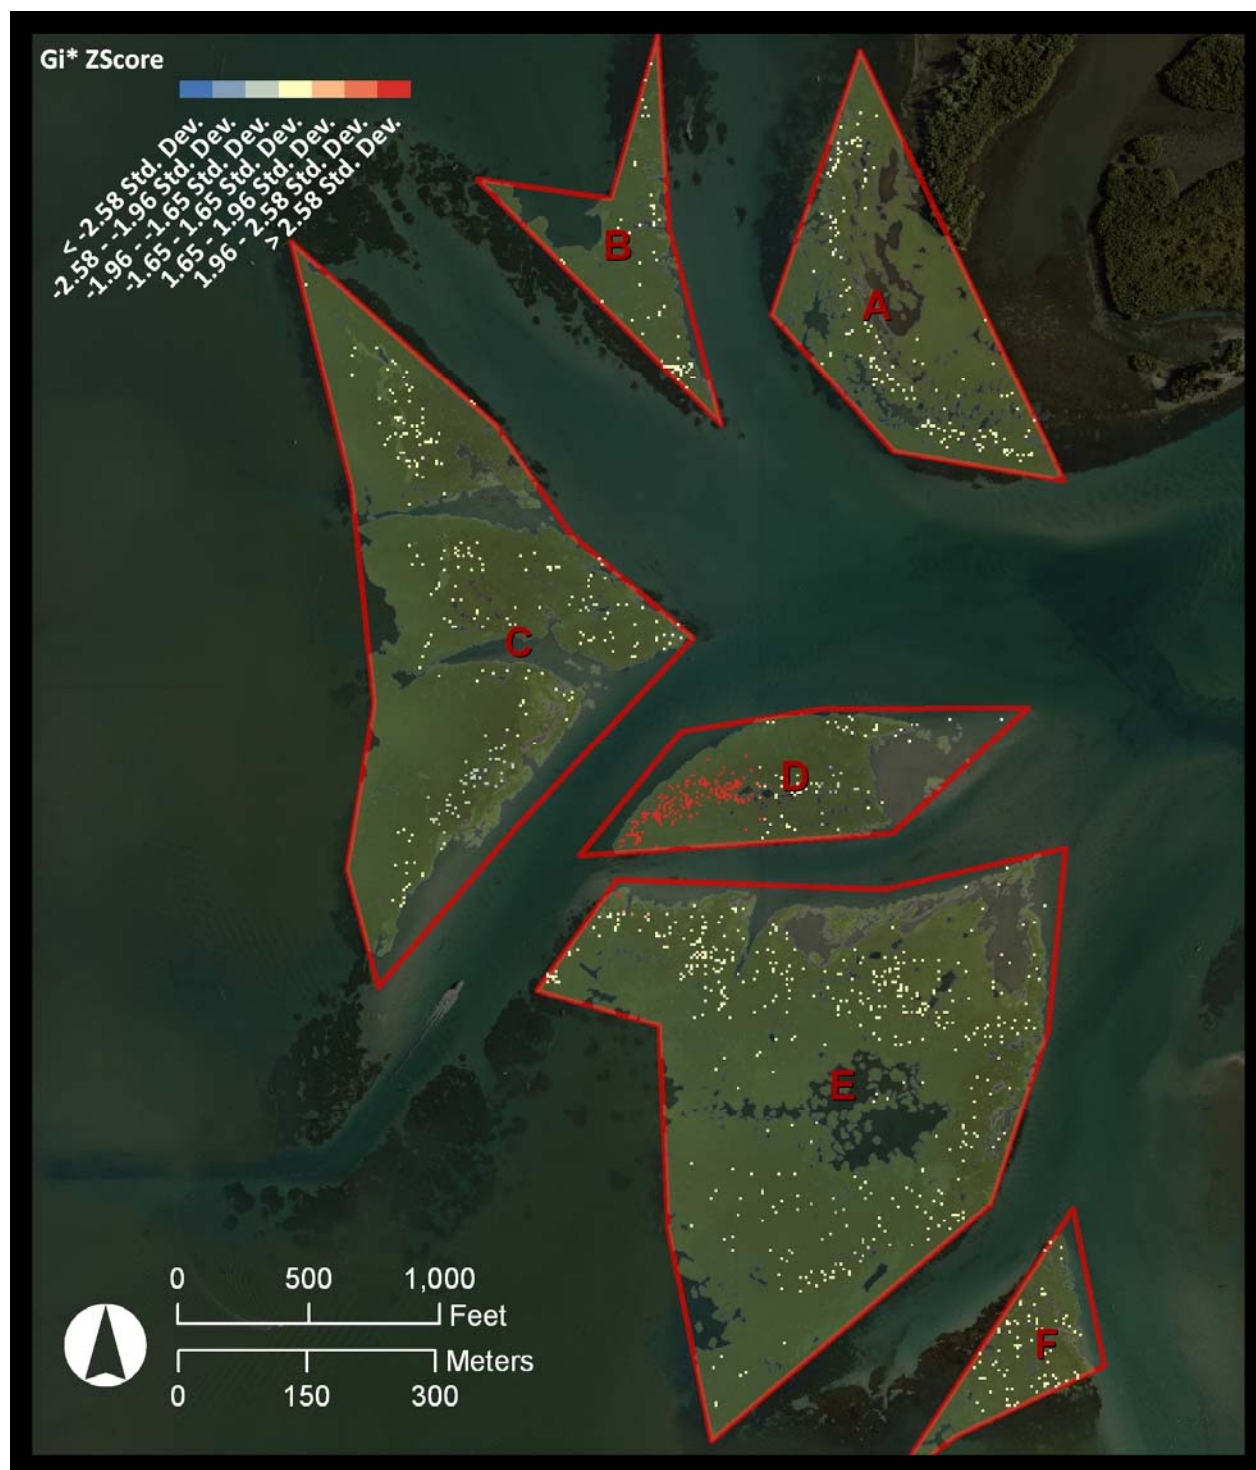
**Figure 24.** The map above depicts the analysis Gi\* Z Score for each 10-m<sup>2</sup> grid in the mitigation protection zones as well as the 2010 photointerpreted and groundtruthed seagrass distribution. The color of the grid cell indicates the relative intensity/strength of clustering (hotspots). Note the significant (Z Score > 2.58 standard deviations from the mean and  $p < 0.05$ ) anthropogenic propscarring intensity in Zone D.

We can offer a tentative evaluation of the propscar distributions and densities mentioned above. The clustering of propscars in the western portion of Zone D may be due to the beaching practices common in that portion of the shoal. During the active restoration and annual monitoring events, numerous vessels were observed attempting to gain access to the area, which necessitates leaving the channel, potentially increasing the impact rates for all areas immediately adjacent to the recreational hotspot. This area also separates the unmarked “channel” between Zones D and E from the navigation channel connecting Sebastian Inlet to the ICW. It is possible that rather than going around the southwestern corner of Zone D, boaters are creating a short cut across Zone D to gain quicker access to the navigation channel and the inlet.

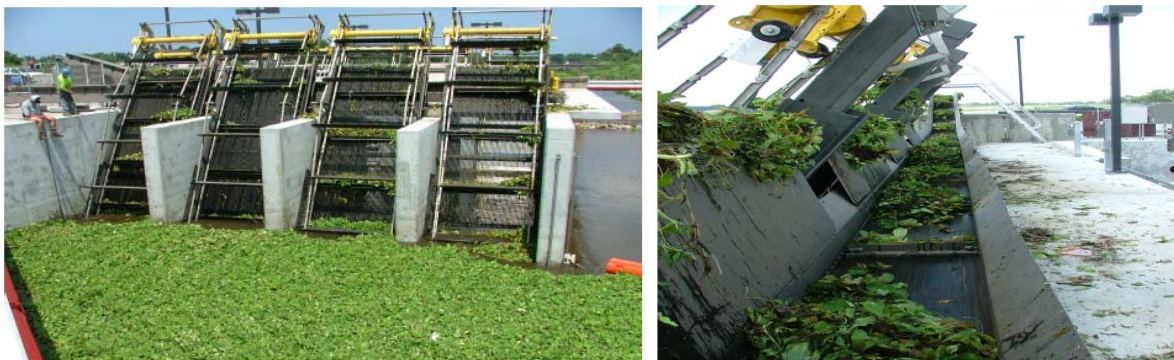
**Figure 27.** Photographs of the Main Relief Canal Stormwater Treatment Facility. The self cleaning screens capture debris and vegetative material and dump it onto a conveyor that discharges the material into dumpsters. Photos courtesy of Indian River County (Turning the Tide 2008).
