# Seagrass Prop Scars in Cockroach Bay - Finding a Logical Solution

Thorne, Laura J. & Lesnett, Eric M.

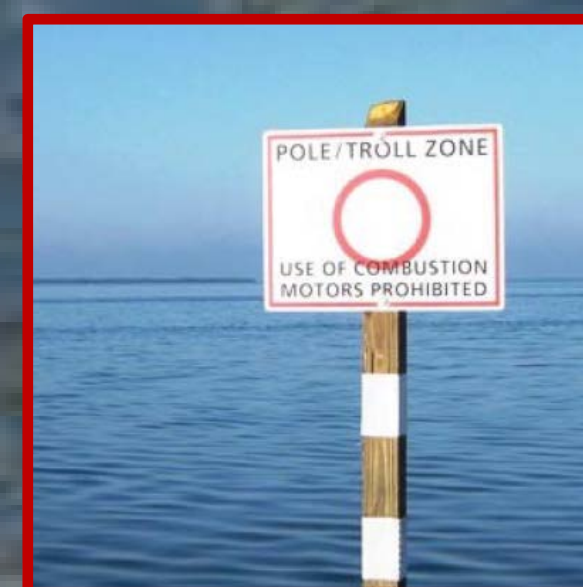
Option 1  
Restricted Access

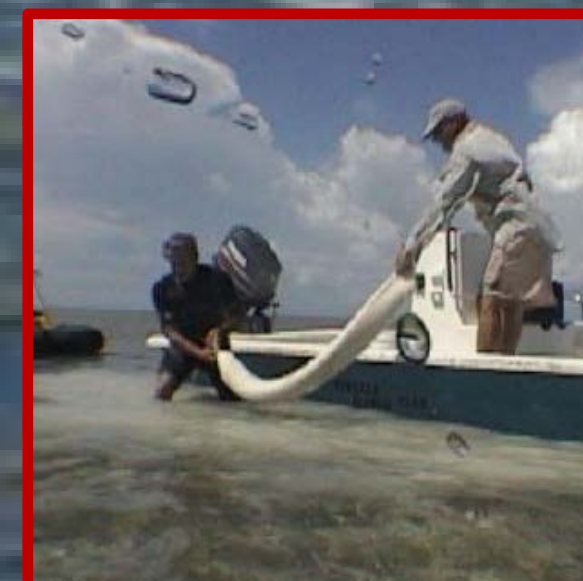
Option 2  
Prop Scar Restoration

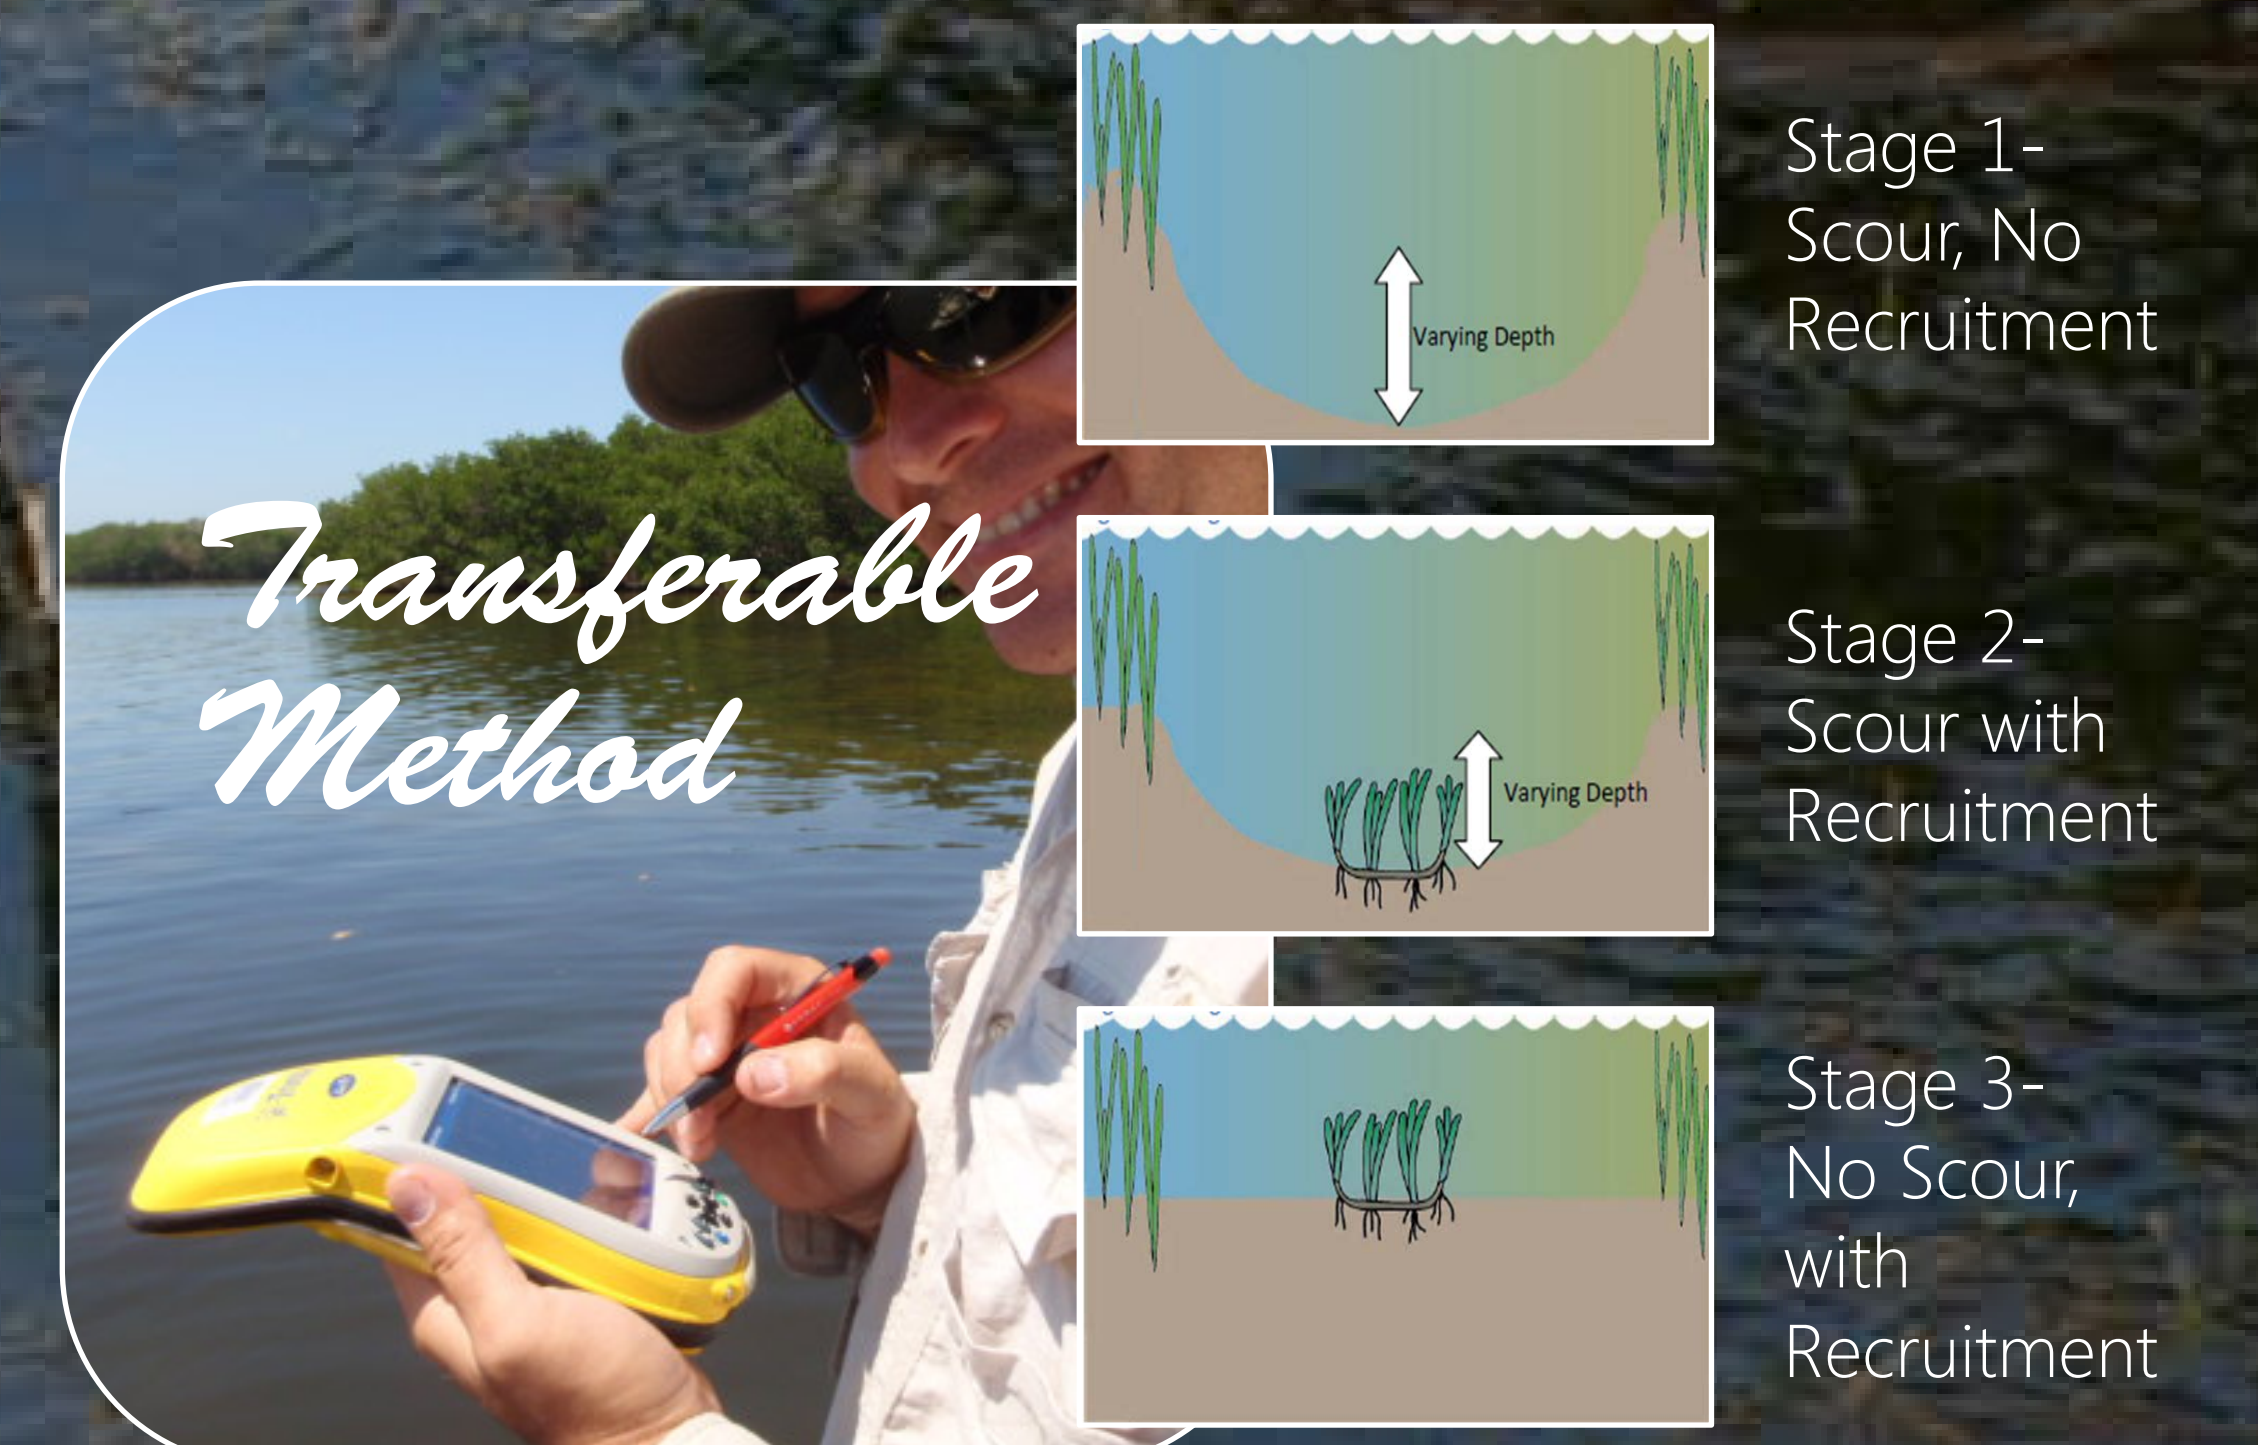
Increase Education/Awareness with Signage like this from Pinellas County/Tampa Bay Watch

Enforce Existing Slow Speed Zone

Transfer Restoration to MacDill AFB. Completed summer 2012 with Tampa Bay Watch volunteers
