# **Seagrass Restoration and Protection in the St. Martins Marsh Aquatic Preserve**

**NFWF-SHELL MARINE: Award #2009-0046-000**

**Final Report**

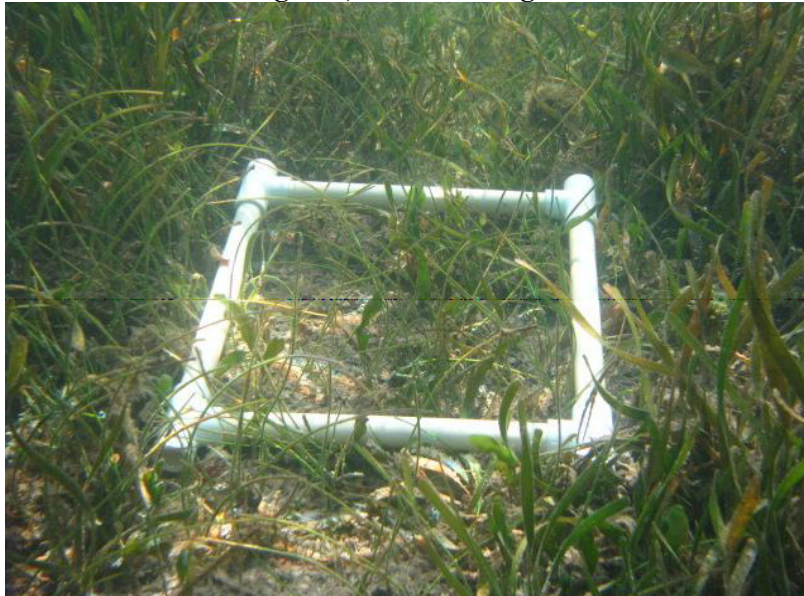
**Figure 7. In treated portions of the prop scars, where the sediment tubes remained at ambient grade, SAV and seagrass colonization was observed.**

When placed at ambient grade, the tubes clearly stabilized the sediment long enough for SAV colonization. However, where they settled below ambient grade, the tubes may be accelerating the undermining of adjacent seagrass beds. Due to the sediment type and depth, many of the sediment tubes have settled 15 – 18 centimeters below ambient grade. It is recommended in future studies that enough

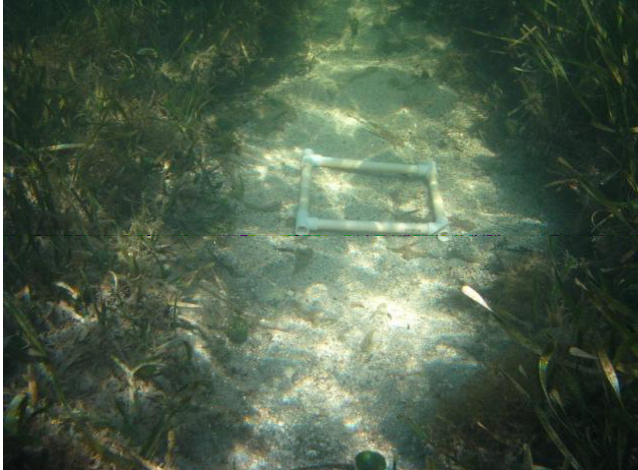
**Figure 9. Observed scouring of the tubes when below ambient grade.**

tubes are placed in the propeller scars to assure the proper grade is established. An analysis of propeller scar sediment depth is recommended to be completed prior to the placement of the sediment tubes.

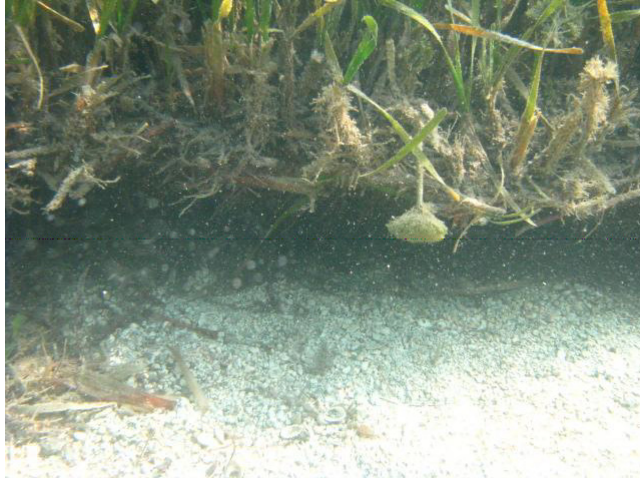
**Figure 10. Undermining of seagrass adjacent to test prop scars was evident where sediment tubes sank below the ambient grade.**

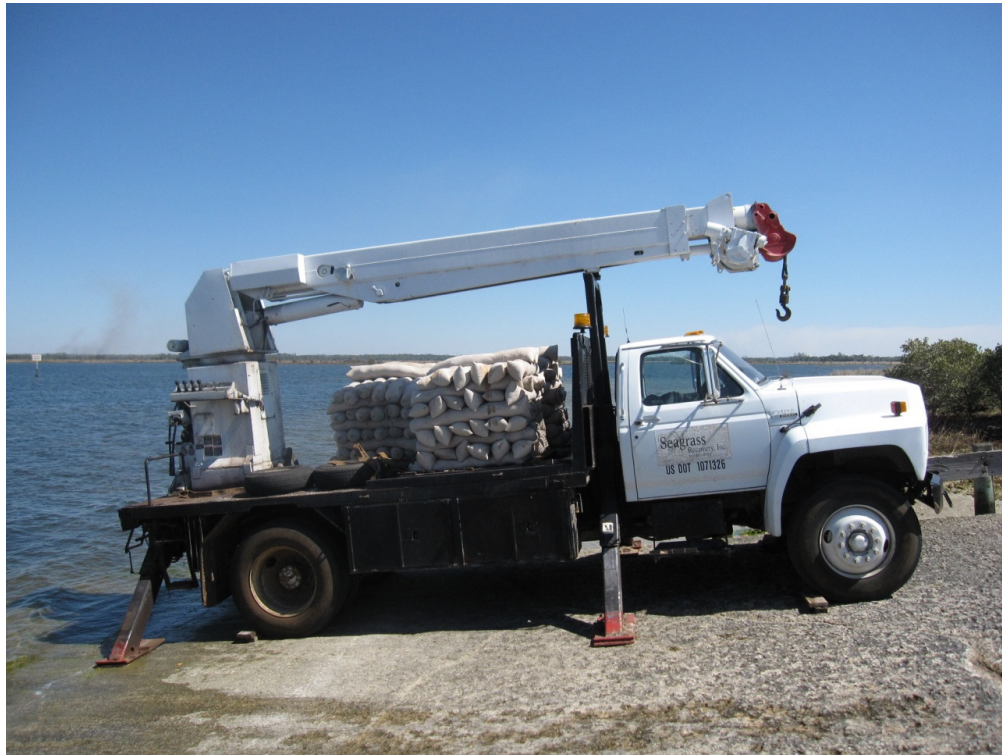
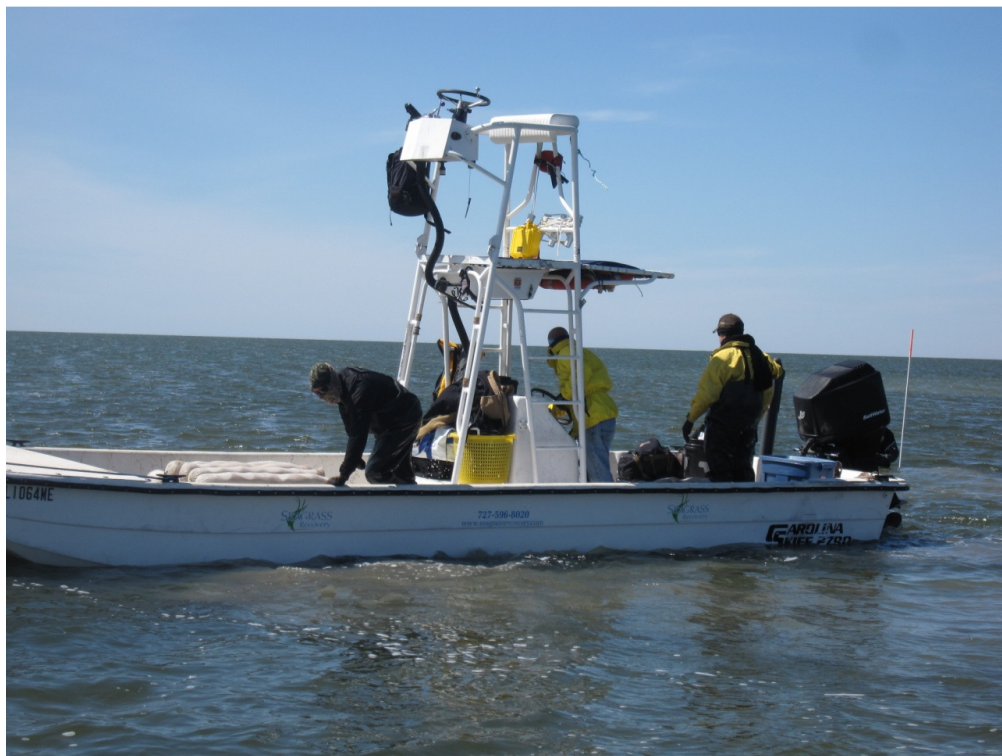
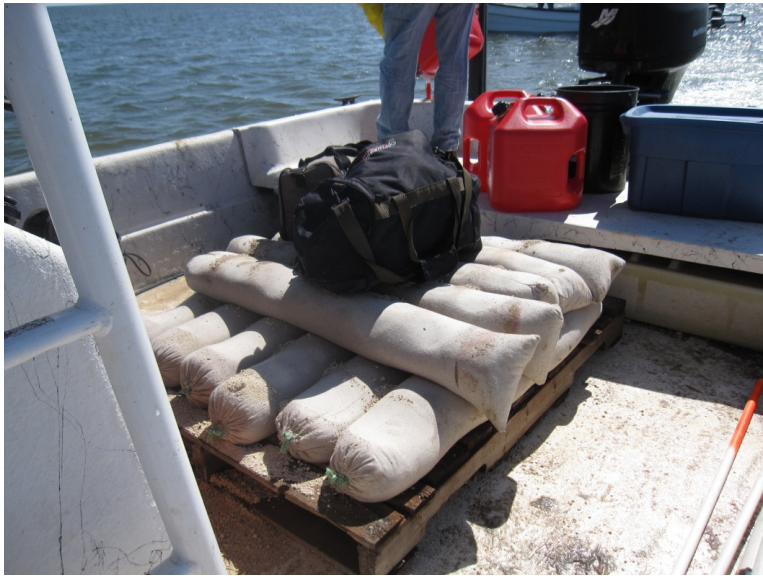
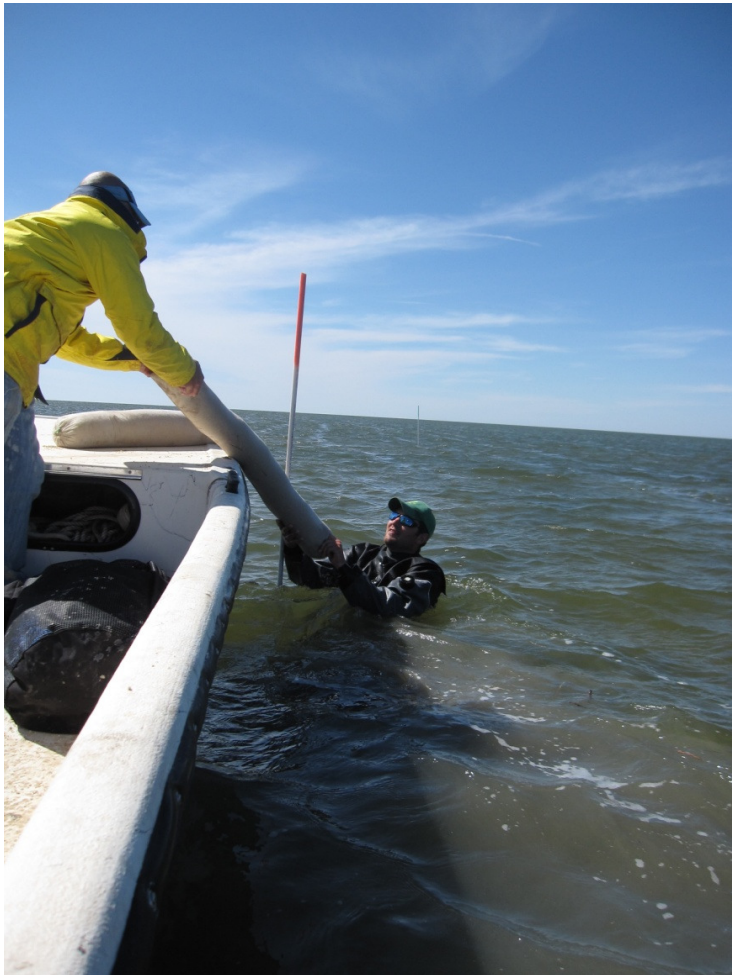
## Appendix 2. Photos from Sediment Tube Deployment Day

On March 9 through 10 2010, 400 sediment tubes were deployed into the 17 selected seagrass scars. The sediment tubes consisted of 20-centimeter diameter biodegradable cotton tubes of approximately 1 meter in length. Tubes were placed in one half the length of the scar until the tubes achieved ambient grade with the surrounding seagrass bed. See Appendix 2 for photos taken on the day of sediment tube deployment. The contractor, Seagrass Recovery, returned on April 6, 2010 to add an additional 200 sediment tubes to the treated scars, as some settling had occurred and additional tubes were necessary to achieve ambient grade with the surrounding seagrass meadows.
