August 6, 2014

**Re: Environmental Assessment for St. Lucie Substation Switchyard Expansion**

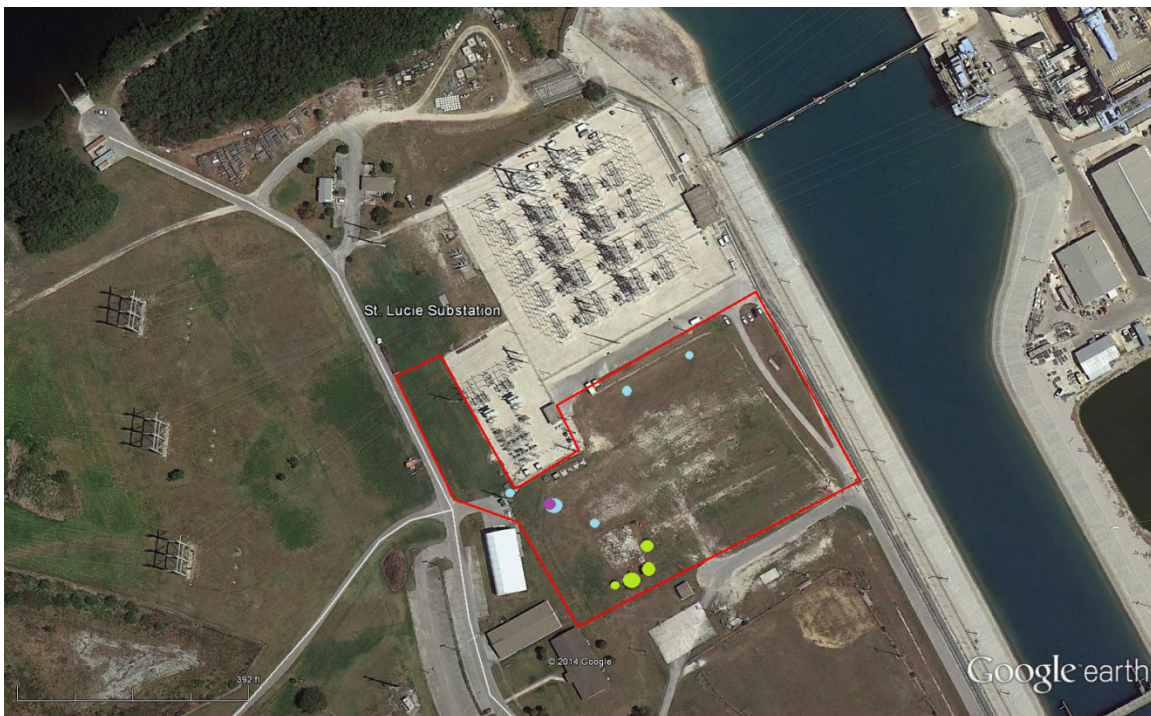
**Figure 2.** Location of survey area (red) at St. Lucie Substation. The colored circles show the location of the following tree species; live oak (green), cabbage palm (blue), and strangler fig (purple).

Proposed ground breaking activities will not encroach on native trees and thus, none are likely to be affected by this project (Figure 2).

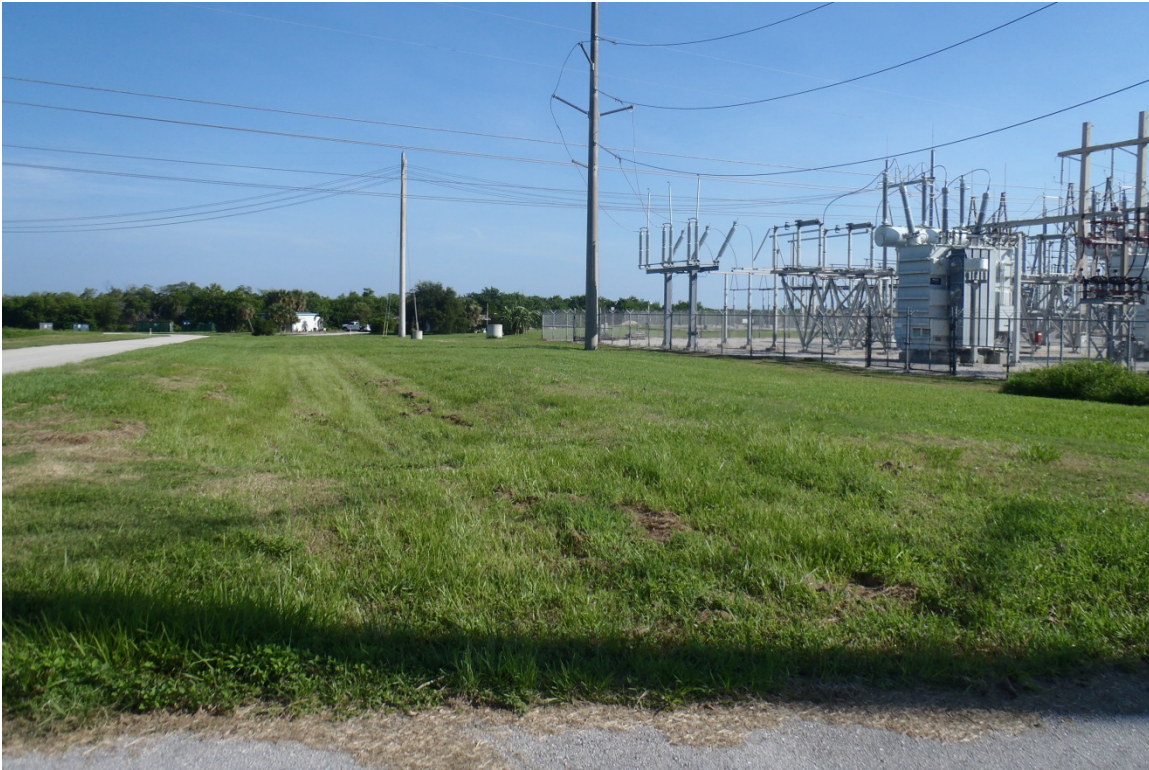
Existing site conditions are shown in Figures 3 and 4. That portion of the site targeted for improvements was bordered by scattered native live oak (*Quercus virginiana*), strangler fig (*Ficus aurea*) and cabbage palm (*Sabal palmetto*) trees. The understory vegetation was mowed and consisted of St. Augustine grass (*Stenotaphrum secundatum*), Mexican clover (*Richardia brasiliensis*), fogfruit (*Phyla nodiflora*), sand blackberry (*Rubus cuneifolius*) beggarsticks (*Bidens alba*), crowfoot grass (*Dactyloctenium aegyptium*), pinebarren flatsedge (*Cyperus ovatus*), coastal sunflower (*Helianthus debilis*) and coastal sandbur (*Cenchrus spinifex*). Based upon information provided by FPL, aerial and other photographs, and data obtained from the National Wetlands Inventory, the work areas are located within uplands. As such, local, State and federal environmental permits are not required.

**Figure 3.** Existing conditions at St. Lucie Substation, facing north.

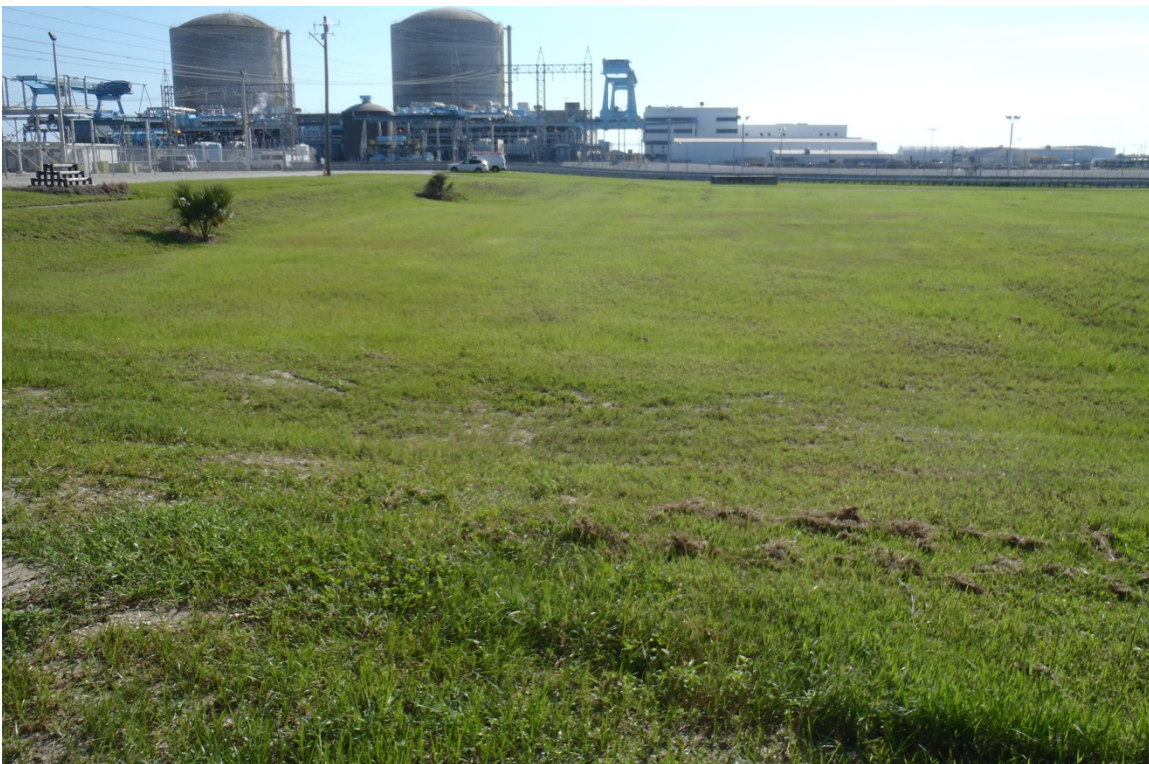
**Figure 4.** Existing conditions at St. Lucie Substation, facing east.
