RE: Seminole Electric Cooperative, Inc.  
Hardee Power Station, Hardee County, FL  
Power Plant Certification PA 89-25  
Post Certification Amendment to Application

**AMENDMENT REQUEST**  
**Hardee Power Station Site Certification Application:**  
**Seminole Solar Project**

**April 8, 2016**

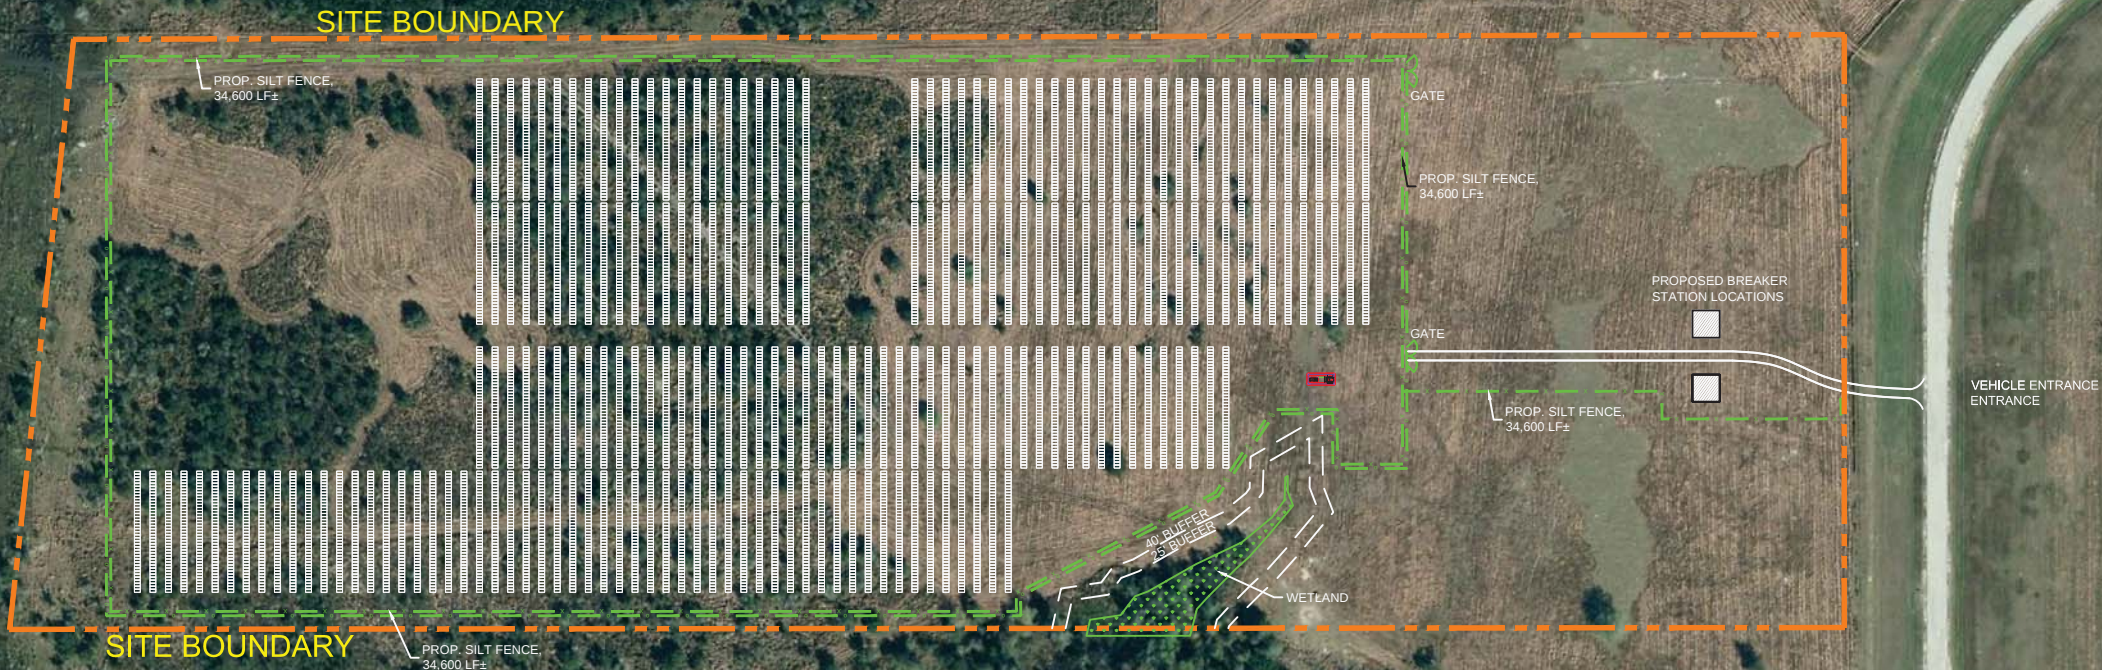
Site size: 794,341.38 sq. ft./18.24 acres  
Modules: 180,768 sq. ft.  
Piles: 83 sq. ft.  
Fence posts: 500 sq. ft.  
Concrete gate posts: 40 sq. ft.  
Concrete inverter/transformer pad: 100 sq. ft.  
Gravel road: 5,568 sq. ft.  
Gravel switch yard: 2,500 sq. ft.

(8,400) Canadian Solar 320W Modules  
2.68 MW DC Total  
2.2 MW AC Total

HPS is located in Hardee and Polk Counties about nine miles northwest of the city of Wauchula, 16 miles south-southwest of the city of Bartow, and 40 miles east of the Tampa Bay area (see Figure 1). The site is bordered on the east by Old Castle, Inc., County Road 663, and a CSX Railroad line. The remaining portions of the site are surrounded by The Mosaic Company property. The solar station will be located completely within Hardee County within a designated approximately 29.52-acre easement. The solar station will be located in the area shown on Figure 2. Figure 3 shows the detailed boundary survey for the solar station.
