**ECOLOGICAL ASSESSMENT  
OSCEOLA SUBSTATION TO CANE ISLAND  
TAP TRANSMISSION LINE MAINTENANCE  
OSCEOLA COUNTY, FLORIDA**

**Orlando Utilities Commission  
500 South Orange Avenue  
Orlando, FL 32801**

**Golder Associates Inc.  
6241 NW 23rd Street, Suite 500  
Gainesville, Florida 32653-1500**

**August 2011**

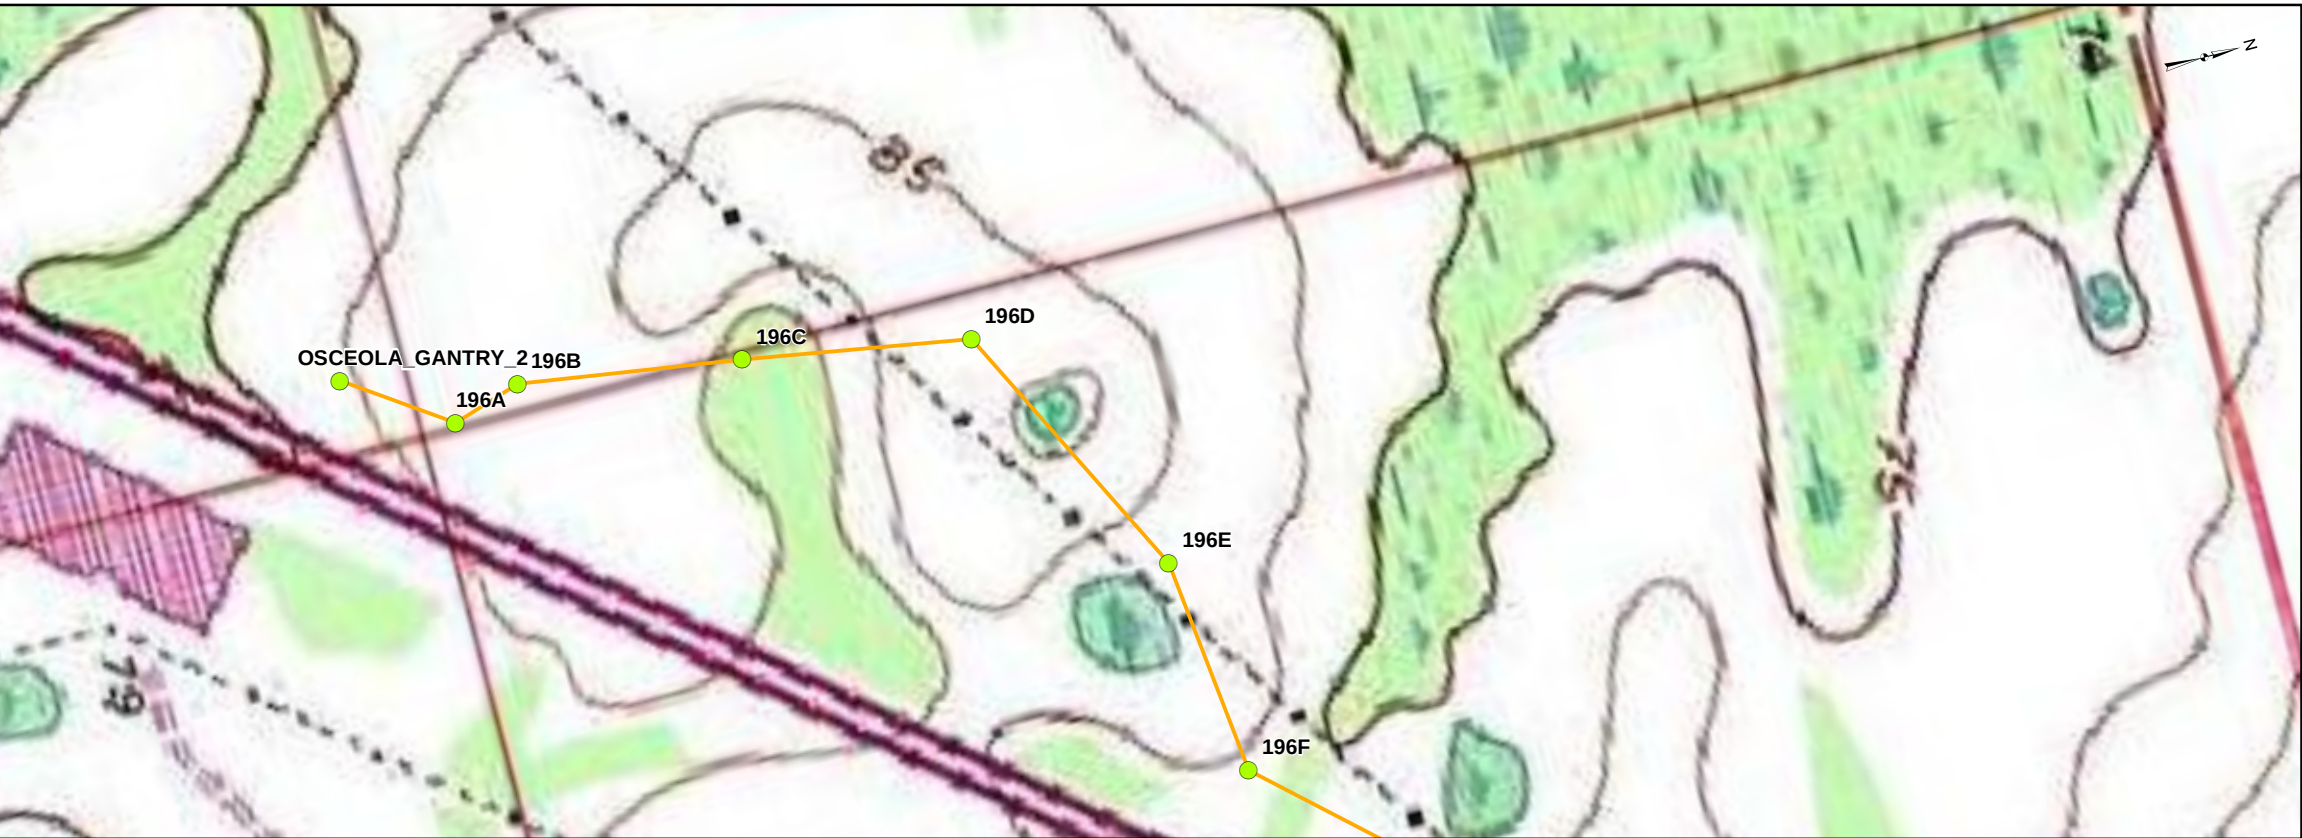
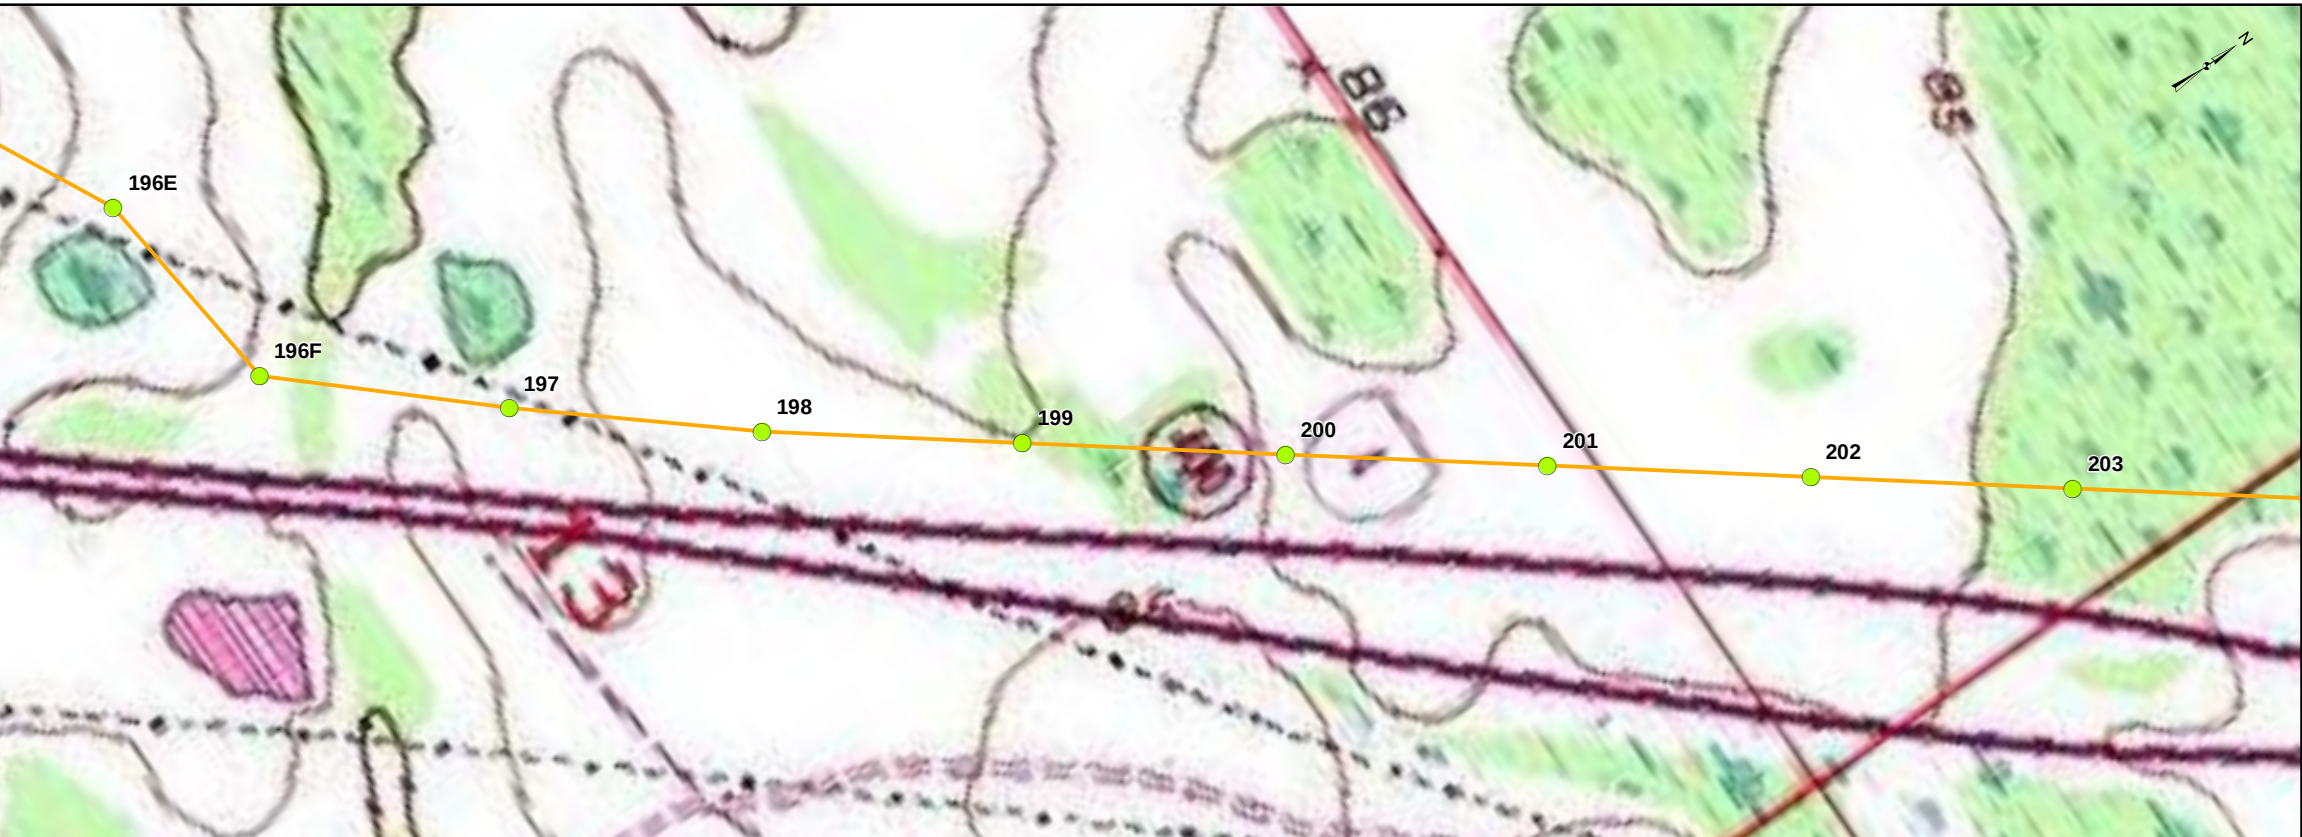
FIGURE 1-1

- Transmission Line Structures
- Transmission Line

The Orlando Utilities Commission (OUC) Osceola Substation to Cane Island Tap 230-kV transmission line is located in Osceola County, northwest of Kissimmee (Figures 1-1 and 1-2). Upgrades to the line required to meet the increased load from 1,000 to 1,250 amps, specifically cross-arm deterioration and pole replacements, were completed in June 2010. The transmission line structure access improvements requested herein (Table 1) are required to support utility maintenance/service trucks and equipment to perform maintenance work in and around the structures.

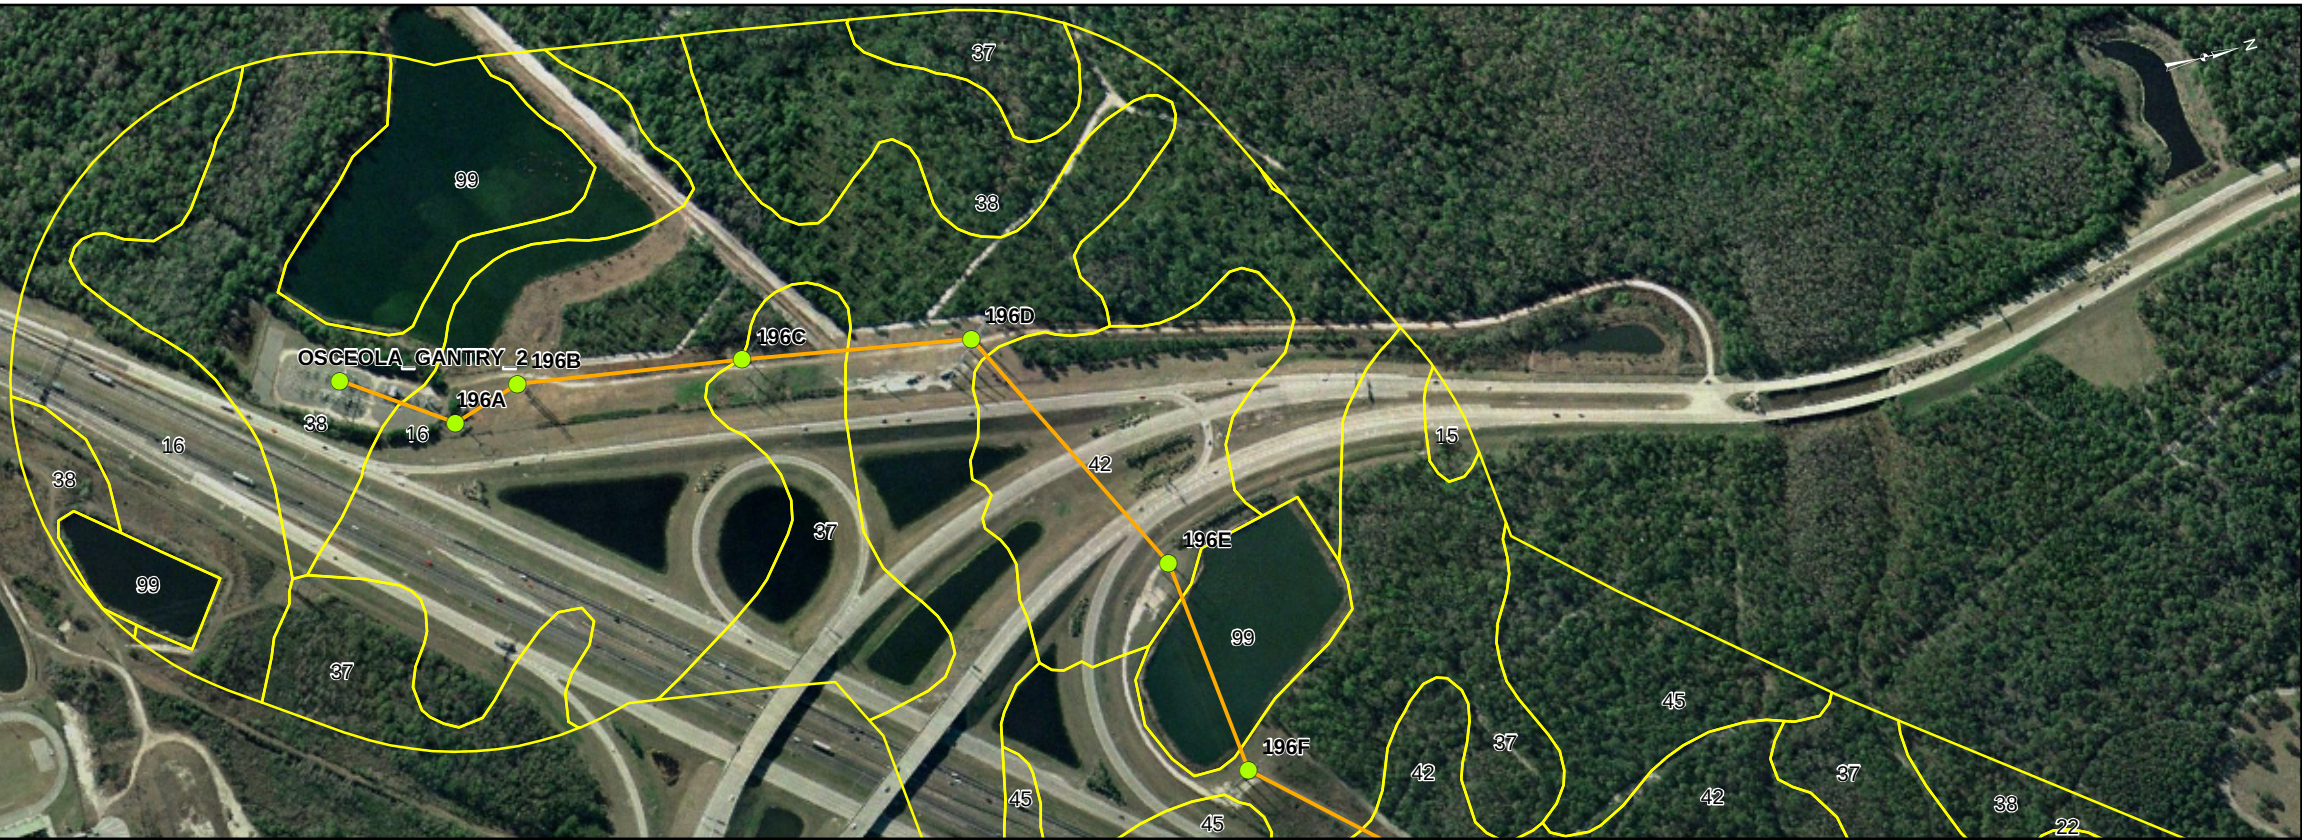
FIGURE 2-1

45 - VERO FINE SAND

99 - WATER

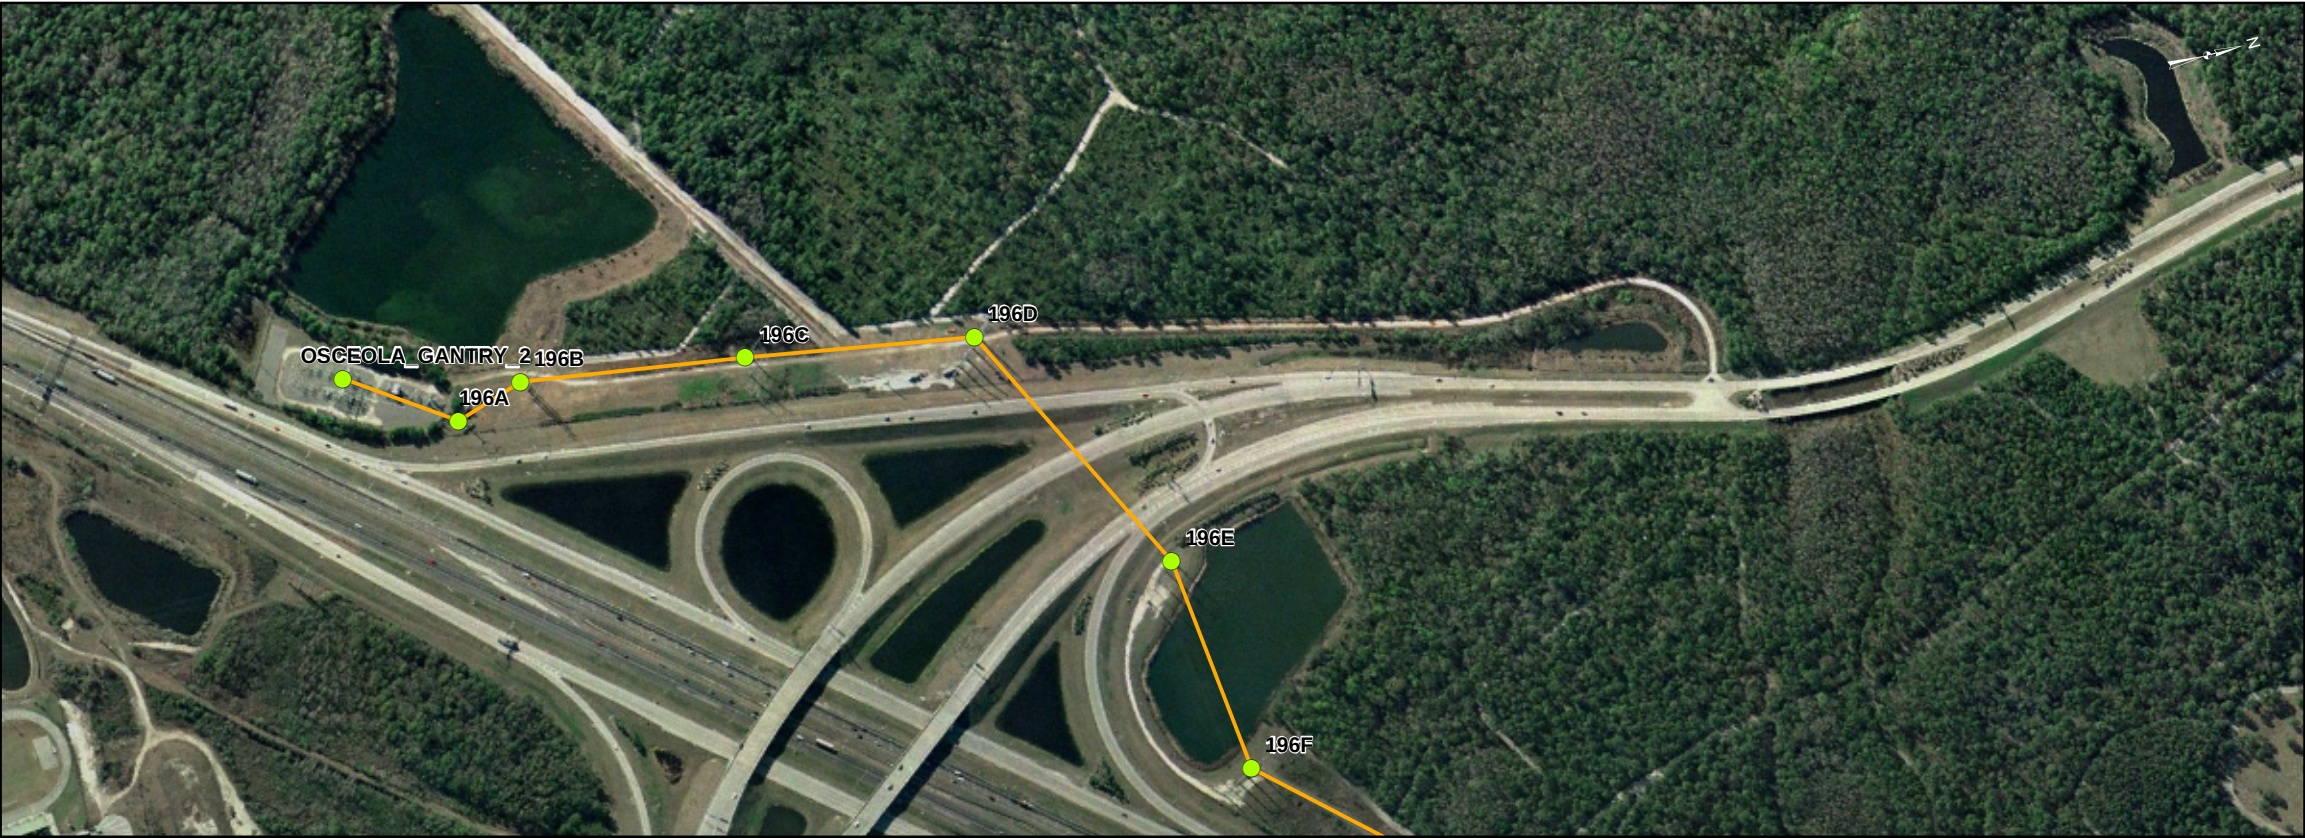
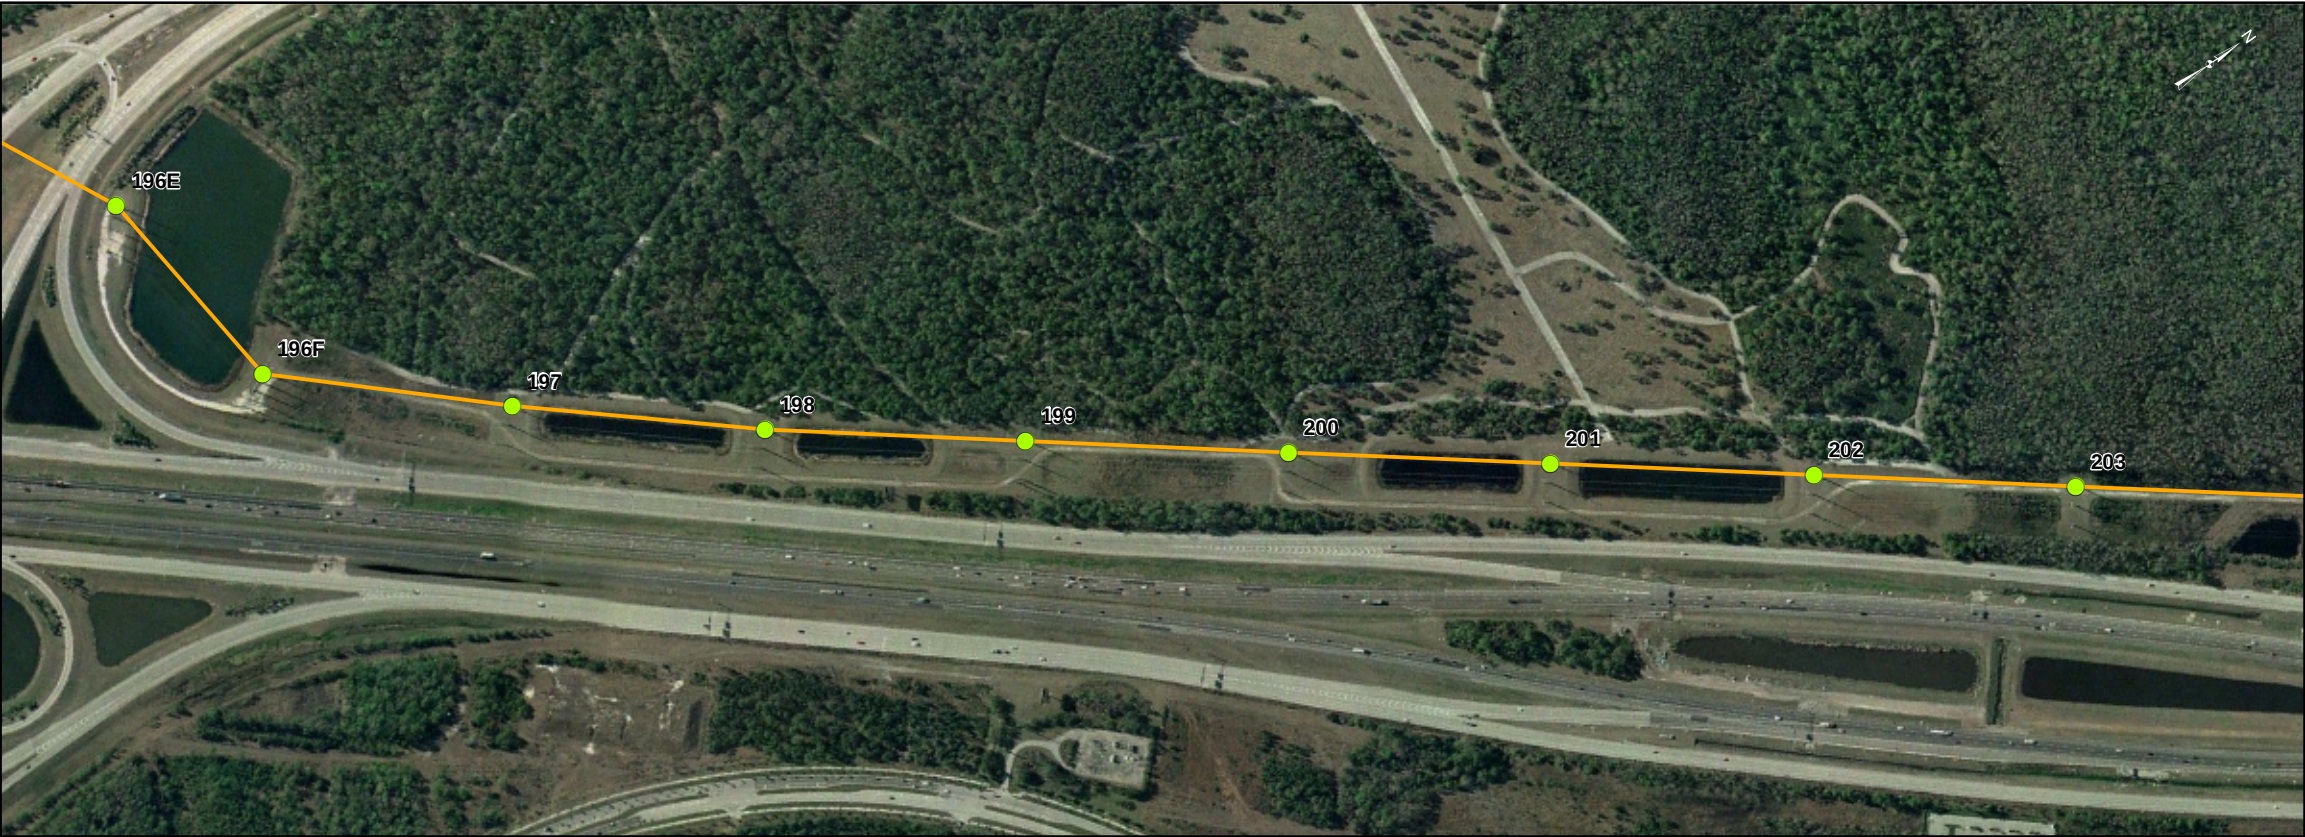
| FIGURE 3-1 | | | |

- Transmission Line Structures
- Transmission Line
- /// 100-Year Floodplain

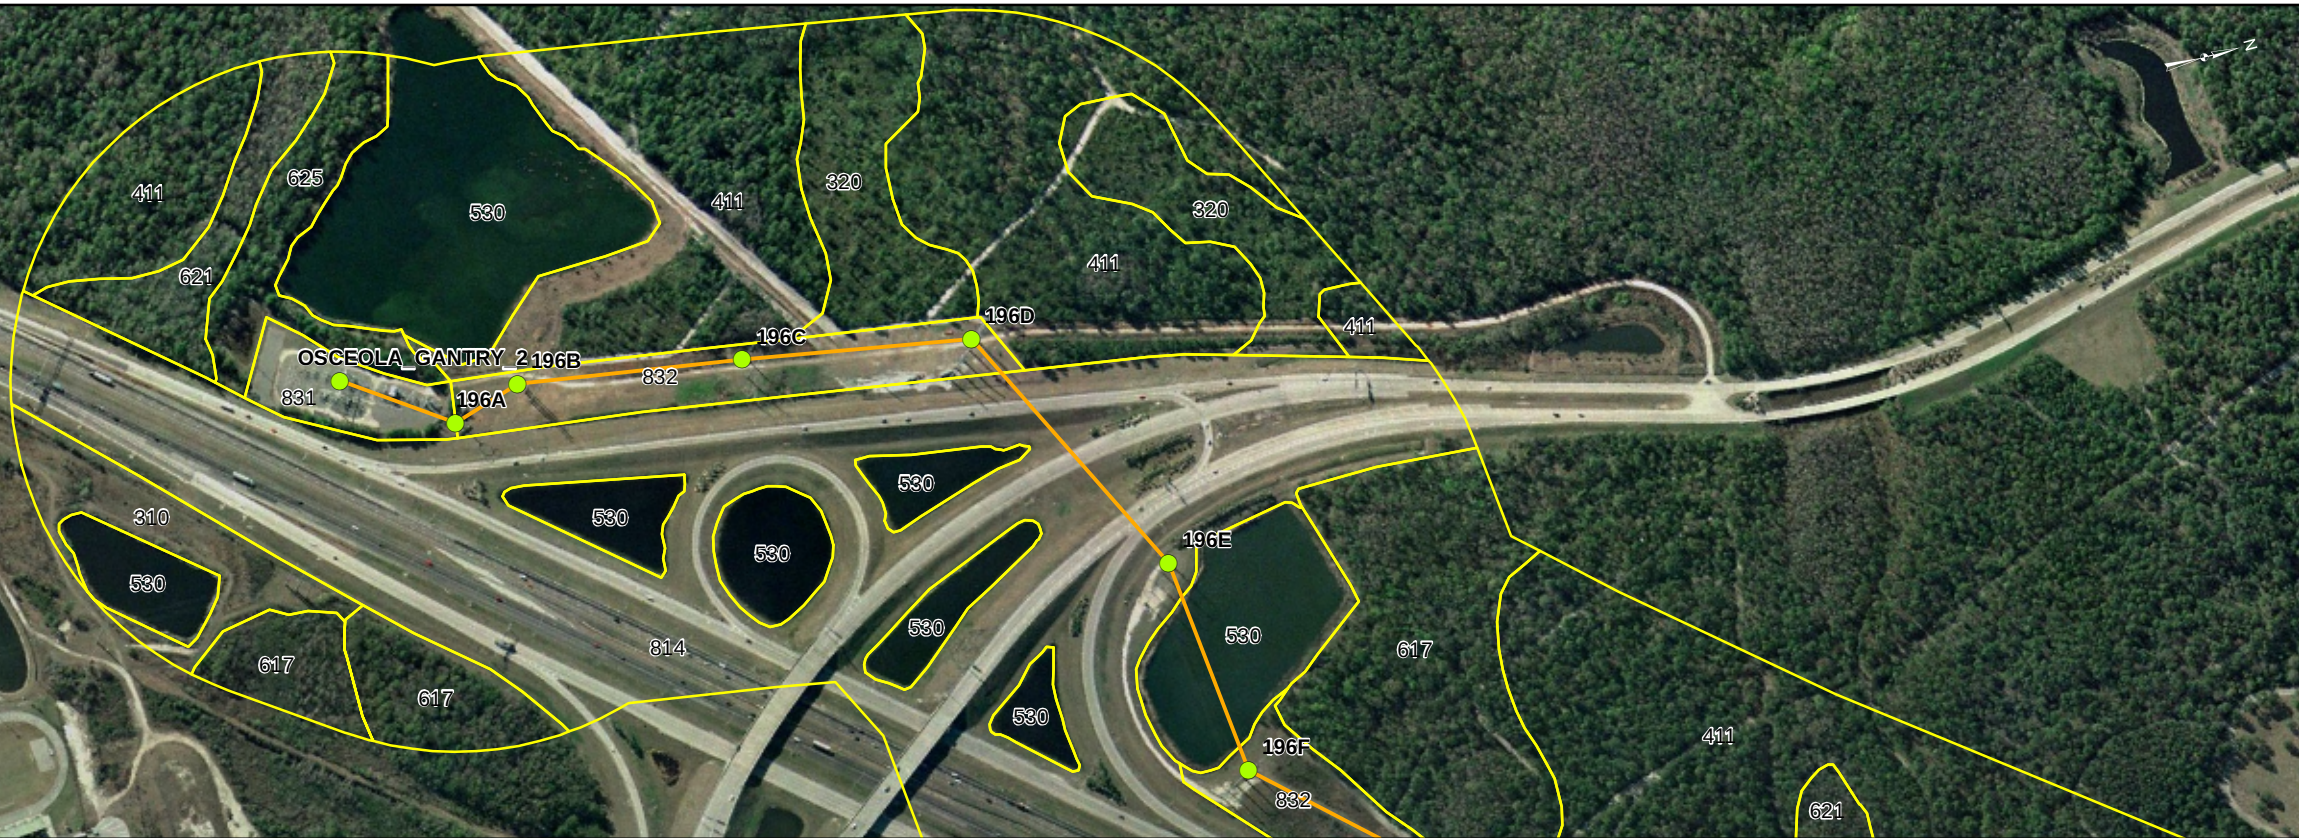
| FIGURE 5-1 | | | REV. 0 |

- Transmission Line Structures
- Transmission Line
- Land Use and Land Cover
  - 140 - Commercial and services
  - 141 - Light Commercial
  - 170 - Institutional
  - 310 - Herbaceous upland nonforested
  - 320 - Shrub and brushland
  - 411 - Pine flatwoods
  - 420 - Upland hardwood forests
  - 434 - Upland mixed coniferous/hardwood
  - 512 - Streams and waterways
  - 530 - Reservoirs - pits, retention ponds, dams
  - 617 - Mixed wetland hardwoods
  - 621 - Cypress
  - 625 - Hydric pine flatwoods
  - 630 - Wetland forested mixed
  - 743 - Spoil areas
  - 814 - Roads and highways
  - 831 - Electrical power facilities
  - 832 - Electrical power transmission lines

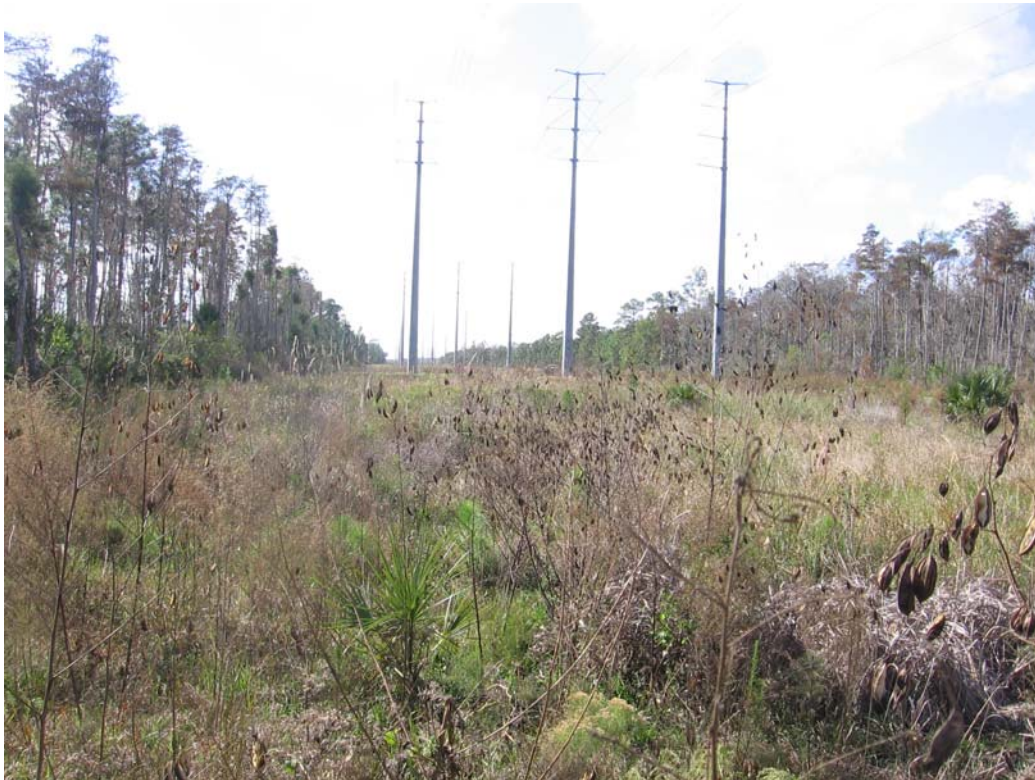
Photograph 1. Freshwater Marsh – FLUCFCS 641.

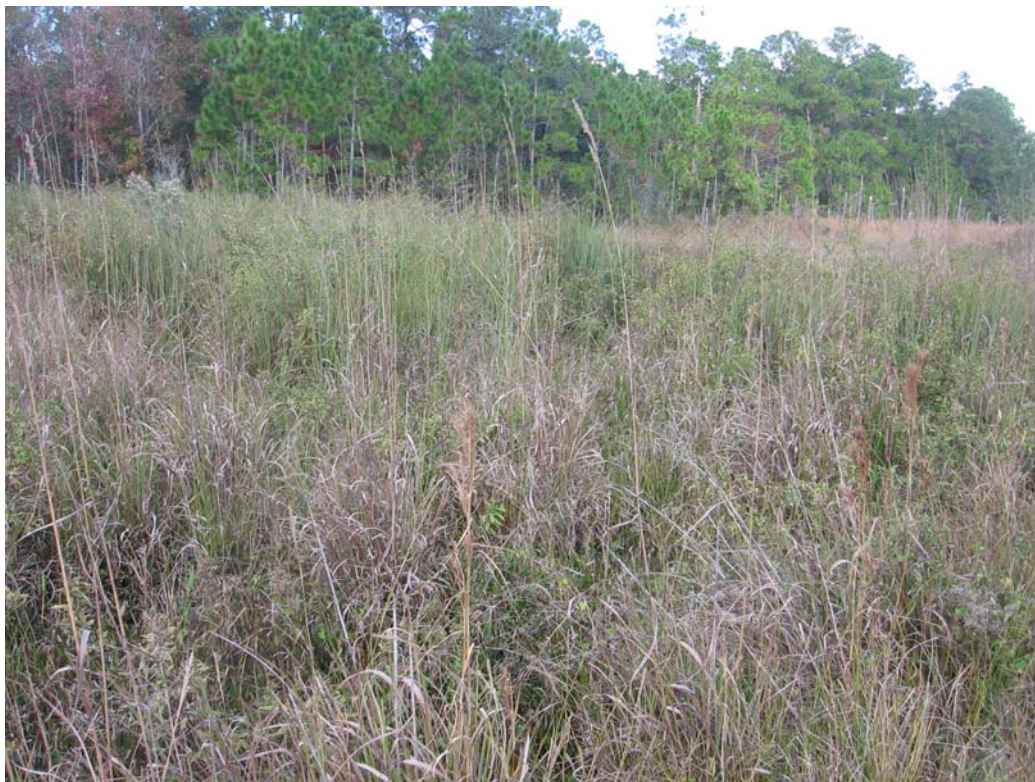
Photograph 2. Freshwater Marsh – FLUCFCS 641.

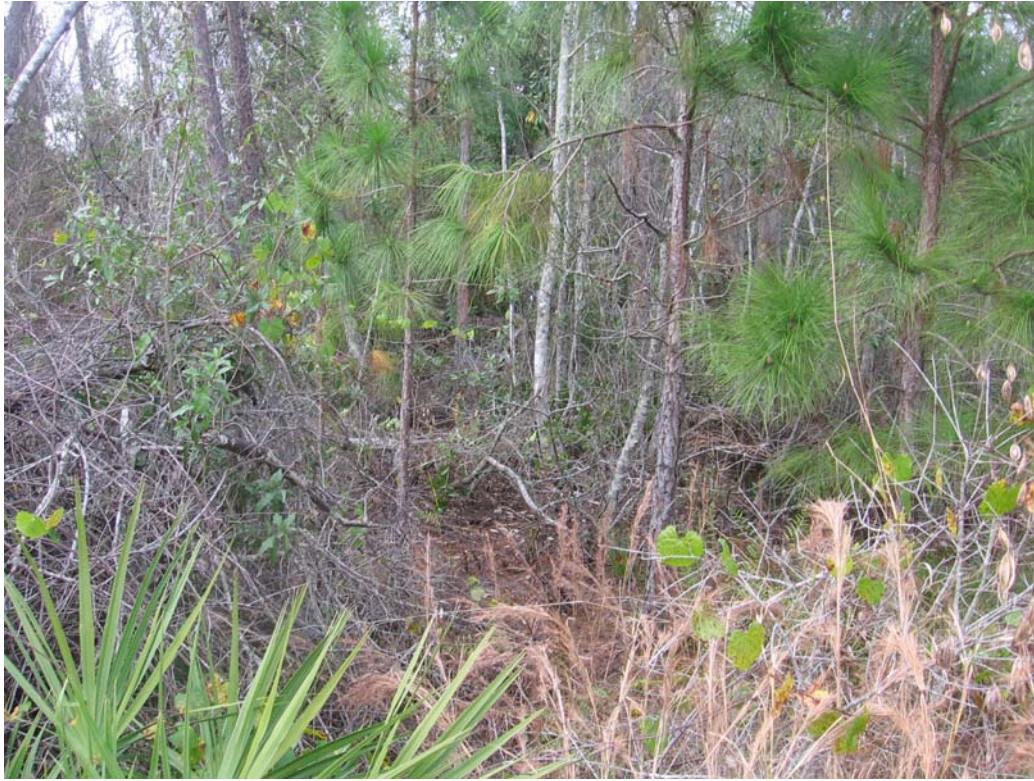
Photograph 3. Wetland Forested Mixed – FLUCFCS 630.

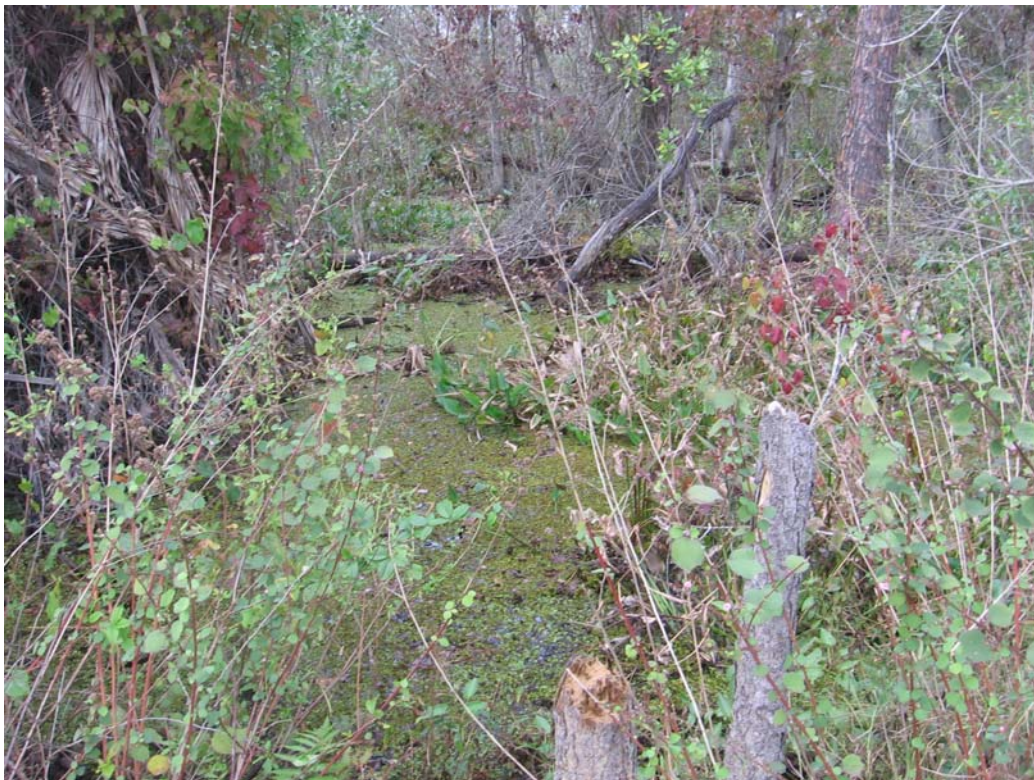
Photograph 4. Wetland Forested Mixed – FLUCFCS 630.

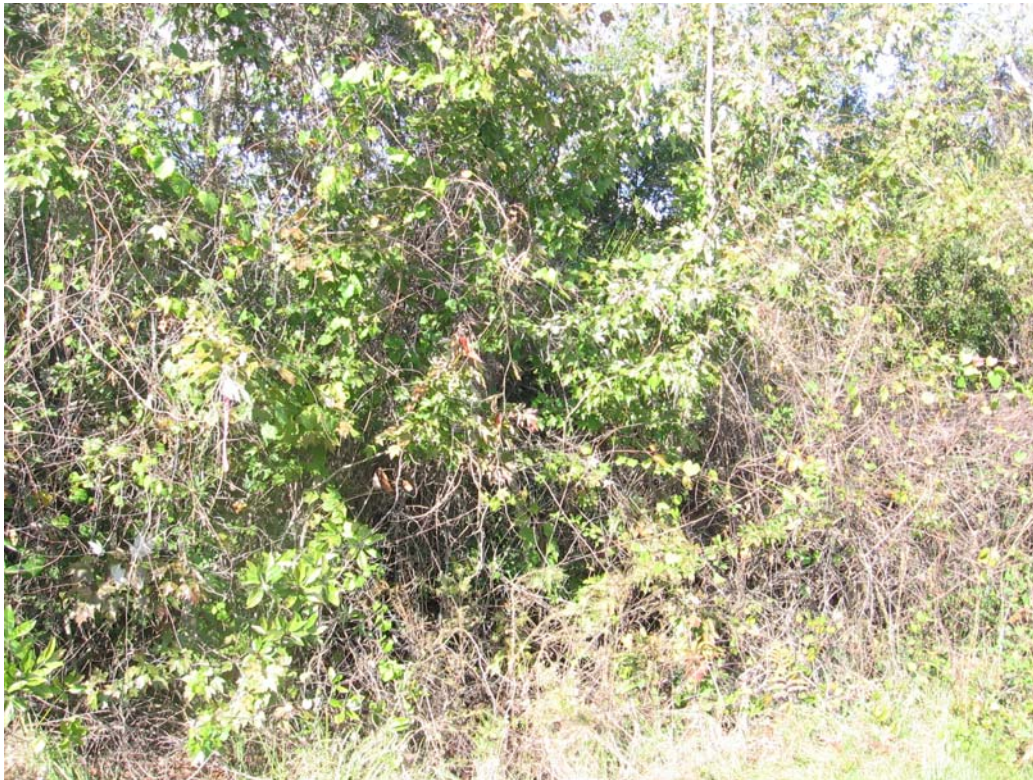
Photograph 5. Hydric Pine Flatwoods – FLUCFCS 625.

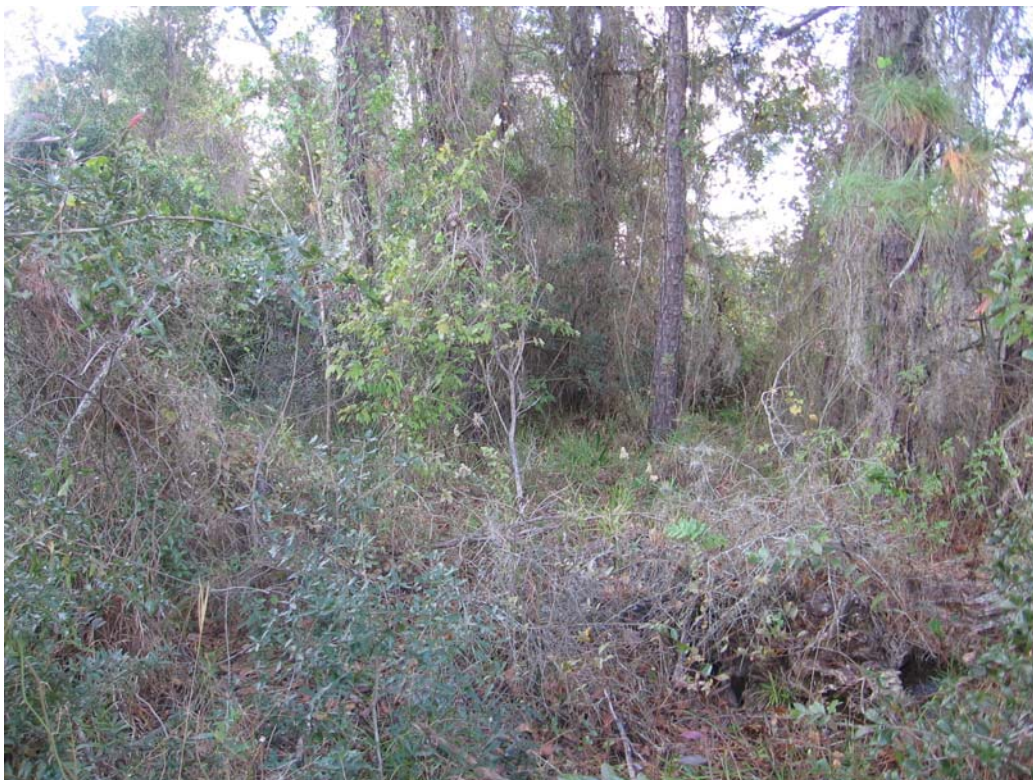
Photograph 6. Hydric Pine Flatwoods – FLUCFCS 625.

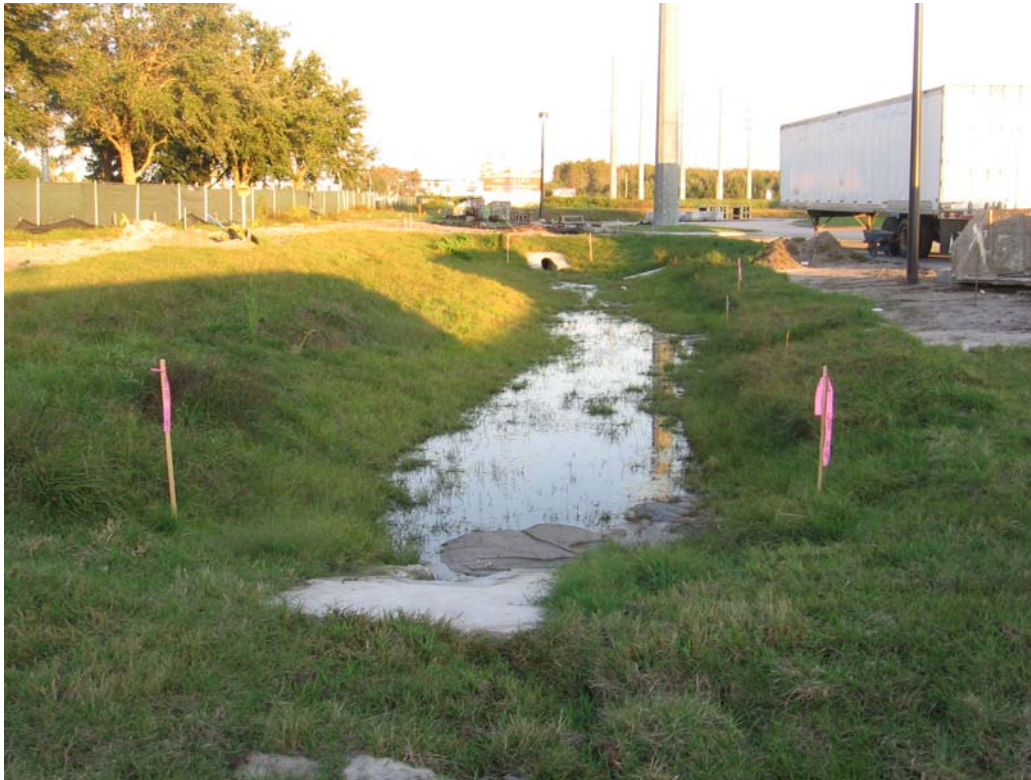
Photograph 7. Ditch – FLUCFCS 511.

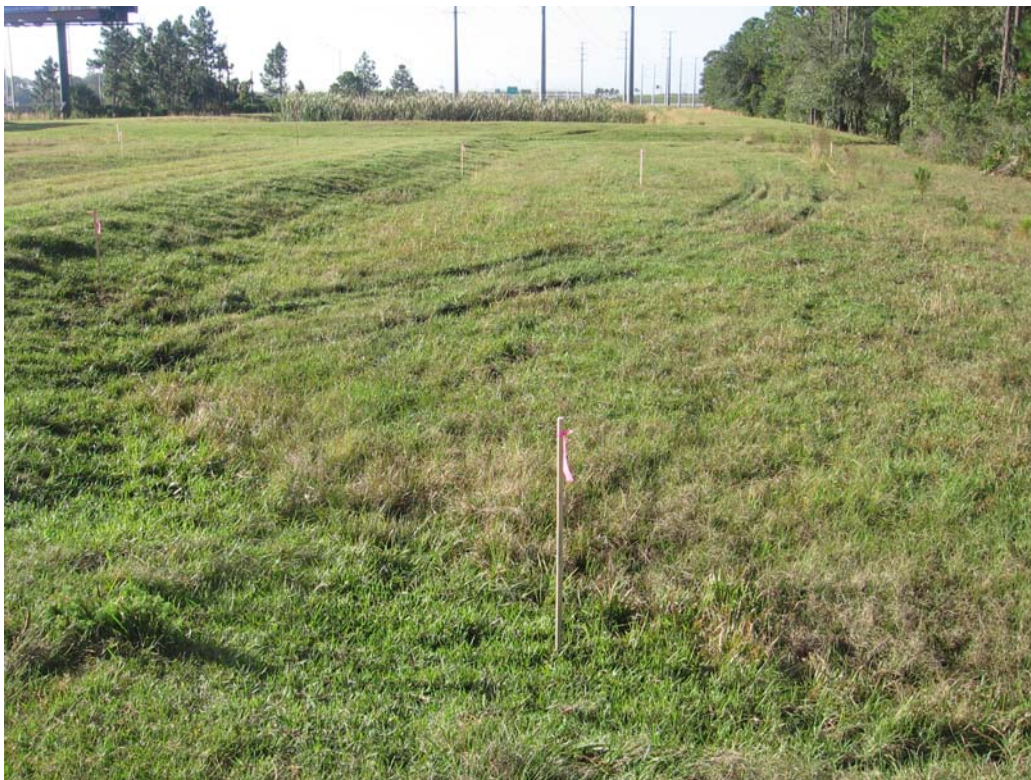
Photograph 8. Ditch – FLUCFCS 511.

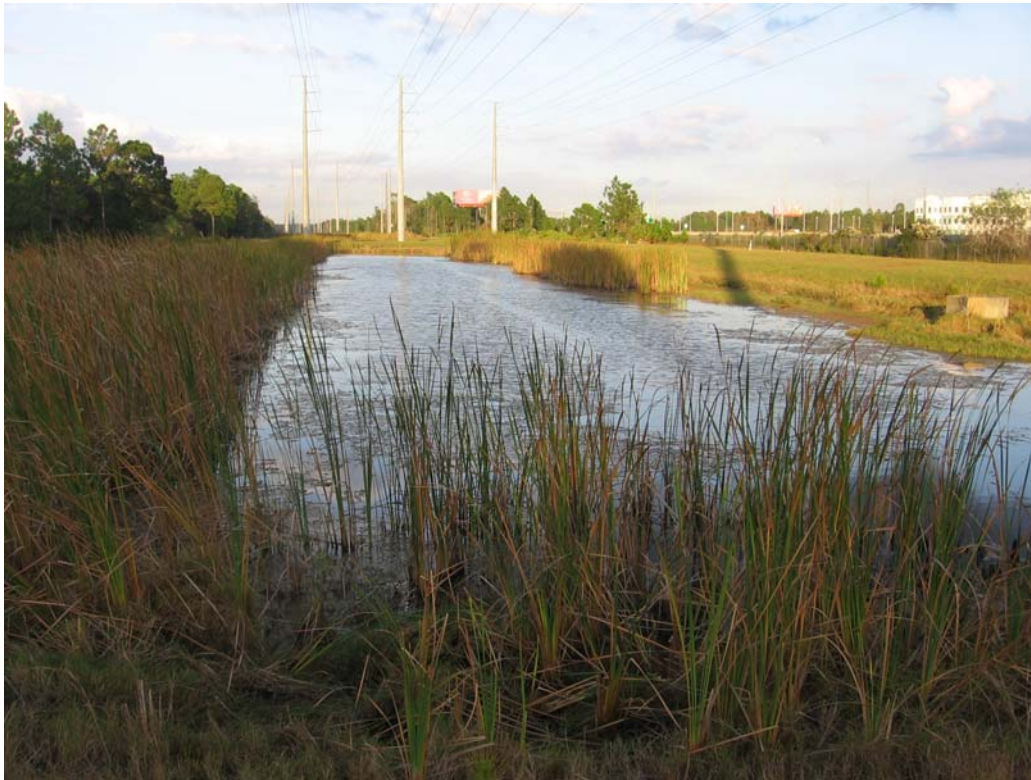
Photograph 9. Reservoir – FLUCFCS 530.

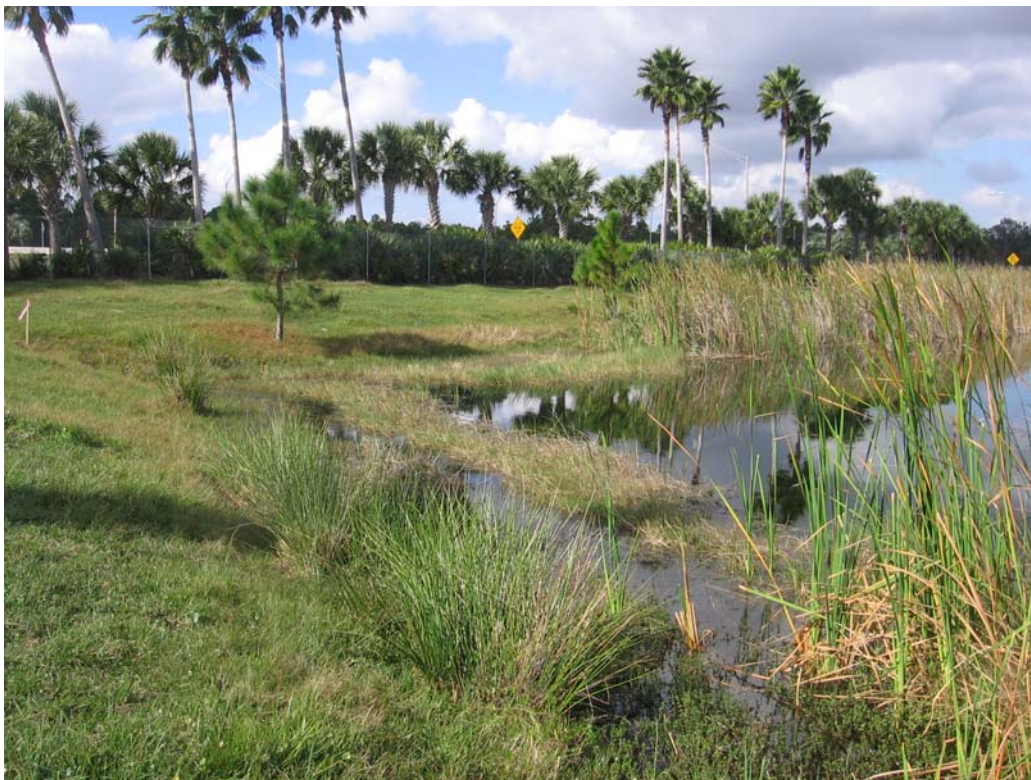
Photograph 10. Reservoir – FLUCFCS 530.
