Biological Assessment of

Mid-County Services WWTP

NPDES #FL0034789

Results of Fifth Year Inspections

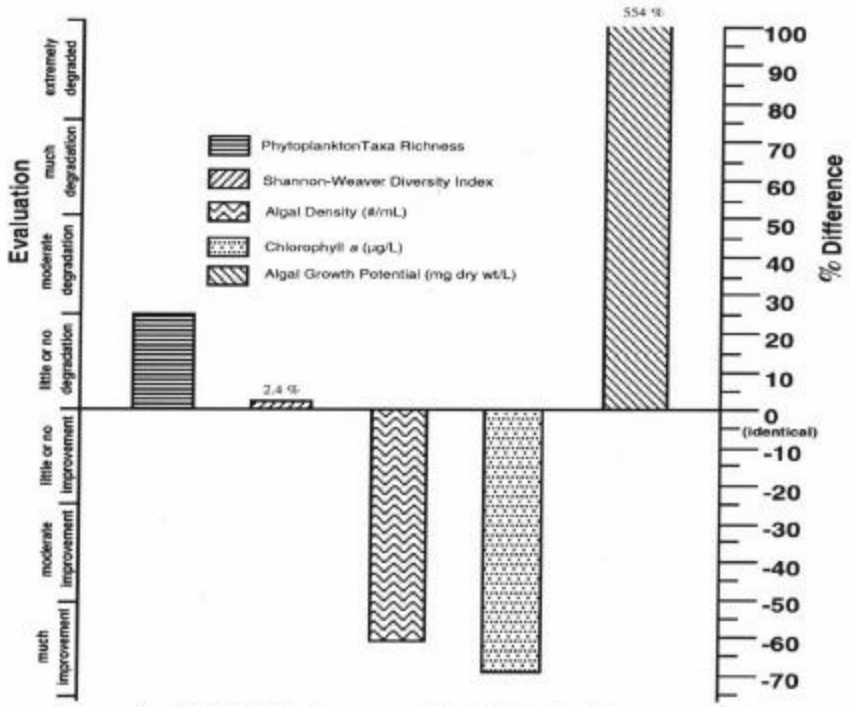
Figure 1. Effect of discharge on the phytoplankton community.

Changes in the phytoplankton community occurred below the discharge. While some measures of algal health indicated degradation, others indicated improvement (Table 2). Taxa richness and the diatom proportion were lower by 25% and 14%, respectively, at the test site compared to the control site, indicating degradation at the test site. Algal density and chlorophyll *a*, on the other hand, indicated improved conditions at the test site (Figure 1).

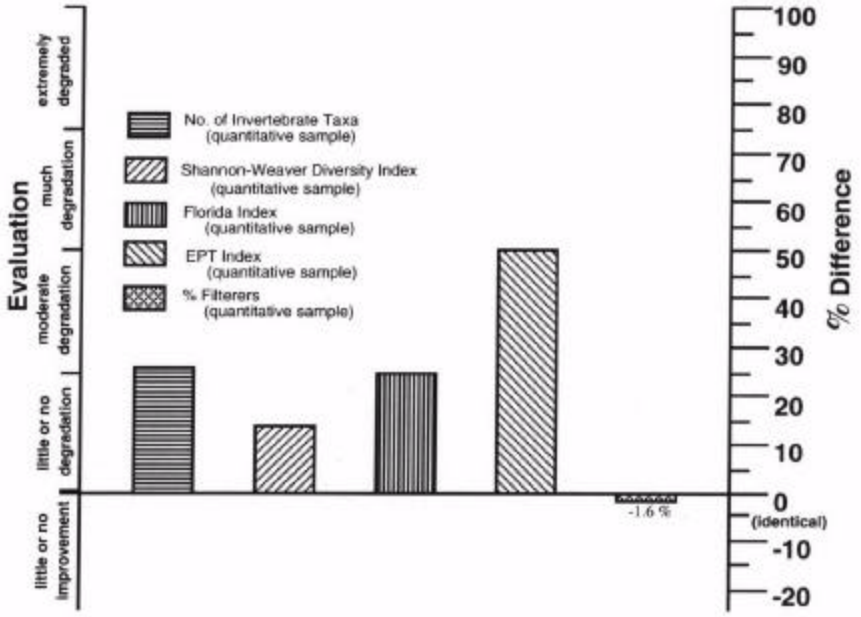
Figure 2. Effect of discharge on the macroinvertebrate community.

Some measures of macroinvertebrate community health showed impairment at the test site compared to the control site (Table 2). For example, taxa richness declined by 19% between the control site and the test site. And there was a 50% decline in the EPT Index from the control site to the test site as shown in Figure 2, which represents quantitative data. There was no change, however, in either the Florida Index or the Stream Condition Index. The SCI scores, with 23 points each, placed both sites in the "good" category. The quantitative measures also indicated some degradation at the test site compared to the control site (Figure 2). Taxa richness declined by 26%, the Florida Index by 25%, the EPT Index by 50%, and the Shannon-Weaver diversity was 14% lower at the test site compared to the control site.

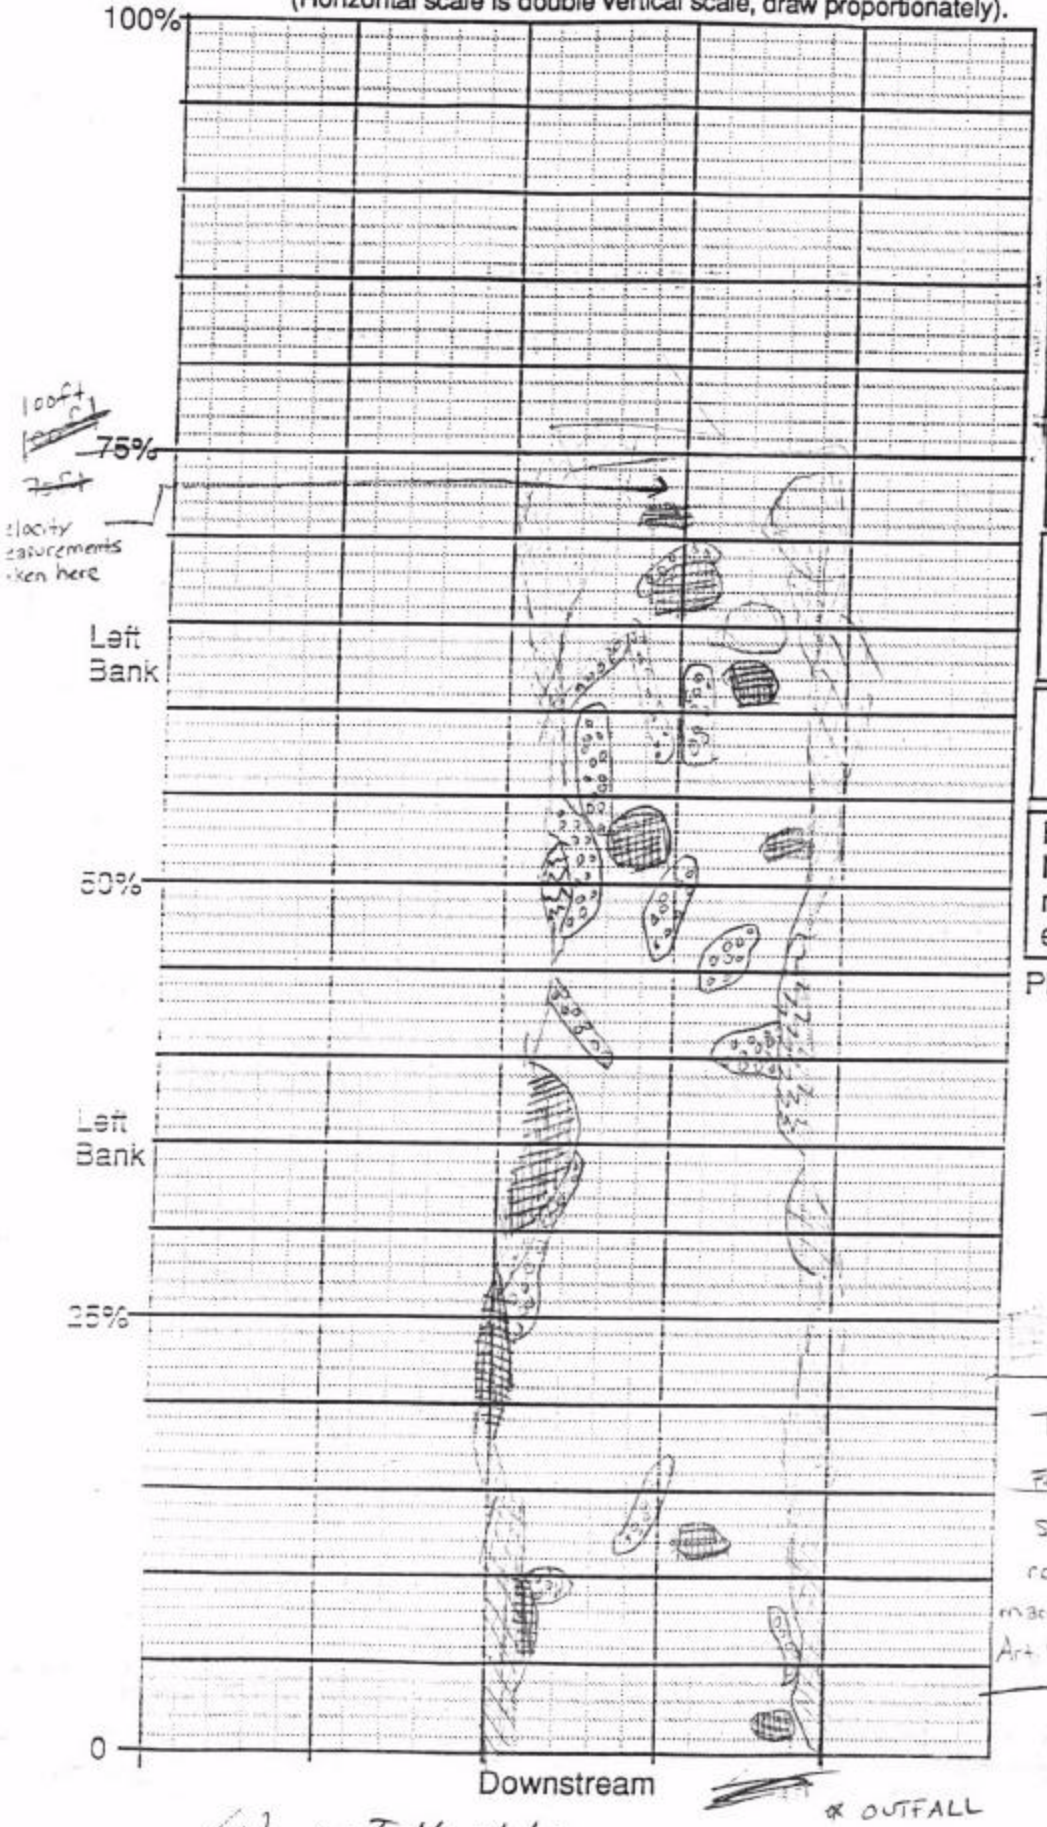
Site Map / Habitat Sketch

Md. County Services - FYI-5 UPSTREAM OF OUTFALL → Curlew Creek

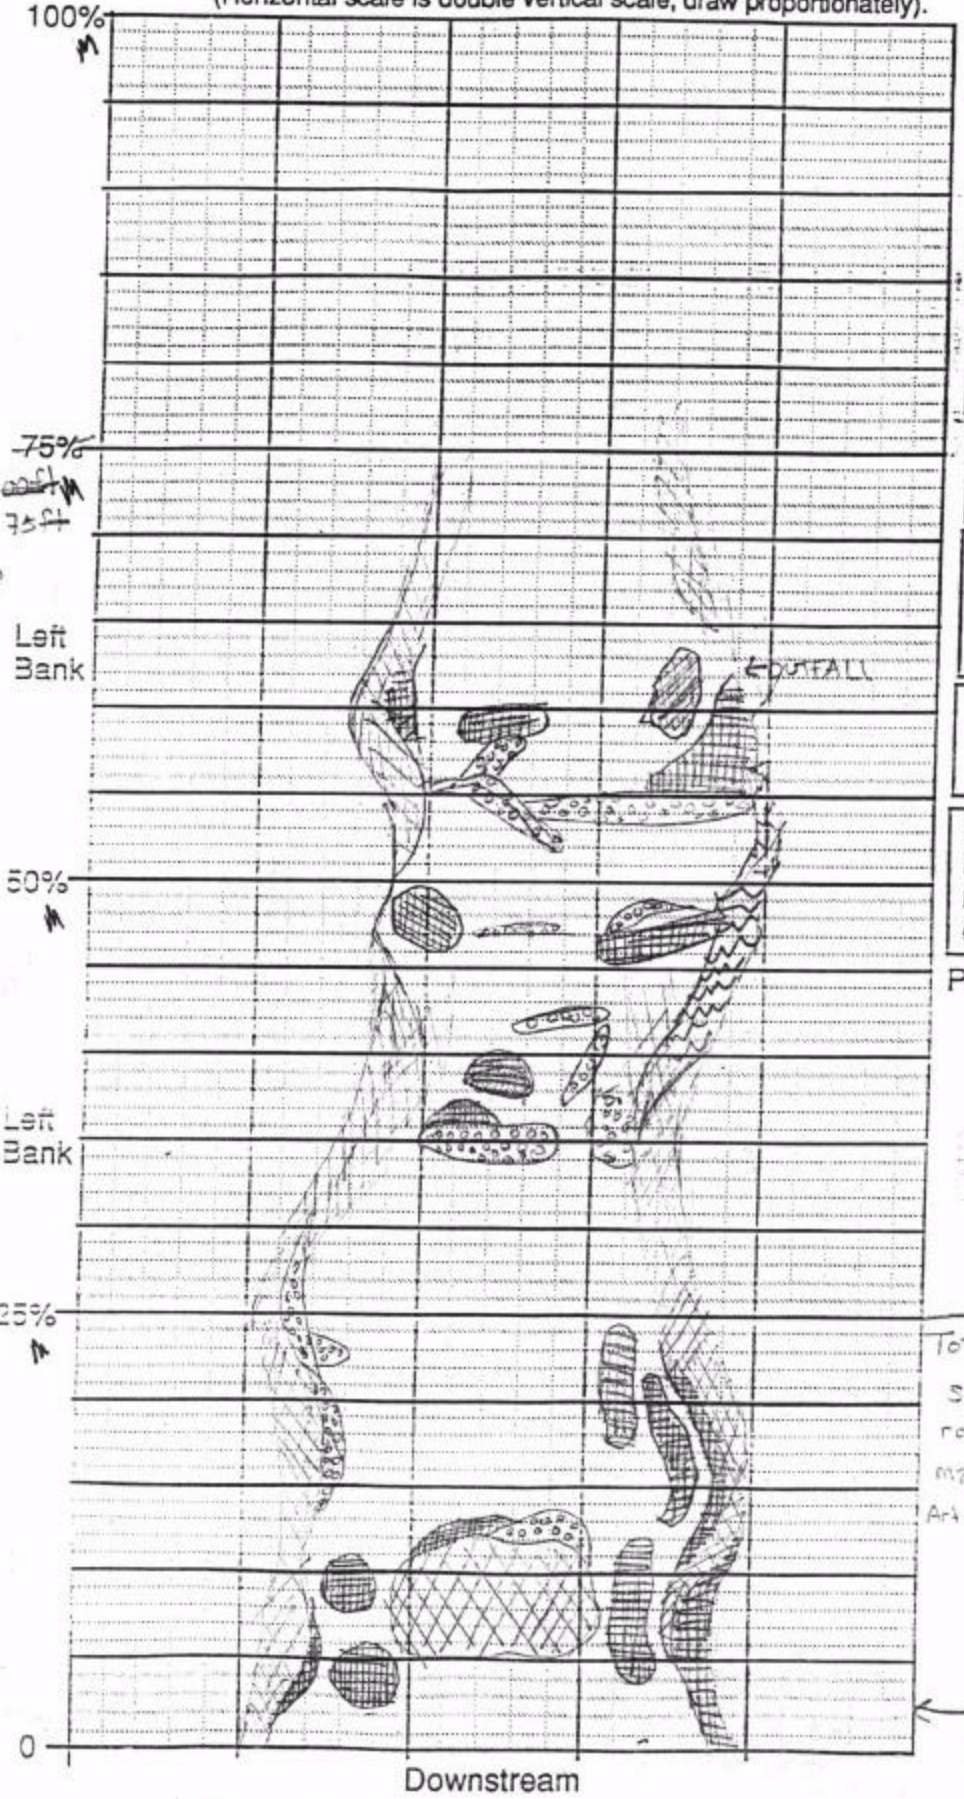
Site Map / Habitat Sketch

Neq-County Services FY15 DOWNSTREAM OF OUTFALL → CURLEW CREEK
