# Summary of Results

## Walk the WBID Exercise for Turkey Creek (WBID 1578B)

*Florida Department of Environmental Protection  
Division of Environmental Assessment and Restoration  
Bureau of Watershed Restoration  
Tallahassee, FL 32399*

August 2012

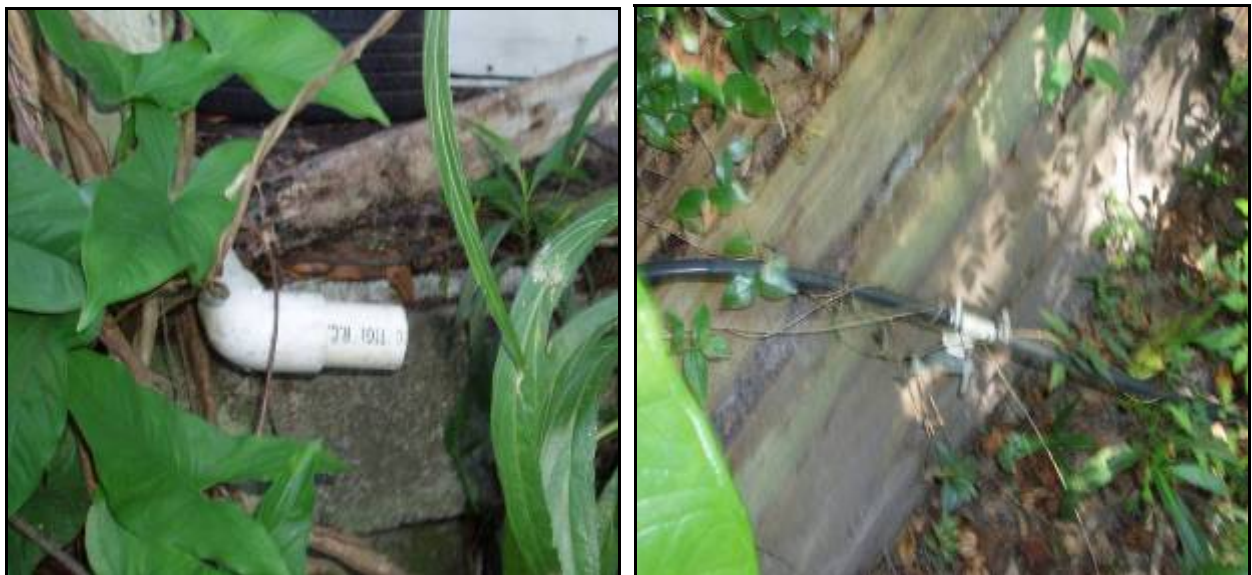
***Figure 51. Potential illicit connections to ditch/tributary along the northern edge of Starlite MHP. PIC is located near the northern terminus of Marge Owens Rd.***

| Location | Suggested Action | Responsible Entity | Date Completed | Results |
|---|---|---|---|---|
| Figure 51 | Investigate potential illicit connections. | FDLE | | Active complaint with Hillsborough County Code Enforcement. Resolution to be determined. |
