**Merritts Mill Pond Arsenic Study  
Marianna, Jackson County, Florida  
Preliminary Contamination Assessment Report**

**SIS Report Number 2005-03  
Issued June 2005**

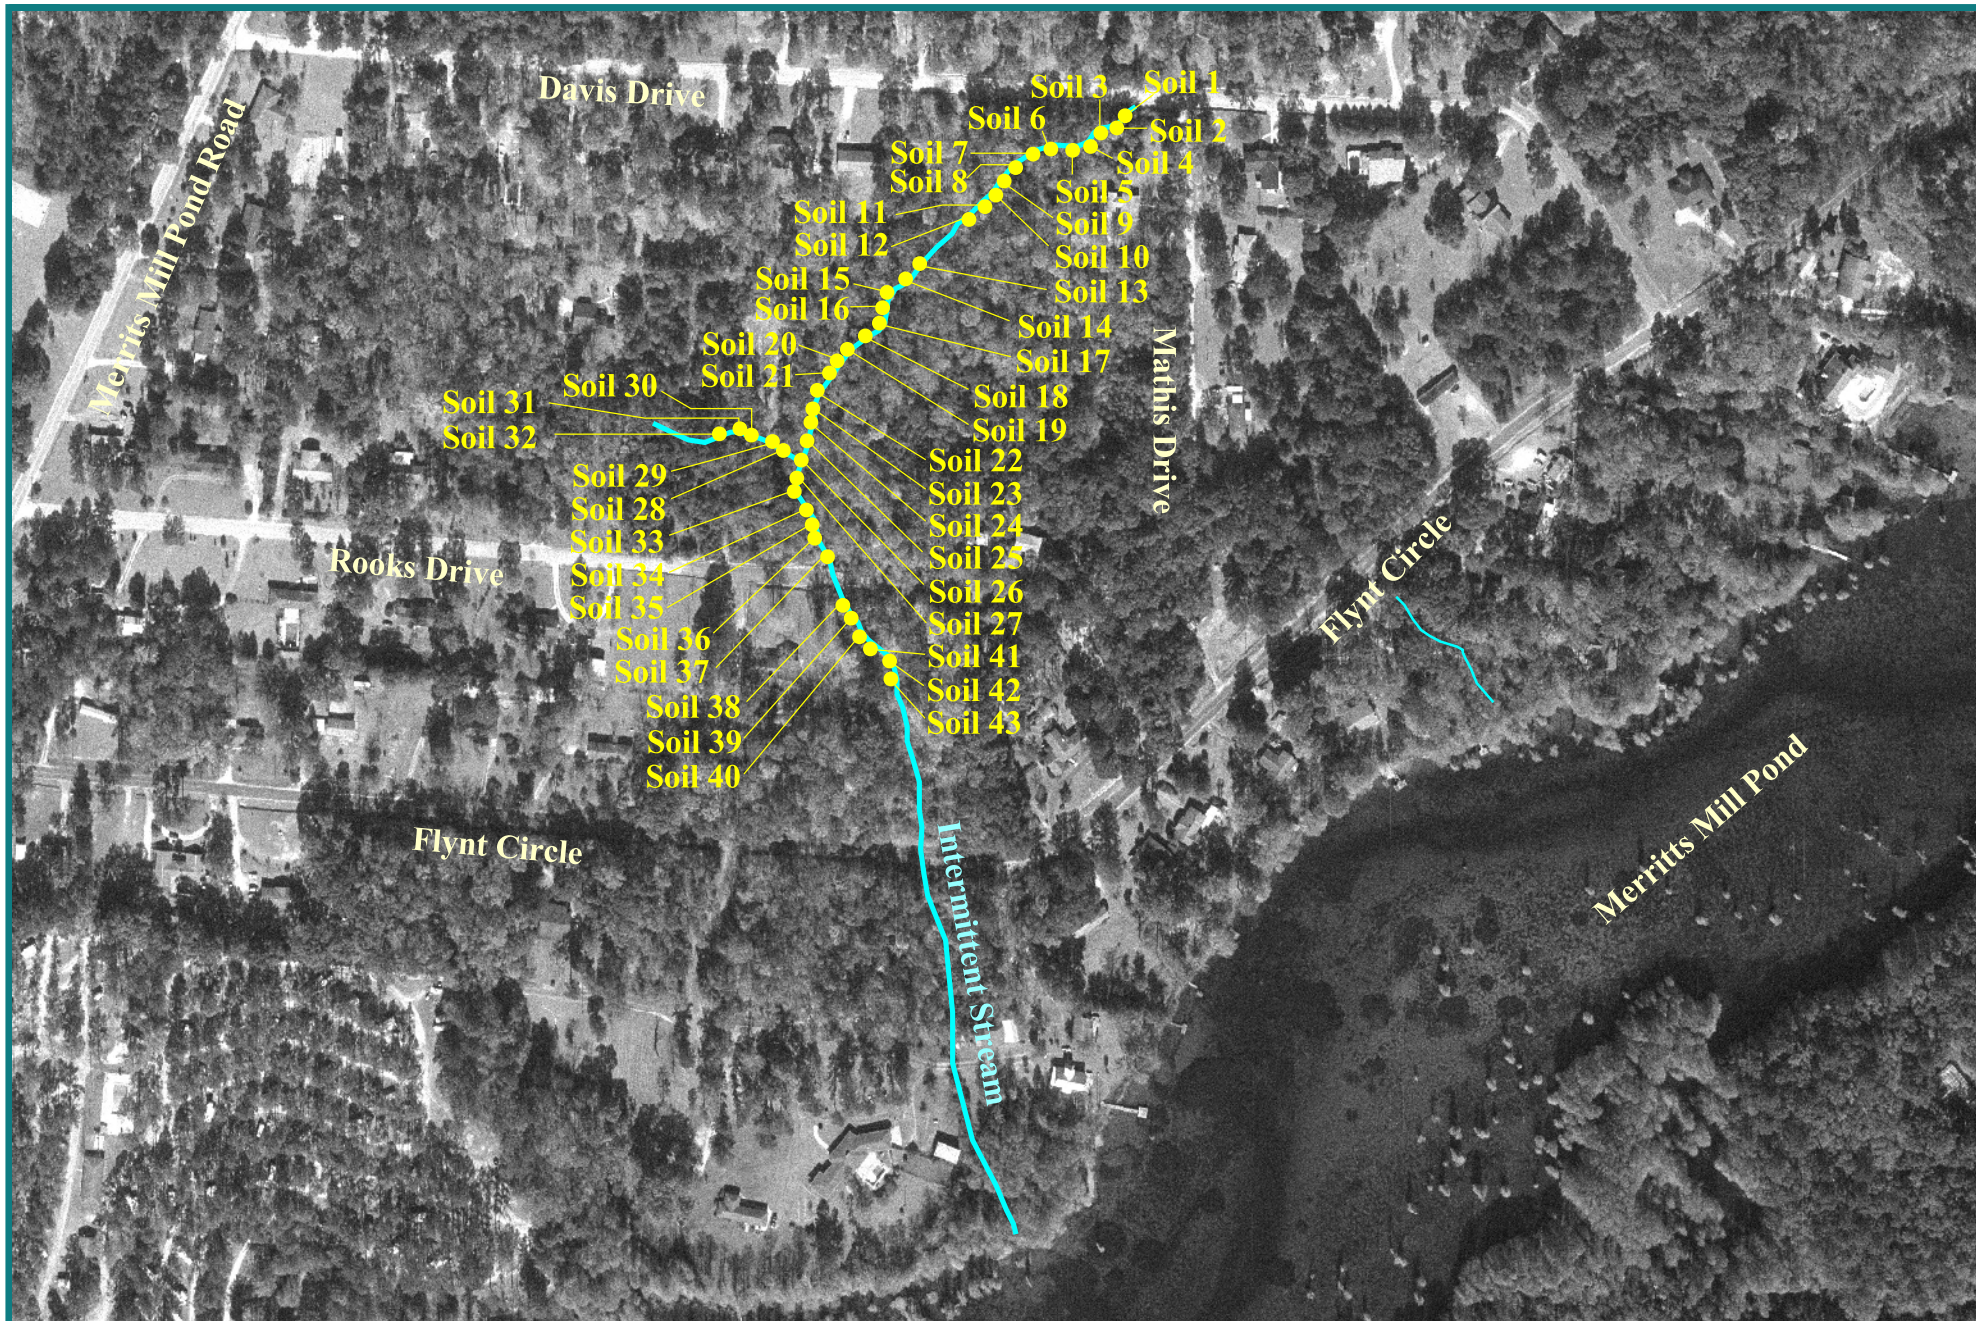
**Figure 6**  
**First Ravine Sediment Sample Locations**  
**Merritts Mill Pond Arsenic Study**  
**Marianna, Jackson County, Florida**

well. Sample points labeled Soil 1 through 43 were collected on thirty-foot centers. The network extended from Davis Drive to approximately 200 feet south of Rooks Drive (Figure 6, Table 3 and Photograph 1). Samples were collected from four different intervals including surface scrapes, 12 to 18 inches below land surface (BLS), 36 to 42 inches BLS, and generally 78 to 92 inches BLS. After collecting samples from the network at a particular interval, SIS would await the laboratory results before returning to collect samples from a lower interval. These deeper sample intervals were thought necessary due to the potential transport of sediment during large storm events within the ravine. Additional ravine samples were collected in the vicinity of location Soil 21 where laboratory results indicated slightly elevated concentrations of arsenic. There is an atypical bend in the intermittent creek at this location (Photograph 2).

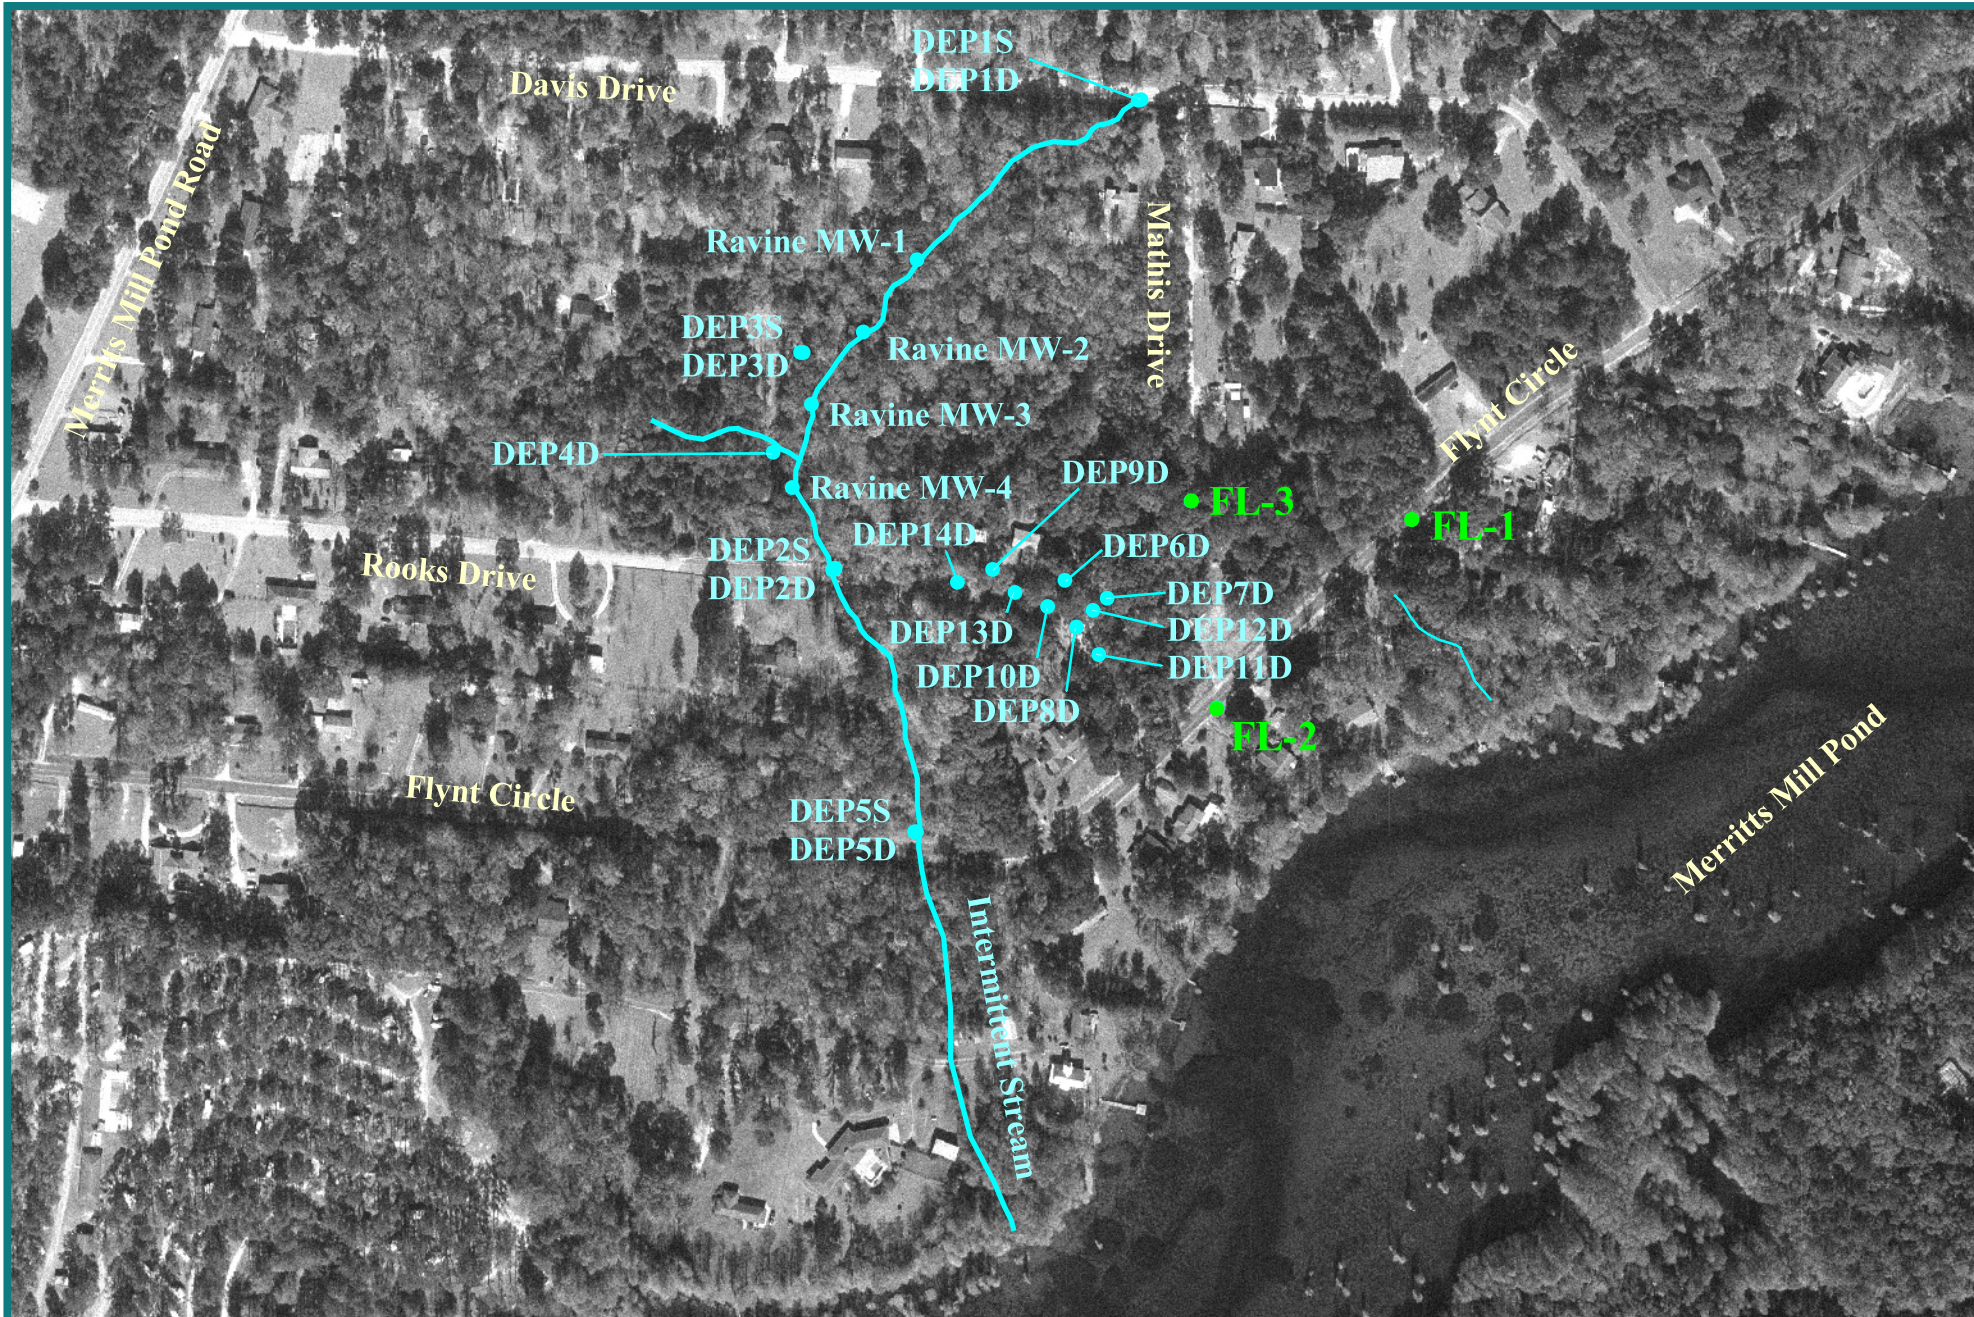
**Figure 7**  
**SIS Monitor Well Locations**  
**Merritts Mill Pond Arsenic Study**  
**Marianna, Jackson County, Florida**

Microwells were installed at several locations to evaluate ground water quality in the surficial aquifer system immediately adjacent to the intermittent stream. Two-well clusters (shallow and deep), designated DEP, were positioned in locations as close to the stream as allowed for by site conditions (Figure 7). The shallow well-screened intervals (typically 8 to 12 feet BLS) were positioned above a zone of low permeability indicated by ECL profiles. The clustered deep well was set where refusal was encountered. This depth was generally 18 to 22 feet BLS. At monitor well DEP 4D, which was located within the ravine, refusal was encountered 8.5 feet BLS due to competent limestone.

Several microwells were installed inside and immediately next to the fill area utilizing the Section's direct push rig (Figure 7 and Table 4). They were constructed and sampled in a manner identical to that discussed in Section 3.2.4. Of the fill area wells, only DEP 6D, 7D, 8D, 10D, and 12D produced water. Monitor wells DEP 9D, 11D, 13D and 14D were dry because refusal occurred before the ground water surface was encountered.

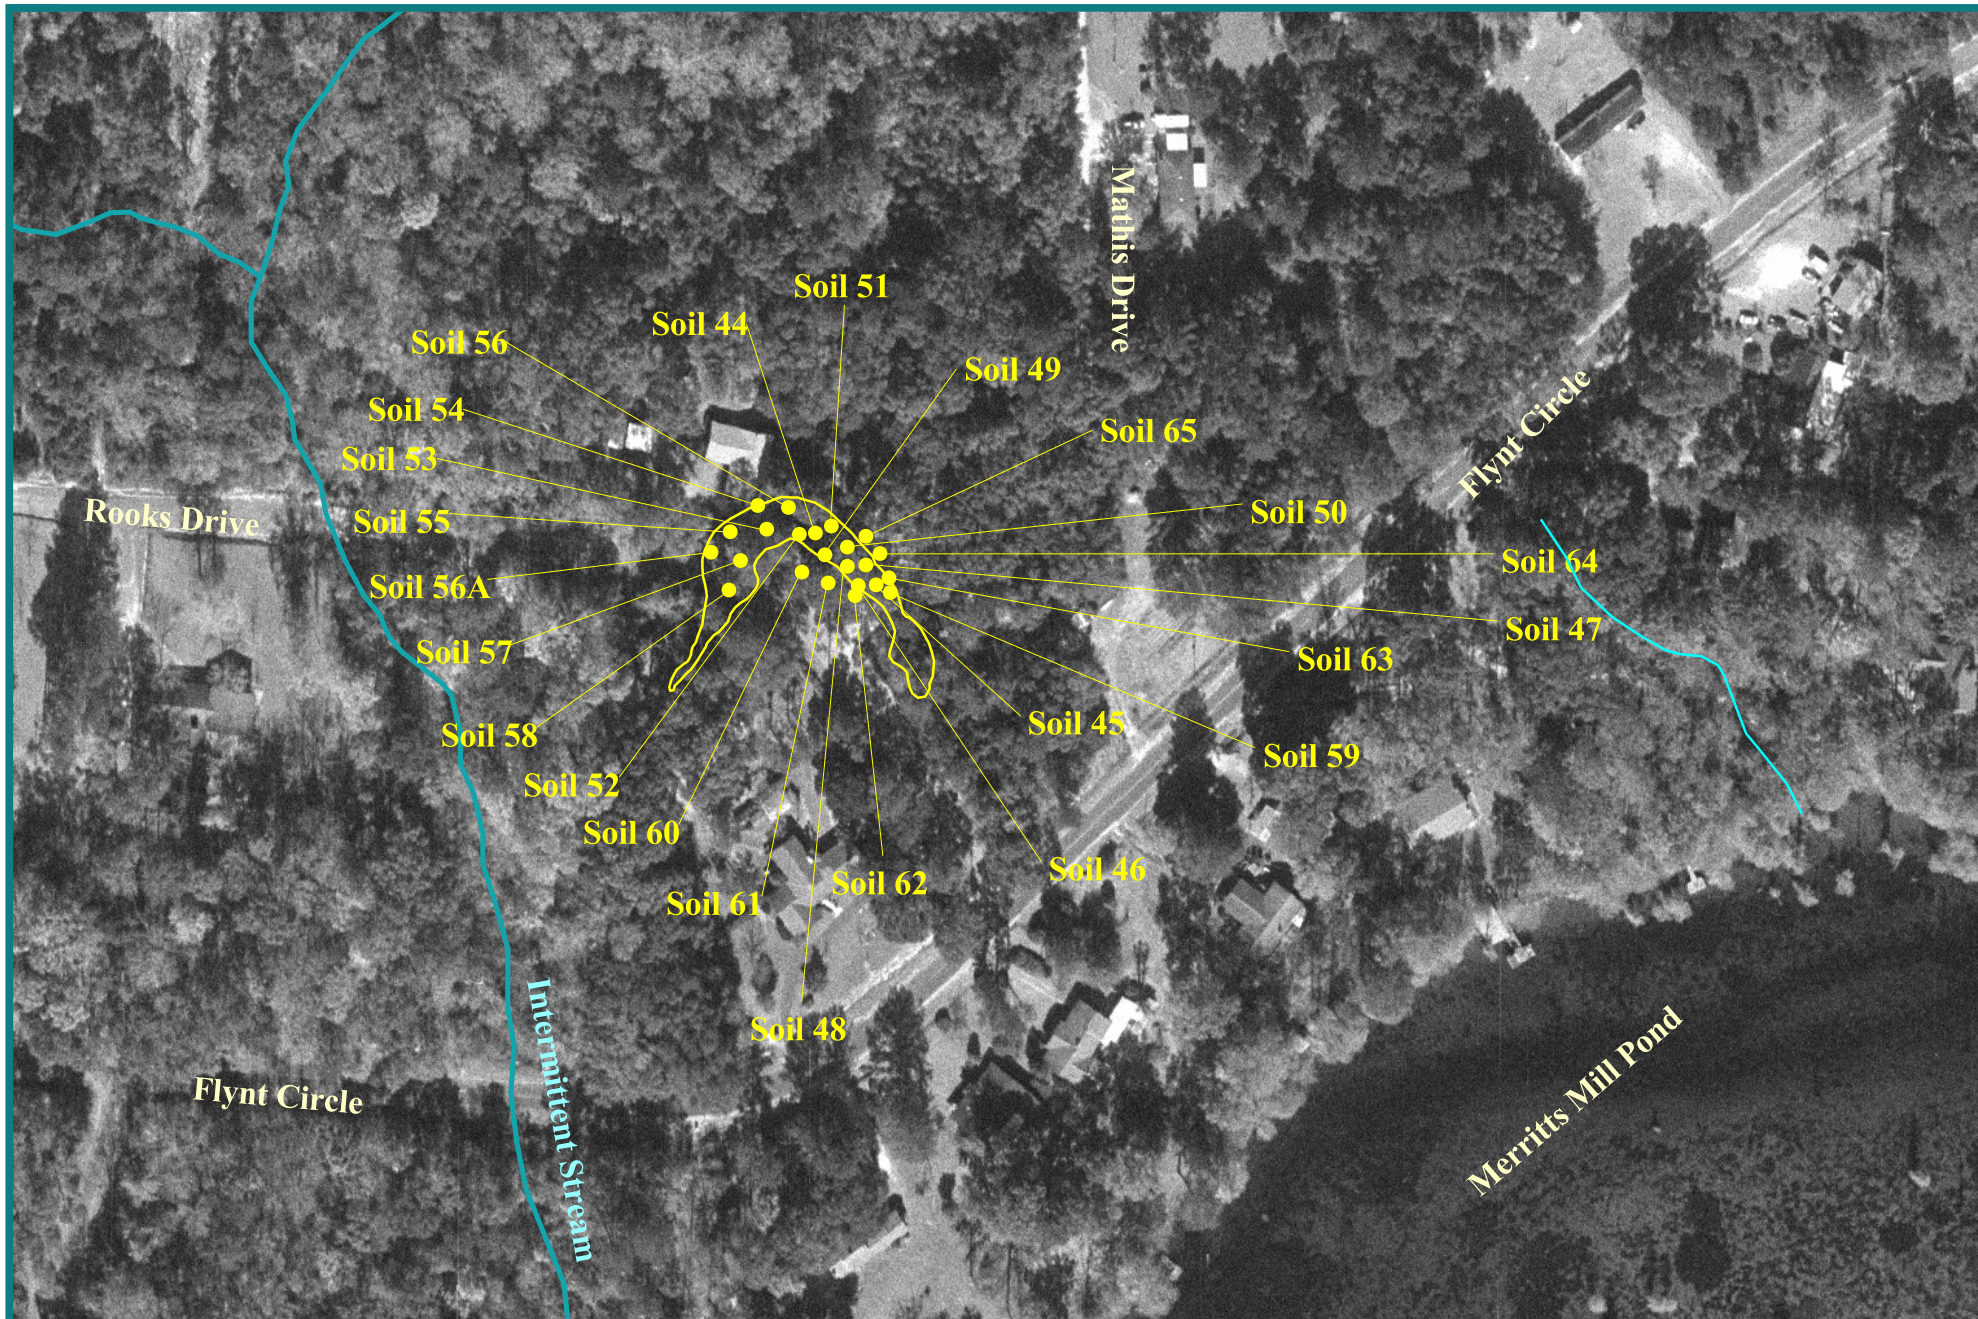
**Figure 10**  
**Fill Area Soil Sample Locations**  
**Merritts Mill Pond Arsenic Study**  
**Marianna, Jackson County, Florida**

Soil sample locations Soil 44 through 65 were collected within an area identified from a 1955 United States Soil Conservation Service aerial photograph (Figures 8 and 9) as a potential fill area. This area of concern is centrally located between the four supply wells reported to have the highest levels of arsenic. The soil sample locations were positioned on a grid with twenty-foot centers as best allowed for by site conditions (Figure 10 and Table 3). Several trees were located within the grid and a septic drain field was located along its northern periphery. The samples were collected from a four-foot long core barrel that was driven six feet into the substrate by the SIS direct push rig. The core itself was collected within a PVC liner positioned within the core barrel. Once the core was brought to the surface, the liner was removed from the barrel and then sliced open to reveal the sample matrix. Samples were stored on ice and delivered under chain-of-custody to the FDEP Central Laboratory for EPA Method 6020 (arsenic and lead) analyses. EPA Method 200.8 (arsenic and lead) was utilized for equipment rinsate blank sample analyses.

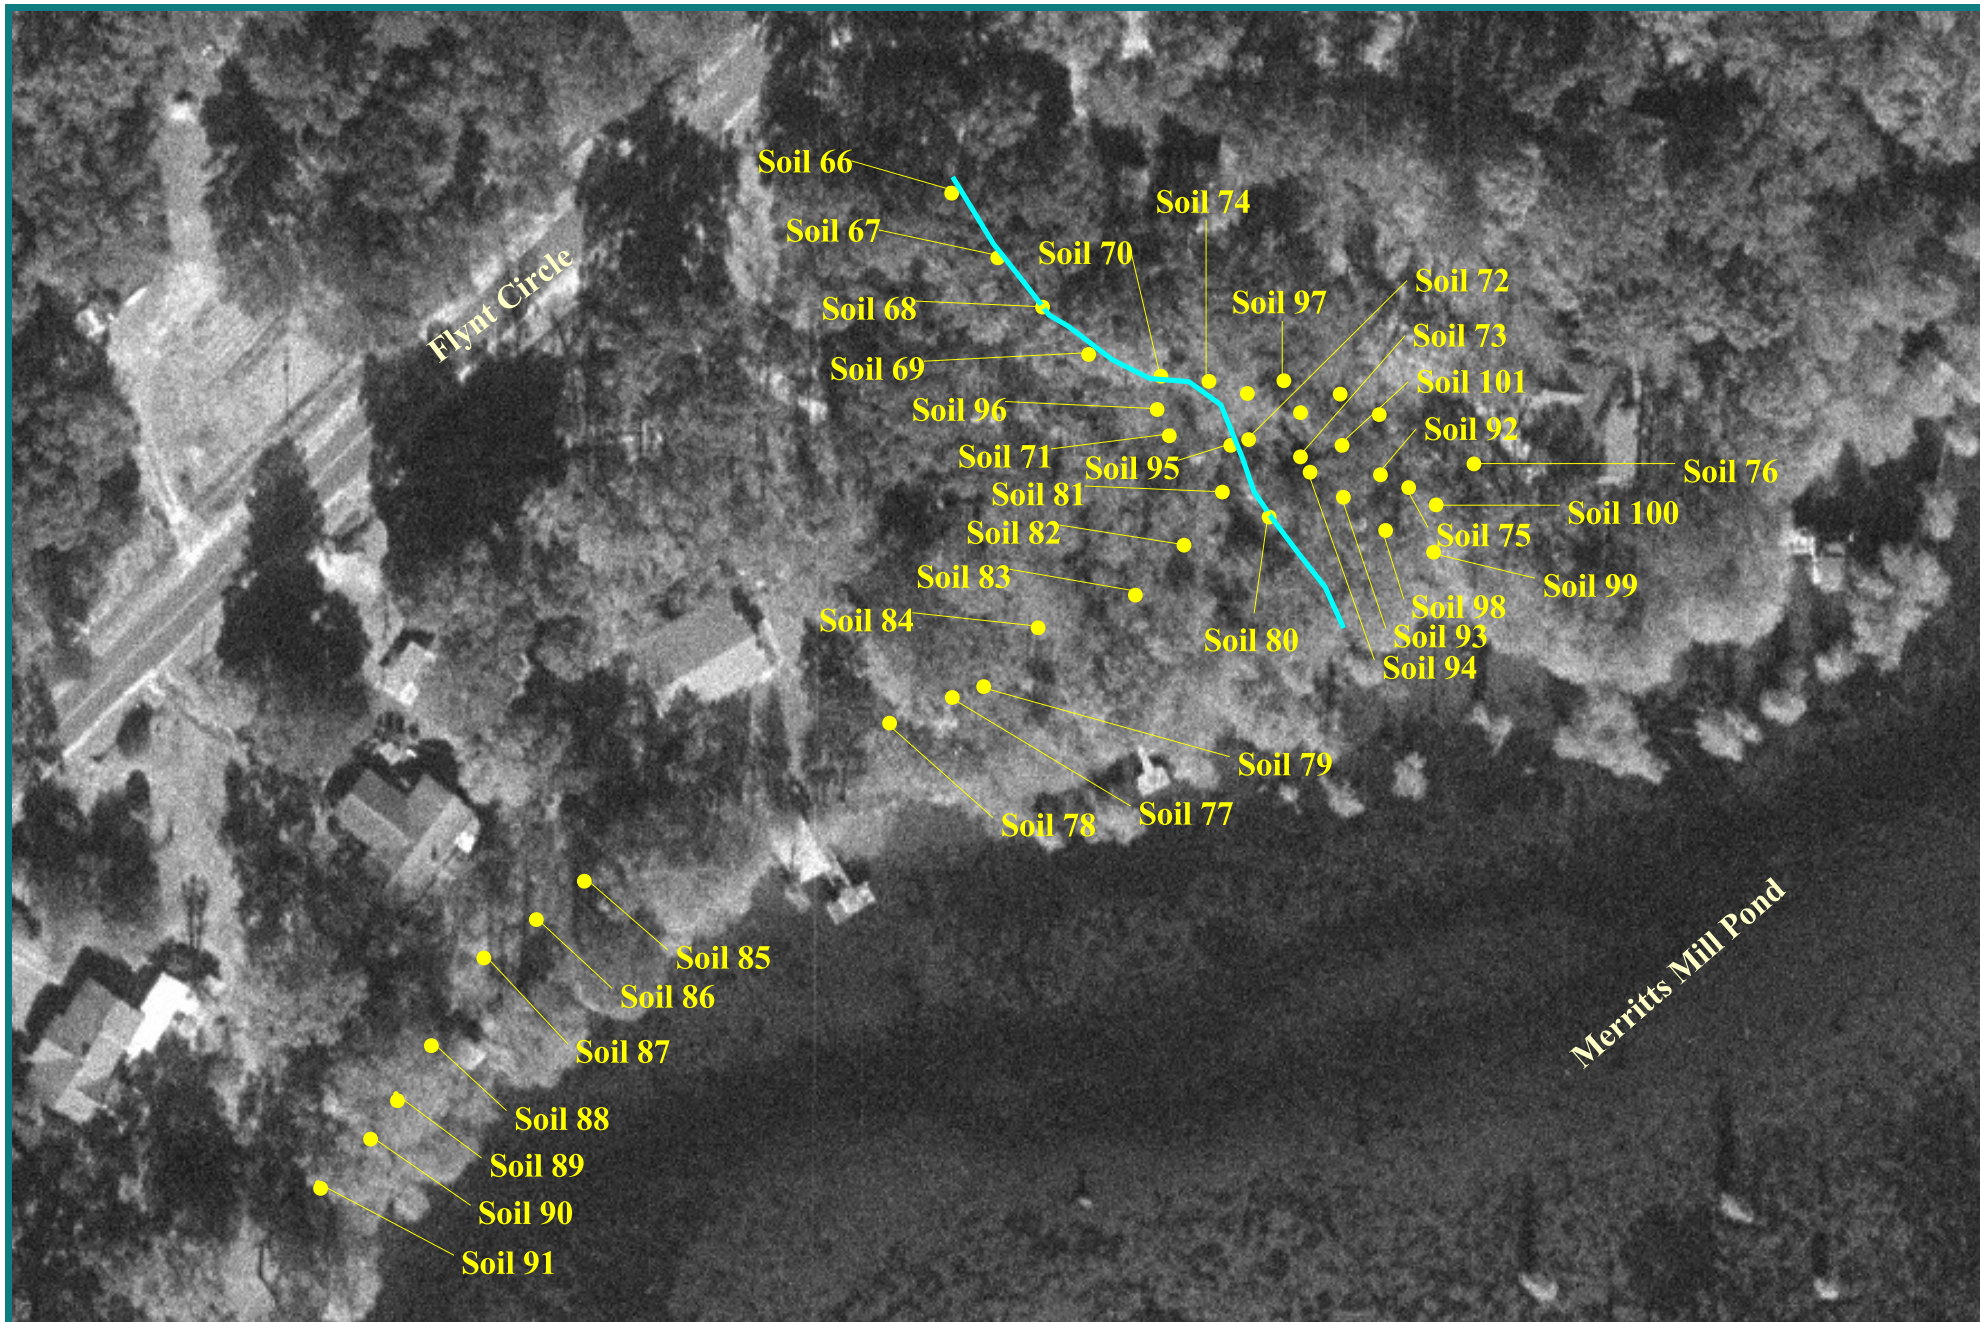
**Figure 12**  
**Second Ravine Area and Water Front Sample Locations**  
**Merritts Mill Pond Arsenic Study**  
**Marianna, Jackson County, Florida**

During the evaluation of the former peach orchard property, a second but much smaller ravine was identified near Flynt Circle ([Figure 12](#)). The ravine is not shown on the United States Geological Survey Marianna Series Topographic Map. The head of the ravine is approximately 100 feet east of Flynt Circle and has a vertical drop of approximately ten to fifteen feet. Ground water seeps out of the ravine's terminus, which in turn forms a small stream that flows to the pond. The ravine quickly opens up into a wide swale that merges with the shoreline. This ravine and the adjacent waterfront are in proximity to several wells that are impacted with high concentrations of arsenic.

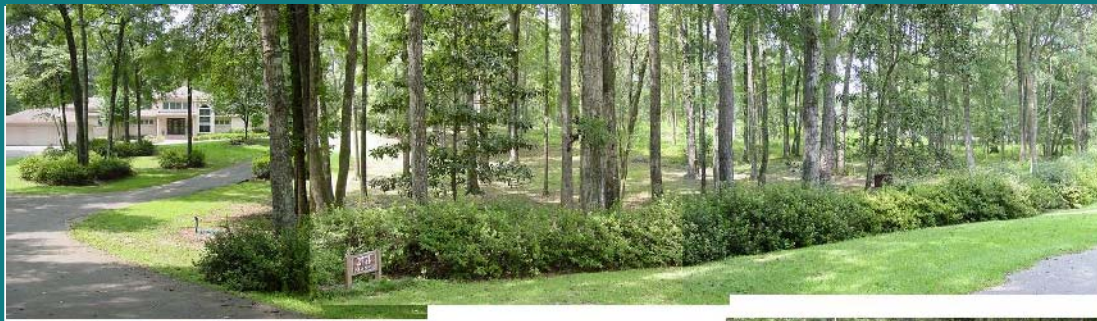
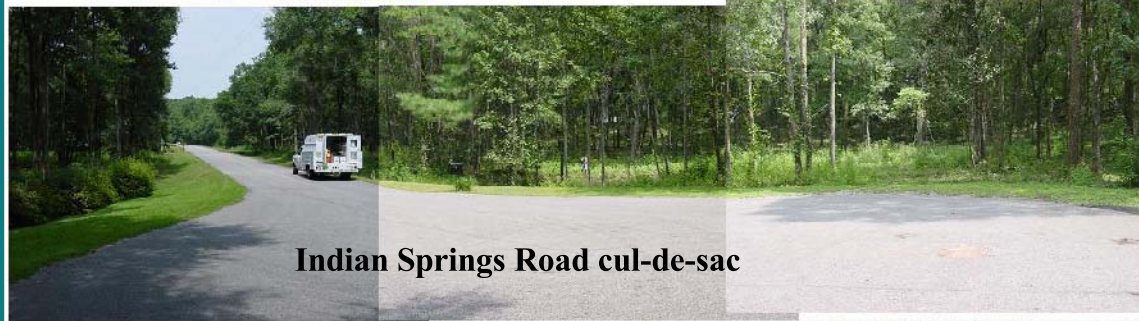
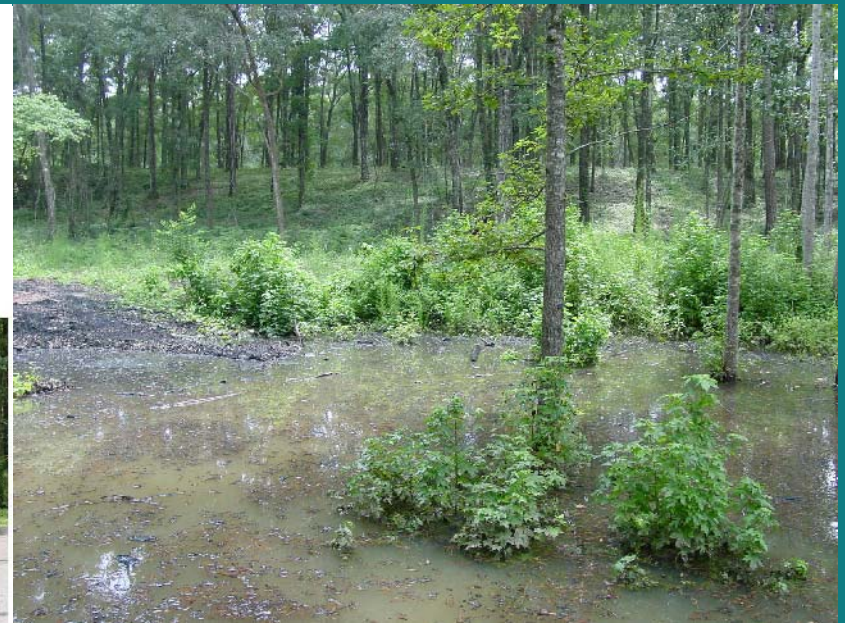
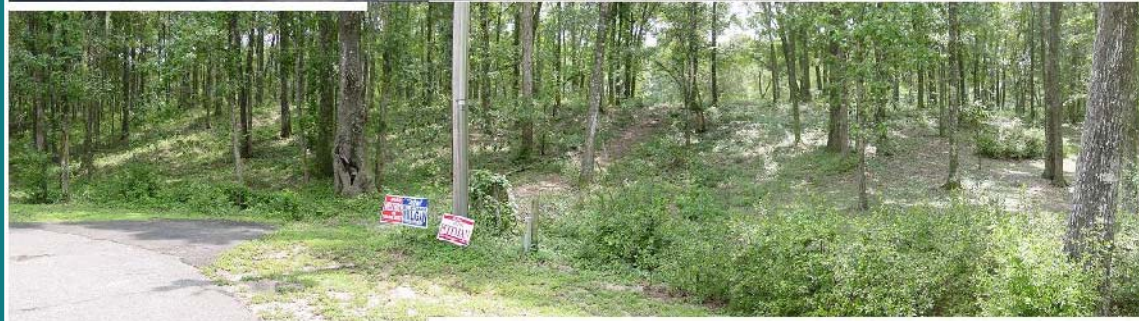
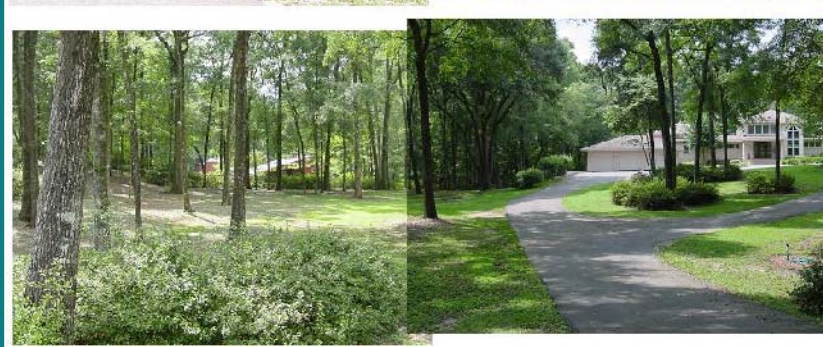
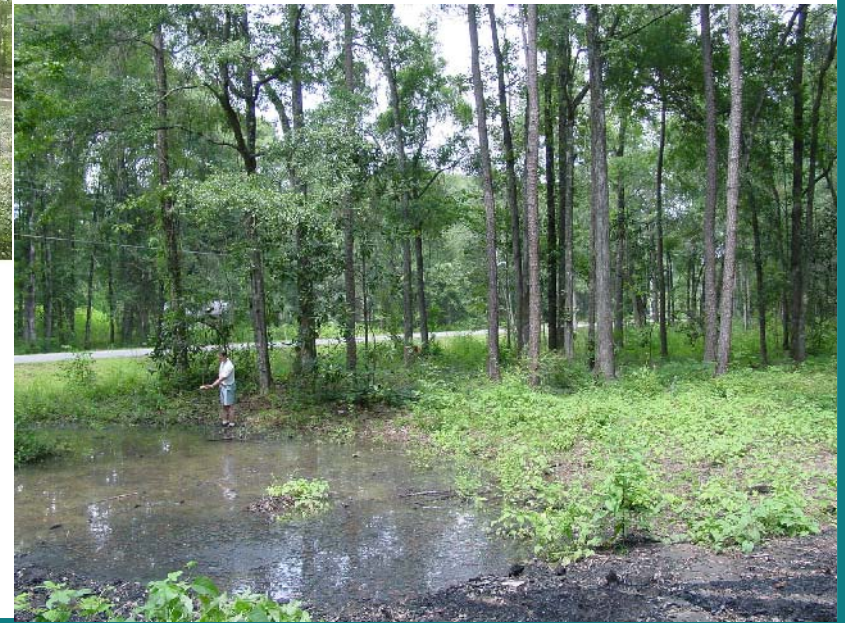
**Photograph 8**  
**Indian Springs Road Karst Feature**  
**Merritts Mill Pond Arsenic Study**  
**Marianna, Jackson County, Florida**

Lastly, during the latter stages of its investigation, SIS identified a geomorphic karst feature located on the eastern side of the pond. Sinkholes provide an avenue for contamination to bypass low permeability surface sediments and impact underlying aquifers. These sinkholes may be connected to fractures present within the limestone that provide preferential pathways for ground water flow within the Floridan aquifer.

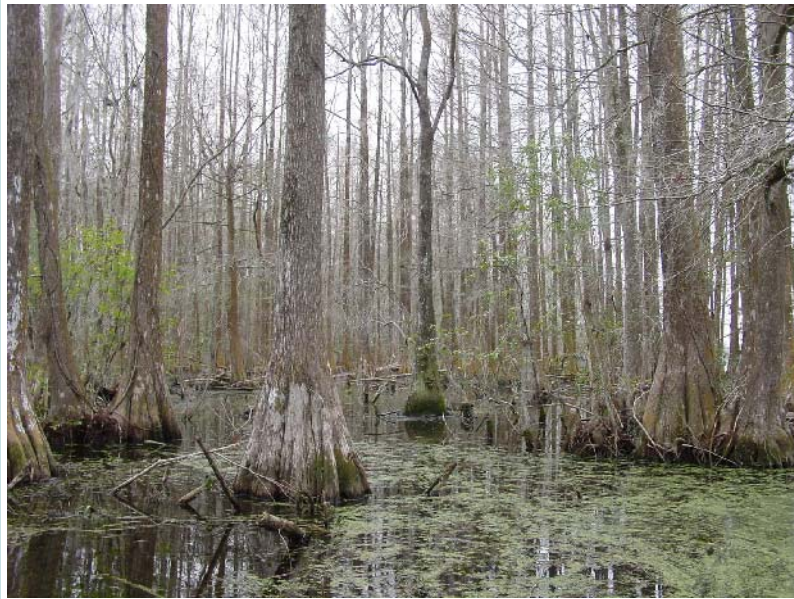
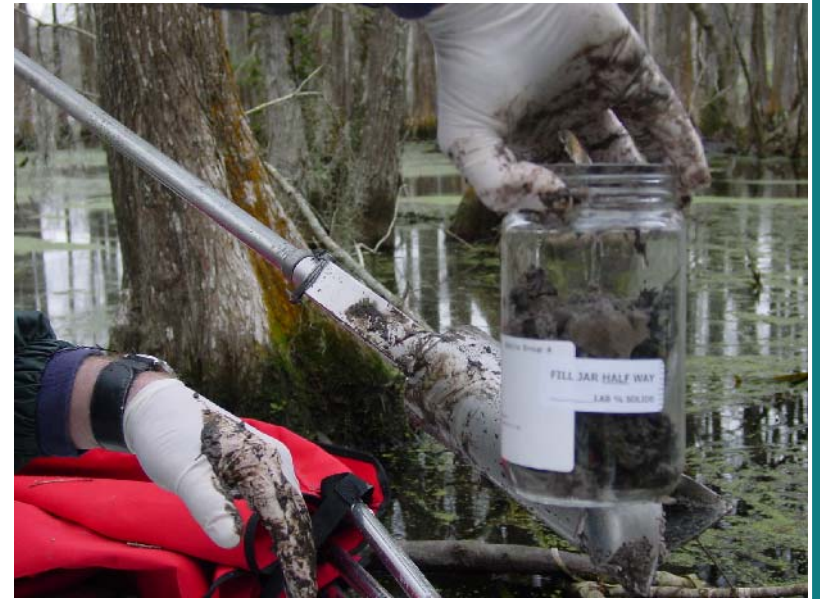
**Photograph 9**  
**Former Arable Land in Pond's Eastern Extent**  
**Merritts Mill Pond Arsenic Study**  
**Marianna, Jackson County, Florida**

In January 2005, sediment samples (Soil 121 to 134) were collected for EPA Method 6020 analysis from the eastern shoreline where Old Hickory Creek flows into the pond ([Figures 16 and 17, Table 3](#)). This area is located hydraulically upgradient to the highest levels of arsenic in ground water located across the western side of the pond. The vicinity adjoins land that appeared to be utilized for grazing over sixty years ago ([Figure 17, Table 3](#)). During the first week of March, a final series of samples (Soil 135 thru 160) were collected by boat within an area of the pond abutting the Old Hickory Creek confluence. During episodes when the pond water level is low, this portion of the lake becomes arable land ([Appendix B](#)). Much of the pond in this location is less than two feet deep ([Photograph 9](#)).

8. The pond along the eastern waterfront near the confluence with Old Hickory Creek. This area was also arable land several decades ago when the pond's surface water level was lower than it is today. Several tens of sediment samples were collected from this area because it once bordered land that was possibly used for cattle grazing. Old Hickory Creek could also be positioned along a lineament, which is a surface reflection of a possible fracture within the subjacent limestone. None of the samples collected from this area were reported to contain elevated concentrations of arsenic.
