**SANITARY SEWER EVALUATION SURVEY**  
**PLAN "B"**

**SMOKE TEST OBSERVATION AND RESULTS**

| Facility Name | VA Hospital |
| Time | June 2nd, 2011 at 11:00 A.M. |

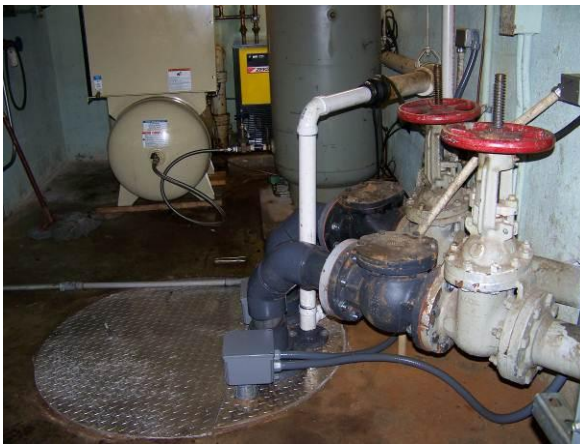
**Pump Station A:** In compliance  
**Address:** On the North West side within; main building. This ejector collects the waste water below the 1<sup>st</sup> floor and discharges it into M.H. # 19  
**Size and Material:** 40 Ø x 10ö concrete precast structure  
**Surface:** Concrete  
**Inflow Potential:** None  
**Defect Rating:** None  
**Task to be performed:**

- No work required

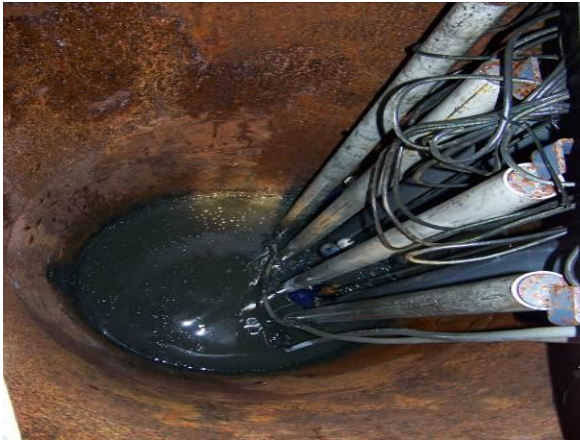
**Pump Station A:** In compliance  
**Address:** On the North West side within; main building. This ejector collects the waste water below the 1<sup>st</sup> floor and discharges it into M.H. # 19  
**Size and Material:** 40 Ø x 10ö concrete precast structure  
**Surface:** Concrete  
**Inflow Potential:** None  
**Defect Rating:** None  
**Task to be performed:**

- No work required

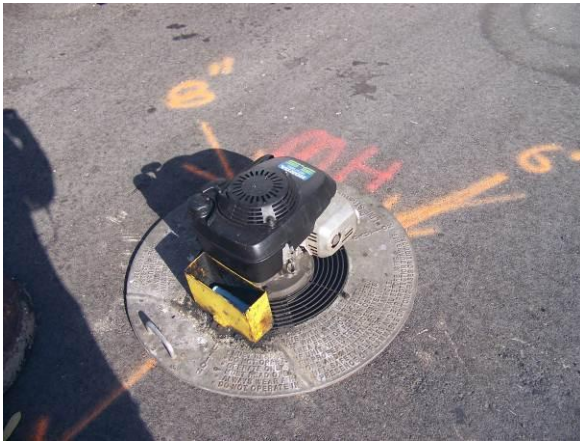
**Point of Injection:** Manhole # 1

**Testing Includes:** M.H # 1, M.H. 7, M.H. 8, M.H 9, Pump Station 6A and P.S. 6B and all associated piping of this section of the SSCY

**Location:** On the northeast side of main building on asphalt driveway

**Result:** The smoke reached all part of the sanitary sewer collection system of the section being tested and their corresponding vents

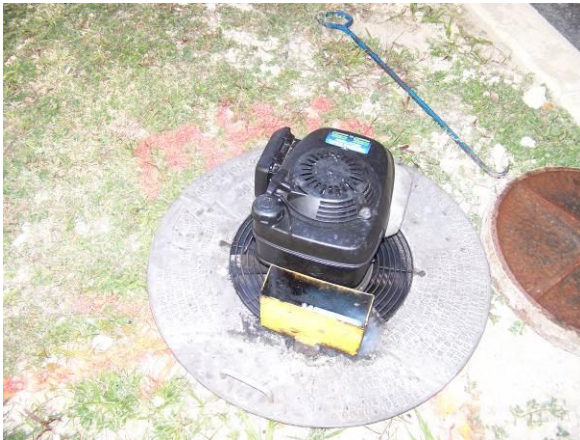
**Point of Injection:** Manhole # 6

**Address:** North of main building on sod

**Location:** On sod area

**Result:** The smoke reached all parts of the sanitary sewer collection system of the section being tested and their corresponding vents

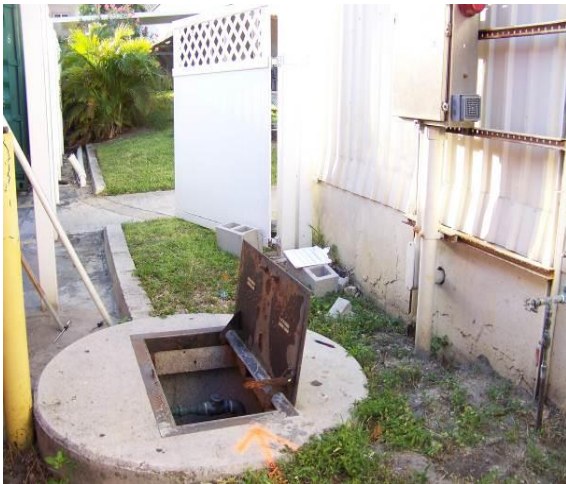
**Pump Station C:** In compliance

**Address:** On the North of a portable building. This ejector collects the waste of a single building and discharges it into M.H. # 6

**Defect Rating:** None

- No work required

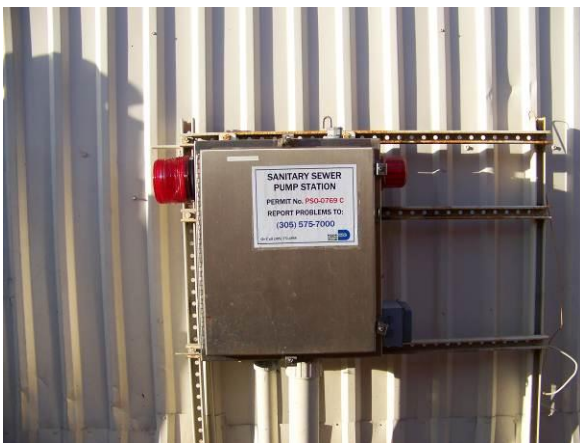
**Pump Station C:** In compliance

**Address:** On the North of a portable building. This ejector collects the waste of a single building and discharges it into M.H. # 6

**Defect Rating:** None

- No work required

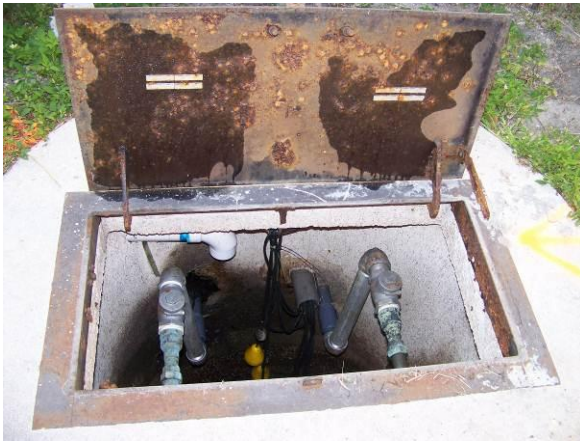
**Pump Station C:** In compliance

**Address:** On the northwest side of building. This ejector collects the waste of that section of the building and discharges it into M.H. # 6

**Defect Rating:** None

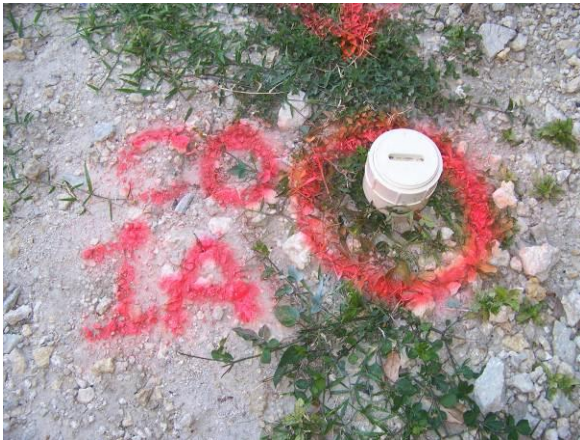
**C.O. # 1A #:** In compliance

**Address:** West the building, on asphalt driveway

**Defect Rating:** None

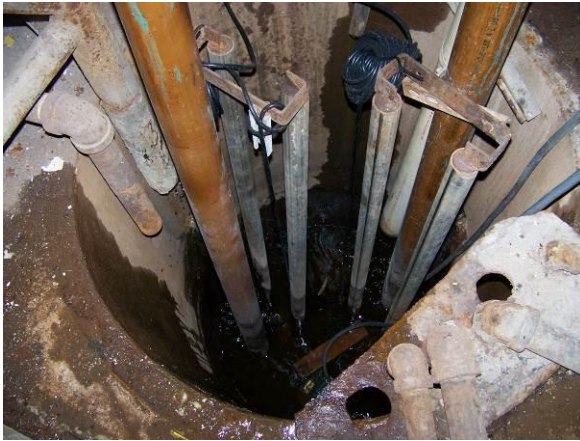
### **Pump Station B: In compliance**

**Address:** Located on the North West side of the building inside of it and discharge its content into Manhole # 19

**Defect Rating:** None

- No work required

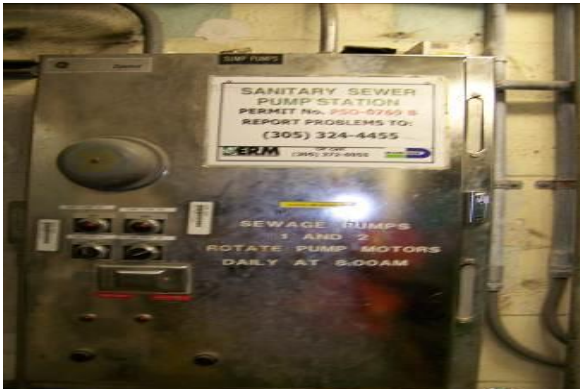
### **Pump Station B: In compliance**

**Address:** Located on the North West side of the building inside of it and discharge its content into Manhole # 19

**Inflow Potential:** None

**Defect Rating:** None

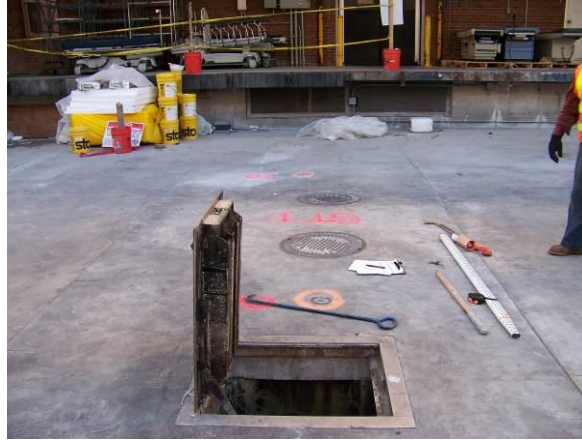
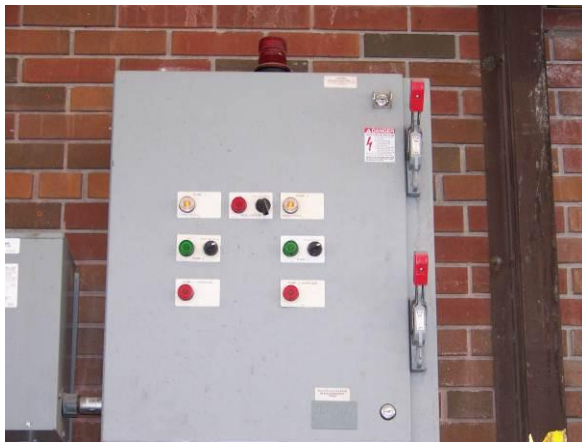
**Pump Station D:** In compliance  
**Address:** North side of the building receiving the flow from grease trap # 1 and discharge its flow into manhole # 8

**Size and Material:** 5' concrete precast  
**Surface:** Unpaved  
**Inflow Potential:** None

**Defect Rating:** None

- No work required

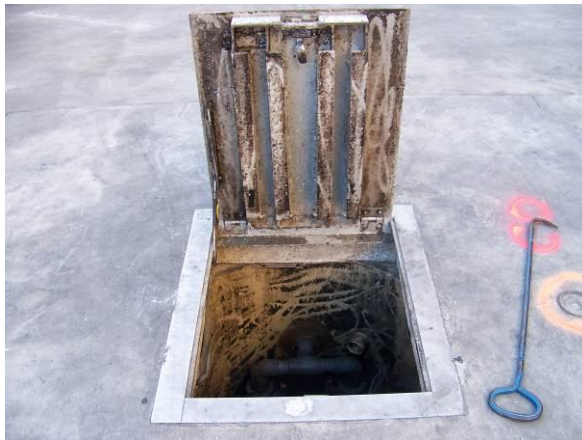
**Pump Station D:** In compliance  
**Address:** North side of the building receiving the flow from grease trap # 1. The pump discharge into M.H. 5 which is cover with concrete

**Size and Material:** 5' concrete precast  
**Surface:** Unpaved

**Inflow Potential:** None  
**Defect Rating:** None
