## Mill Creek Eglin Golf Course below Trout Lake, Okaloosa County August 13, 1998

BioRecon: A rapid, cost-effective screening mechanism for identification of biological impairment

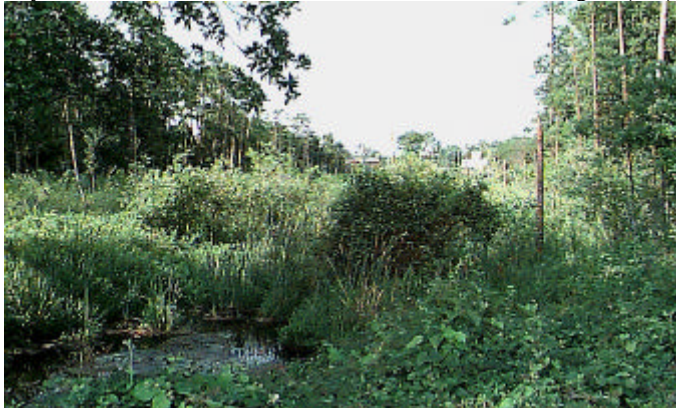
The aquatic wildlife community was dominated by pollution tolerant species. Canopy removal and dams in the lower Creek elevated water temperatures (27.5 °C) compared to upstream at hole #13 (23.5°C). The area's sand hill seepage slope features allow fertilizer applied to the golf course to rapidly percolate into the ground and surface waters. A severe drought in the Florida panhandle during the past 2 years has reduced leachate from applied nutrients. Higher concentrations of fertilizer could be expected to leach from the golf course during normal to high rainfall years. Water quality tests indicated an increase of total nitrogen in Mill Creek below the Trout Lake impoundment (0.59mg/l) compared to upstream above the golf course (0.03mg/l). Conductivity at this site increased to 45.5 umho/cm from 20.7 umho/cm above the golf course, which indicate leaching of dissolved salts. Trout Lake impoundment had a filamentous alga bloom and mowed greens for riparian zones. The nitrogen tied up in these plant materials decays to form the organic sediment deposits found below the golf course down to Highway 20. The natural stream channel in lower Mill Creek was eliminated and its former forested riparian zone

converted to a stagnant cattail swamp. Aquatic habitats (2% coverage) were limited by sediment smothering (98%). Sheet flow, 50 meters in width, replaced the natural stream channel. The riparian zone quality rated marginal, as disruption in the community was evident by the dominance of cattail and presence of invasive exotics (Chinese tallow, torpedo grass) in place of the natural forested buffer.
