# Summary of Results

## Walk the WBID Exercise for Wagner Creek (WBID 3288A)

September 2011

This report summarizes the results of the Walk the WBID exercise for the Wagner Creek watershed (WBID 3288A), located in the northwestern portion of the City of Miami, on November 18, 2010. (WBID is the abbreviation for **WaterBody ID**entification number, which is very similar to a watershed.) This field reconnaissance and source elimination effort was carried out to gain a better understanding of conditions within the watershed, including the hydrology of the creek and its contributing ditches and branches, flood-prone areas, the location of sewer and stormwater infrastructure, and potential sources that are contributing fecal coliform bacteria to the creek.

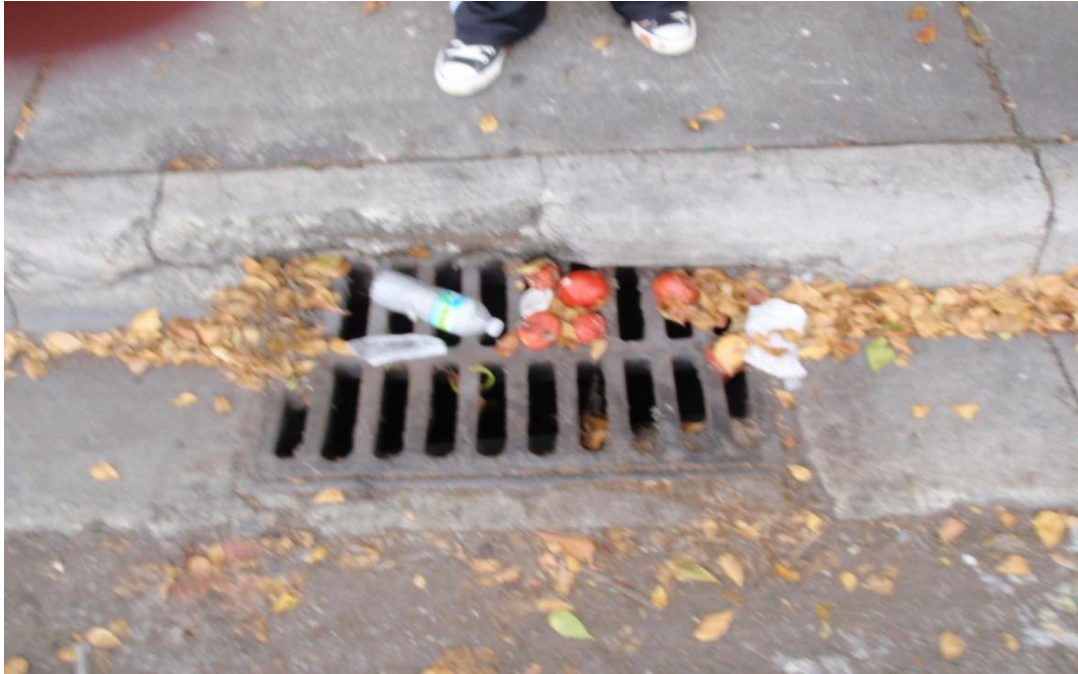
**Figure 10. Fruit and trash collected on a storm drain at the Allapattah Produce Market.**

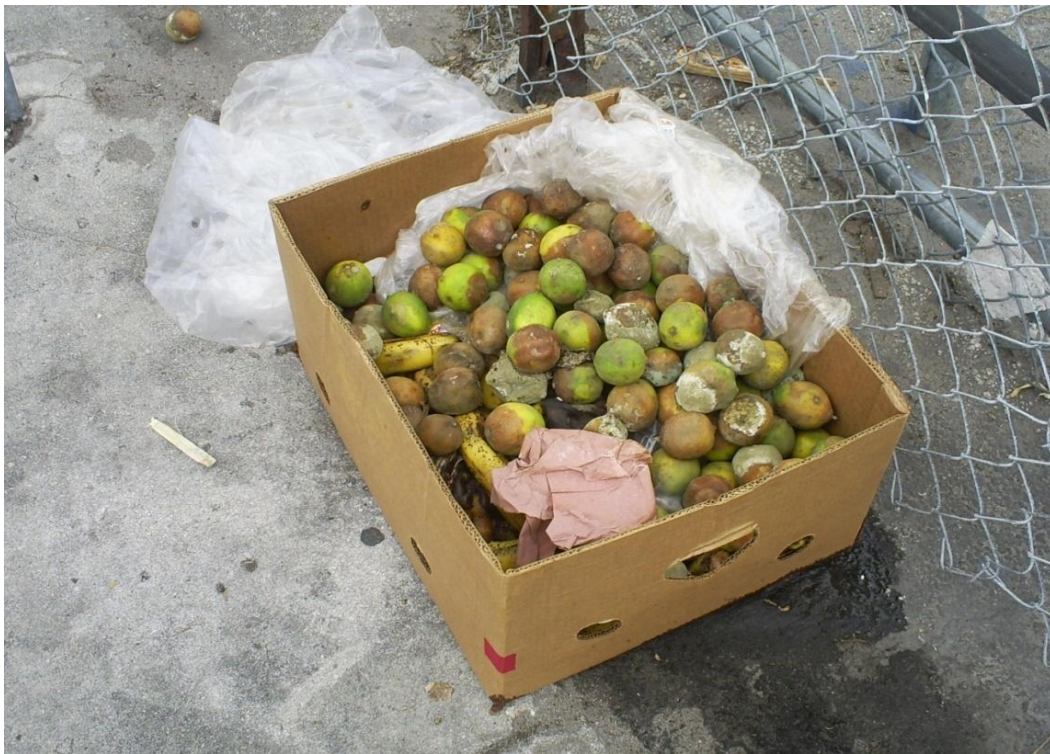
**Figure 11. Box of rotting fruit outside a warehouse at the Allapattah Produce Market.**

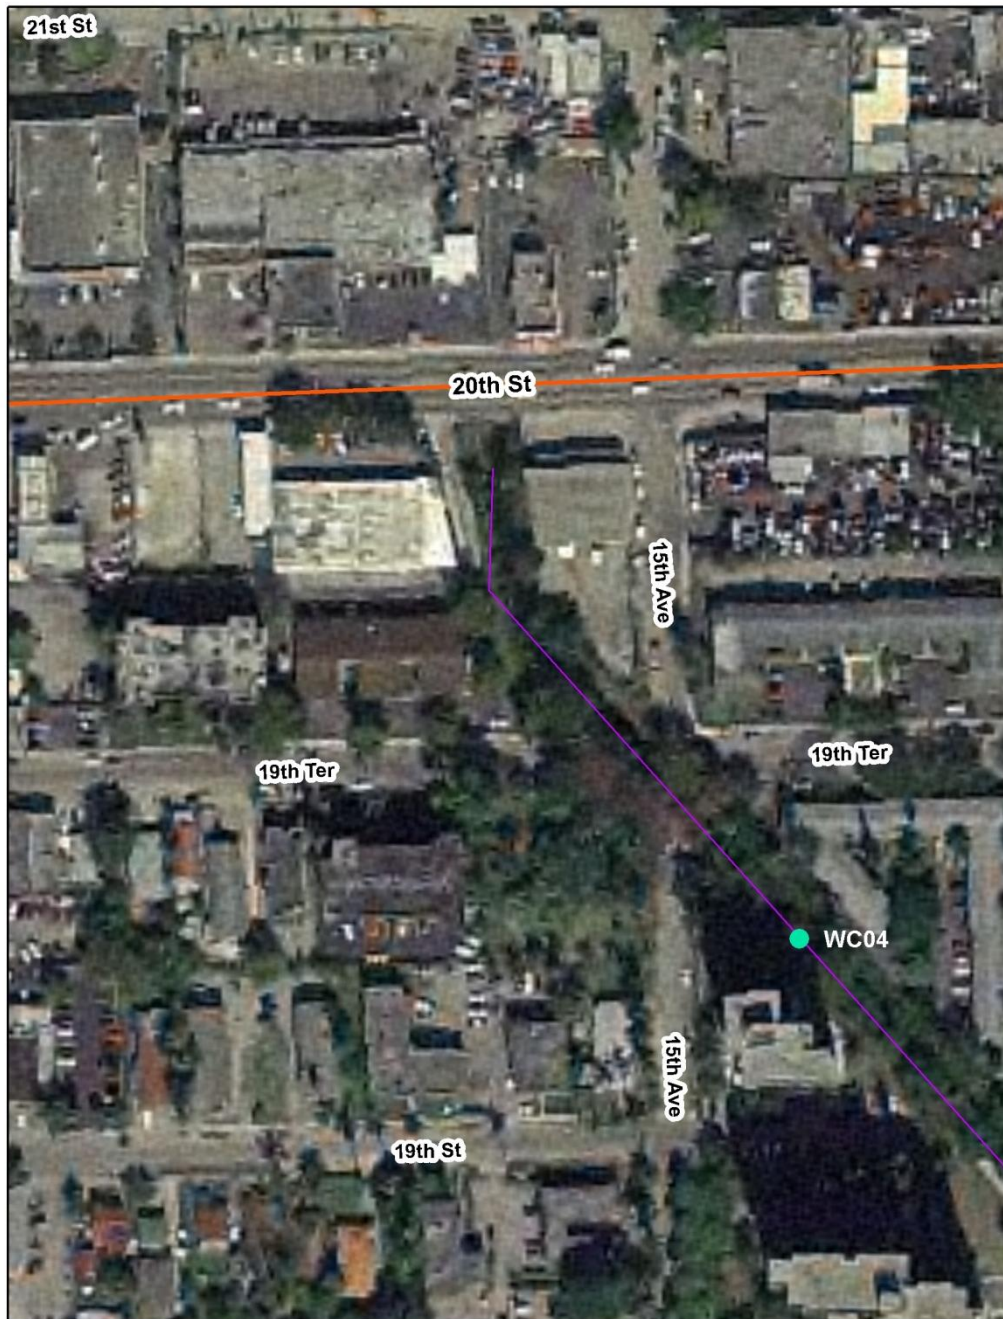
**Figure 14.** Aerial photo showing the location of Station DADEWC04, in Wagner Creek–Seybold Canal. Popeye’s Chicken is located on the north side of NW 20<sup>th</sup> Street near where Wagner Creek first emerges from the underground culvert. A storm drain belonging to the Popeye’s Chicken parking lot was observed to be completely full of debris.

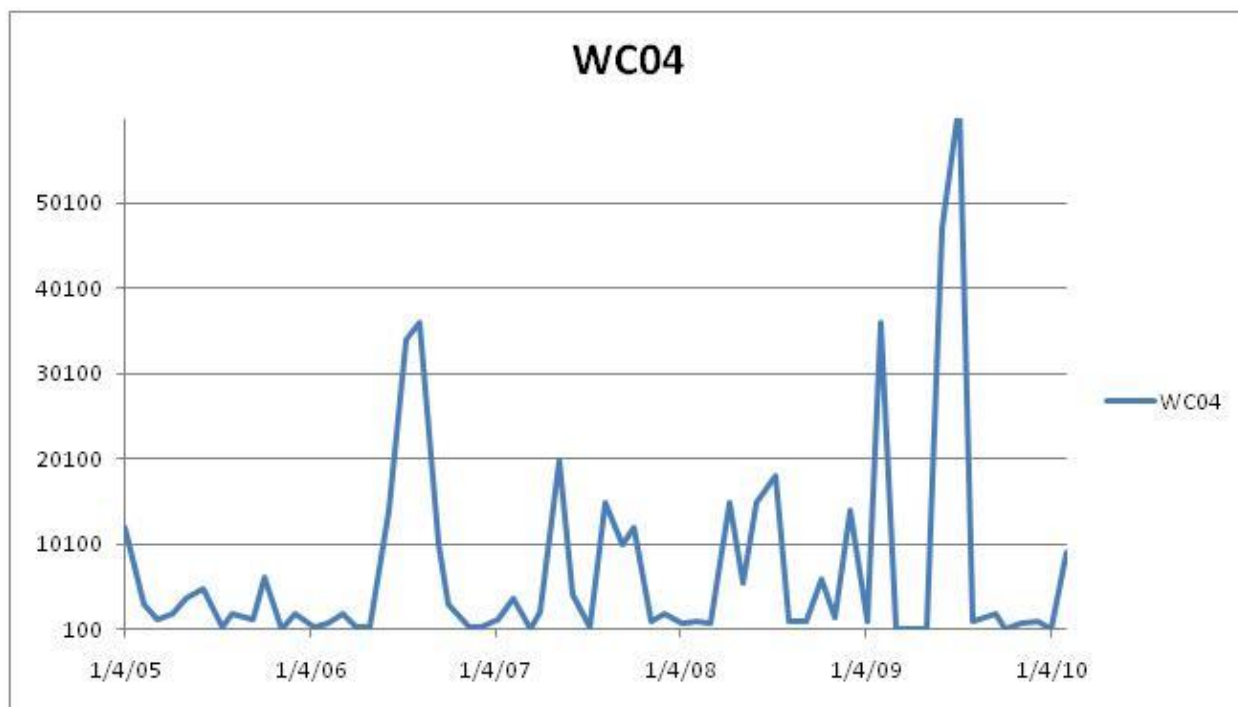
**Figure 15. Results of annual sampling for Station WCO4, 2005–10. An SSO that occurred on May 1, 2007, resulted in fecal coliform levels of 20,000 CFU/100mL; a second SSO took place on January 6, 2008, resulting in levels of 700 CFU/100mL.**

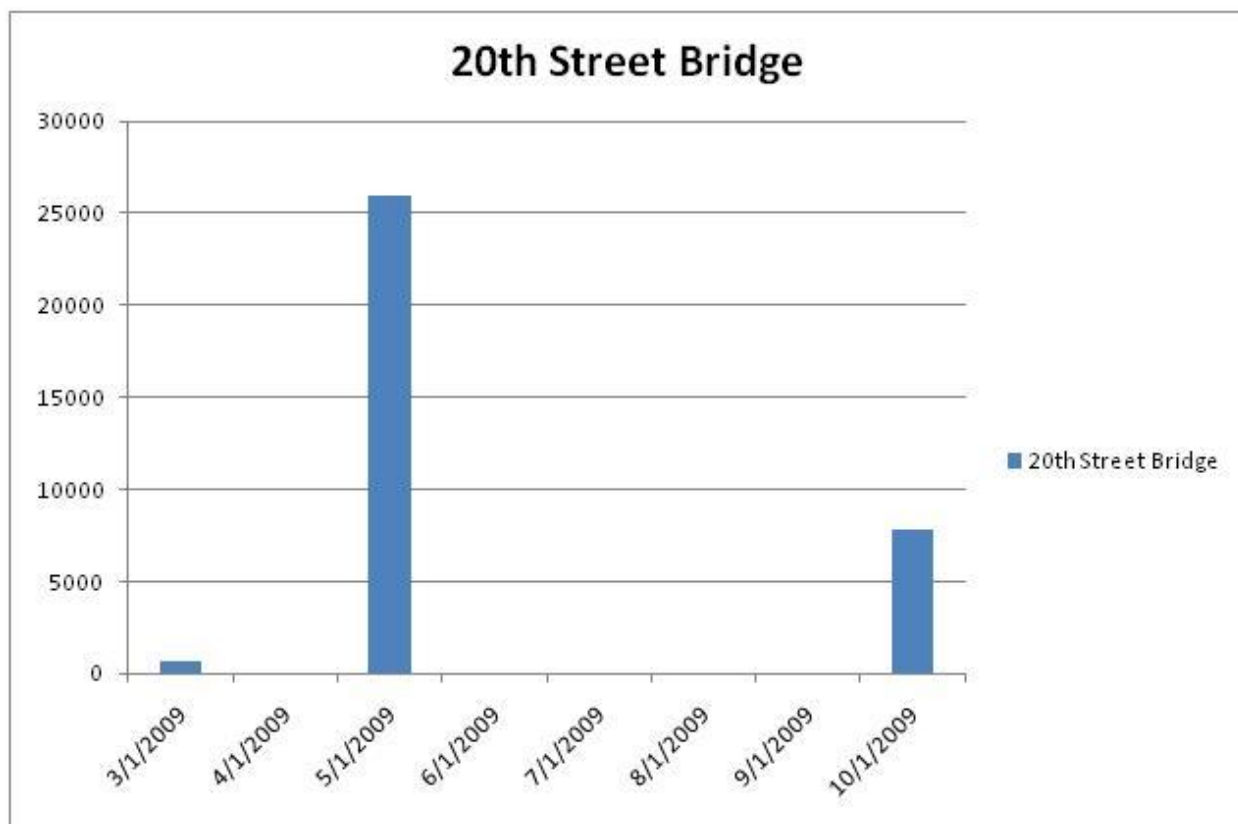
**Figure 16. Sample results for 21FLWPB 28040446, March–October 2009, were as follows: 3/25/2009 = 660 CFU/100mL; 5/20/2009 = 26,000 CFU/100mL; 10/28/2009 = 7,800 CFU/100mL; 3/25/2009 = 660 CFU/100mL; 5/20/2009 = 26,000 CFU/100mL; and 10/28/2009 = 7,800 CFU/100mL.**

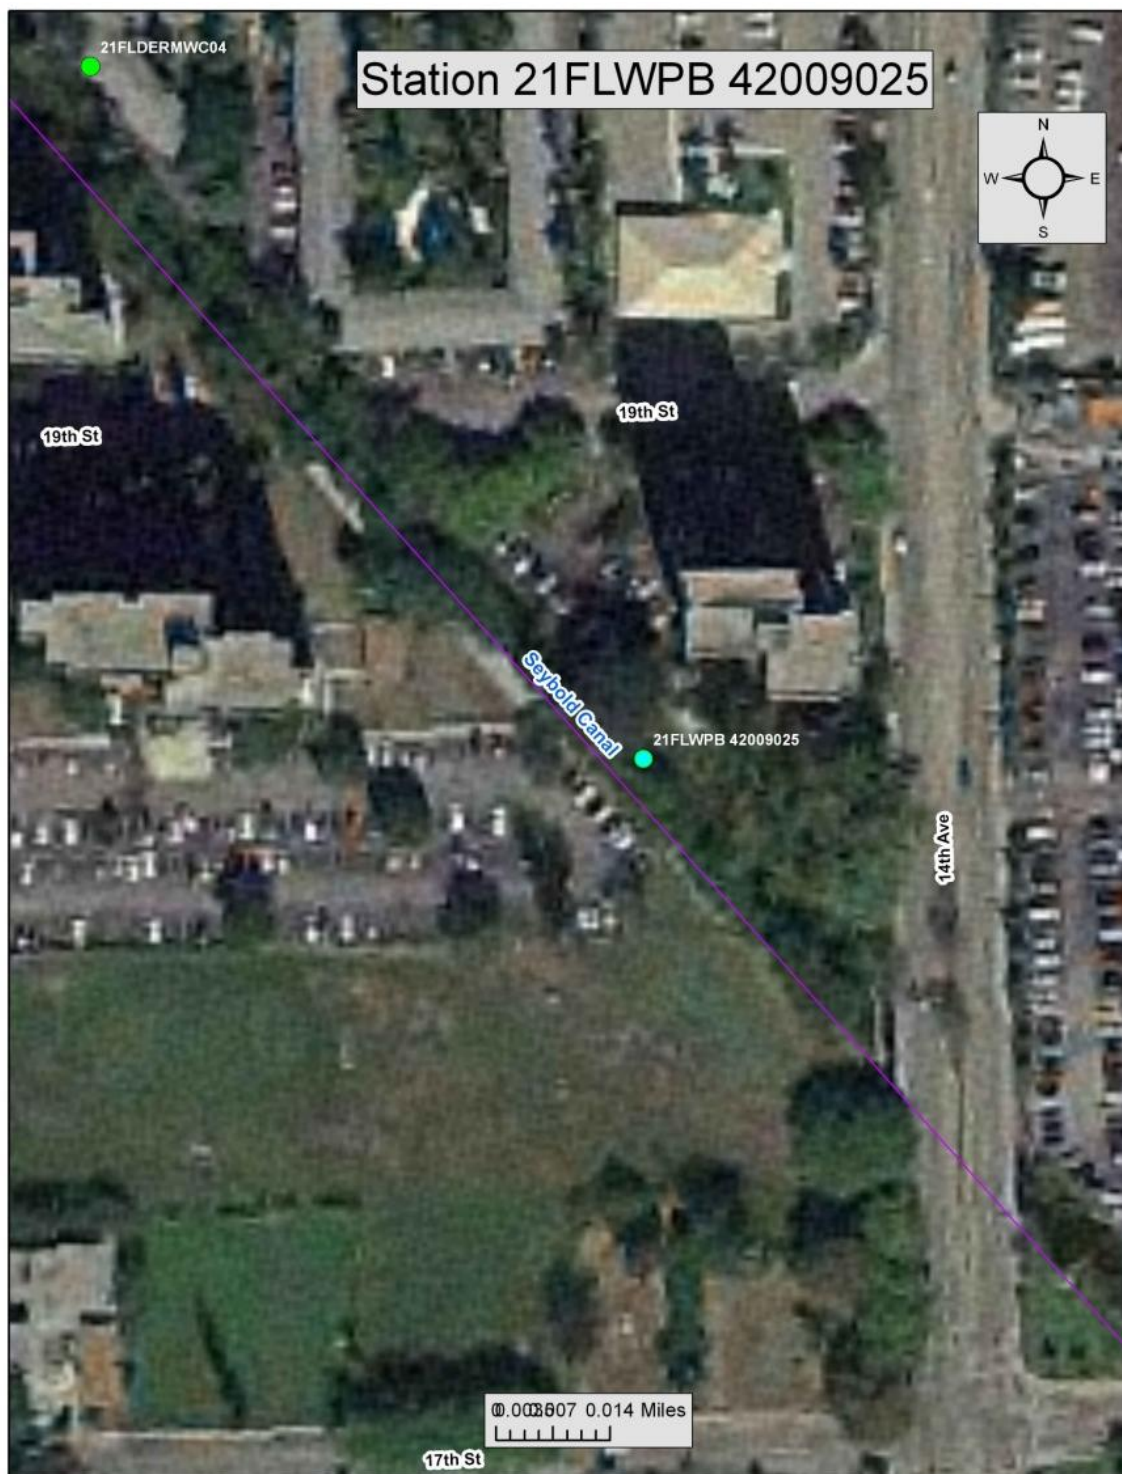
**Figure 23. Aerial photo showing the location of Station 21FLWPB 42009025 along Wagner Creek–Seybold Canal. Note the apartment properties along the waterway. Additional research is needed to determine whether any of the apartments have a direct connection to Wagner Creek. The follow-up boat tour revealed several direct connections from the apartment complex to Wagner Creek.**

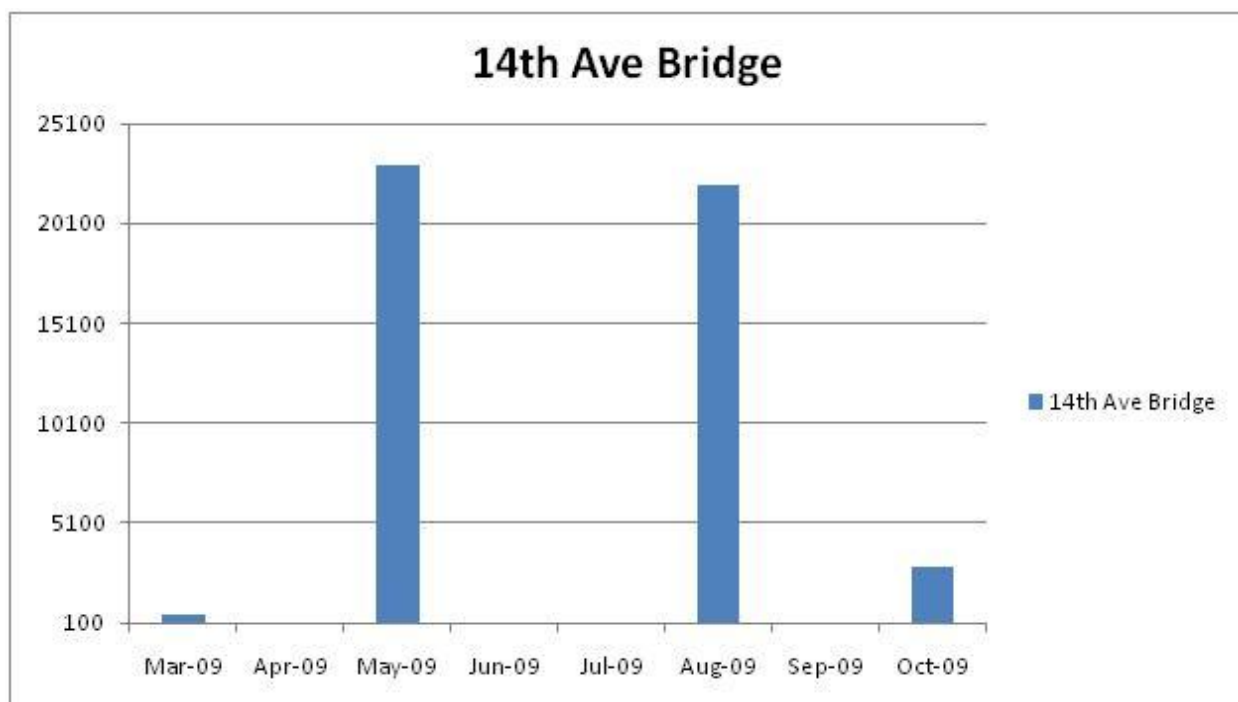
**Figure 24. Sampling results for the 14<sup>th</sup> Avenue Bridge, March–October 2009, are as follows: March 2009 = 530 CFU/100mL; May 2009 = 23,000 CFU/100mL; August 2009 = 22,000 CFU/100mL; and October 2009 = 2,900 CFU/100mL.**

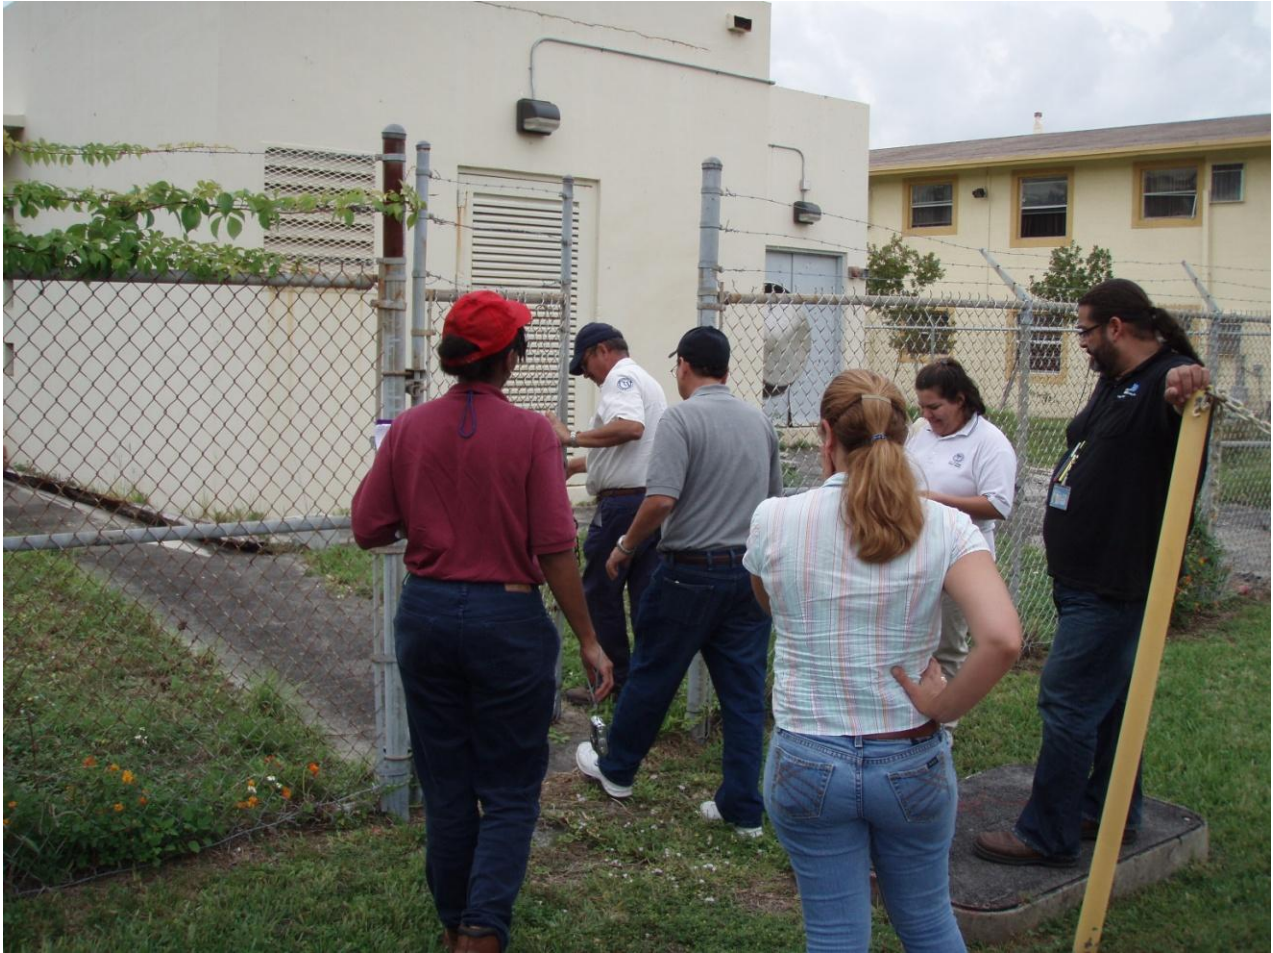
**Figure 45.** Team members inspecting the City of Miami Overtown stormwater pump station, where construction upgrades are incomplete.

**POST-FIELD EVENT NOTE:** The City of Miami is currently in litigation with the contractor who was supposed to complete the upgrades. The station has been inoperable for four years, and there is passive gravity flow to the creek from ponds. Documents are not available, and FDOT is checking on the hydrology of the area. The City of Miami obtained the project drawings that show how the Overtown Pump Station connects to Seybold Canal. The information is contained in three separate projects. Drawings for two of the projects were in the City of Miami records, and drawings for the third project had to be requested from FDOT archives. The records indicate that FDOT built the existing Overtown Pump Station as a replacement for a pump station constructed by the City of Miami that had to be removed due to FDOT's Midtown Interchange Project, which routed Interstate 95 and State Road 836/Interstate 395 through the Overtown neighborhood. The project plans confirmed the connection between the Overtown Stormwater Pump Station, the FDOT ponds, and Seybold Canal.

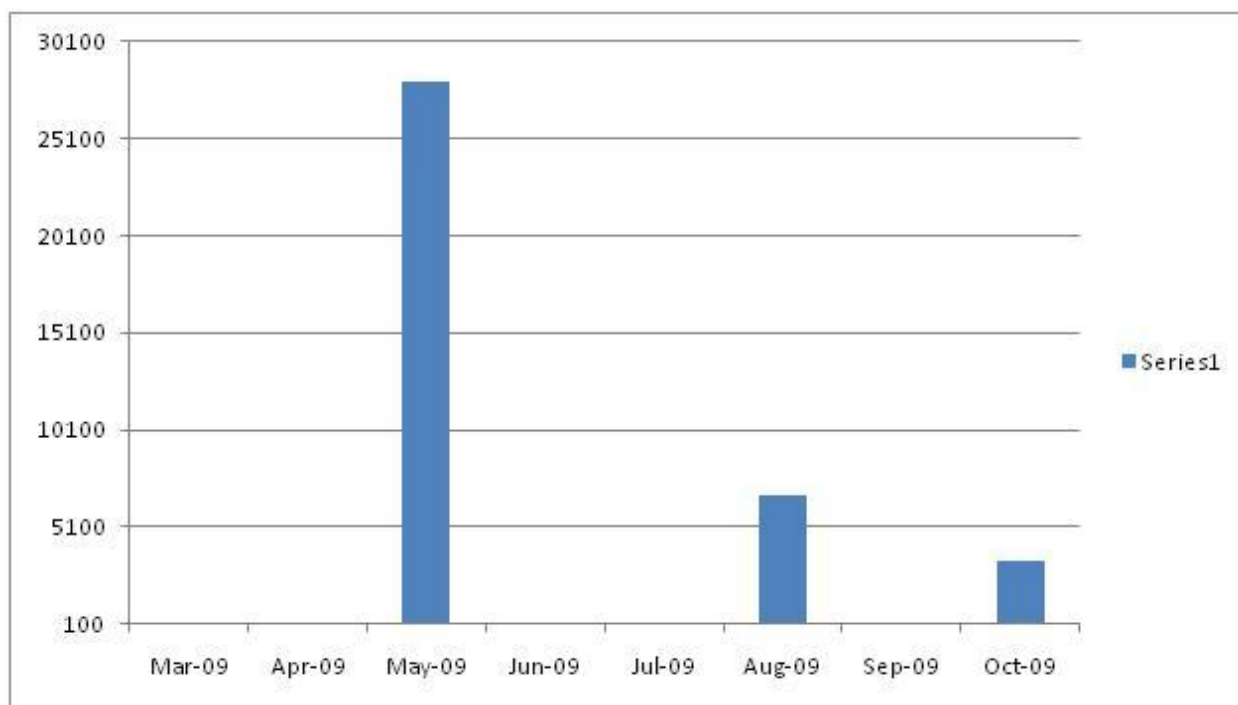
**Figure 49. Sampling results for Station 21FLWPB 28040445, March–October 2009. Results were as follows: March 2009 = 150 CFU/100mL; May 2009 = 28,000 CFU/100mL; August 2009 = 6,700 CFU/100mL; and October 2009 = 3,400 CFU/100mL.**

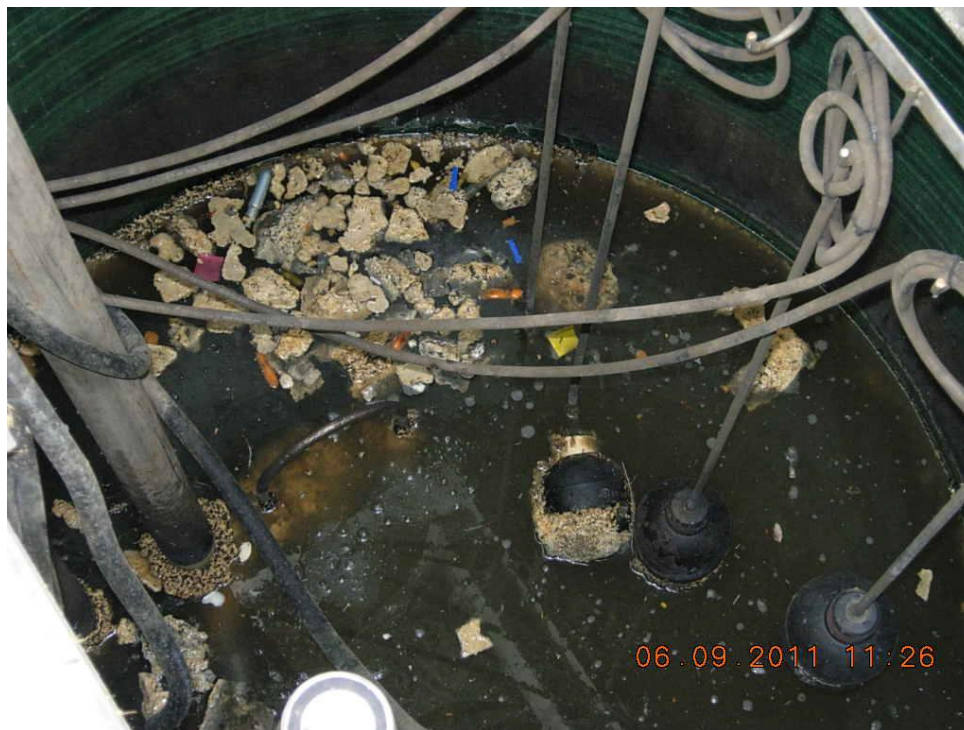
**Figure 58.** View of the fourth VA Hospital sanitary lift station near NW 17<sup>th</sup> Street, close to the newly completed Fisher House. The Wagner Creek guardrail is just visible in the upper left corner of the photo. This is a new lift station that had not yet completed the DERM permitting process at the time of inspection. Scott Olsen of the VA Hospital opened the pump station. Debris and some globules were observed. Allen Cox from DERM suggested pumping out the new station.

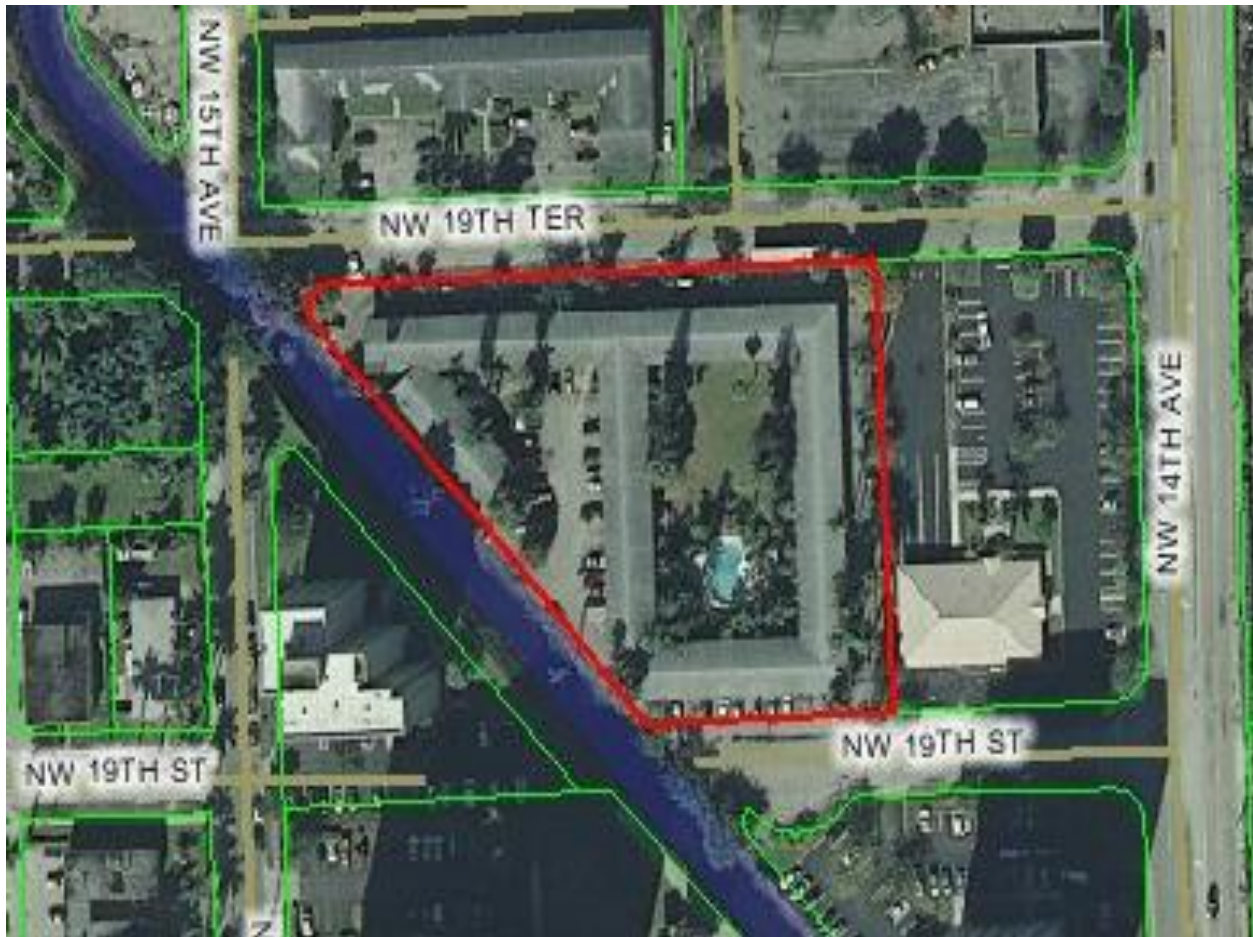
**Figure 62.** Aerial photo of Creek Club Apartments, 1434 NW 19<sup>th</sup> Terrace. The team observed several PICs connected to the apartment complex.

**POST-BOAT TOUR NOTE:** None of the connections observed appear in any of the City of Miami's Public Works records.

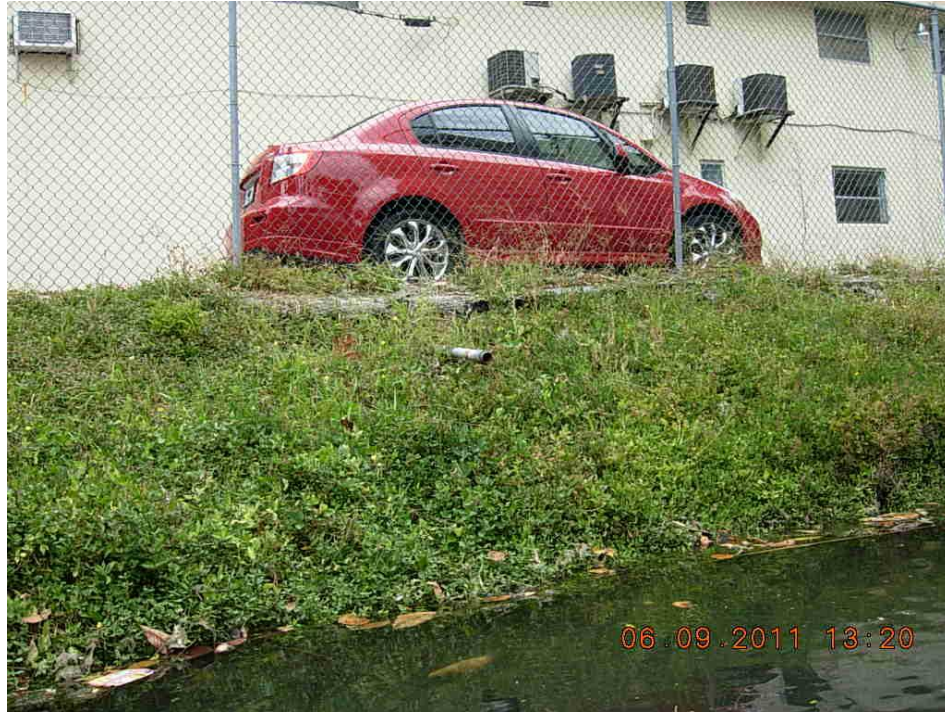
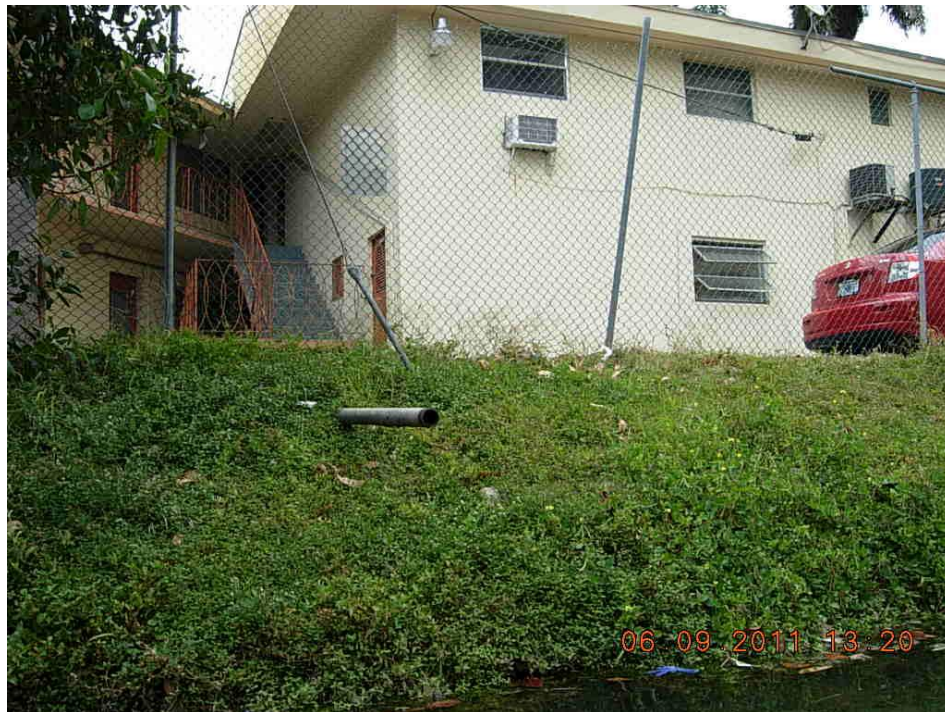
**Figure 64.** Farther south, two 2-inch diameter metal pipes extended from the same apartment complex. The pipes were within 10 feet of each other. GPS coordinates are 25 47' 36.699" N, 80 13' 15.300" W.

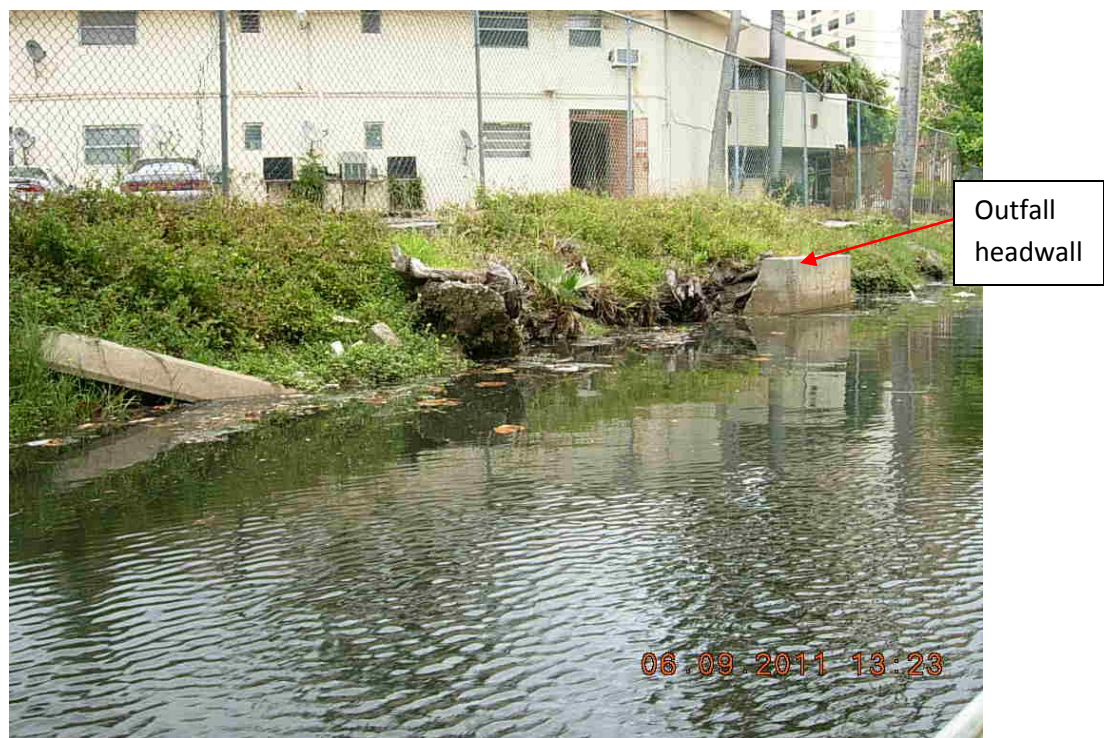
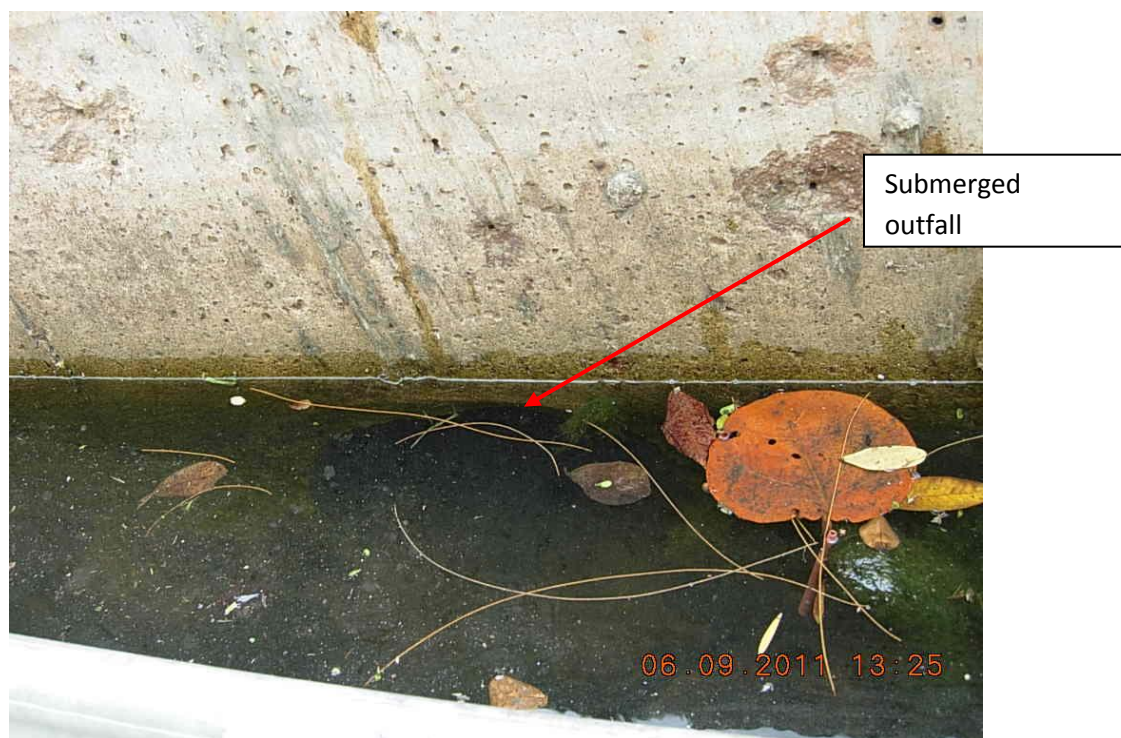
**Figure 66.** Farther to the south, a fully submerged outfall with a headwall also appeared to belong to the same apartment complex. GPS coordinates are 25 47' 35.516" N, 80 13' 13.977" W.

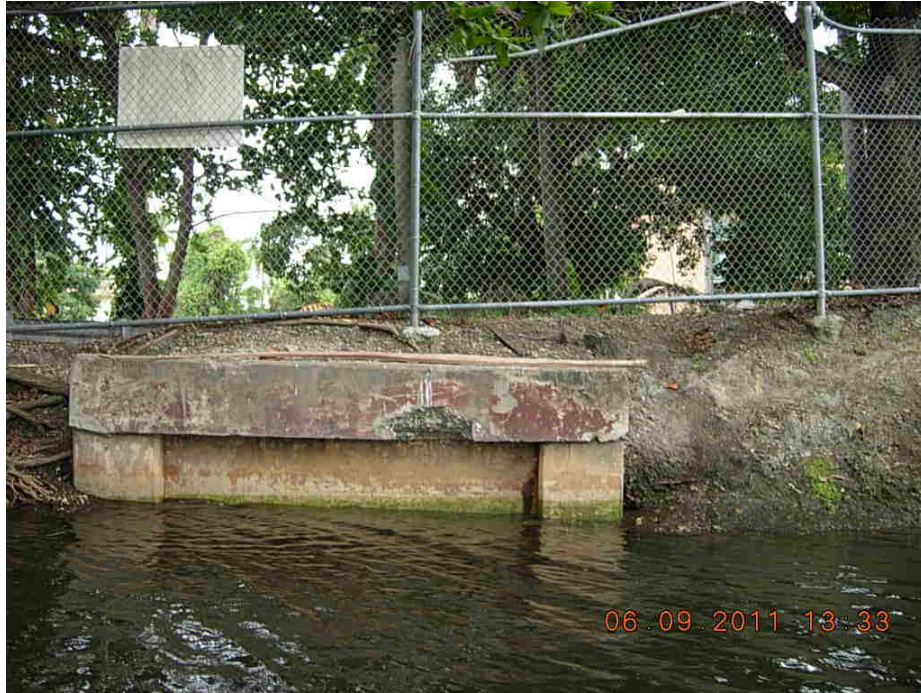
**Figure 68.** A submerged outfall that appears to be from the public storm sewer system is located across the street from NW 19<sup>th</sup> Terrace near the put-in point.

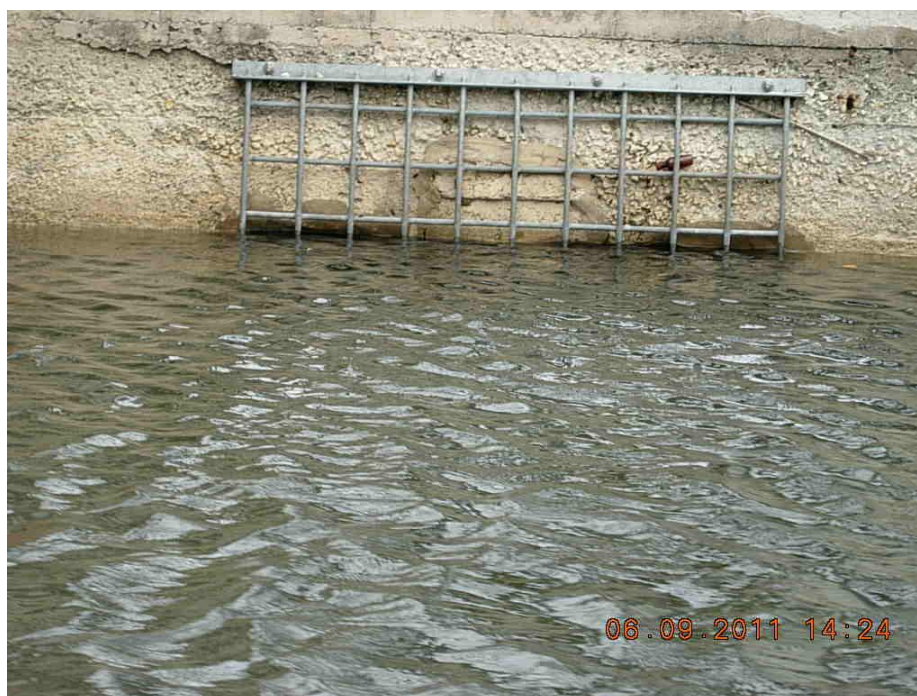
**Figure 74.** A sealed outfall with a manatee grate at NW 7<sup>th</sup> Avenue and NW 7<sup>th</sup> Street. No GPS coordinates were taken.

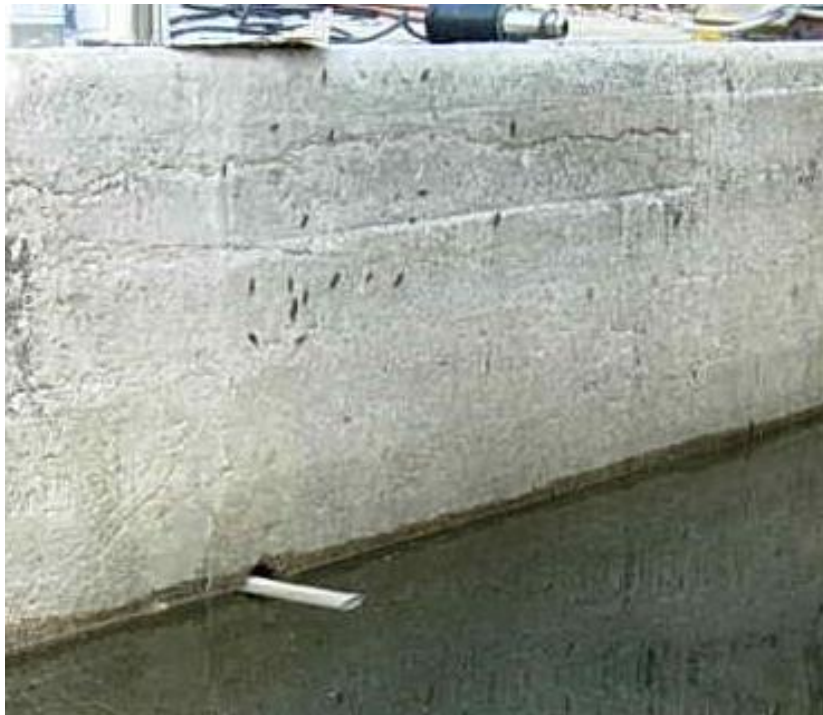
**Figure 78. A 2-inch diameter PVC pipe protruding from a private residence. The approximate address is 922 or 938 NW 8<sup>th</sup> Street. GPS coordinates are 25 46' 57.121" N, 80 12' 29.900" W.**

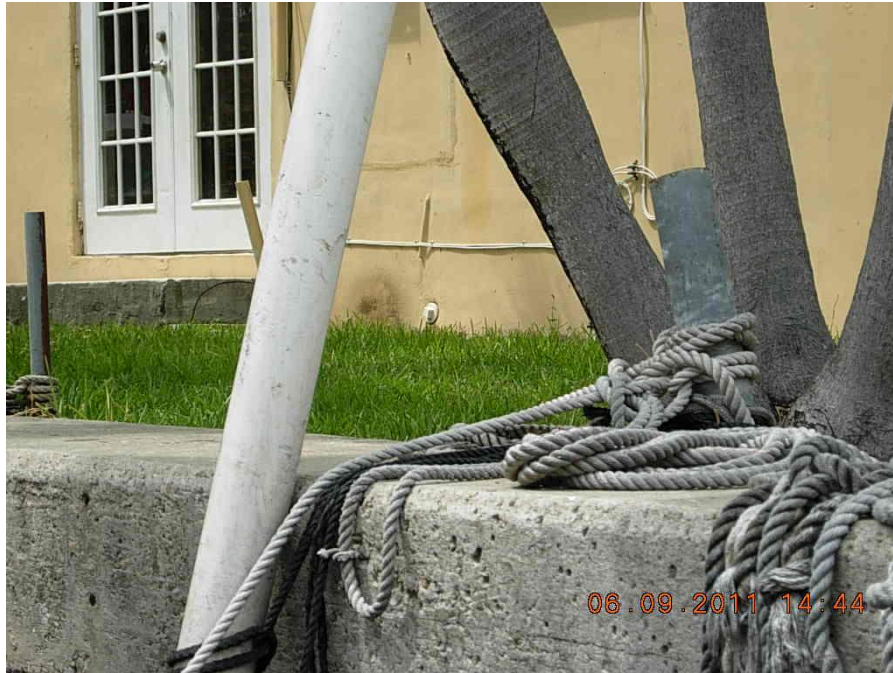
**Figure 79.** A capped lateral (possibly sanitary) at what appeared to be an apartment house. The approximate address is 938-942 NW 8<sup>th</sup> Street. GPS coordinates are 25 46' 57.495" N, 80 12' 31.280" W.

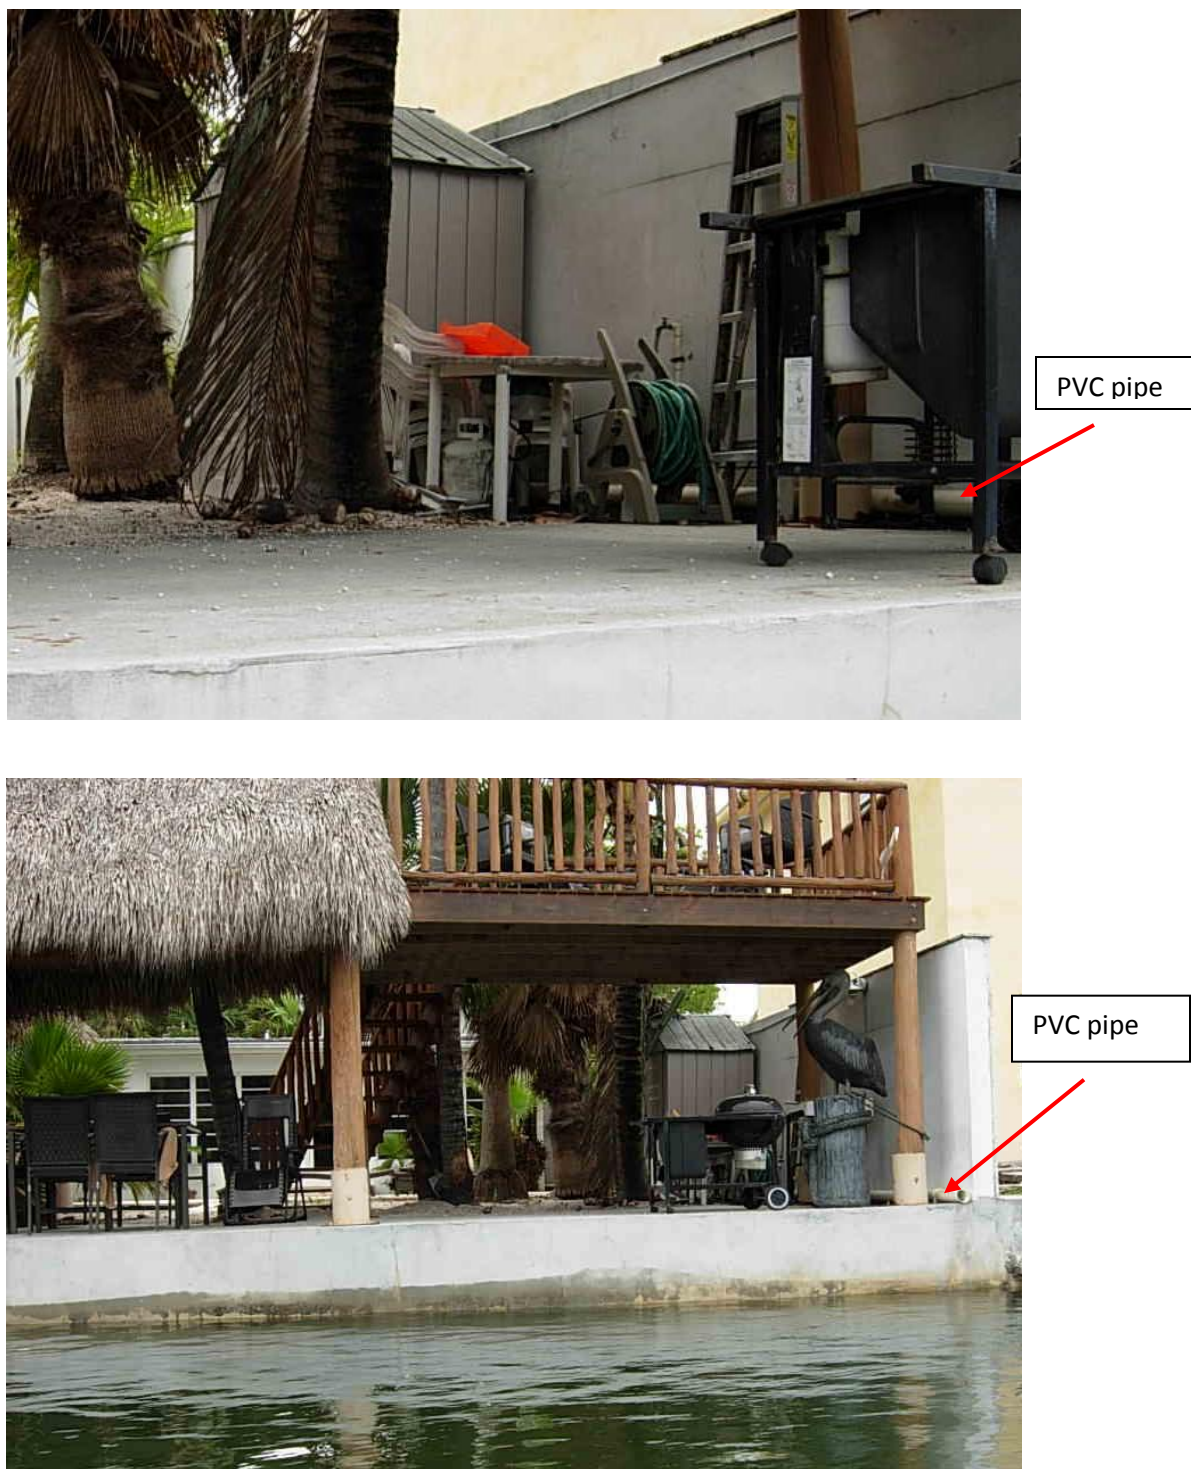
**Figure 81.** At 727 NW 7<sup>th</sup> Street, the team observed a 4-inch white PVC pipe running from the property line at Seybold Canal towards the front of the property.
