# Vessel Mooring Study - Boca Chica Harbor - Monroe County, Florida

## Final Project Report

May 17, 2011

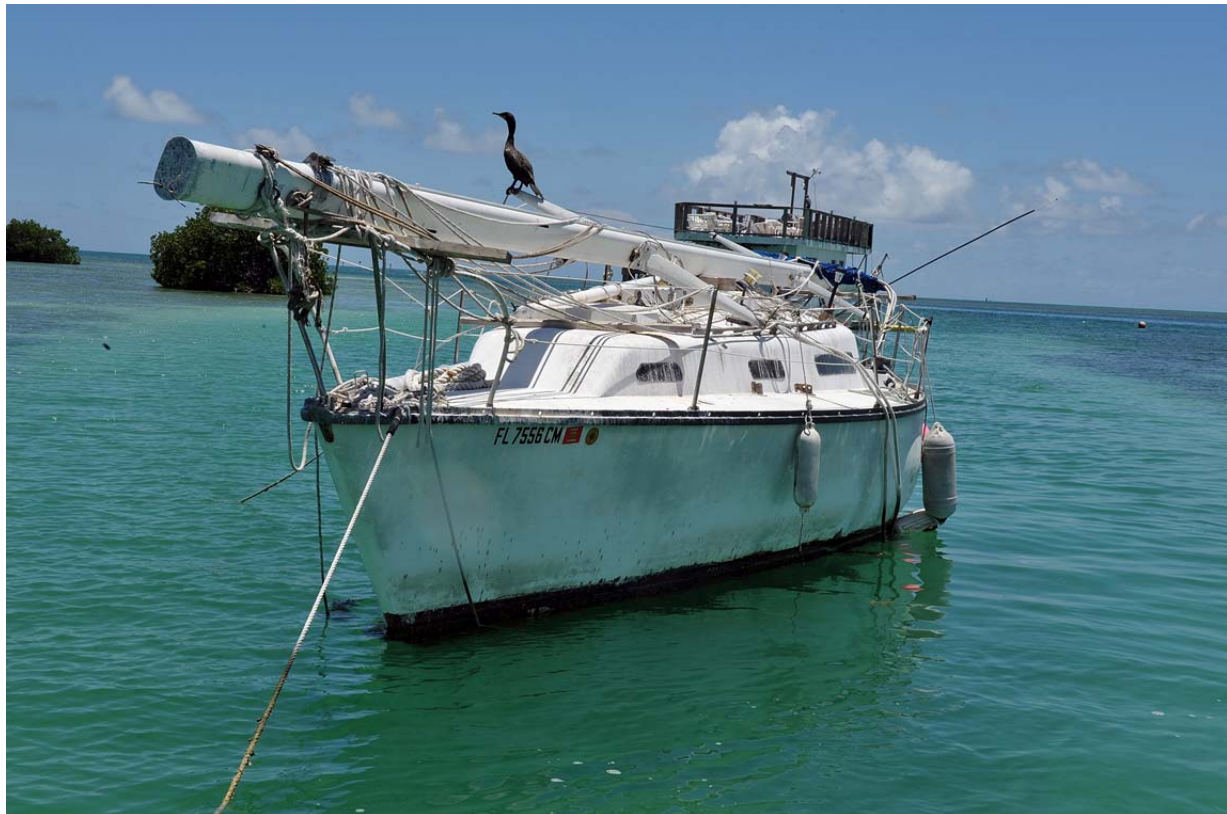
Photo of a stored sailboat. This vessel is not being used as a liveaboard. Seabirds commonly take up residence on stored vessels that are not actively maintained, fouling the vessel with guano.

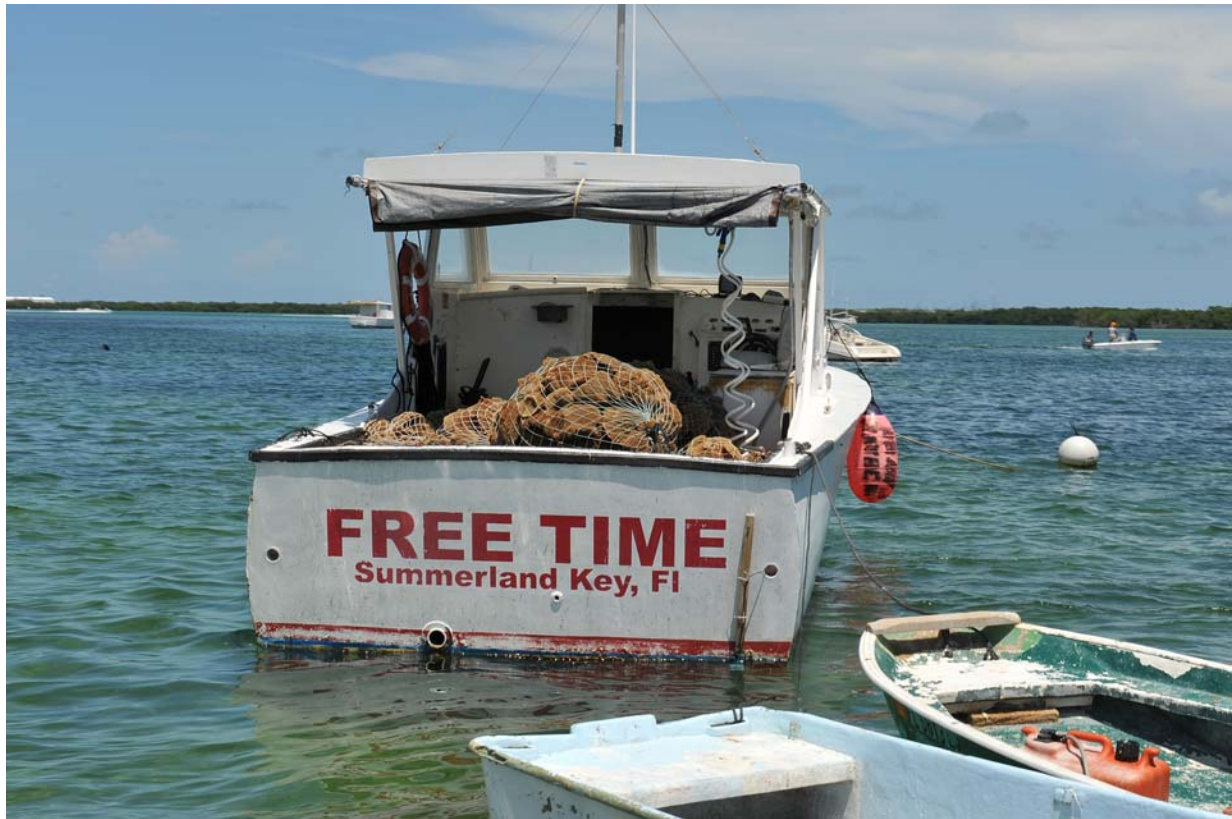
Photo of a stored powerboat being used in support of commercial sponge fishing.
