# **WETLAND MITIGATION EVALUATION REPORT FLORIDA KEYS BRIDGE REPLACEMENT**

**WETLAND MITIGATION EVALUATION REPORT**  
**FLORIDA KEYS BRIDGE REPLACEMENT**  
WPI No. 6116901; SP No. 90000-1560

March 30, 1994

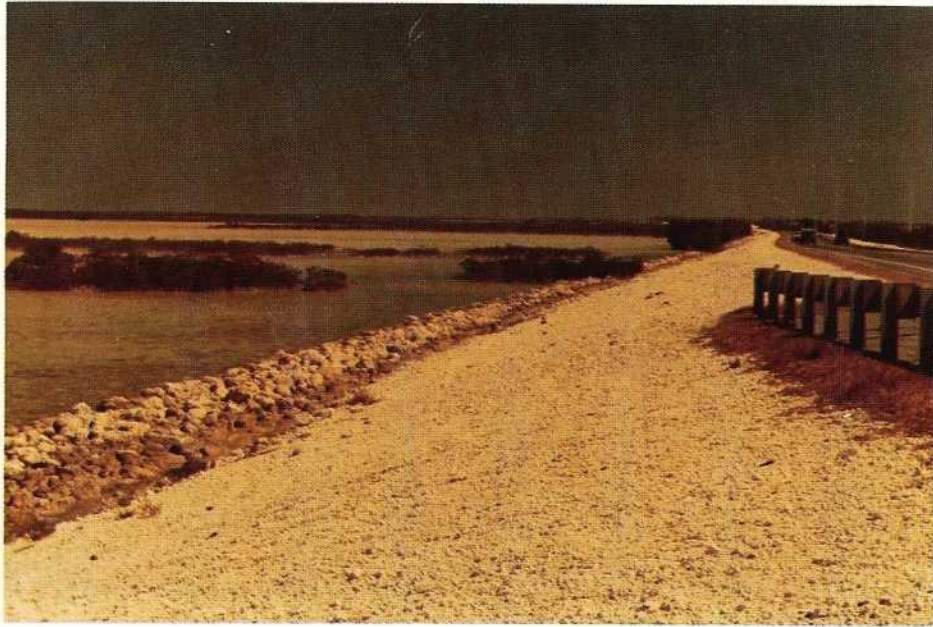
Figure 6. Shark Channel, Miami Gulf side, view east, 2/81.

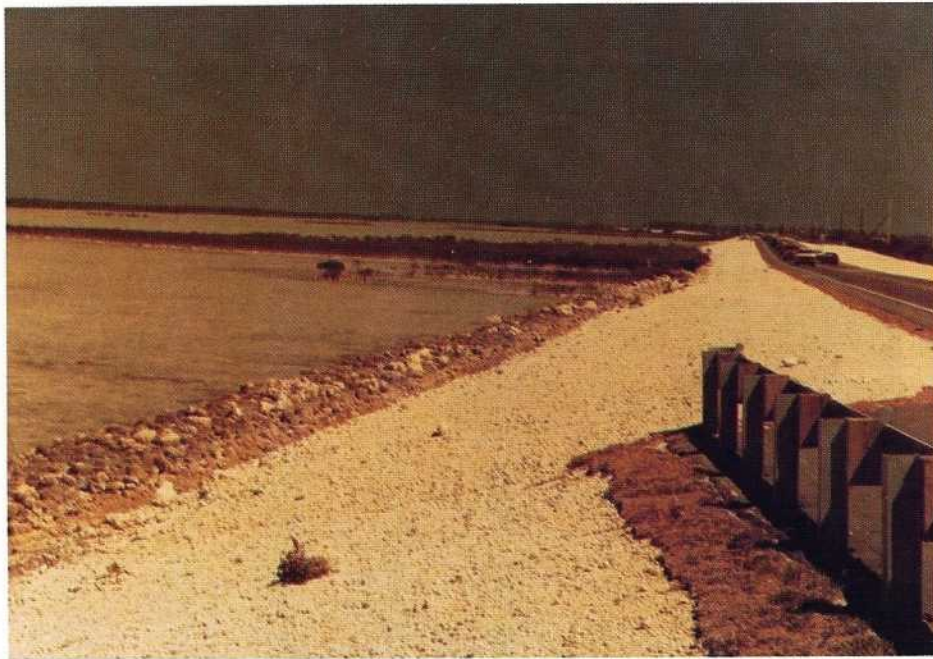
Figure 8. Saddlebunch #5, Miami Gulf side, view east, 2/81.

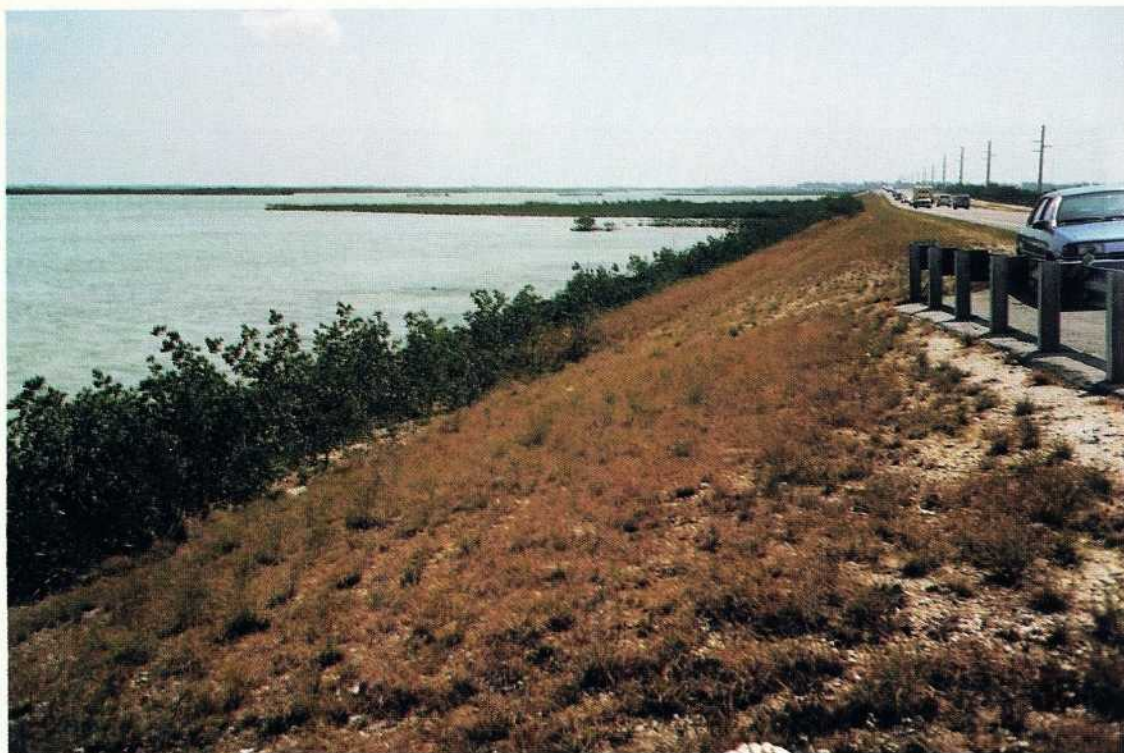
Figure 9. Saddlebunch #5, Miami Gulf side, view east, 5/93.

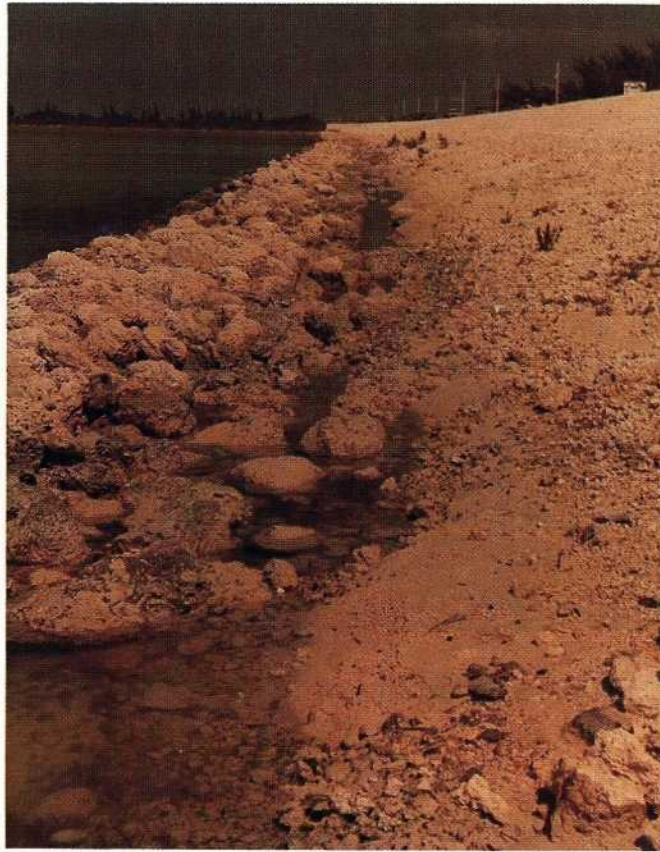
Figure 10. Saddlebunch #2, Miami Gulf side, view east, 2/81.

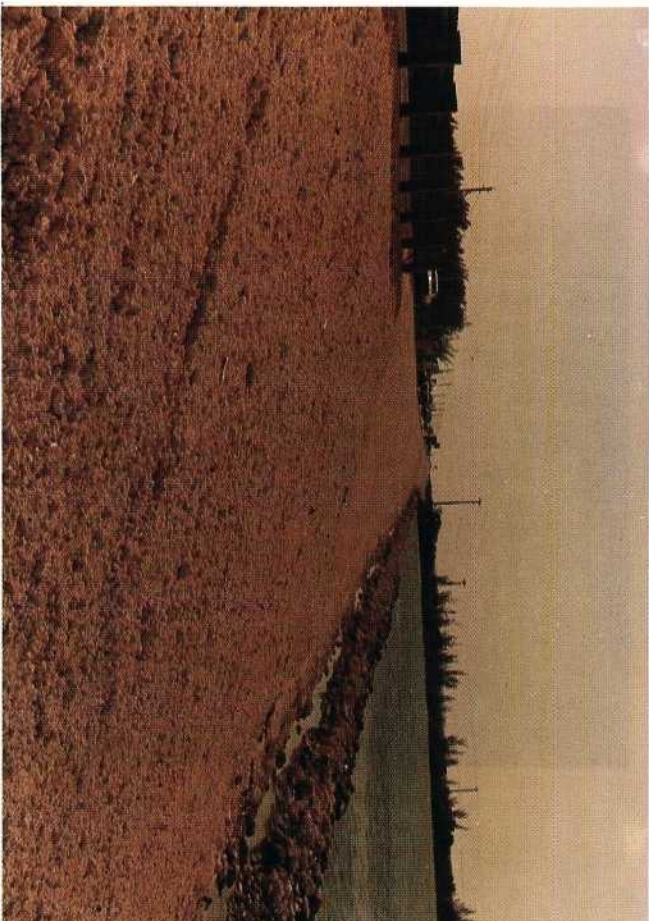
Figure 12. Lower Sugarloaf Channel, Key West Gulf side, view west, 2/81.

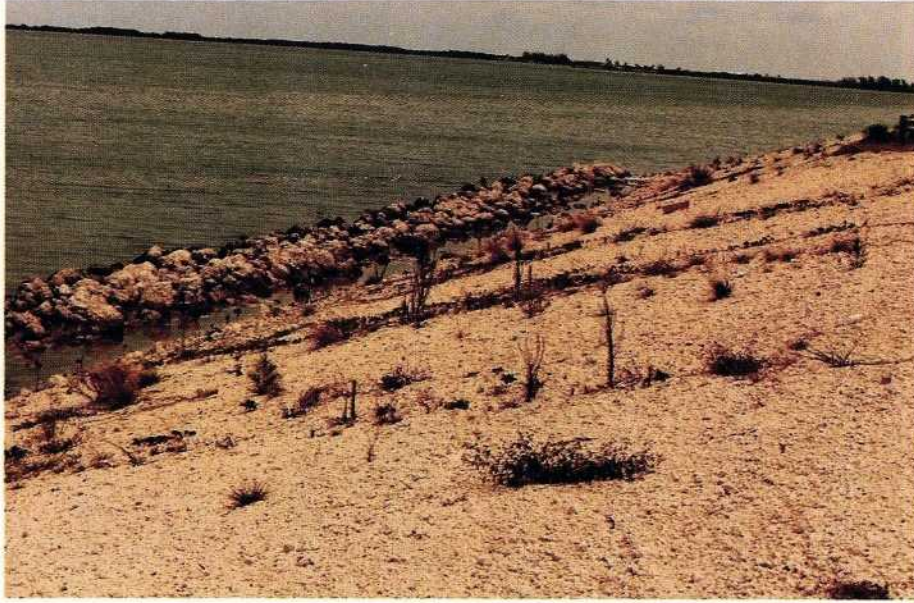
Figure 14. Lower Sugarloaf Channel, Key West Gulf side, test plantings (mulch) on slope, view east, 4/82.

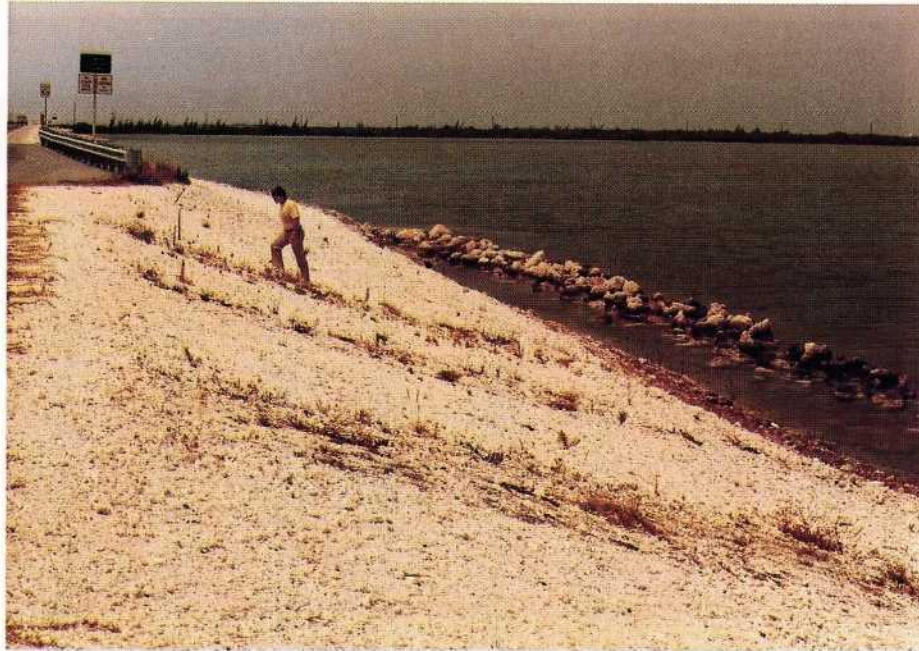
Figure 16. Lower Sugarloaf Channel, Miami Gulf side, view west, 4/82.

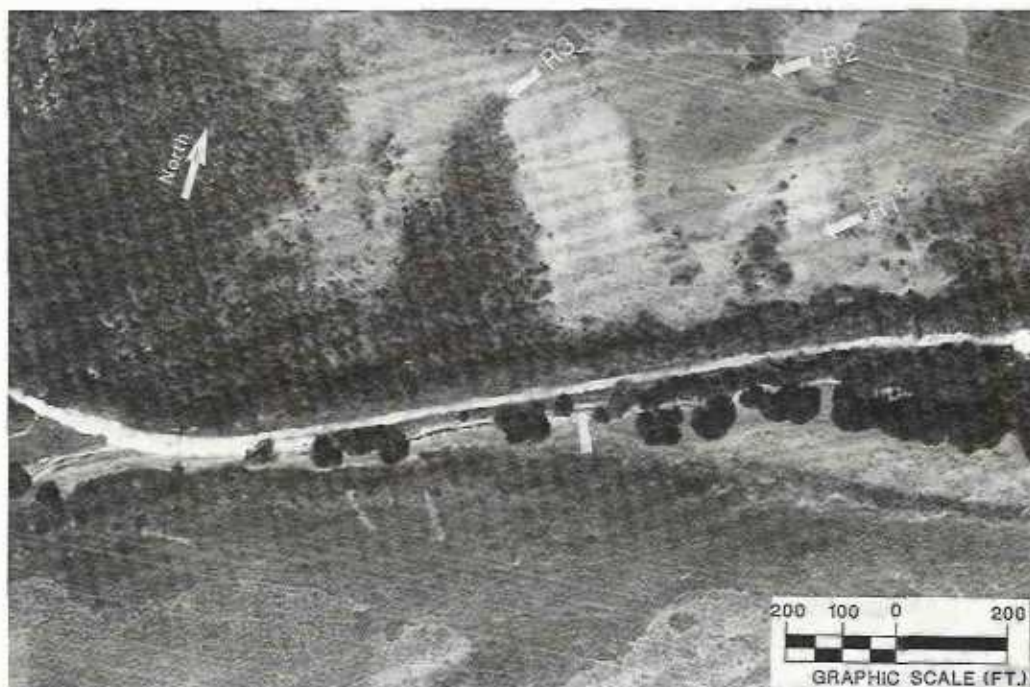
Figure 19. Vertical aerial photograph taken February 25, 1981, of the south side of the Boca Chica Lagoon at the location of culvert C4. Reference points R1, R2 and R3 are also shown below. Arrow indicates future location of culvert (see below).

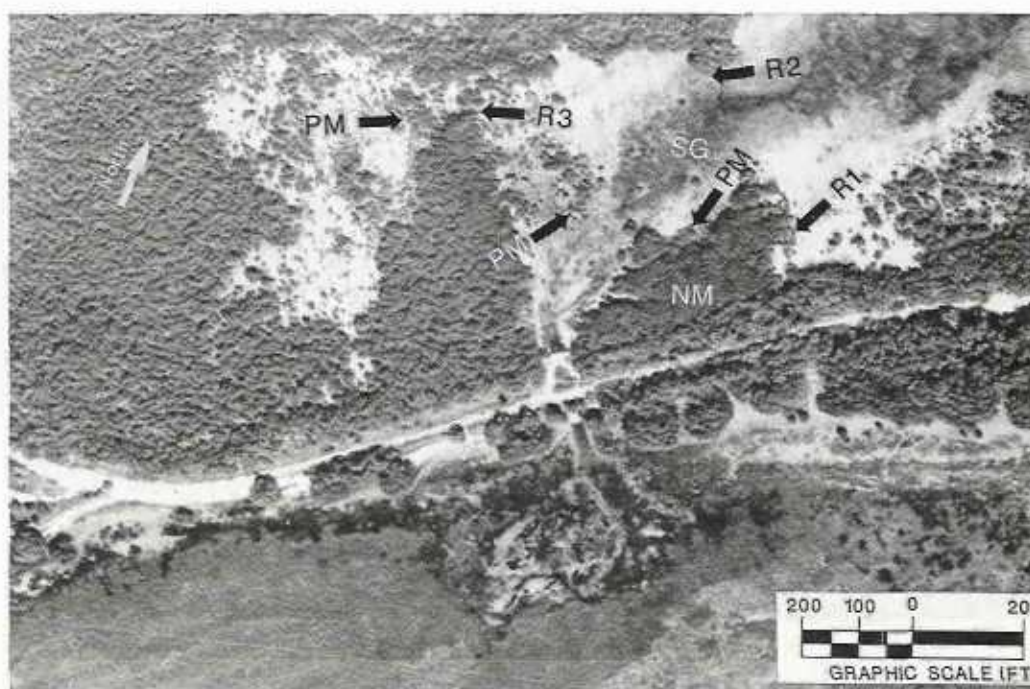
Figure 20. Vertical aerial photograph of the same site, taken February 17, 1991. Reference points are the same as above. R1 indicates a square planted mangrove plot. NM indicates new volunteer mangroves mixed with additional planted mangroves (PM) and SG new volunteer seagrass.

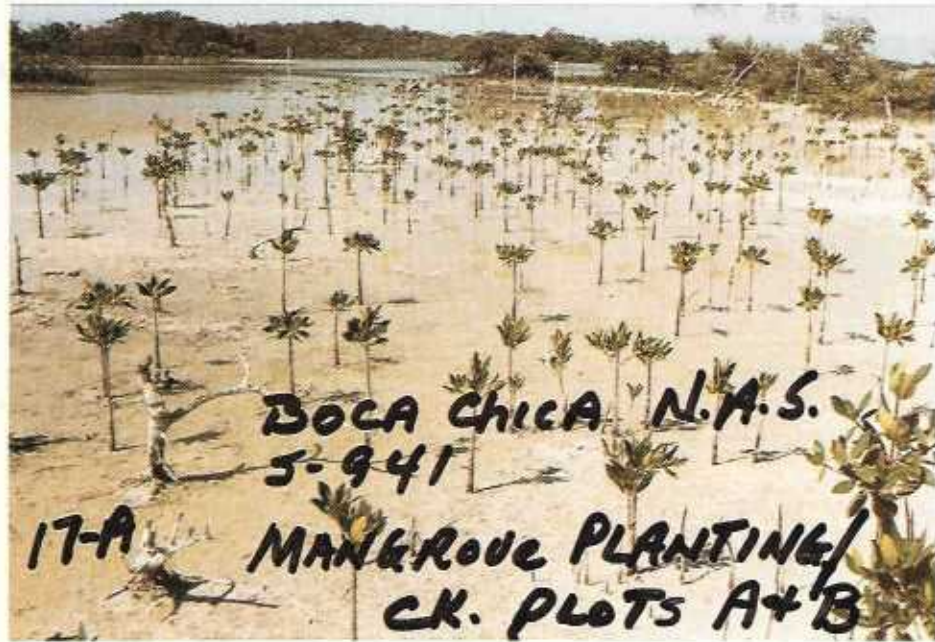
Figure 21. Typical planted red mangroves at culvert C-4, Boca Chica Lagoon, 1985.

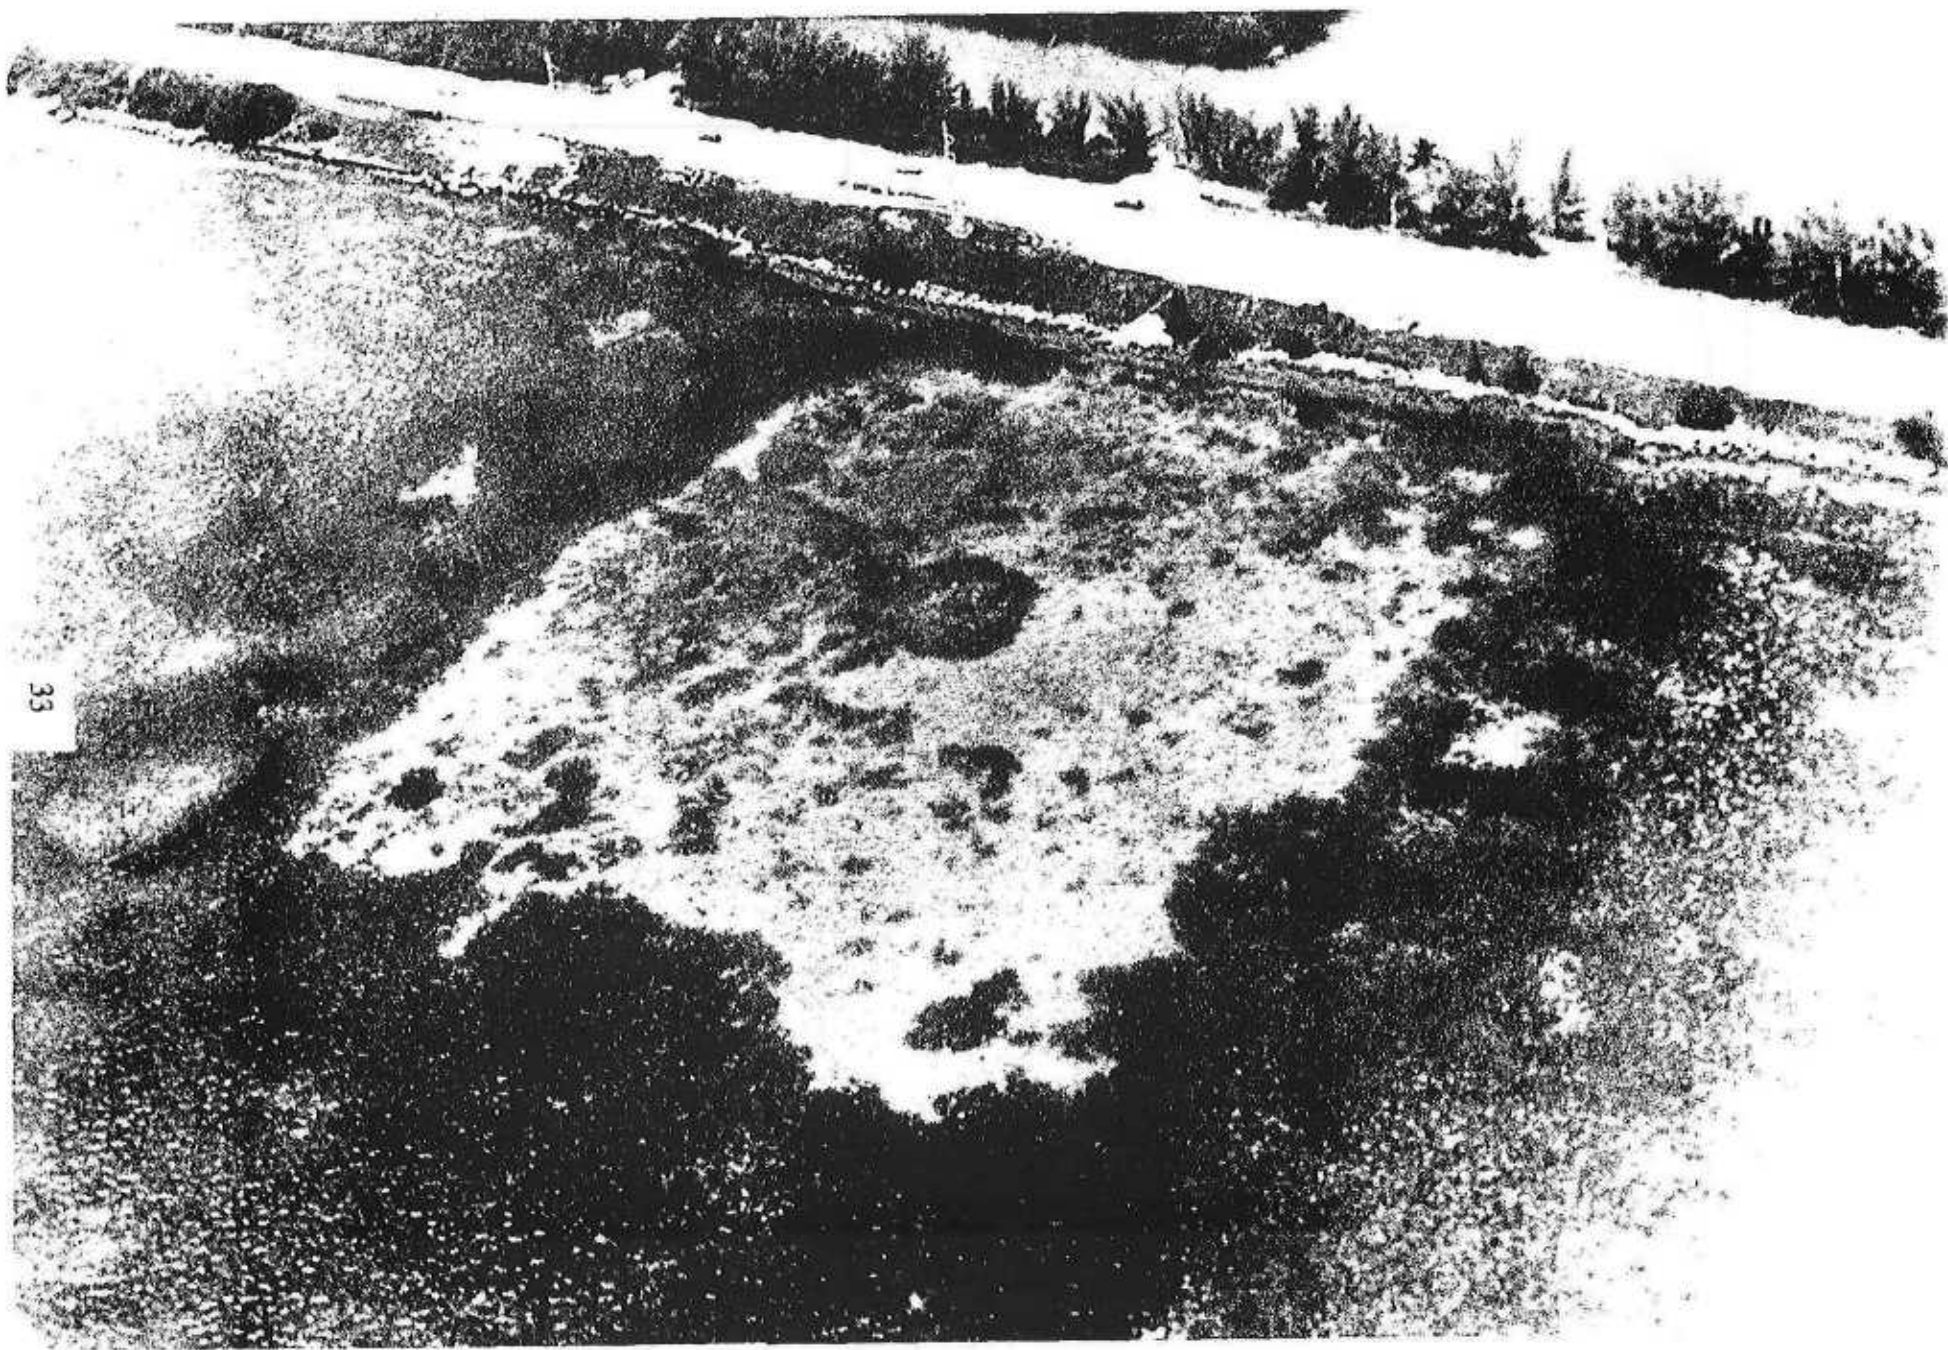
The Craig Key site is located on the southeast side of Craig Key and consists of a 3.4-acre borrow pit that had silted in with fine calcareous sand and silt since its creation during dredging activities approximately 35 years earlier (Figure 26). Water depths averaged 1.2-1.5 m at mean low water and the area was surrounded with a shallow (0.3-0.6 m MLW) sill, probably corresponding to the original undisturbed bottom. This adjacent area was well-vegetated with *Thalassia testudinum*. A large portion of the site was vegetated with green algae or colonizing seagrasses (*Thalassia*, *Halodule*, *Thalassia-Halodule* mixture). Approximately 25% of the site was largely barren of vegetation (Lewis and Phillips 1981).

FIGURE 26. Oblique aerial photograph taken August 15, 1980, of the Craig Key seagrass restoration site.

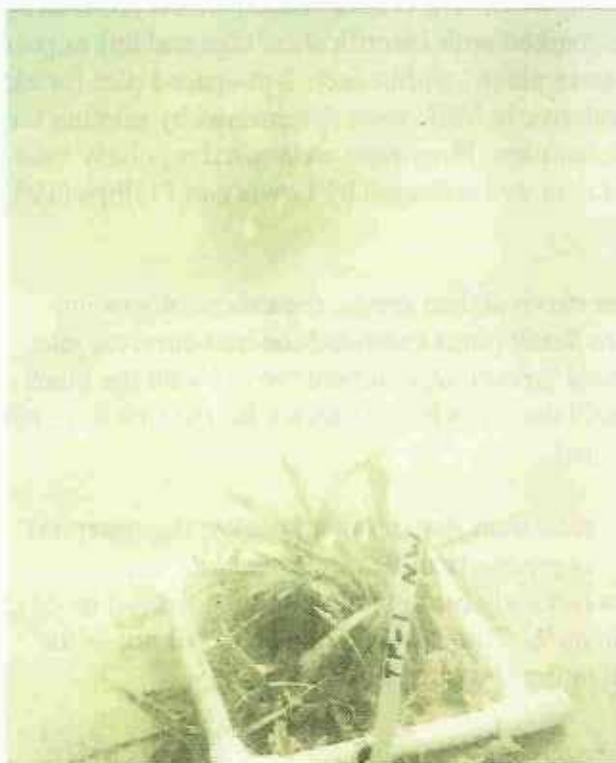
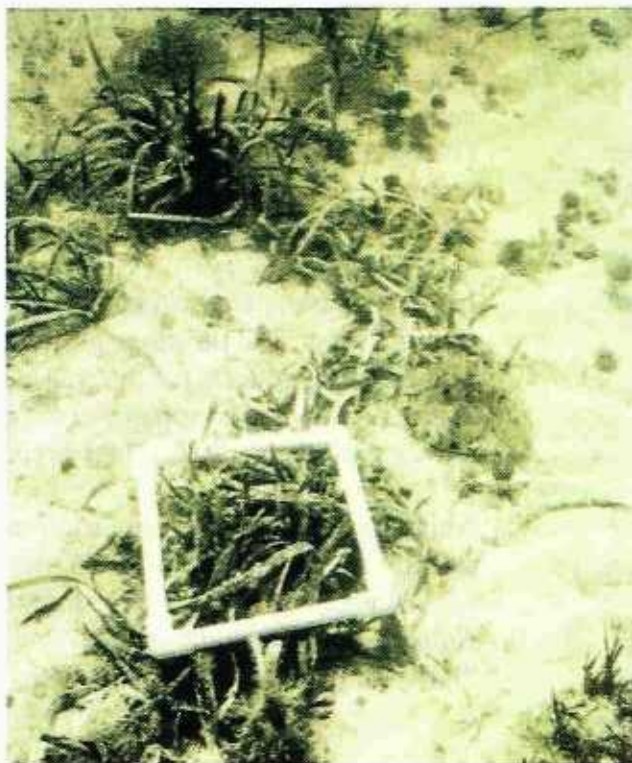
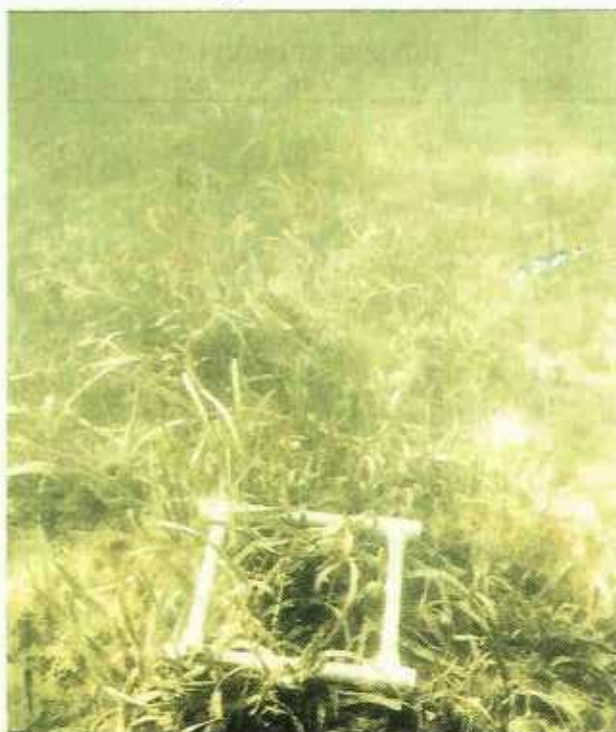
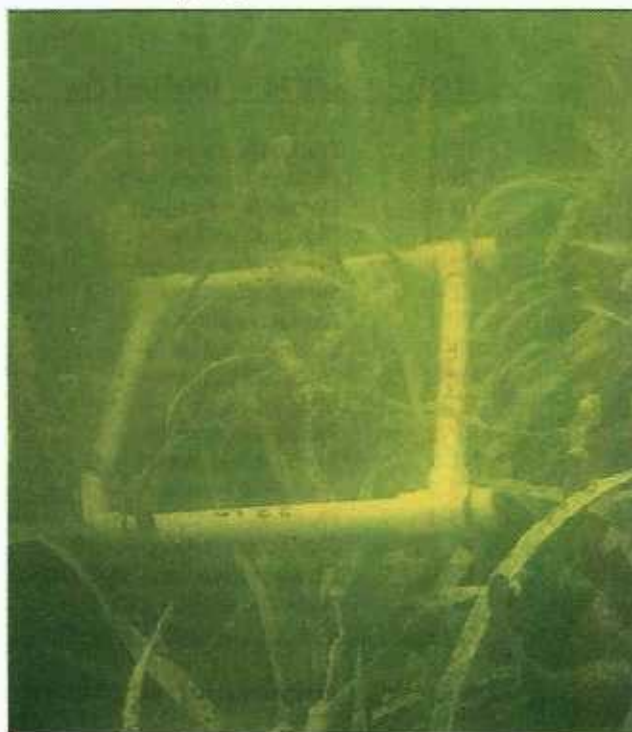
Figure 28. *Thalassia* plot TP-1, Craig Key

Although *T. testudinum* plug survival was greater than that of other species, the observed spread of both *H. wrightii* and *S. filiforme* was greater than that of *T. testudinum*. Coalescence (meeting of spreading rhizomes from adjacent planting units) occurred in *Halodule* plots within 6 months, and in *Syringodium* plots within one year, but not in the *Thalassia* plug plots until 18 months after planting (Figures 28, 30, 31).

The 1993 mapping (Figure 34) indicates that the 3.4-acre borrow pit, which originally (1979) had a total seagrass cover of only 25% (21.8% *Halodule*, 3.3% *Thalassia*) with 74% cover by algae and bare sand, had achieved 58.9% cover by seagrass in 1993 (39.8% *Thalassia*, 14.7% *Halodule* and 4.4% *Syringodium*); algae and bare sand area was reduced to 41.1% (Figure 34). Exactly how much of this increase was due to planting and how much to natural recolonization cannot be determined. Only two of the eight planted test plots could be definitively located during the monitoring. These were the SP-1 plot (*Syringodium* plugs on one meter centers, Figure 30D) and the TP-1 plot (*Thalassia* plugs on one meter centers, Figure 28D).

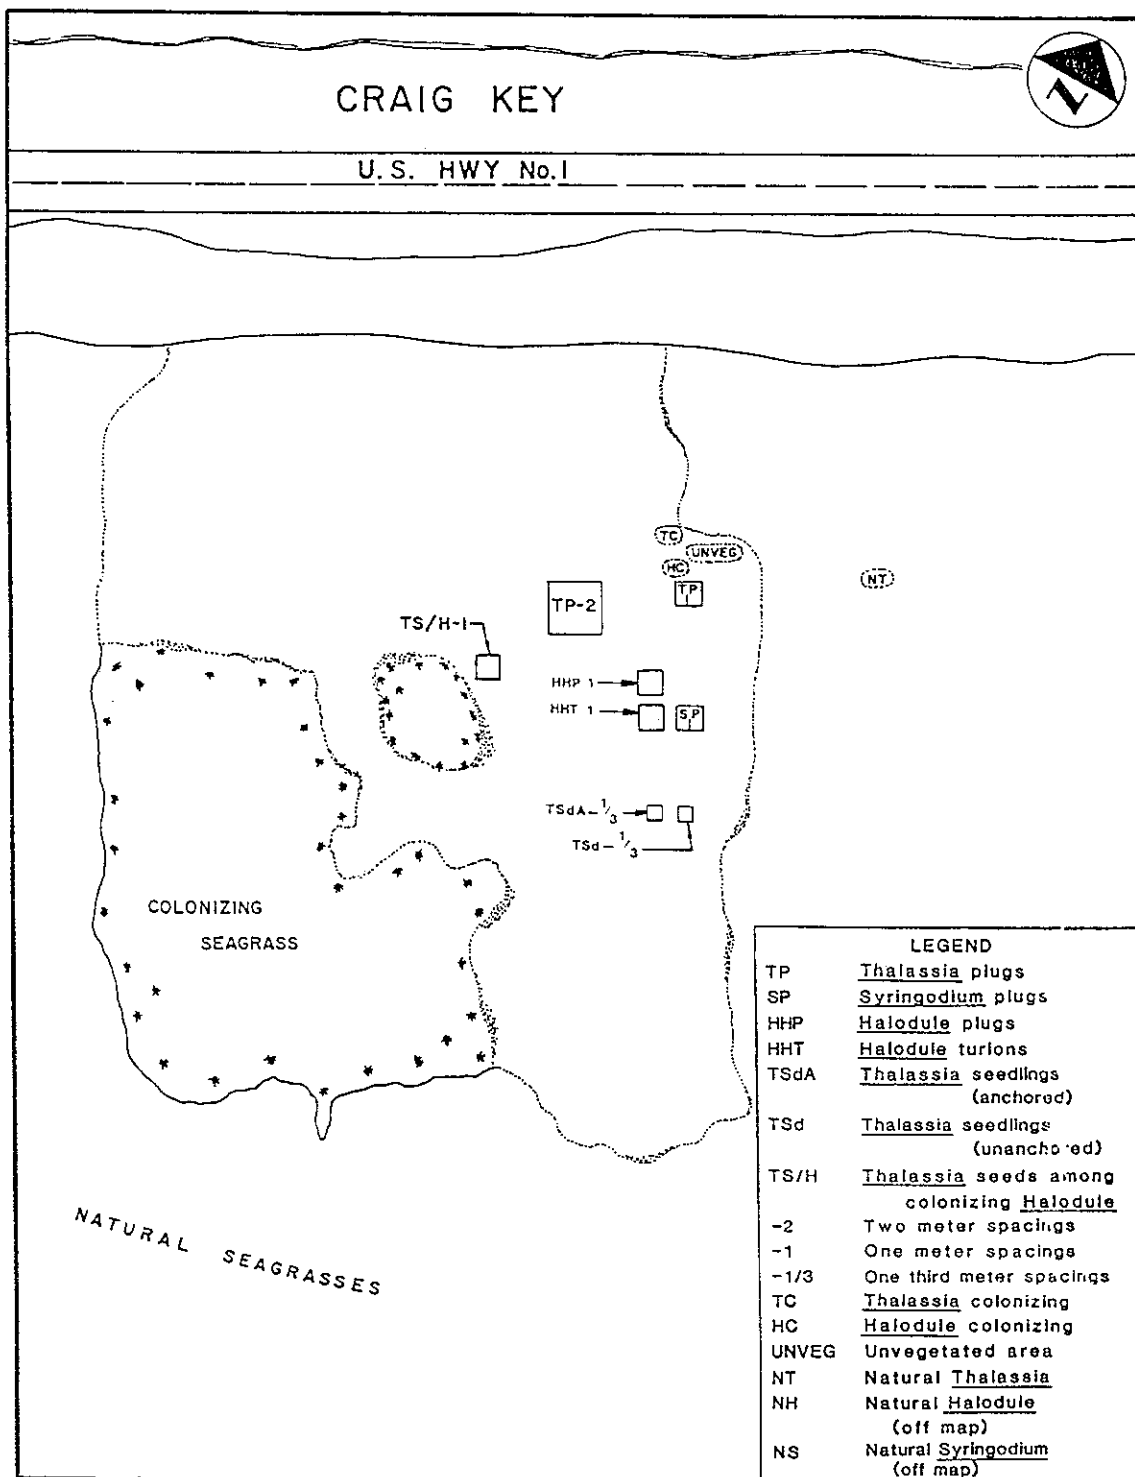
Figure 29. From CSA 1982.

In all instances, plug material showed greater survival than sprigs, regardless of spacing (Figure 29). Of all the plugs planted, *T. testudinum* plugs exhibited the best survival rate. This probably reflects the difference in the total amount of sediment moved with the plant material. Survival of sprigs was approximately the same for all species for the first 6 months; however, all the sprig plantings eventually failed.

Of the 18 planting/methodology combinations tested, only three proved successful (Figure 29, Table 4). All three involved the transplanting of large (22 cm x 22 cm) intact plugs of seagrass. *Thalassia testudinum* plugs spaced at 1 m showed 98% survival after 36 months; those spaced at 2 m showed 90% survival. Survival of *S. filiforme* plugs spaced at 1 m was lower (61%, Table 4), but coalescence had occurred by 12 months after planting (Figure 30). Bioturbation by large, burrowing callianassid shrimp was possibly a major factor limiting seagrass survival. Thorhaug (1979) also felt that bioturbation was a factor contributing to the loss of *Thalassia* seedlings. Suchanek (1983, p. 281) has since shown experimentally that "transplants of turtle grass ... into regions of high ... *Callianassa* density produced a dramatic deterioration of *Thalassia* within 2-4 months."

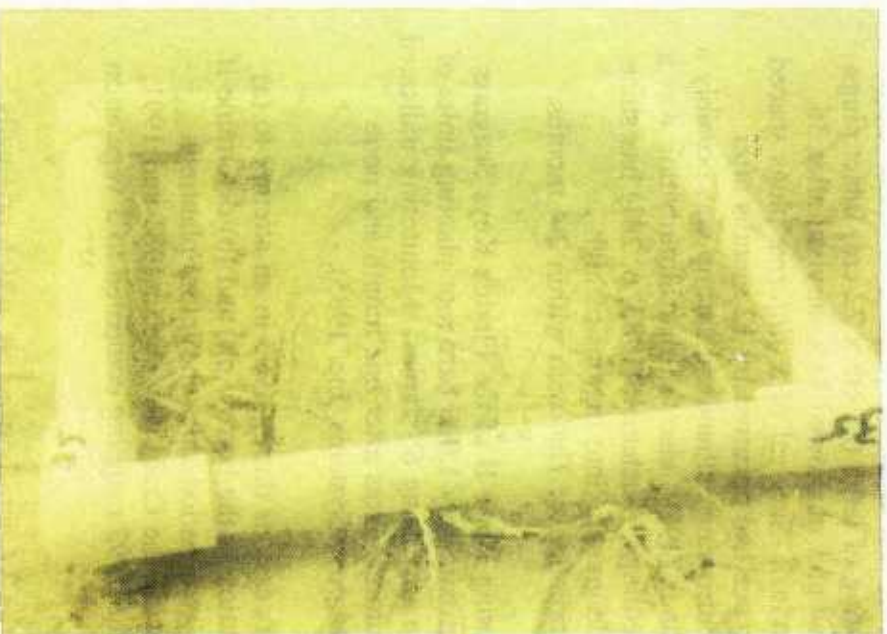
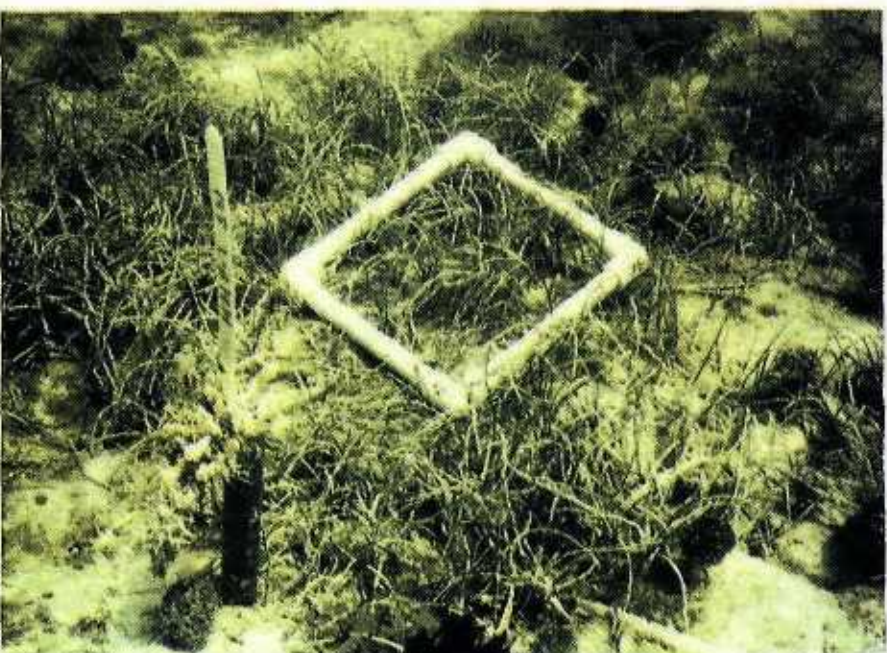
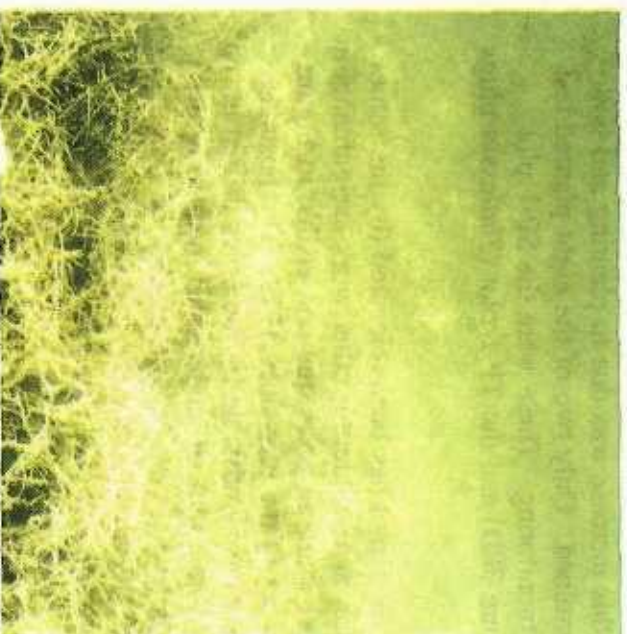
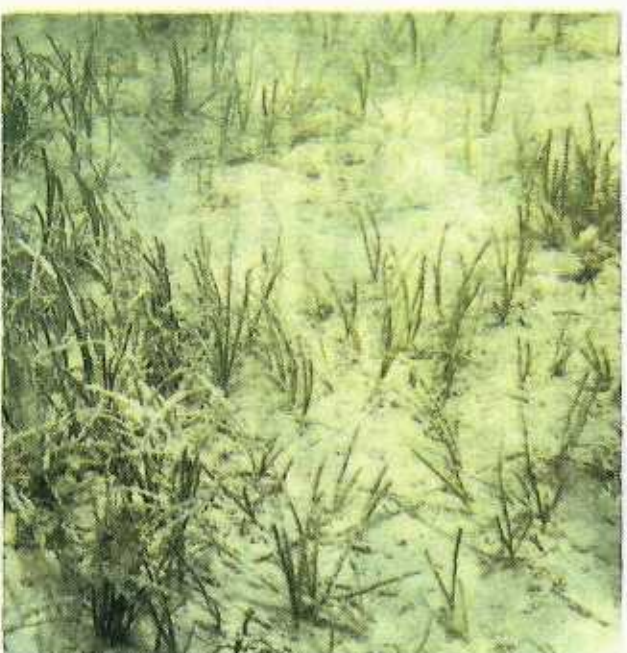
Figure 31. Halodule plot HHP-1, Craig Key.

These two plots could be located because the SP-1 plot has been relocated (by the senior author) at least annually since its initial planting in 1979 during other work assignments in Monroe County. One of the four unique corner marking posts (the one visible in Figure 31A) has been maintained at the southwest corner of the plot since 1979. The posts are unique in that even without the marked tag they are identifiable by the holes drilled in the side. Knowing this was the southwest corner of that plot, an underwater measuring line was placed between it and the shore to determine where the inshore patches of *Thalassia* began. The *Thalassia* patch visible in Figure 34 (with star) directly north of the *Syringodium* area (with star) begins exactly where one would expect to encounter *Thalassia* originating from the TP-1 planting. In addition, a stake with the unique extra hole was located in the patch. While this is not definitive, it generally supports the "planted" origin of this plot.

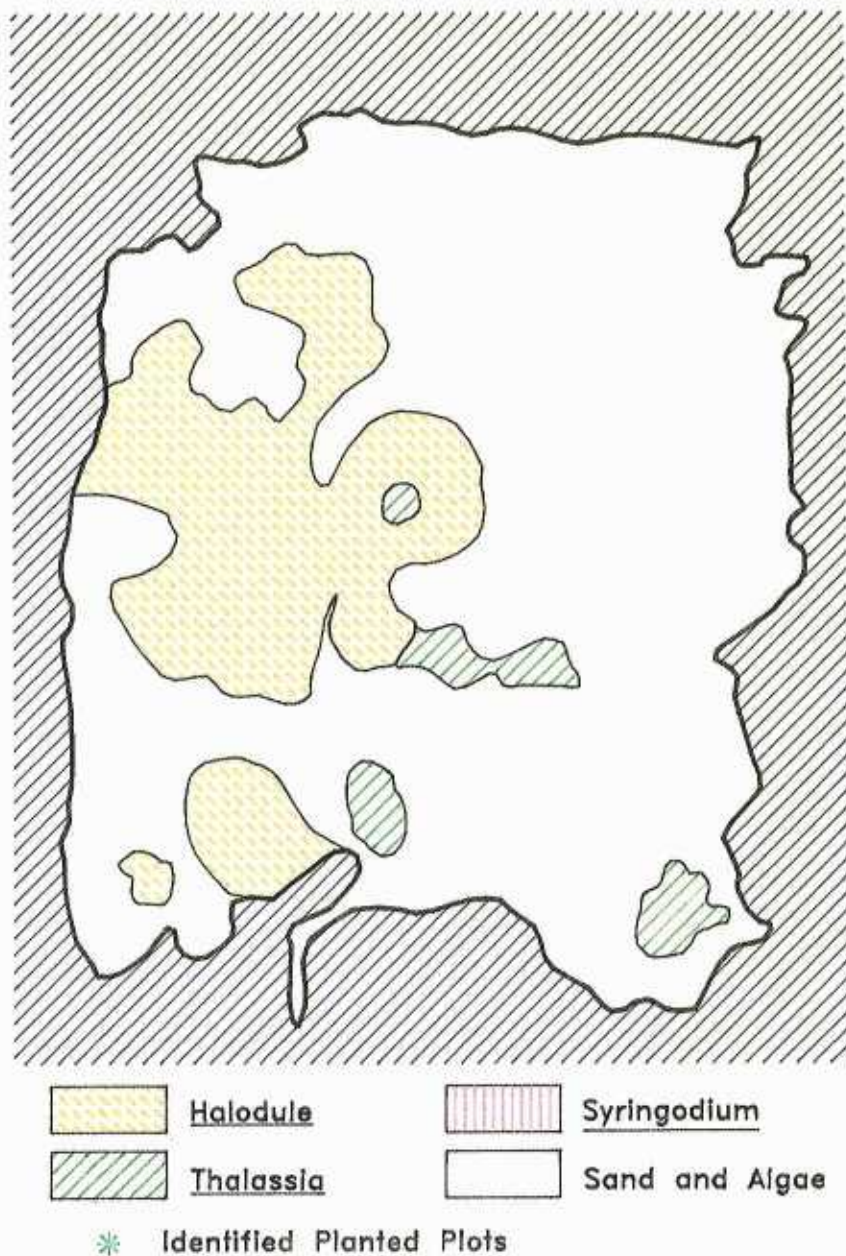
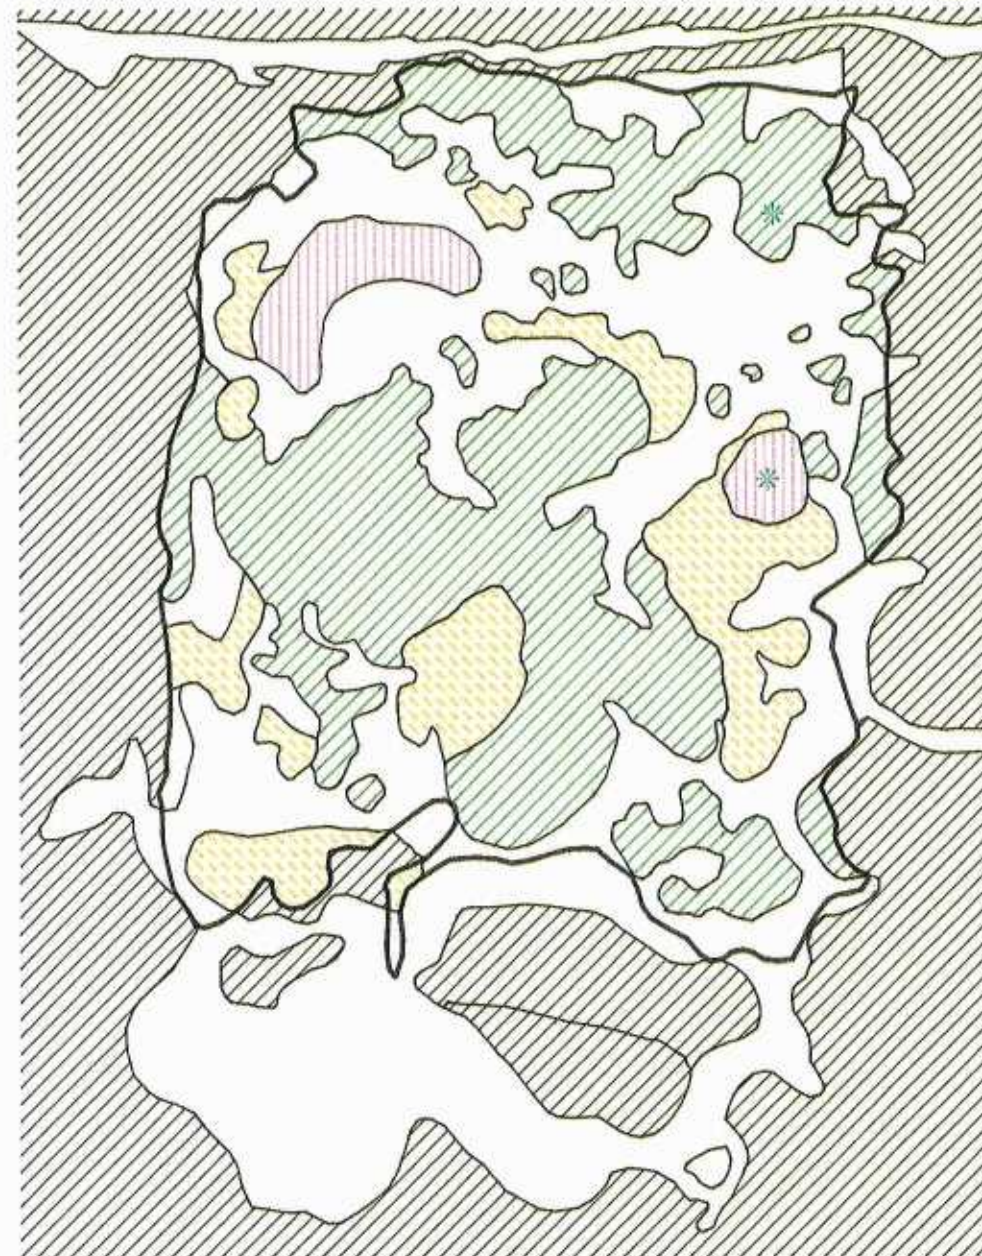
Figure 34. Submerged aquatic vegetation maps of Craig Key, 1979 and 1993.

As to the origin of the balance of the "new" seagrass, it is likely that at least some of the several thousand seagrass units (seeds and seedlings) installed between 1979 and 1983 and subsequently "lost" did not die or leave the site due to currents, but simply were relocated by activities in the pit. It has been observed over the years that the pit is a popular shoreside fishing site, small boat launching point, swim, dive and snorkel area, and frequent crossing point for boats traveling in the area.

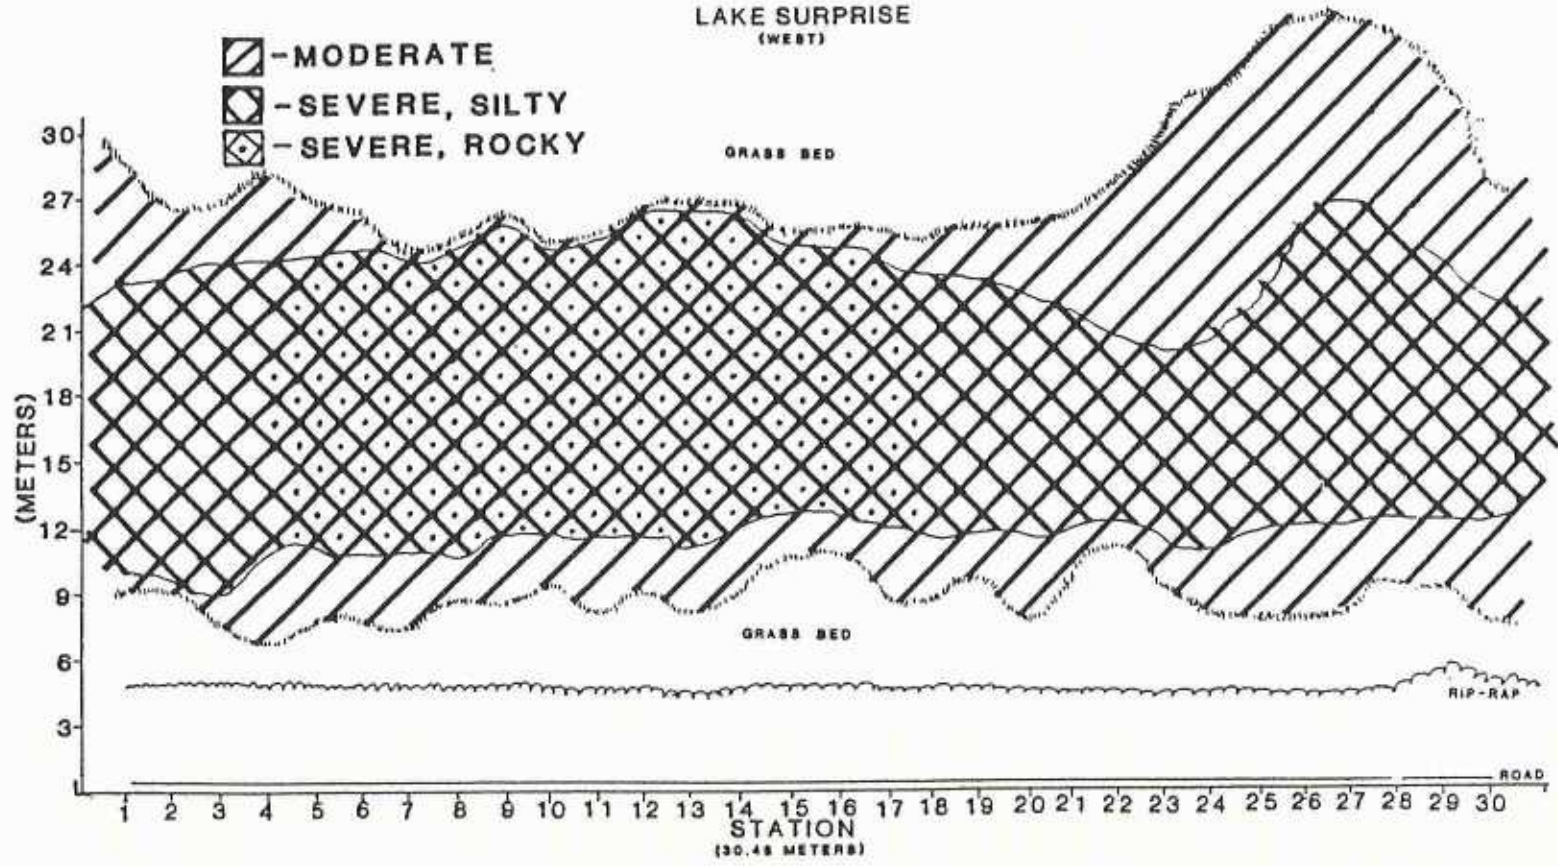
Figure 35. From Derrinbacker and Lewis 1983.

The pipeline construction left two types of impacted areas (Figure 35): a "moderately" impacted area, located along either side of a "severely" impacted strip. The moderately impacted area still had the original water depth (1 m), sediment type (shell hash), and topography, but the seagrass had been removed. This area had not been excavated, but had been disturbed by construction activities. The severely impacted area had been completely excavated to a depth of about 4 m below MSL; the 1-m-diameter pipeline was installed, and the area was backfilled (June 1981). After construction, this area was generally deeper (1.5-3 m), irregular in topography, and consisted mainly of two types of substrate: one was an unstable, fine, silty sediment up to 1 m deep; the other consisted of limestone rubble of various sizes.

LOCATION OF MODERATELY AND SEVERELY IMPACTED AREAS

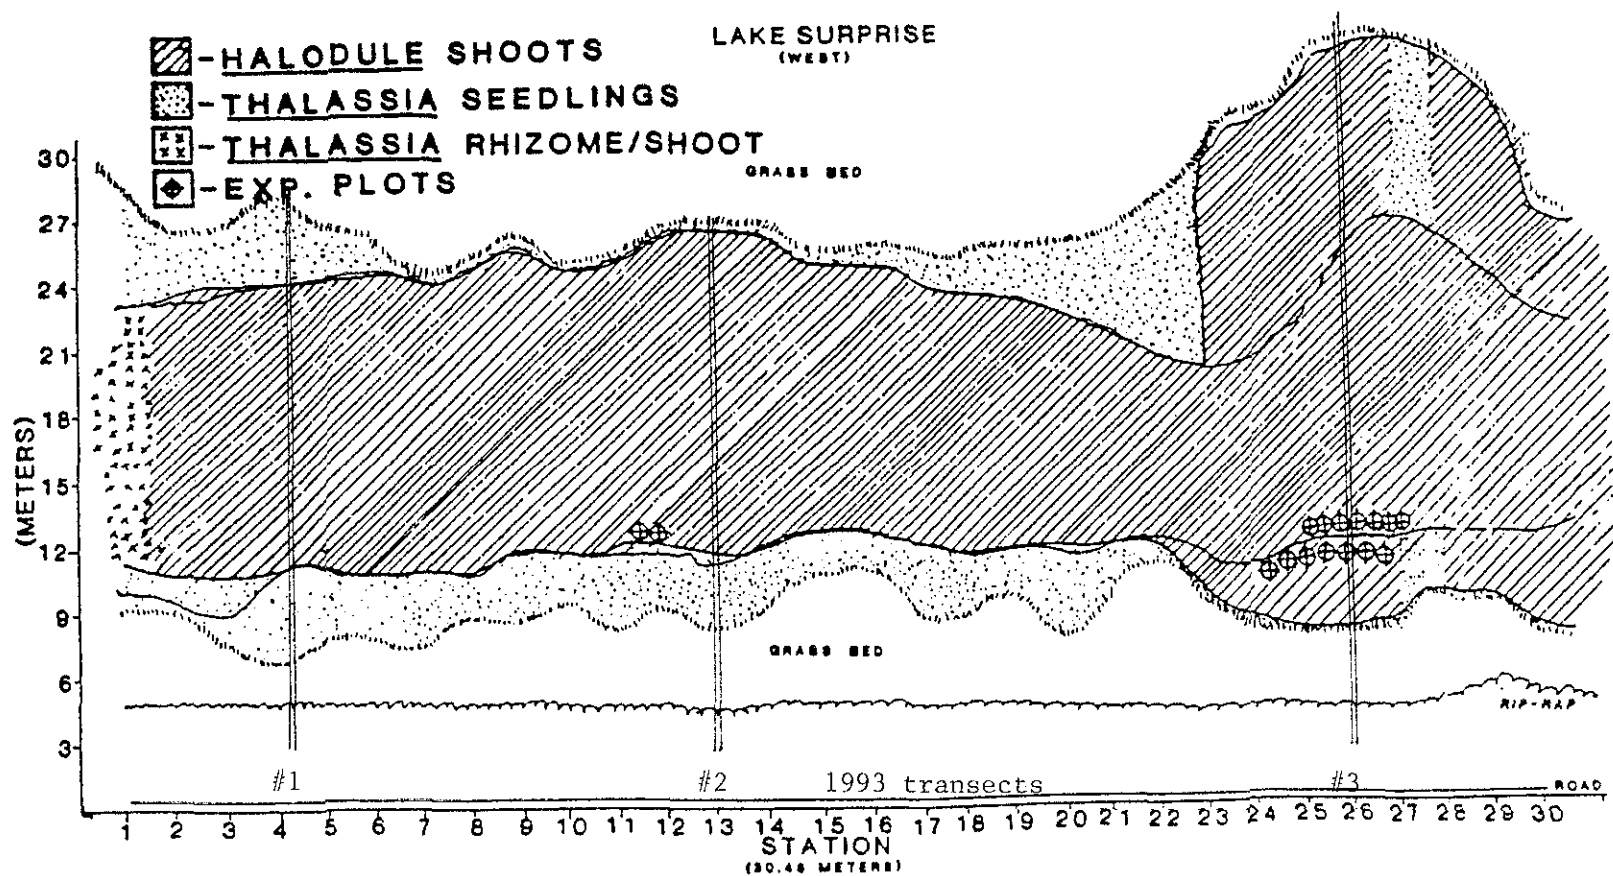
Figure 36. From Derrenbacker and Lewis 1983.

- 1) *Halodule wrightii* planted in a moderately impacted shell hash area, a severely impacted fine silt area, and a severely impacted rocky area;
- 2) *Thalassia* seedlings broadcast over moderately impacted areas;
- 3) *Thalassia* rhizomes with short shoots planted in a severely impacted fine silt area.

AREAS TRANSPLANTED WITH HALODULE AND THALASSIA  
BY MANGROVE SYSTEMS, INC.

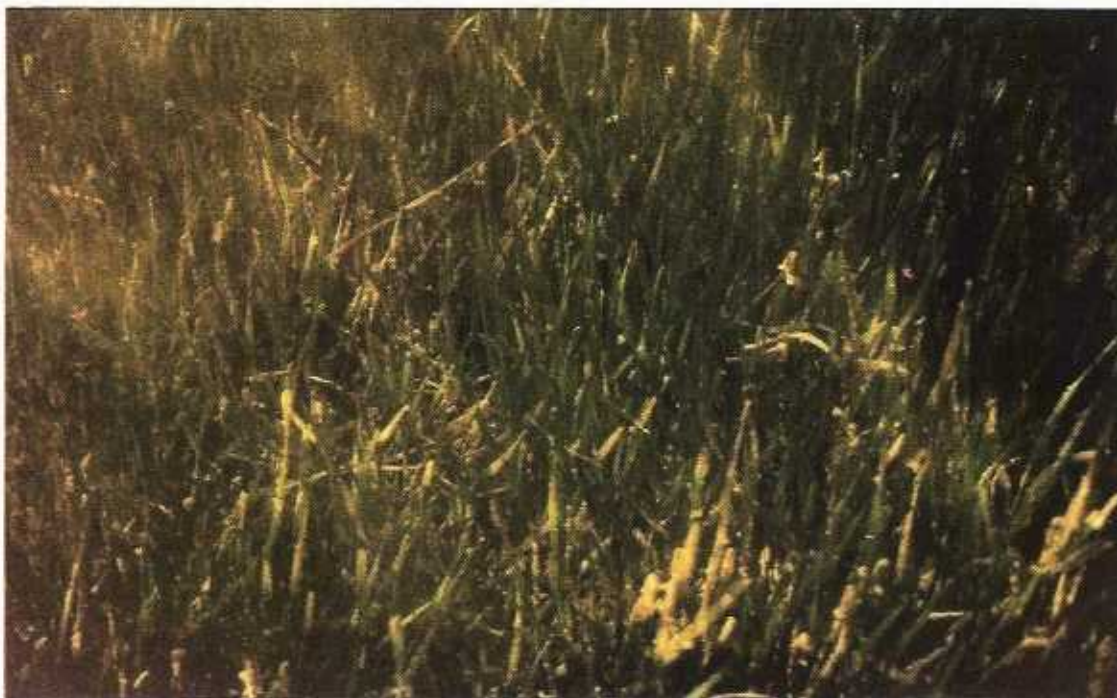
It is apparent from the data (Tables 6 and 7) and the associated photographs (Figures 37-39) that eleven years after restoration, the site is still vegetated with only approximately 40% turtle grass, similar to what was present prior to pipeline installation (15 of 38 stations; Figures 37 and 38). The rapid growth of planted *Halodule* observed by Derrenbacker and Lewis (1983) has stalled at an intermediate stage of succession and full recovery can be expected only after another ten years, and then probably only in the moderate to moderate and silty areas (Figure 35). It is also apparent that some continued disturbance of the area is occurring with seagrasses being "blown-out", probably by wave runners known to use the area (Figure 38A). The failure to completely restore the original level of sediment over the rocky substrate encountered during construction will probably limit the degree of final recovery in these areas of sparse to dense *Halodule* with sparse *Thalassia*, if present at all. This may mean that the area could be a candidate for backfilling with additional sediment and seagrass from impacts associated with the widening of U.S. Highway 1 in the area where approximately 10 acres of *Thalassia* are to be destroyed by excavation or filling.

Figure 37A. Lake Surprise, transect 1, 4-5 m from shore, November 1993.
